NTSB File No.: WPR13FA244

Aircraft: Beechcraft A36, Bonanza

Propeller Teardown Report**Date of Investigation:** August 28, 2013**Location:** Piqua, Oh**Propeller Model:** PHC-C3YF-1R with 8468-6 blades**Representatives:** Daniel Boggs, Hartzell Propeller Inc.
Chris Richards, FAA**General Comments:**

Aircraft Accident/Incident Report No: 130528

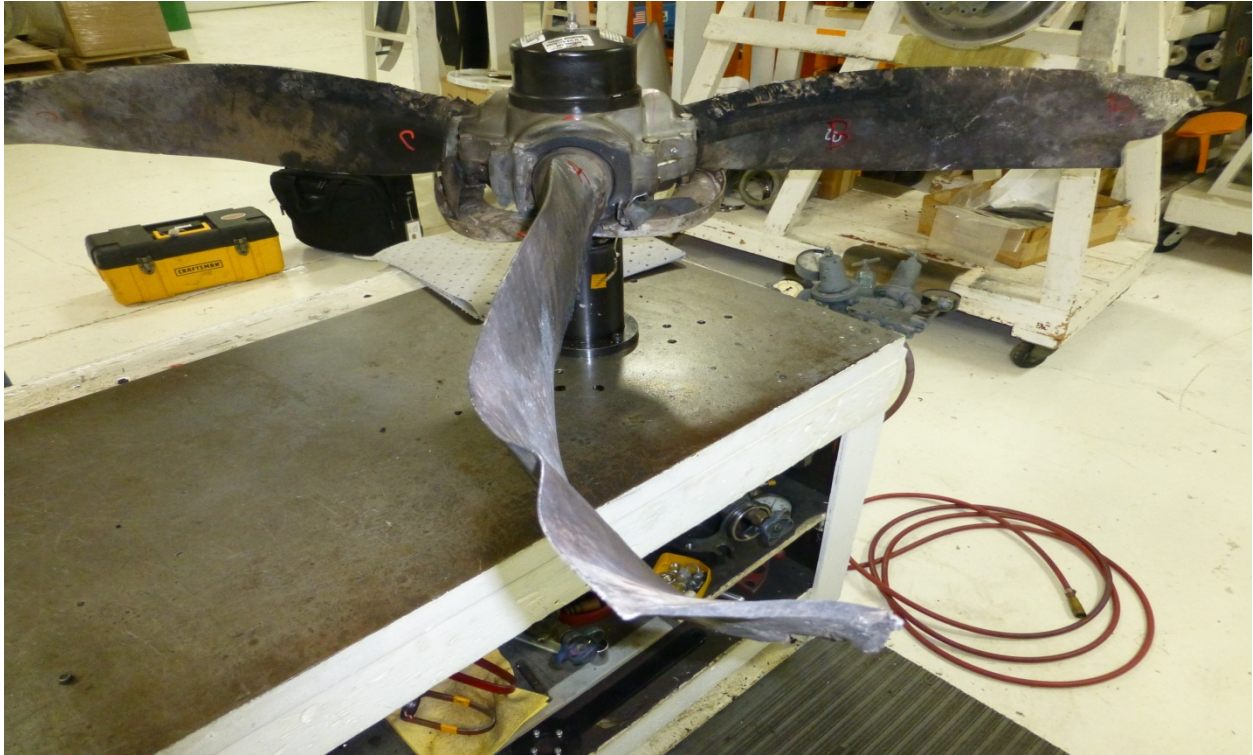
The propeller experienced some moderate thermal damage. "A" blade was spun 180 degrees when received. B-C blades were in extreme high blade angle. All three blades were moving independently of each other in the hub. A-B blades have the last 10" of the tips missing. Rotational scoring was noted on all blades.

Photo #1, Propeller as received.

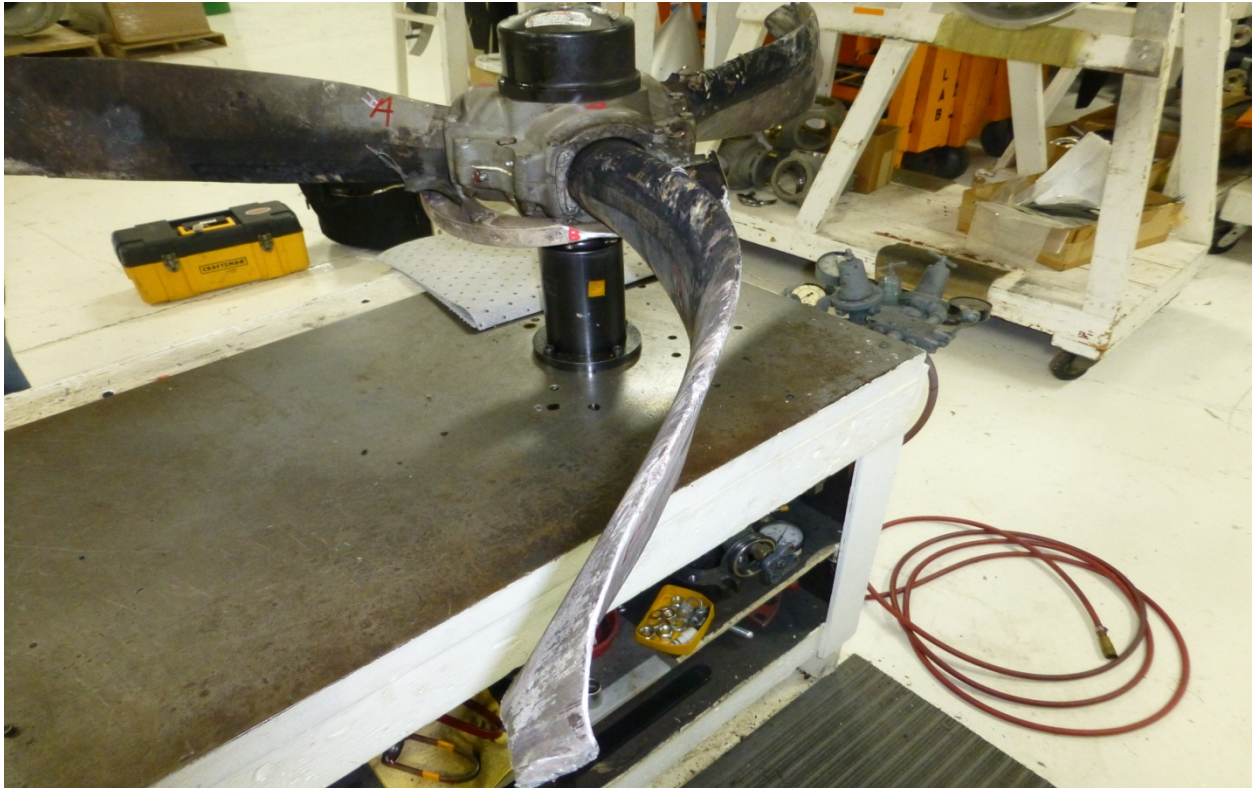
The spinner bulkhead was intact, however fractured in a couple areas and bent all around the circumference.

Photo #2, Propeller as received.

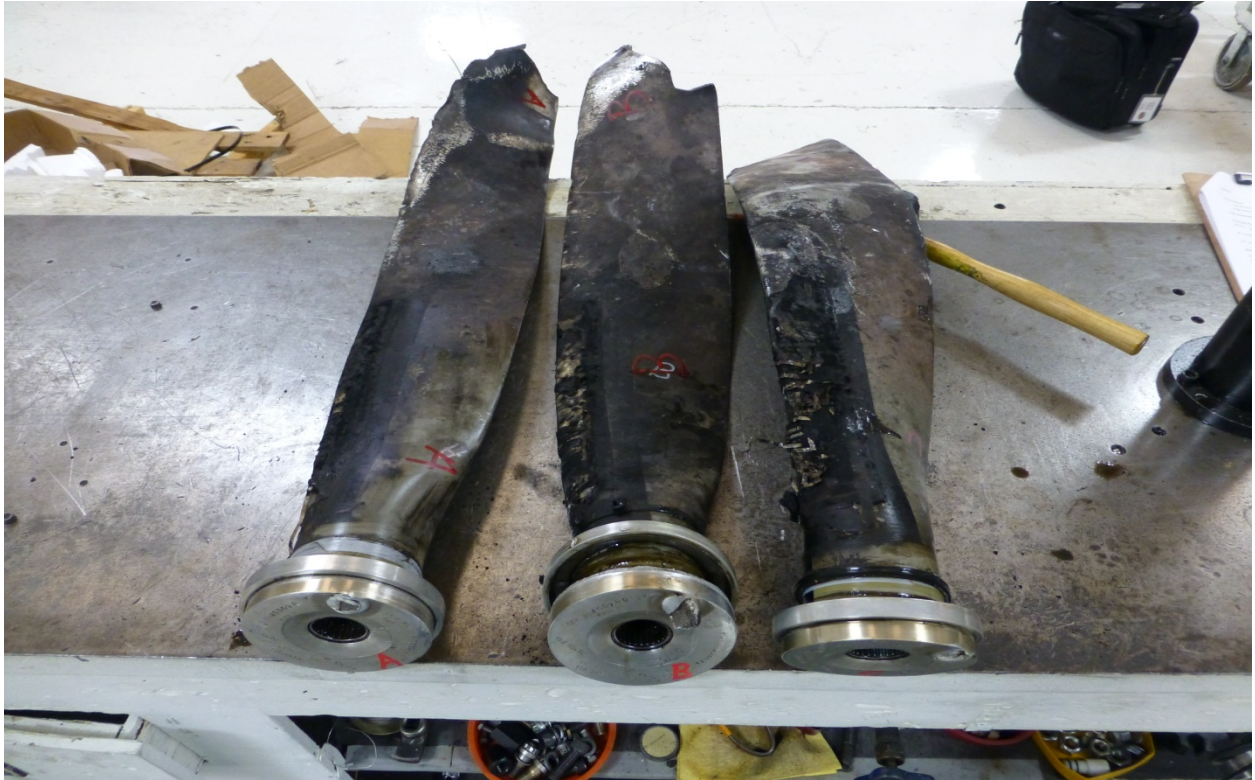
paint, camber side	-	missing, thermally damaged.
paint, flat side	-	missing, thermally damaged.
bend	-	slight bend forward on last ¼ of blade.
twist	-	slight twist towards tip, forward.
lead edge damage	-	nicks and gouges, tip missing.
trail edge damage	-	bends, tip missing.
knob condition	-	fractured.

paint, camber side	-	missing, thermally damaged.
paint, flat side	-	missing, thermally damaged.
bend	-	slight bend forward at midblade.
twist	-	none.
lead edge damage	-	nicks and gouges, tip missing.
trail edge damage	-	nicks and gouges, tip missing.
knob condition	-	fractured.

Photo #3, Propeller blades.

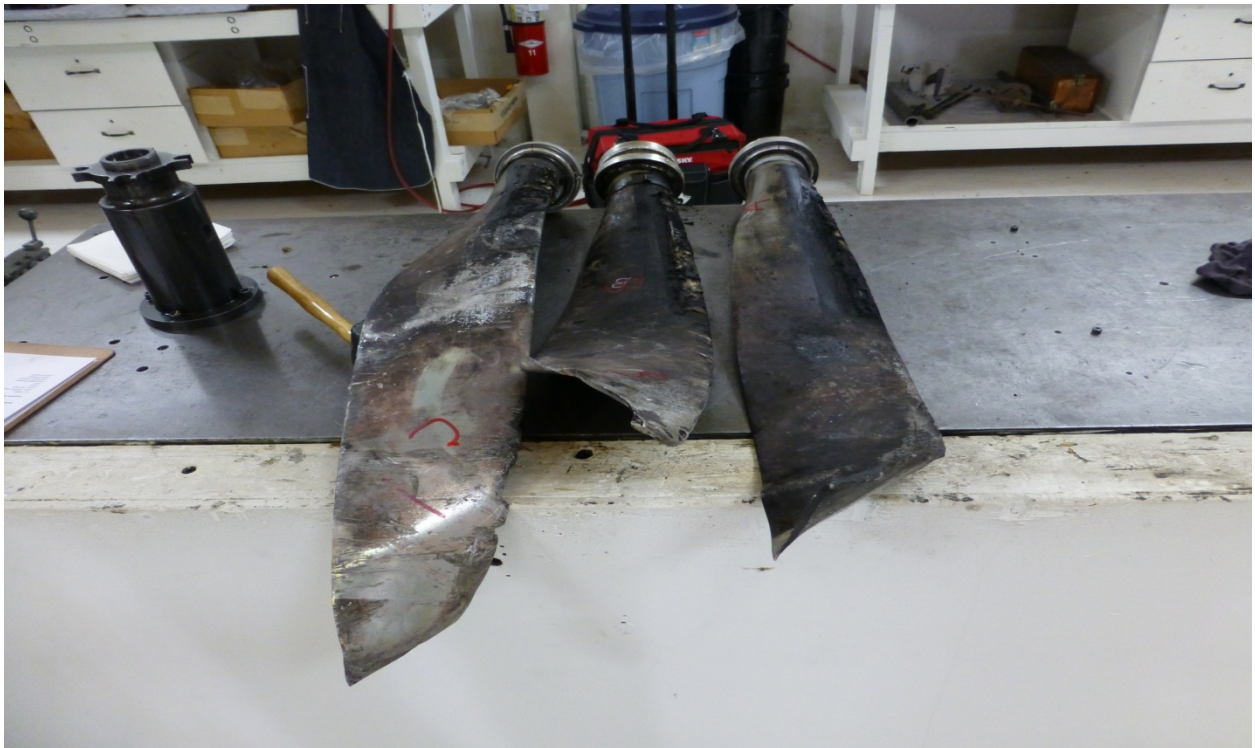
paint, camber side	-	missing, thermally damaged.
paint, flat side	-	missing, thermally damaged.
bend	-	bent aft at midblade.
twist	-	slight twist aft from leading edge.
lead edge damage	-	nicks and gouges, tip curled under.
trail edge damage	-	nicks and gouges, tip curled under.
knob condition	-	fractured.

Photo #4, Propeller blades.
