**Aircraft Accident/Incident Report No.: 110308**

NTSB File No.: ERA11FA183

Aircraft: DeHavilland DHC-6-100 Twin Otter  
Registration No.: N157KM  
Serial No.: 057

Aircraft Accident/Incident Report No.: 110308**PROPELLER TEARDOWN REPORT****Date of Investigation:** March 10 & 11, 2011**Location:** Atlanta Air Recovery  
Griffin, GA**Propeller Model:** HC-B3TN-3 with T10173B+1 blades**Representatives:** Tom McCreary      Hartzell Propeller Inc.  
Luke Schiada      NTSB.  
Tom Berthe      Pratt & Whitney**General Comments:**

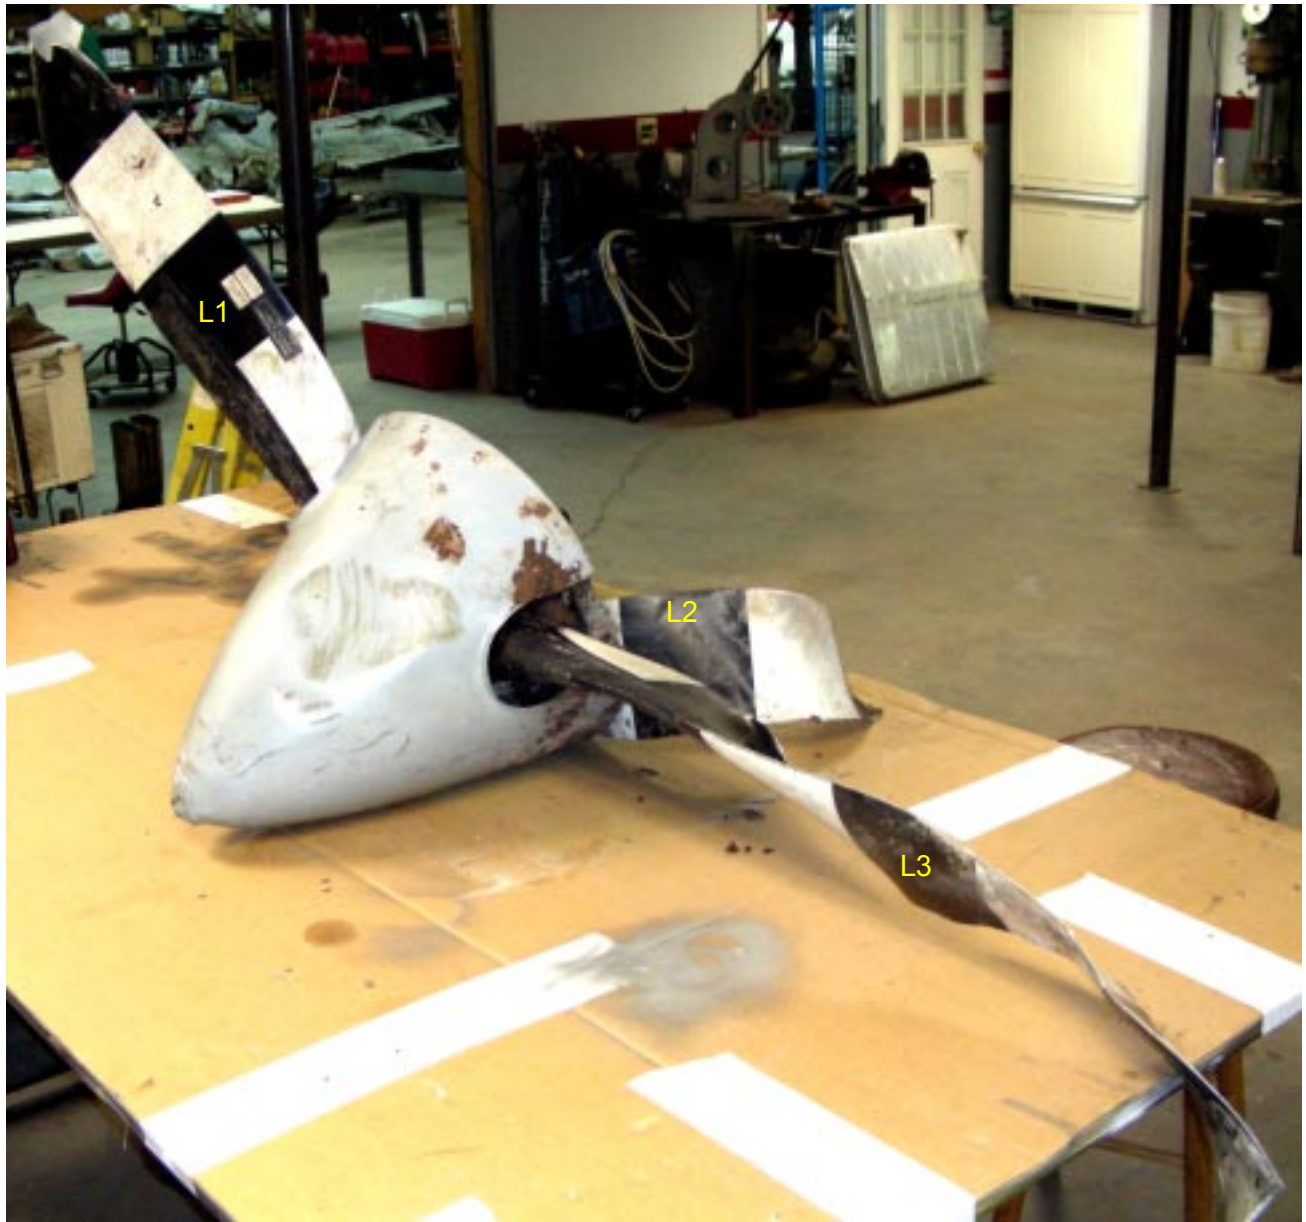
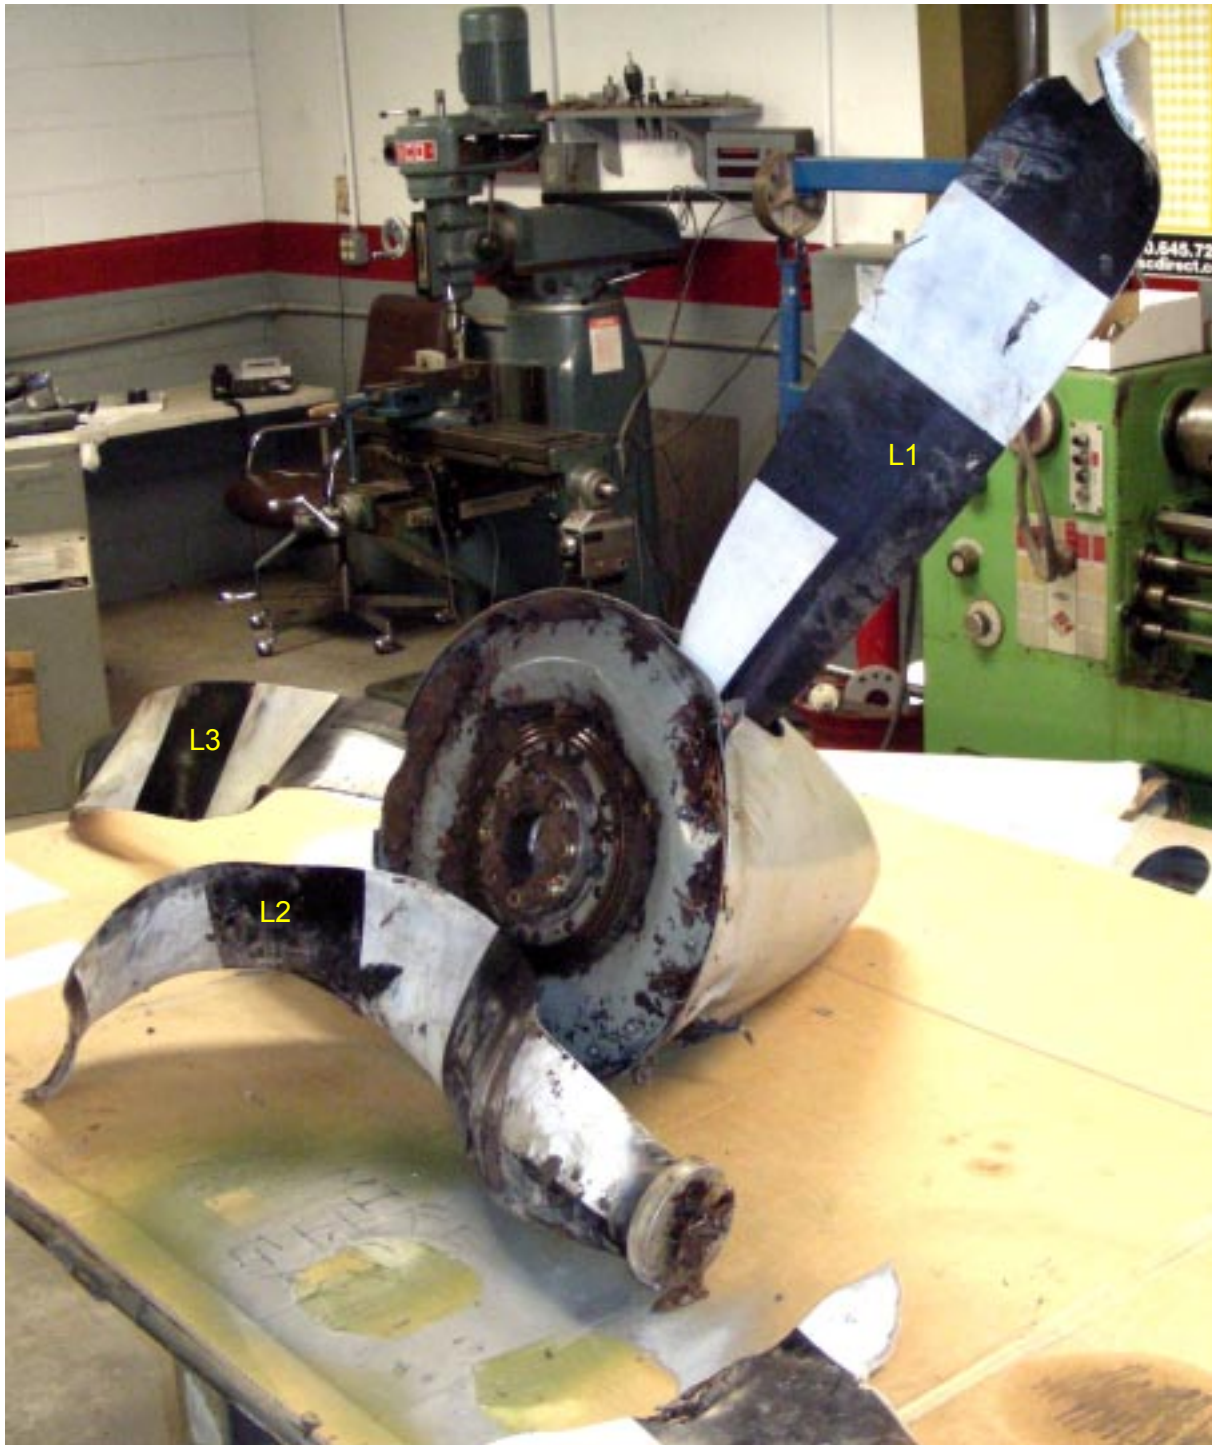
The spinner dome had not been removed. The propeller had separated from the engine due to a fractured engine shaft. L1 blade was disconnected due to link screw separation; the blade could be manually turned. L2 blade had separated from its clamp. L3 blade remained connected to its linkage and was at a high blade angle.

The beta feedback collar had separated and was missing. The tips of all three blades were torn off, only one of the blade tips was recovered.

The piston/cylinder assembly had separated from the hub at the cylinder/hub attachment threads. The piston was in the feather position with respect to the cylinder (due to lost oil pressure and feather spring force).

The engine flange and mounting bolts were intact. The engine shaft was fractured just aft of the propeller mounting flange.

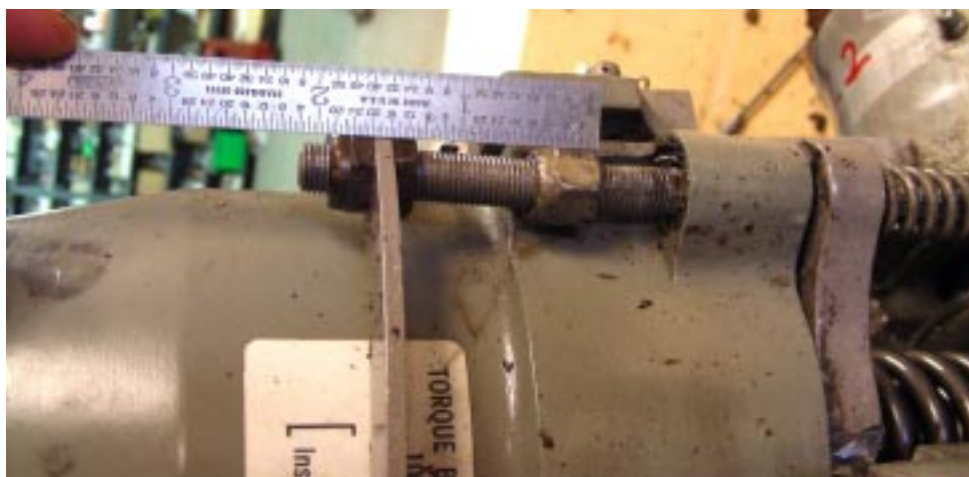
Photo 3. Left Flight Idle Stop Nut

The position of the flight idle stop nuts was measured and found to be 2-3/32 inches from the outer end of the beta rod on all three blades. The beta feedback collar was missing and all three beta rods were disconnected.

**Beta rods:** All three beta rods were loose and had separated from the feedback collar (which was missing). All three beta rods were mildly bent. The flight idle stop nuts (3) were measures to be 2-3/32 inches from the outer end of the beta rods.

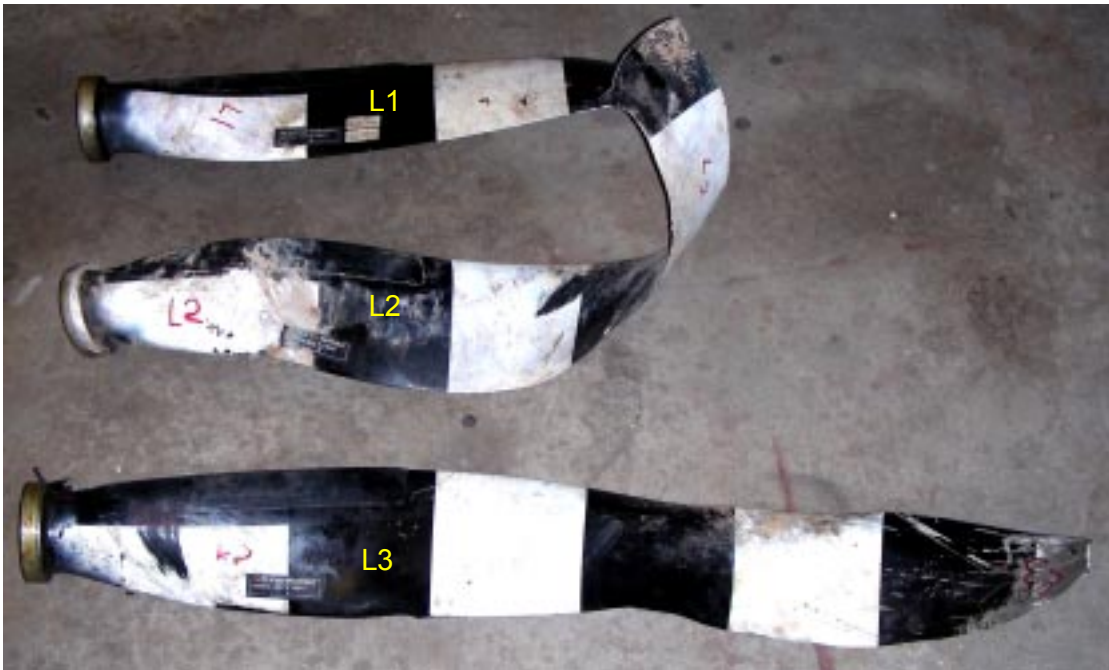
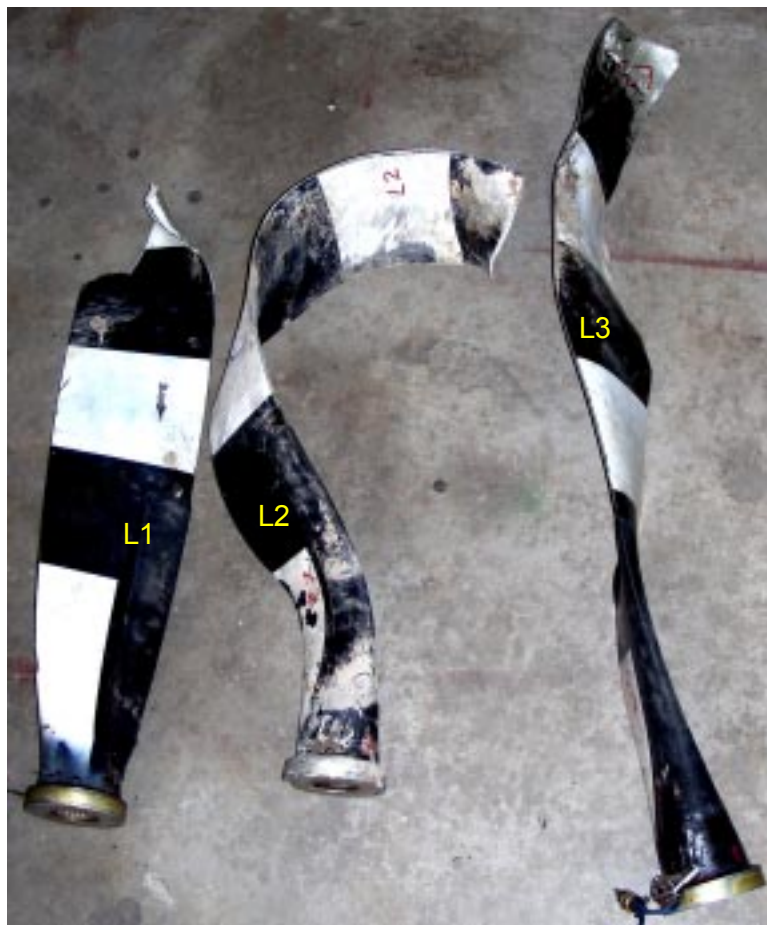
Blade L1 was fractured diagonally across the blade chord approximately 12 inches from the tip. The leading edge was bent aft and twisted toward lower pitch in the area of the fracture. The fractured portion had multiple bends with two harsh impacts on the leading edge.

Blade L2 had separated from its clamp. Its retention shoulder was rounded/deformed. The blade was bent aft approximately 30° at 1/4 radius. The outer 2/3 of the blade had a large radius bend, greater than 90°. The tip was curled aft and torn off approximately 9 inches from the tip. The fractured portion was not recovered.

Blade L3 had multiple wavy bends with several bends along the trailing edge. Overall, it was slightly bent forward. The outer 3 inches of the tip was torn off and missing.

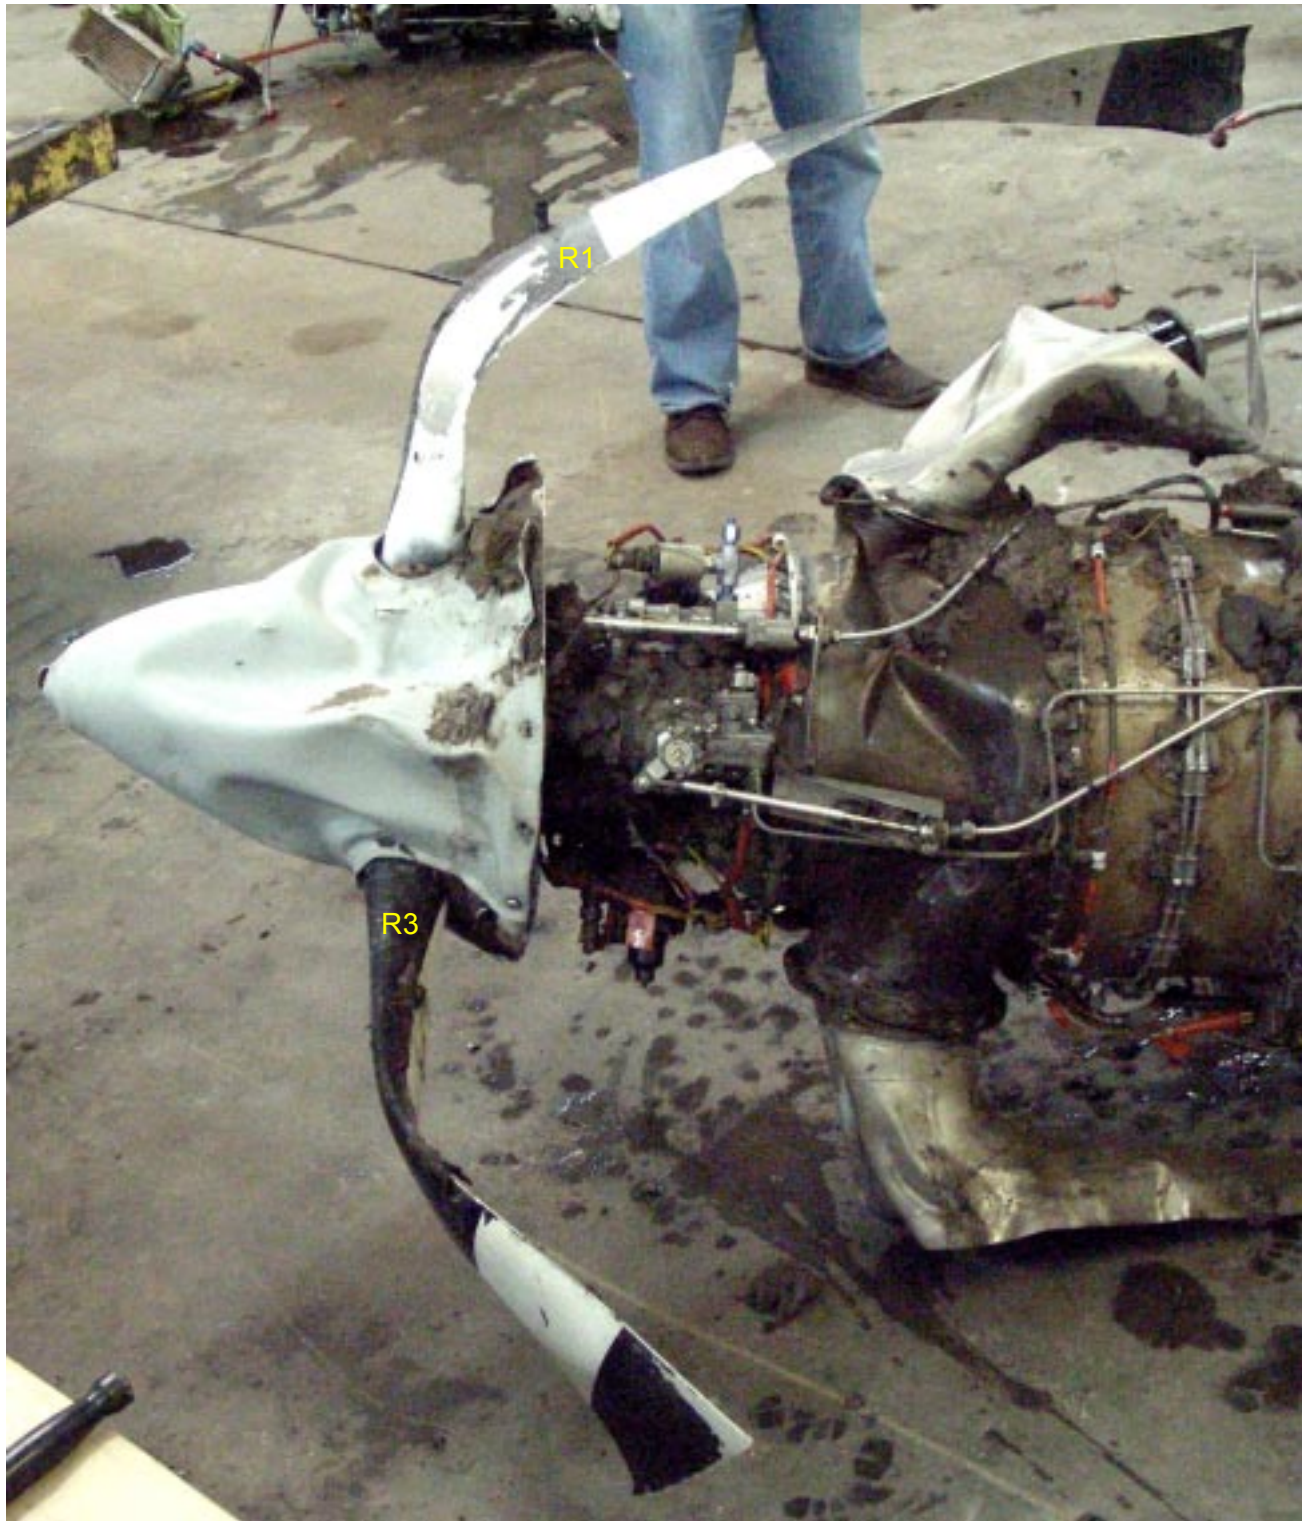
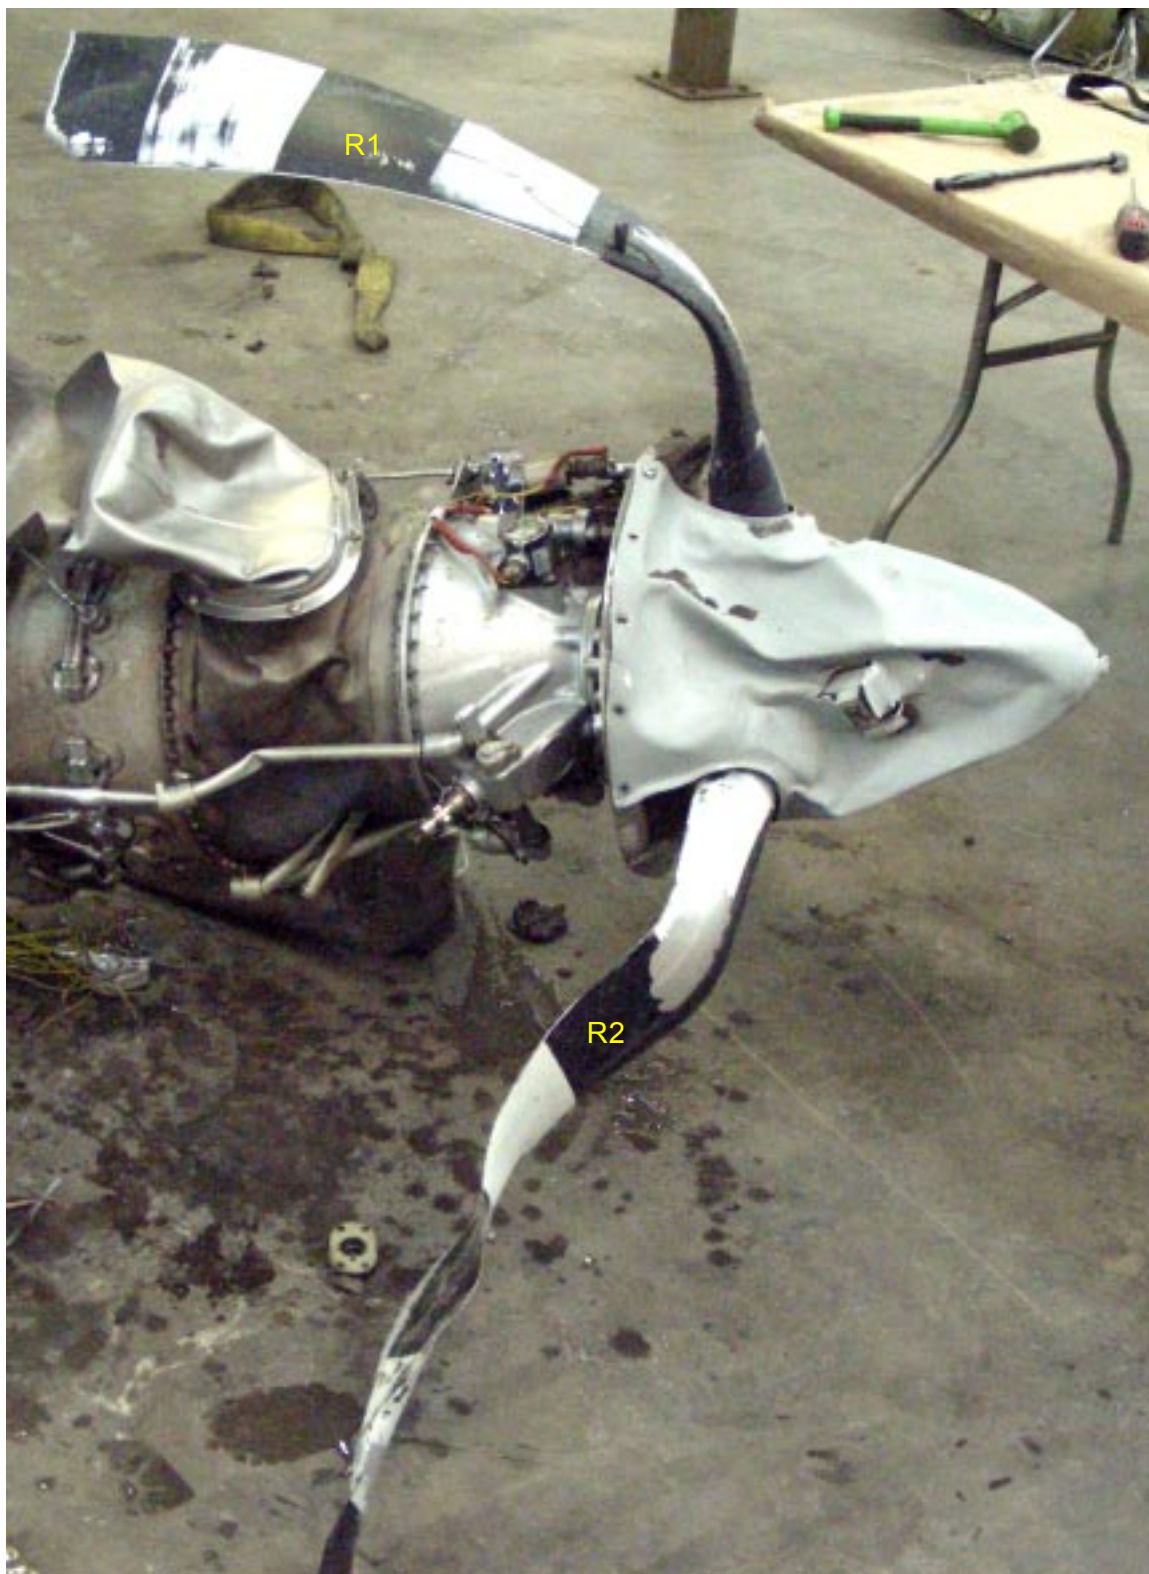
The spinner dome had not been removed and the propeller remained attached to the engine. One blade counterweight was protruding through the spinner dome; the blade/counterweight was in a reverse pitch position.

The pitch change mechanism was jammed in a reverse pitch position. The feather spring and two link arms had to be disconnected and the mechanism actuated to the feather position in order to facilitate removal from the engine.

Each of the three blades had a portion of the tip torn off; all three tips were missing.

The spinner dome was significantly crushed and had to be cut apart to facilitate removal

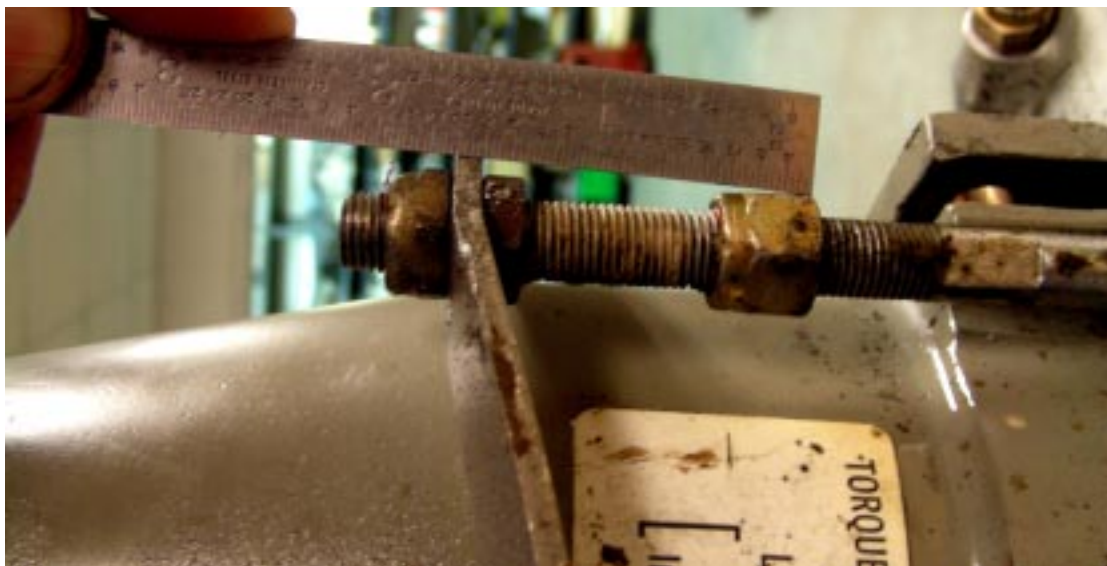
Photo 8. Right Flight Idle Stop Nut

The position of the flight idle stop nuts (all 3) was measured to be 2-3/32 inches from the end of the beta rods (which is the same position as the Left propeller).

**Beta Rods:** The beta rods and beta mechanism was intact and unremarkable. The flight idle stop nuts (3) were measures to be 2-3/32 inches from the outer end of the beta rods.

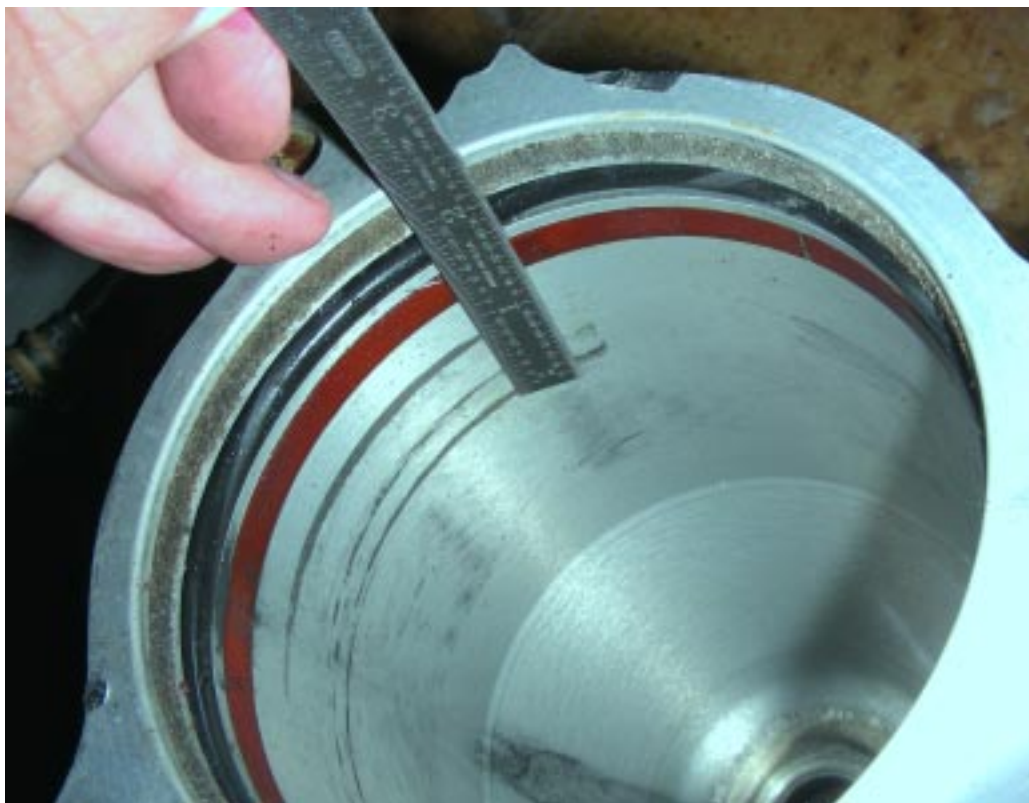
Impact marks on the right propeller piston indicated that the propeller blade angle was at 18 degrees or higher prior to impact. Otherwise, there were no blade angle witness marks to suggest a pre-impact blade angle.

The piston had multiple impact marks caused by contact with the forward end of the cylinder. The mark at the highest blade angle position was 2-9/32 inches from the aft end of the piston. This equates to approximately 18 degrees blade angle.

The aft end of the piston was 2/32 inch from the guide collar with the piston in the feather position.

Photo 9. Right Cylinder Impact Marks on Piston

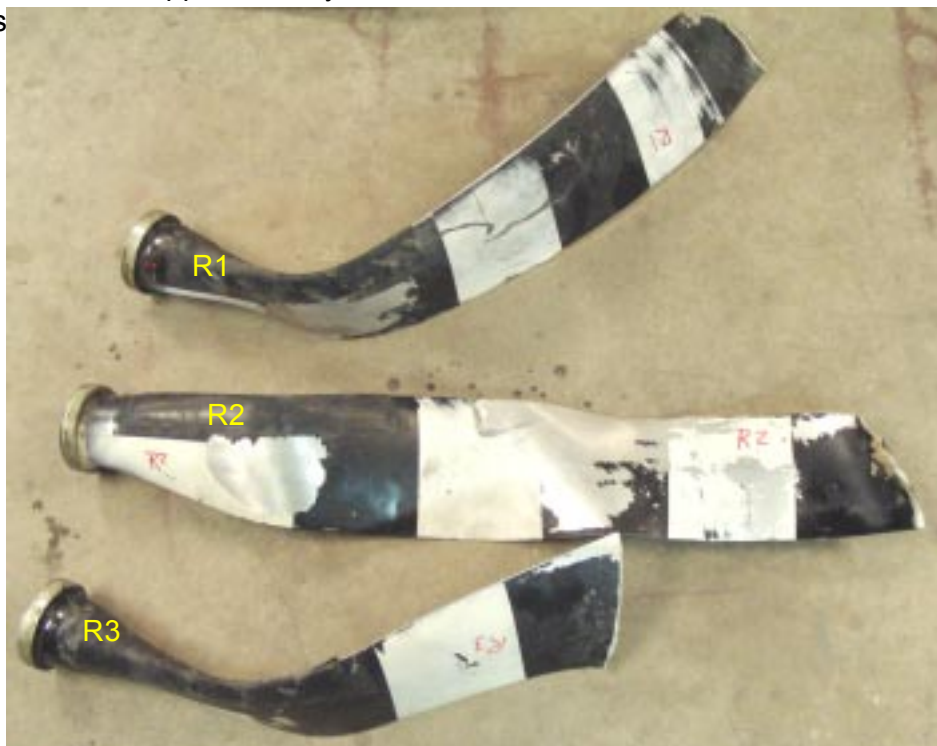
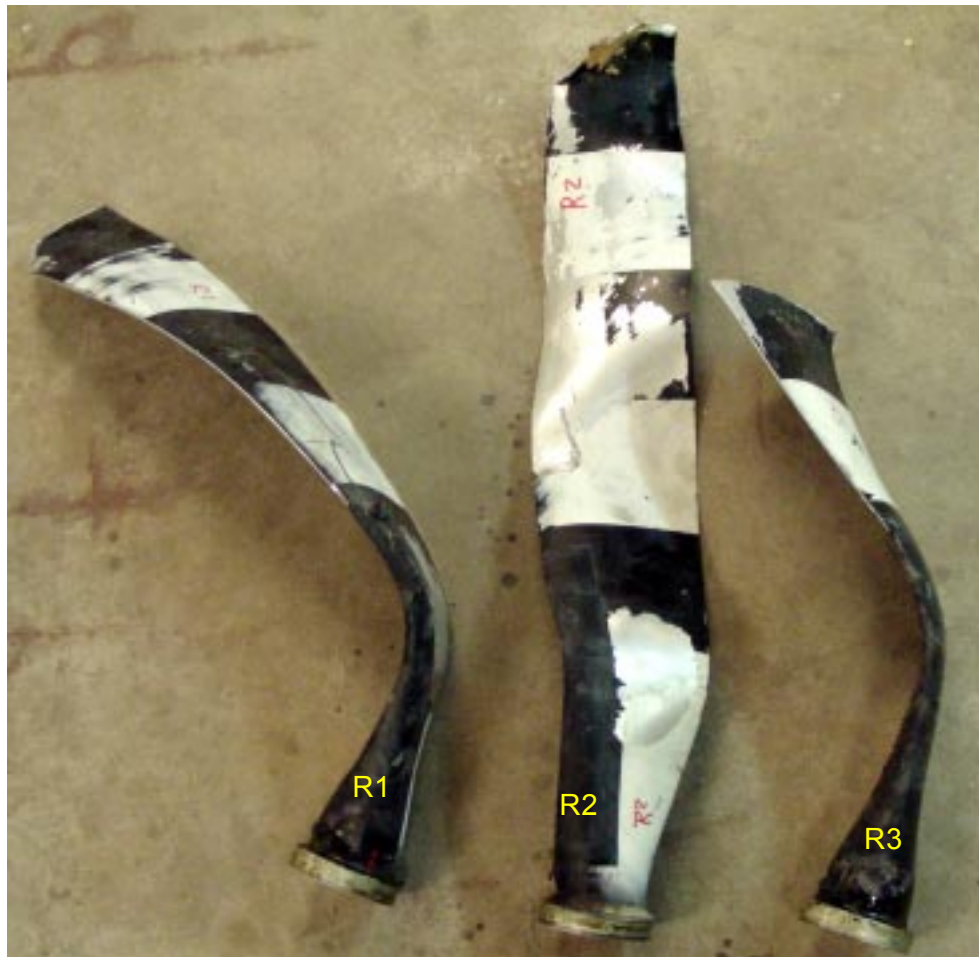
Blade R1 was bent aft approximately 70° at 1/4 radius. It had rotational scoring in the paint on the camber side. The outer 7 inches of the tip was torn off and missing. The leading edge of the blade was twisted toward low pitch near the fracture.

Blade R2 was bent aft approximately 20° at 1/4 radius. The outer 6 inches of the tip was torn off and missing. The blade was bent forward and twisted toward higher pitch near the fracture. The blade had multiple fore and aft bends and the trailing edge had wavy bends on the outer 1/2 of the blade.

Blade R3 was bent aft approximately 30° at 1/4 radius. The outer 18 inches of the tip was torn off and miss

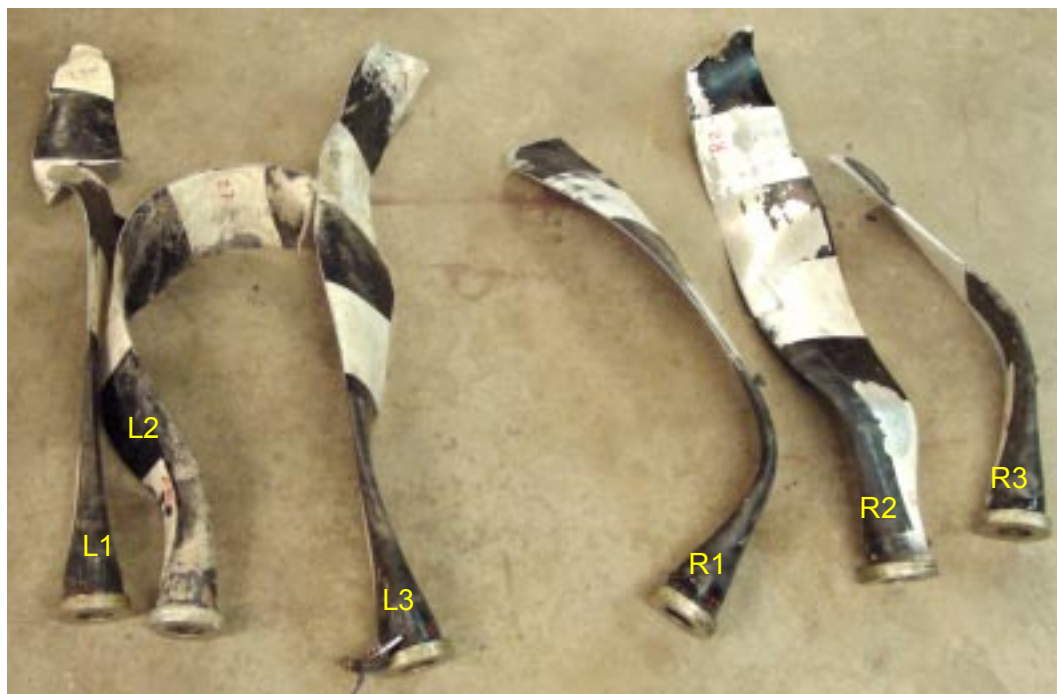
The blades of both propellers had remarkably similar damage. All six blade tips were torn off. Blades from both propellers had a similar amount of bending and twisting. This indicates that they were being operated at similar power at the time of impact. Such blade damage is characteristic of being operated at moderate or high power. Assessment of power output is made solely from observation of the blade damage.

Photo 12. All Six Propeller Blades
