NTSB File No. CEN18LA363

Turbocharger System Component Exam Notes

Aircraft: Cessna P210N, N210PF

Engine: Continental TN-550-P (S/N: 1009768) Vitatoe Aviation STC SA02918CH

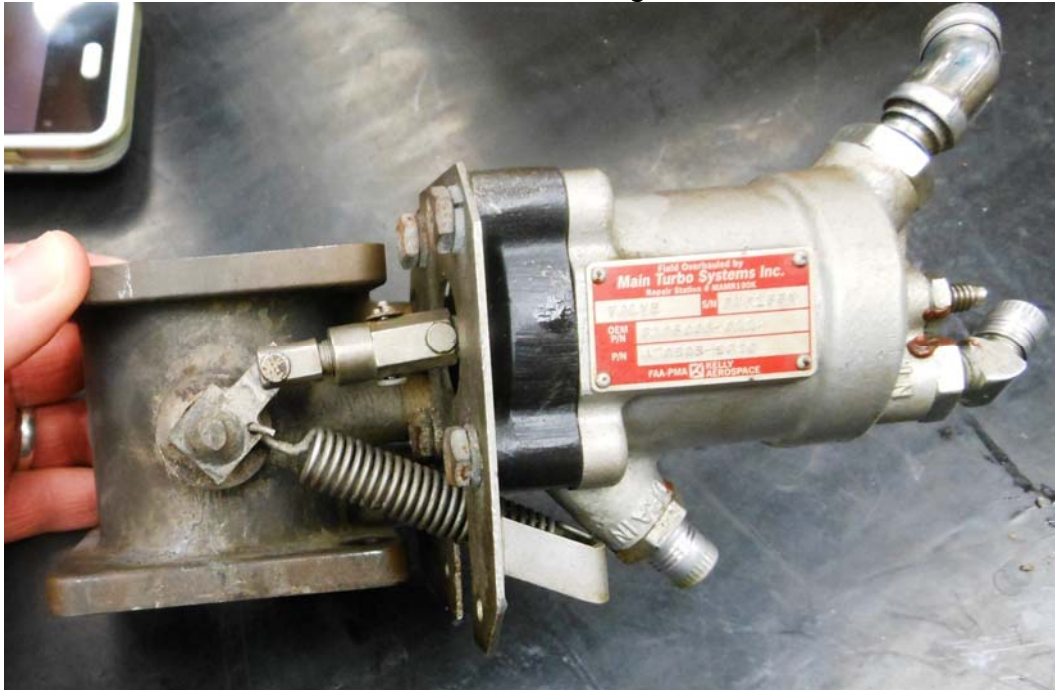
Photo #1 – Wastegate

The turbocharger controller and wastegate were removed from the engine after the engine examination and test run at Continental Aerospace Technologies in Mobile, AL. They were shipped to HET in Montgomery, AL and presented for examination in the conditions shown in Photos #1 and #2. The Pressure Relief Valve was removed from the accident engine by JD Aviation in Crete, NE on approximately April 17, 2019 and shipped to HET in the condition as shown in Photo #3. The PRV was still attached to a segment of the upper deck ducting along with a hose coupling, clamps and a metal braided hose. The upper deck ducting had a small dent along one edge/sealing bead as shown in the lower portion of Photo #3.

All three turbocharger system components were in good condition considering time in service. The PRV had some minor chaffing on top of the cover due to contact with what appeared to be braided hose marks. All three components had red, field overhaul data plates indicating the last service was performed by Main Turbo Systems Inc.

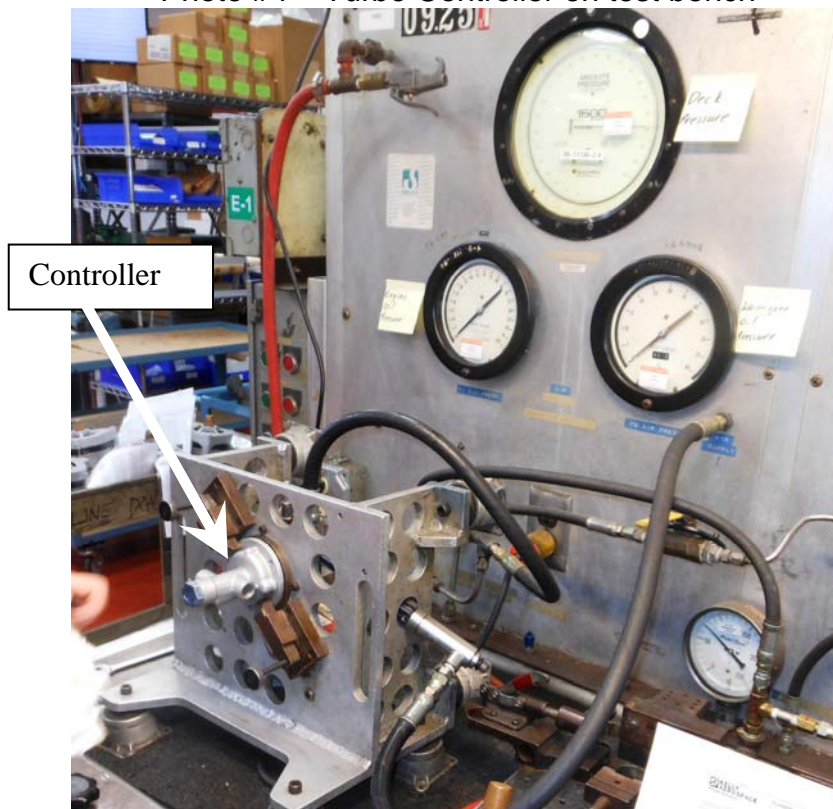
Photo #4 – Turbo Controller on test bench

The cover was removed and the controller was mounted to a test bench at HET as shown in Photo #4. The controller regulation test consisted of determining the as-received actuation pressure. The factory specification for the 470688-8 controller that is used on the TSIO-520-P engine in the P210N is 38.5" Hg deck pressure with a corresponding maximum manifold pressure of 36.5", for an approximate 2" drop across the throttle valve. The Vitatoe Aviation STC for the TN-550-P requires adjusting the controller setting until an actuation pressure that results in a maximum manifold

pressure of 31" Hg is obtained. The deck actuation pressure for the tested controller was measured to be approximately 33.2" Hg, which is consistent with an approximate 2" drop across the throttle valve. The hysteresis checks determined hysteresis to be within factory specification of +/-0.2" Hg. The controller also passed the Stroke Test and Case Leakage Test requirements.

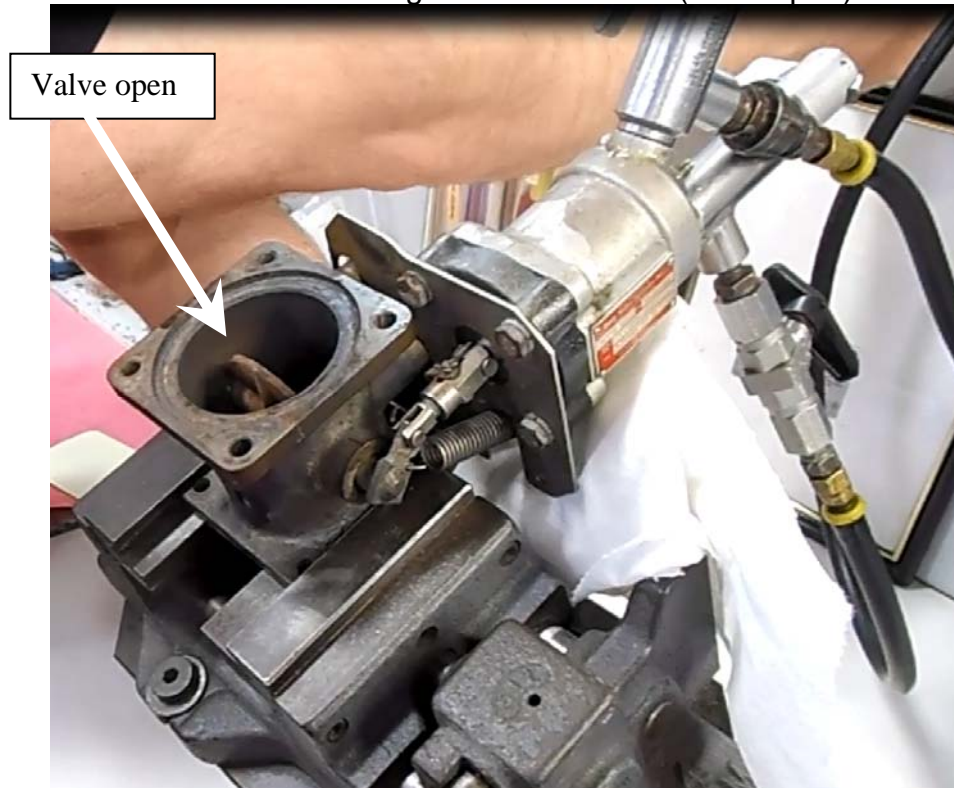
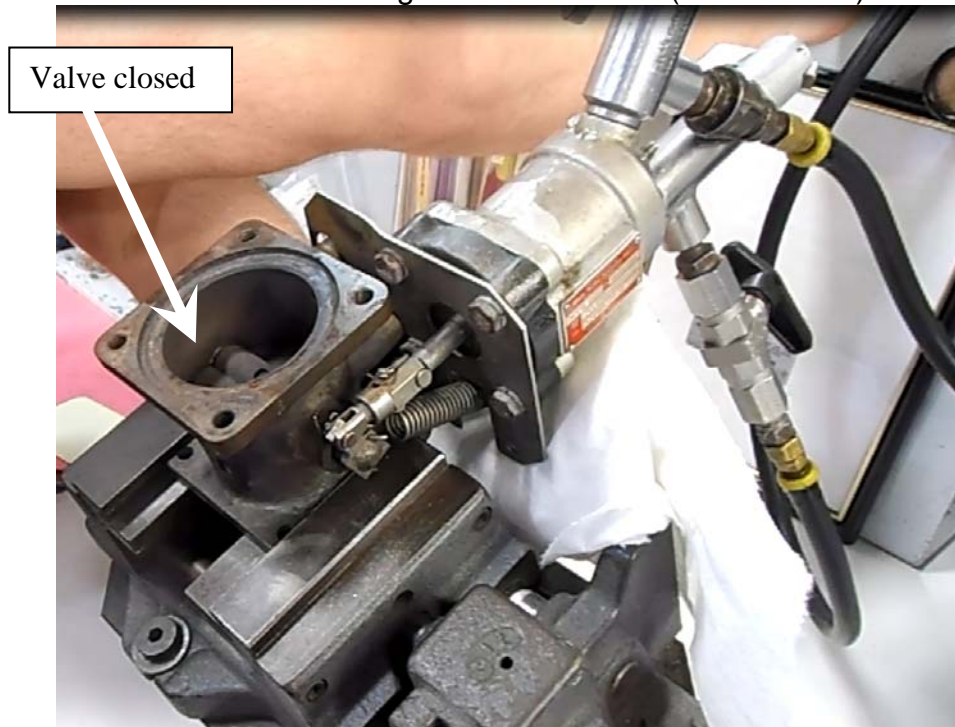
The engine specific fittings were removed from the wastegate actuator and the wastegate assembly was mounted to a test bench at HET as shown in Photos #5 and #6. The wastegate was subjected to functional tests specified in the Overhaul Manual 400999-0000.

The wastegate actuator passed the leak tests and the butterfly valve open and closed position checks were performed. The closed position was visually verified and the open position was checked with a go/no-go gage. The wastegate was cycled several times with smooth actuator and valve movement noted, no binding or "stickiness." The capillary check was deemed unnecessary and thus not performed.

Photo #5 –Wastegate on test bench (valve open)

Photo #6 –Wastegate on test bench (valve closed)

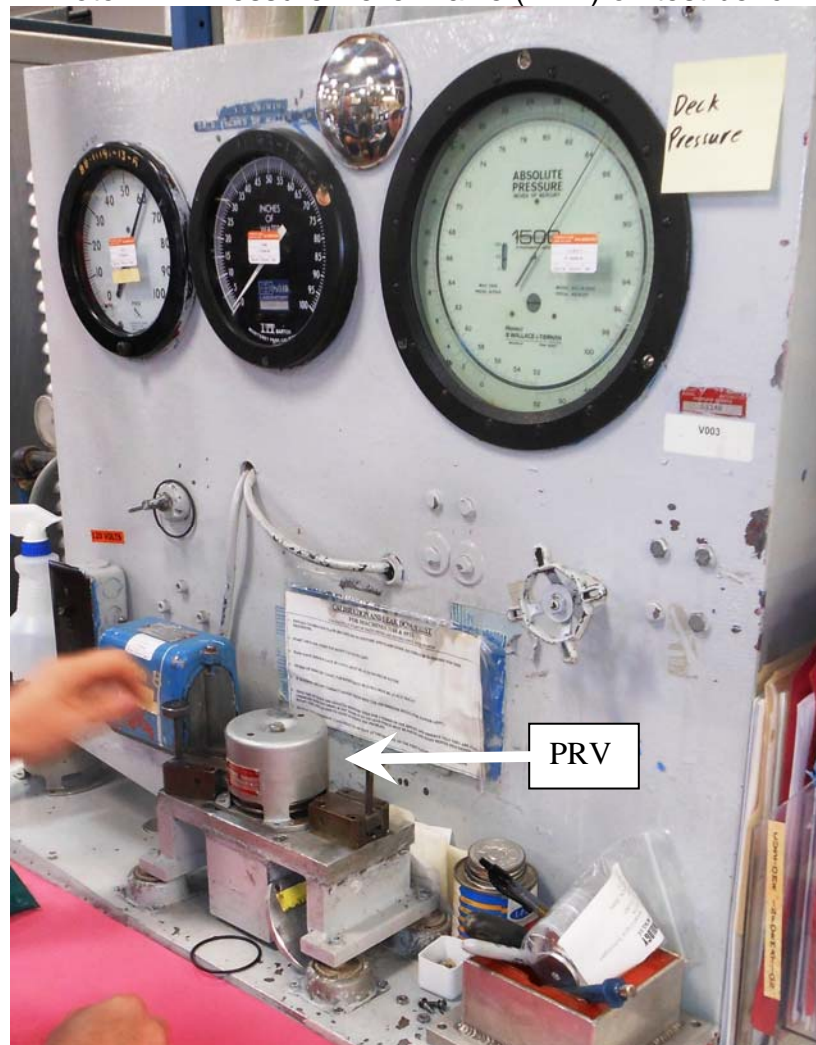
Photo #7 – Pressure Relief Valve (PRV) on test bench

The PRV was removed from the engine duct and subjected to the factory test procedures defined in Process Instruction PI-477350. Before installation on the test bench a hand/finger force check of the valve head movement confirmed the bellows was still functional. The PRV was mounted to a test bench as shown in Photo #7. The PRV passed the Seat Leakage test and Hysteresis test and Regulation Pressure was determined to be approximately 34.75" Hg vs. a requirement of 34.4 +/-0.25" Hg.

The turbocharger controller, wastegate and PRV exhibited normal operation with no discrepancies noted that would prevent or degrade operation. The PRV regulation pressure was determined to be approximately 0.1" Hg higher than maximum specification but that would not affect normal turbocharger system operation.
