Model Communiqué

Executive Series

Communiqué No. 116
June, 2008

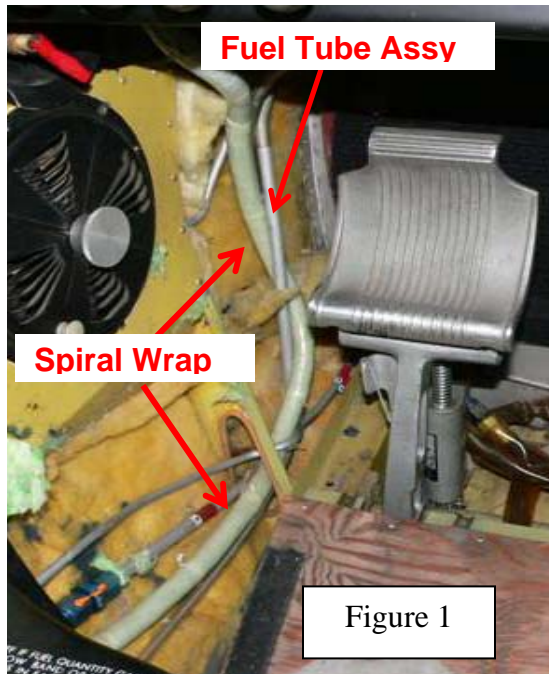
Figure 1

HBC has received reports of wiring and wire bundles chafing on the airplane structure and other components. Chafing can lead to failed components, inadvertent operation of equipment and the potential for smoke and fire. In one case, electrical wire bundle chafing in a Bonanza resulted in a small hole in the fuel tube assembly that runs along the pilot's kick panel (Ref. Figures 1 and 2). During a maintenance ground run to troubleshoot the related flap system malfunction, an electrical short-circuit in one of the flap wires ignited the fuel coming from the pin hole resulting in a cockpit fire. The airplane was on the ground and the fire was quickly extinguished. Upon investigation it was noted that the wire bundle was "open" in this area with no mechanical protection and that wires had been added to the bundle to support post-delivery modifications. The factory configuration requires wire bundle protection adjacent to the fuel tube assembly by use of nylon spiral wrap on earlier airplanes (Figure 1) or continuous Varglas sleeving (Figure 2) on later airplanes.

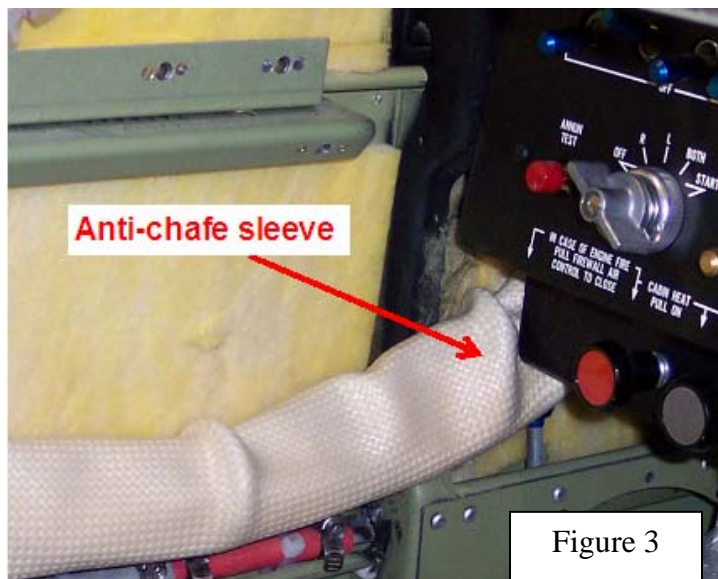
Figure 3

HBC has received Bonanza Model 36 wire chafing reports from three main areas; under the instrument panel (Figure 3), in the engine compartment next to the battery box (Figure 4) and wiring routed close to fluid tubes. The area under and forward of the instrument panel not only has the greatest concentration of wiring but also has moving components that can damage improperly secured wiring in a very short period of time. The wiring around the battery box is routed with sharp bends close to structural components. There are multiple locations throughout the airplane where wiring and wire bundles are in close proximity to fluid lines where proper security and protection are important to minimize the potential for chafing damage.

The preceding photographs are specific to Bonanza Model 36 airplanes, but protection of electrical wires from chafing damage applies to all Beechcraft Models. Any time maintenance is performed in areas with wiring, maintenance technicians should be aware of how maintenance activities may affect the routing and protection of electrical wires. After maintenance is performed in any area, wiring and wire bundles should be inspected for proper security, clearance and mechanical protection. Particular attention should be given to wiring with sharp bends, close proximity to sharp edges, close to movable components such as flight control systems and landing gear, and close to fluid lines/tubes. Factory-installed conduit, wraps and sleeving used to enclose wire bundles are required for mechanical protection of wiring. Maintenance and inspection personnel are reminded that factory-installed wire bundle protection is important to minimize the likelihood of chafing damage. Factory-enclosed wire bundles should never be left open and unprotected after maintenance.

Periodic inspection of wiring is required at each 100 hour or Annual inspection for proper routing and security. In addition to routine maintenance and inspections, any time wiring is modified, repaired or relocated, it is imperative that it is properly secured and protected from chafing in accordance with guidelines in the applicable Hawker Beechcraft maintenance manual, FAA Advisory Circular AC43.13-1B and AC65-15A.

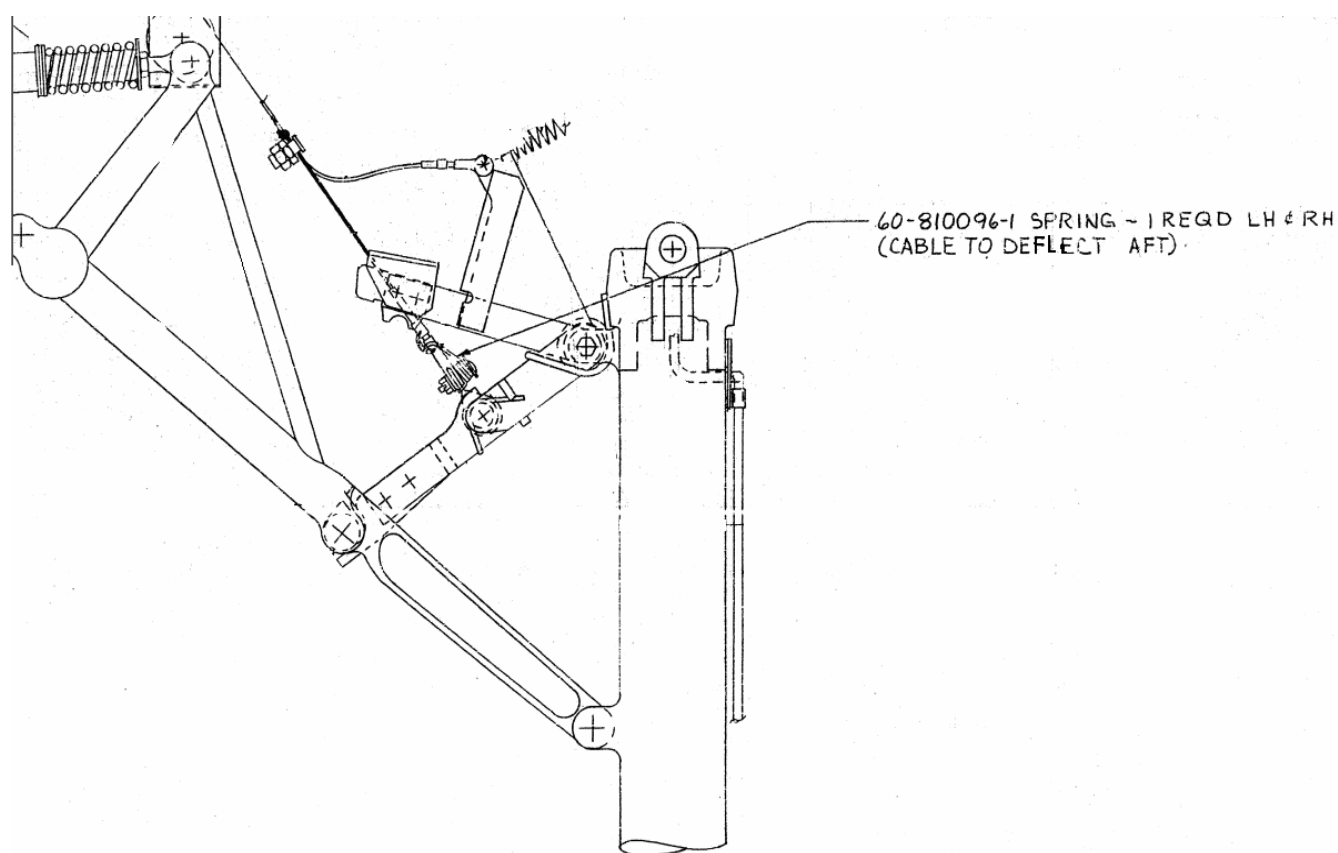
HBC has received a report of a model B60 Duke main landing gear down-lock cable torsion spring, Part Number 60-810096-1 installed incorrectly. When installed correctly, the spring moves the down-lock cable aft and away from the drag brace knee joint and up-lock pivot point when the landing gear is retracted. In the reported case, the spring was installed backwards resulting in the cable being forced into the drag brace knee joint and up-lock pivot point. When the gear was extended, the cable became entangled with the drag brace knee joint and up-lock pivot point preventing the main gear from fully extending. The pilot attempted to extend the

gear using emergency procedures, but was not able to extend the gear to the down and locked position and had to perform a gear-up landing.

The 60-810096-1 spring was factory installed on Duke and Baron Models beginning in 1971 and was provided in Factory Kit 60-8006-1 for earlier Duke Airplanes. Any time this spring is removed during maintenance, care should be taken to ensure it is reinstalled with the proper orientation (deflects the down-lock cable aft). Maintenance personnel are reminded to observe all maintenance manual instructions when servicing retractable landing gear systems. Special attention should be given to the up-lock and down-lock systems to assure proper operation and adequate cable loop clearance from all possible points of hang-up when cycling the landing gear for inspection prior to returning an airplane to service. Not adhering to the noted landing gear system maintenance practices can result in injury to personnel and/or damage to the airplane.
