National Transportation Safety Board Tank Car Damage Assessment Form

4				
Reporting Marks	CBTX 7	41712	Car Location City/State			
Date inspected	Railr	oad	DOT Specification	DOTIII		
Last Contained	A John Wall		Was product released?	YES		
(Indicate One)	Jacket No		Does car contain product	NO		
Car builder	ARI	Stub Sill Design		Built Date	7-2012	
Capacity (GAL)			LD Limit (LB)

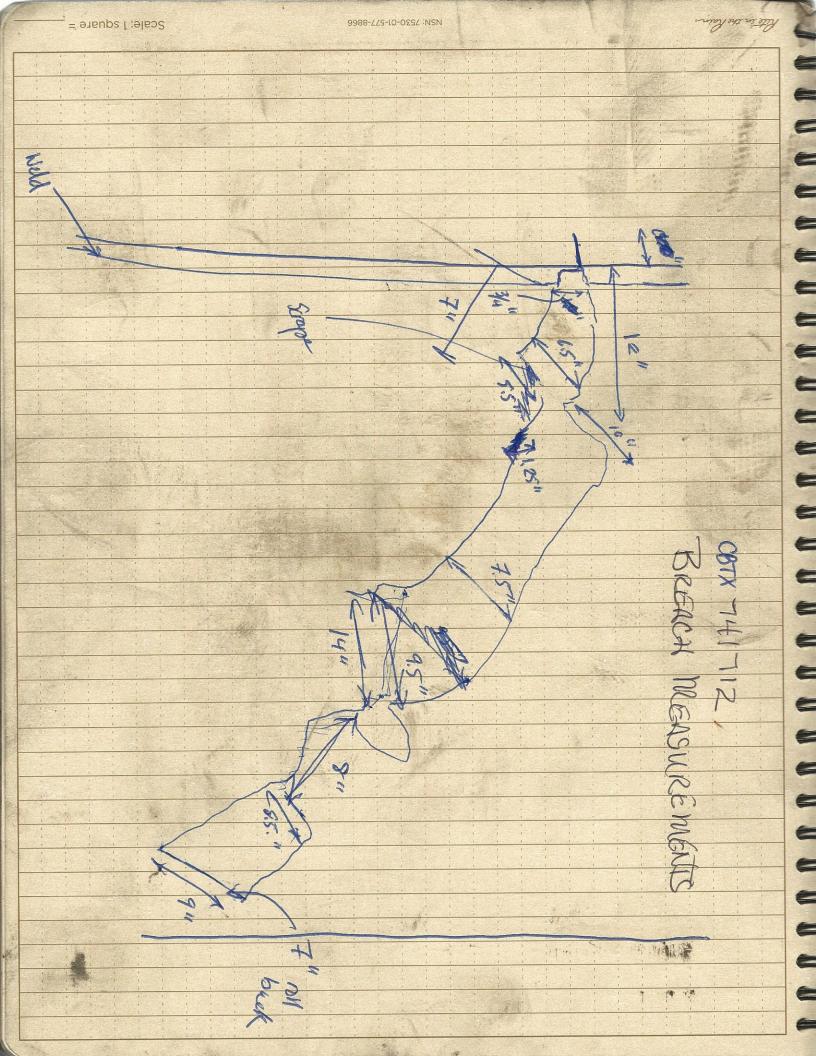
CBTX 7417:12

CBIX 741712 A B LEFT - Side B RIGHT-SIDE TOP 12" x 55" x: 1/2. W. College A. A. BOTTOM

Indicate number on figures below within damaged areas. (sketched in by inspector) Walt Right A-END Top Center Line dup 811 wide A 101" Right Center Line Pain dur OK A B Left Center Line

Inspector's Name dent glant burnt of 26 00 0 Paint OK 23" 1/2 erack toweld Deflection 1/2 1311W-1811n Page 4 of 4

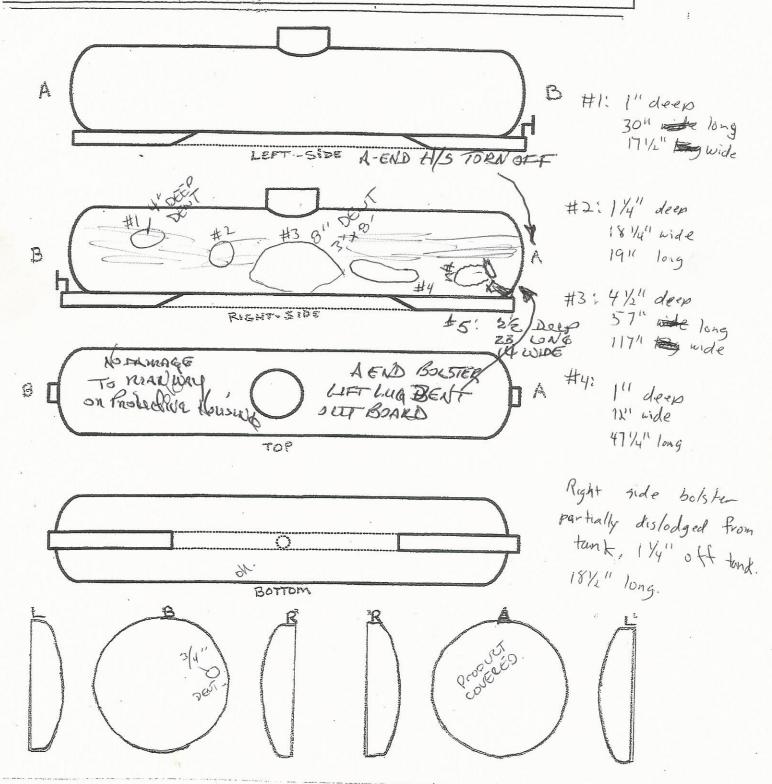
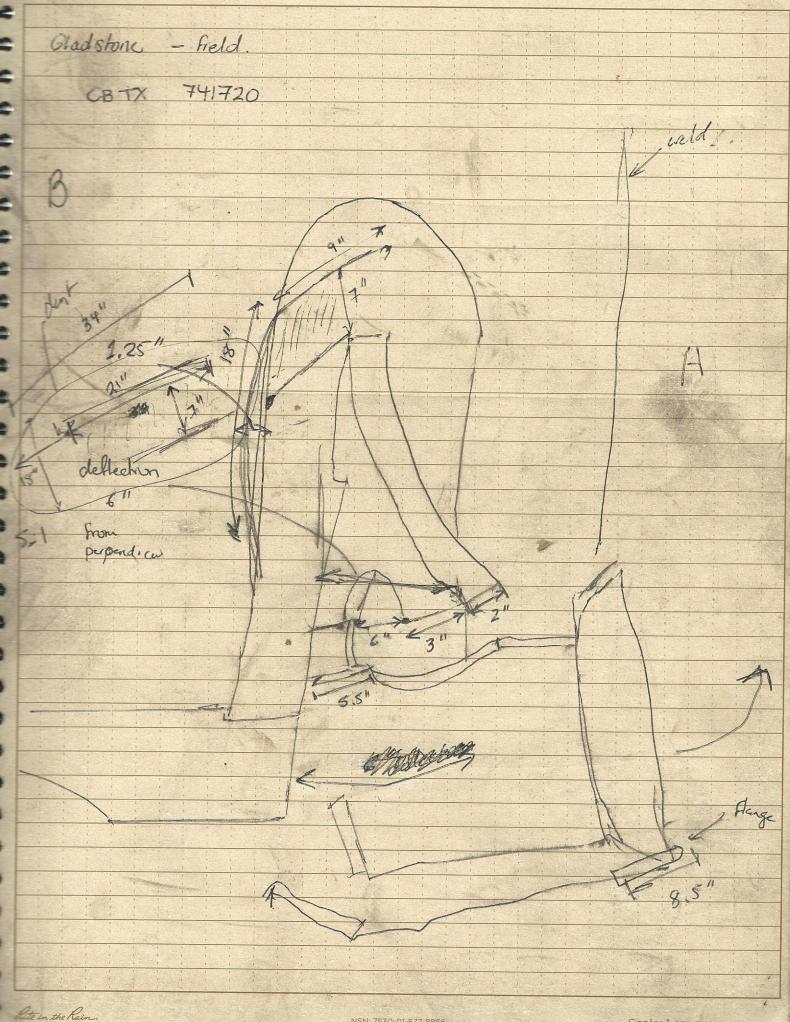
CBTY 741720

Indicate number on figures below within damaged areas. (sketched in by inspector) A-END Top Center Line - Oil mark 11 dep 300 deep 47.85 Left Center Line

Park care land of her box	N.	And his			
		Station Stencil	Qual.	Due	
Mu Mu	Tank Qual.				
The state of the s	Thickness			1420	
	Serv. Equip.				
	PRD	CAME			
9					
\mathbb{C}^n	Lining				
/6 \	Rule 88				
	Stub Sill				
Comments: And Forn head	yd M

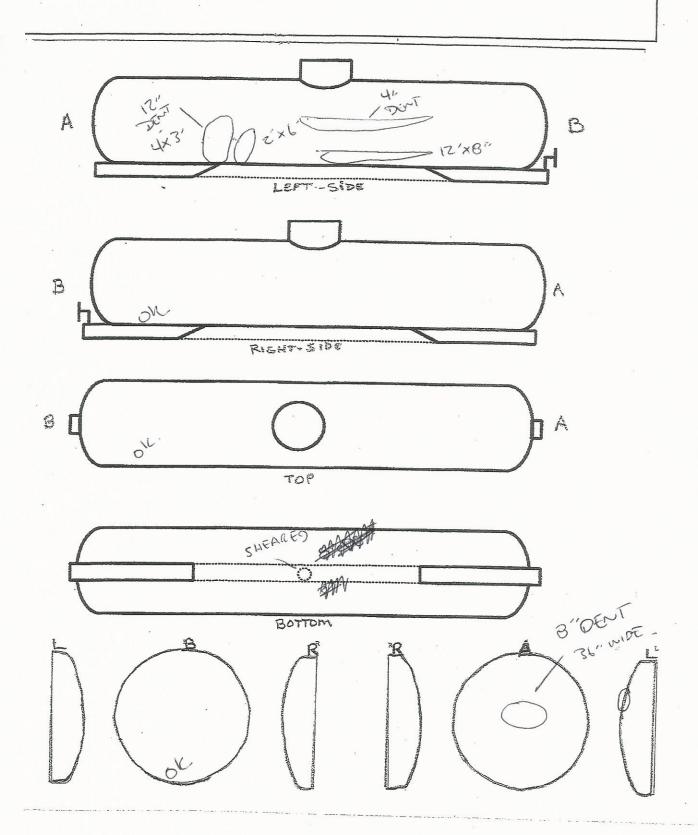
_	Car Ini	tiple ?			
Tanl	Car D	amage Assess		Numbe	er 743025			
Tar	Tank Car Characteristics/Features							
Type of Car:	Type of Car: ☑ Non-pressure ☐ Pressure ☐ Cryogenic ☐ Other							
Specification N	DOT IL	5 100wl Tank Test	pressure:	Tan	k Capacity: 31830			
Build Date:	5-201	Underframe:	Continuous 🔀	Stub S	ill			
Jacketed: Y	The The	ermal Protection: Jack	ceted T Sprayed	-оп	Insulated: Y N			
Construction M	laterial: Typ	oe/Grade	Thickness		Stress: TMCON			
	Fittings L	Damage	Jacket, Ta	ank ai	nd Head Damage			
Type fitting	Damaged?	Description Damage/Leak	Indicate location and s gouges, wheel burns, the appropriate diagra	dents, rai	damage (punctures, cracks, scores, il burns, underframe, and leaks) on			
☑ Liquid Valve	Y Mi □ Leaking	3"	•					
∕d Vapor/ Air Valve	☑ M □ Leaking	1"						
Bottom Outlet Type:	Y € Leaking	SHEARED						
☐ Pressure Relief Device Type:	Y N □ Leaking							
☐ Vacuum Relief Valve	Y N □ Leaking	a a
