Car Damage Report

Wreck Index Number #1

Consist # 20

Car Number TAEX 1638

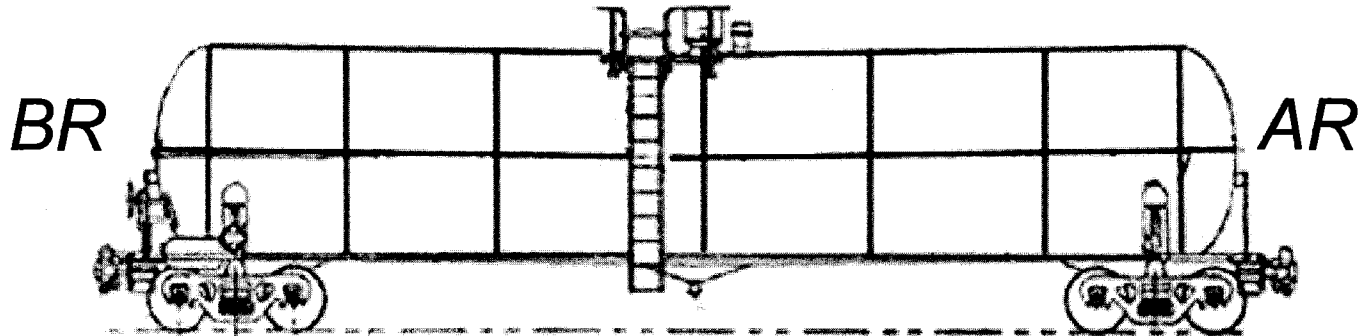
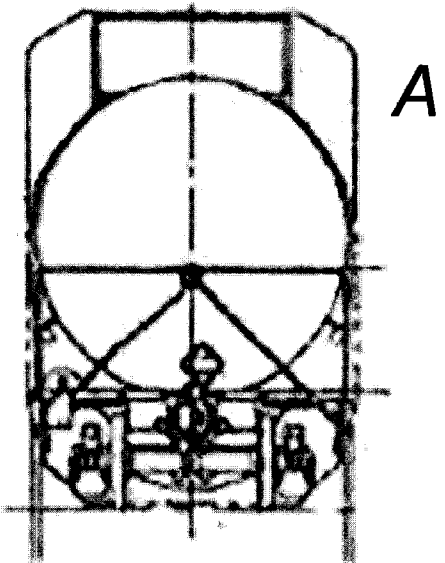
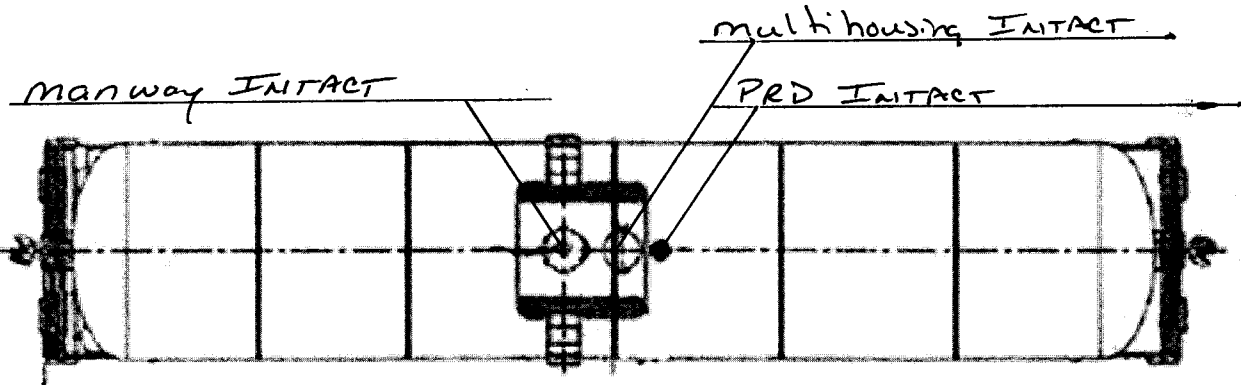
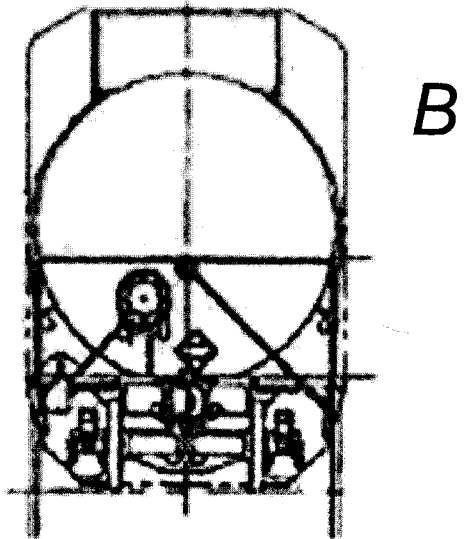
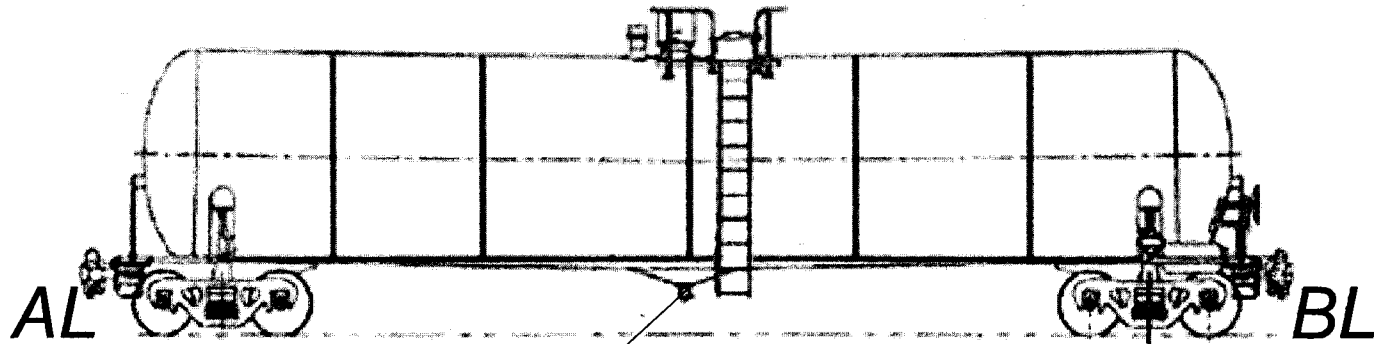
*Bottom outlet valve is buried
I cannot determine its condition.*

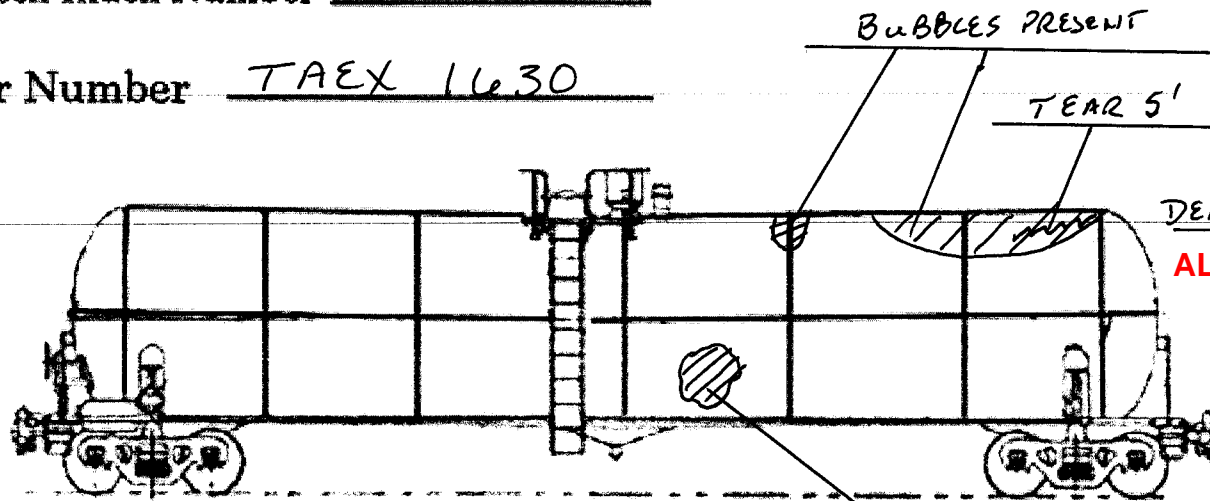
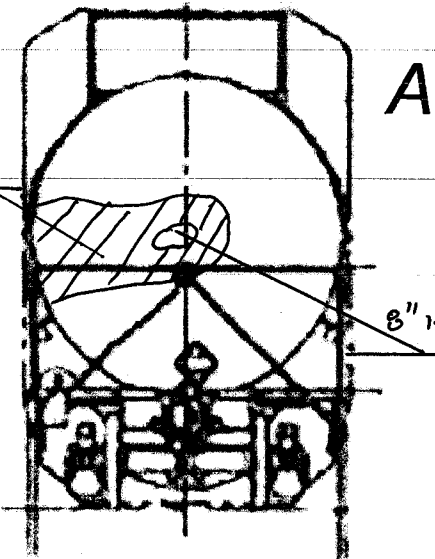
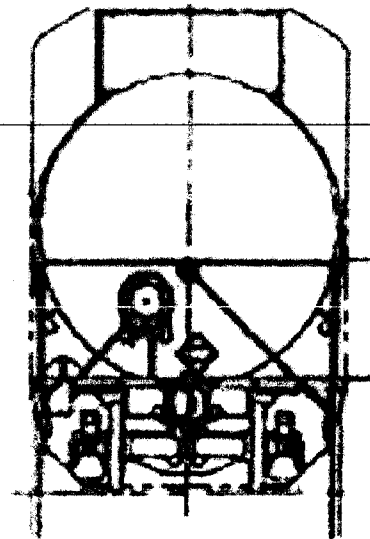
Wreck Index Number 2

multihousing - Lid BENT
VALVES damaged
manway INTACT

PRD INTACT

Light DEFormation

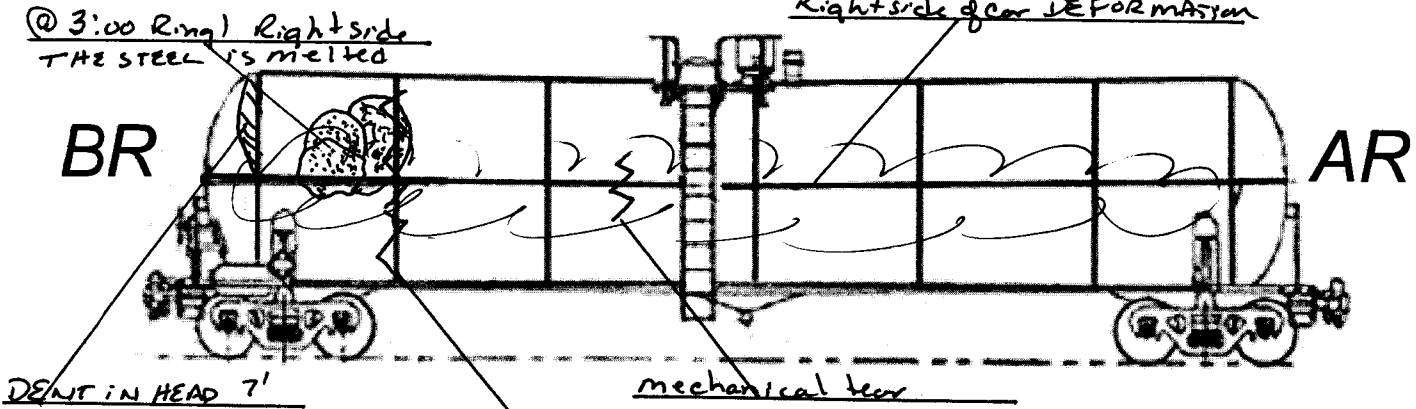
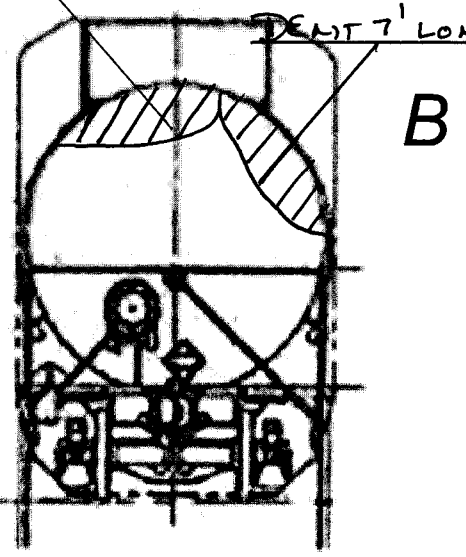
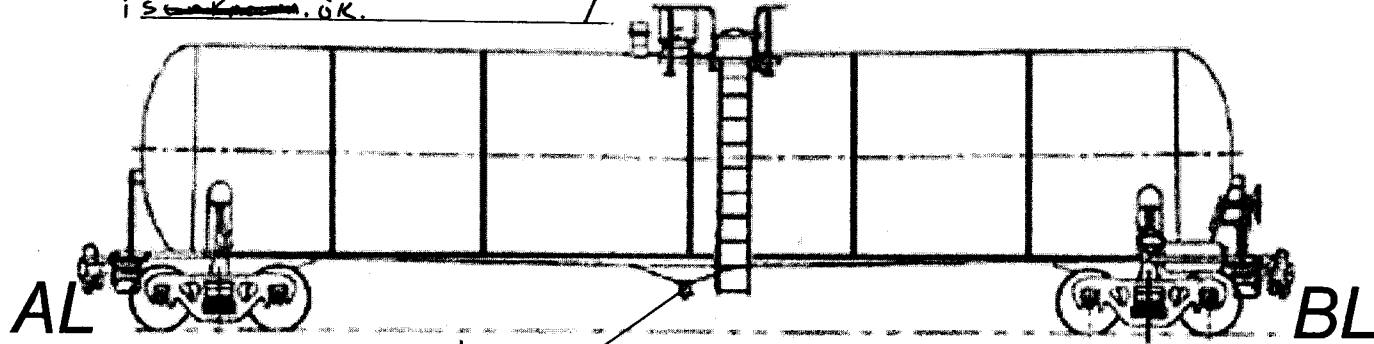
Wreck Index Number #3

@ 3:00 Ring) Right side THE STEEL IS MELTED

TEAR OR CROSS bottom flap Rightside extending into the melted STEEL.

DENT 3'x4'

DENT 7' LONG

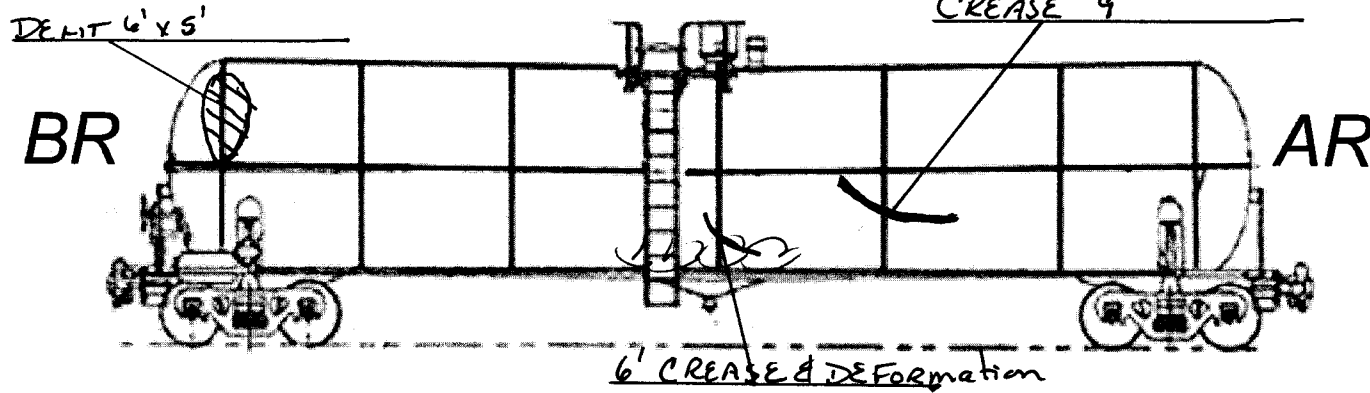
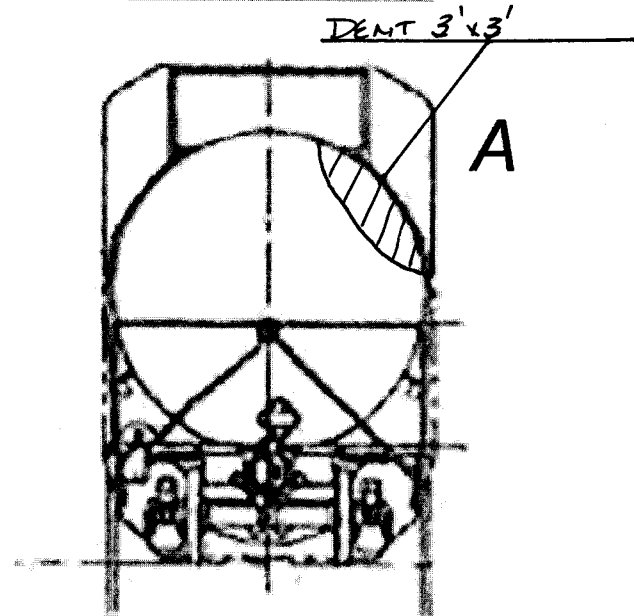
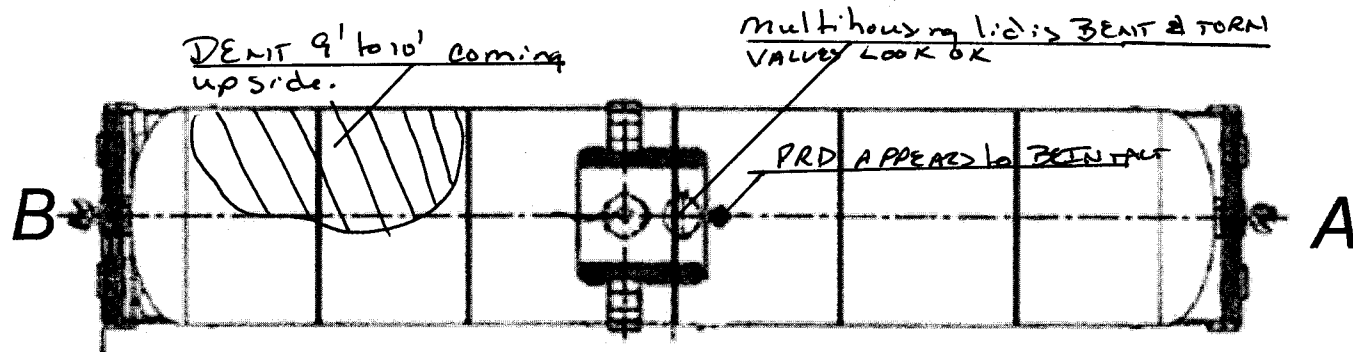
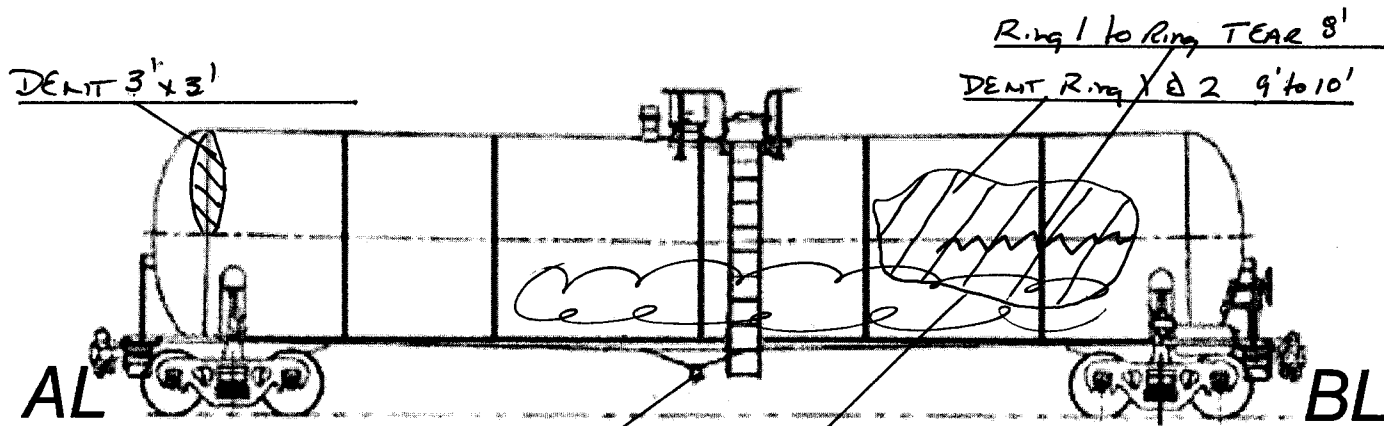
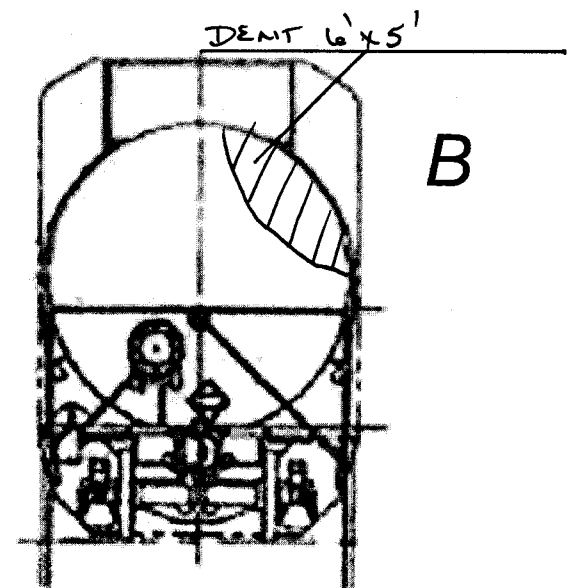
Wreck Index Number #4

BOTTOM outlet valve EXTRACT HANDLE was damaged & MISSING.

DEFORMATION RING 1 to 4 7:00 to 8:00

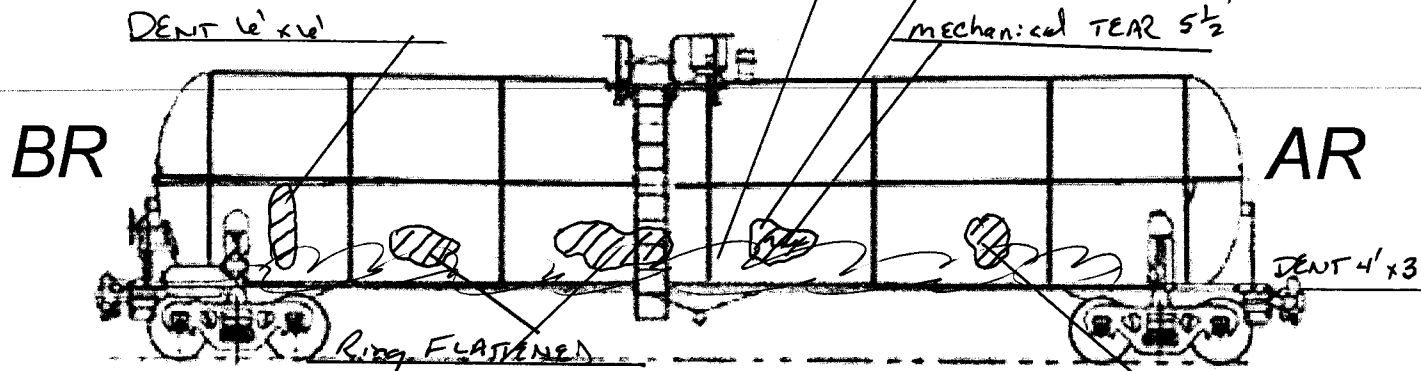
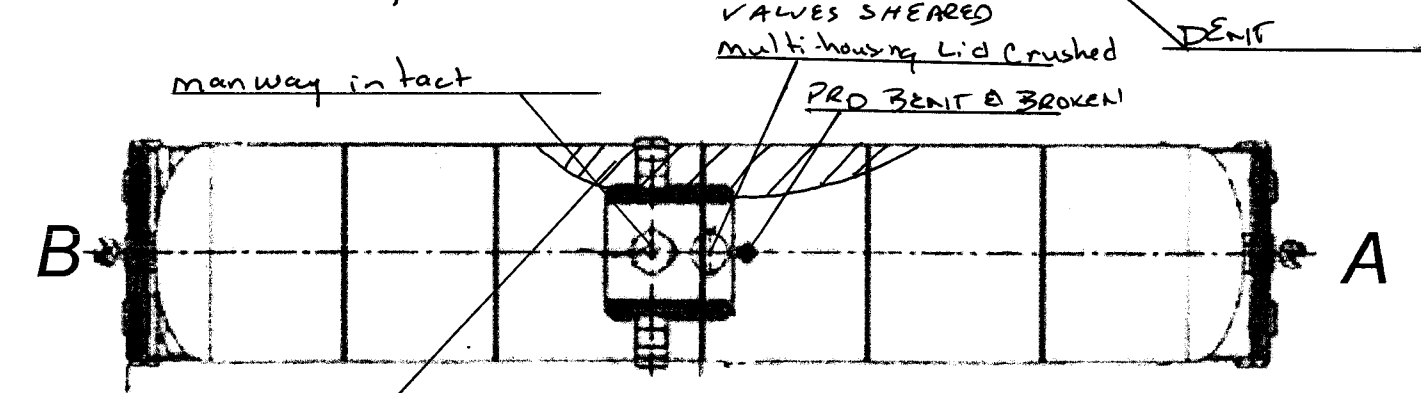
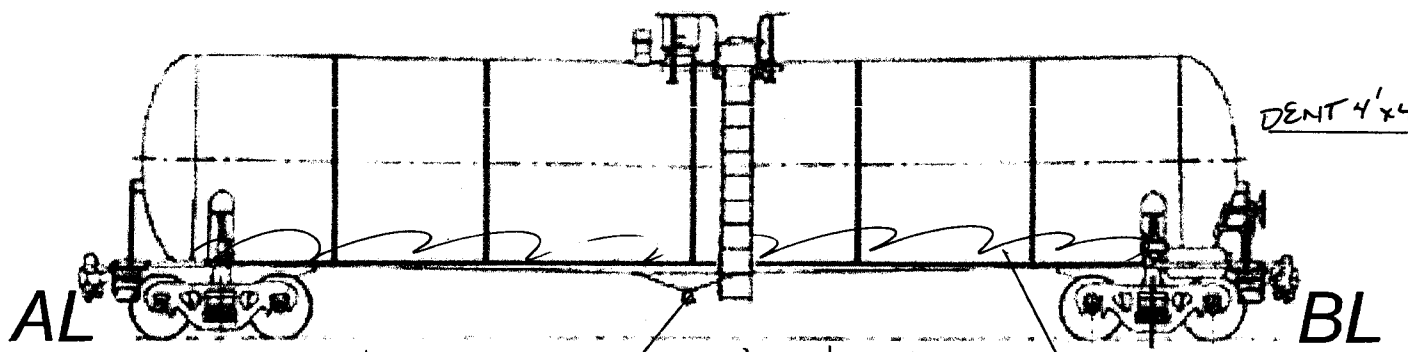
Wreck Index Number # 5

Deformation on Bottom Full length

Bottom outlet valve adapter sheared handle BENT

Bottom Full length Deformation

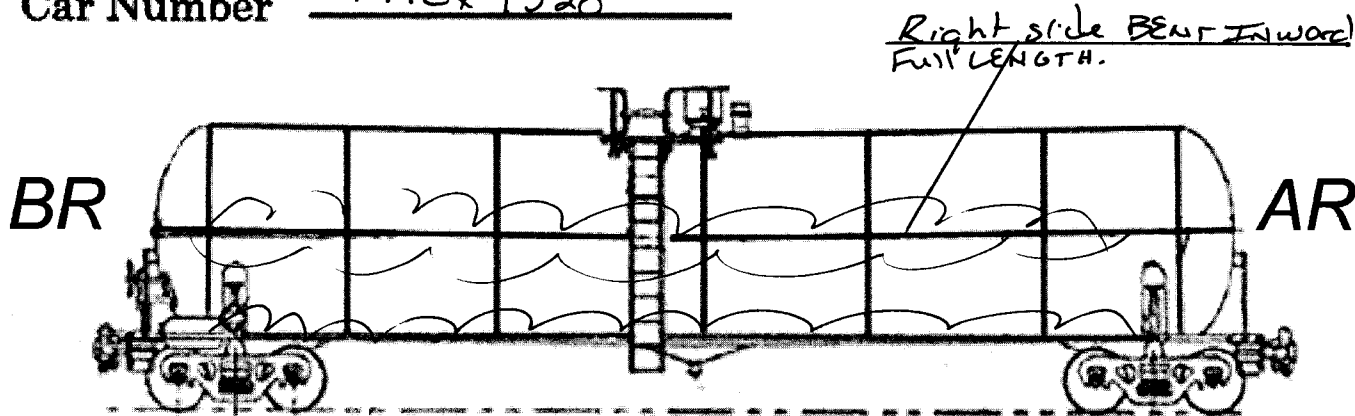
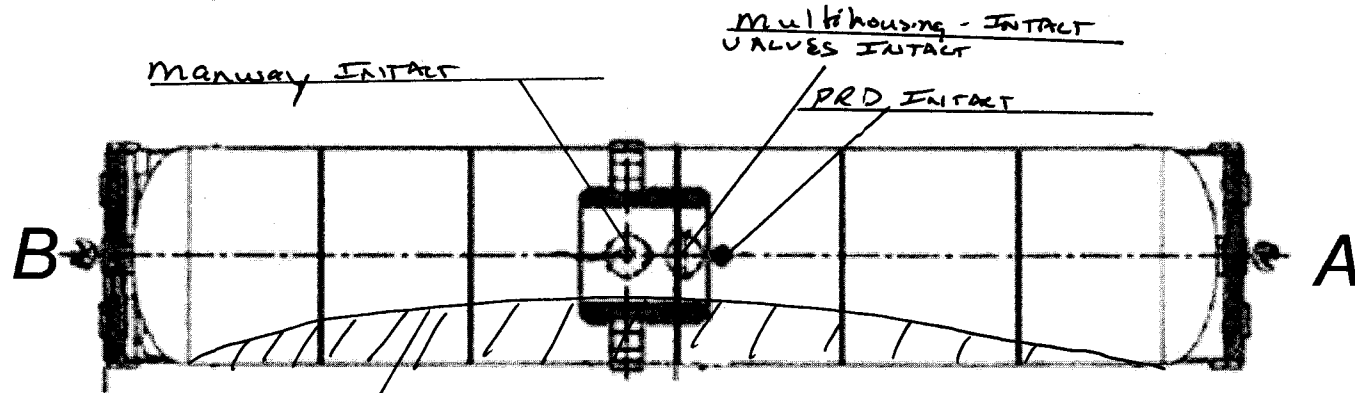
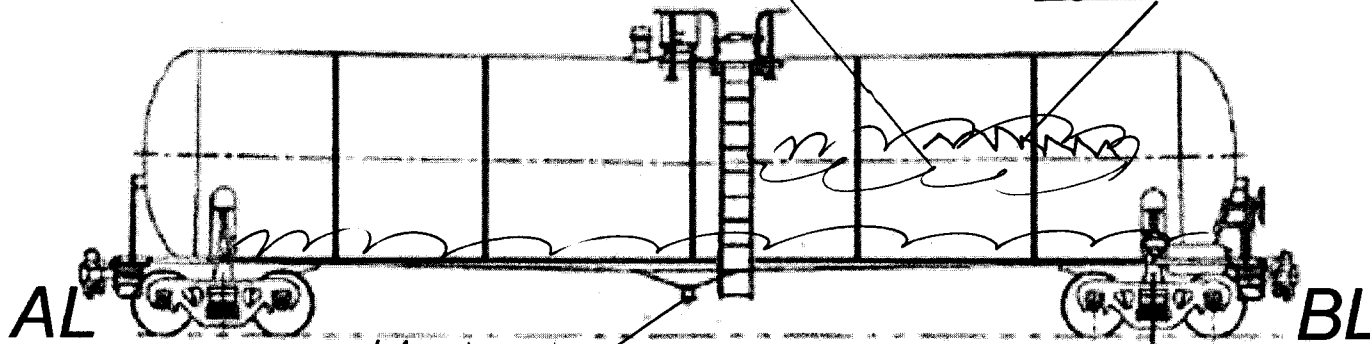
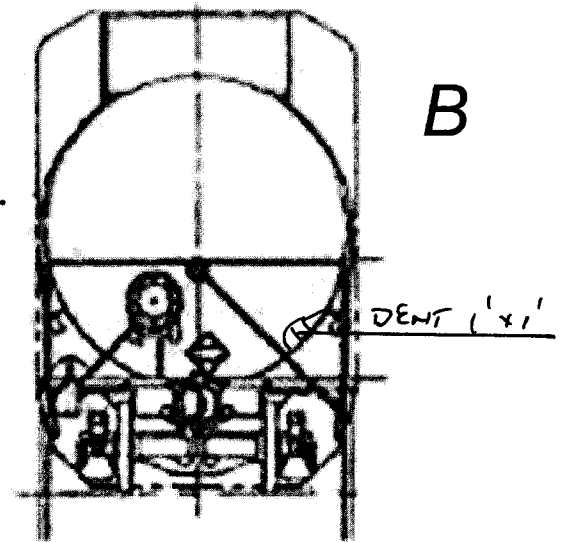
Wreck Index Number 6

RIGHTSIDE BENT INWARD

DEFORMATION of the shell.

TEAR 8'

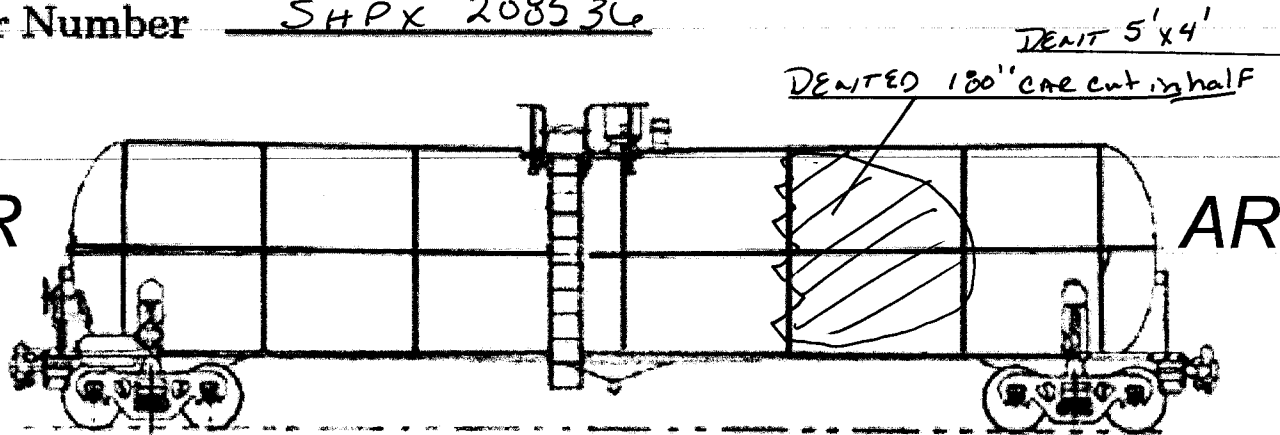
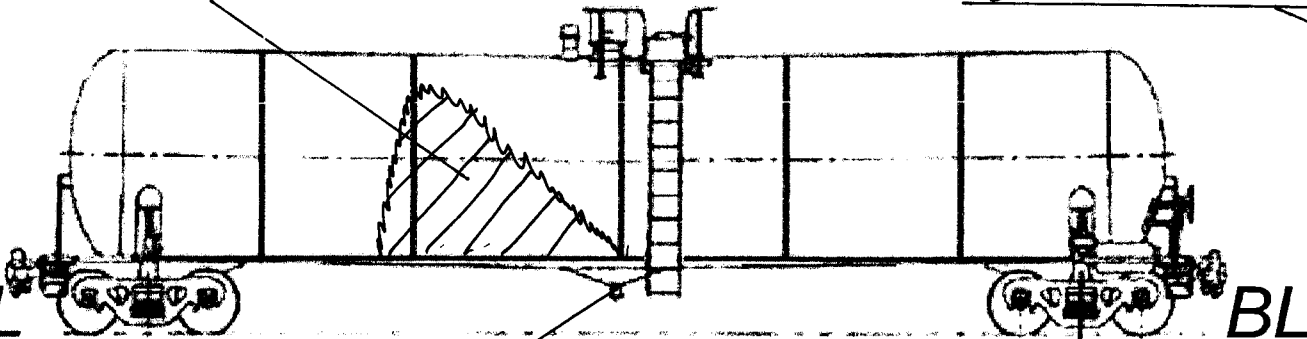
Wreck Index Number 7

DENT 6'x5'

manway intact 2 BOLTS
are LOOSE. EAR BENT

multi-housing Lid missing
VALVES ARE SHEARED

WRD INTACT 1 BOLT SHEARED

CAR is cut in half
180° DENT

DENT 2 1/2 x 2 1/2'

CAR is cut in half.

DENT ~~2 1/2 x 2 1/2'~~ 1'x1'

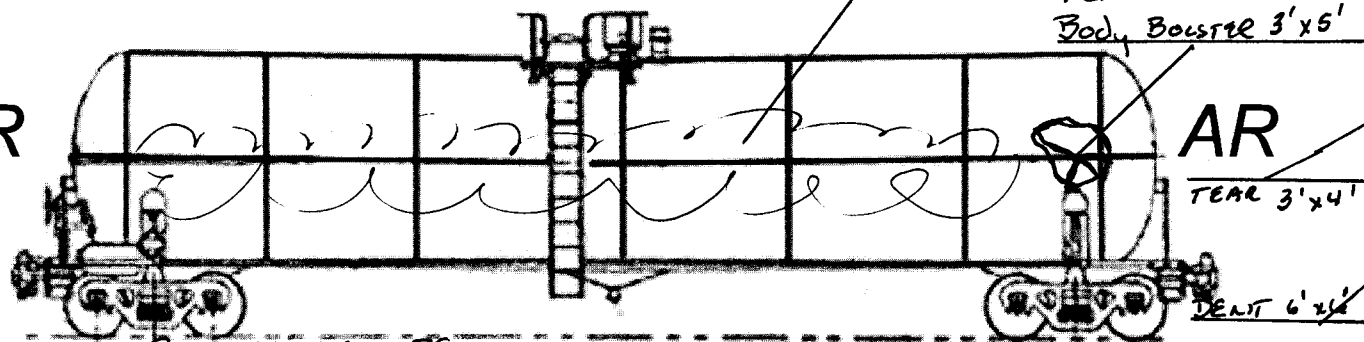
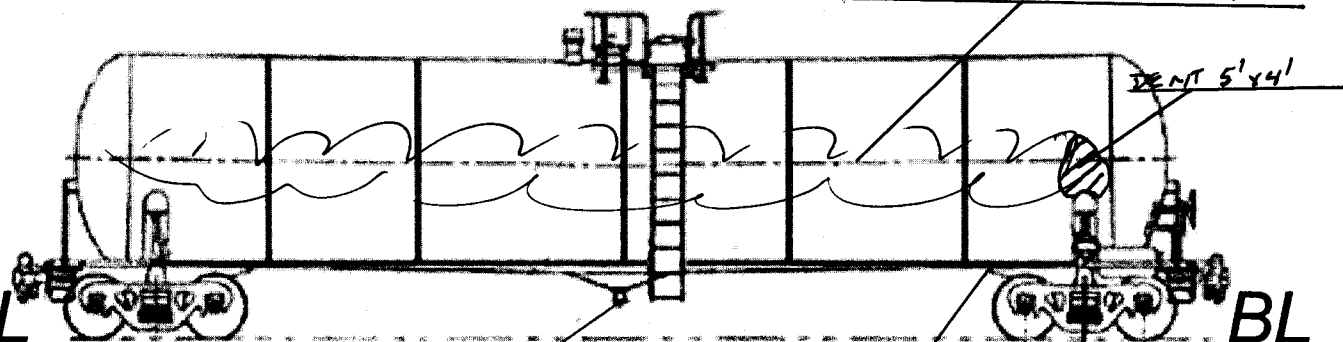
Wreck Index Number 8

DEFORMATION Full LENGTH

PRD NOZZLE IS BENT

manway is intact

multi housing - Lid BENT & BROKEN
VALVES SHEARED

TEAR above the
Body BOSTER 3'x5'

TEAR 3'x4'

DENT 6'x4'

TEAR 2'x1'

TOP & BOTTOM BOTH HAVE
Full LENGTH DEFORMATION

DENT 3'x2'

DENT 6'x6'

Bottom outlet valve adapter sheared
BOV HANDLE IS INTACT

TANK PULLED AWAY FROM THE
IB SILL & RE-REINFORCEMENT PAD.

DENT 5'x4'

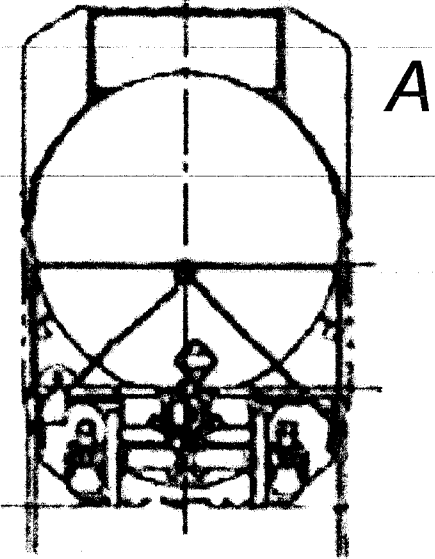
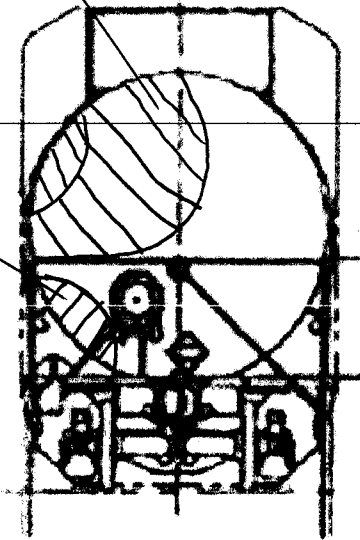
Wreck Index Number 9

HOCE
270" x 6'

multi housing - damaged

manway - INTACT

PRD INTACT

DENT 8' x 7'

DENT 3' x 3'

Bottom outlet valve - INTACT
BOY HANDLE - INTACT

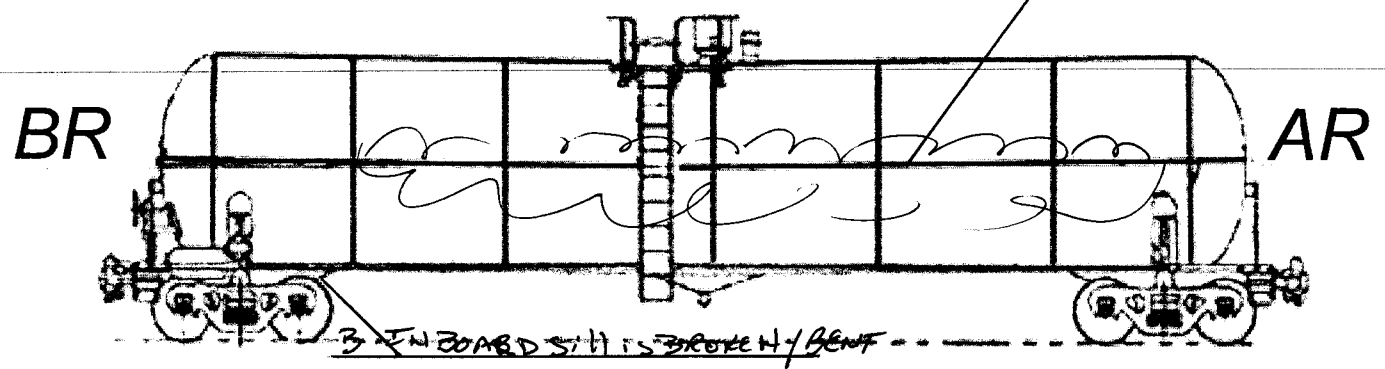
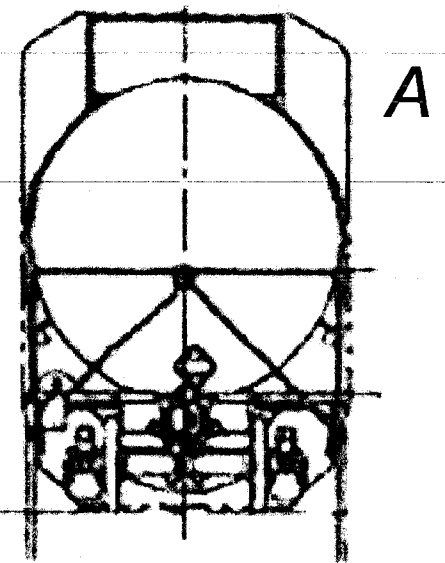
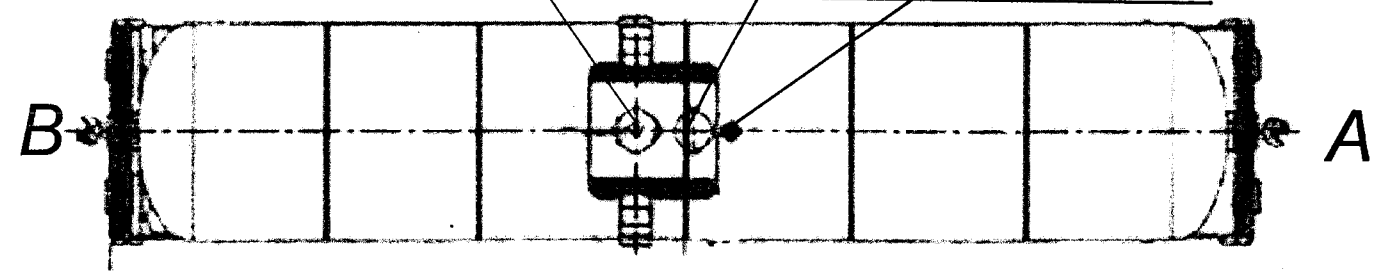
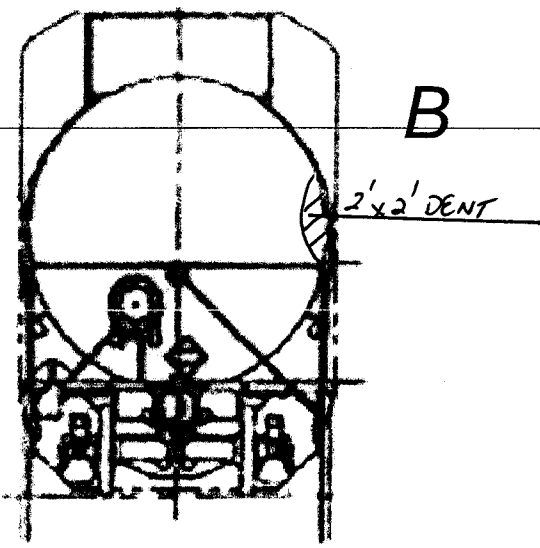
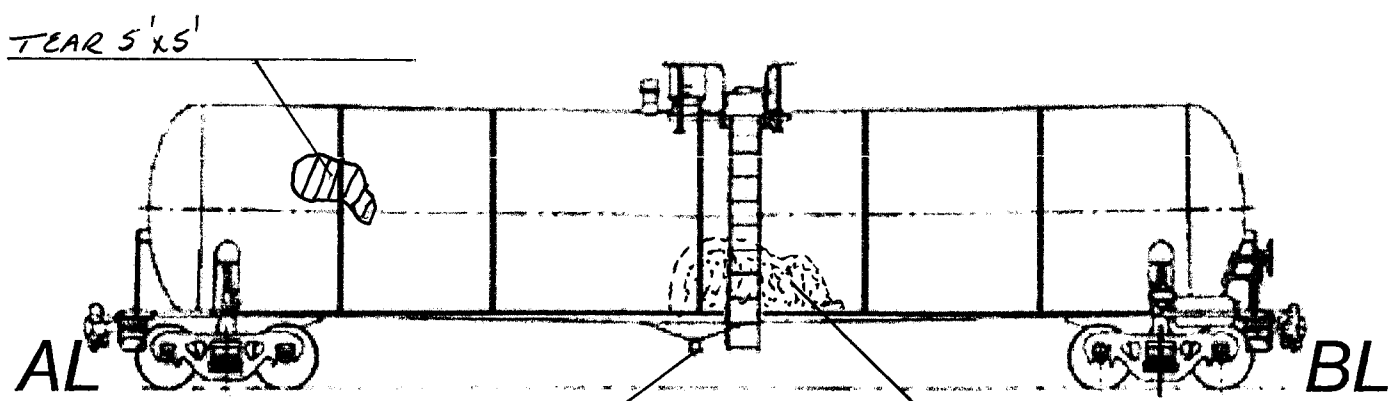
Wreck Index Number 10

Right side deformed #2 Ring to #6 Ring

Bottom outlet valve adapter sheared
BOY HANDLE missing

STEEL IS BURNT THROUGH.

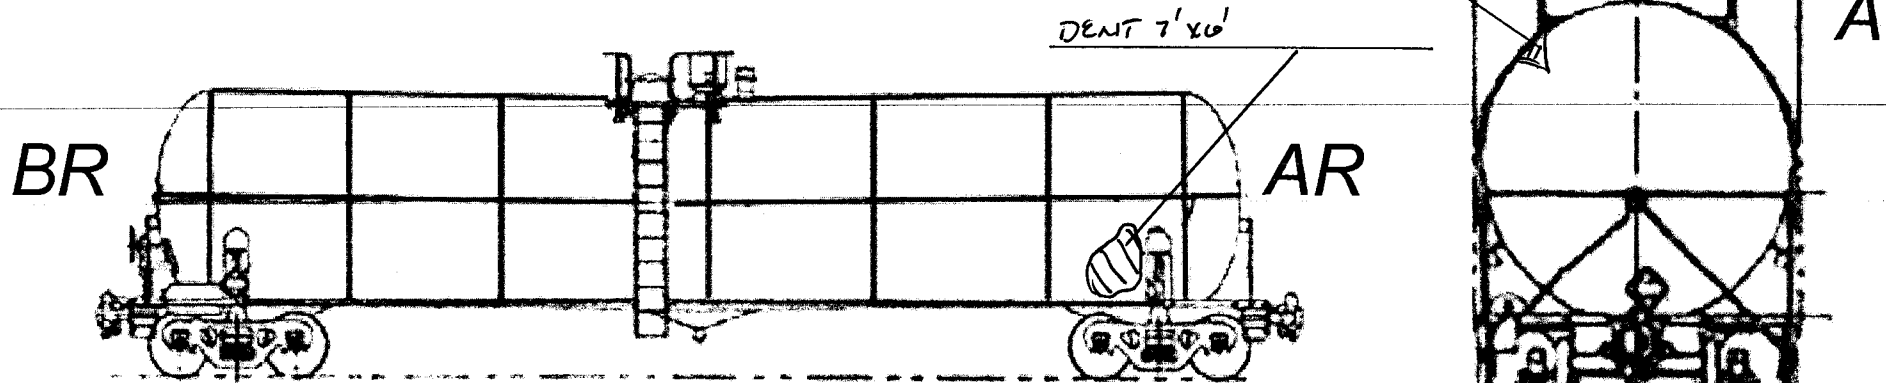
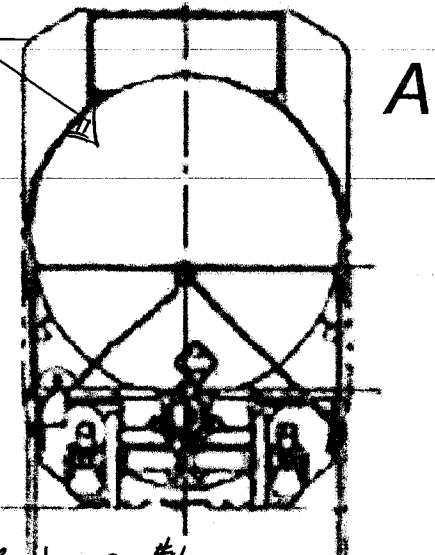
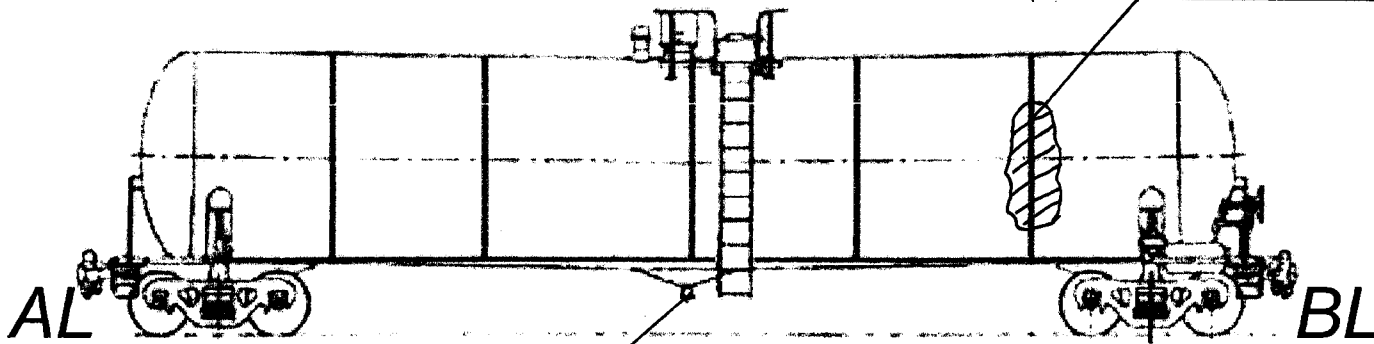
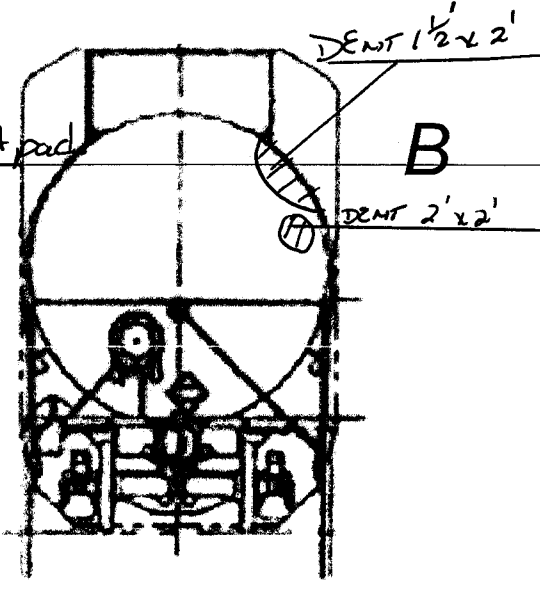
Wreck Index Number 11

manway INTACT

multi-housing crushed VALVES DAMAGED

PRO BOLTS sheared

DEFORMATION on Bottom Ring #2
90" x 6' wide

DENT 1 1/2' x 2'

DENT 2' x 2'

DENT 6' x 4'

Bottom outlet VALVE adapter sheared
HANDLE IS INTACT

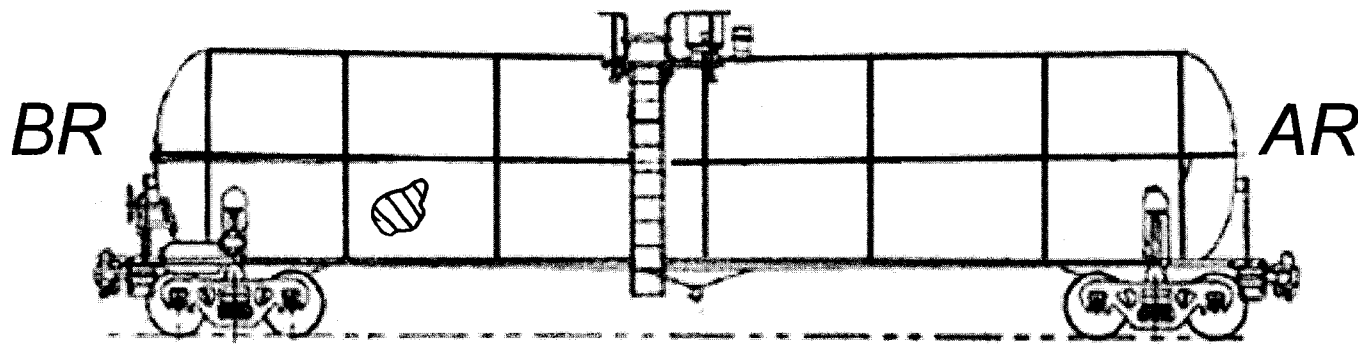
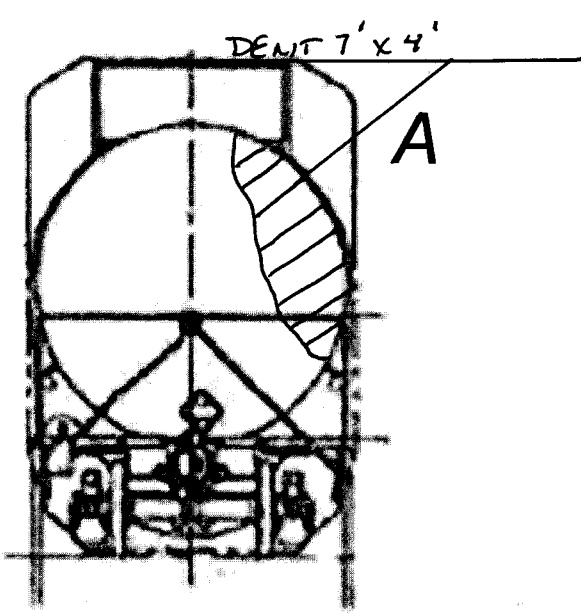
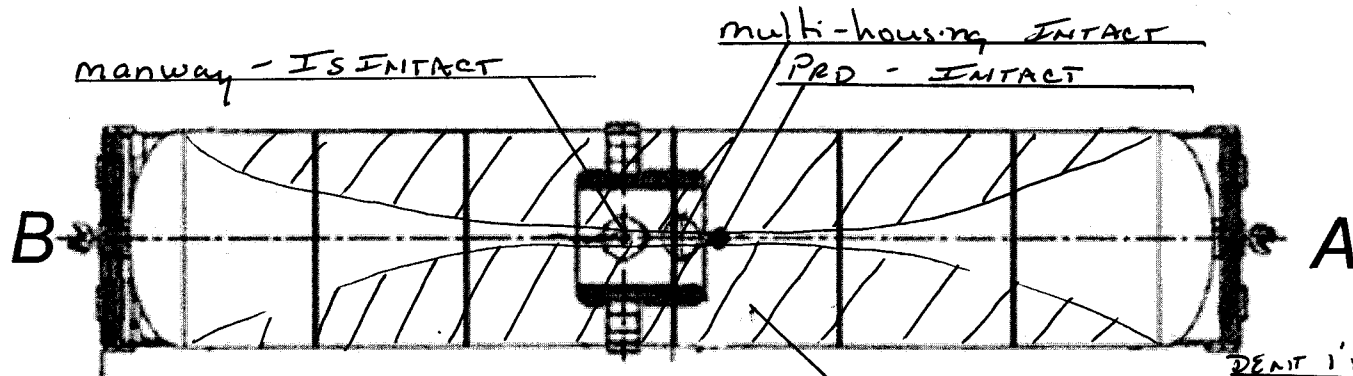
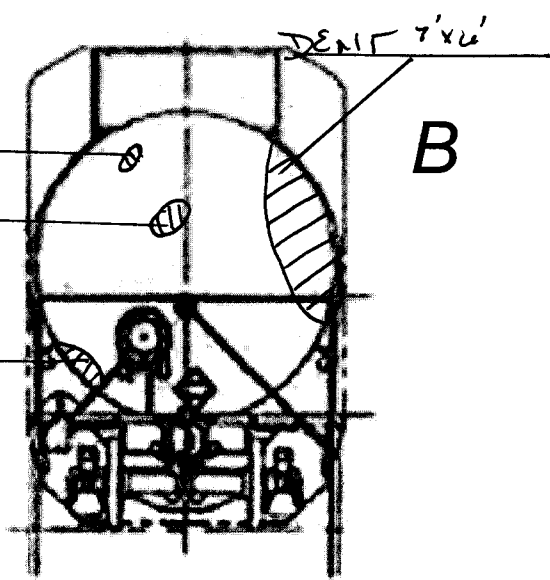
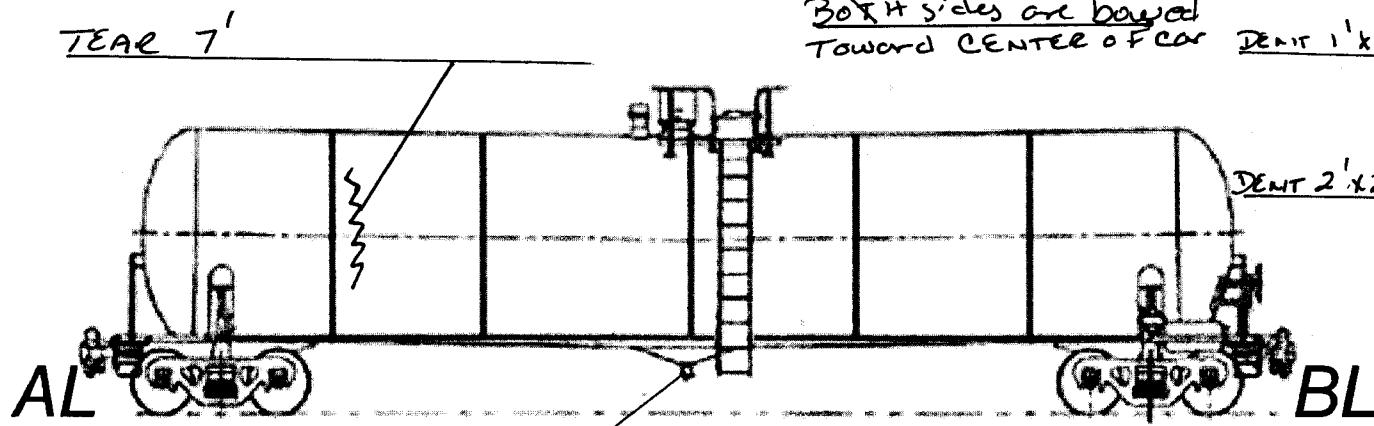
Wreck Index Number 12

BOTH sides are bowed TOWARD CENTER OF CAR

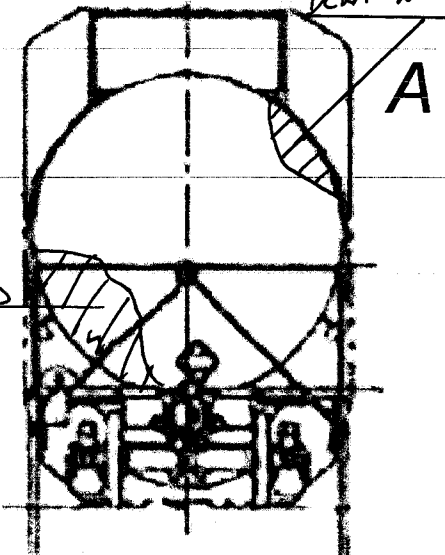
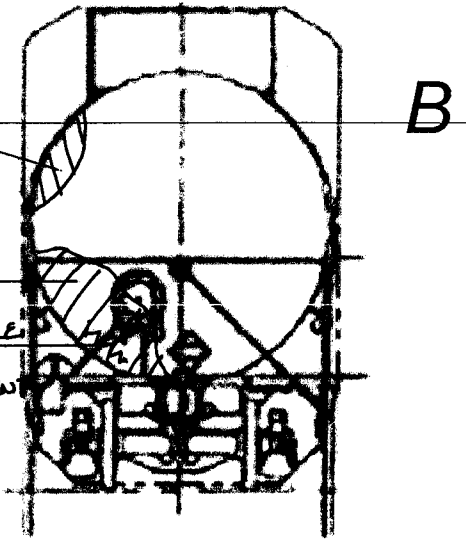
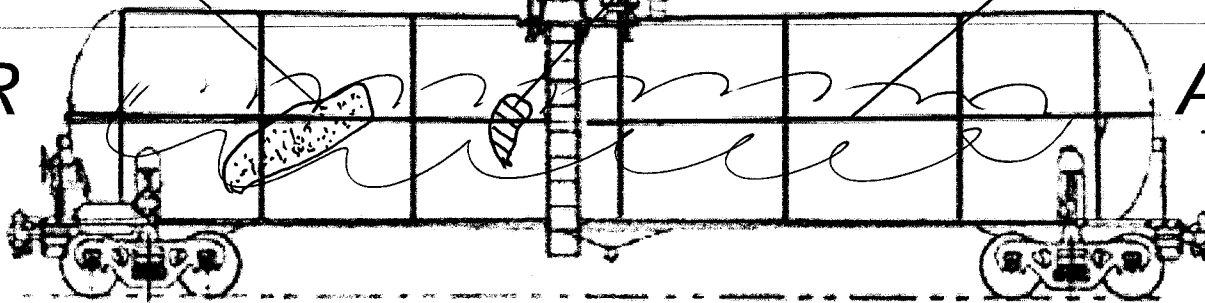
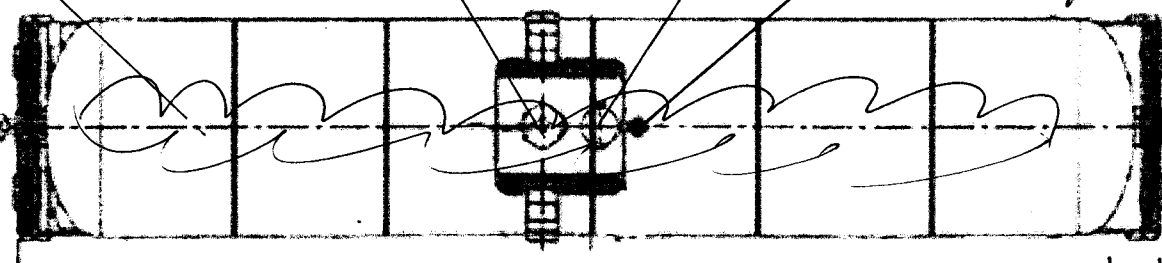
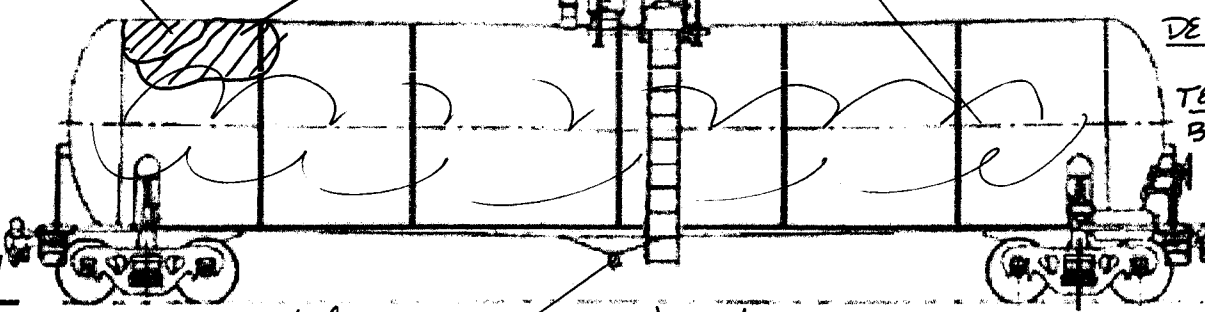
Wreck Index Number 13

Burn through 9'x2'

TEAR 2 1/2' x 3'

Right side Full length DEFORMATION.

DENT 2 1/2' x 1'

Man way is intact 2 BOLTS OPEN

Multihousing - LID BENT VALVES DAMAGED

PRD - HEAT DAMAGE

DENT 8' x 8'

LEFT side has Full Length DEFORMATION

DENT 6' x 6'

TEAR POSSIBLE Buried but oil present

Bottom outlet valve & depth not heared HANDLE IS INTACT

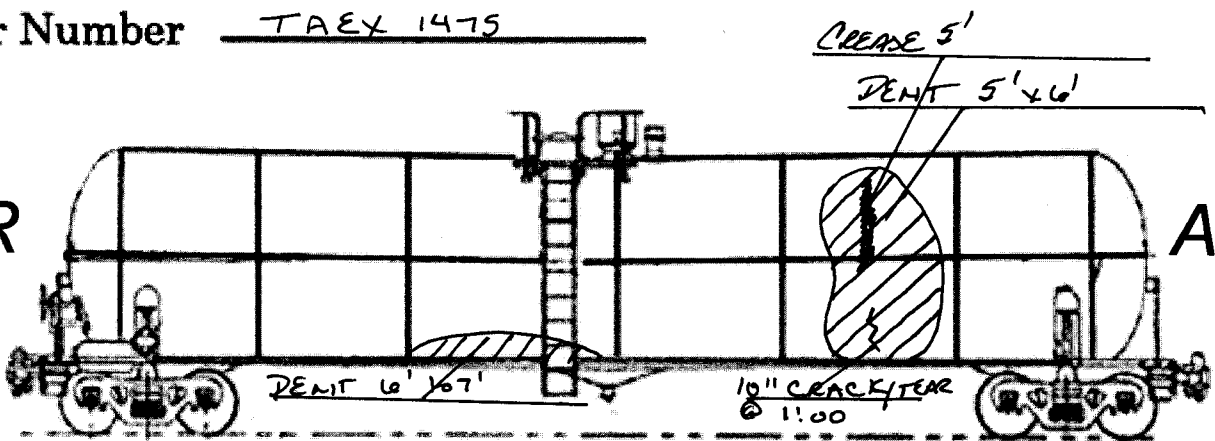
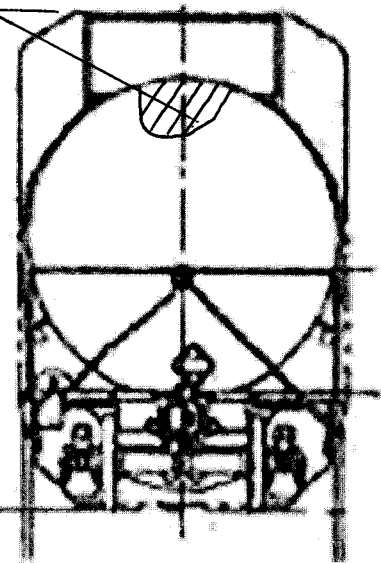
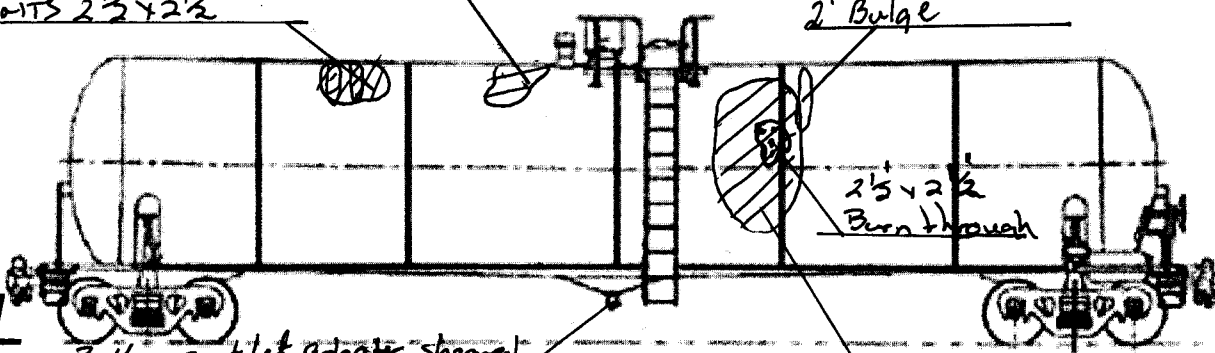
Wreck Index Number # 14

DENT 2 1/2' x 4'

manway was ~~open~~ closed BOLTS are OK.
 multi housing - Lid ~~missing~~ missing
 VALVE condition BROKEN
 PRD ~~is~~ INTACT

Bulges 2 1/2' x 2 1/2'

DENT Ring 2 to Ring 6

2' CREASE

DENTS 2 1/2' x 2 1/2'

2' Bulge

Bottom outlet adapter sheared
 BOY HANDLE IS ~~missing~~ missing
 BENT BALL IS closed.

2 1/2' x 2 1/2' Burn through

Bulge 6' x 8'
