Car Damage Report

Wreck Index Number #1

Consist # 20

Car Number TAEX 1638

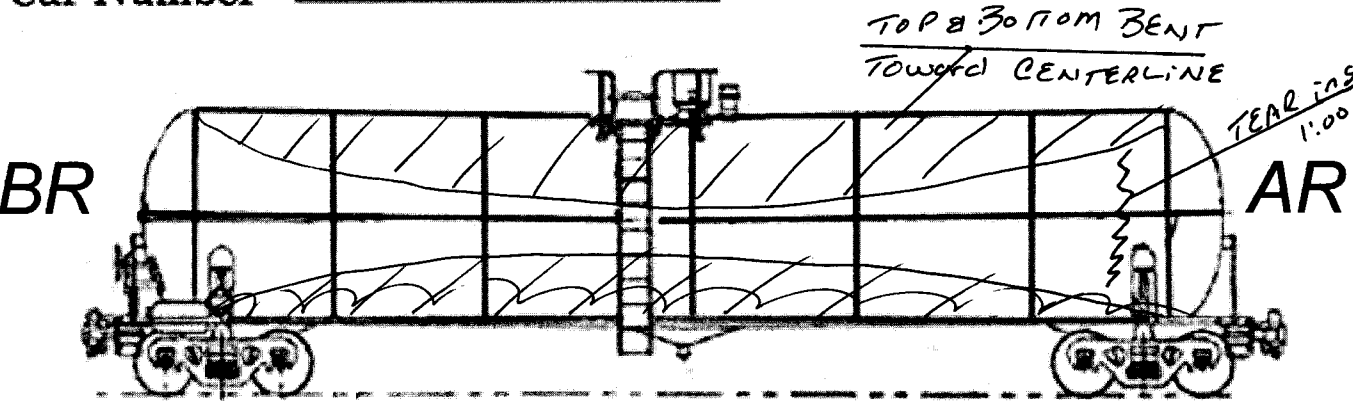
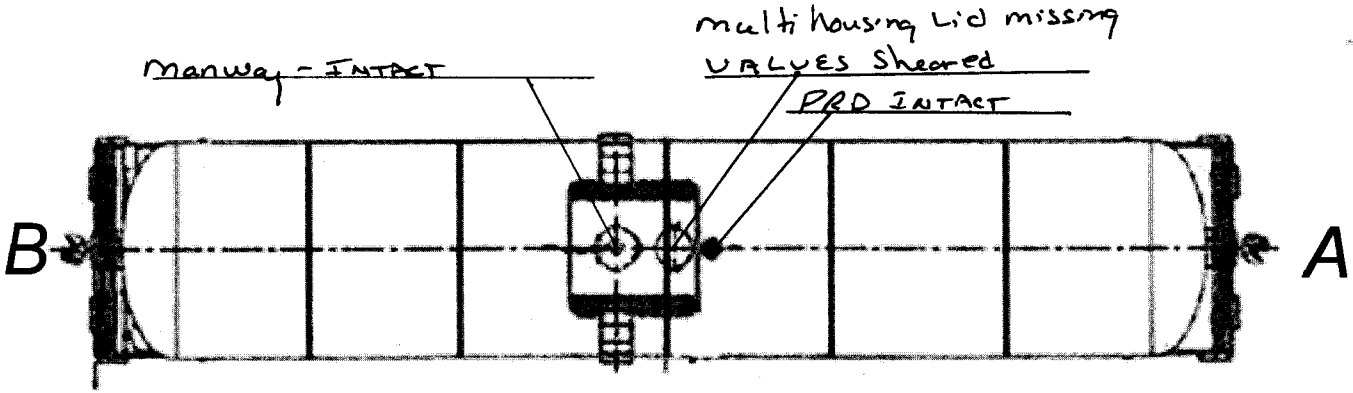
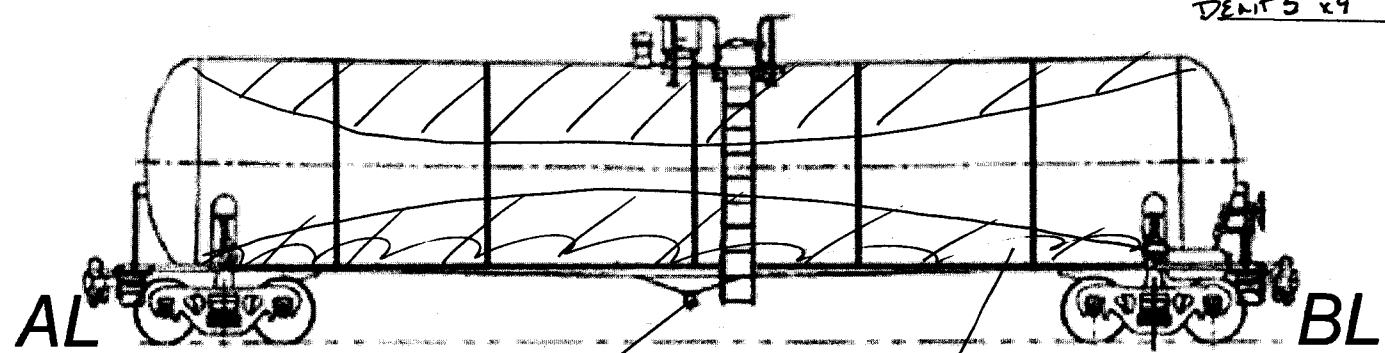
Wreck Index Number 15

Bottom outlet valve sheared
Bar Handle BENT - BALL closed

Bottom FLATTENED A to B

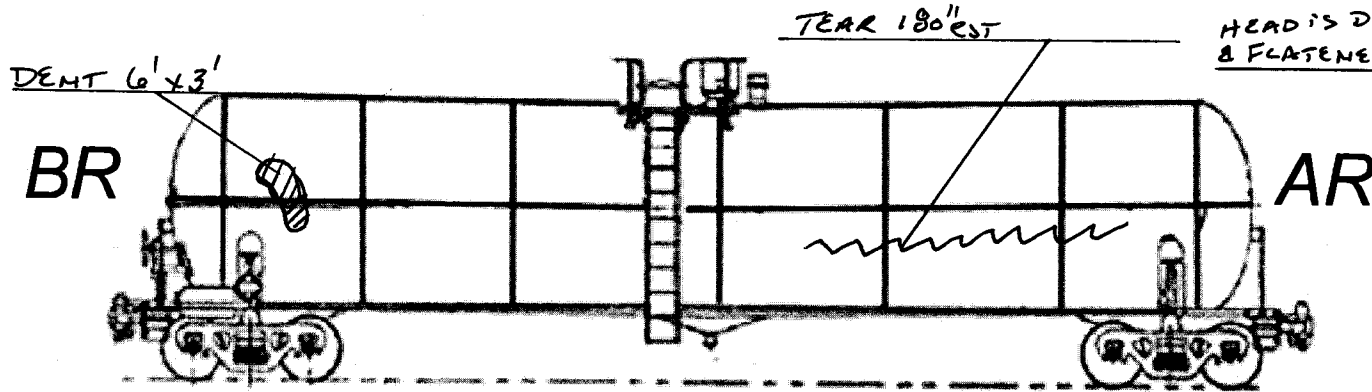
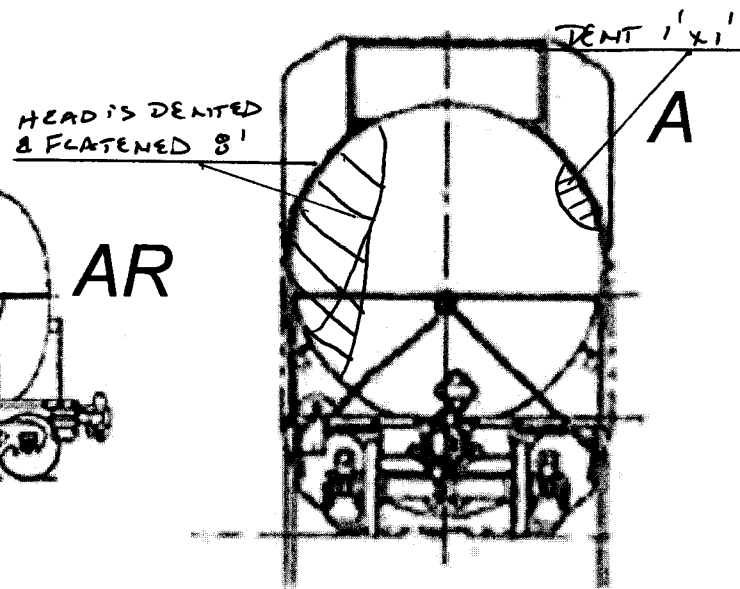
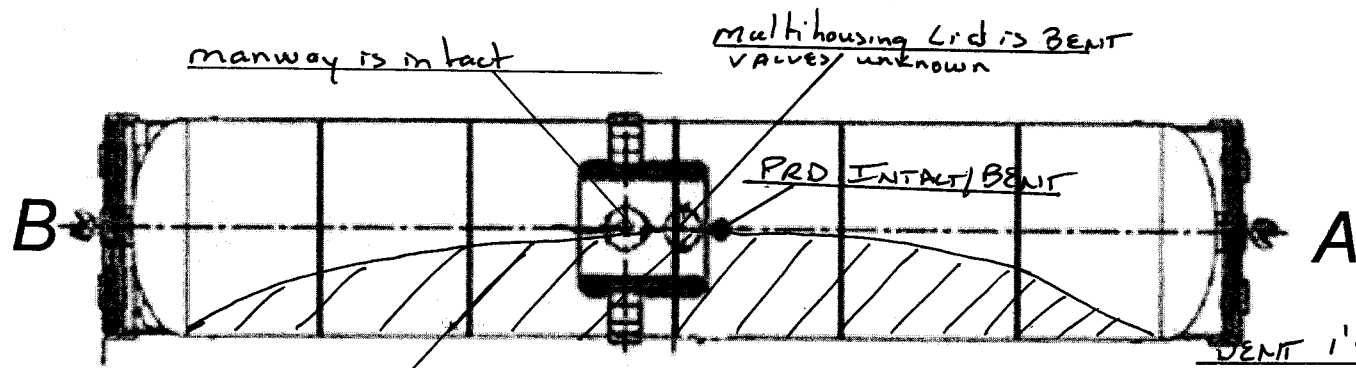
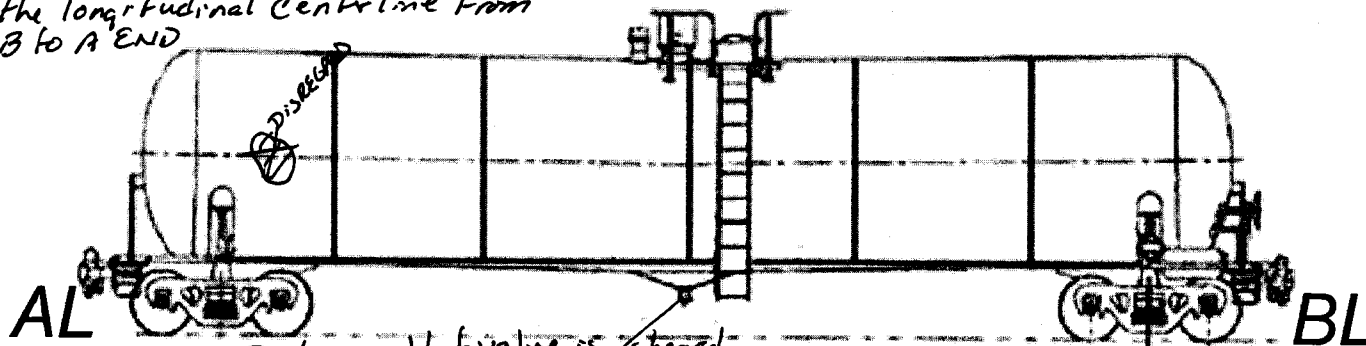
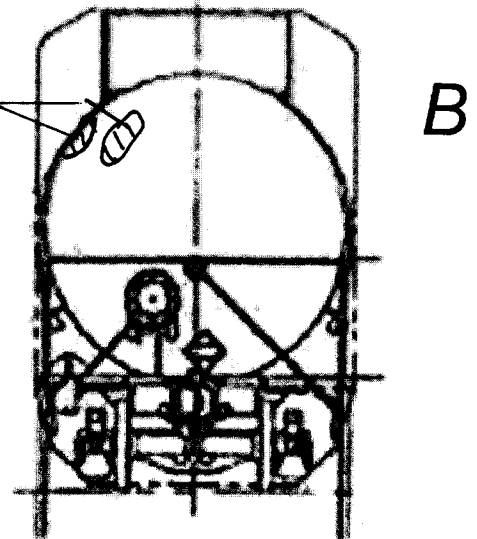
Wreck Index Number # 116

THE RIGHT SIDE IS BOWED TOWARD THE LONGITUDINAL CENTRELINE FROM B TO A END

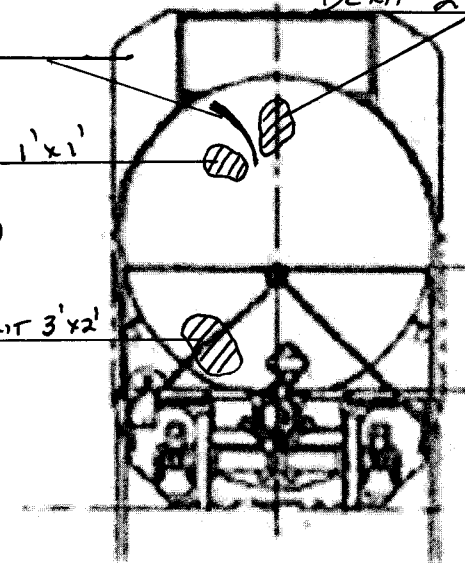
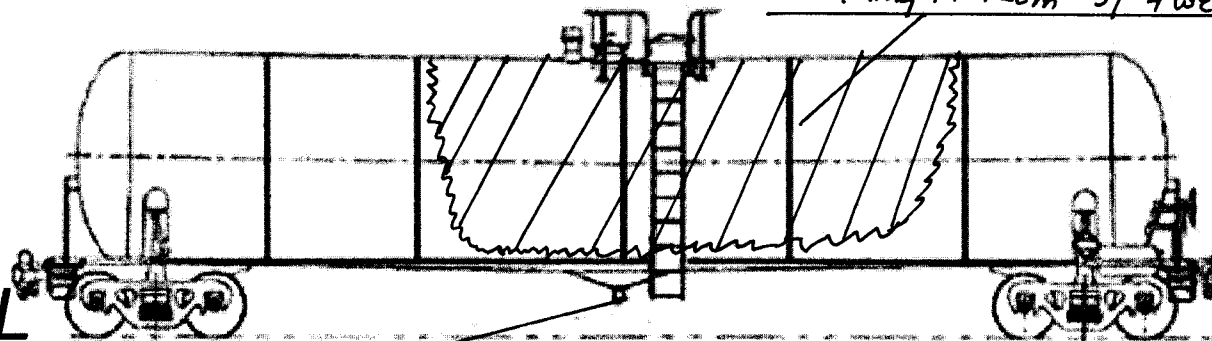
Wreck Index Number 17

TEAR #4 RING to 14" of #4 #5 SEAM WELD

DENT 3'x2'

CREASE 3'

DENT 1'x1'

DENT 2'x2'

AIR INLET VALVE SHEARED
MULTI HOUSING - LID MISSING
VRV LEAKED
PRD IS FULL OF DIRT

MANWAY IS IN TACT

HEAD DEFORMED OVAL

TEAR #4 RING to 14" of #4 #5 WELD SEAM

TEAR (THERMAL?) LEFTSIDE #2 RING TO #4 RING 14" FROM #5/#4 WELD SEAM

BOY IMPACT
HANDLE DAMAGED

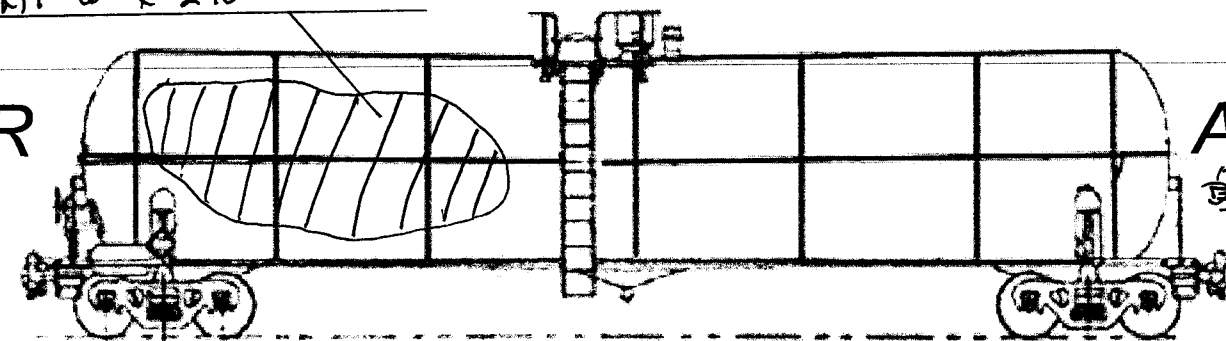
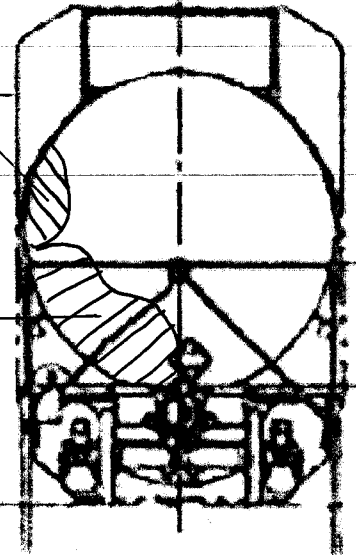
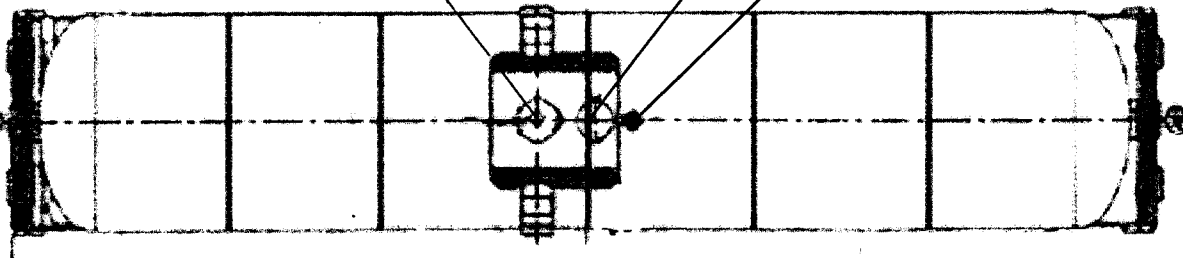
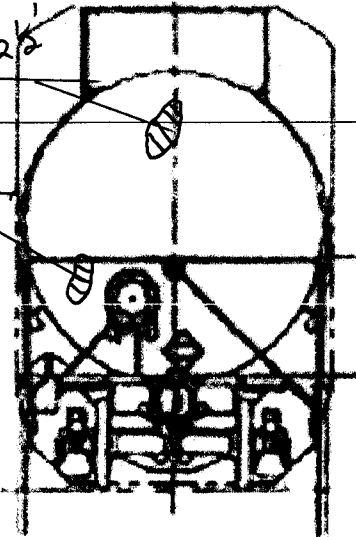
Wreck Index Number #18

DENT 6' x 240"

DENT 2 1/2' x 2 1/2'

HOLE
~~DENT~~ 5' x 3'

manway - INTACT
multi-housing - INTACT
PED - INTACT

LEFTSIDE DEFORMATION DENT 2 1/2' x 2 1/2'
Full LENGTH.

Bottom outlet valve adaptor NOT sheared
HANDLE INTACT

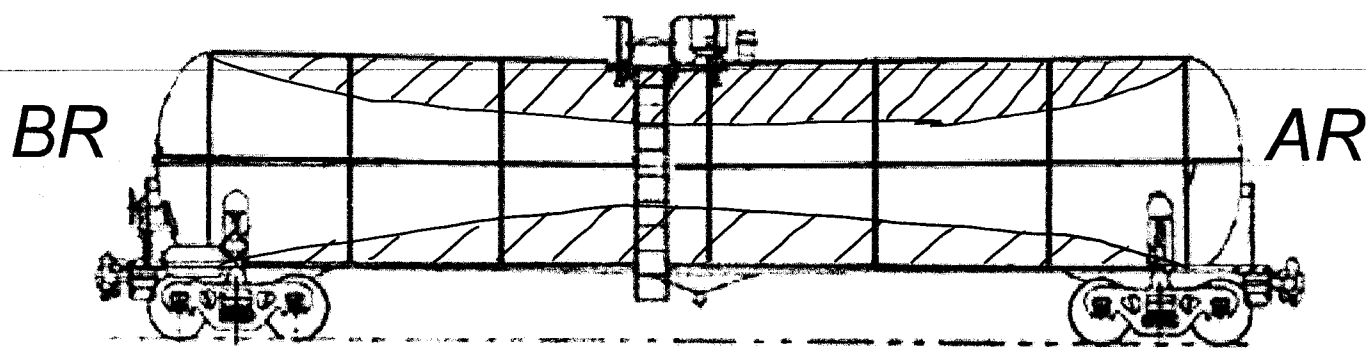
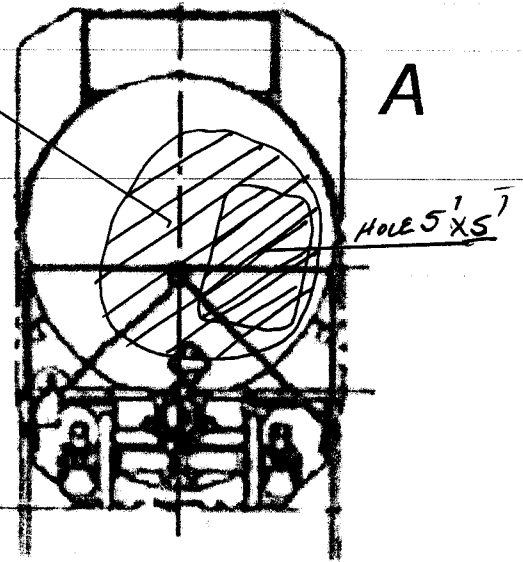
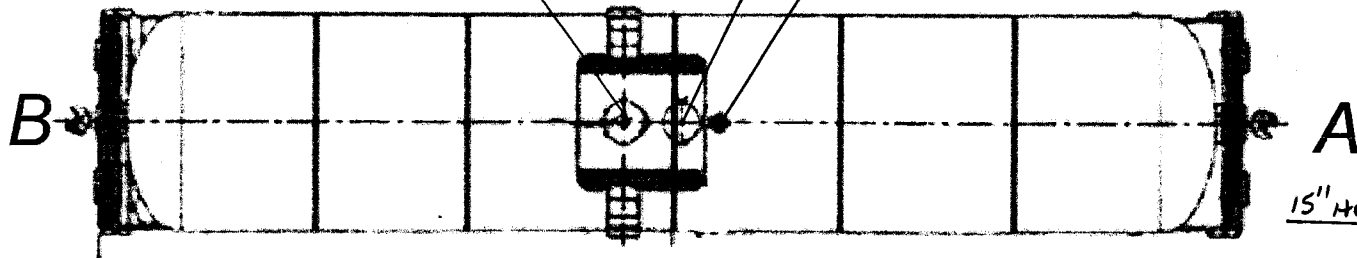
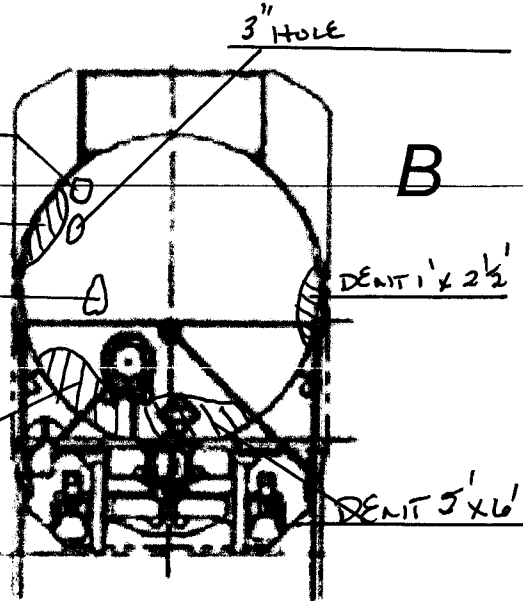
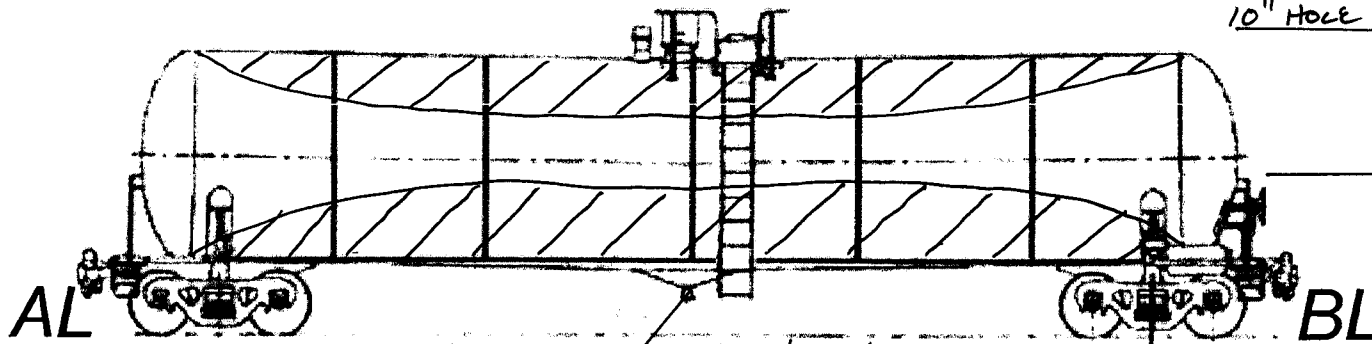
Wreck Index Number # 19

manway - INTACT

multi housing - Lid missing

PRD INTACT

Bo Horn out Let valve/adapter sheered
HANDLE IS INTACT - BALL CLOSED
