National Transportation Safety Board
Washington, D.C. 20594

Hazardous Materials Group Factual Report

Carrier: CSX Transportation
Train No.: K08227
Location: Lynchburg, Virginia
Date/Time: April 30, 2014, at 1:57 p.m. Eastern Daylight Time
NTSB No.: DCA14FR008

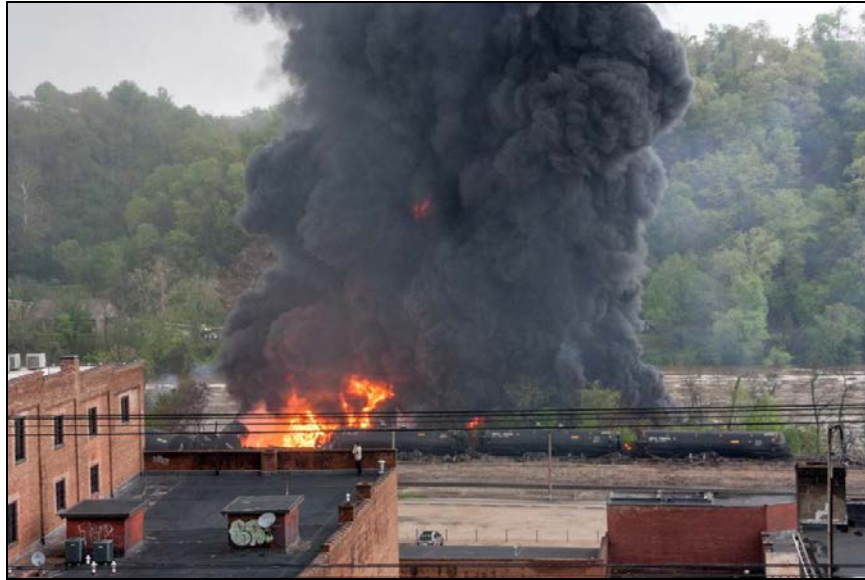
Only one (1) tank car, CBTX 741712 (position 44), was breached (shell breach) and released its contents that ignited, creating a large fire. See figures 2 and 3. Tank cars GATX 286291 (position 43) and CBTX 741672 (position 46) were also involved in the resulting fire; however, they were not breached and did not release their contents. See figure 4.

Figure 2: Large fire and smoke as a result of derailment.

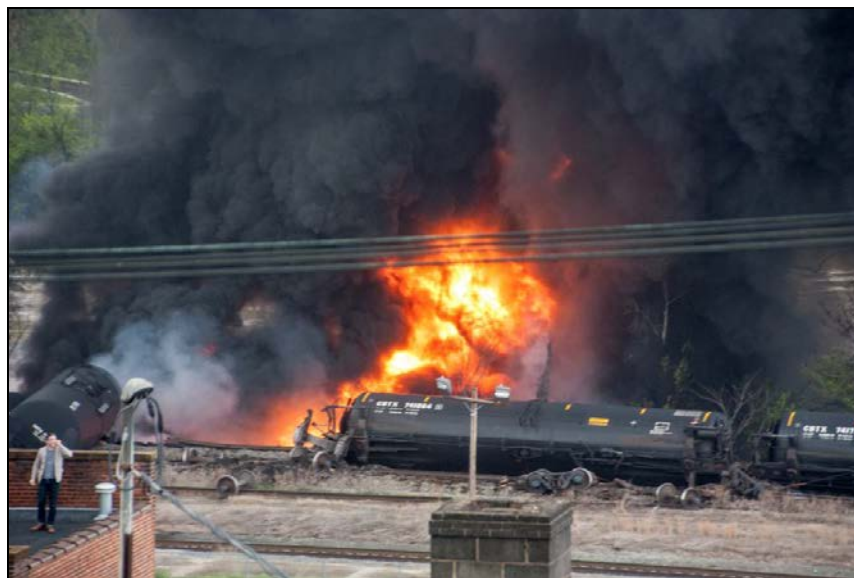
Figure 3: Close-up view of post-derailment fire and smoke.

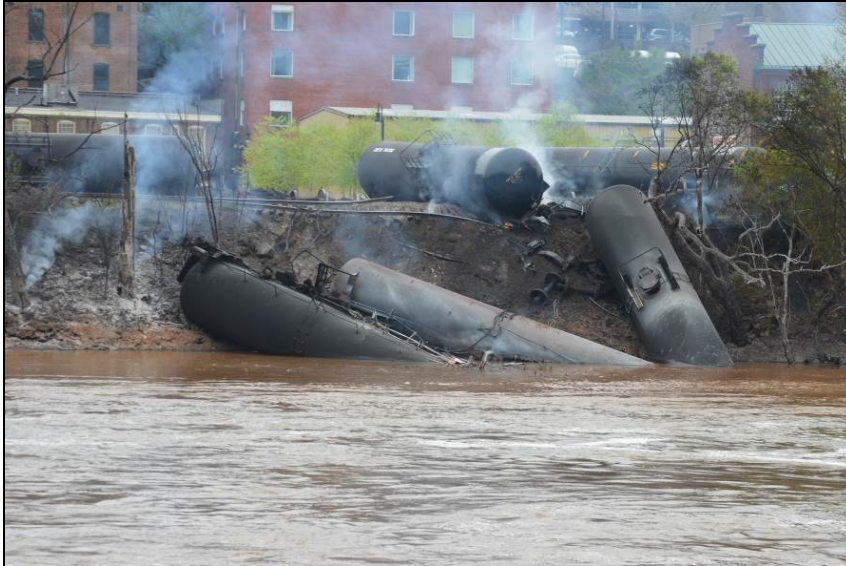
Figure 4: View of tank cars involved in post-derailment fire.

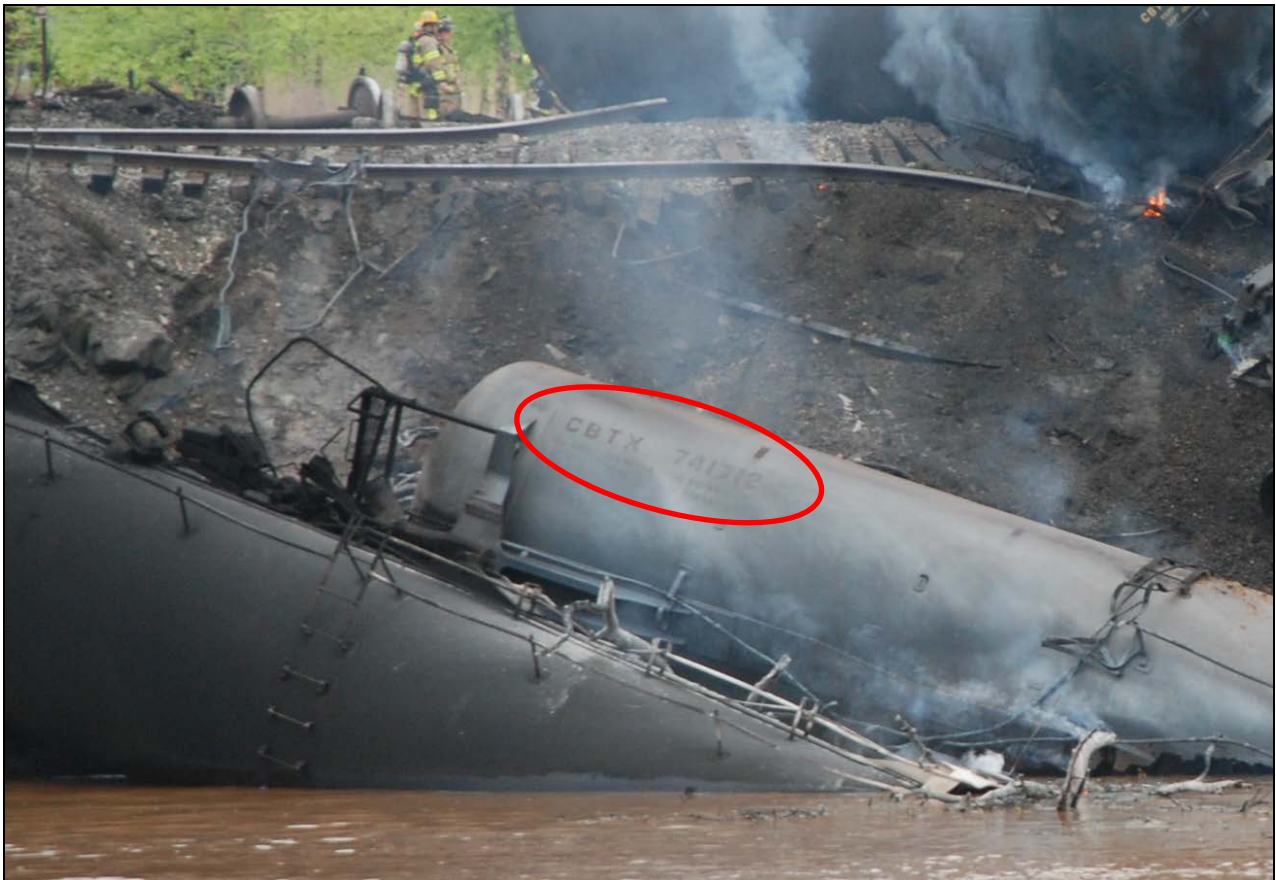
The derailed tank cars were GPS tagged to record the position at which they came to rest after the derailment. Arcadis, a CSX contractor, produced a diagram of GPS locations which is provided in attachment 17. There is an error in the diagram - the locations of tank cars GATX 286291 and CBTX 741712 are reversed. Tank car CBTX 741712 came to rest on top of GATX 286291 and was located closer to the river embankment. This is supported by the photograph in figure 6.

Figure 6: Close-up of tank car reporting marks – CBTX 741712.

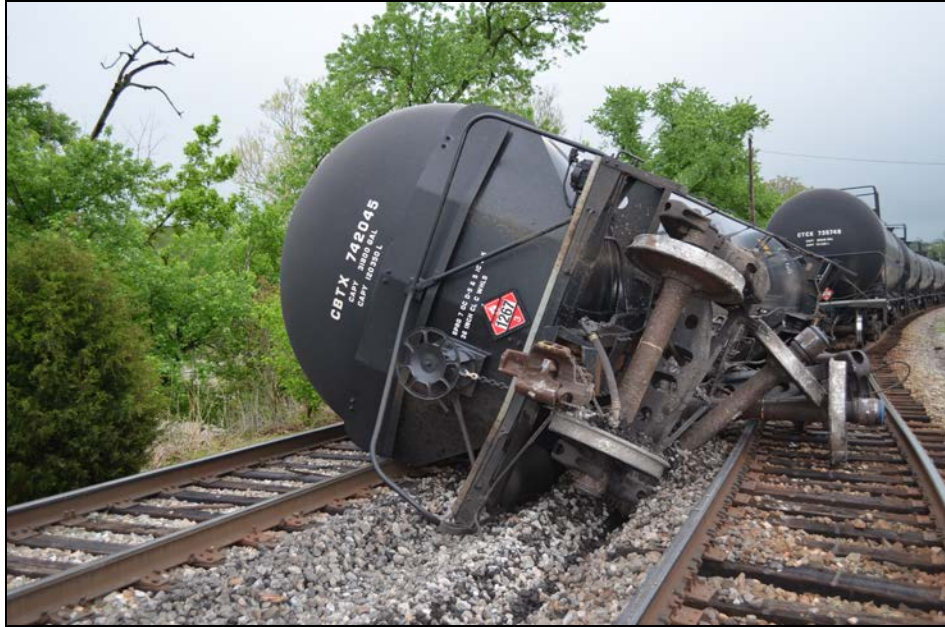
The seven (7) tank cars in positions 35 through 42 fell on their sides towards the James River, traversing track 1. These cars had their sides leaning against the south-side rail of track 1. See figures 7 and 8.

Figure 7: CBTX 742045 leaning against the south-side rail of track 1.

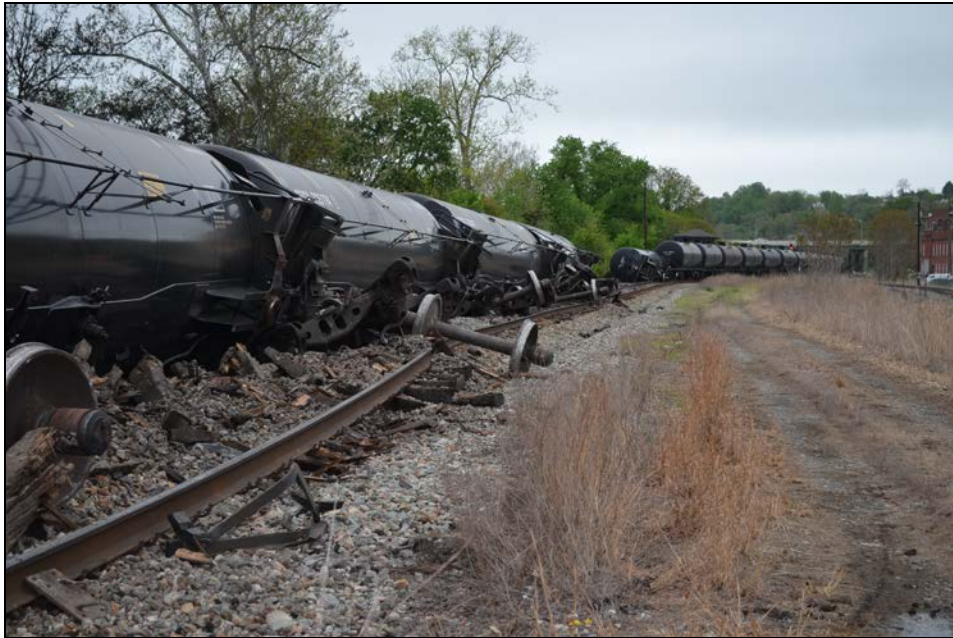
Figure 8: Overturned tank cars leaning against the south-side rail of track 1.

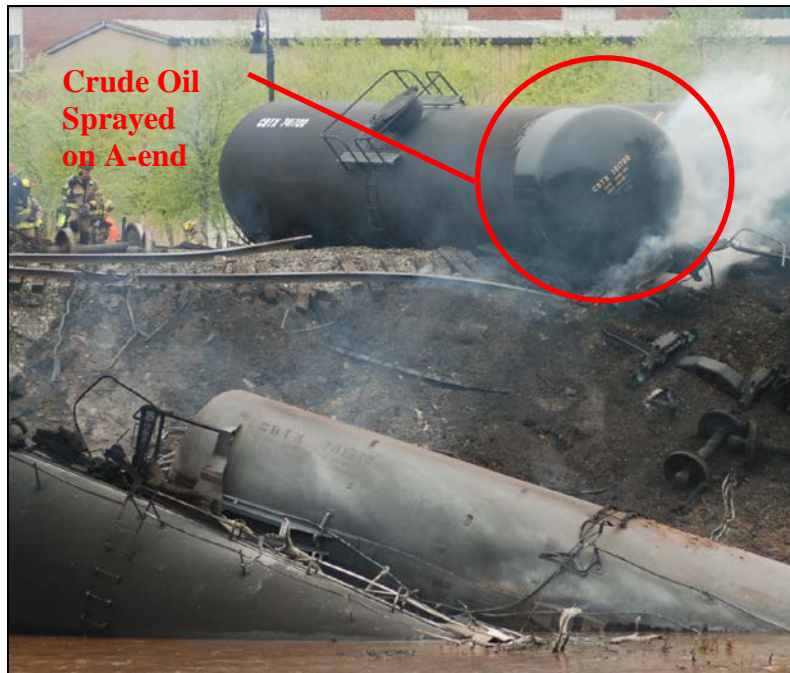
CBTX 741720 was found perpendicular to track 1 with its A-end on the embankment. The A-end head and portions of the shell were covered with unburnt crude oil. The oil had a directional spray

pattern focused around the A-right body bolster. See figures 9 and 10. CBTX 741672 (position 46) was found on the river embankment with its A-end submerged in the river (1/3 submerged). The tank cars in positions 47 through 51 accordioned on the tracks.

Figure 9: A-end of CBTX 741720 with sprayed crude oil.

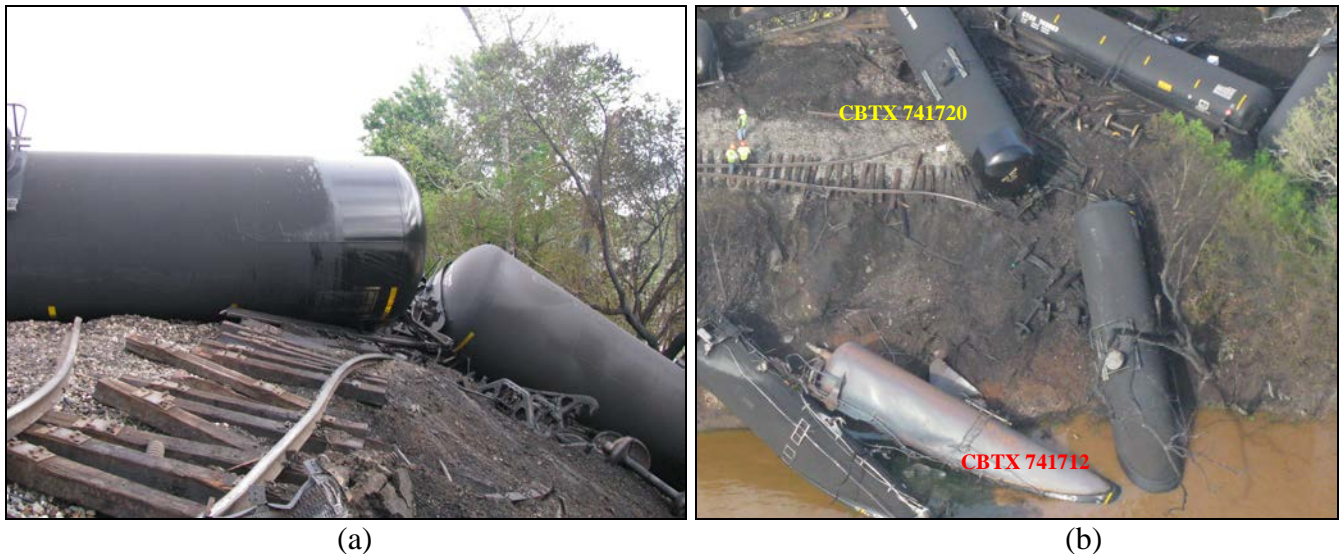
Figure 10: Other angle views of A-end of CBTX 741720 with sprayed crude oil.

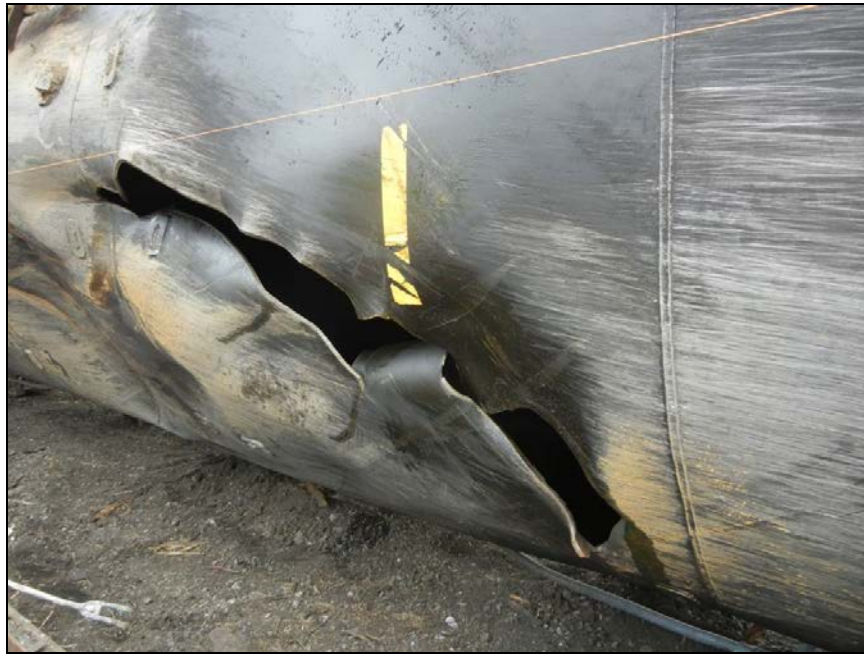
CBTX 741712 had a mechanical tear approximately 95-inch long in its right-side shell that ran through rings 4 and 5. See figures 11 and 12. The tear occurred below the right-side centerline. The examination indicated that an object scraped the shell of the tank car and, at the longitudinal seam weld between rings 4 and 5, tore into the shell producing two coiled up rolls of metal extending into the inside of the tank. See figure 13.

Figure 11: Mechanical tear in shell of CBTX 741712 with dimensions.

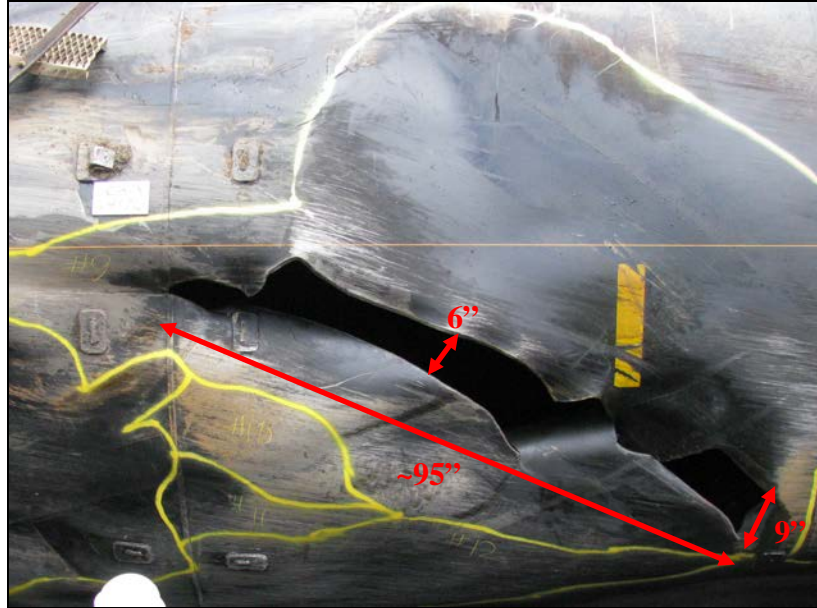
Figure 12: Mechanical tear in shell of CBTX 741712 with dimensions.

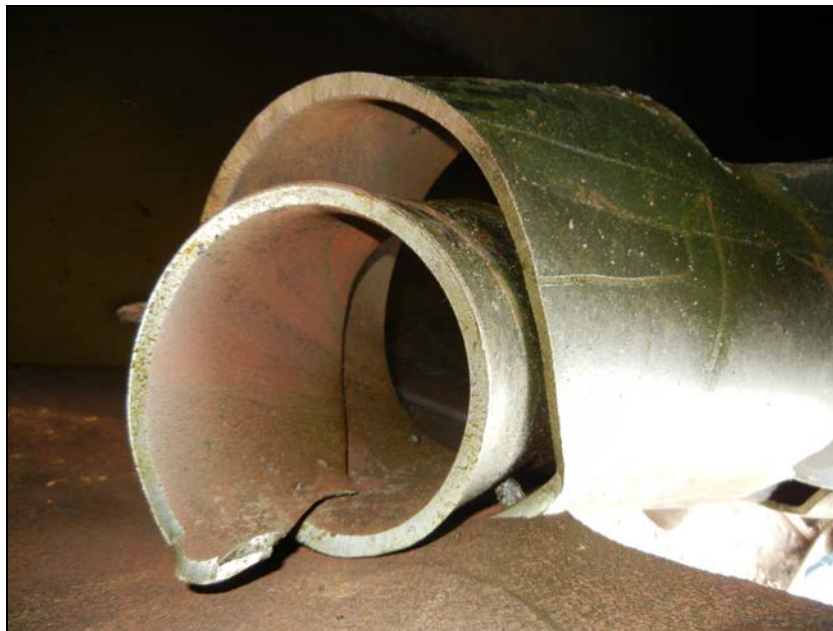
Figure 13: Coiled up shell metal inside the tear in CBTX 741712.

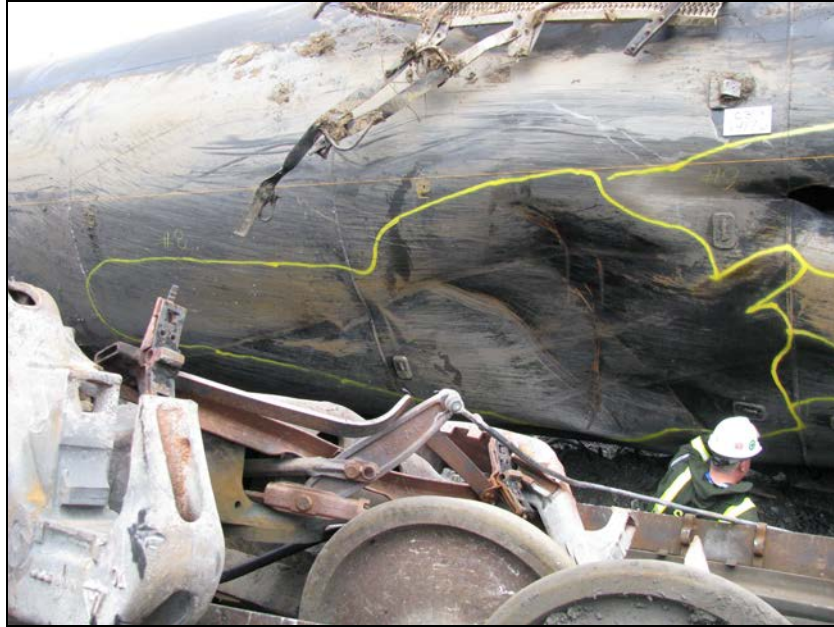
Other damage to CBTX 741712 included a large dent extending the full width of shell rings 2 and 3 (see figure 14), a sheared off bottom outlet valve nozzle (see figure 15), a large dent in the A-head (above the half-height head shield) that was approximately 9.5 inches deep (see figure 16), a large dent in rings 5 and 6 on the underside of the tank car's right-side (see figure 17), a 4 inch deep dent in ring 3 of left-side that was approximately 36 inches by 67 inches, and bulging of the left-side shell towards the B-end that was submerged in the river water (see figure 18). There was no damage to the multi-housing or valves of the tank car (see figure 19). The A-end half-height head shield was torn off the tank; however, the B-end shield remained attached.

Figure 14: Large dent in shell rings 2 and 3 of right-side of CBTX 741712.

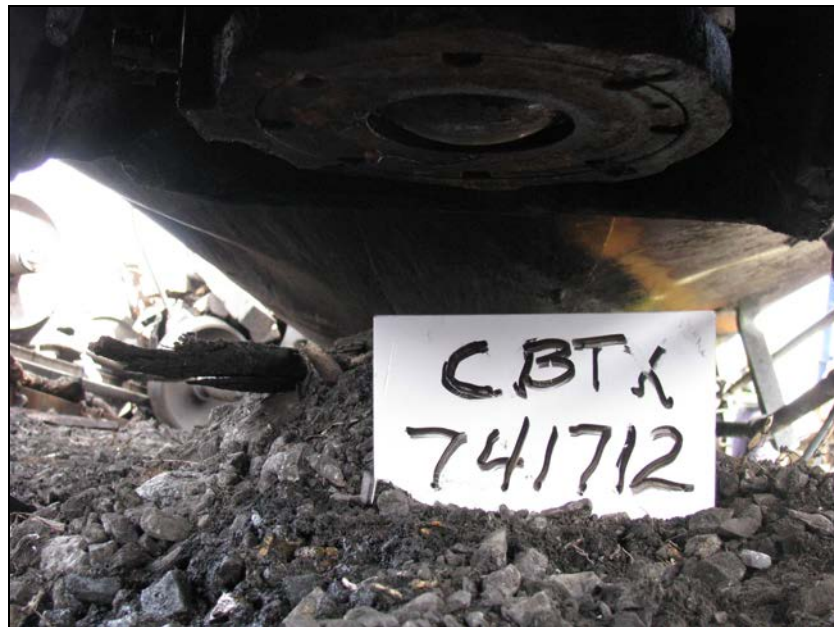
Figure 15: Sheared off bottom outlet nozzle of CBTX 741712.

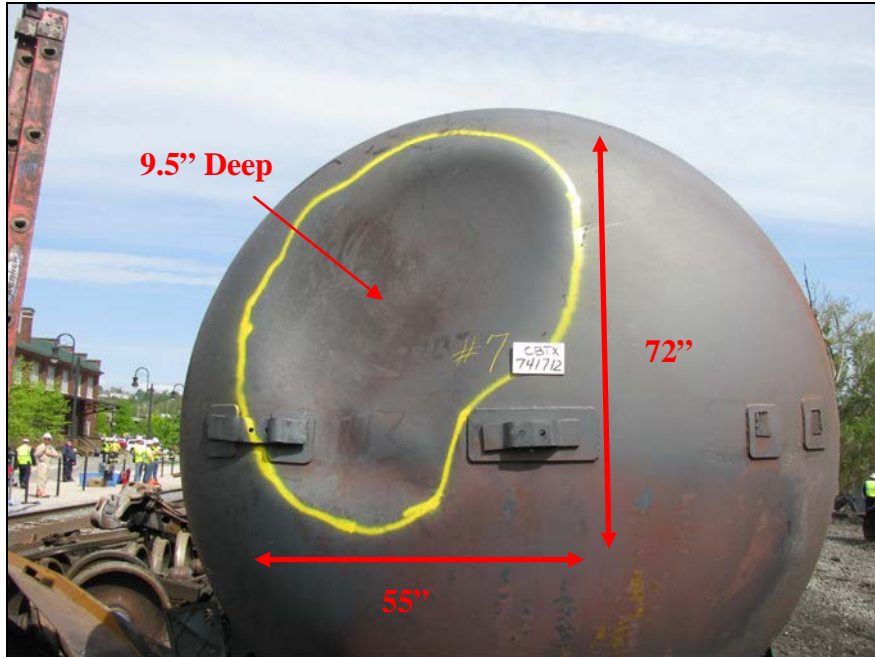
Figure 16: Large dent in the A-head of CBTX 741712.

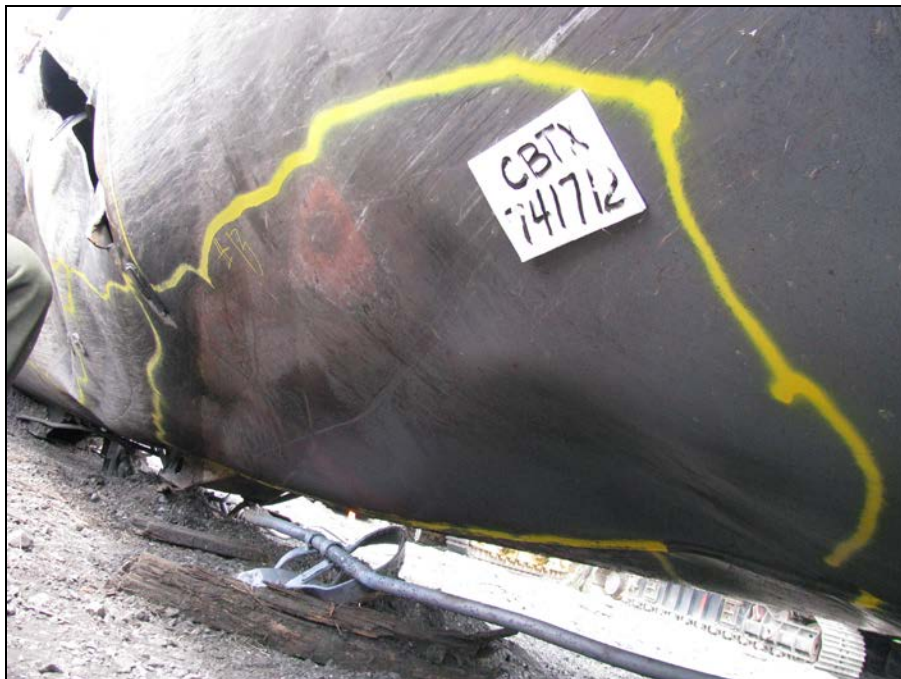
Figure 17: Large dent in rings 5 and 6 on the bottom of the right-side of CBTX 741712.

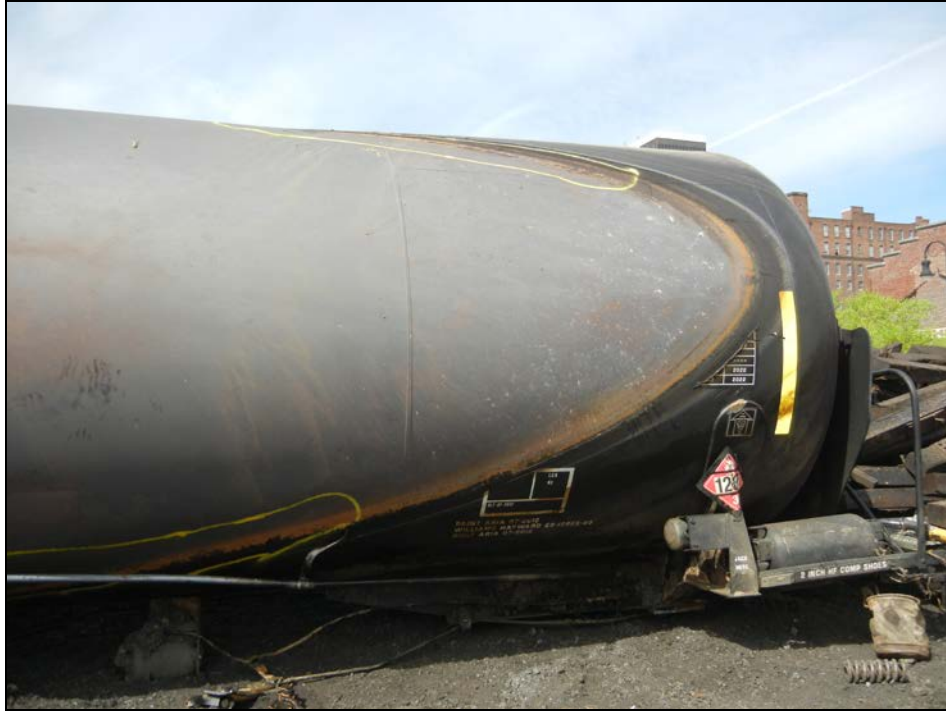
Figure 18: Bulging of the left-side shell of CBTX 741712 towards the B-end that was submerged in the river water.

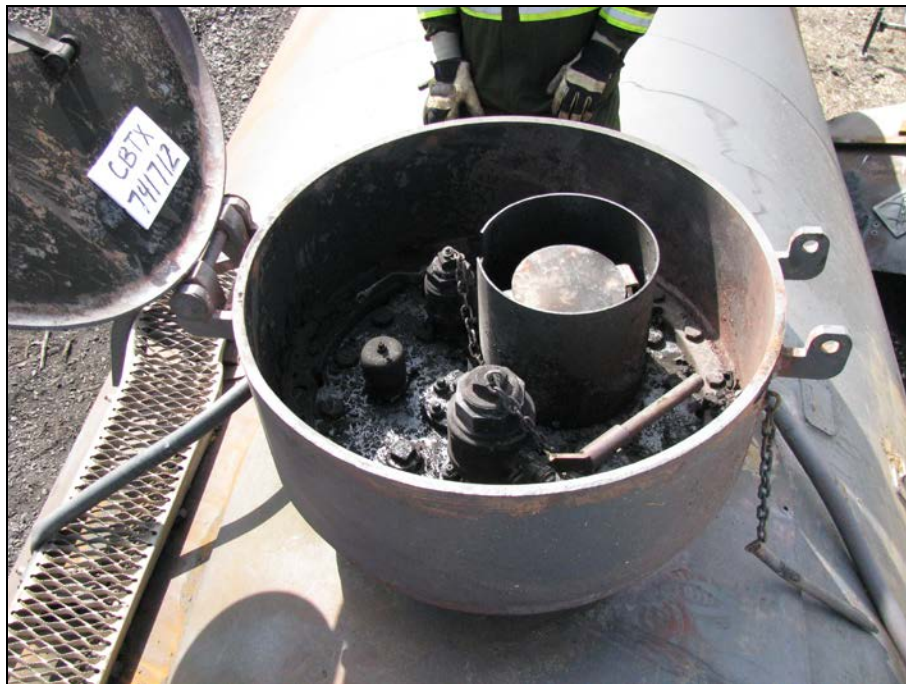
Figure 19: Multi-housing of CBTX 741712.

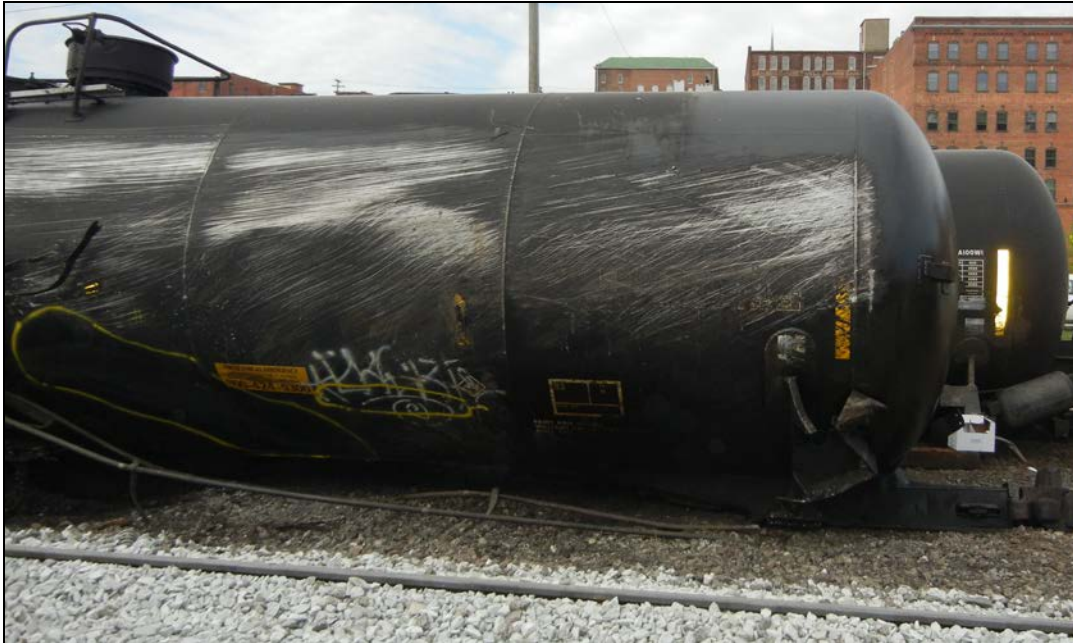
Most damage to CBTX 741720 occurred on the right-side of the tank, particularly to the A-right body bolster. The lower portion of the body bolster web was deflected outboard toward the A-end, while the upper portion - made of solid 2inch thick steel- was partially deflected outboard. An 18.5 inch section

of the A-right body bolster pad (toward the middle of the tank) was pulled apart 1.25 inches from the shell. See figures 20 through 23. The bottom right-side had several large dents that extended the entire length of the tank car. The A-end half-height head shield was torn off the tank; however, the B-end head shield remained attached. There was minimal damage to the left-side of the tank. See figure 24.

Figure 20: Tank car CBTX 741720.

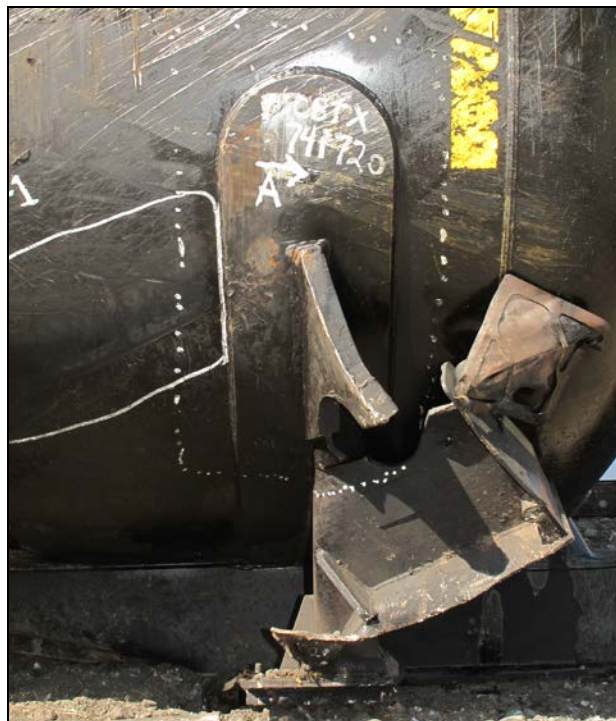
Figure 21: Damage to CBTX 741720 A-right body bolster.

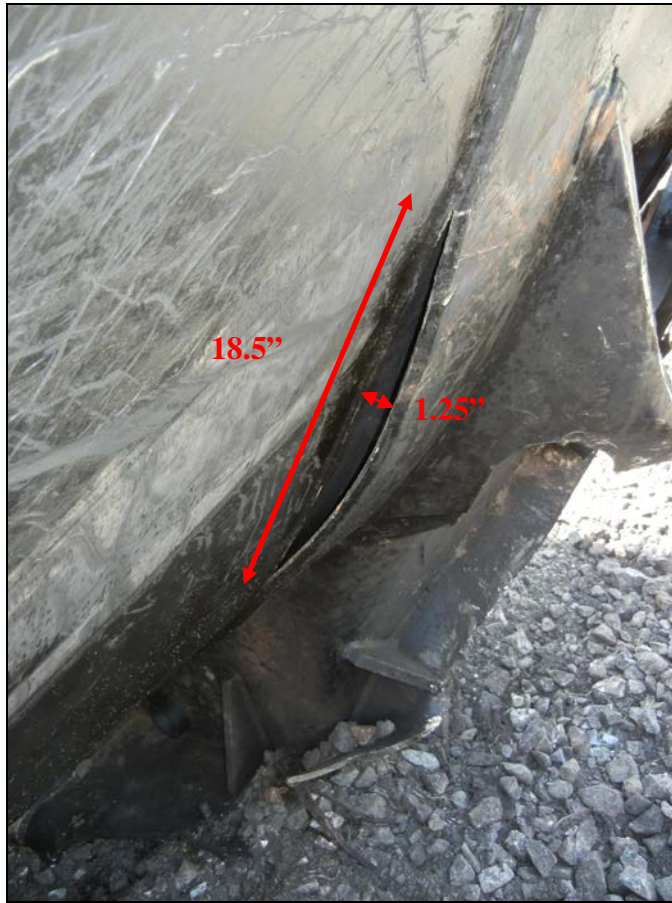
Figure 22: CBTX 741720 A-right body bolster pad separation from shell.

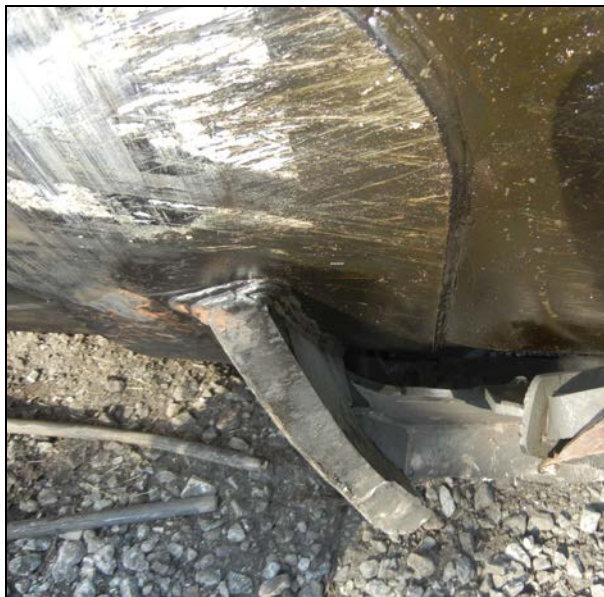
Figure 23: Deflection of CBTX 741720 A-right body bolster.

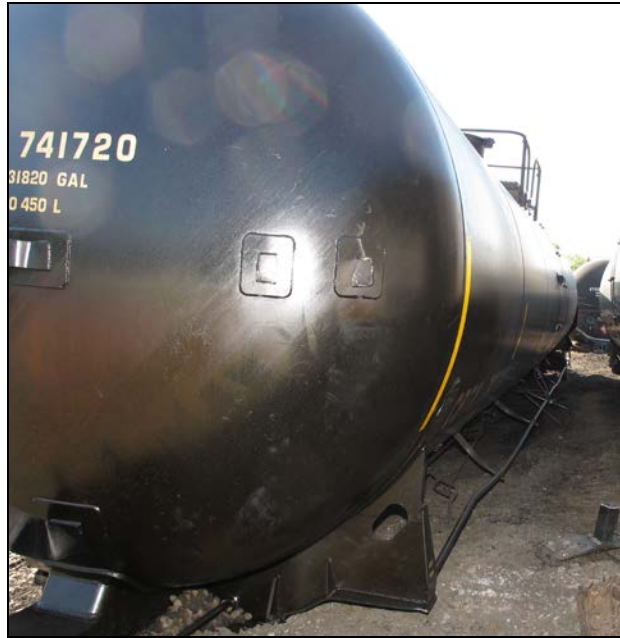
Figure 24: Minimal damage to left-side of CBTX 741720.

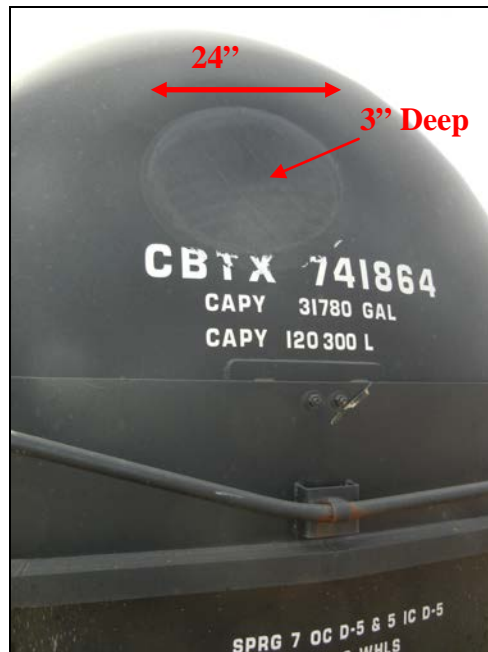
Three tank cars (CBTX 741864, CBTX 741712, and CBTX 743190) had impact dents on a head that occurred above the half-height head shield. See figures 25 and 26.

Figure 25: Head impact above half-height head shield (A-end) on CBTX 741864

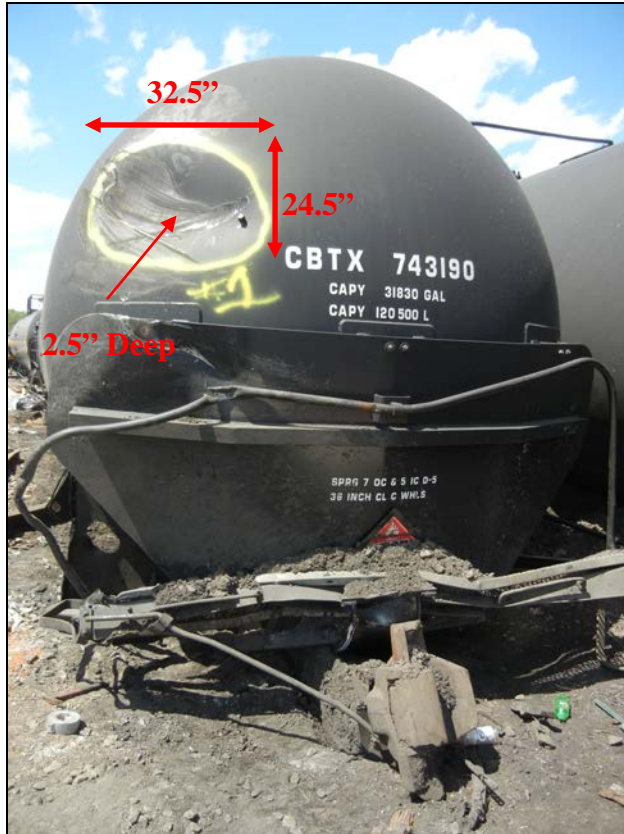
Figure 26: Head impact above half-height head shield (A-end) on CBTX 743190.

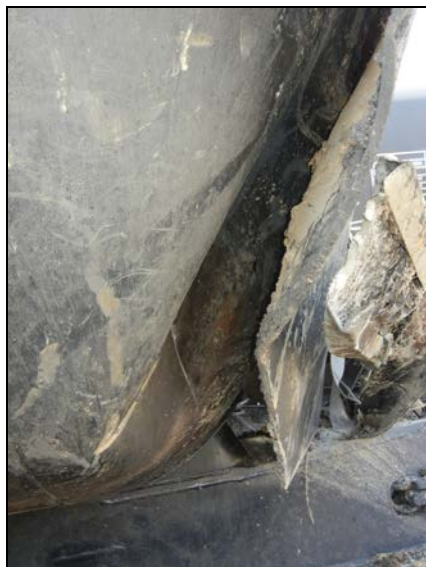
CBTX 741672 sustained a head impact that dented the A-end half-height head shield and resulted in a large dent behind the head shield. This dent measured approximately 3.5 feet in diameter and was about 10 inches deep.

Figure 27: Head impact behind the half-height head shield (A-end) on CBTX 741672.

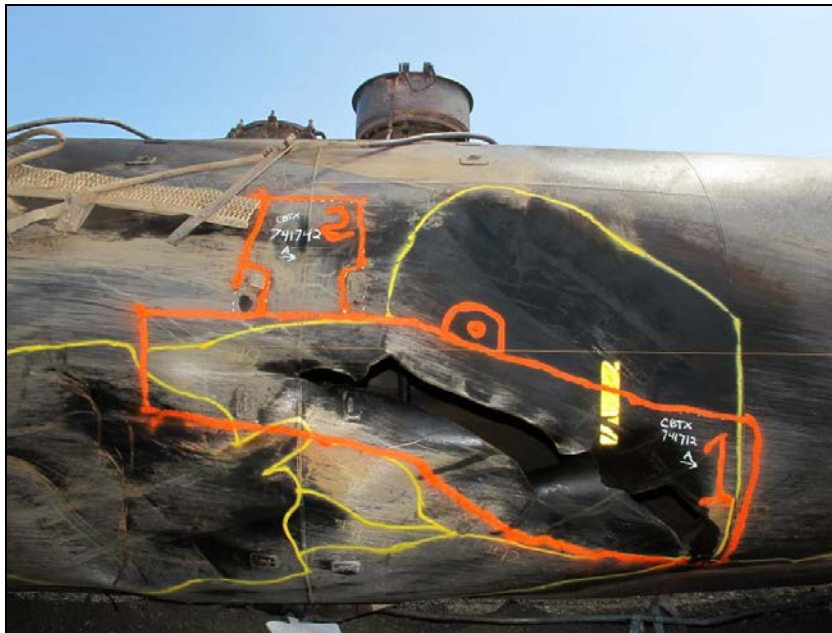
1. NTSB Evidence Control # 14FR008-HM-001
CBTX 741712 - rectangular section encompassing the entire breach in the right-side of the tank car.
2. NTSB Evidence Control # 14FR008-HM-002
CBTX 741712 - rectangular section encompassing a non-affected longitudinal weld between shells 3 and 4.
3. NTSB Evidence Control # 14FR008-HM-003
CBTX 741720 – A-right body bolster.

Figure 28: Mechanical tear in shell of CBTX 741712 outlined in orange and the #1.

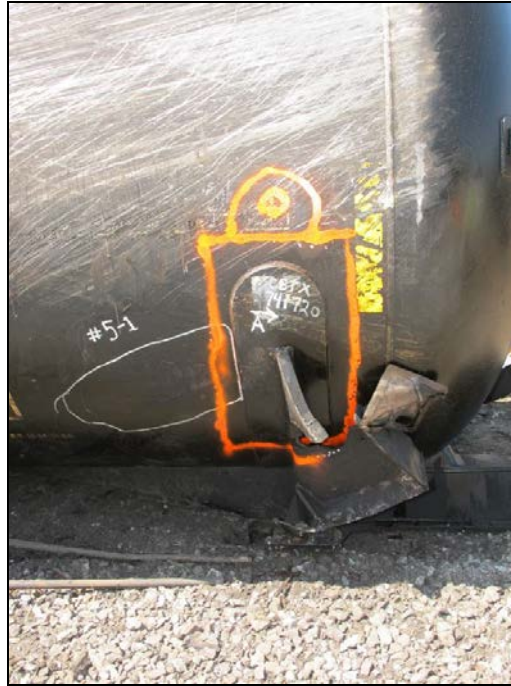
Figure 29: A-right body bolster of CBTX 741720 outlined in orange.

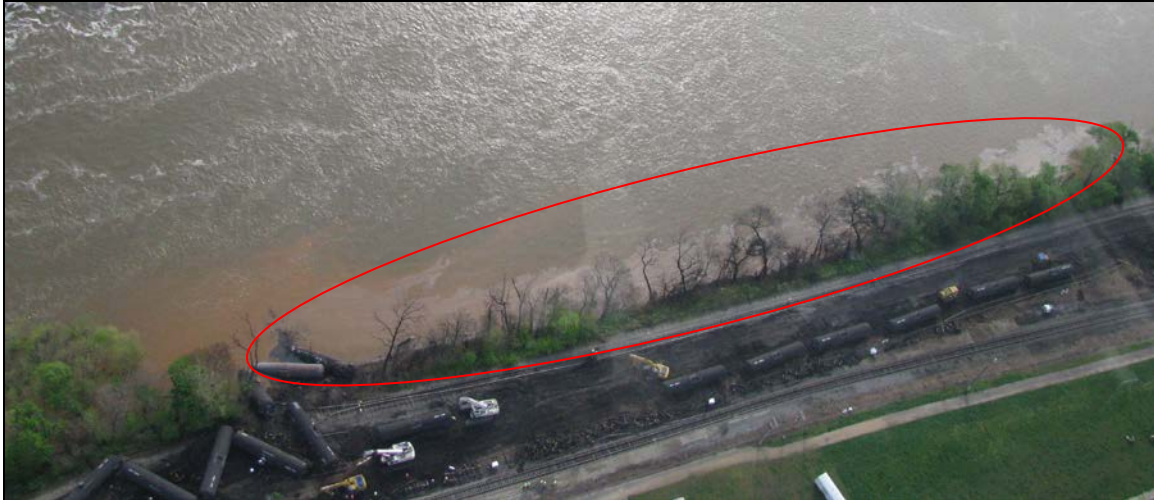
Figure 30: Accident scene showing crude oil sheen moving down river.

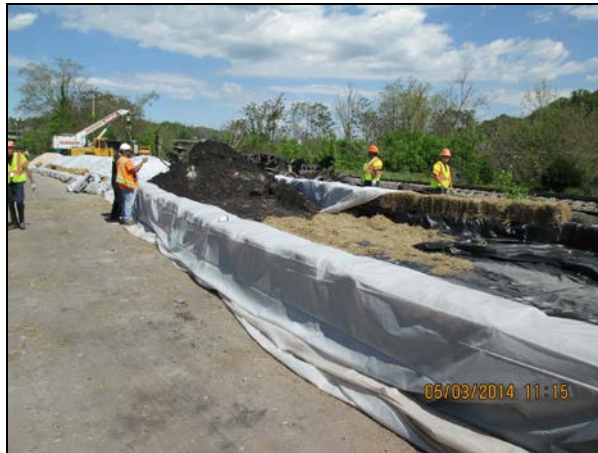
Three phases of soil excavation were completed at the accident site, on May 2, 3, and 20, 2014. Soil excavation was performed to remove impacted material from the track bed and slope without destabilizing the embankment. Approximately 260 tons of soil and ballast were removed during the excavations.

Figure 31: Soil excavation and collection from the accident site.
