Car Damage Report

1-07-14
DGT-004
Rev 2

Location Graettinger IA

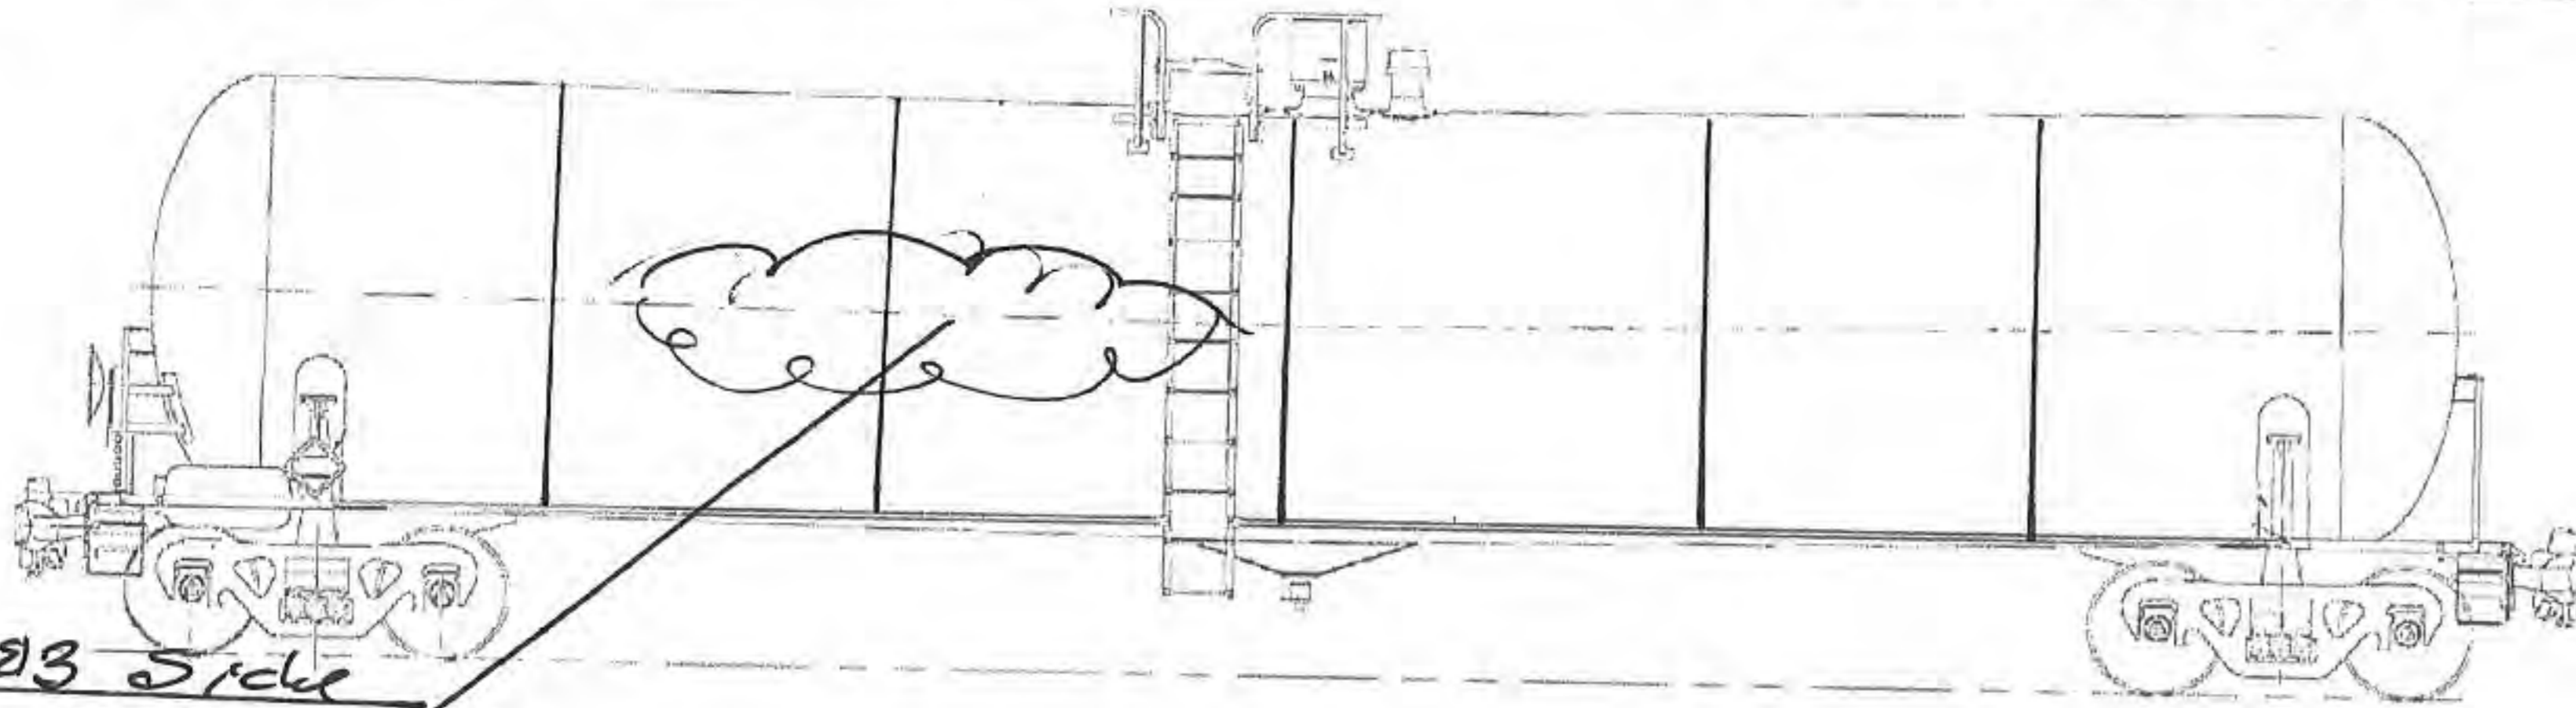
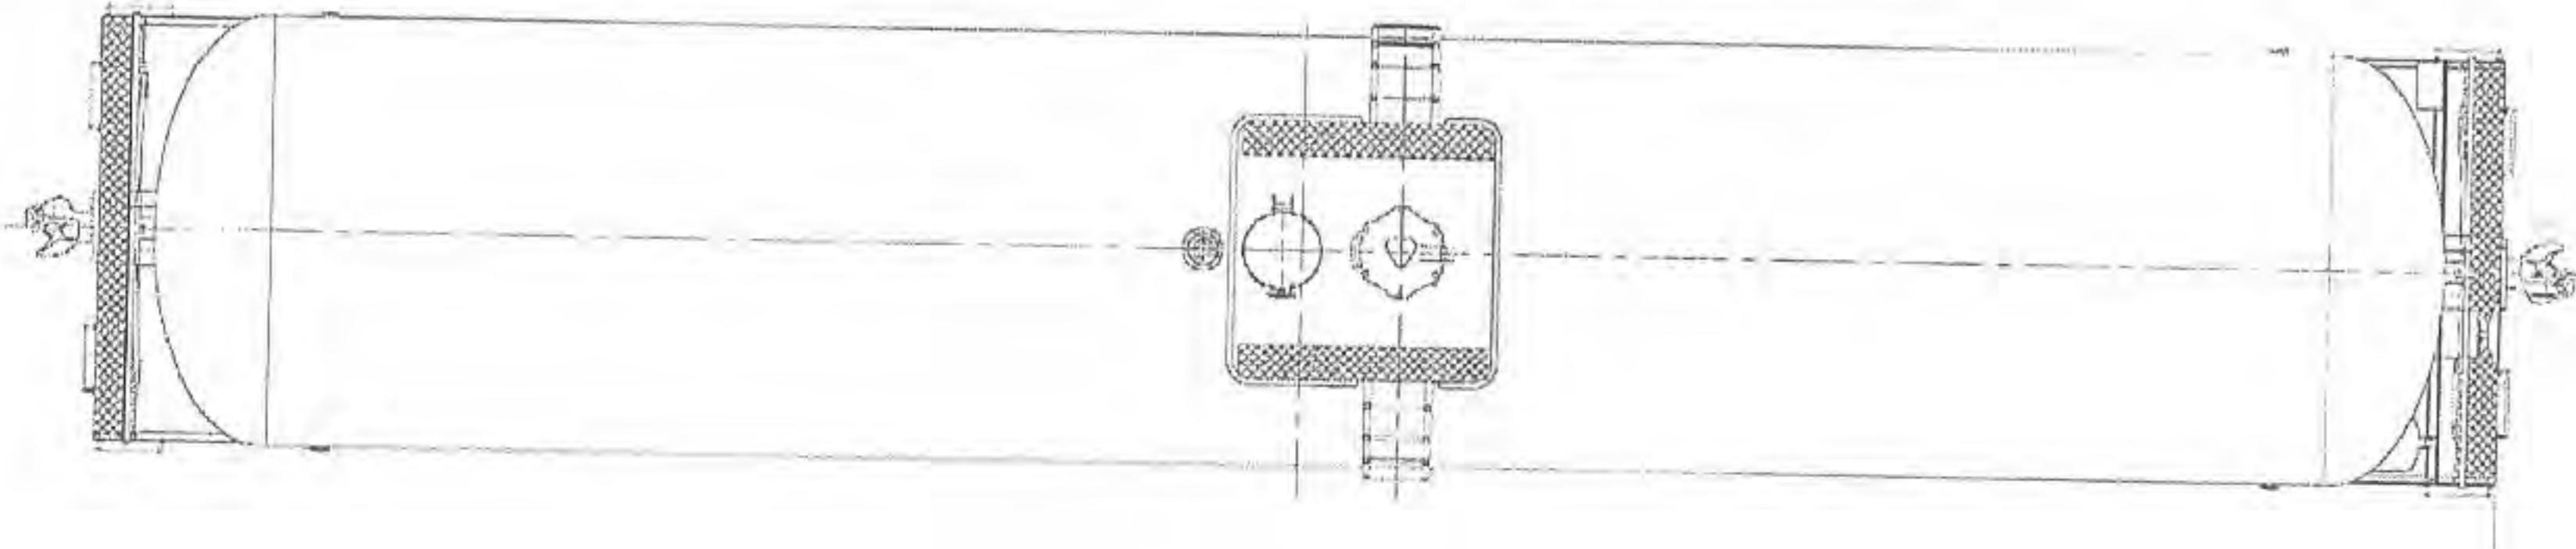
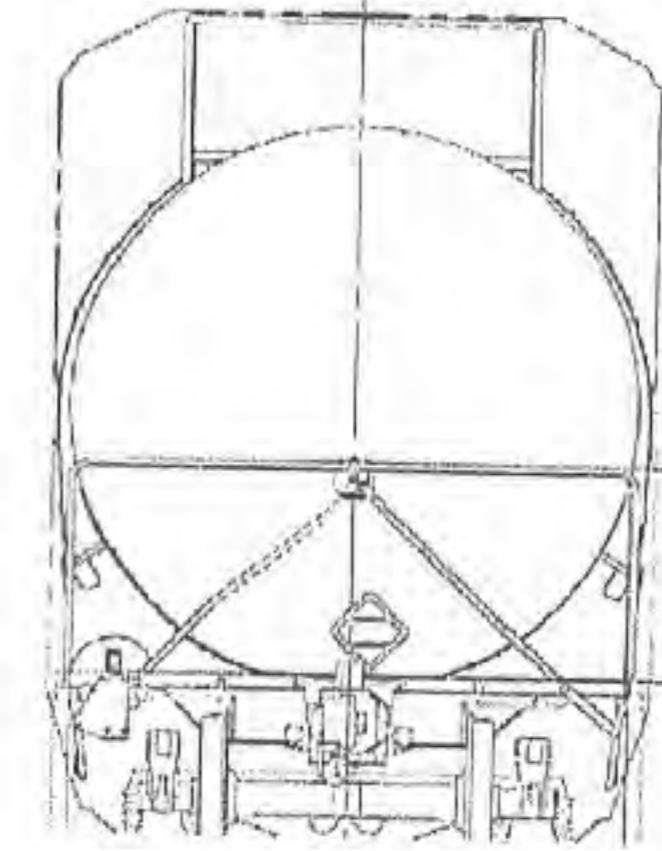
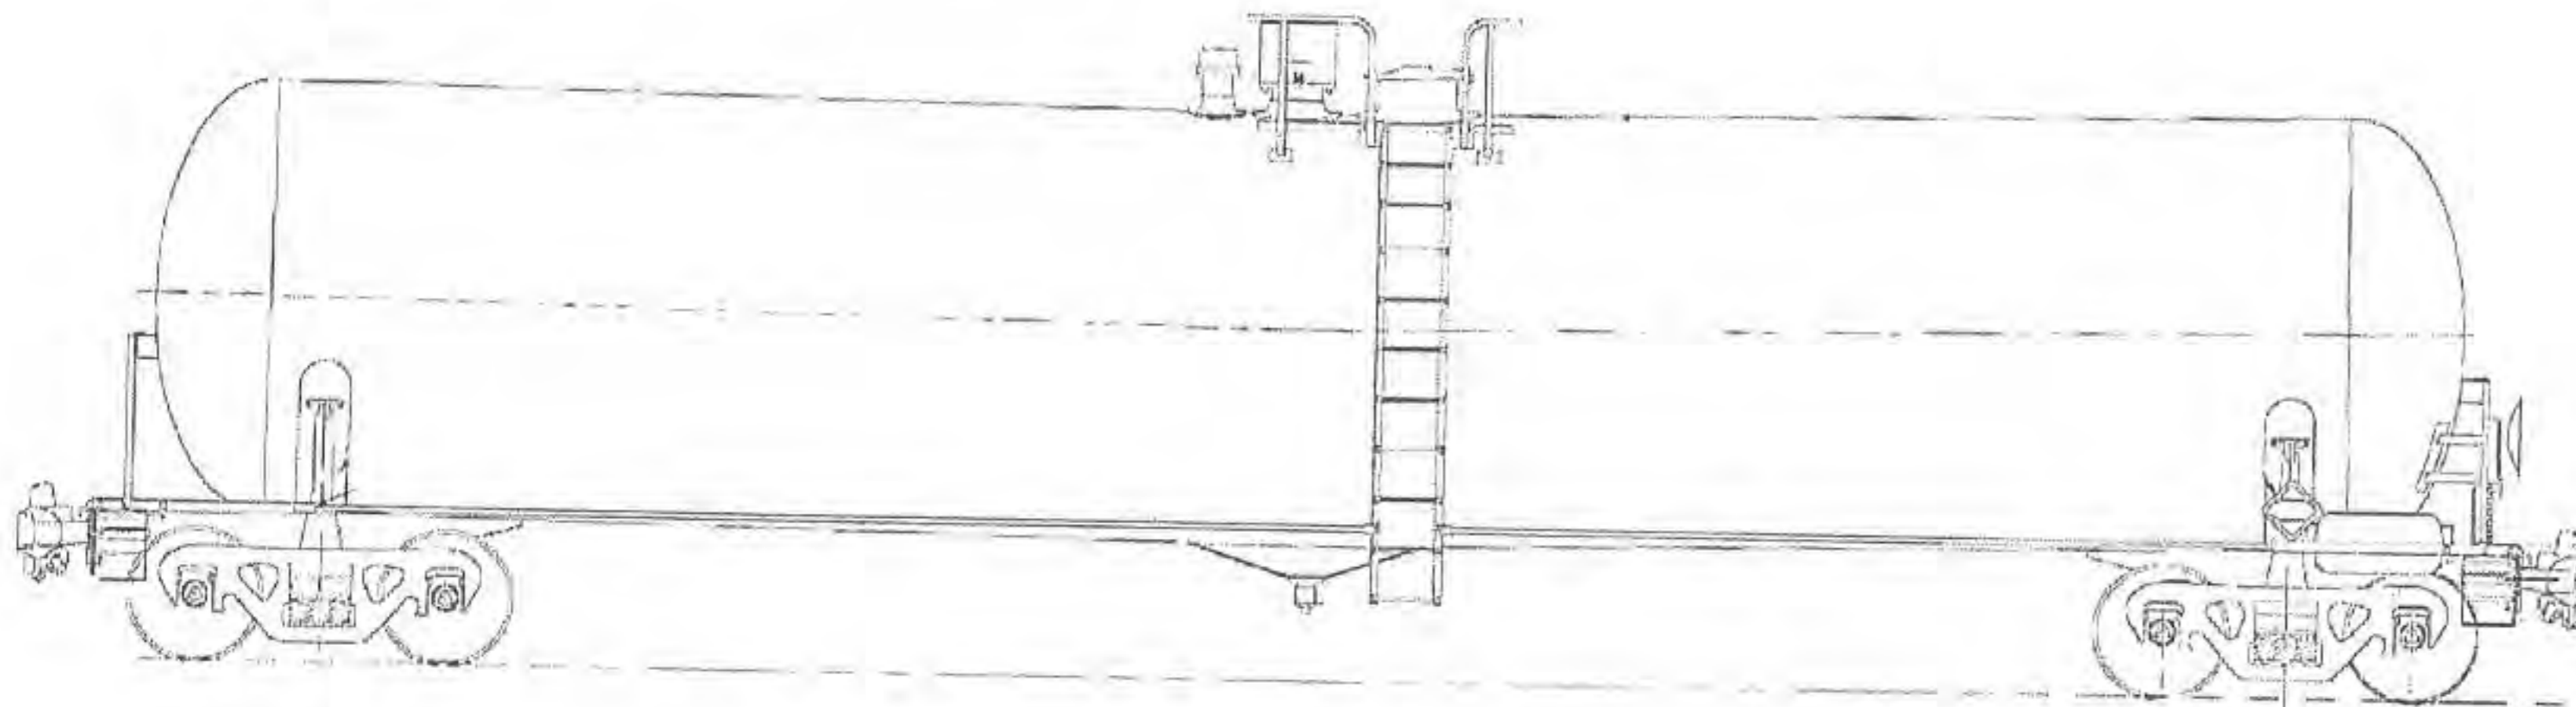
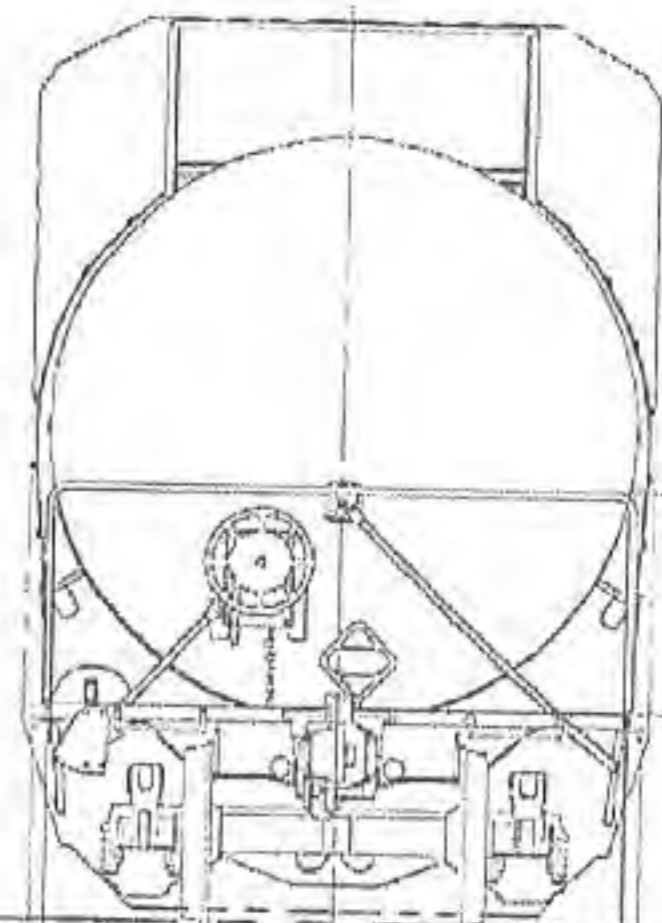
Car Number DBuy 301674

Ring 283 Side
SHEET DEFORMATION

Top fittings multi-housing 2" VAPOR VALVE HIPPLE BLEW FROM PLATE
Bottom Outlet manway & PRD INTACT
Punctures INTACT - HANDLE NO DAMAGE
Draft sill NO DAMAGE

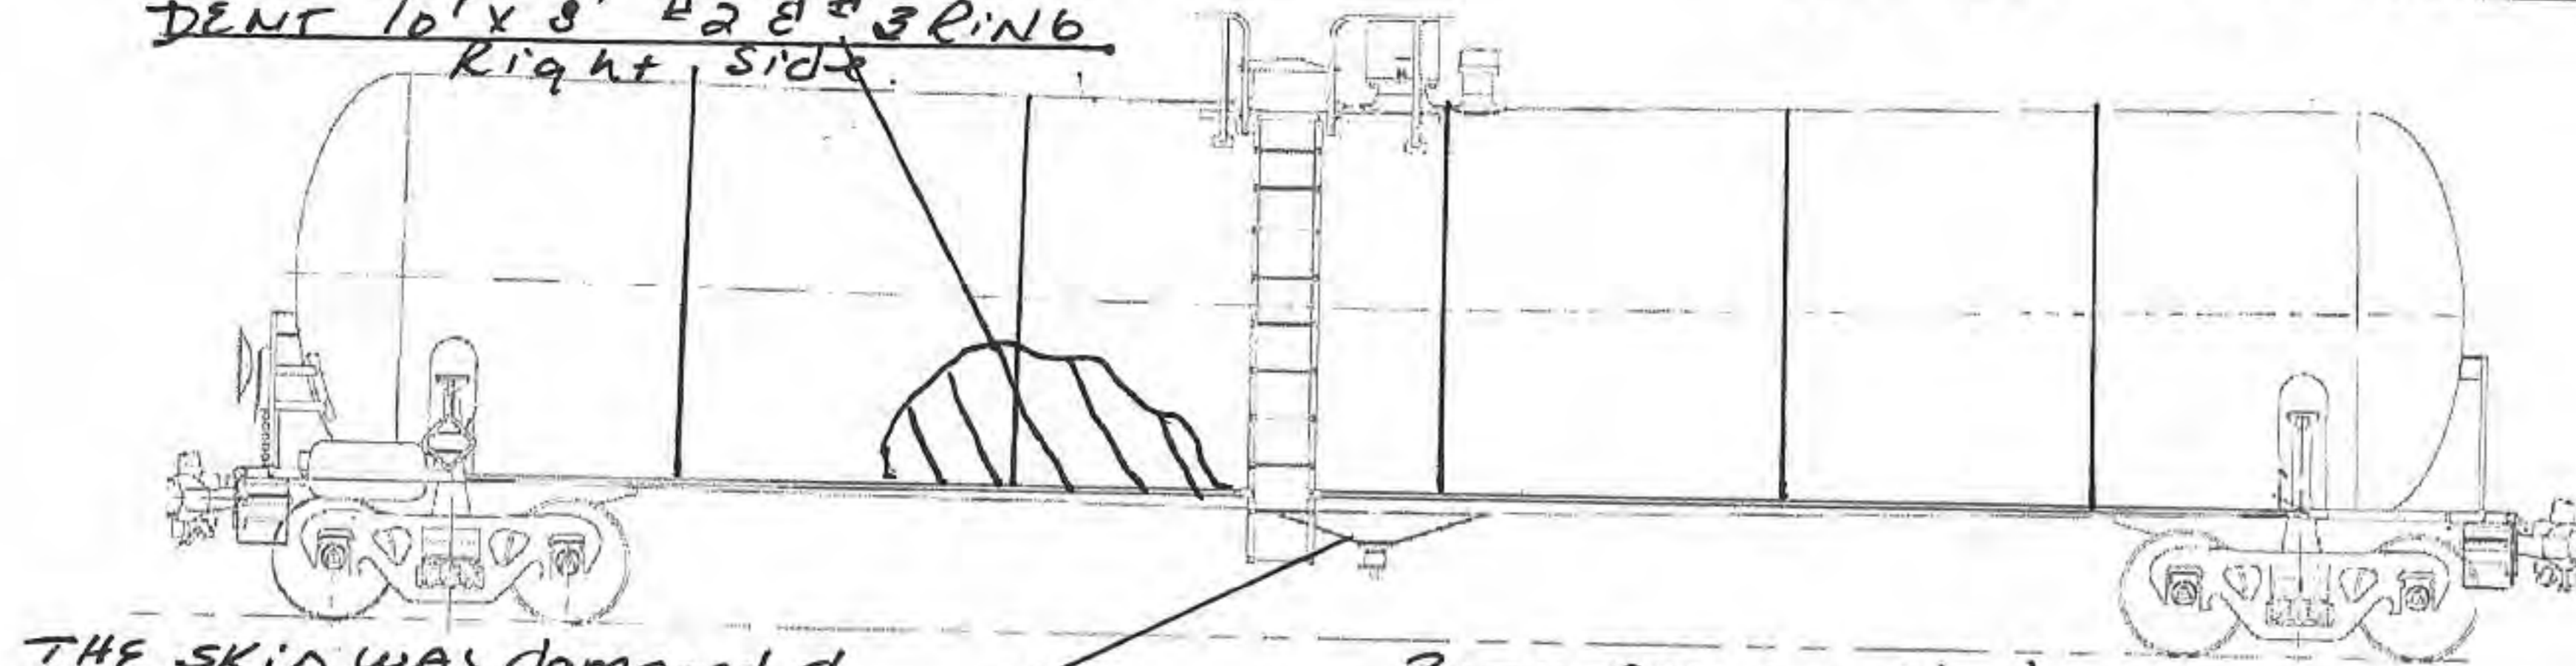
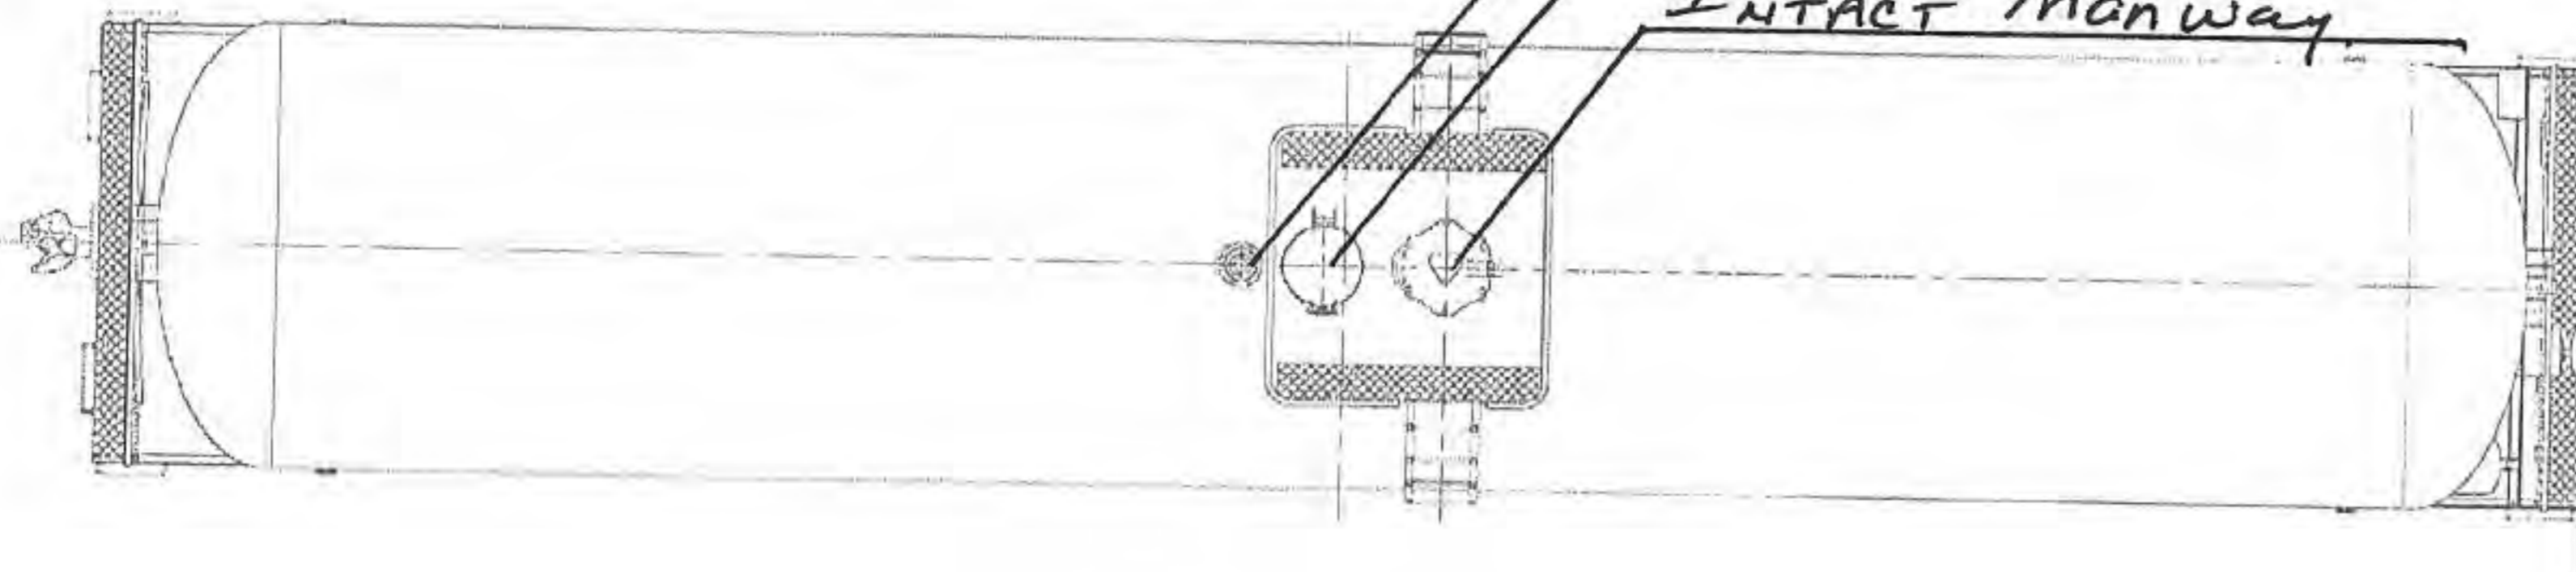
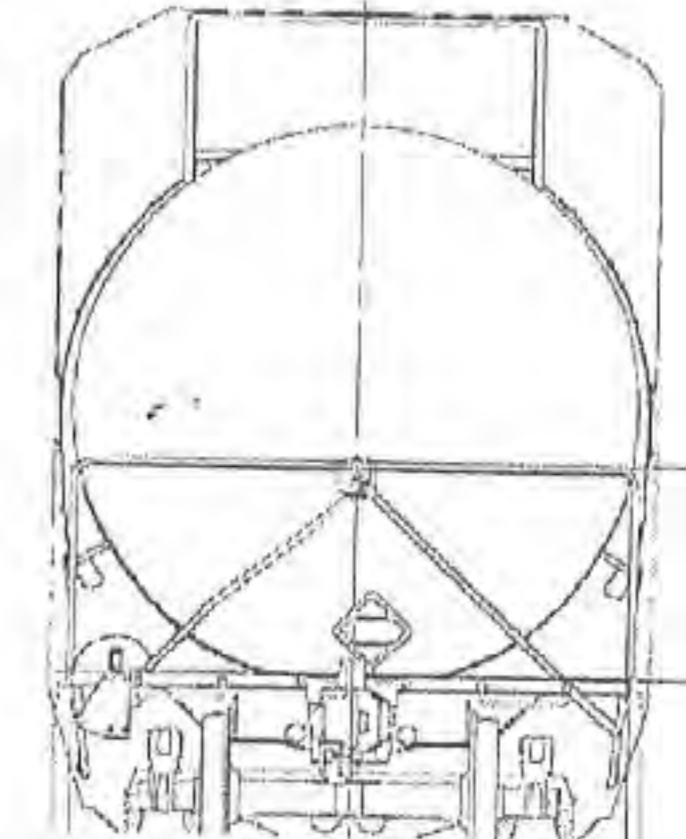
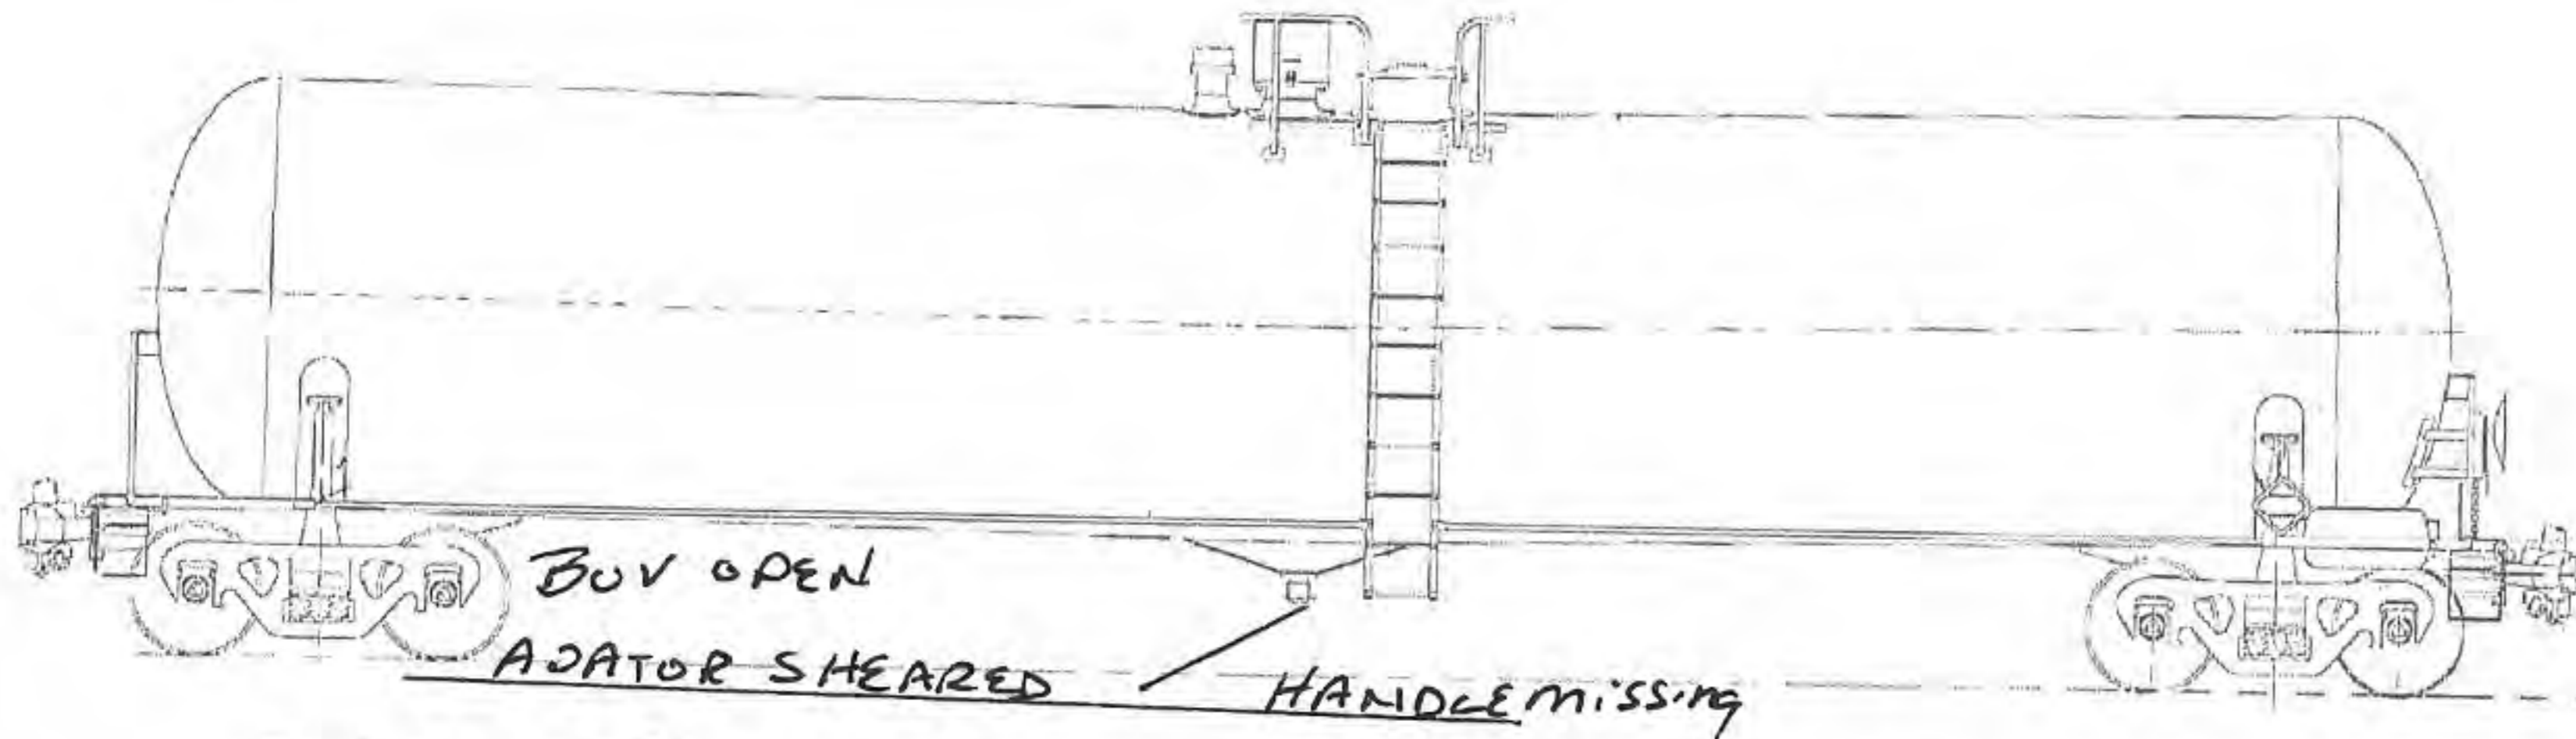
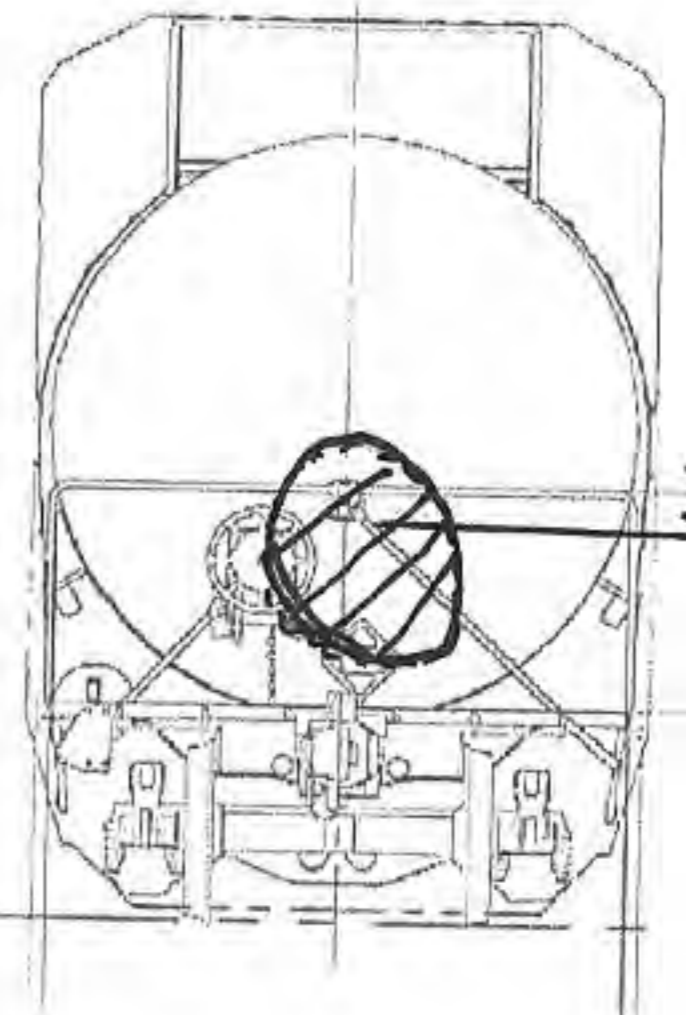
Car Number TAEX 2893

DENT 10' x 8' H2E#3RING
Right side

THE SKID WAS DAMAGED & EXPOSED THE BOV TO DAMAGE

BOTH PRO & MULTI-HOUSING INTACT

INTACT MANWAY

B STUB SILL TORN

Top fittings _____
Bottom Outlet OPEN, ADAPTOR SHEARED, HANDLE MISSING
Punctures _____
Draft sill _____

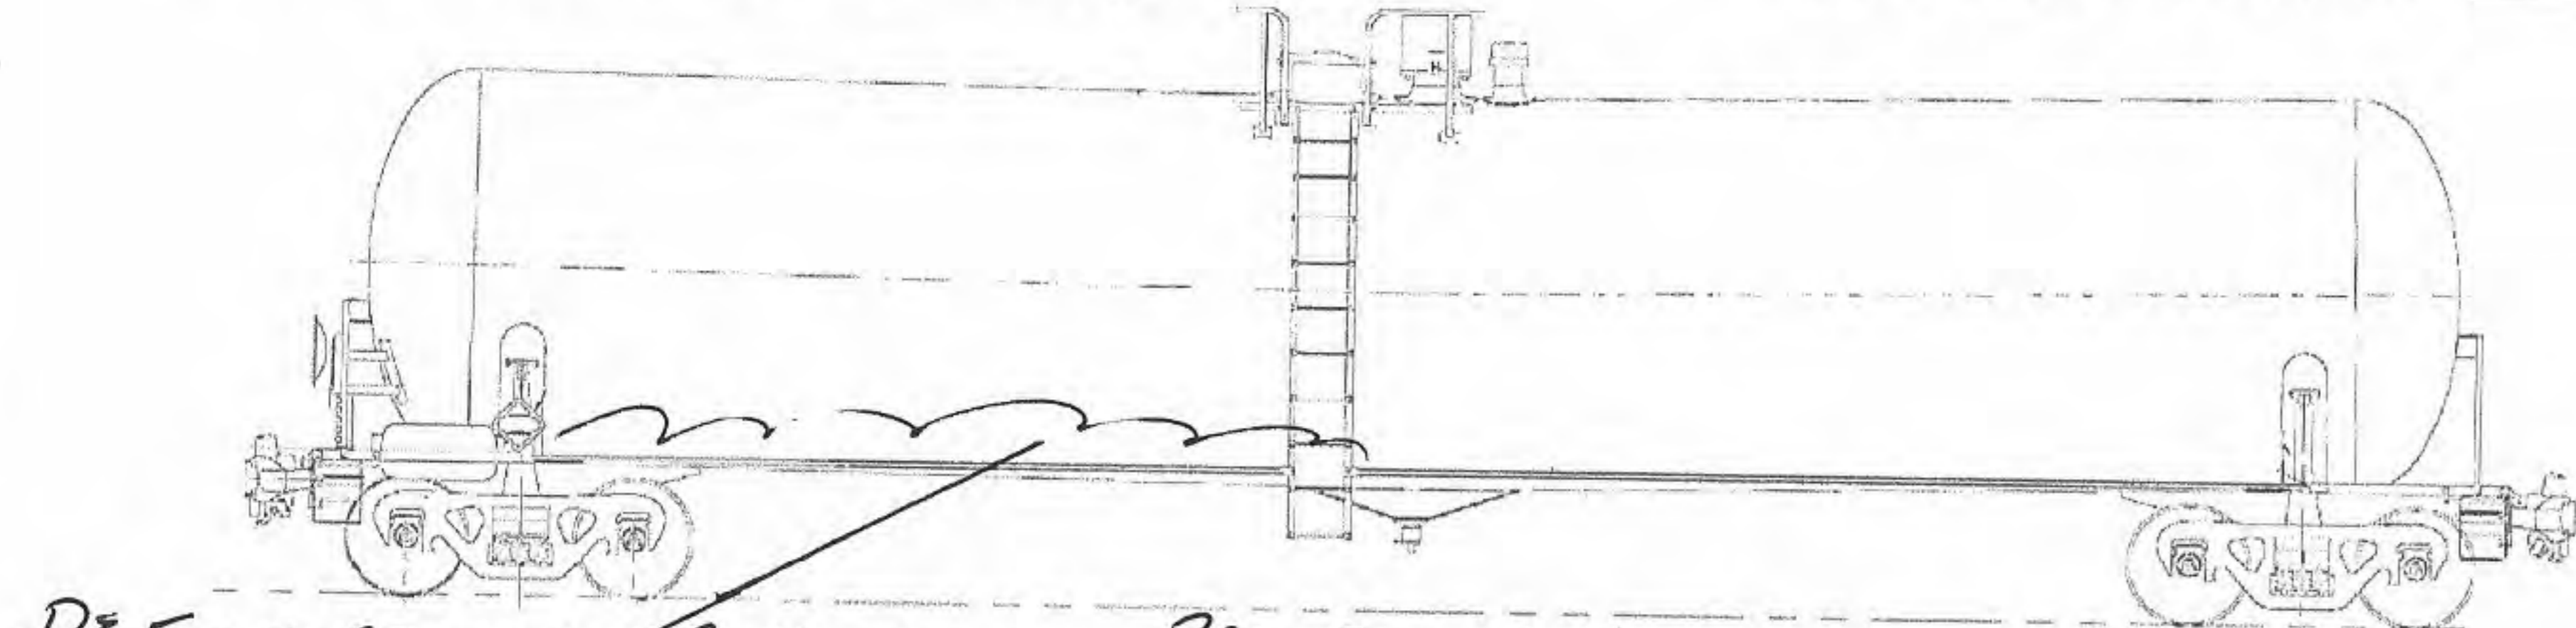
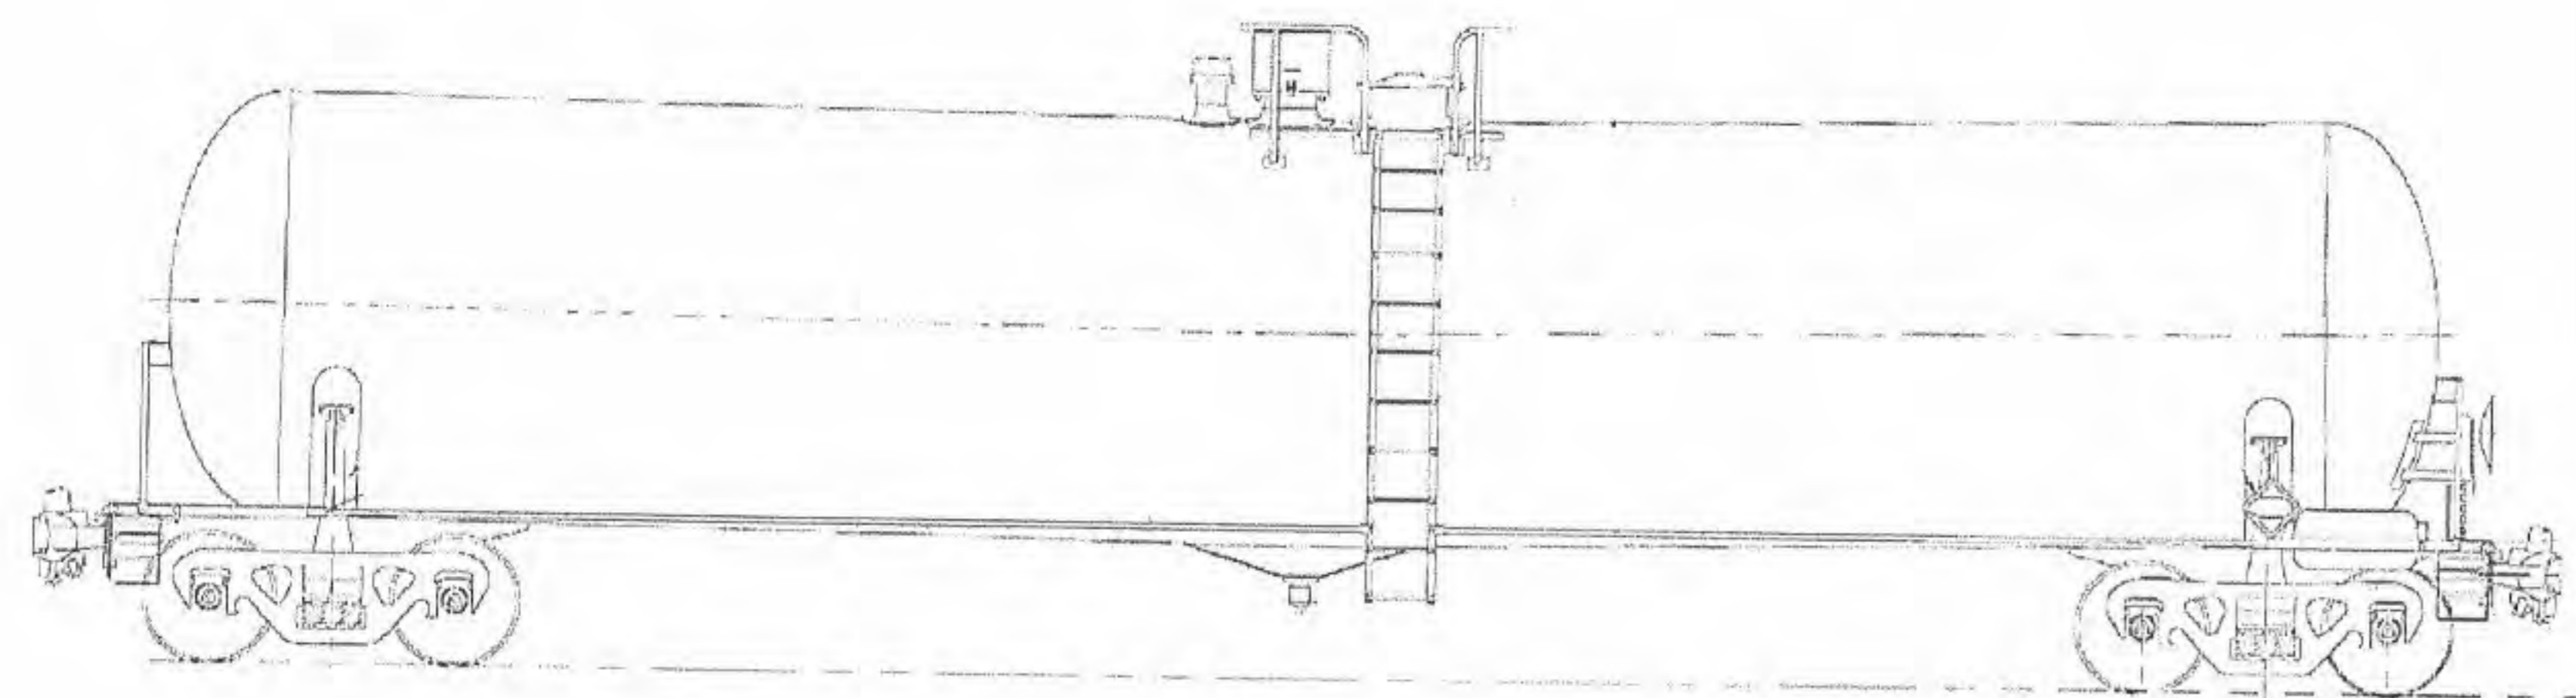
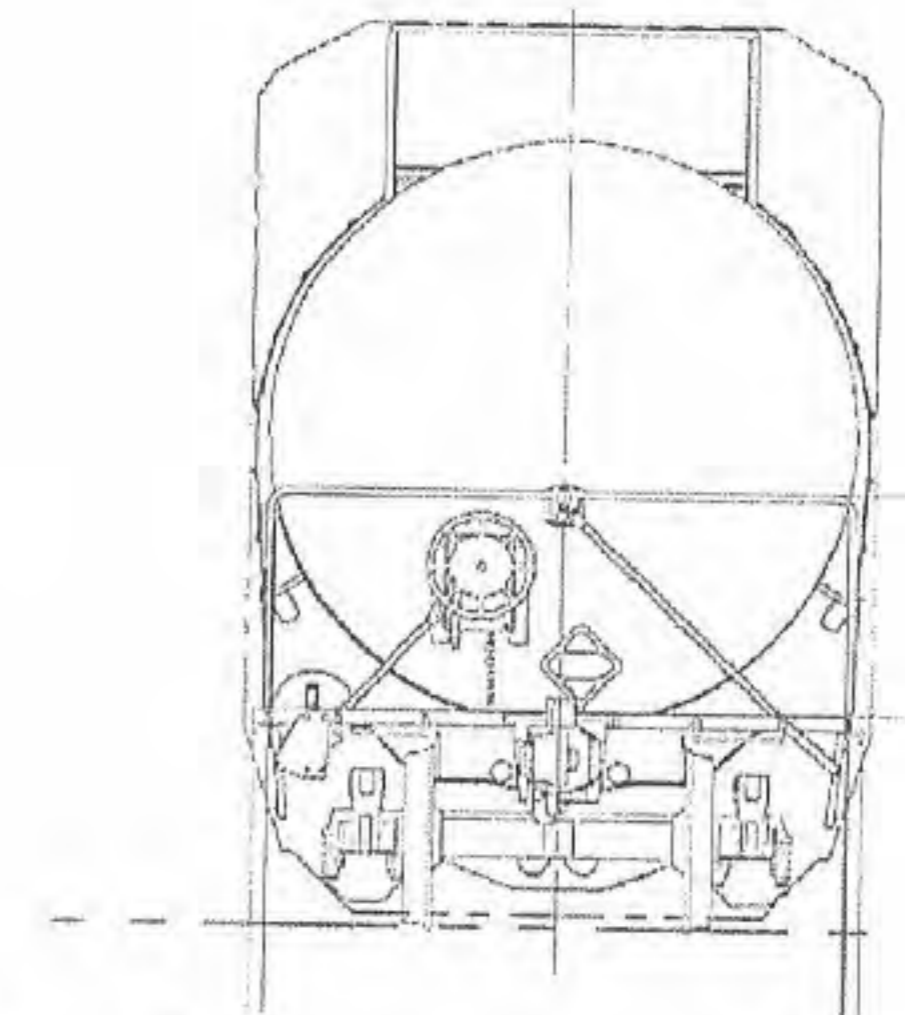
Car Number TILY 199147 ~~199147 9E~~

DEFORMATION of Bottom of car TO BOV FROM B-END

PRD & multi-housing INTACT

Manway INTACT

CREASE 2.5'
DENT 2' x 2.5'

DENT 3' x 4'

#1 HOLE APPROXIMATE 24" x 1"
#2 HOLE APPROXIMATE 12" x 8"

DENT 4' x 5'

Top fittings PRD, Manway, Multi-housing INTACT
Bottom Outlet BOV CLOSED, ADAPTOR SHEARED, HANDLE MISSING.
Punctures _____
Draft sill TRN-023

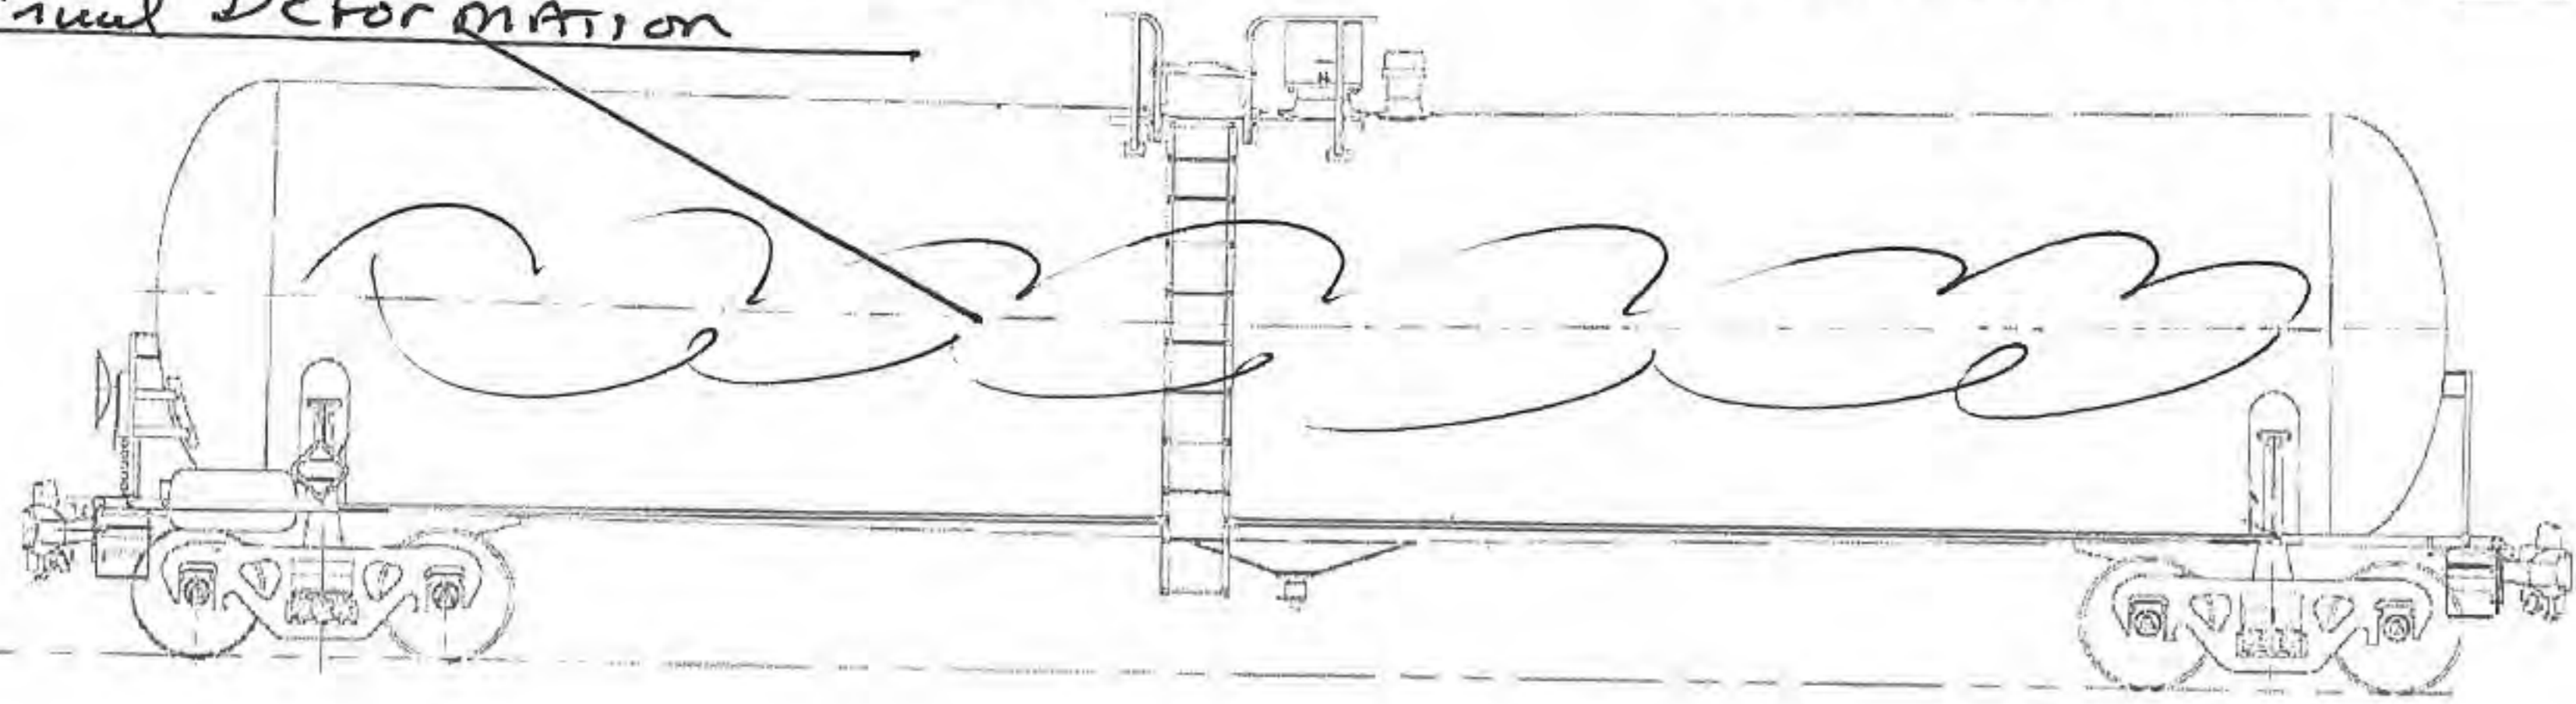
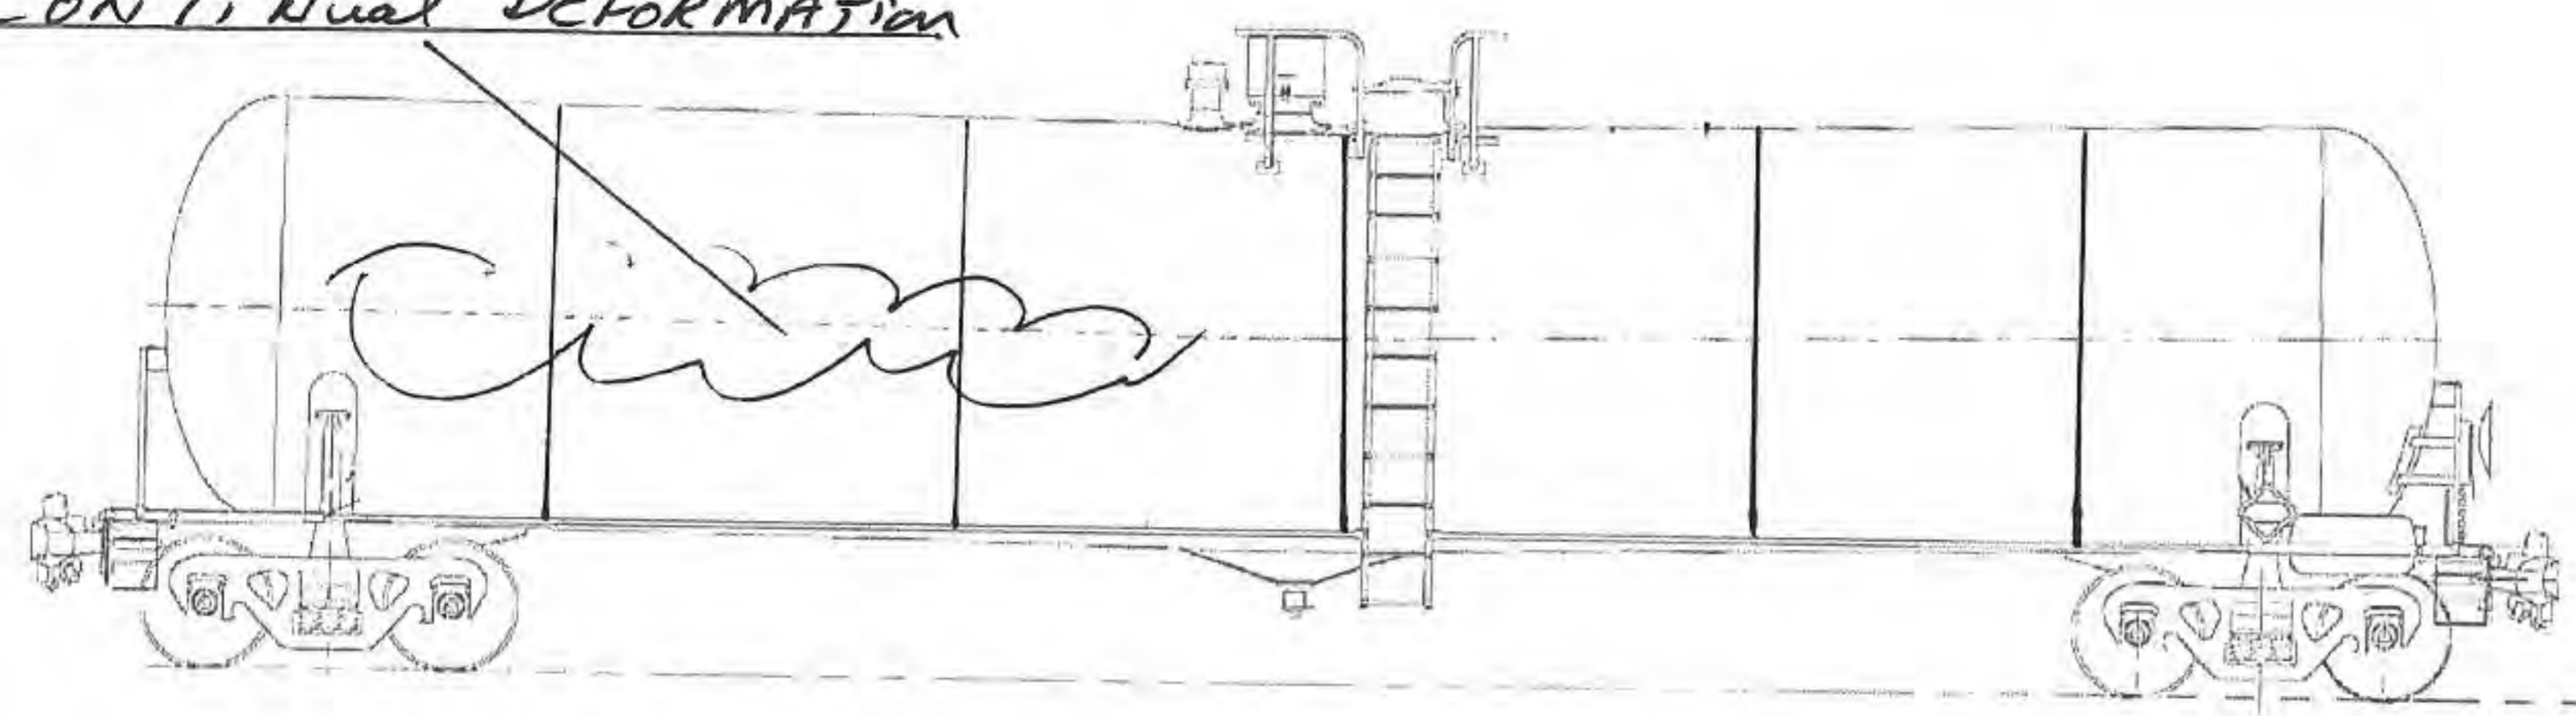
Car Number TCBX 198194
Continual DEFORMATION

CONTINUAL DEFORMATION

Top fittings PRD, manway, multi-housing INTACT
 Bottom Outlet INTACT - HANDLE UNKNOWN
 Punctures A-HEAD 24" x 15"
 Draft sill BOTH BENT TRN - 023
