Car Damage Report

1-07-14
DGT-004
Rev 2

Location Graettinger IA

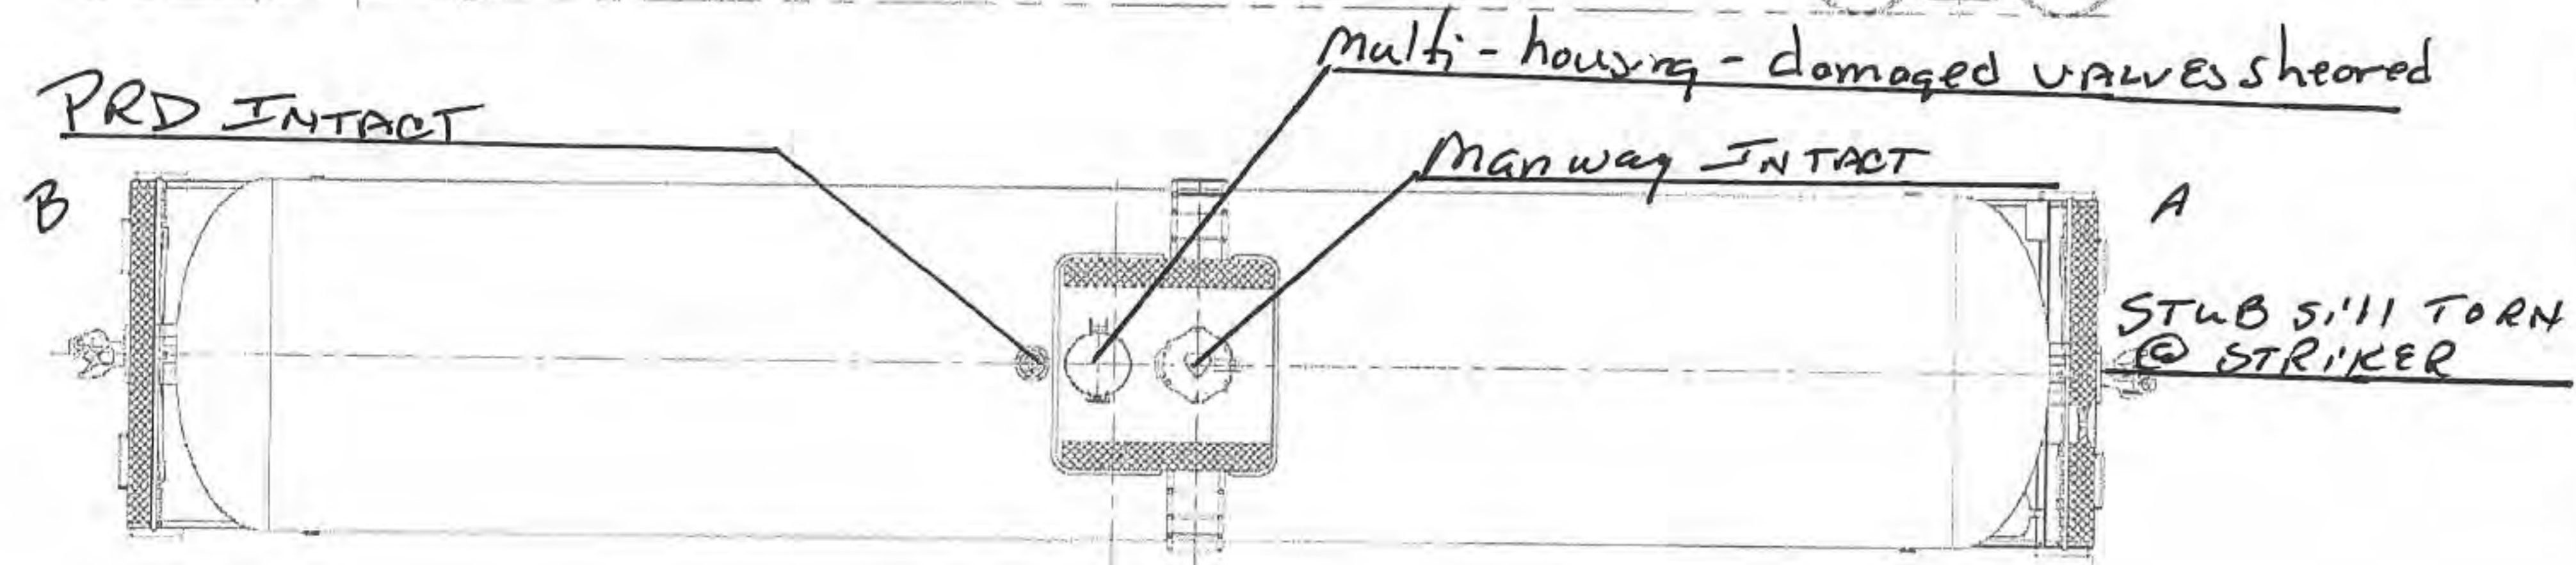
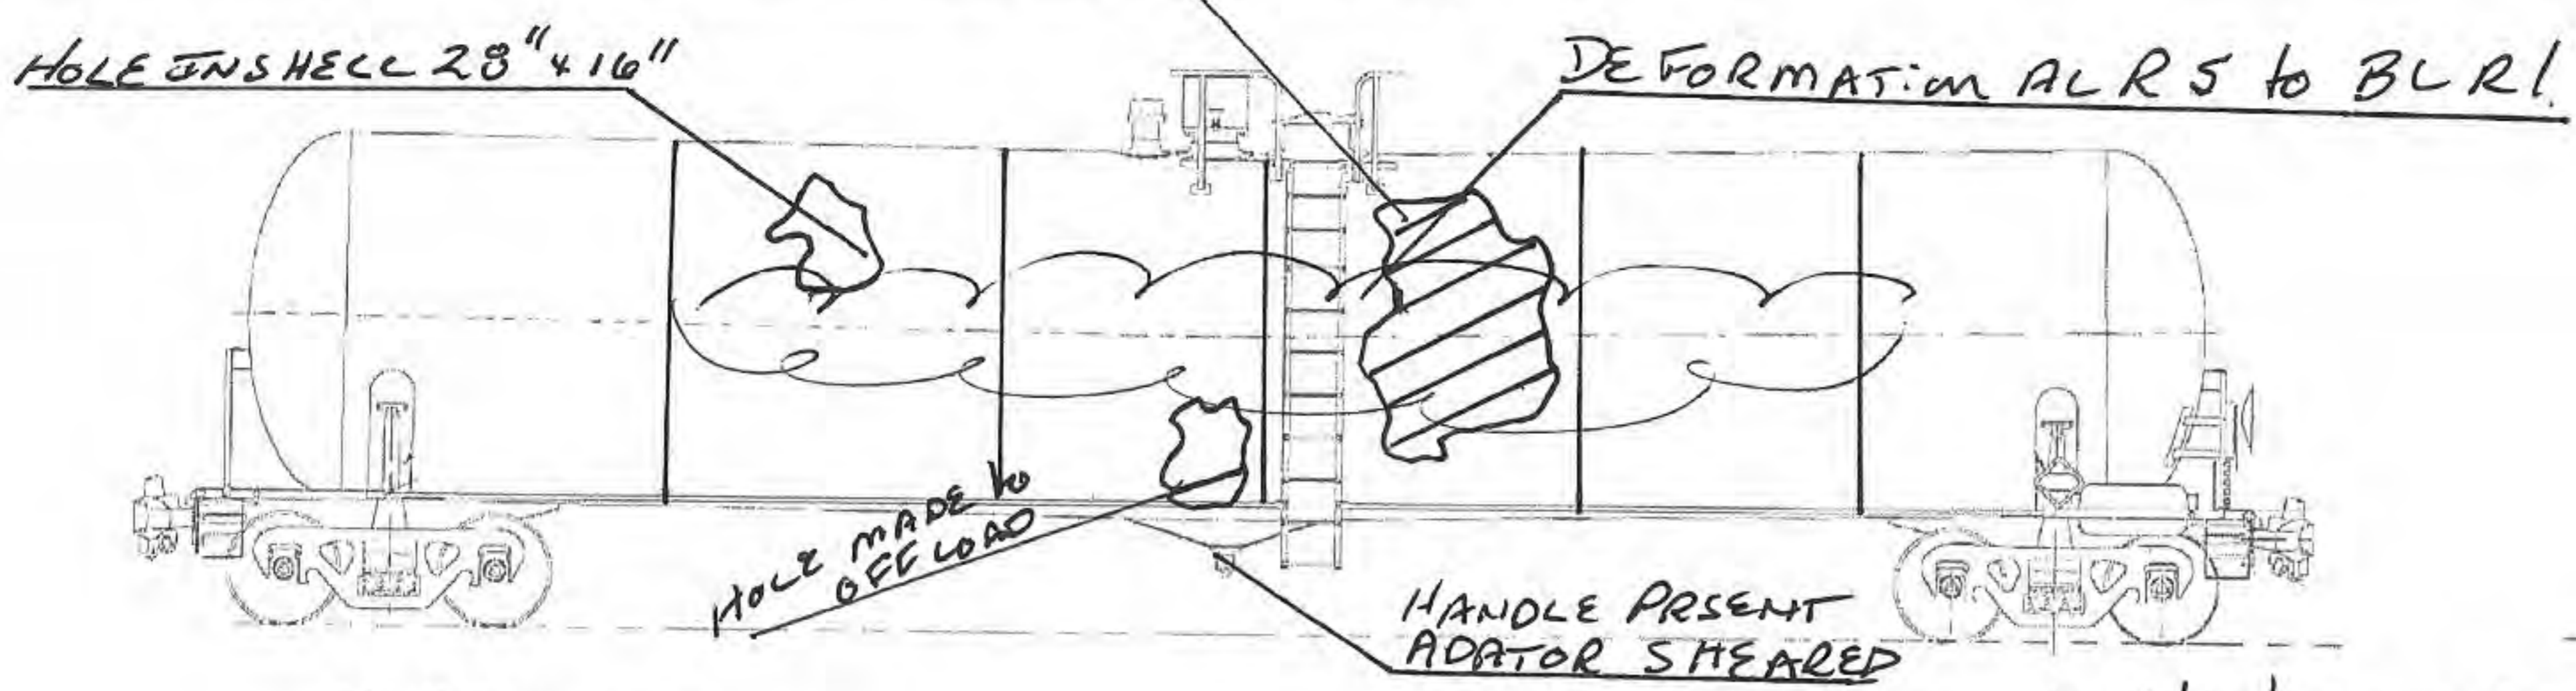
Car Number CTCY 732 108

LEFT side Ring 3 there is a LARGE 10' TEAR/HOLE.

Top fittings multi-housing damaged - VALVES SHEARED

Manway INTACT - PRD INTACT

Draft sill TORN A-END

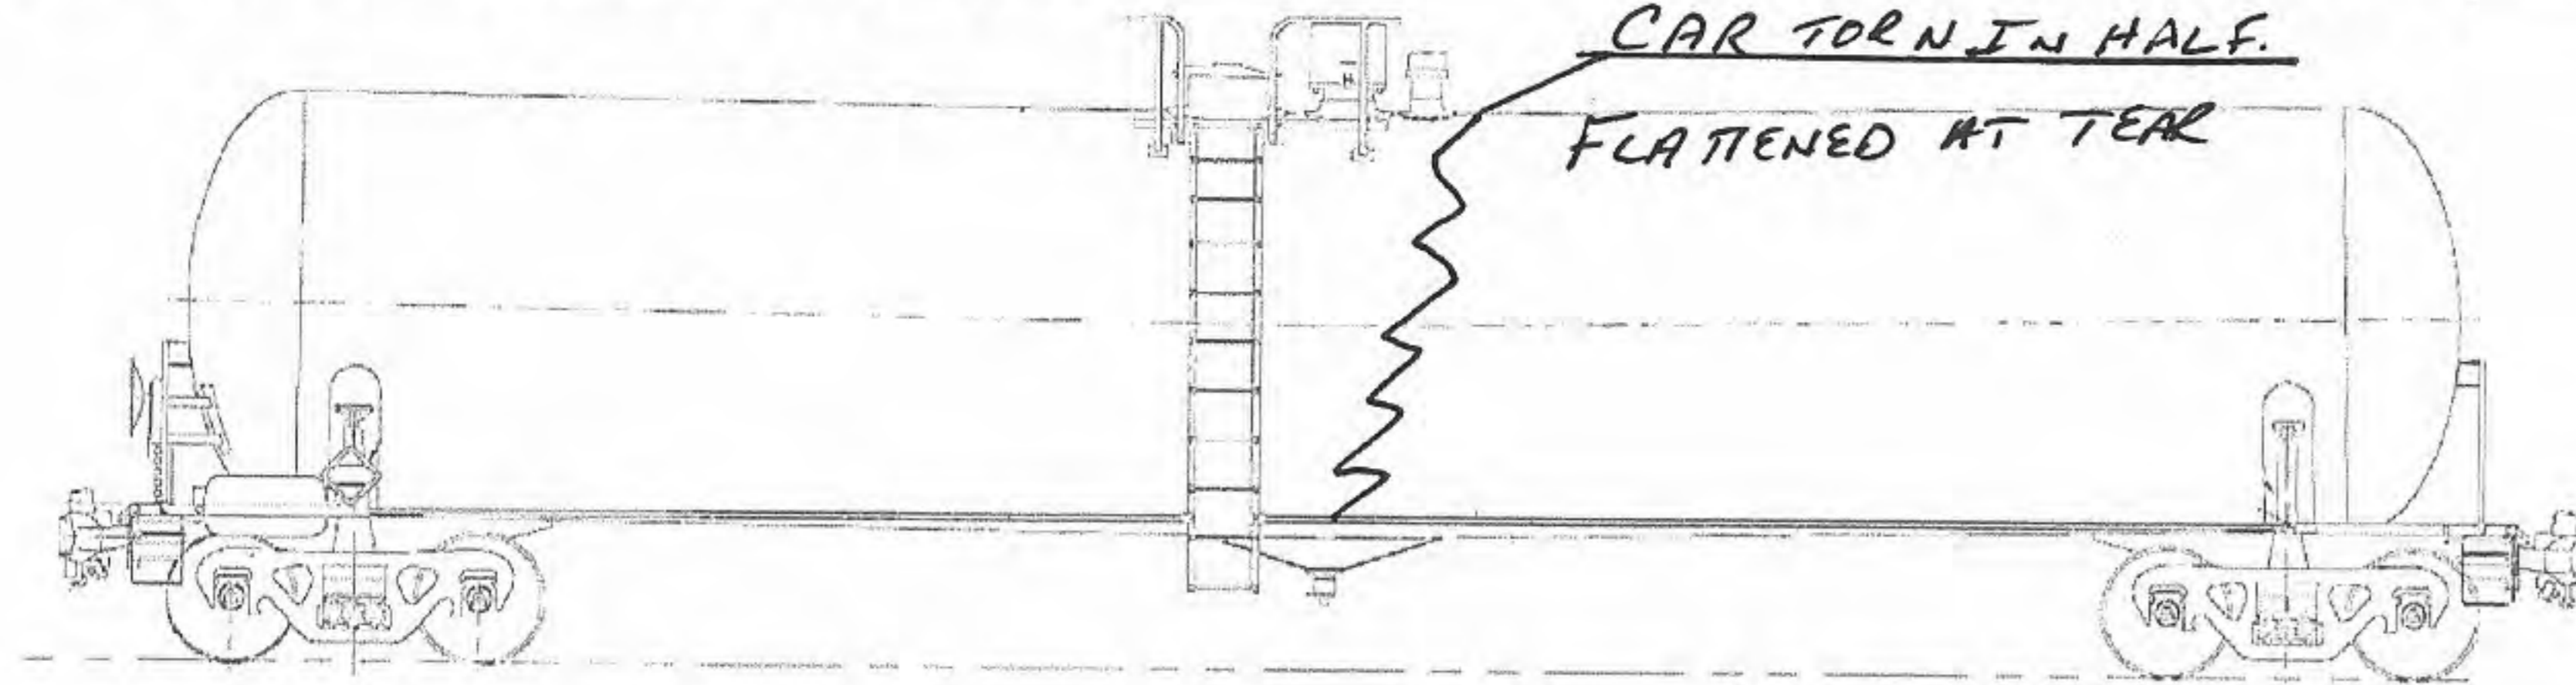
Car Number TIEX 197694

CAR TORN IN HALF FLATTENED AT TEAR

DENT 6' x 5'

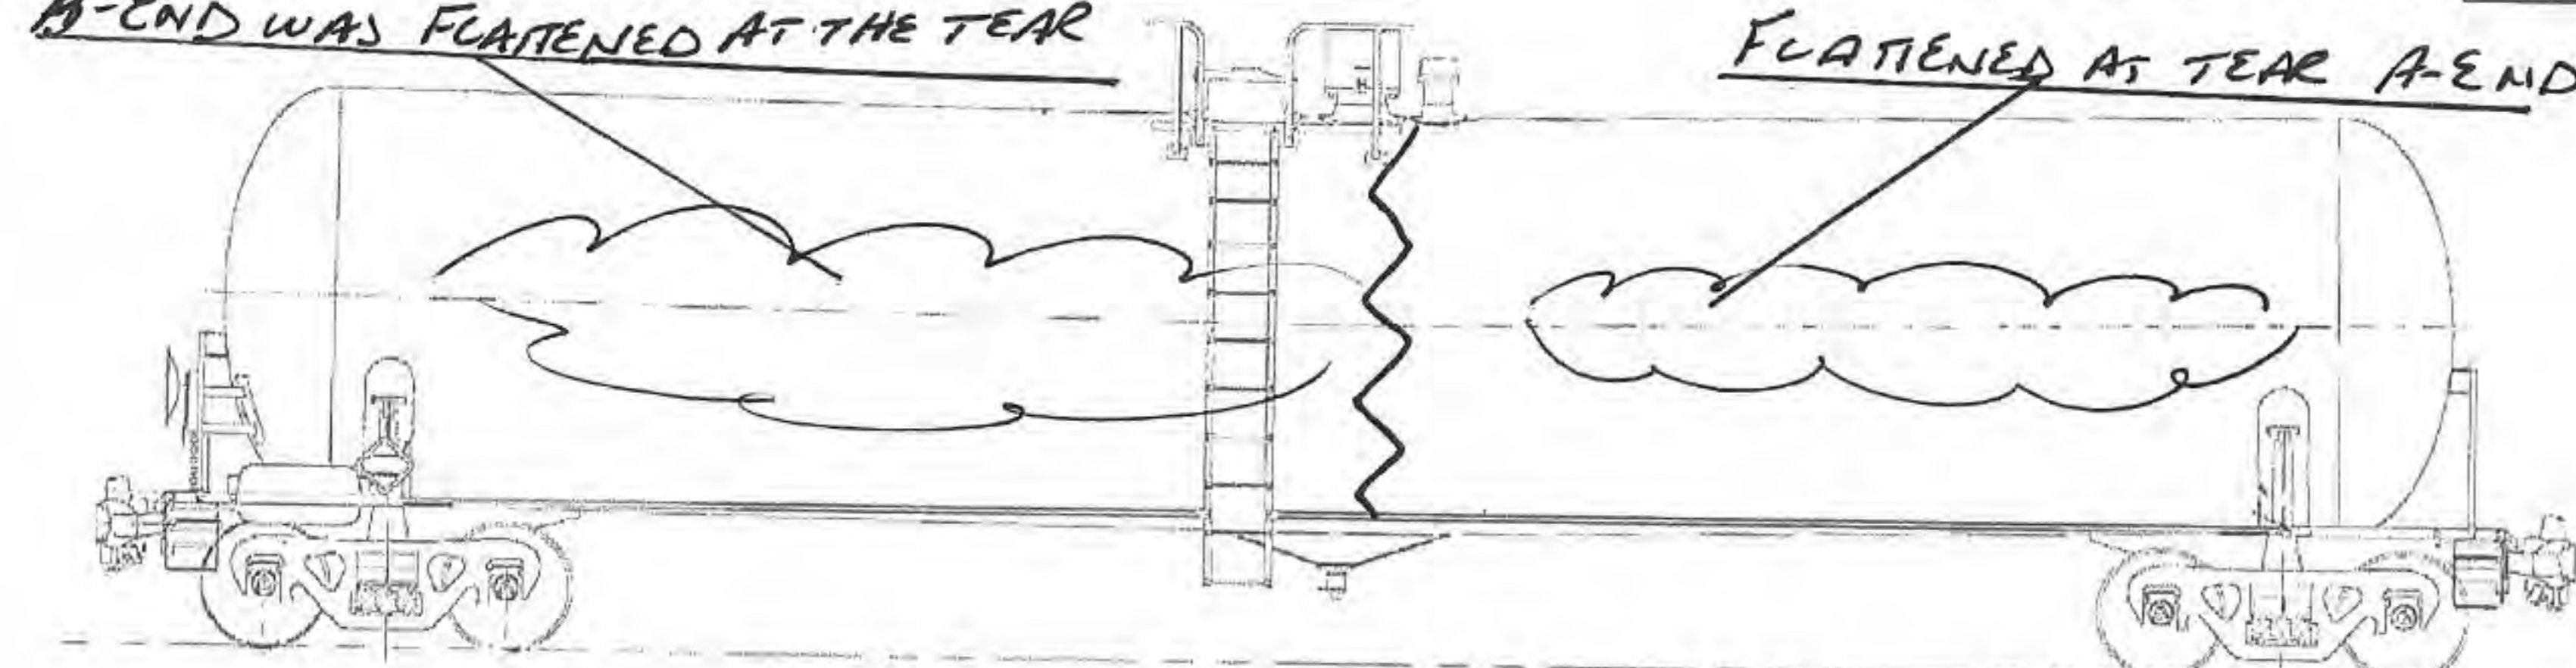
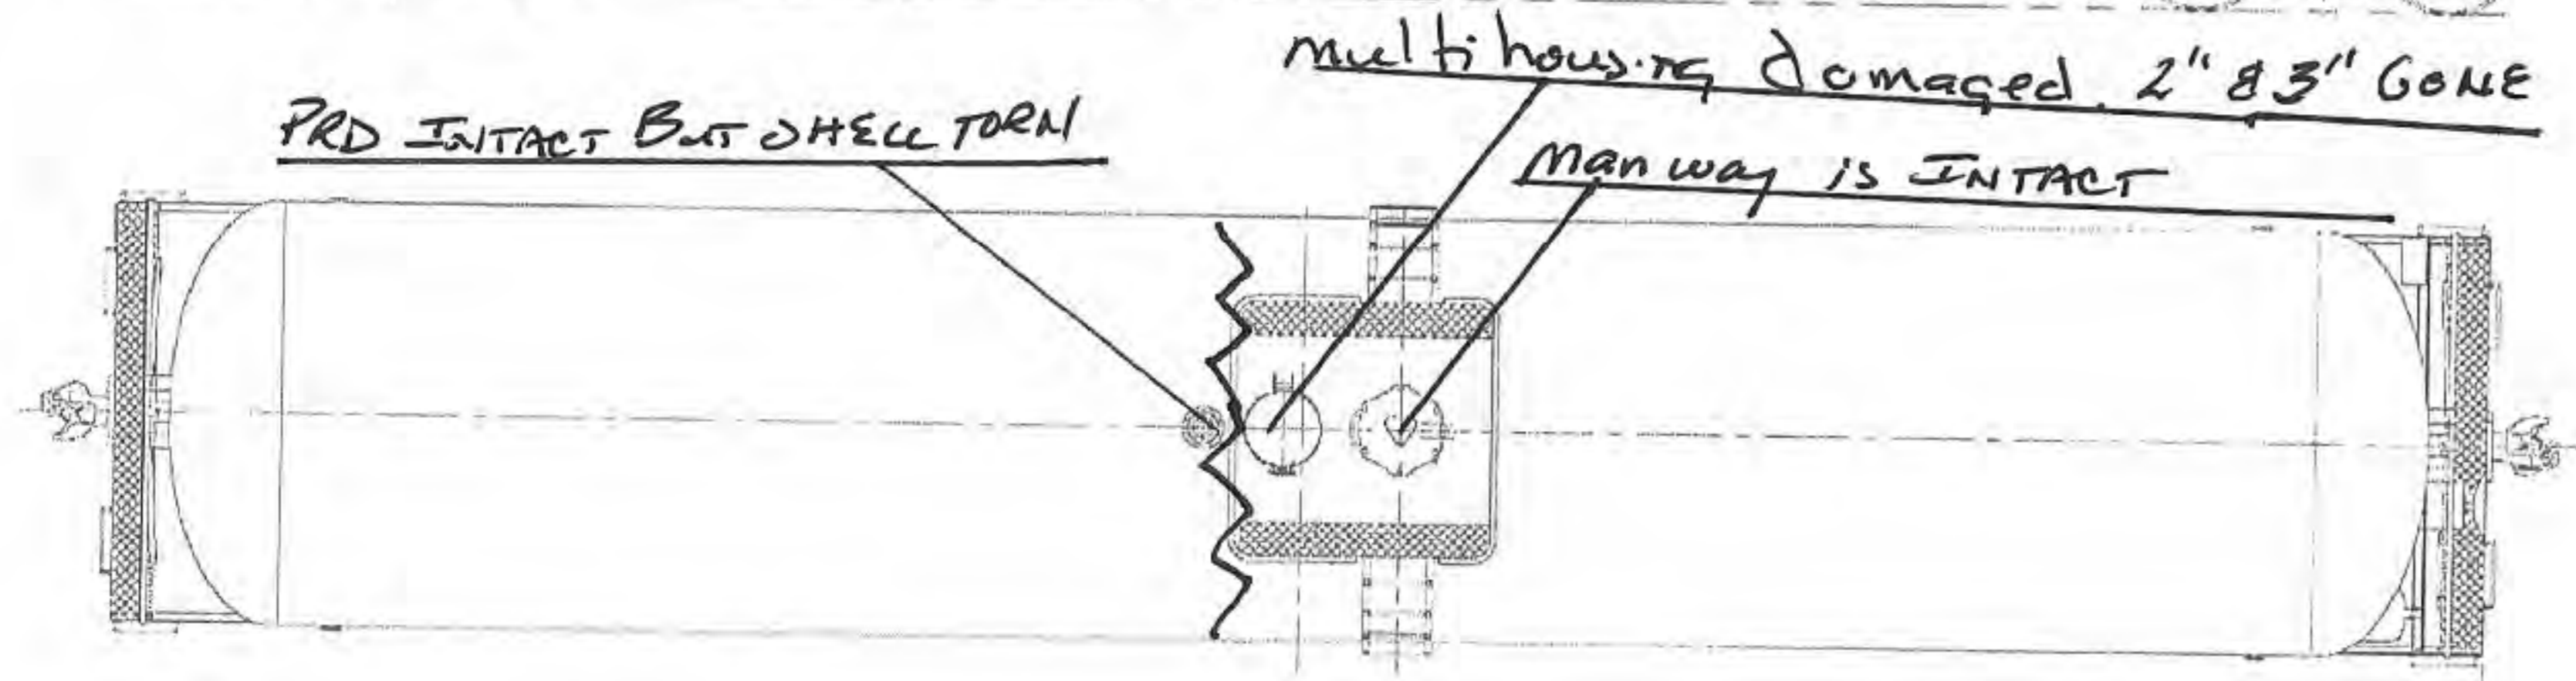
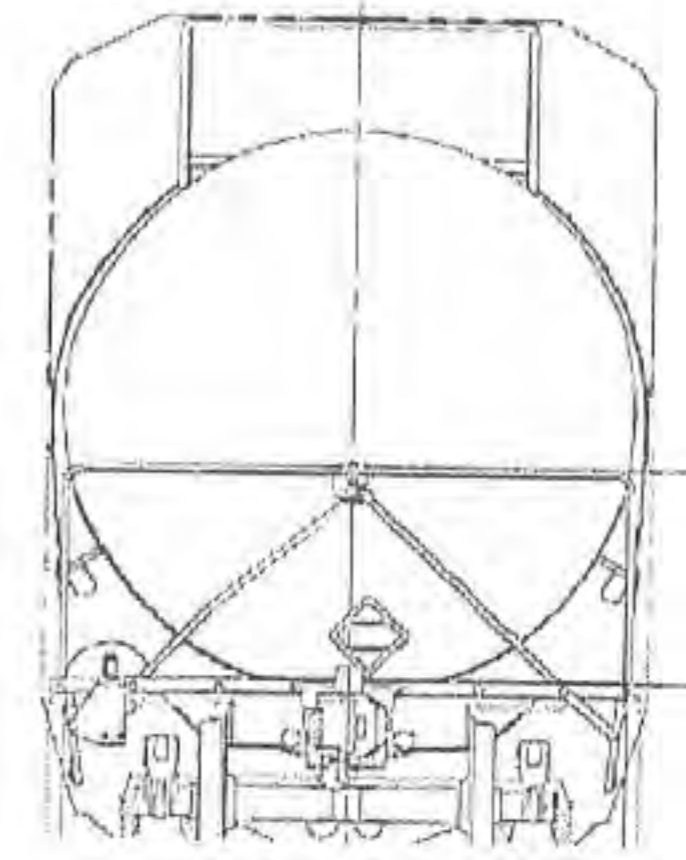
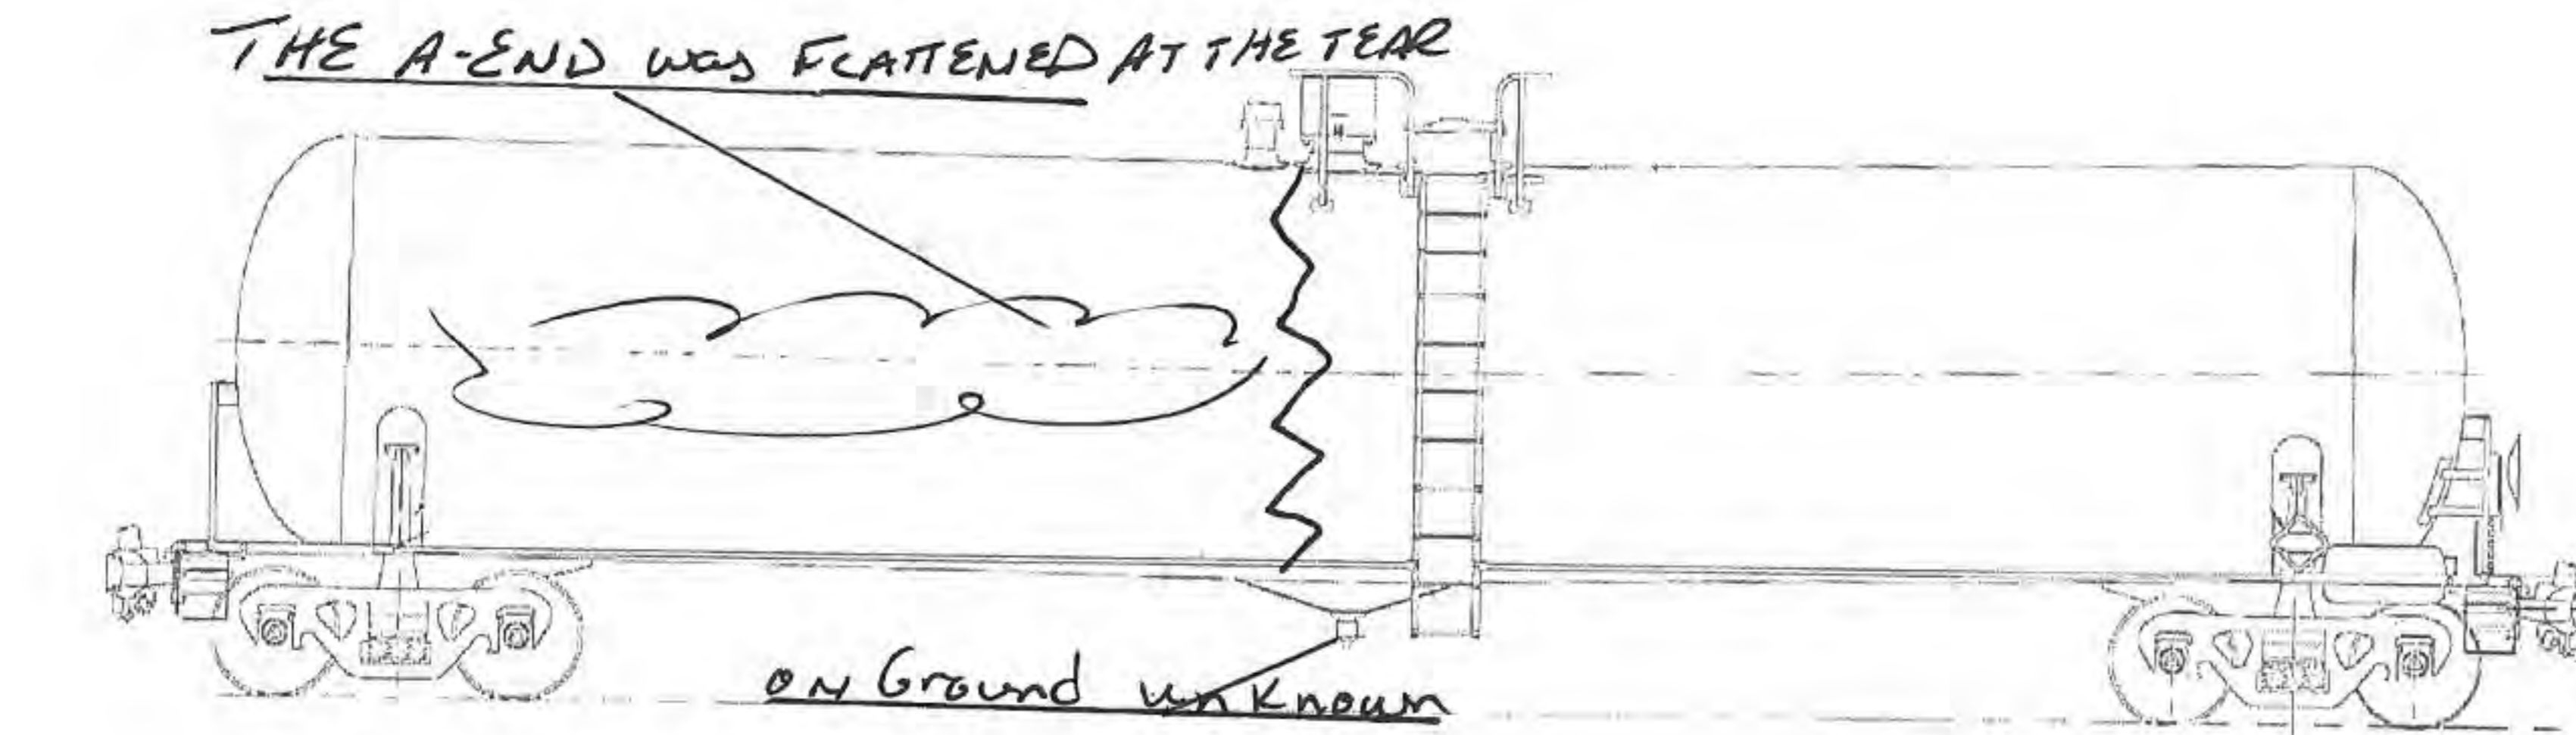
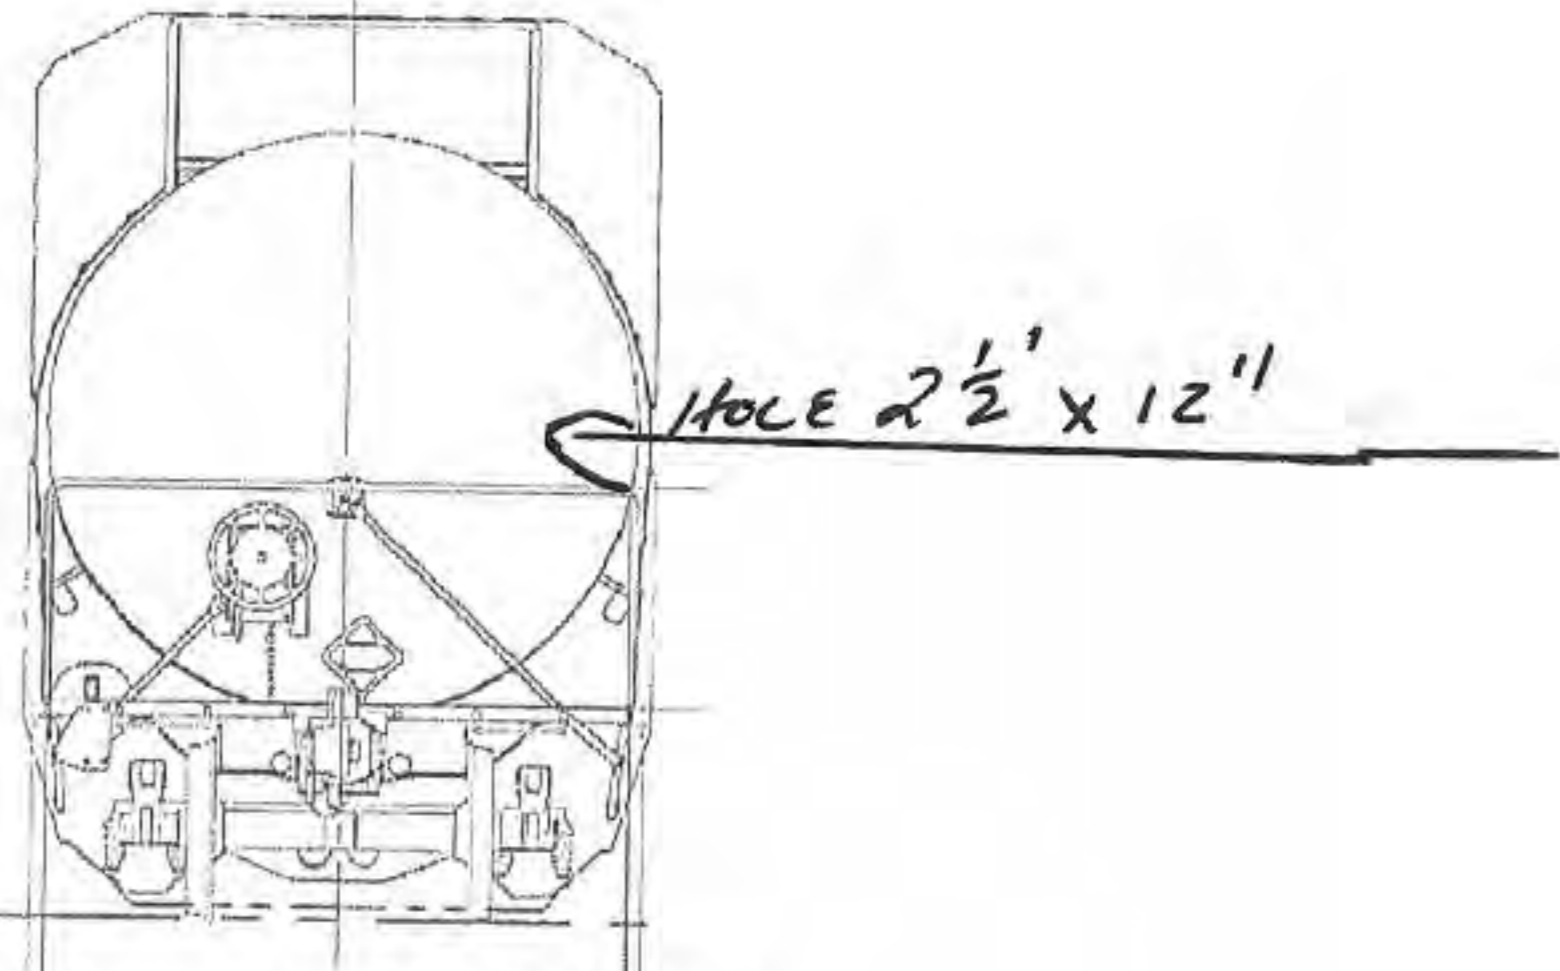
Car Number D Bux 302 834
B-END WAS FLATTENED AT THE TEAR

Wreck index Number _____
FLATTENED AT TEAR A-END

Top fittings multi-housing damaged VALVES missing
PRD INTACT - manway INTACT
Bottom Outlet unknown
Punctures TORN IN HALF
Draft sill TRN-023

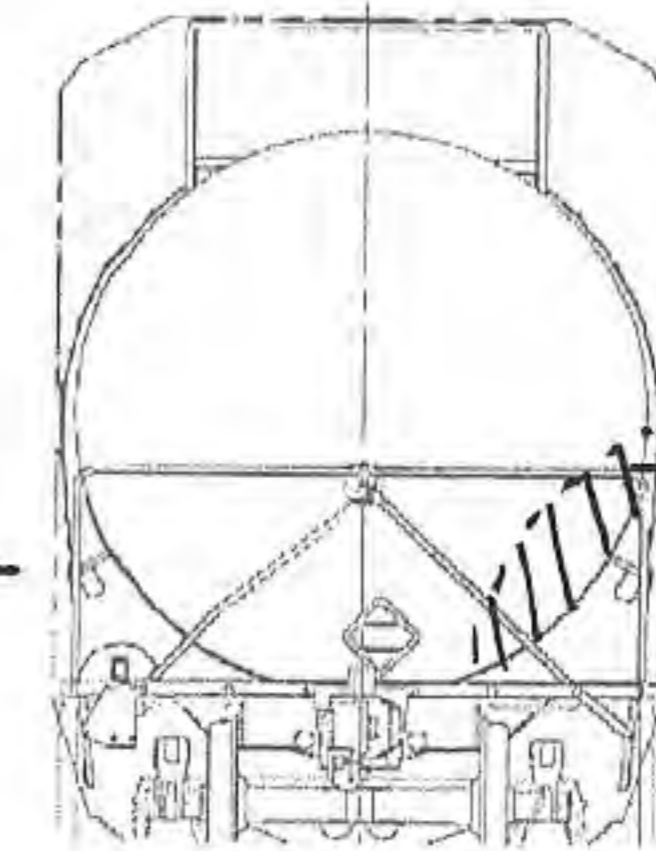
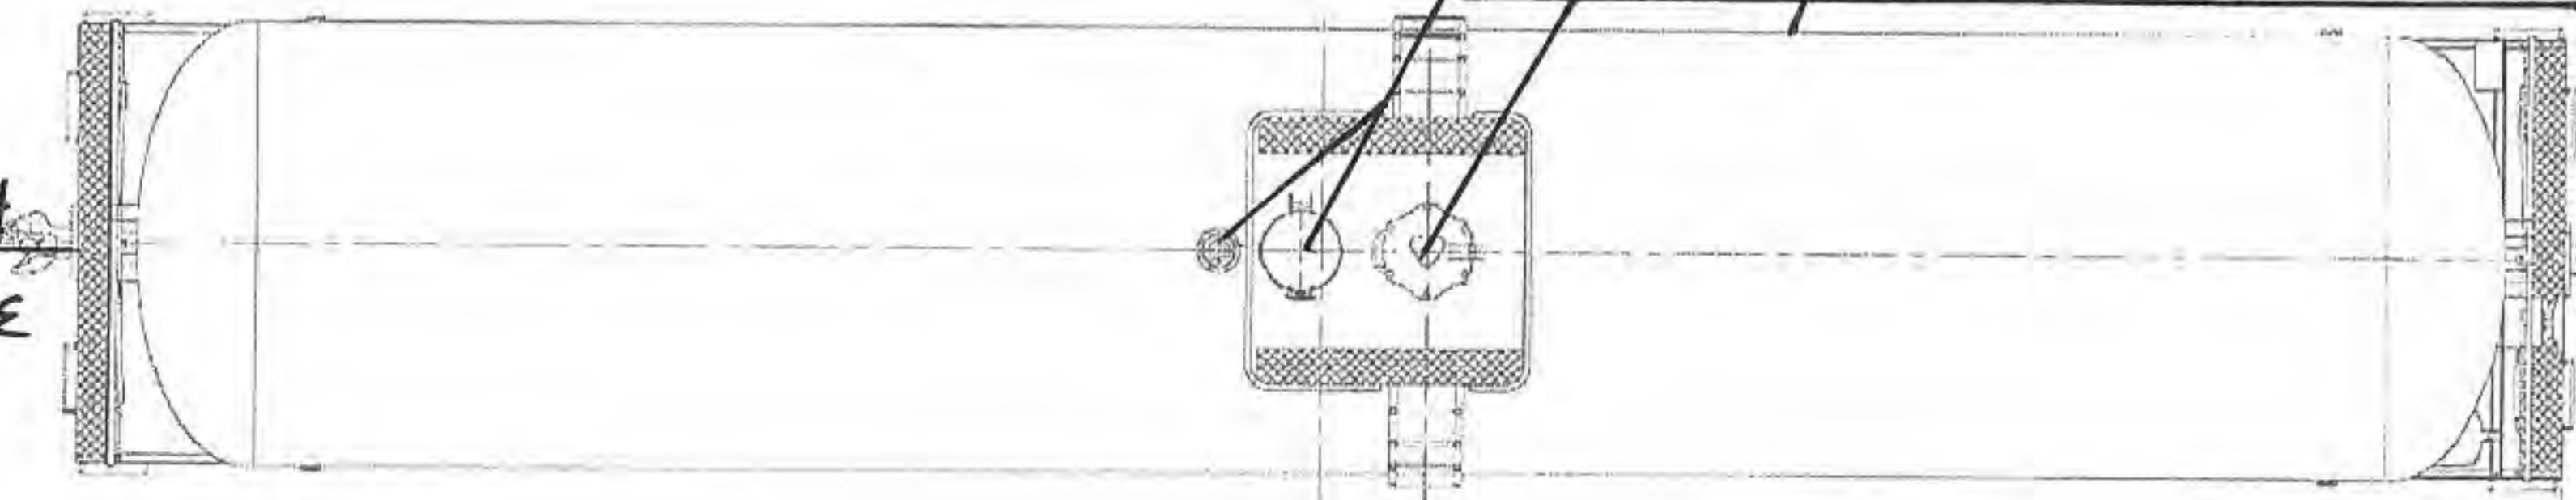
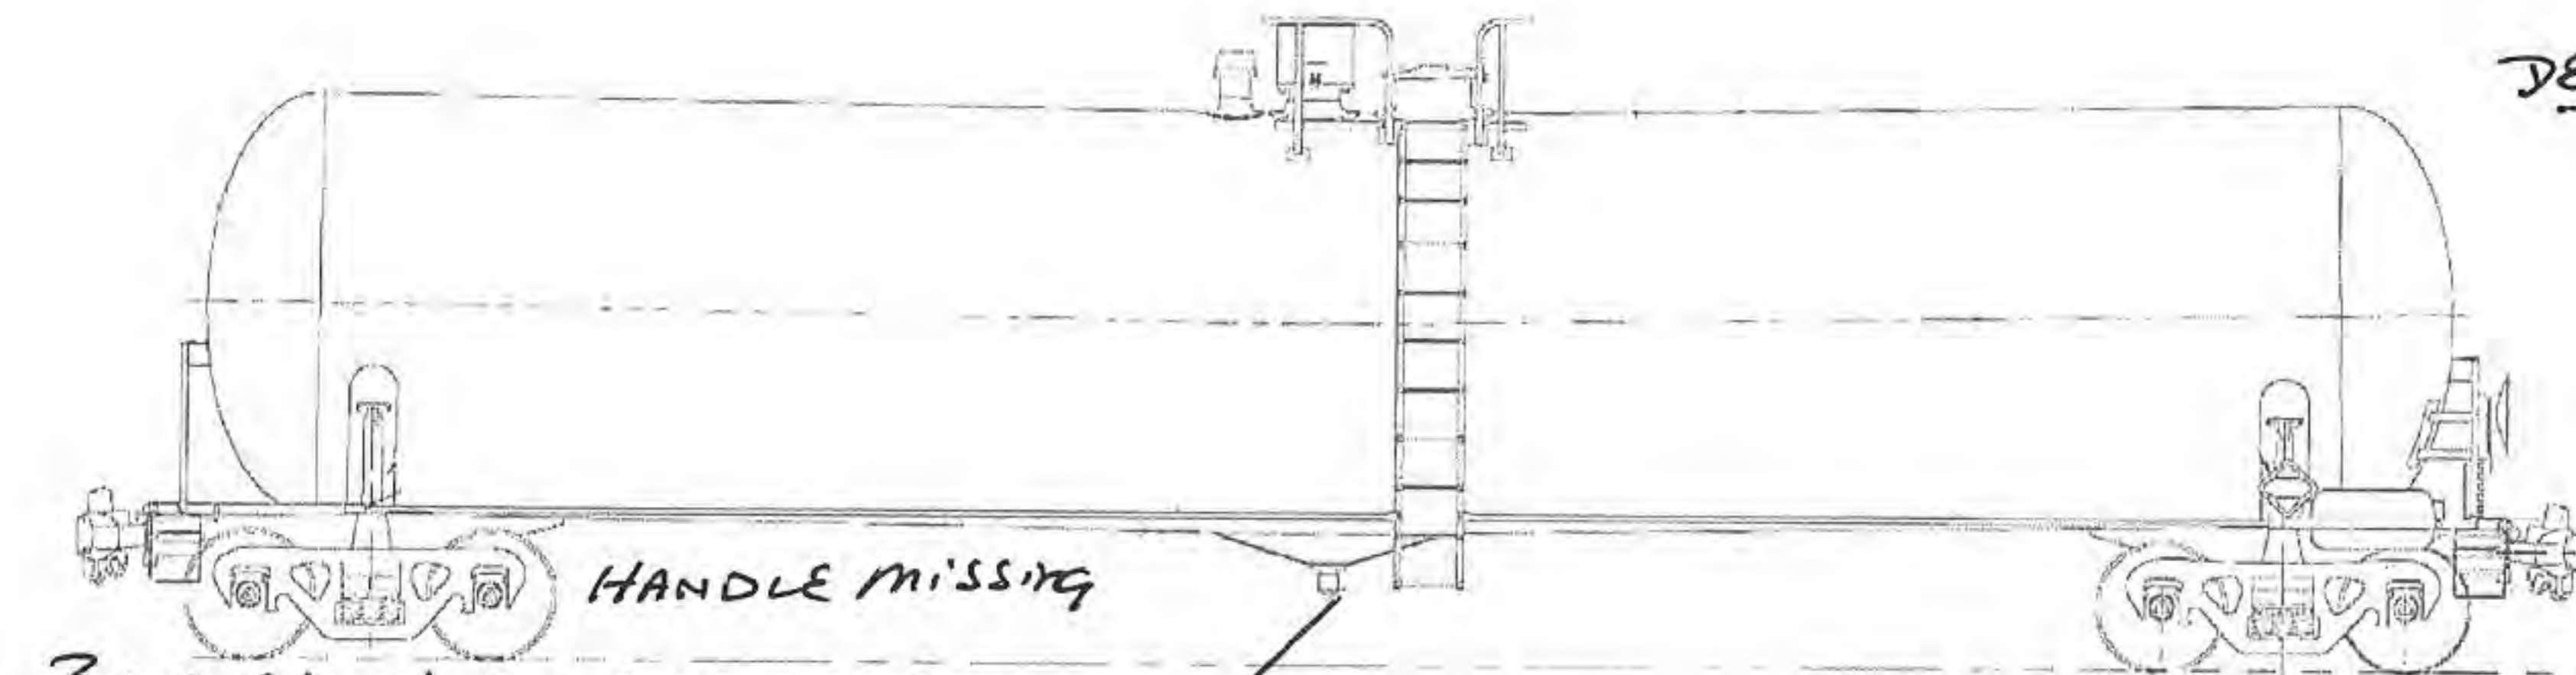
Car Number TAEX 2909

PRD INTACT - Multihousing INTACT

Manway is INTACT

A BENT & TORN OFF

B STUB IS BENT & TORN OFF

DENT 5' x 6'

HANDLE MISSING

DENT 3' x 3'

DENT 8' x 4'

10" x 11" HOLE

BOV CLOSED, ADAPTOR SHRED

Top fittings PRD, Manway, Multihousing INTACT
 Bottom Outlet closed, ADAPTOR SHRED, HANDLE MISSING
 Punctures B - HEAD
 Draft sill BENT

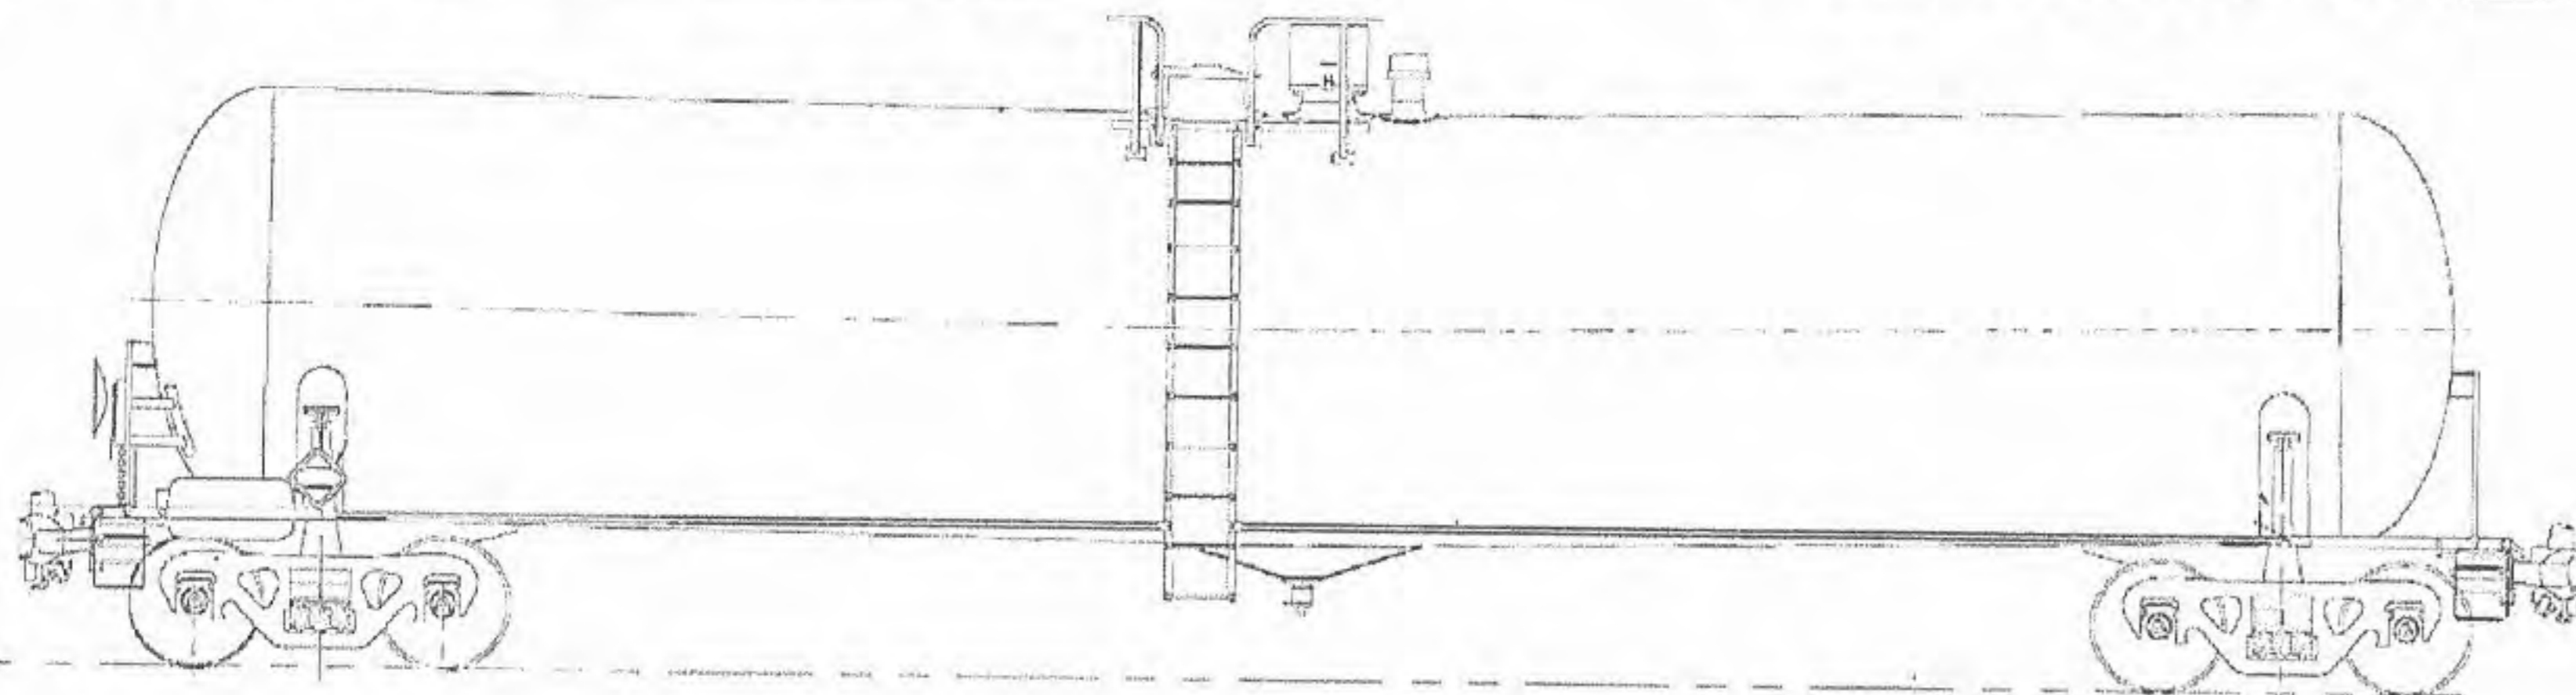
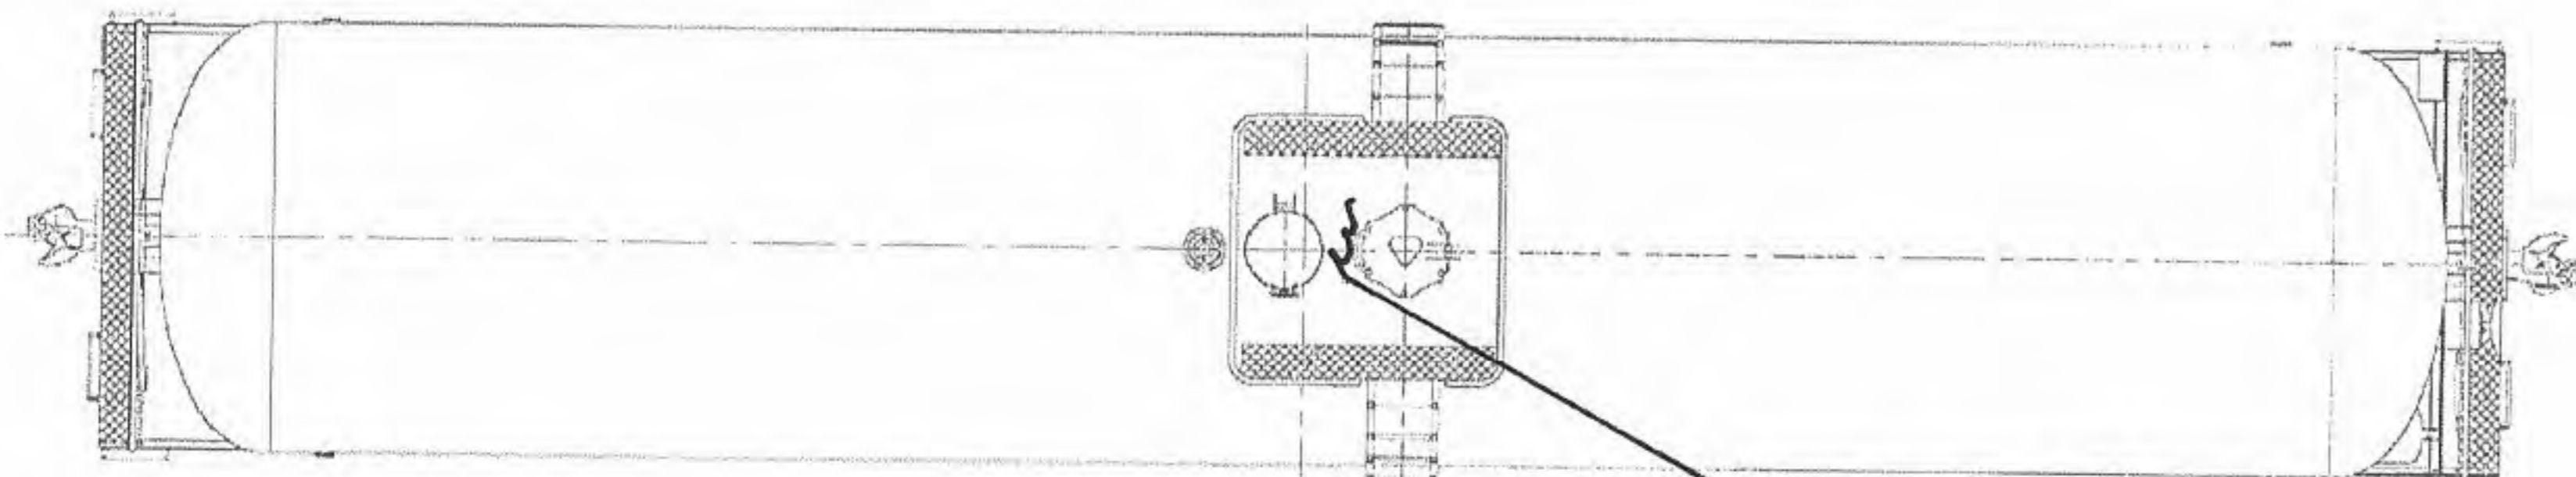
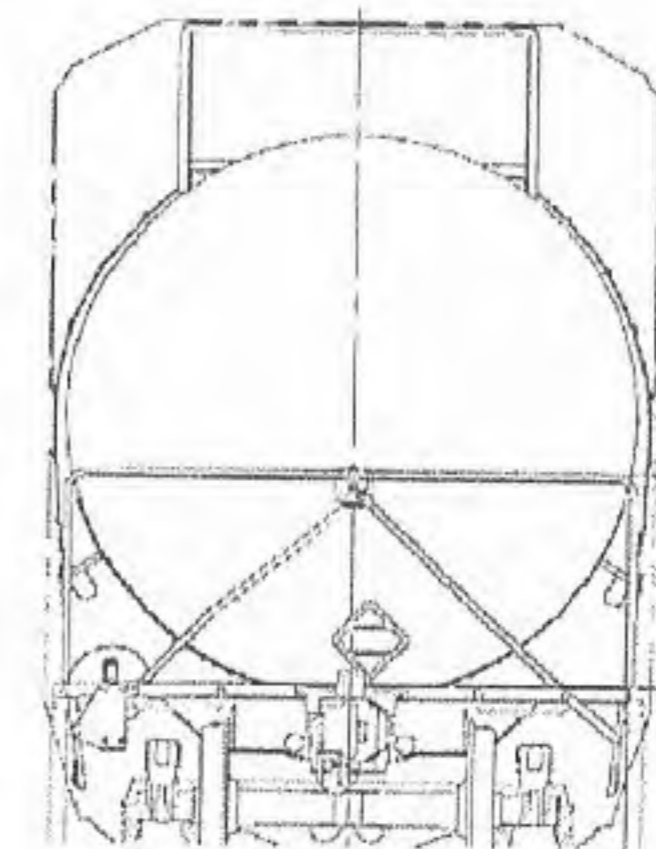
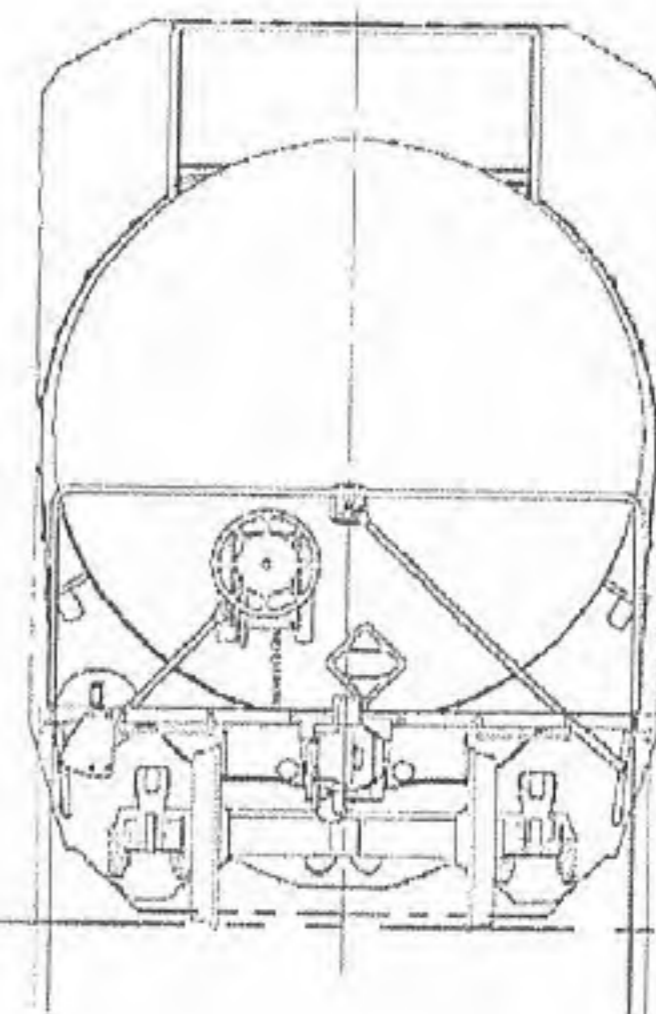
Car Number WC HX 30078

SHELL MATERIAL WAS CREASED &
CAUSED A SPILT SIZE UNKNOWN.
