Car Damage Report

1-07-14
DGT-004
Rev 2

Location Graettinger IA

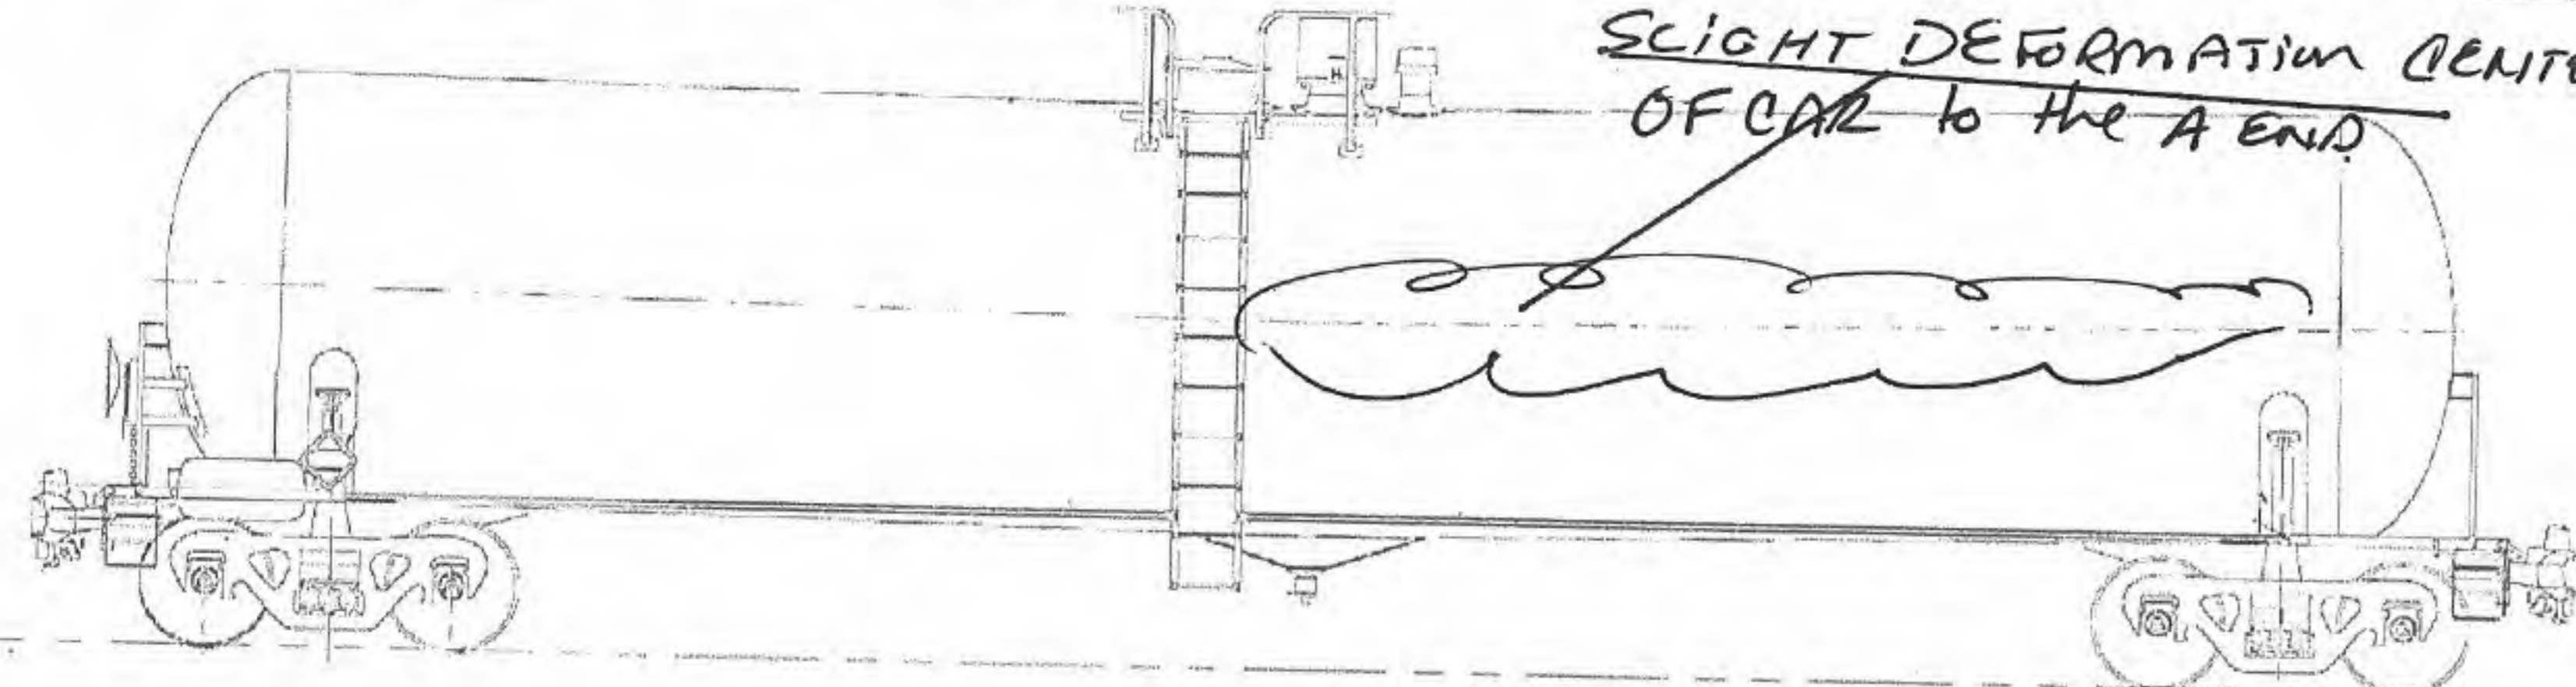
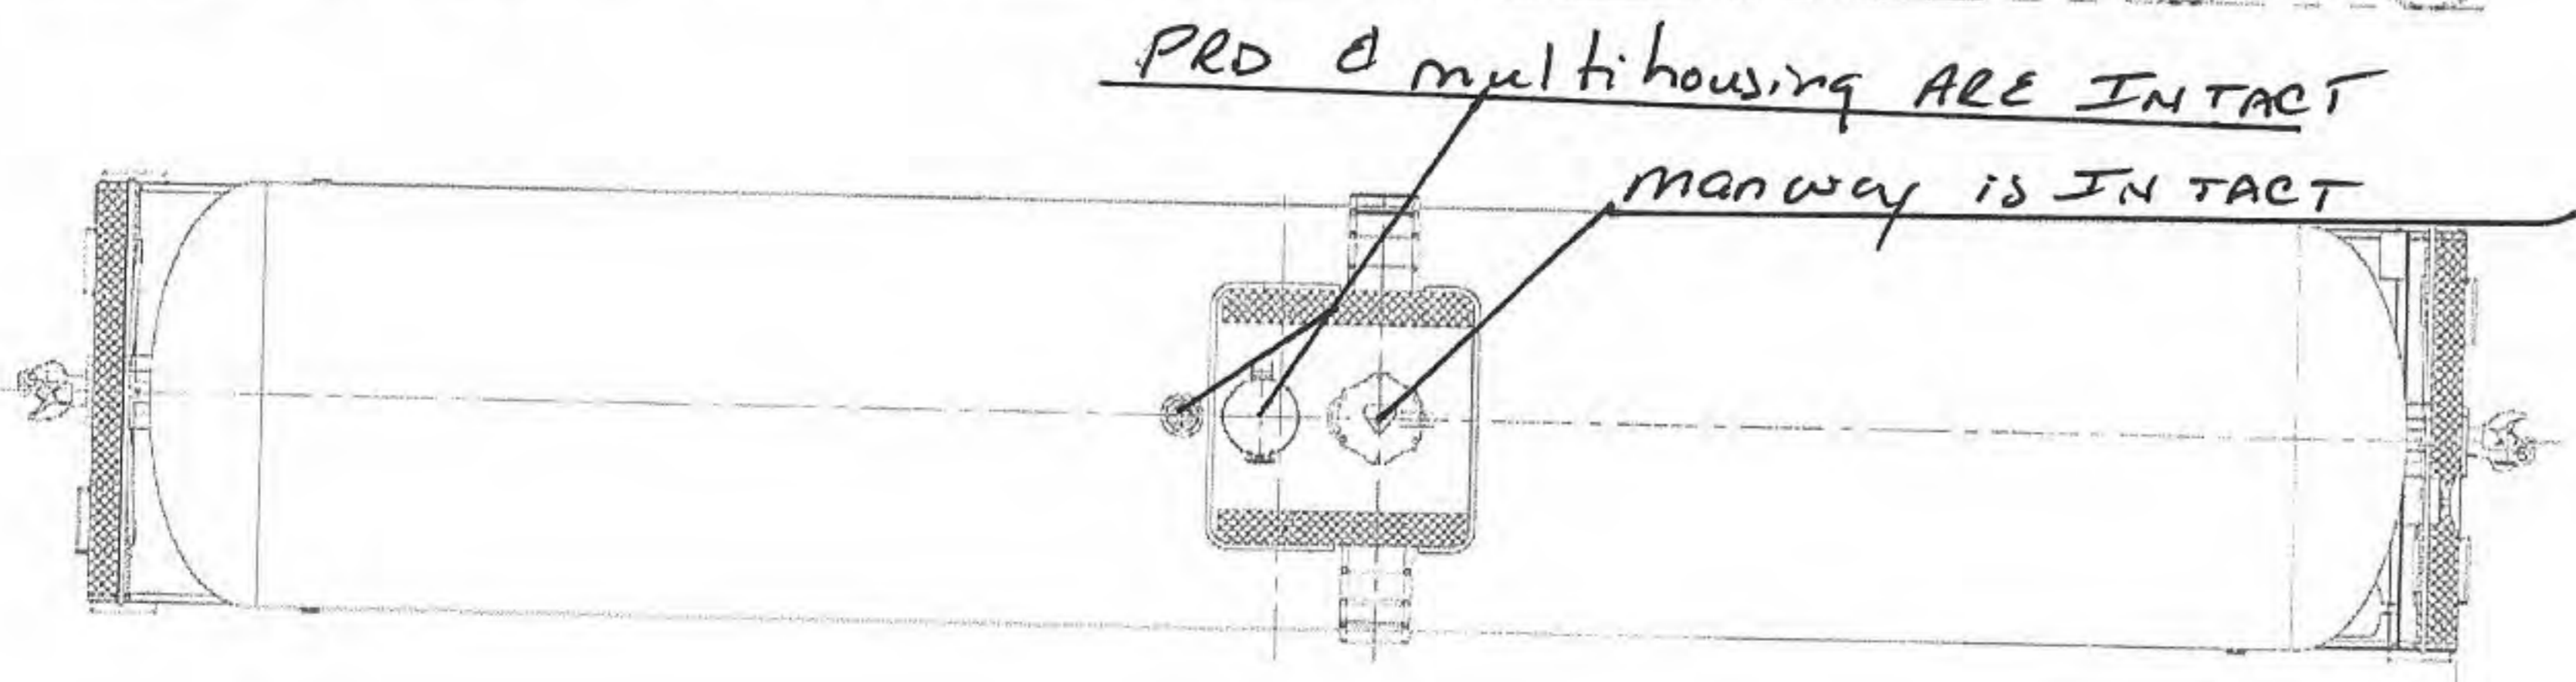
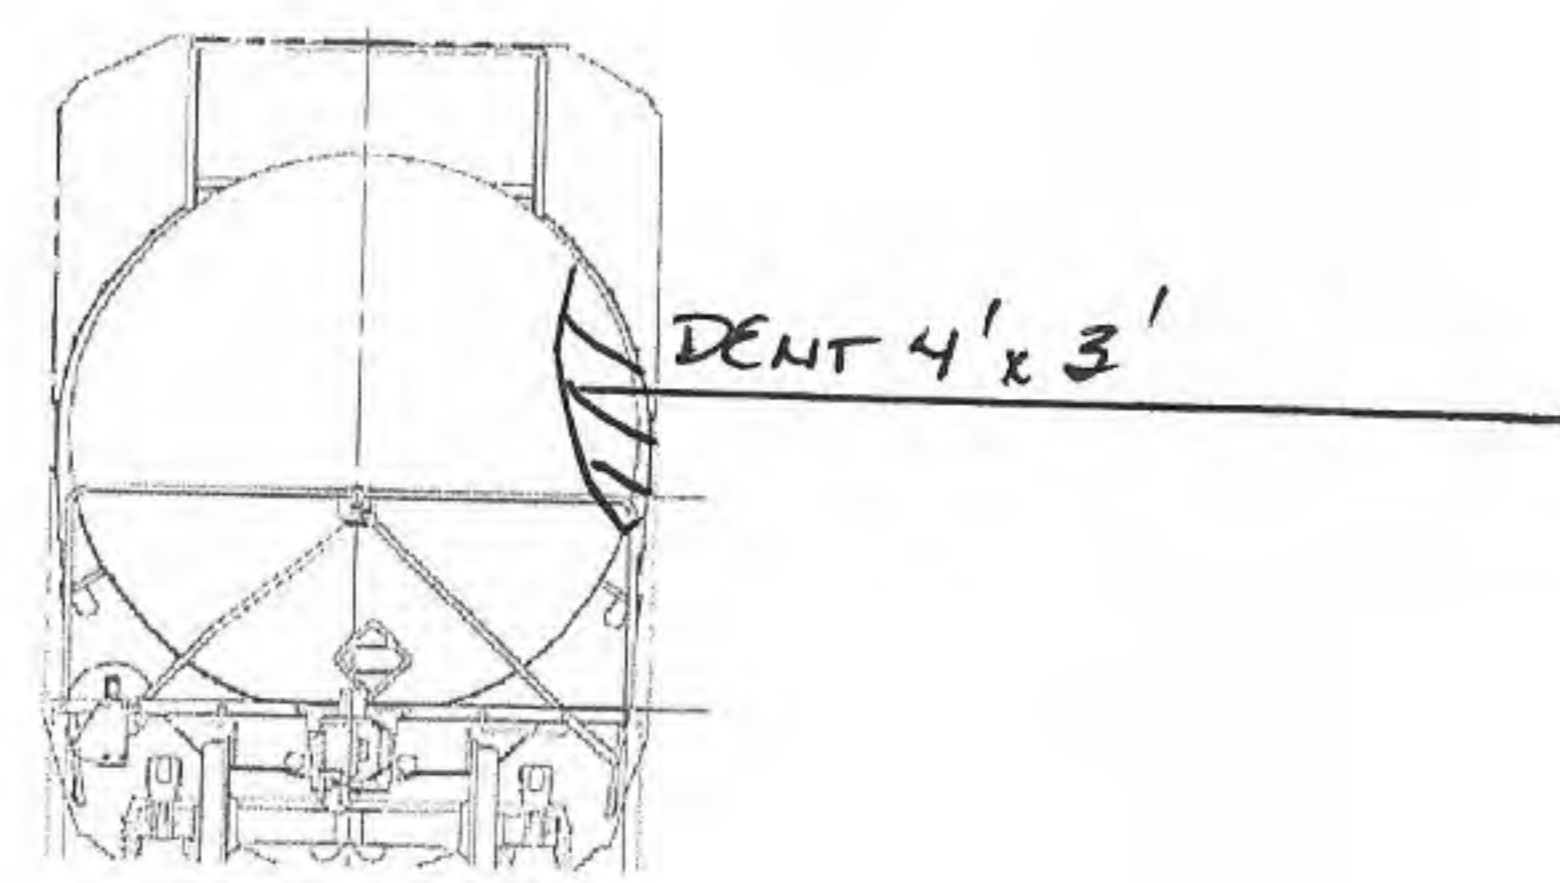
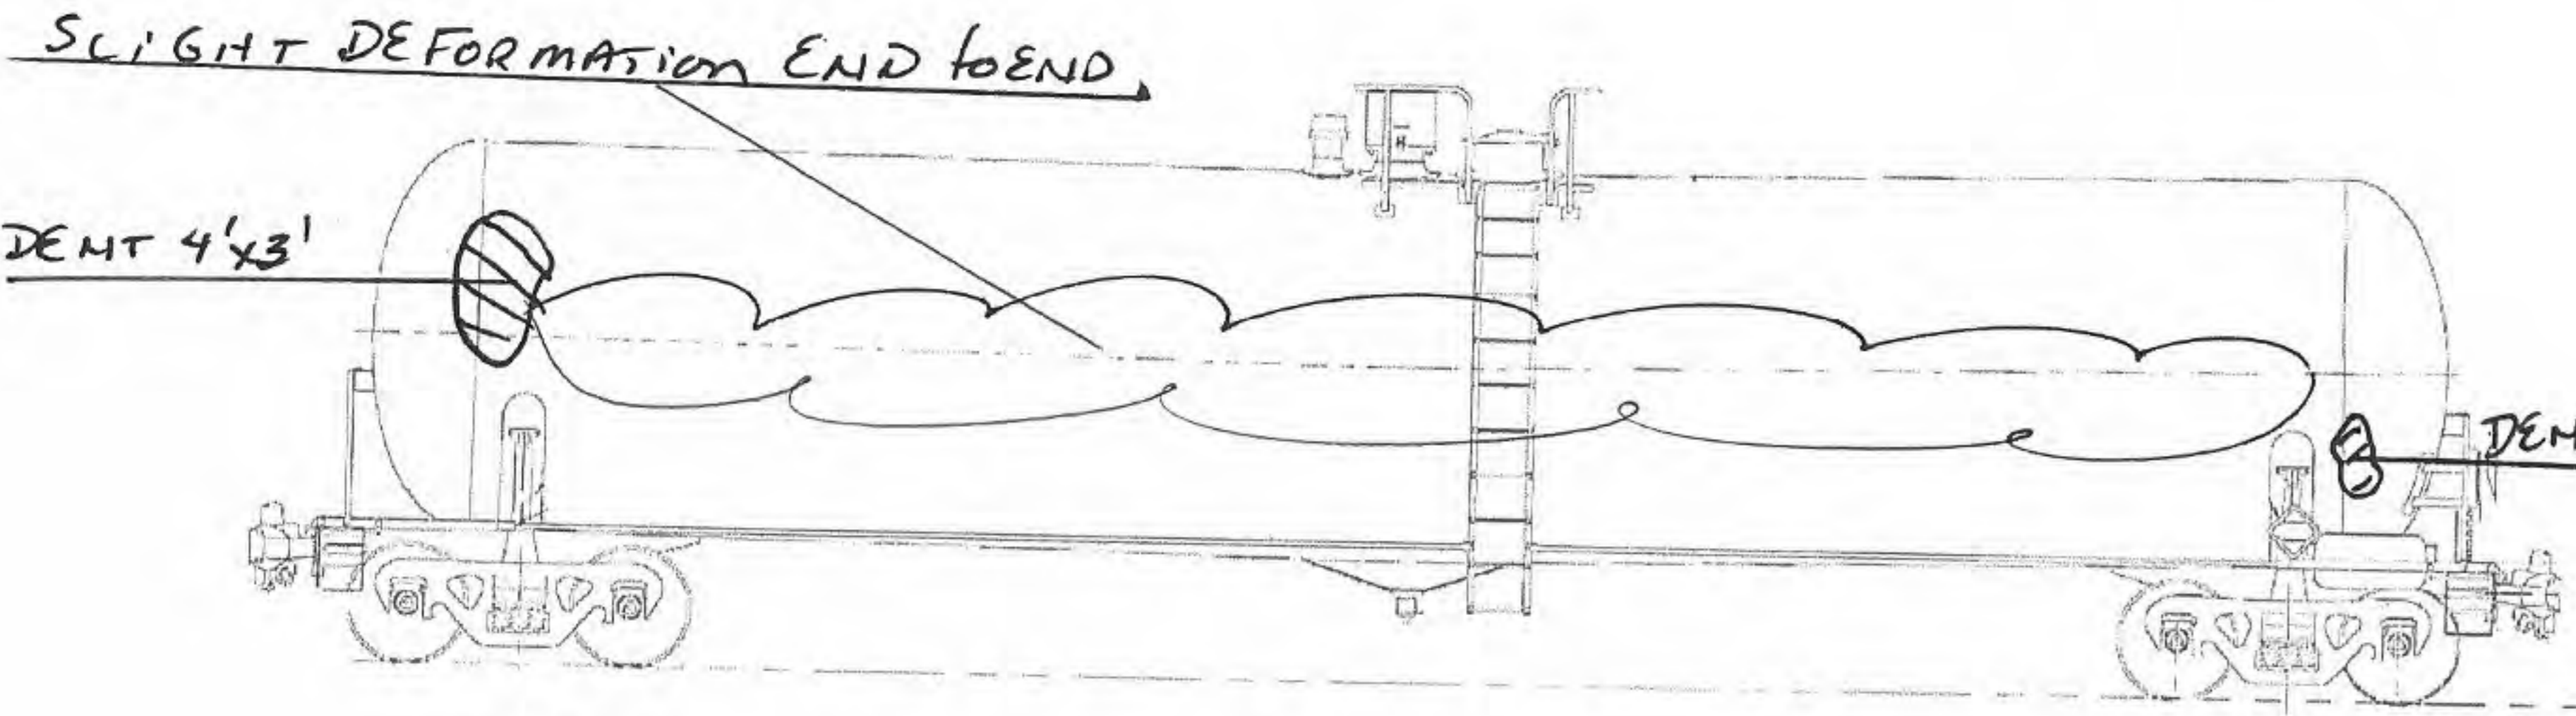
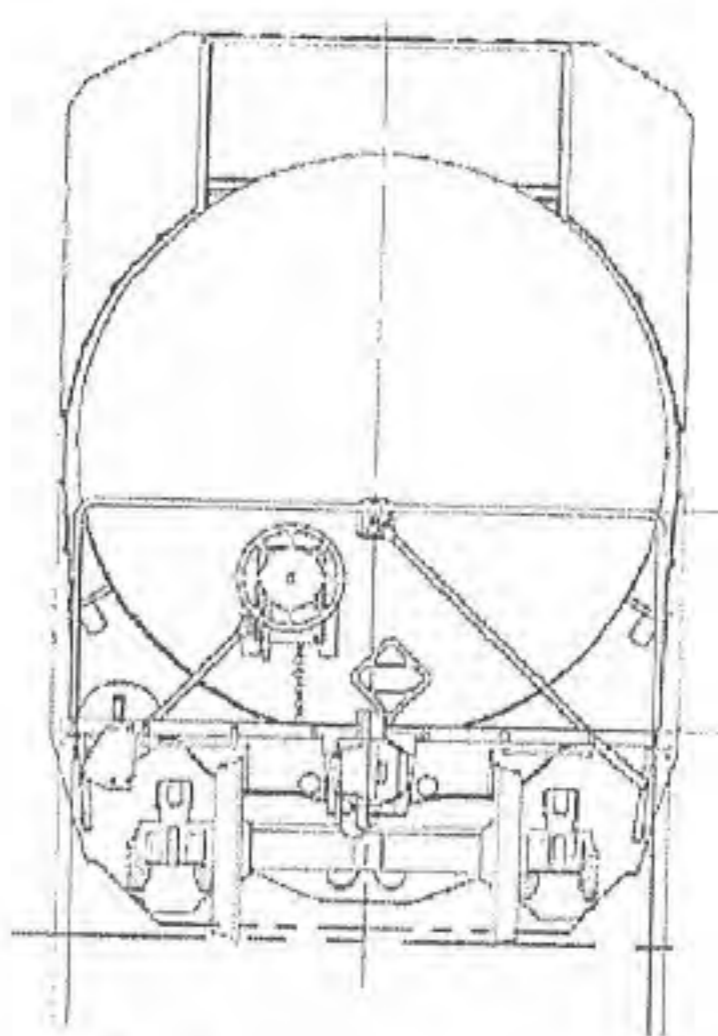
Car Number WCHx 30098

Top fittings PRD, manway, multihousing INTACT
Bottom Outlet BOV Closed - LEAKING, ADAPTOR SHEARED. HANDLE INTACT
Punctures _____
Draft sill ARI-300

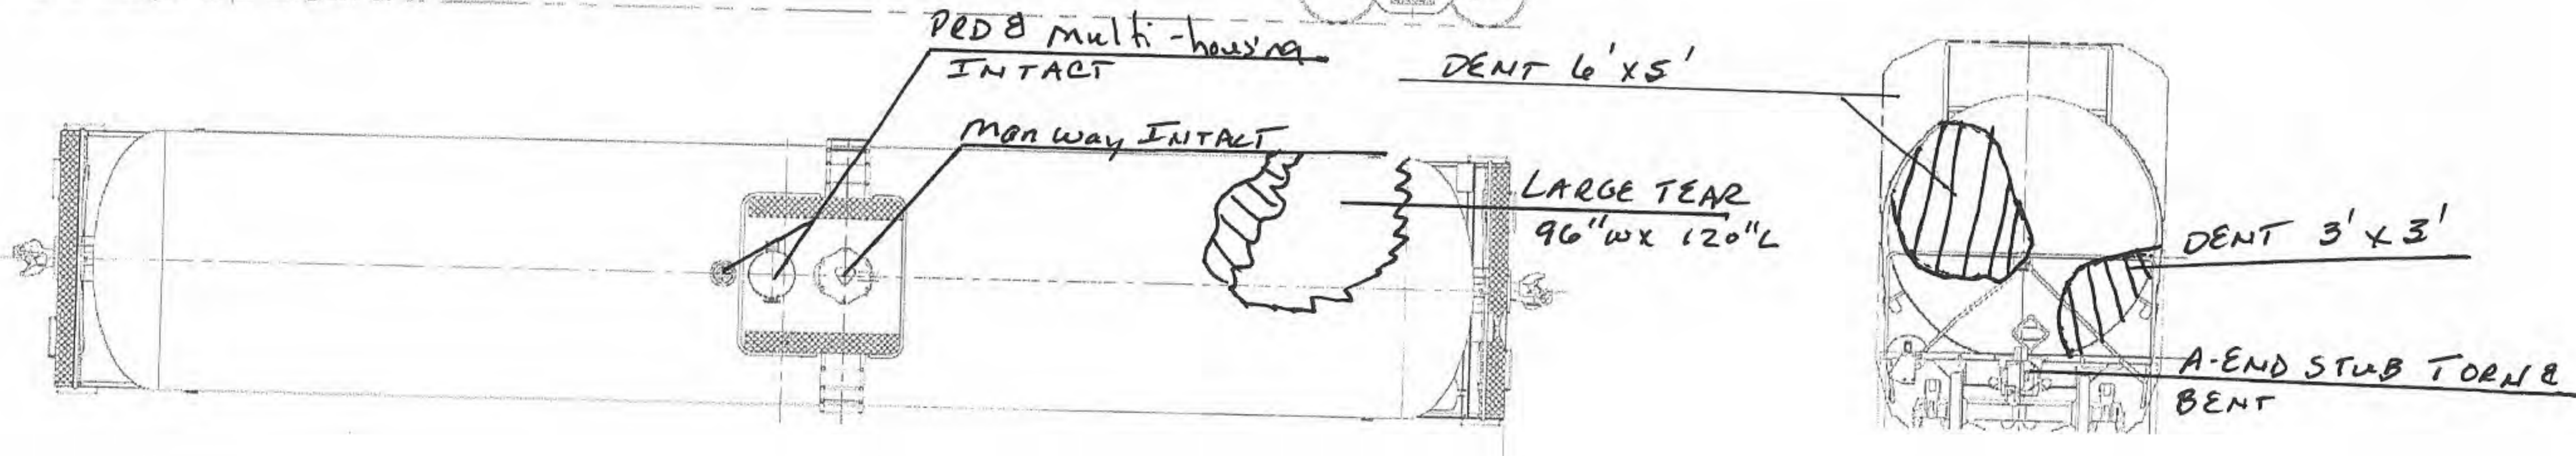
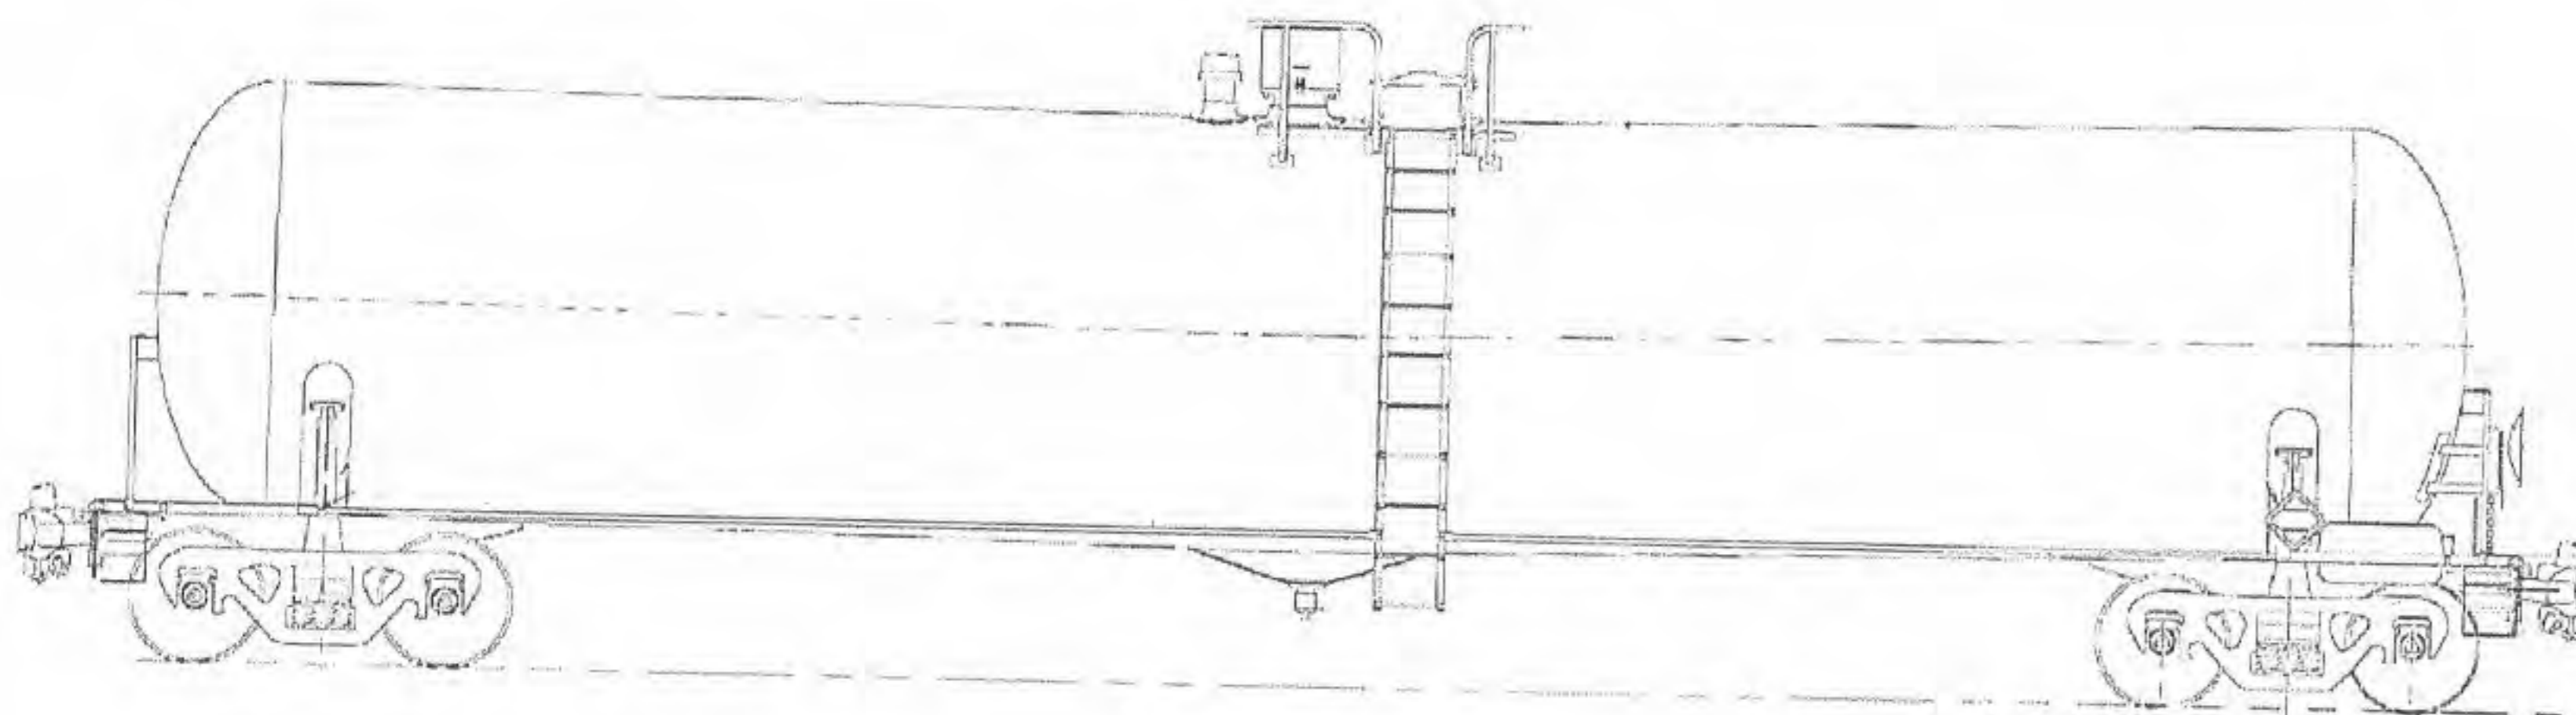
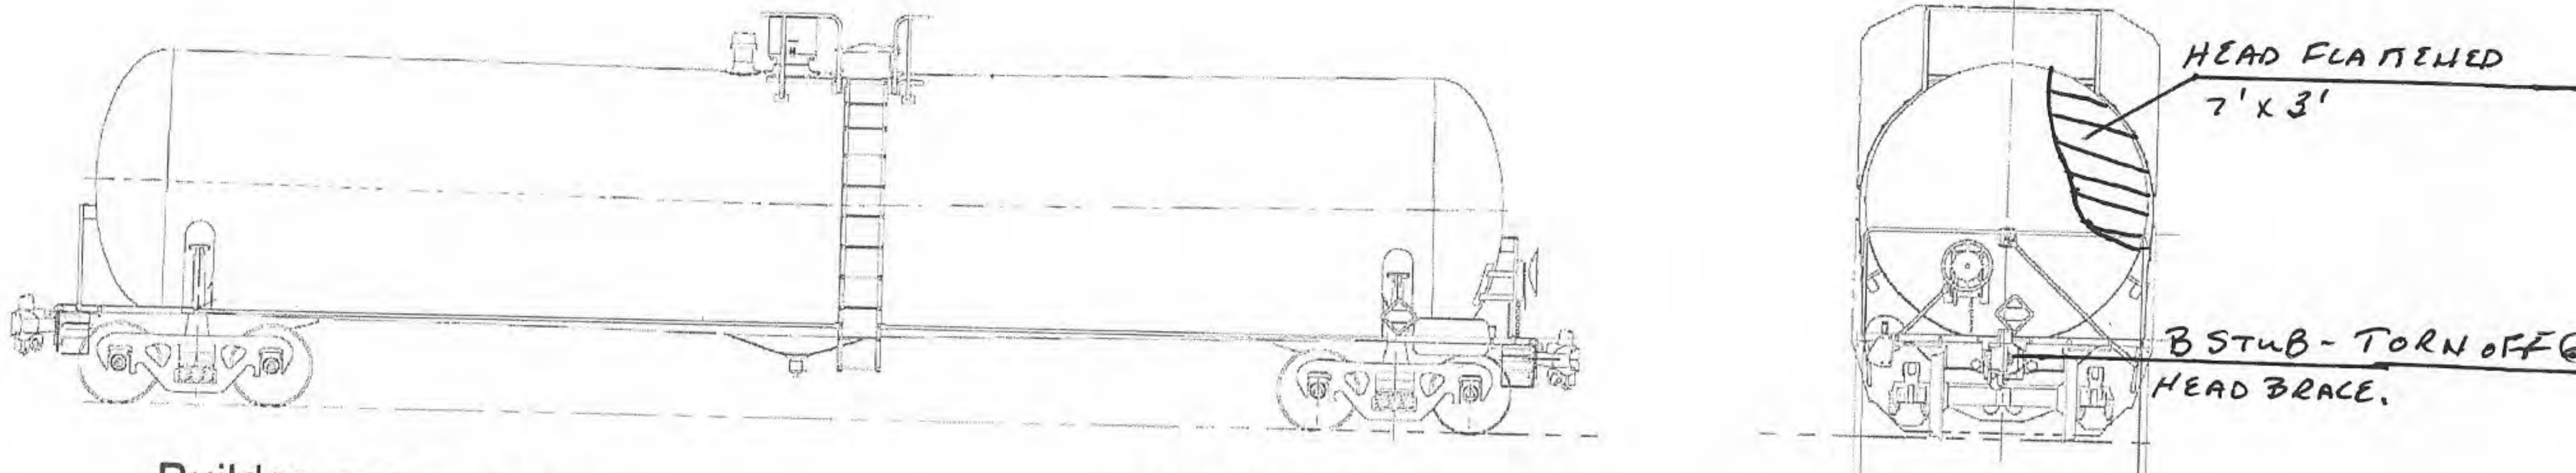
Car Number TILX 199819

TEAR AT BOLSTER PAD WELD & SHELL 96" x 120"

Additional
DEFORMATION
6' x 10'

PRD Multi-housing
INTACT

DENT 6' x 5'

MANWAY INTACT

LARGE TEAR
96" W x 120" L

DENT 3' x 3'

A-END STUB TORN &
BENT

HEAD FLATTENED
7' x 3'

B STUB - TORN OFF @
HEAD BRACE.

Top fittings PRD, manway, multi housing INTACT
Bottom Outlet ADAPTOR SHRED, BOV CLOSED, HANDLE MISSING
Punctures TEAR
Draft sill TRN - 023

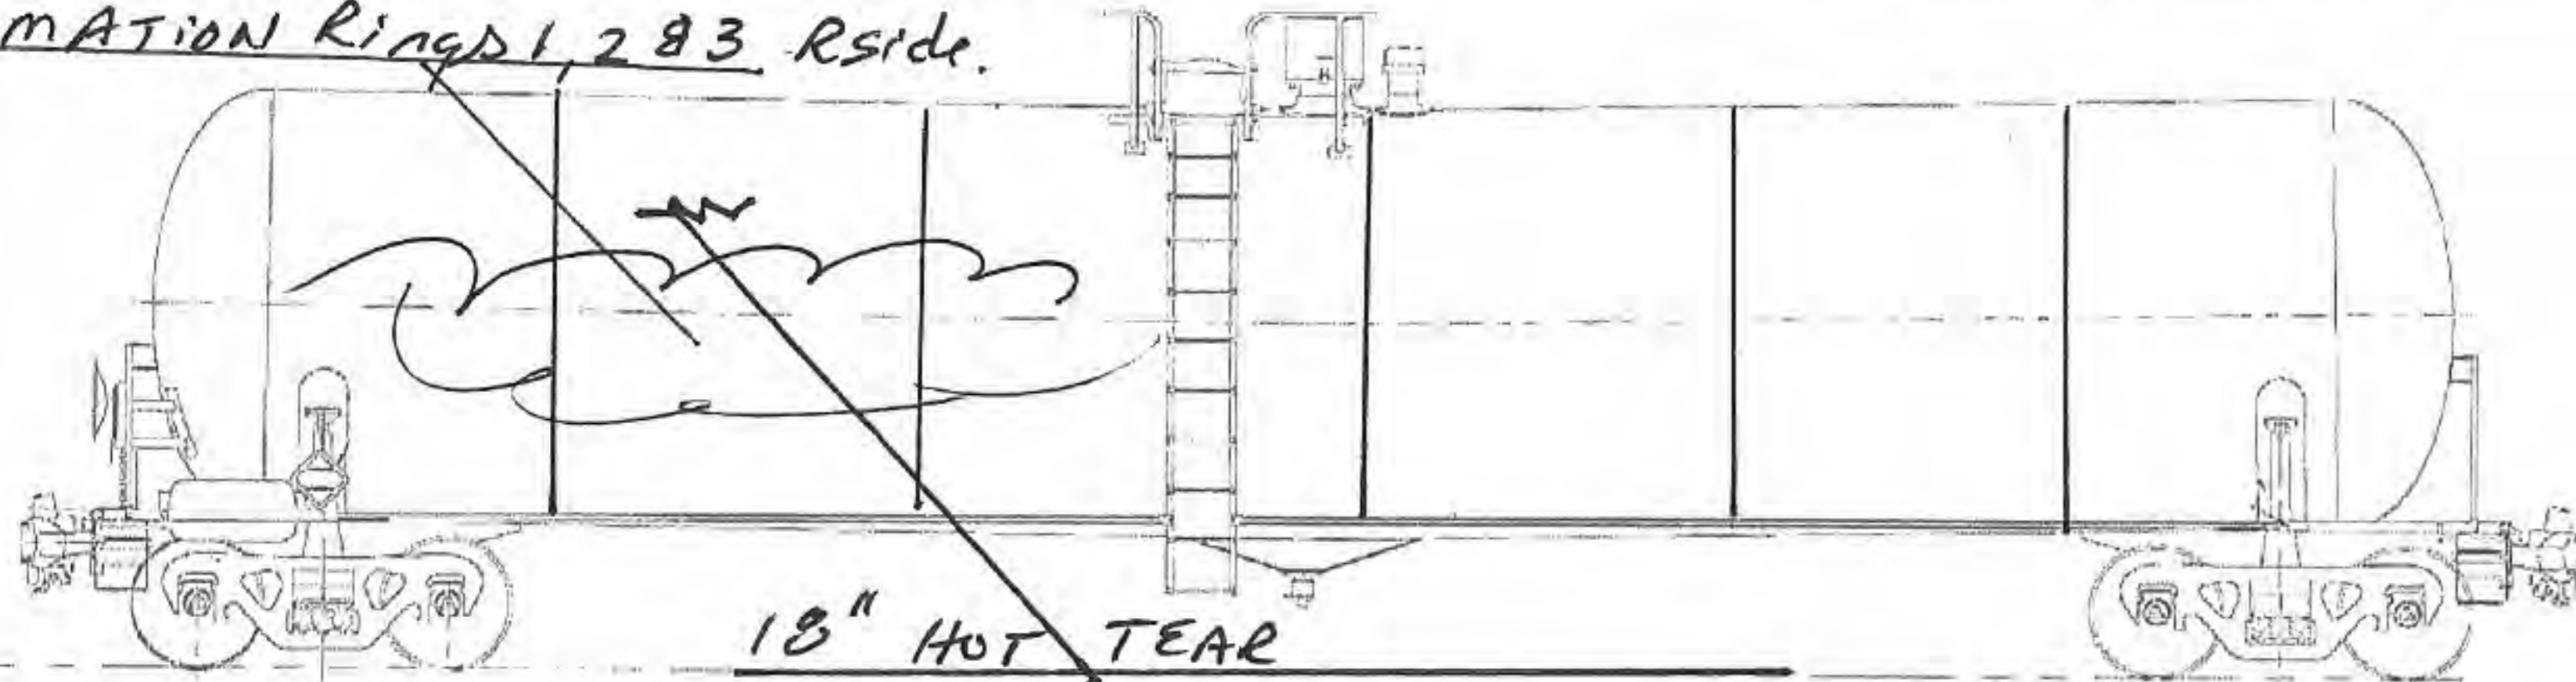
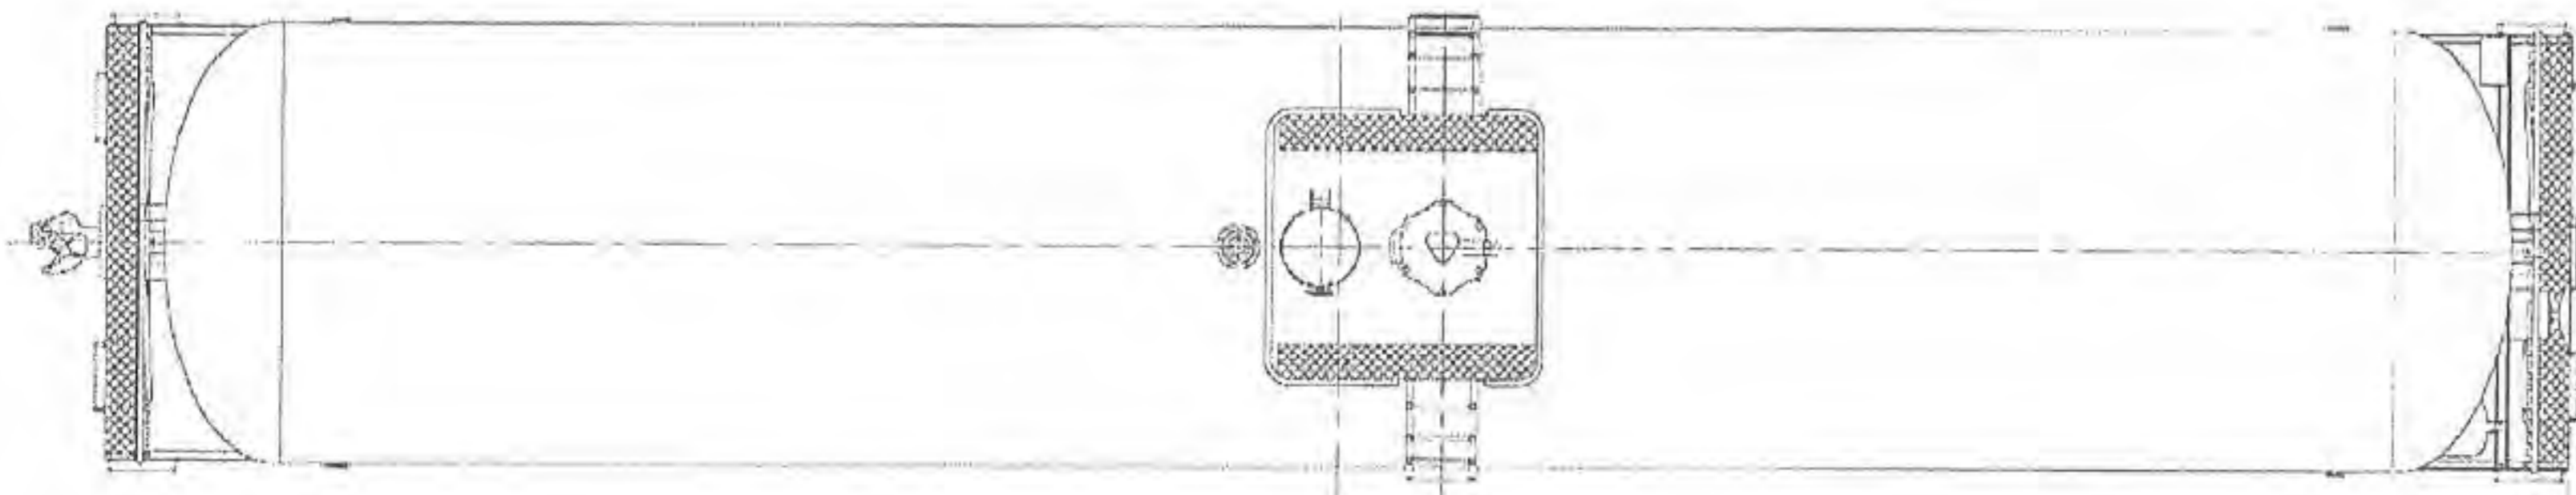
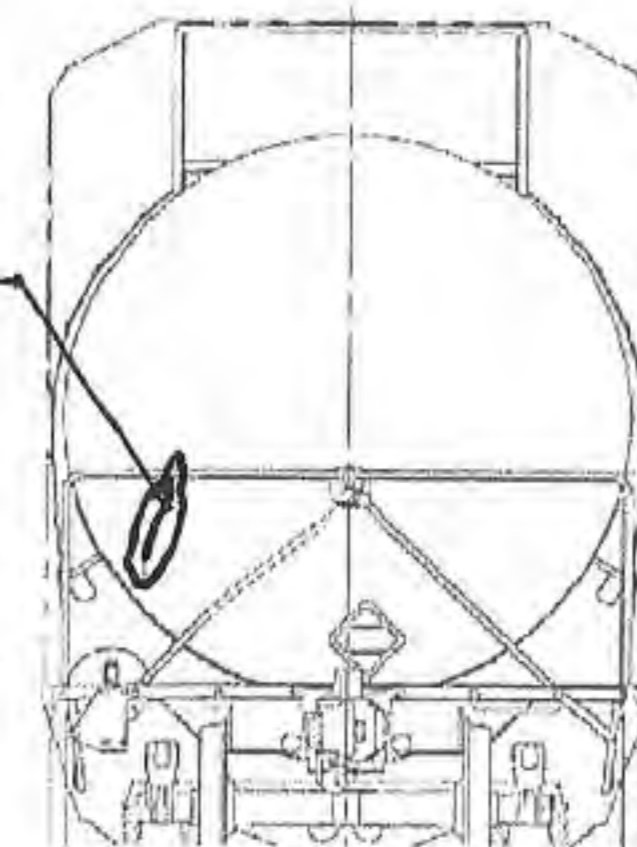
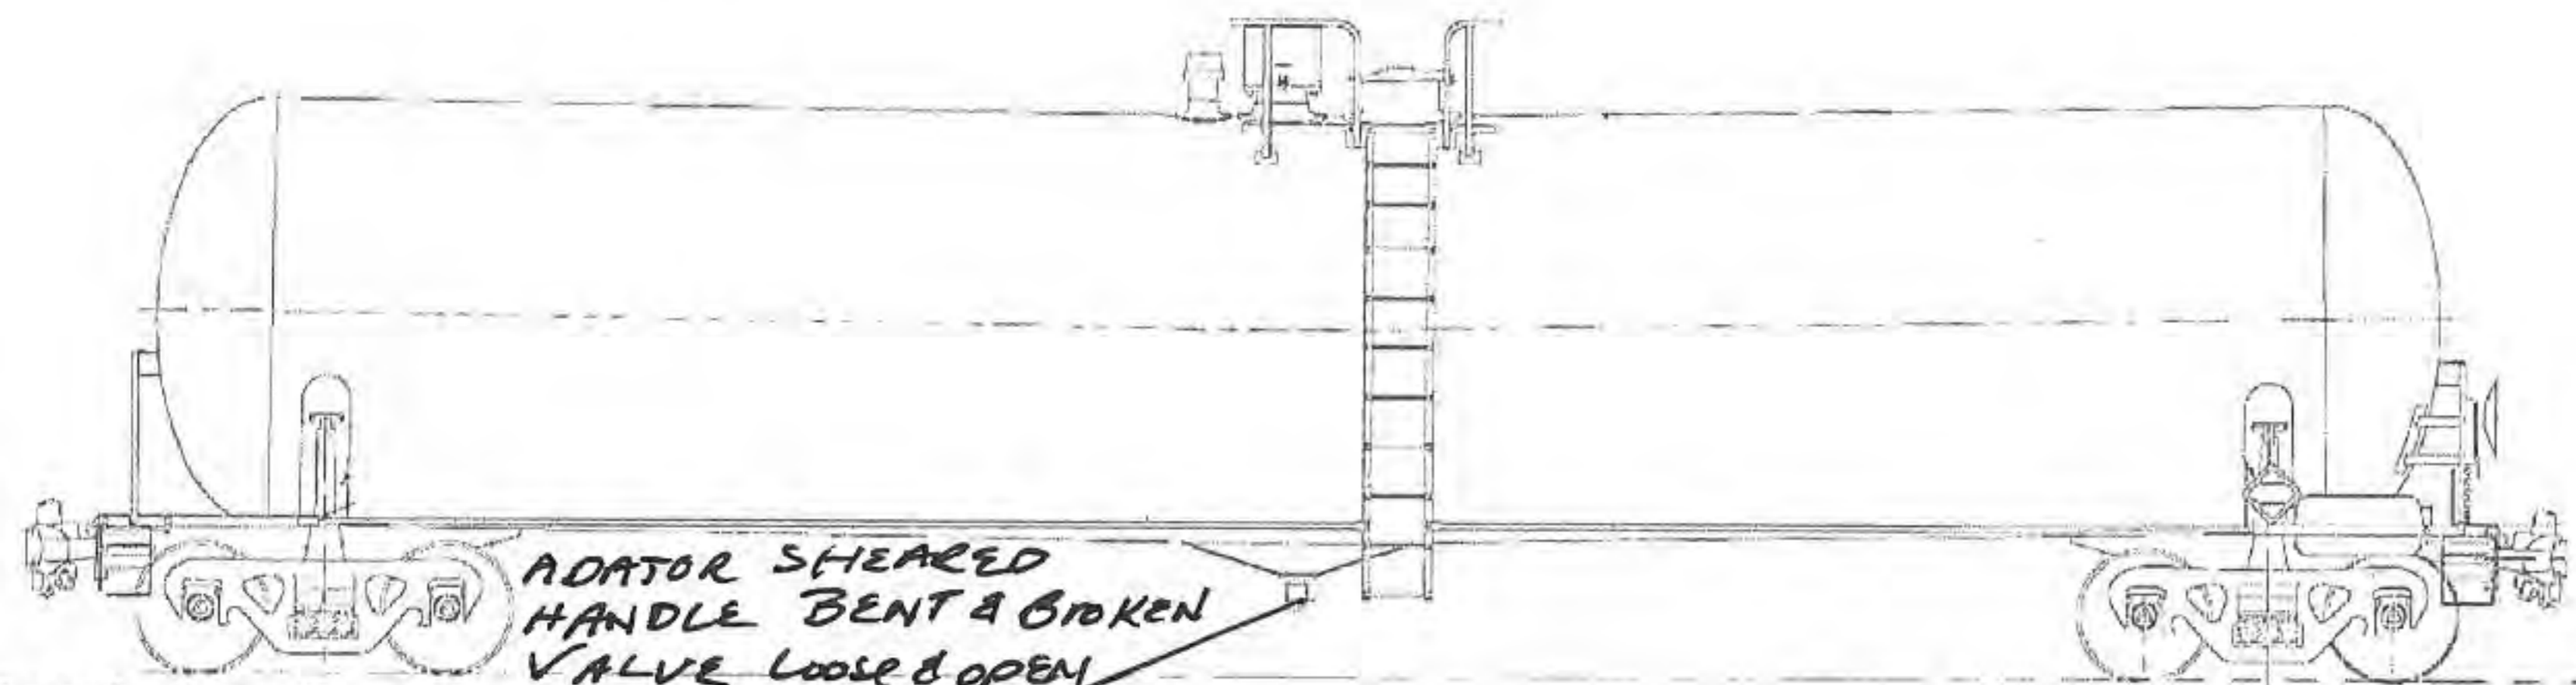
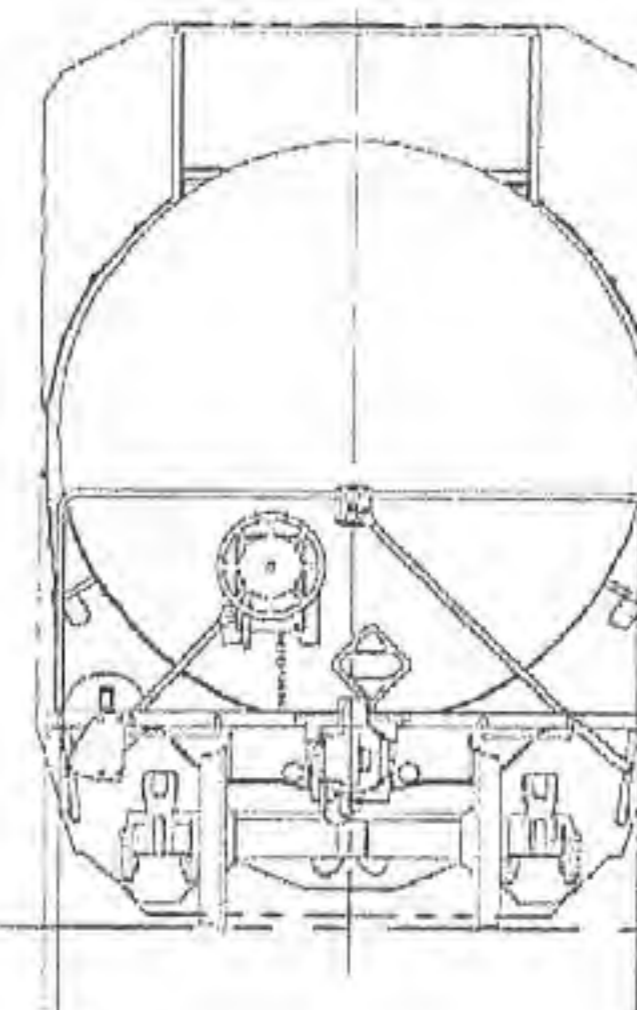
Car Number TILX 195202

PERFORMANCE Ring 1, 2 & 3 Rside.

CREASE/DENT
 3 STUBS BENT
 & TORN
 COUPLER BROKEN.

BOV SEATS ARE BURNT OUT

Top fittings PRO, man way, Multi housing INTACT
 Bottom Outlet SEATS MELTED - ADAPTOR SHEARED, HANDLE BROKEN
 Punctures HOT TEAR 18"
 Draft sill TRN-023
