Car Damage Report

1-07-14
DGT-004
Rev 2

Location Graettinger IA

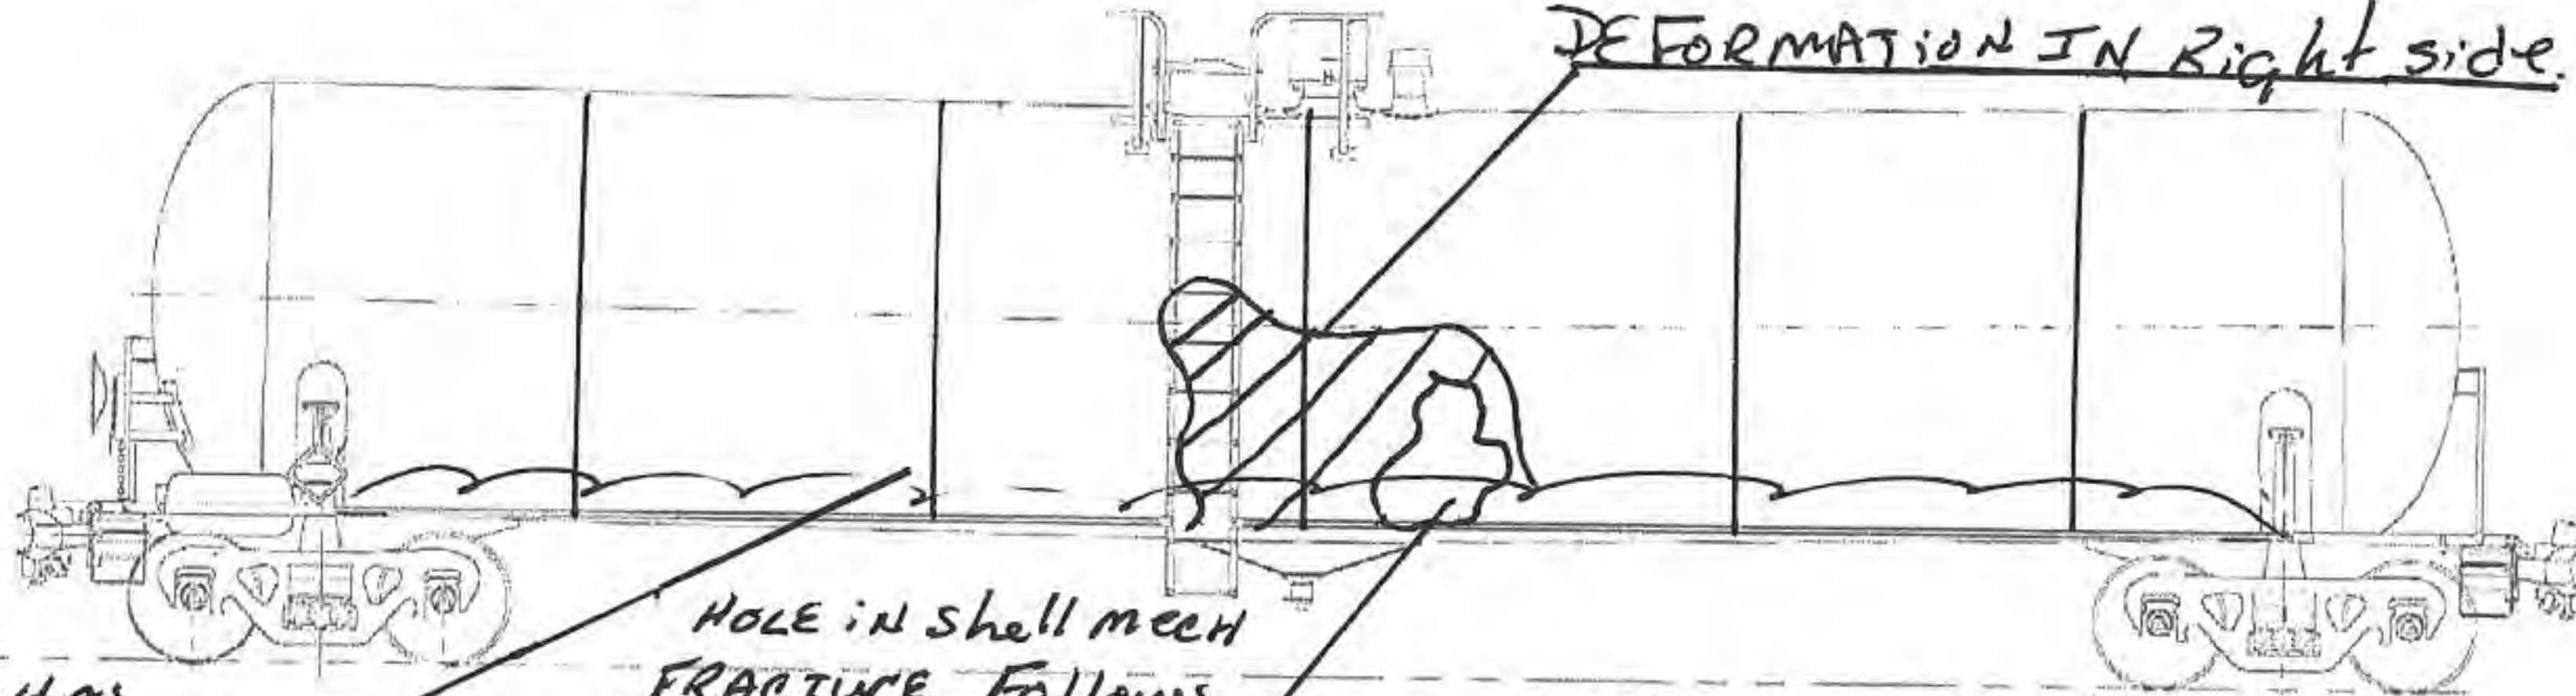
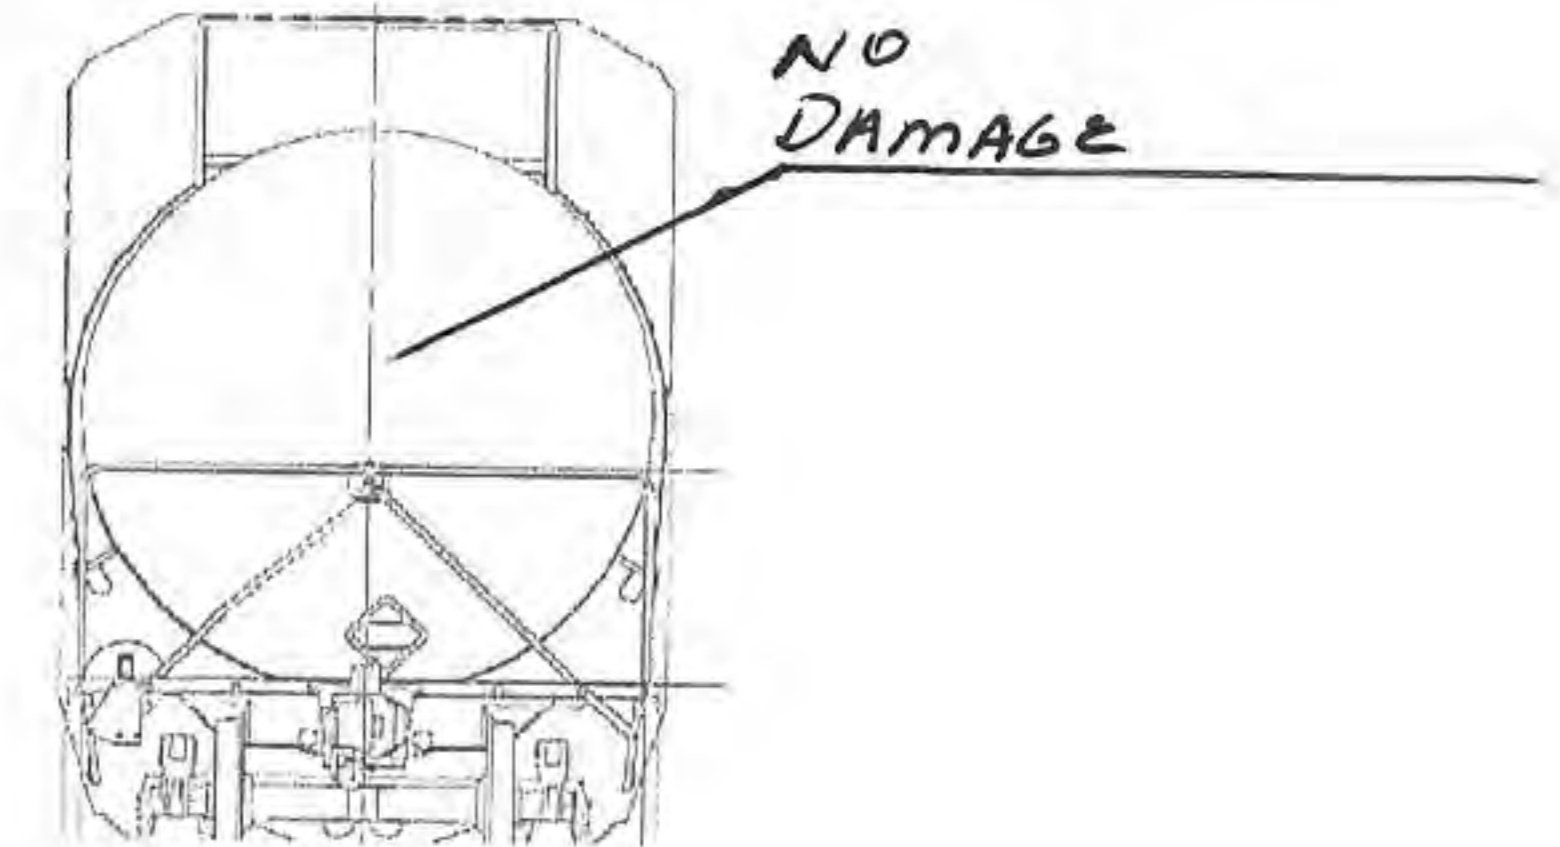
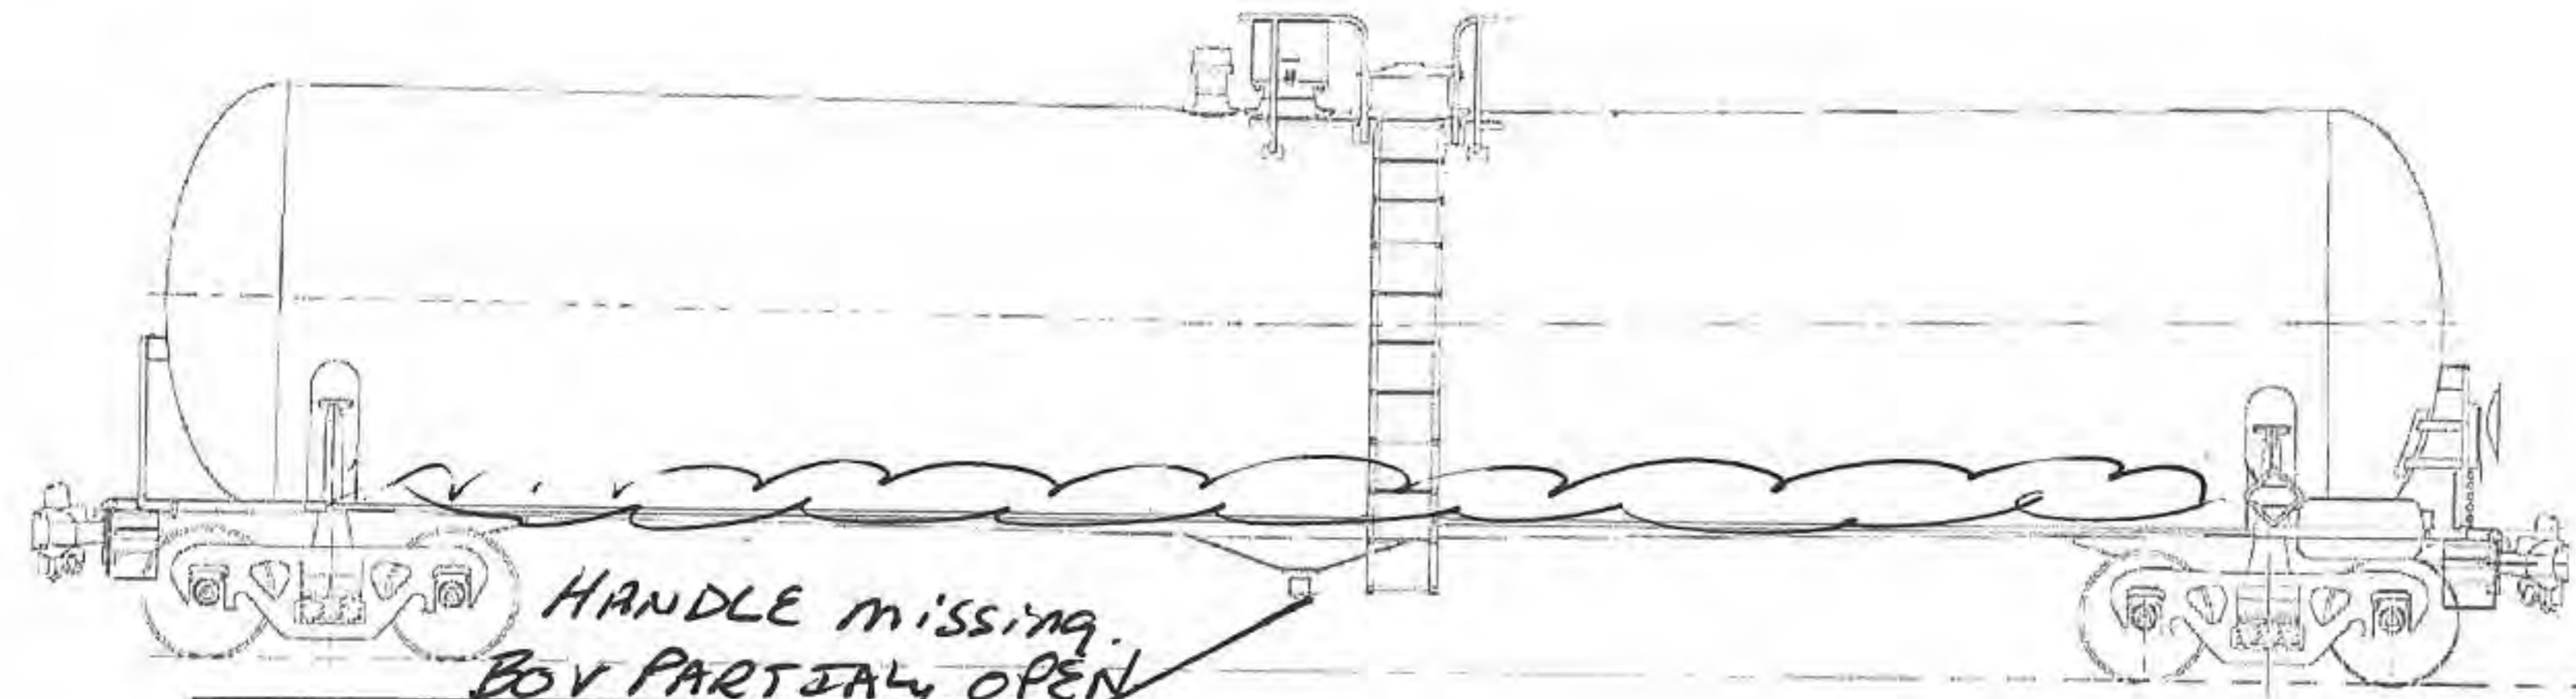
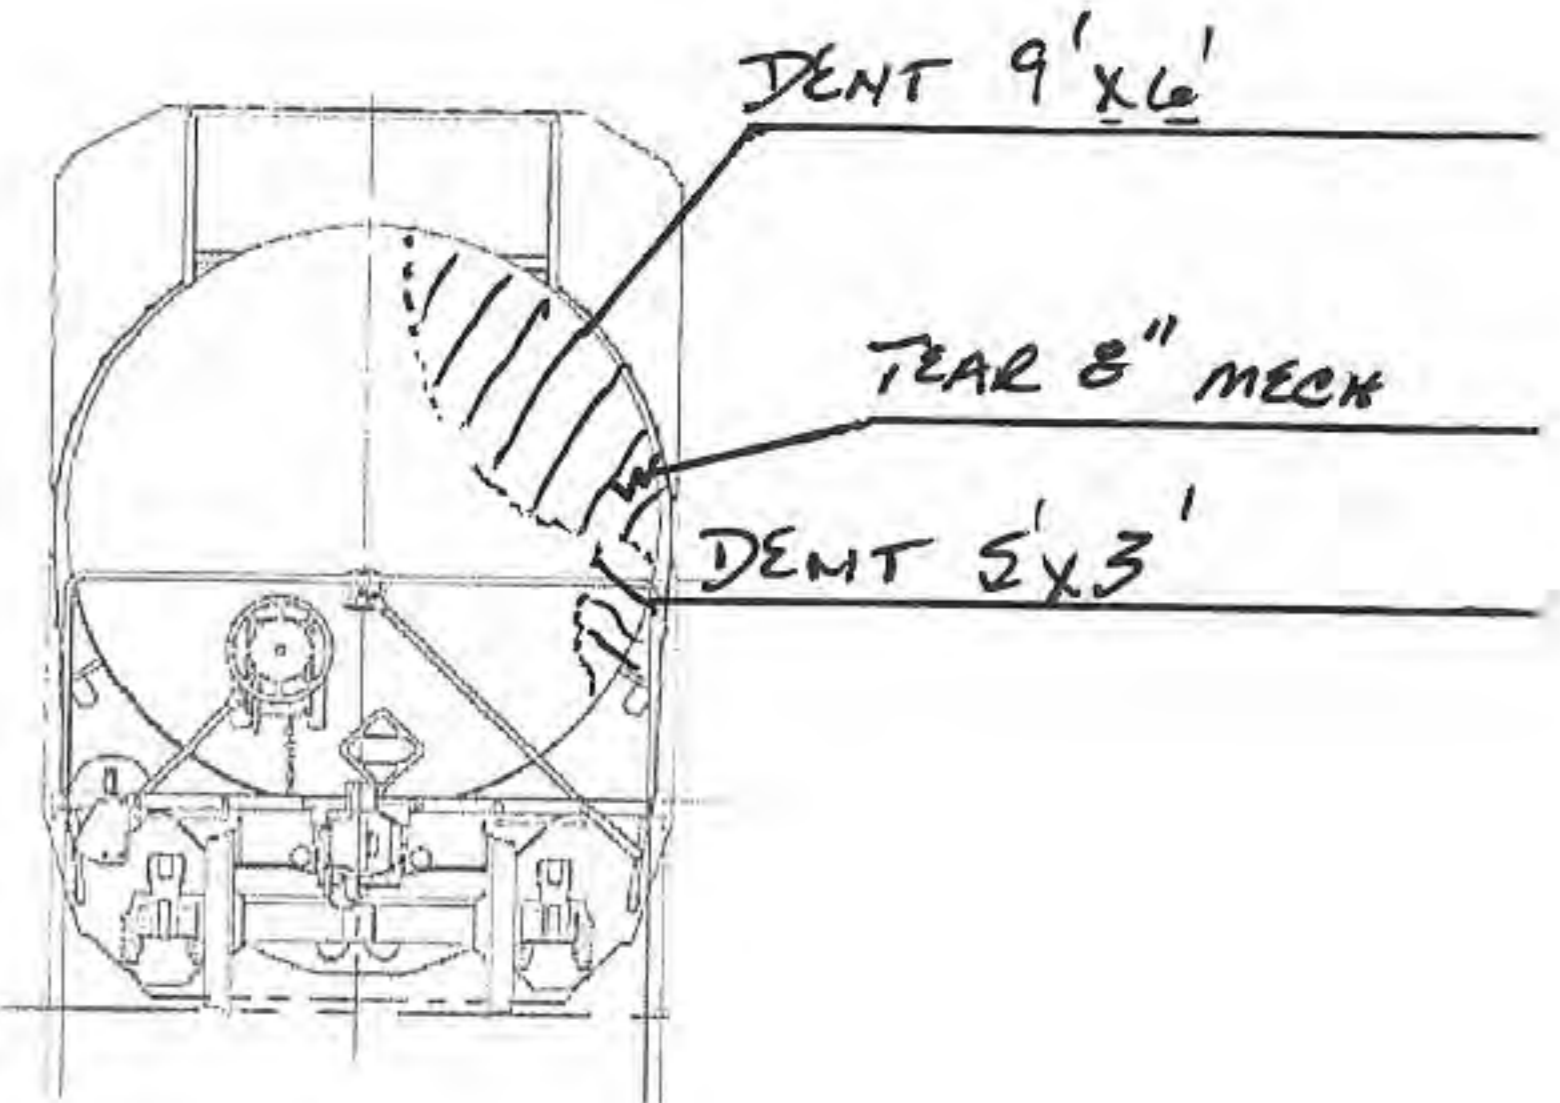
Car Number CTCX 731 383

DEFORMATION IN Right side 10'x8'

BOTTOM HAS DEFORMATION FULL LENGTH.

HOLE IN shell MECH FRACTURE Follows DOWN THROUGH BARS at SKID. 6' TEAR 2 1/2' x 3' hole.

INTACT PRD & multi housing manway opened to empty

NO DAMAGE

COUPLER & STUB SILL INTACT

A Coupler sheared STUB INTACT

AL BOTTOM COVER PLATE TORN

HANDLE missing. BOV PARTIALLY OPEN

DENT 9' x 6'

TEAR 8" MECH

DENT 5' x 3'

Top fittings INTACT
Bottom Outlet OPEN - ADAPTOR SHEARED - HANDLE MISSING
Punctures Rside Ring 3.
Draft sill TRN - 023

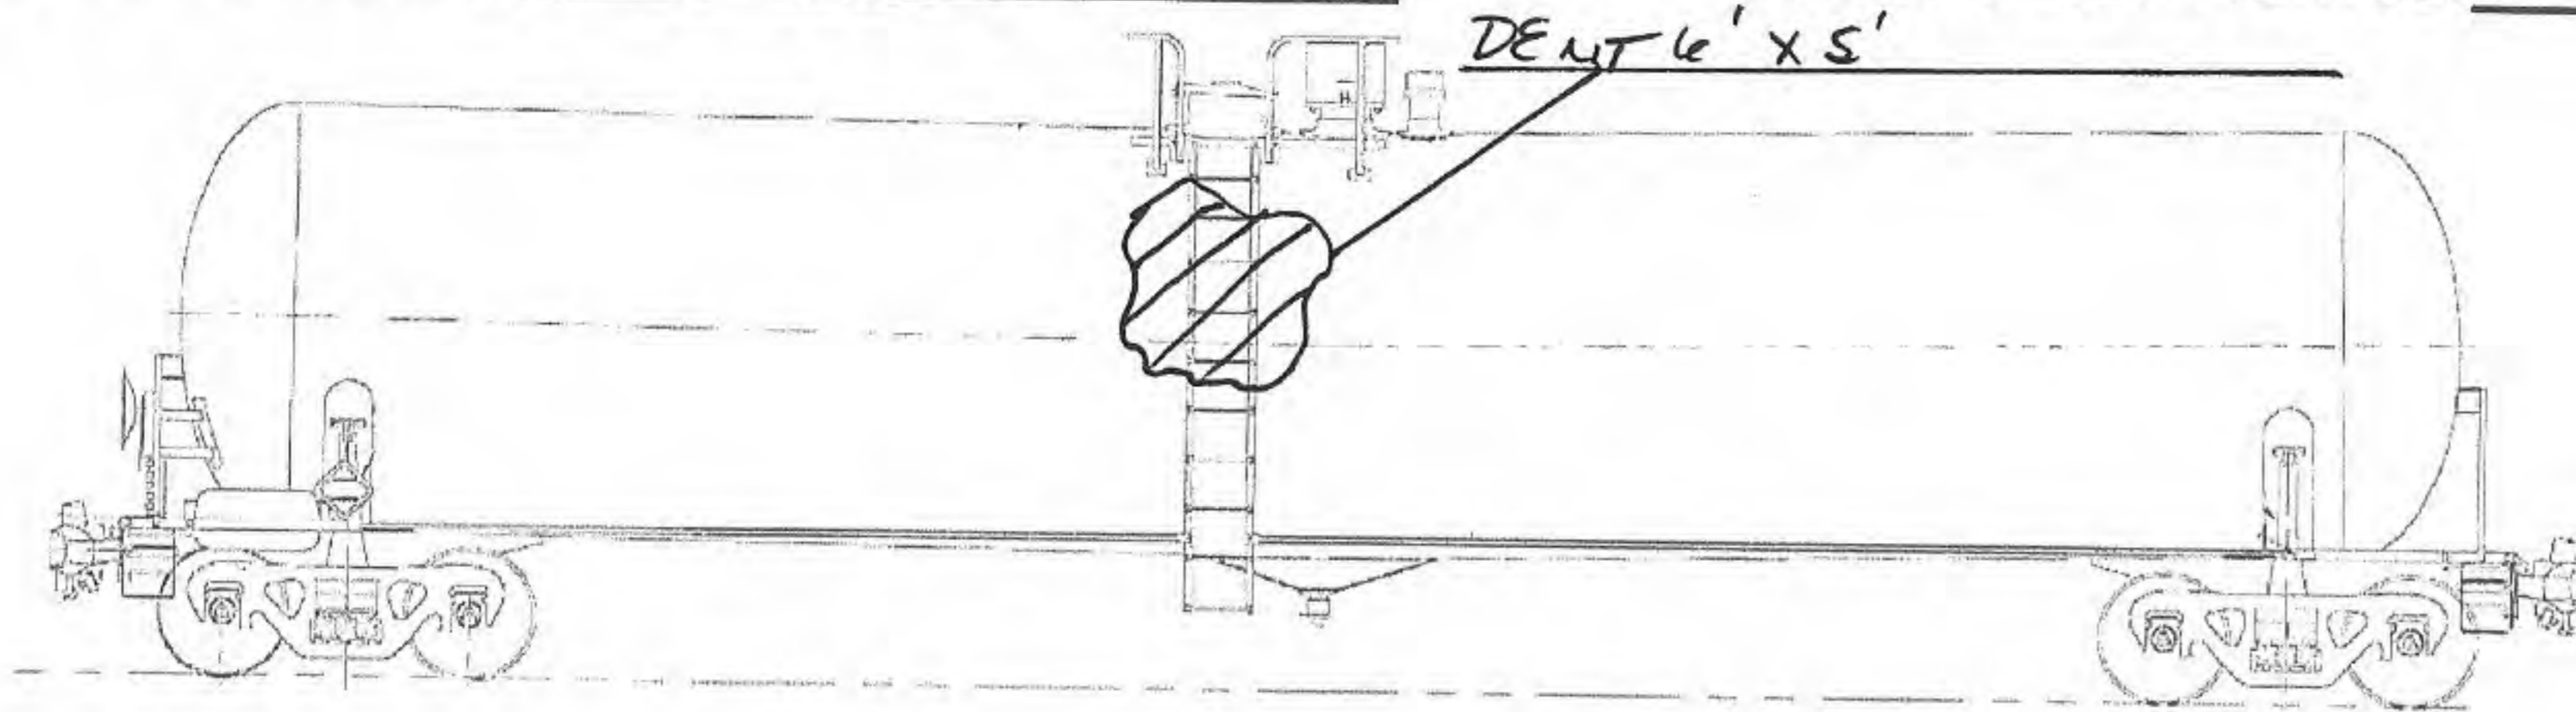
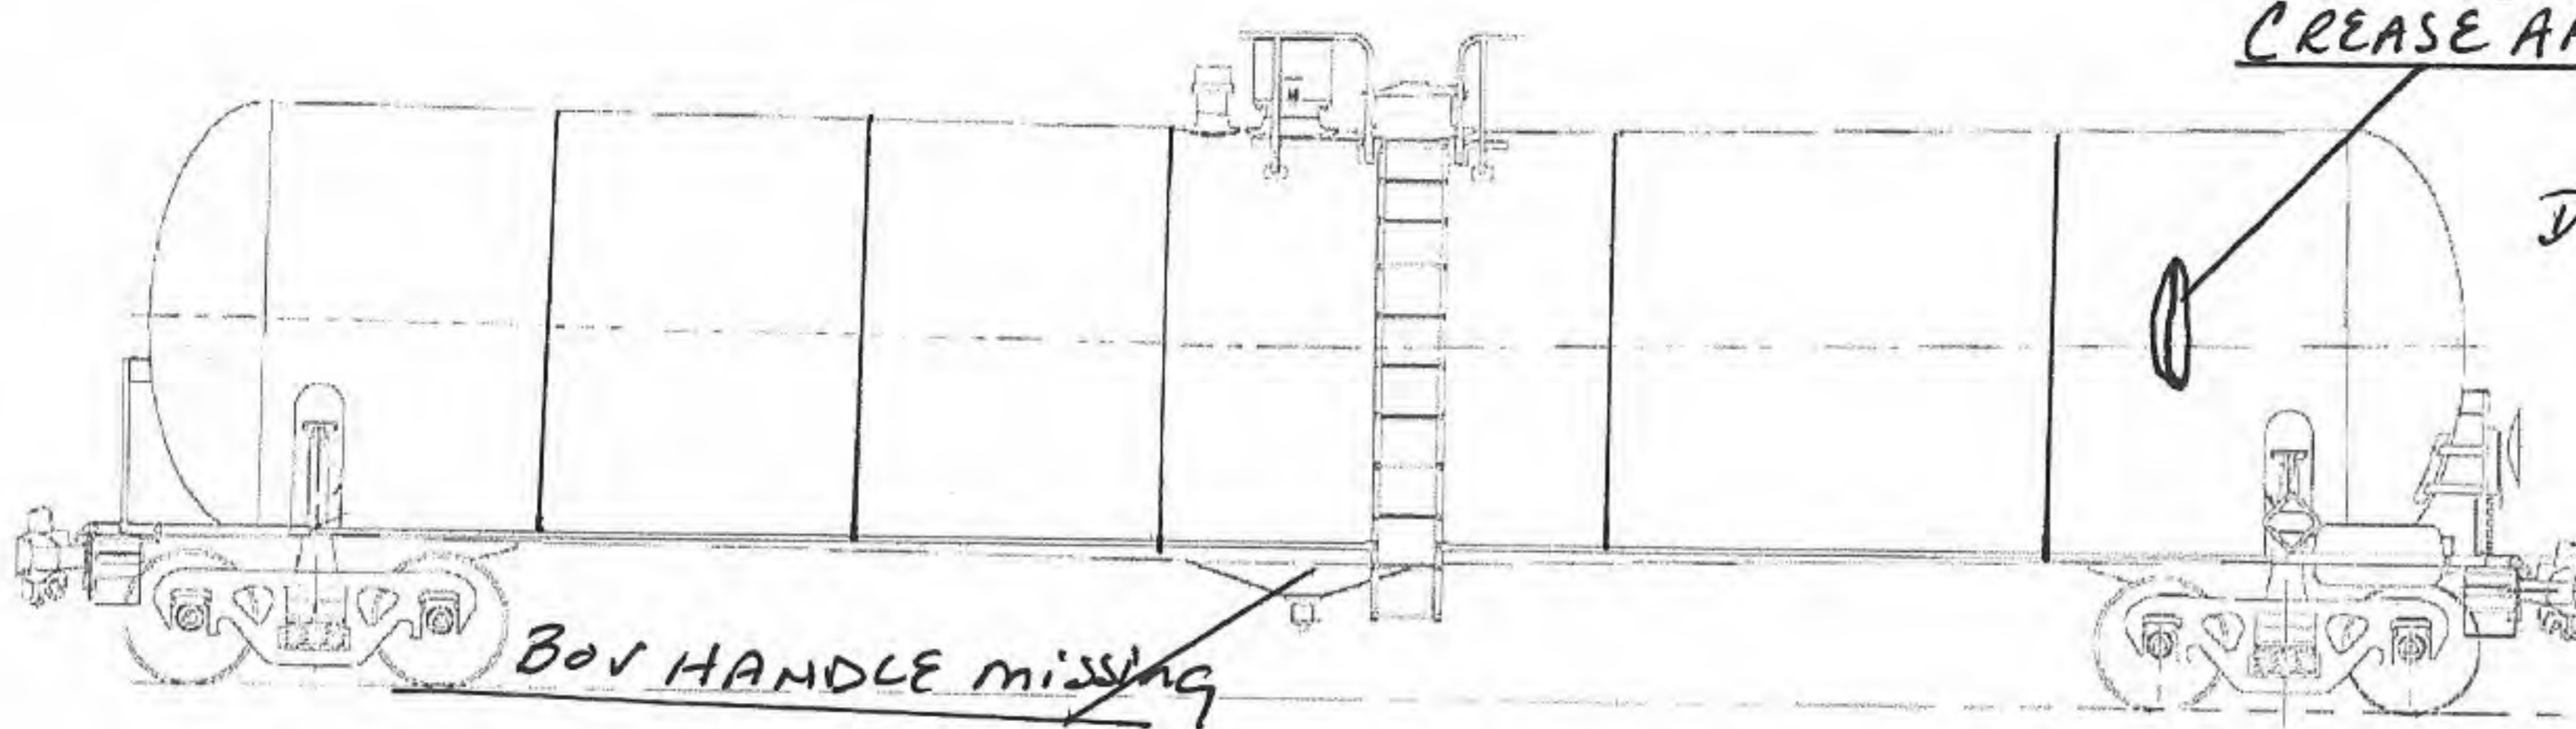
Car Number TILX 195386

A
BENT &
TORN

B stub sill
BENT & TORN

DENT SIMILAR IN SIZE.
CREASE APPROXIMATE 3'

DENT 7' x 5'

BOV HANDLE missing

Top fittings PRD, manway, multi-housing INTACT
Bottom Outlet INTACT ADAPTOR INTACT HANDLE missing
Punctures _____
Draft sill TRN-023

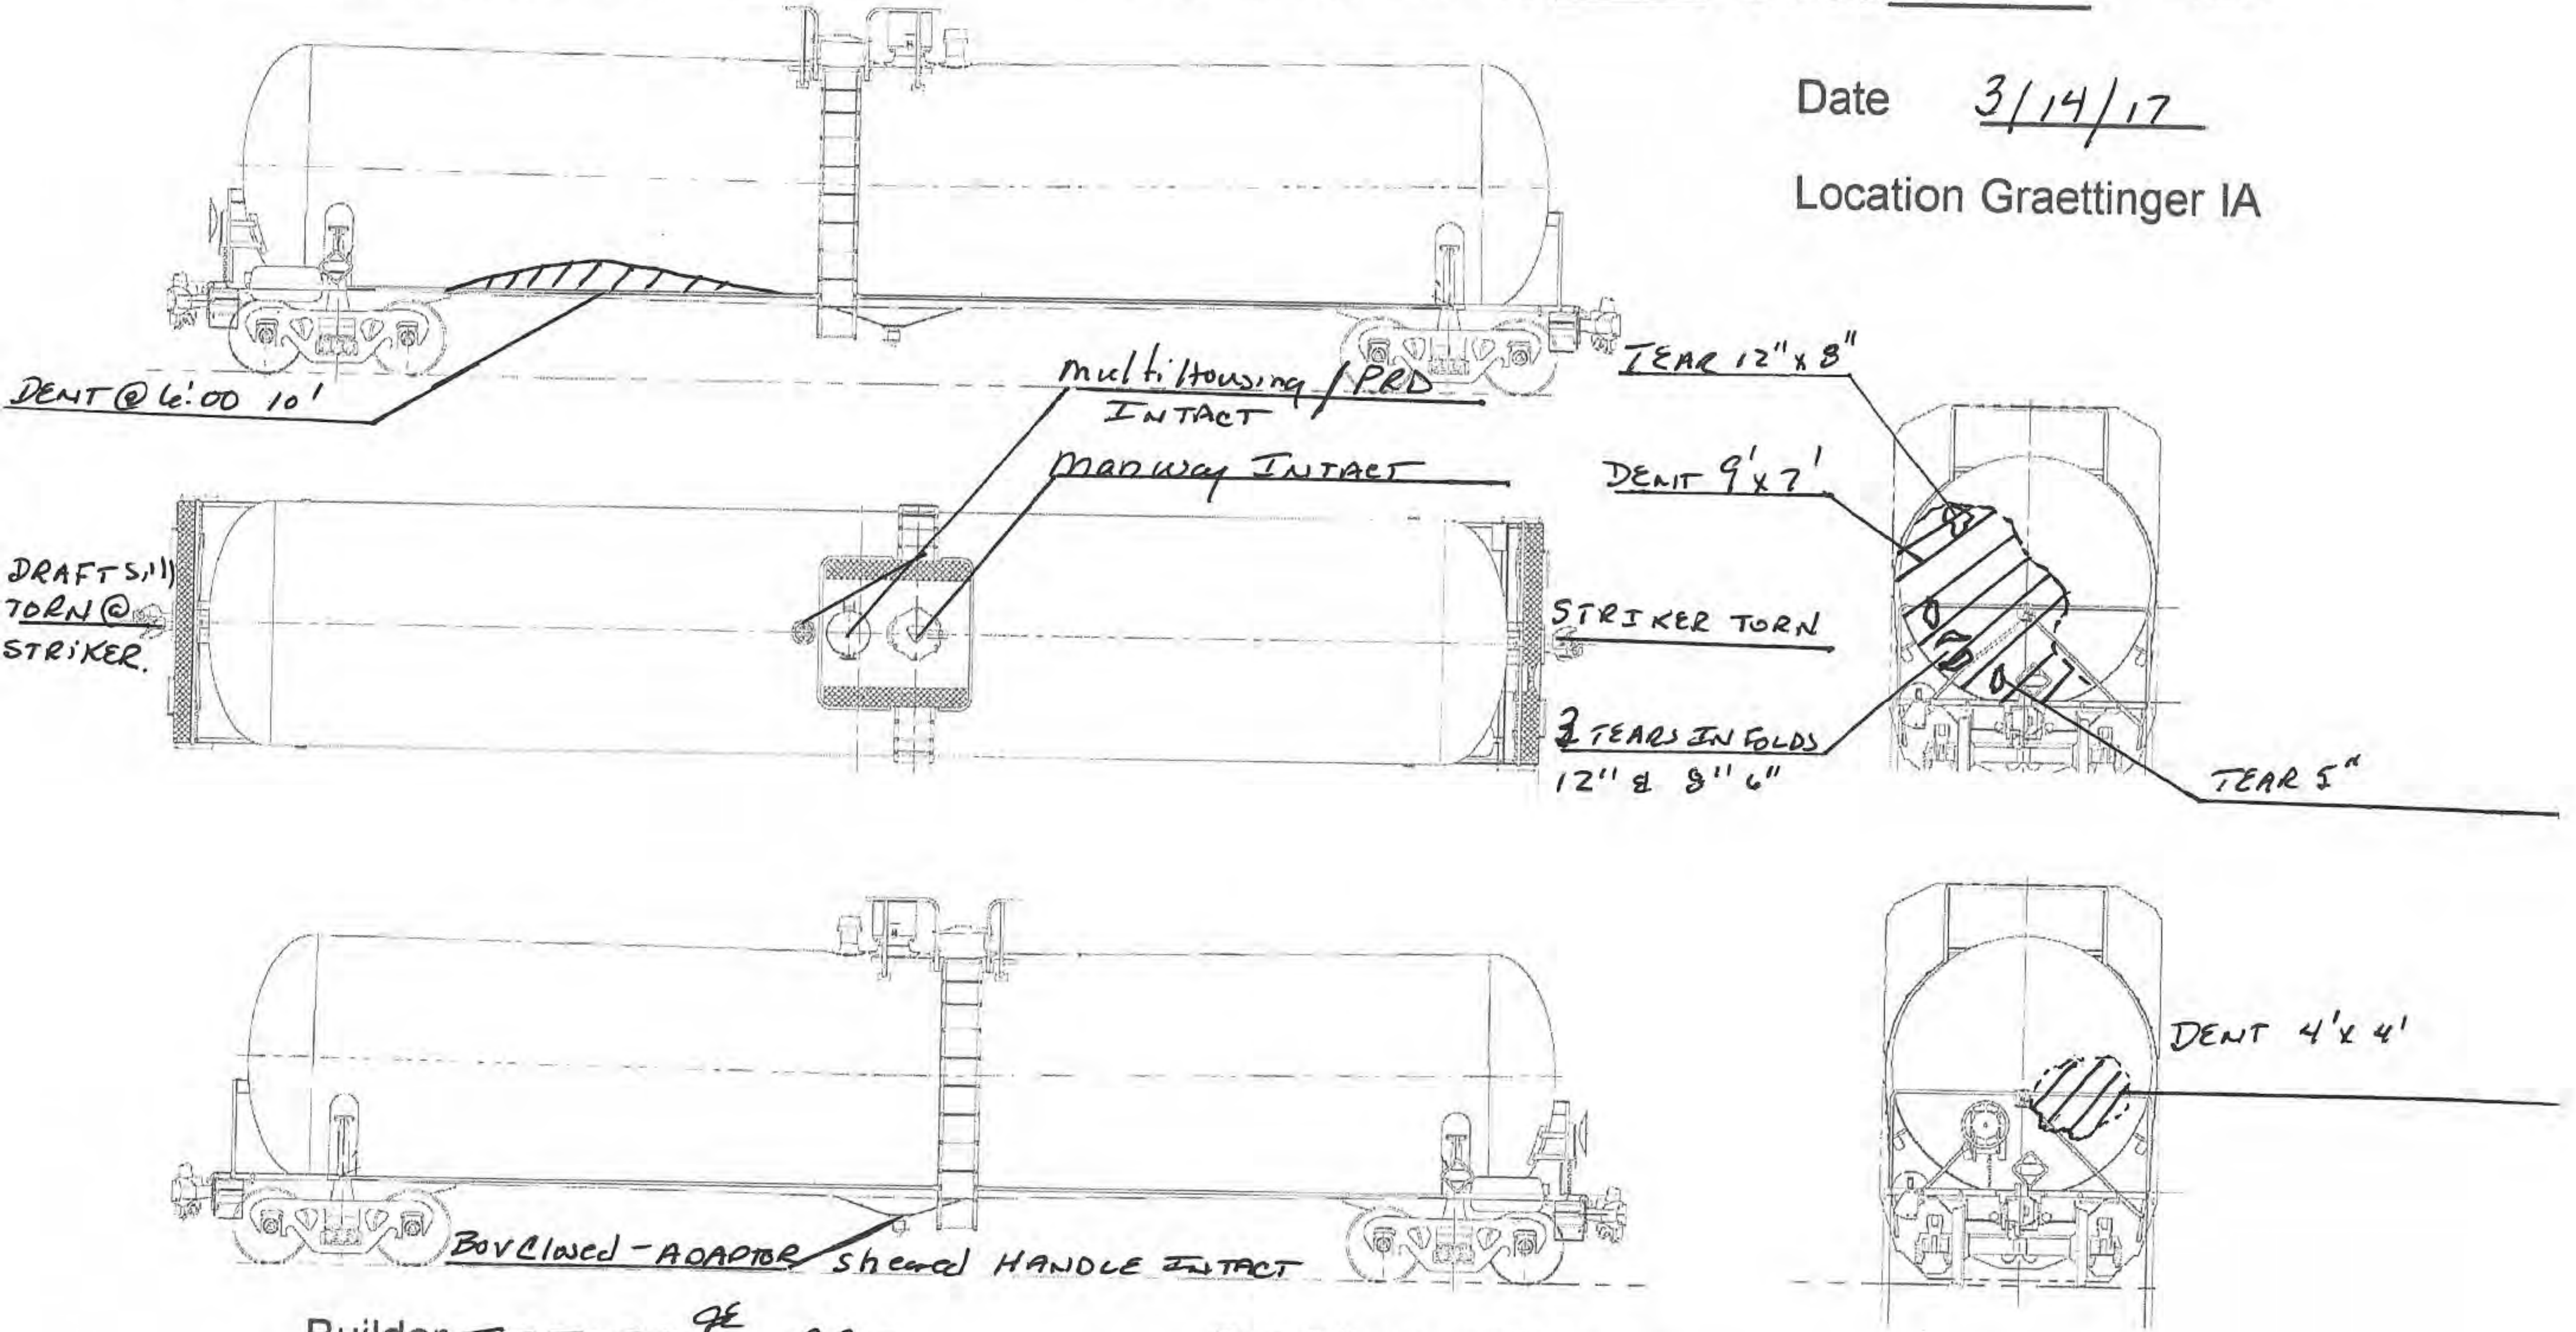
Car Number CTC^x 731997

Top fittings INTACT
Bottom Outlet BOV Closed - ADAPTOR SHEARED - HANDLE INTACT
Punctures (5) A-HEAD
Draft sill FRN - 0239E
ARI - 300

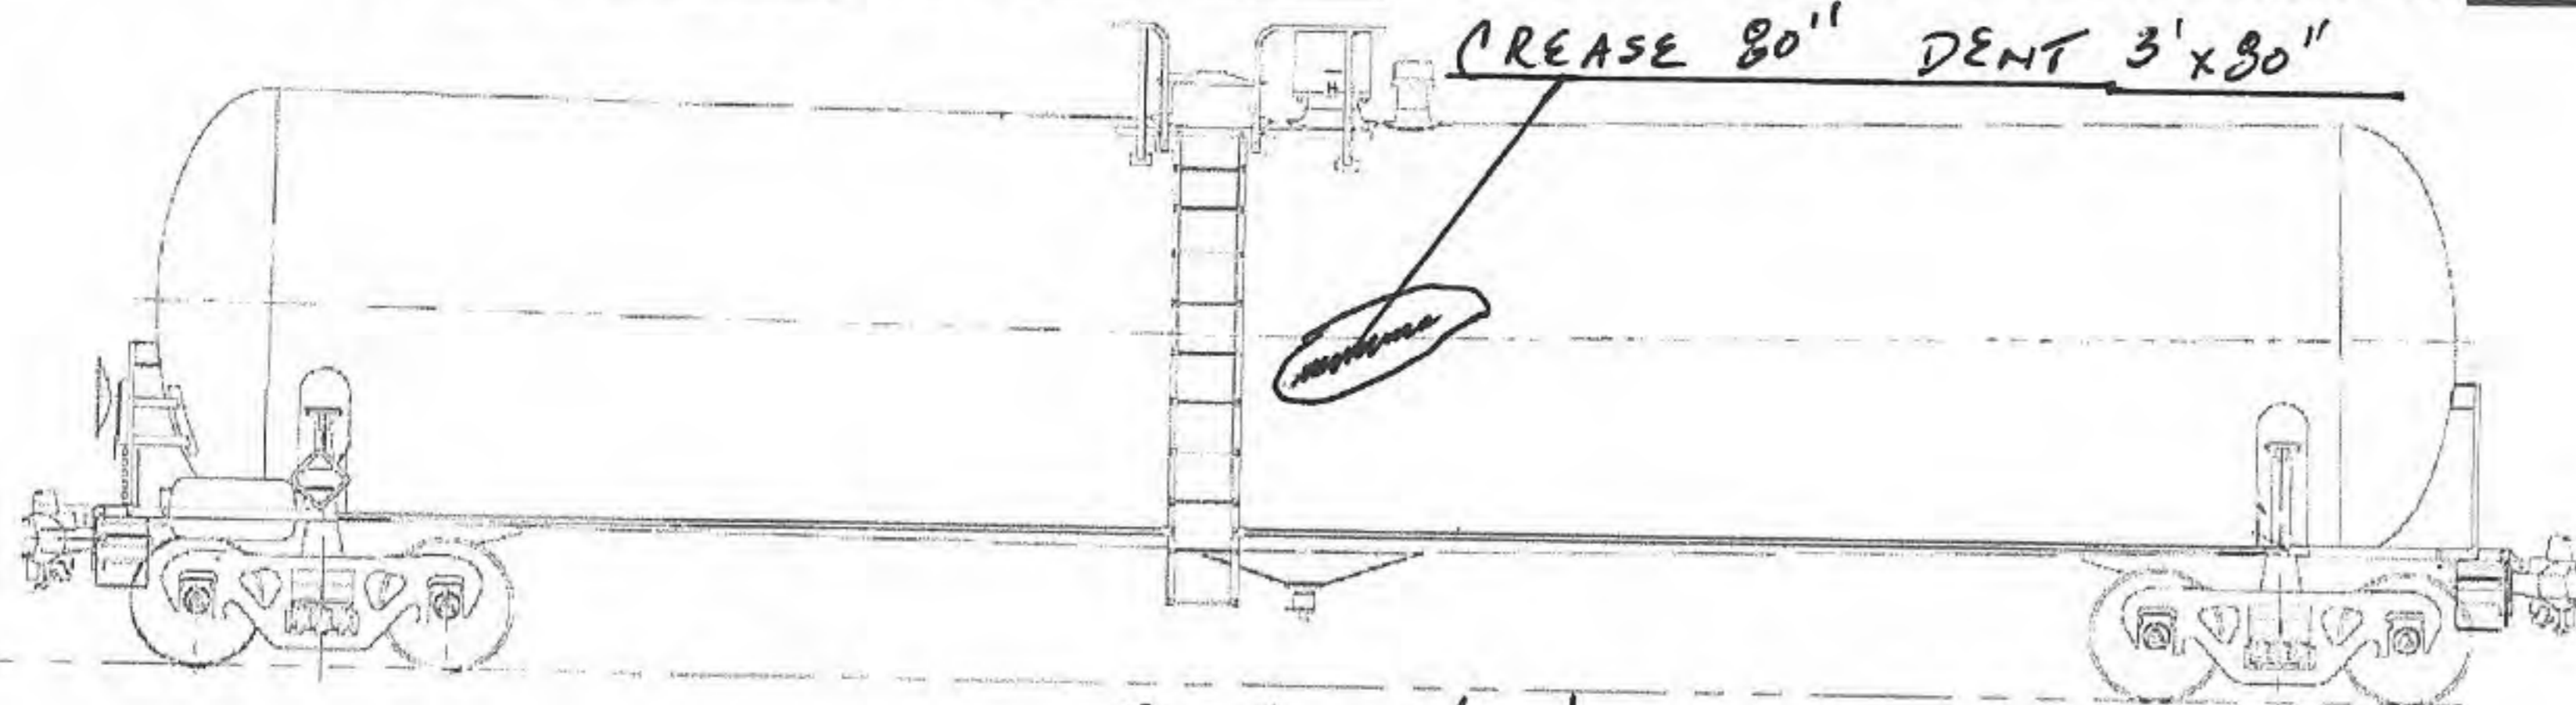
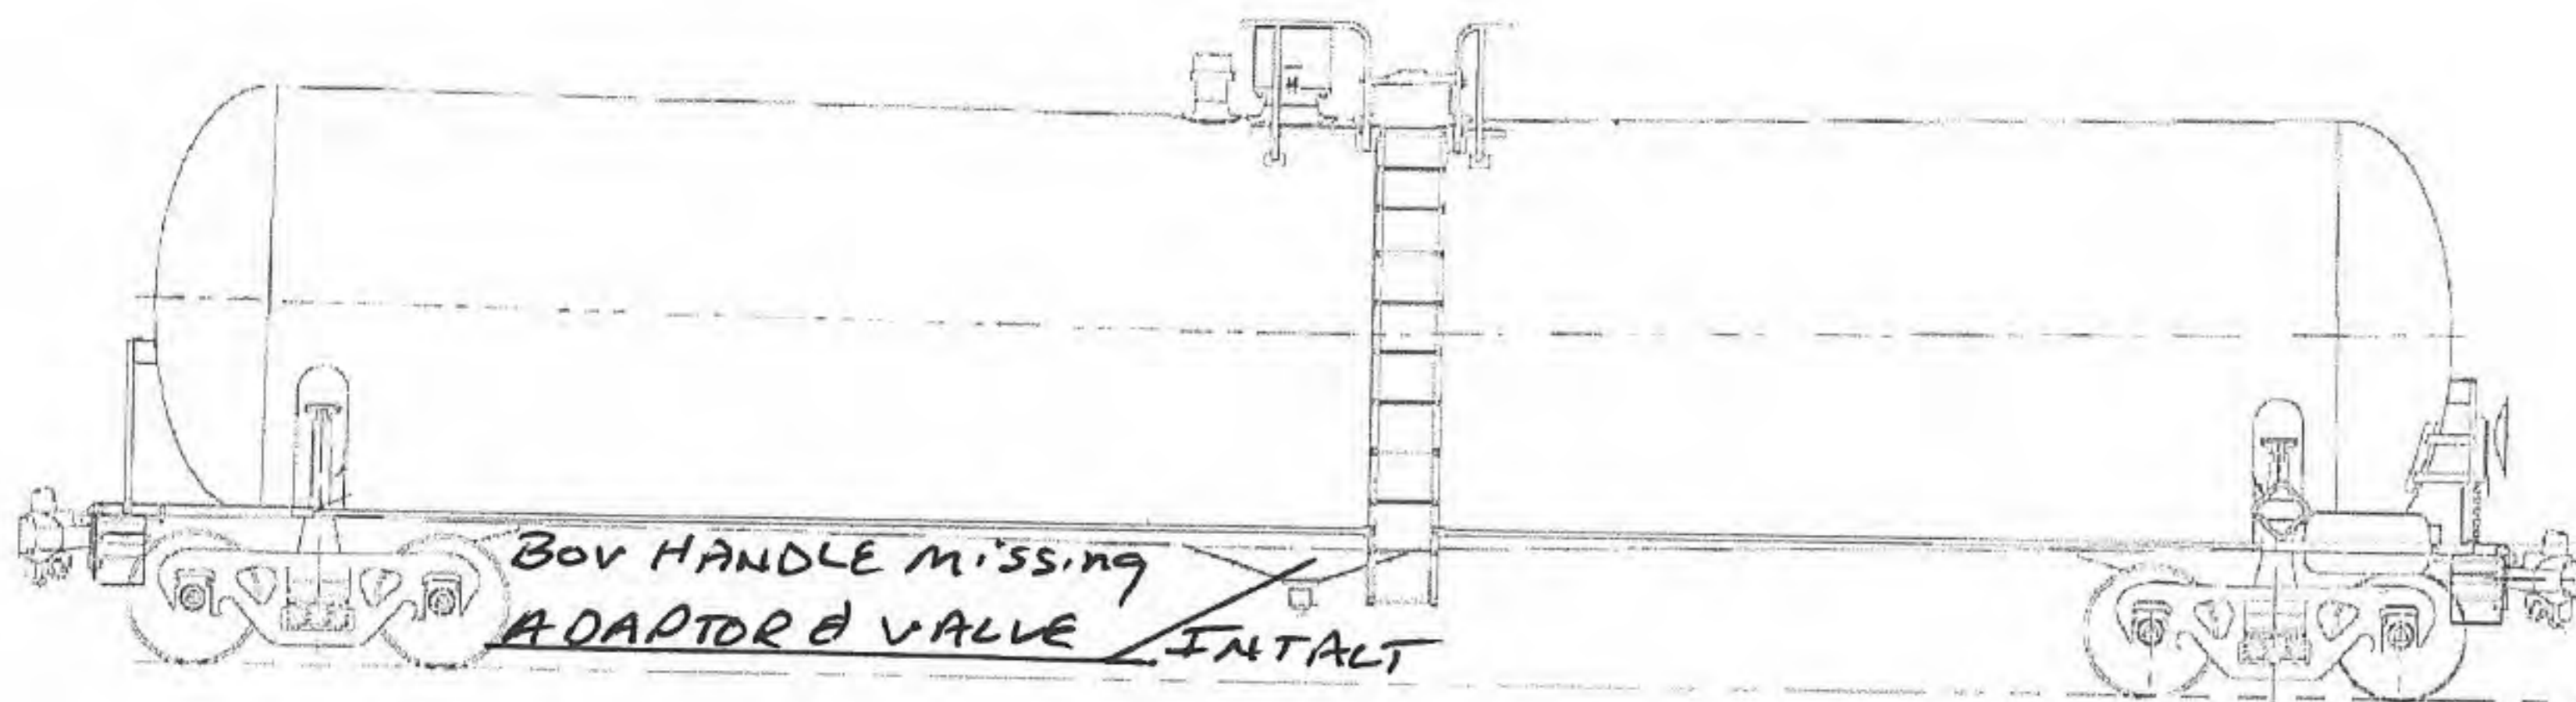
Car Number TELX 197615

PRD & multi-housing are INTACT

manway is intact

DENT 6'x5'
B
STUBS 5:11 SEPERATED
@ HEAD BRACE

Bottom Outlet BOV & Adaptor INTACT - HANDLE is missing
