Federal Railroad Administration
Tank Car Damage Assessment Form

Reporting Marks	UTLX 207398		Car Location City/State	Paulsboro, NJ	
Date inspected	12/17/12	Railroad	CRSH	DOT Specification	111A100W1
Last Contained	Ethanol			Was product released?	NO
(Indicate One)	Jacket	Non-jacketed		Does car contain product	YES
Car builder	Union Tank	Stub Sill Design		Built Date	04/2007
Capacity (GAL)	30220		LD Limit (LB)	196600

Reporting Marks	OC PX 80323		Car Location City/State	Paulsboro, NJ	
Date inspected		Railroad	CR	DOT Specification	105 J 300 W
Last Contained	vinyl chloride stabilized		Was product released?	No	
(Indicate One)	Jacket	X	Non-jacketed	Does car contain product	Yes
Car builder	Trinity	Stub Sill Design	TRN023	Built Date	20060301
Capacity (GAL)	24650		LD Limit (LB)	182200

Reporting Marks	OCPX 80234		Car Location City/State	
Date inspected		Railroad	DOT Specification	105J300W
Last Contained	Vinyl Chloride		Was product released?	Yes
(Indicate One)	Jacket		Does car contain product	No
Car builder	TrinityRail	Stub Sill Design	Built Date	11/90
Capacity (GAL)		LD Limit (LB)	178200 lbs

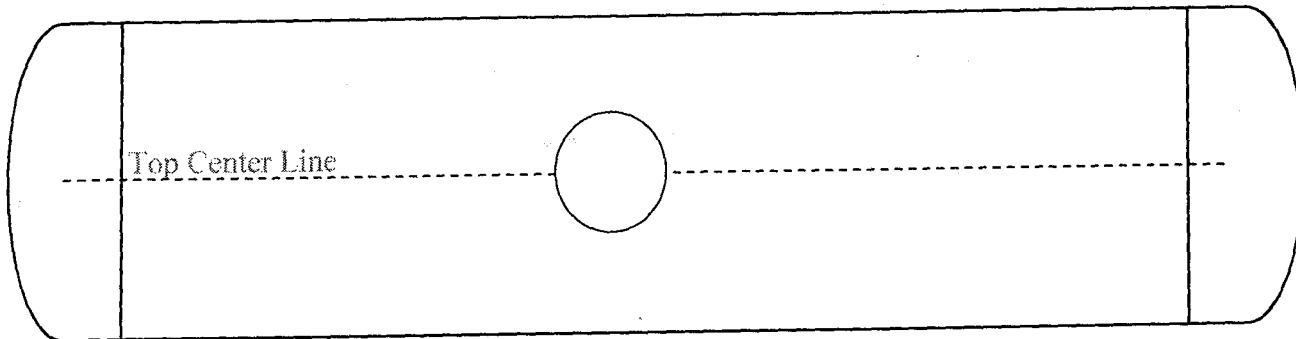
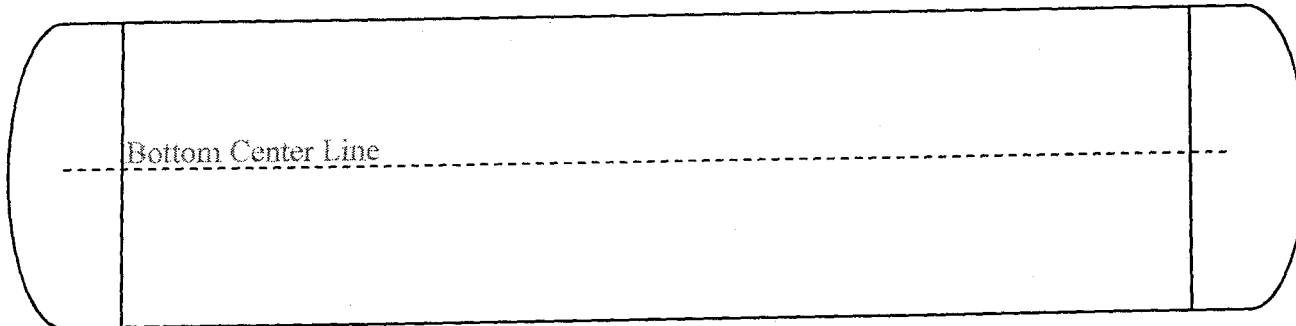
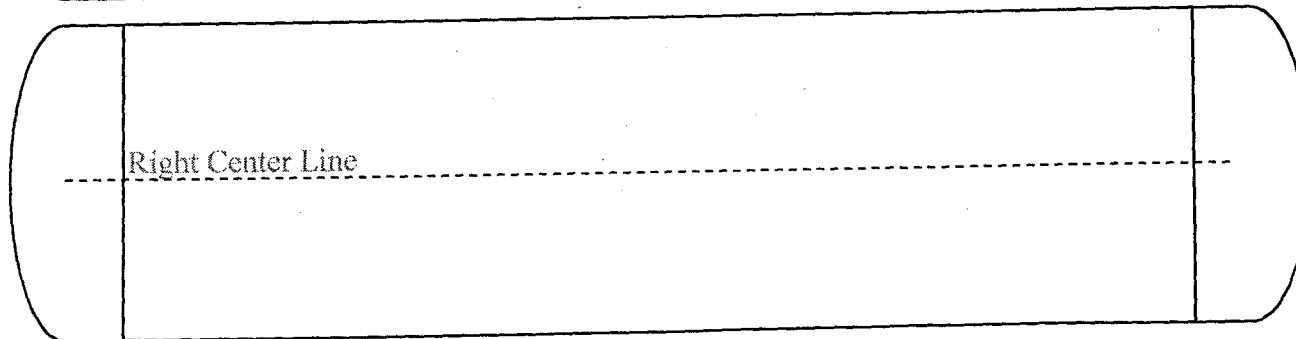
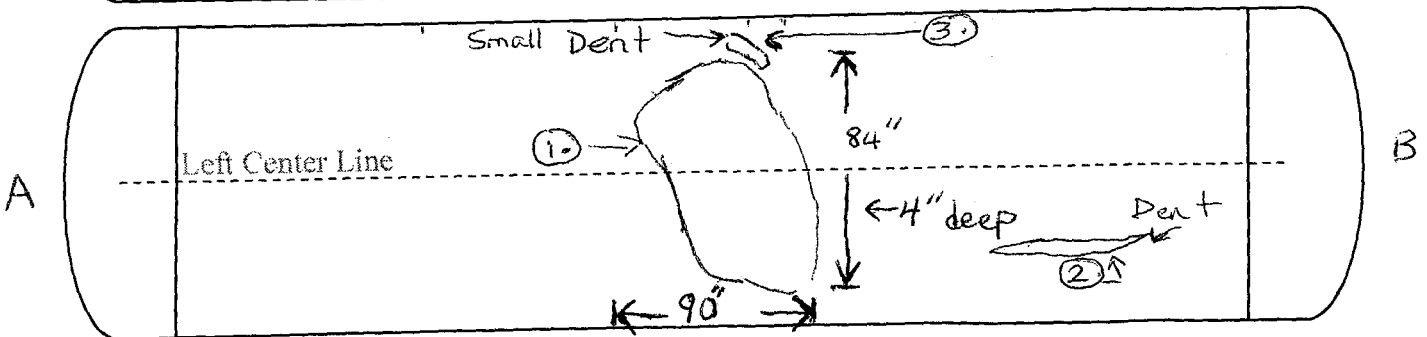
THIS CAR WAS DERAILED AND LANDED ON ITS SIDE HALF SUBMERGED IN CREEK

1.	Affected?	TANK	Location?	LEFT SIDE	Dimensions:	Length	90"	Width	84"	Depth	4"
-	Defect type?	DENT	Shape?	OBLONG	Possible Cause?	IMPACT WITH GROUND

2.	Affected?	TANK	Location?	L/S BOT	Dimensions:	Length	33"	Width	18"	Depth	2.25"
-	Defect type?	DENT	Shape?	OBLONG	Possible Cause?	IMPACT WITH DEBRIS

3.	Affected?	TANK	Location?	L/S TOP	Dimensions:	Length	?	Width	?	Depth	?
-	Defect type?	DENT	Shape?	OBLONG	Possible Cause?	IMPACT WITH GROUND					
4.	Affected?		Location?		Dimensions:	Length		Width		Depth

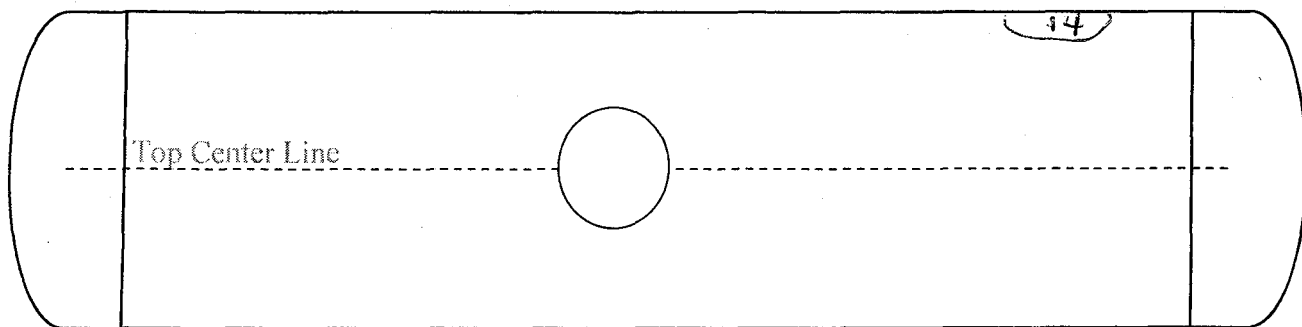
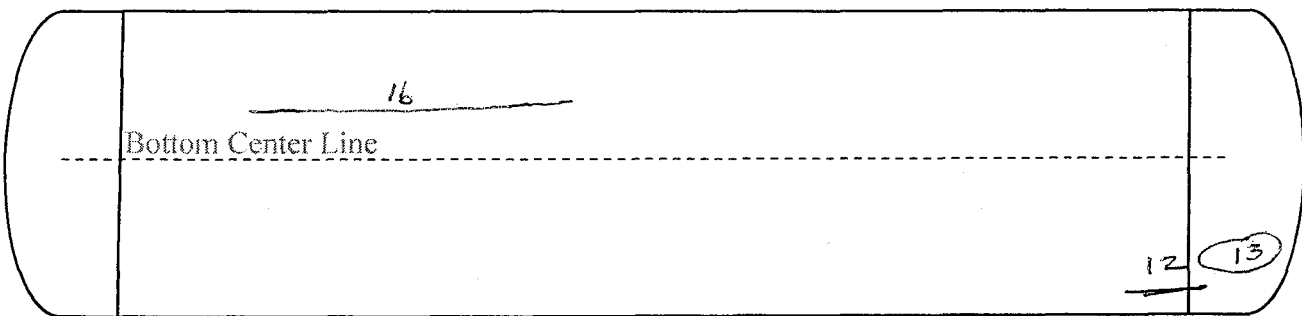
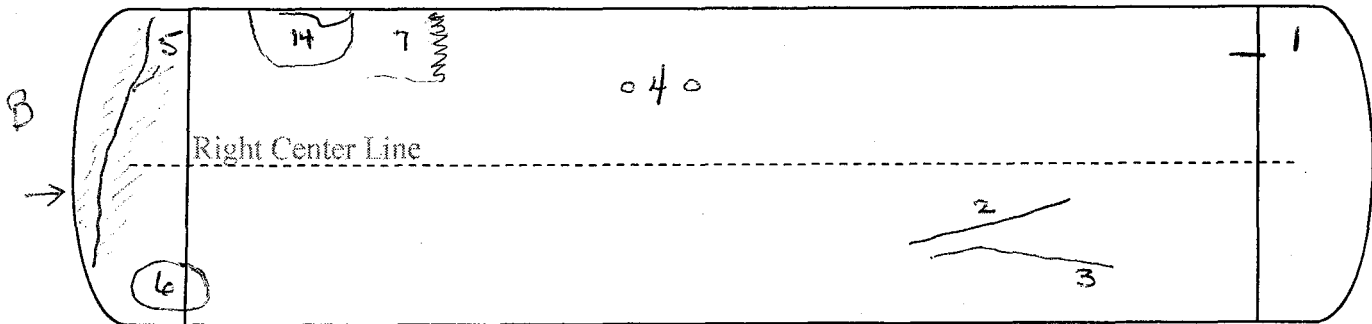
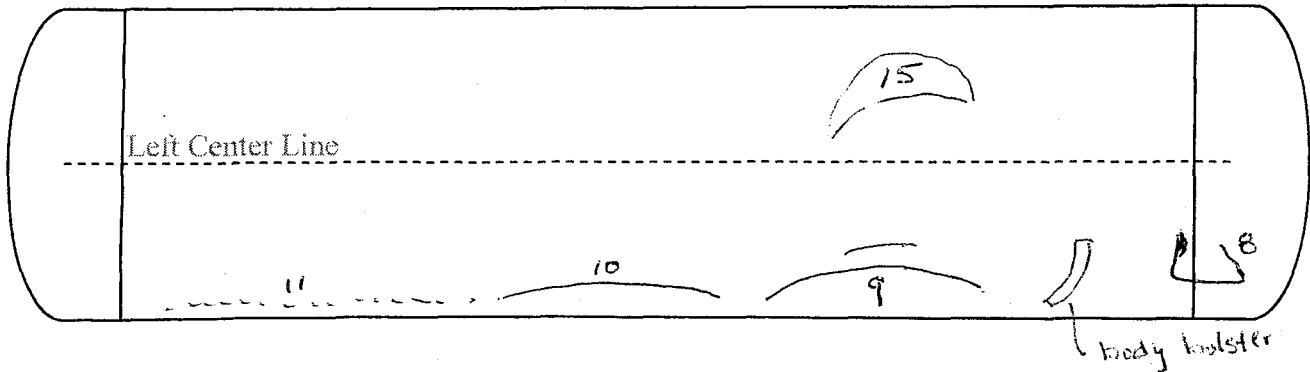
1.	Affected?	jacket	Location?	AR _{top}	Dimensions:	Length	6"	Width		Depth	
-	Defect type?	puncture	Shape?	slit	Possible Cause?						
2.	Affected?	jacket	Location?	AR	Dimensions:	Length	36"	Width	1/2"	Depth	thru

-	Defect type?	tear	Shape?	line	Possible Cause?						
3.	Affected?	jacket	Location?	AR	Dimensions:	Length		Width		Depth	
-	Defect type?	fold	Shape?		Possible Cause?	ladder torn from pads

4.	Affected?	jacket	Location?	R ladder	Dimensions:	Length		Width		Depth	
-	Defect type?	tear	Shape?	2 circles	Possible Cause?						
5.	Affected?	jacket	Location?	BR _{end}	Dimensions:	Length	11'	Width		Depth

-	Defect type?	fold/crush	Shape?	linear	Possible Cause?	struck bottom of creek					
6.	Affected?	jacket	Location?	BR	Dimensions:	Length		Width		Depth	
-	Defect type?	dent	Shape?	circular	Possible Cause?

7.	Affected?	jacket	Location?	BR _{top}	Dimensions:	Length		Width		Depth	
-	Defect type?	dent/scraps	Shape?	rectangle	Possible Cause?						
8.	Affected?	jacket	Location?	BL	Dimensions:	Length		Width		Depth

-	Defect type?	dent w/ hole	Shape?	u	Possible Cause?	4" slit

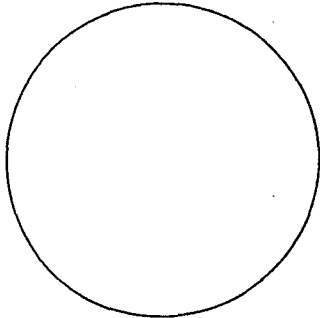
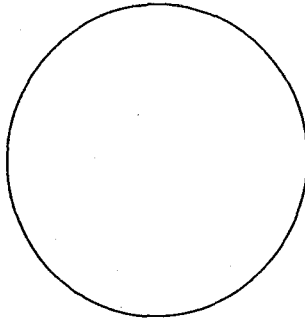
0cPX 80323

9	1	Affected?	jacket	Location?	BL	Dimensions:	Length	6'	Width		Depth	
		- Defect type?	dents	Shape?	crescent	Possible Cause?	wheels bridge					
10	2	Affected?	jacket	Location?	L mid	Dimensions:	Length	7'	Width		Depth

- Defect type?	dent	Shape?	crescent	Possible Cause?	bridge					
11	3	Affected?	jacket	Location?	AL	Dimensions:	Length		Width		Depth	
		- Defect type?	dents	Shape?	linear	Possible Cause?	bridge walkway & timber					
12	4	Affected?	jacket	Location?	BR bottom	Dimensions:	Length	20"	Width		Depth

- Defect type?	tear	Shape?		Possible Cause?						
13	5	Affected?	jacket	Location?	BR bott	Dimensions:	Length		Width		Depth	3 3/4"
		- Defect type?	dent	Shape?	oblong	Possible Cause?						
14	6	Affected?	jacket	Location?	BR top	Dimensions:	Length		Width		Depth

- Defect type?	dent	Shape?	oval	Possible Cause?						
15	7	Affected?	jacket	Location?	BL	Dimensions:	Length		Width		Depth	
		- Defect type?	dent	Shape?	crescent	Possible Cause?						
16	8	Affected?	dent jacket	Location?	2' off center	Dimensions:	Length	10'	Width		Depth

- Defect type?	dent	Shape?	line	Possible Cause?

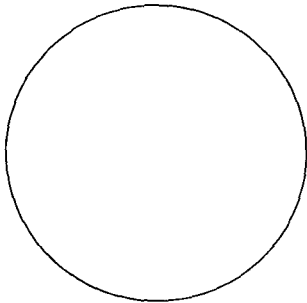
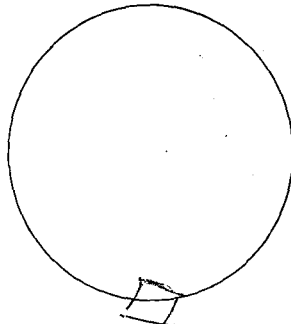
A stub sill driven down & twisted clockwise.

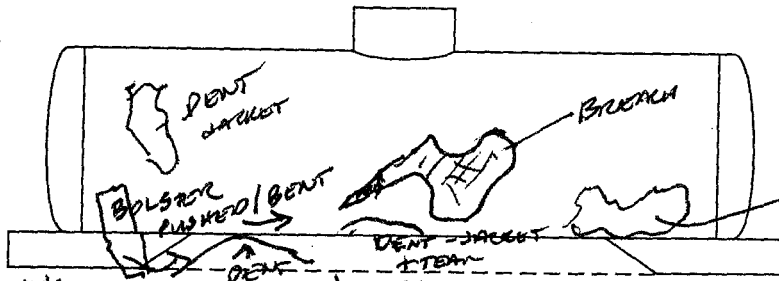
SIDE VIEW

B-END
 AIR
 MEASURING
 BRACKET

EDGES OF BRACKET
 TURNED INWARD

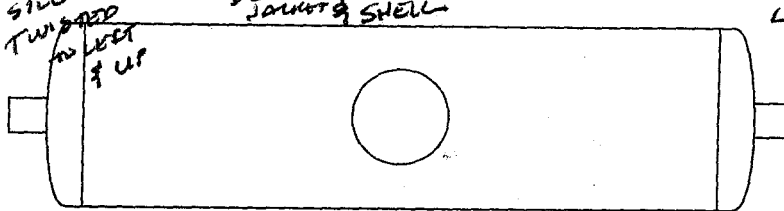
TOP VIEW

LIGHT
 TRUSS
 TO SILL
 10°

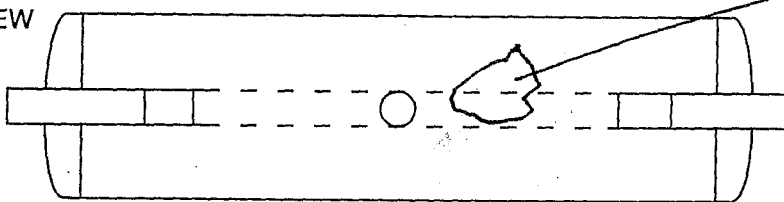
BOTTOM VIEW

DENT
 JACKET &
 SILL

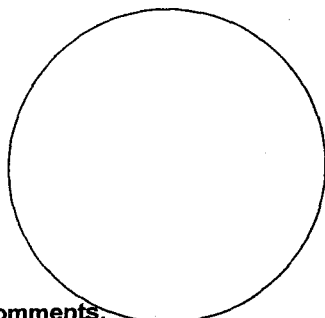
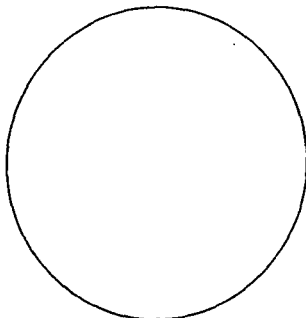
OCPX 80234

9 Jacket torn triangle 6" off center 25" L 15" W

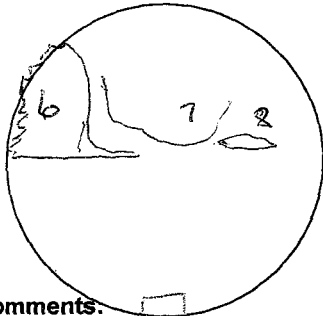
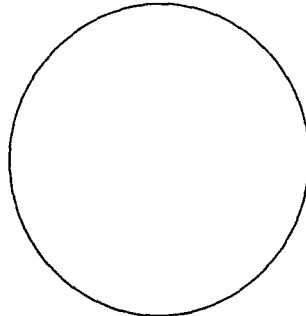
13 stub with twisted & torn

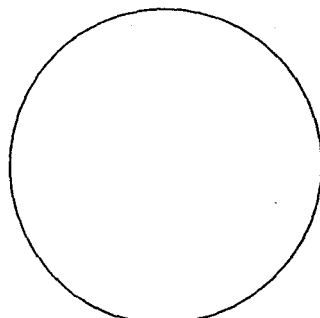
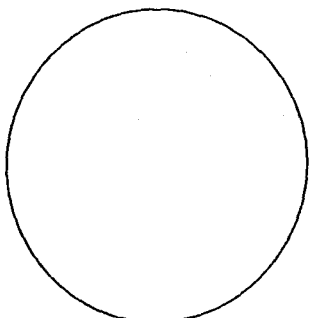
UTLX 98097

9	1	Affected?	jacket	Location?	BL	Dimensions:	Length	44	Width	12	Depth	
		- Defect type?	dent	Shape?	teardrop	Possible Cause?						
10	2	Affected?	jacket	Location?	BL	Dimensions:	Length	36	Width	18	Depth

- Defect type?	dent	Shape?		Possible Cause?						
11	3	Affected?	jacket	Location?	L mid	Dimensions:	Length		Width		Depth	
		- Defect type?	holes	Shape?		Possible Cause?	ladder pad ripped out					
	4	Affected?		Location?		Dimensions:	Length		Width		Depth

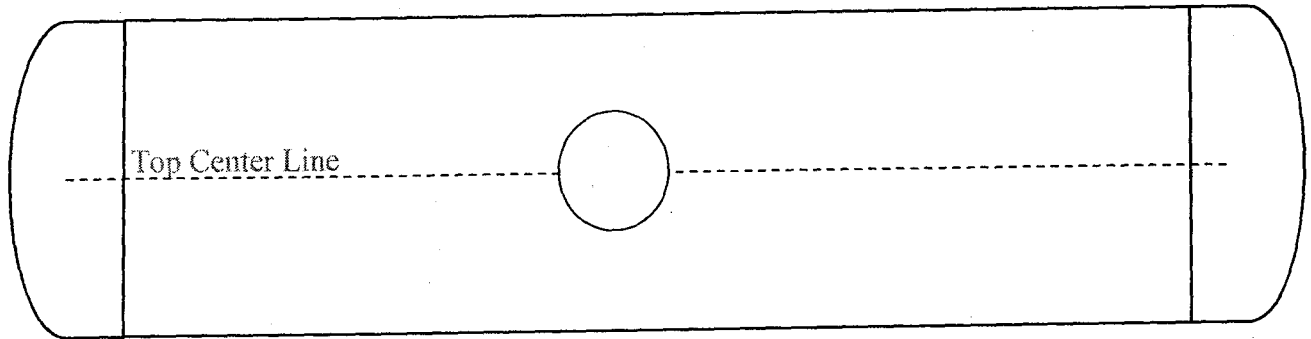
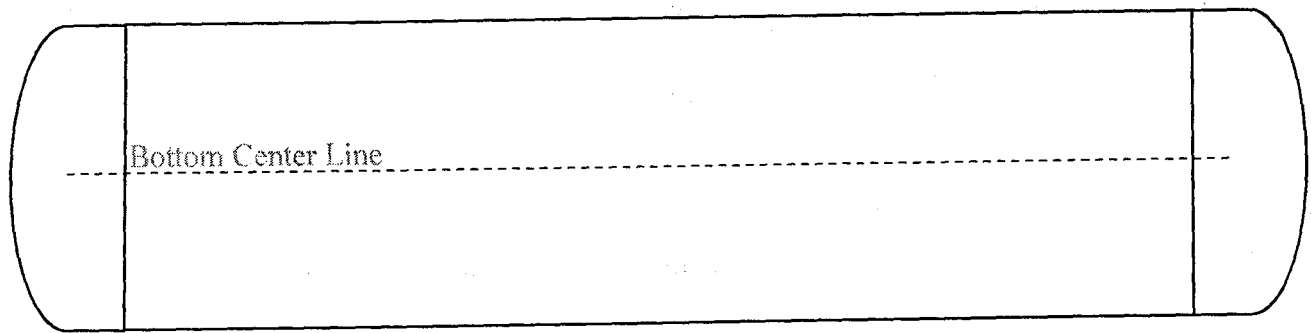
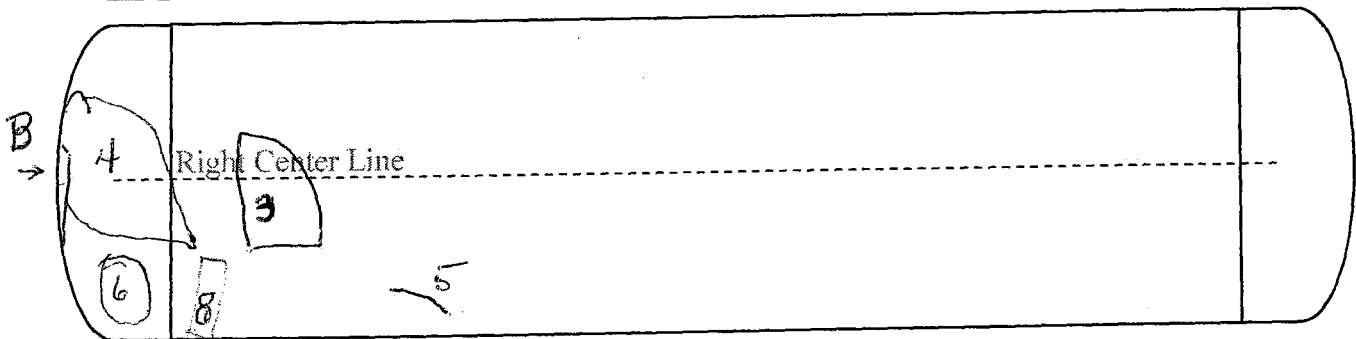
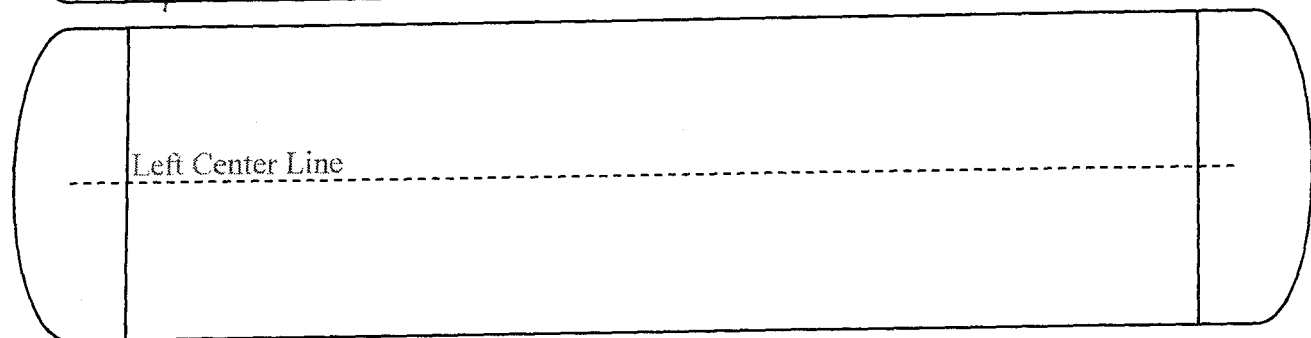
1.	Affected?	B JACKET	Location?	TOP HALF	Dimensions:	Length	7'	Width		Depth	
-	Defect type?	DENT	Shape?		Possible Cause?	IMPACT W/ UTLX 98097					
2.	Affected?	B jacket	Location?	mid top half	Dimensions:	Length	22 1/2	Width	4 3/4	Depth	thru

-	Defect type?	hole	Shape?	slit vert	Possible Cause?						
3.	Affected?	jacket	Location?	above BR bolster	Dimensions:	Length		Width		Depth	
-	Defect type?	dent	Shape?	oval w/ flat bottom	Possible Cause?	UTLX 98097 pressure fold from car body into end

4.	Affected?	jacket	Location?	BR corner	Dimensions:	Length	6	Width	16"	Depth	
-	Defect type?	dent/fold	Shape?		Possible Cause?						
5.	Affected?	BR jacket	Location?	bottom	Dimensions:	Length		Width		Depth

-	Defect type?	dent	Shape?	crescent	Possible Cause?	R2 wheel					
6.	Affected?	jacket	Location?	BR	Dimensions:	Length		Width		Depth	
-	Defect type?	dent	Shape?	oval	Possible Cause?

7.	Affected?	jacket	Location?	BR top	Dimensions:	Length	19 1/4	Width	17	Depth	
-	Defect type?	hole	Shape?	invert triangle	Possible Cause?						
8.	Affected?	bolster	Location?		Dimensions:	Length		Width		Depth

-	Defect type?	bent	Shape?		Possible Cause?
