National Transportation Safety Board  
Washington, D.C. 20594

**Hazardous Materials Group Chairman's Factual Report - Addendum**

Carrier: Consolidated Rail Corporation (Conrail)  
Train No.: FC4230  
Location: Paulsboro, New Jersey  
Date/Time: November 30, 2012, at 6:59 a.m. EST  
NTSB No.: DCA-13-MR-002

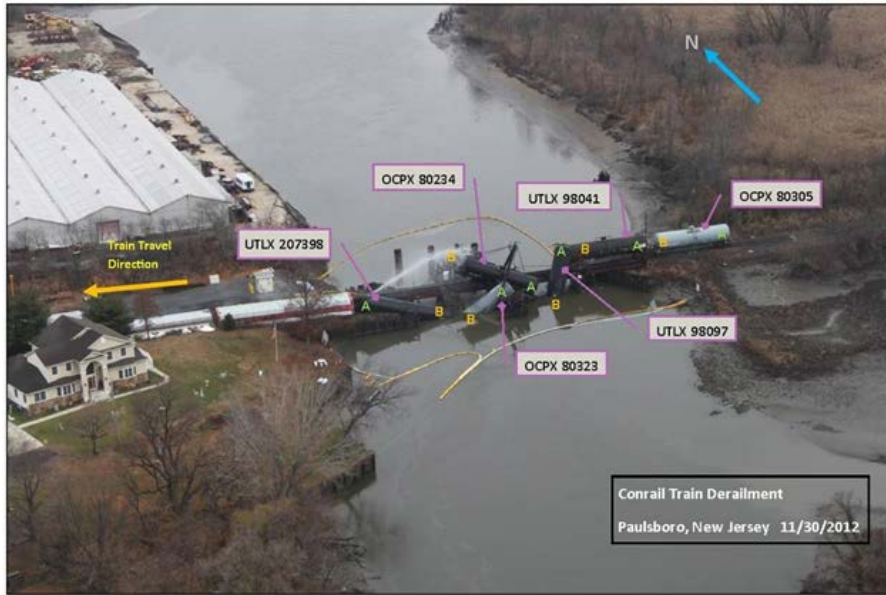
Figure 1: Photograph of the derailment with tank car ends labeled.

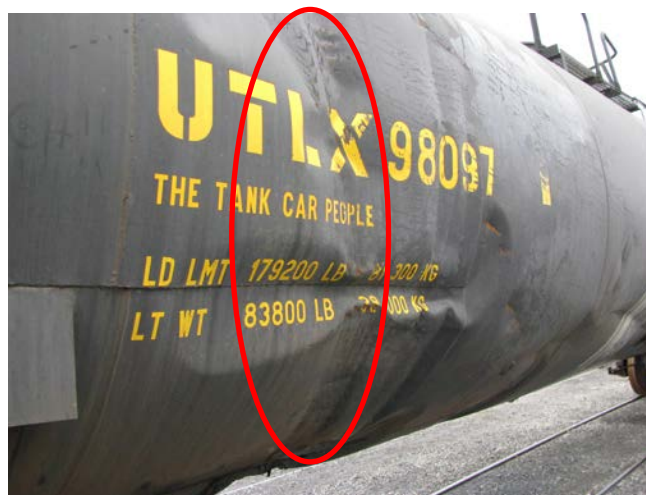
The derailed tank cars were examined on January 30, 2013, after they were emptied of their contents, cleaned, purged, and moved to Conrail’s Camden Yard. Several of the tank car jackets sustained damage as a result of crane lifting operations. However, this crane cable damage was easily discernable from the damage to the tank cars that resulted from accident impact forces. See figure 2.

Figure 2: Example of discernable damage (highlighted in red) to tank car jackets as a result of crane lifting cables.

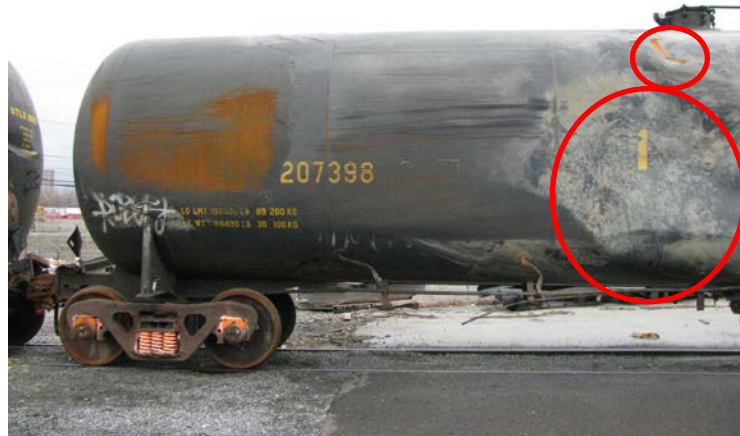
shell ring 4<sup>10</sup>, the tank car sustained a large oblong-shaped dent centered on the tank car's centerline (at the 9 o'clock location<sup>11</sup>). See figures 3 and 4. The dent's dimensions were 90 inches in length by 84 inches in width (from top to bottom). The dent's depth was approximately 4 inches. A second smaller oblong-shaped dent was found above the larger dent in shell ring 4 (at the 11 o'clock location). See figures 3 and 4. A third dent (at the 7 o'clock location) was found that traversed shell rings 2 and 3. See figure 4. This dent was approximately 33 inches in length by 18 inches in width and 2.25 inches in depth. The B-end top striker plate and stub sill were torn upwards. See figures 5 and 6. The tank car service equipment suffered minimal damage with no loose closures. The bottom outlet valve was not damaged in the accident. There were several other smaller dents and scrapes in the shell, but no damage resulted in a breach.

*Figure 3: Scrapes above A-left body bolster and two oblong dents (highlighted in red) on tank car UTLX 207398.*

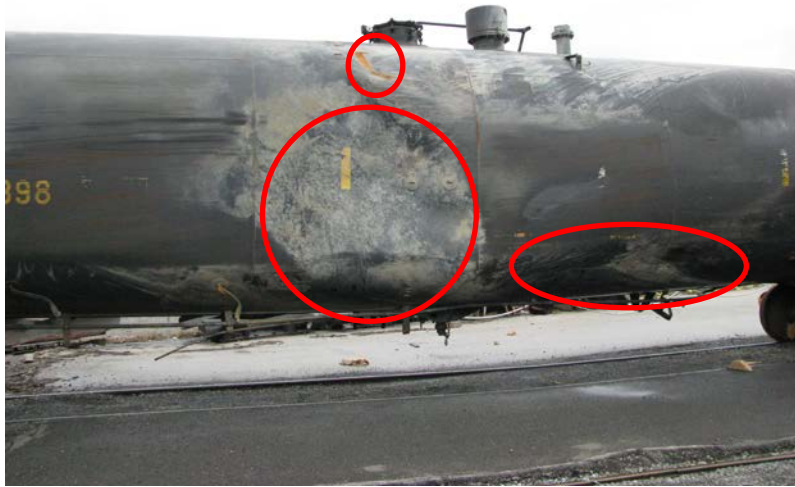
*Figure 4: Three dents (highlighted in red) found on the left side of tank car UTLX 207398.*

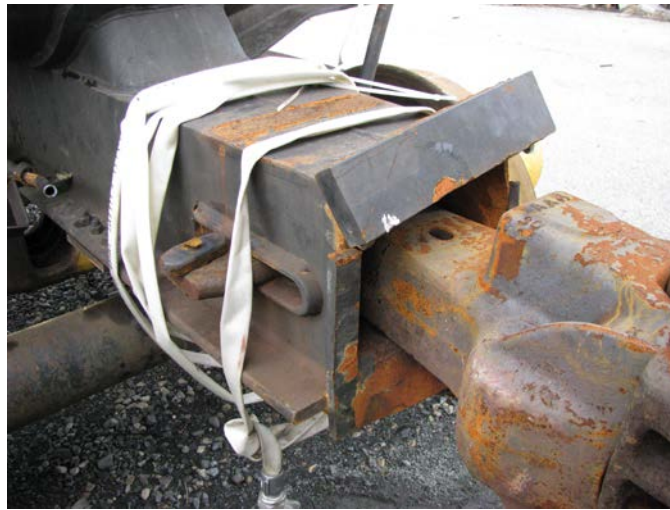
*Figure 5: Damage to B-end striker plate on tank car UTLX 207398.*

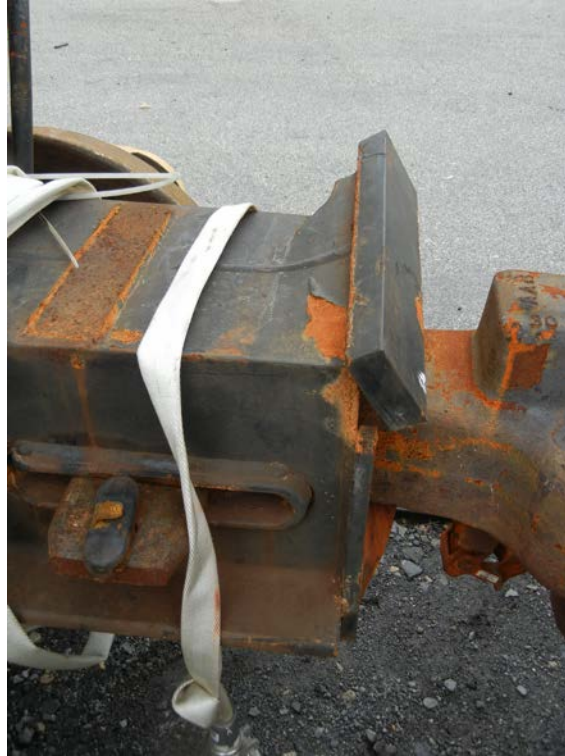
*Figure 6: Damage to B-end striker plate and stub sill from a different angle.*

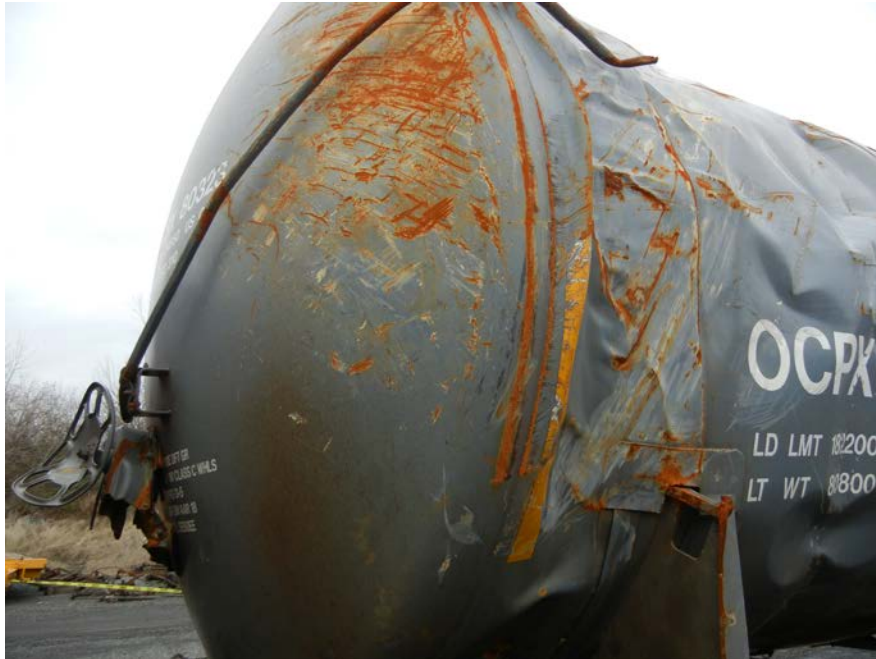
Tank car OCPX 80323 (line number 9) derailed and fell into Mantua Creek during the accident. The tank car's B-end was submerged in the water with the A-end supported by bridge components. The A-end stub sill and body bolster impacted tank car OCPX 80234. The B-right jacket sustained buckling adjacent to the head shield/jacket seam. See figures 7 and 8. Scrapes in the B-right side of the head shield indicate where the tank car came to rest on the bottom of the creek.

*Figure 7: Damage to the B-end head shield and jacket on tank car OCPX 80323.*

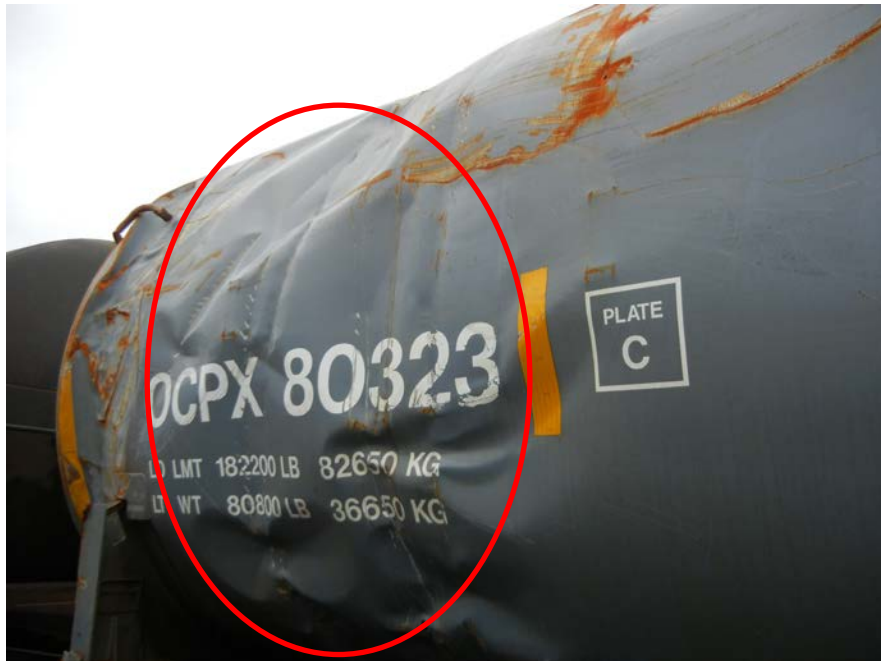
*Figure 8: Damage to the B-right side (including damage caused by crane operations – highlighted in red) of tank car OCPX 80323.*

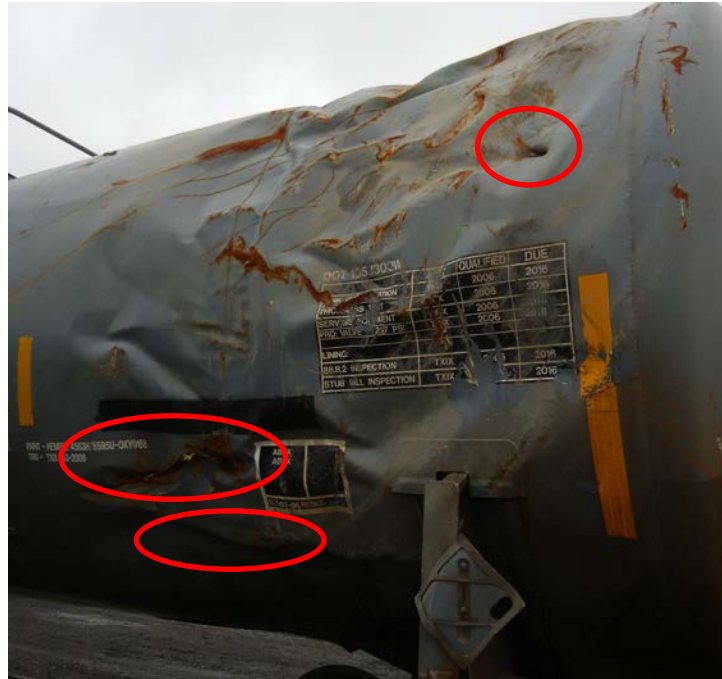
At approximately the 2 o'clock location on the A-right side jacket of tank car OCPX 80323, there was a slit-shaped puncture that was approximately 6 inches long. The crushed and crumpled jacket damage in the area surrounding this puncture was produced by crane lifting cables. However, below the tank car's A-right centerline there was a jacket tear (at the 4 o'clock location) that was 36 inches long and ½ inch wide. Slightly below this tear was another jacket fold. See figure 9. The B-left body bolster web was deformed inboard

Figure 9: Gouges (highlighted in red) in tank jacket on A-right side of tank car OCPX 80323.

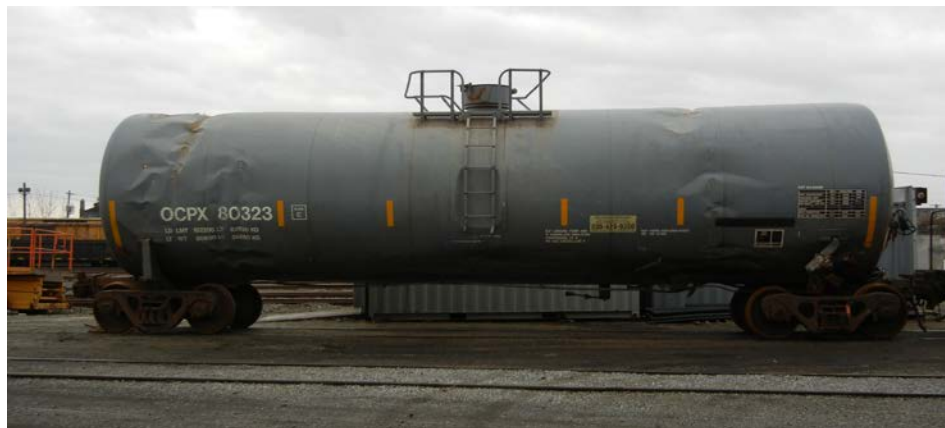
(pushed away from B-end). See figures 10, 11, and 12. Additionally, there was a puncture in the jacket next to the B-left body bolster (approximately 1 foot from the B-end head shield/jacket seam) that was 4 inches long. See figures 11 and 12. After the accident, the B-end coupler and the B-right body bolster were found wedged inside the breached tank car (OCPX 80234). See figure 13. A mounting plate that is ordinarily welded to the draft sill next to the coupler was found inside tank car OCPX 80234 during the examination. See figure 14. The A-end double-shelf coupler was an SE60EE with a broken bottom shelf. See figures 15 and 16. Despite the damage to the jacket and tank car components, the tank car was not breached.

Figure 10: B-left side of tank car OCPX 80323.

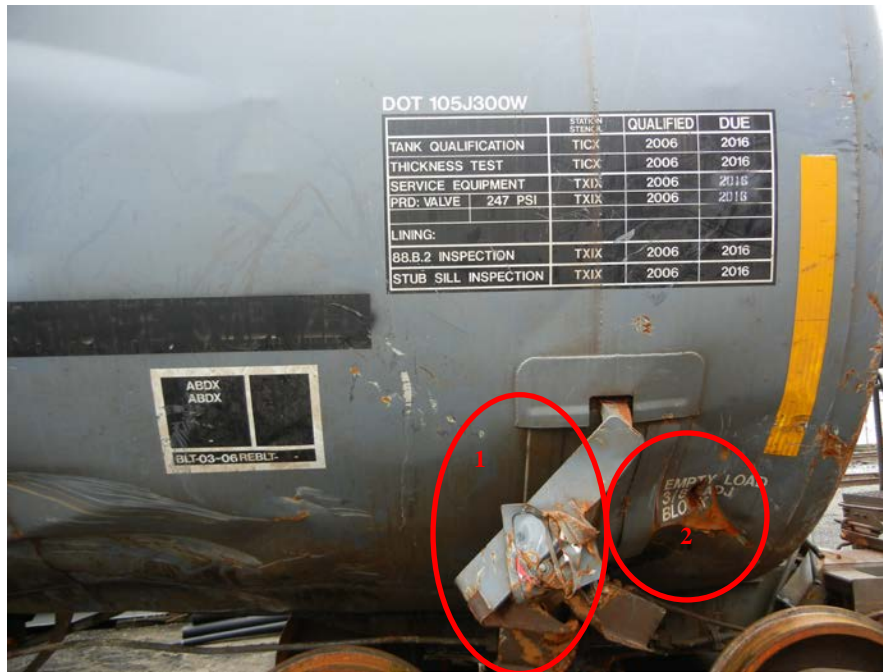
Figure 11: Close-up image of B-left body bolster and web deformation (labeled 1) and adjacent jacket puncture (labeled 2) in tank car OCPX 80323.

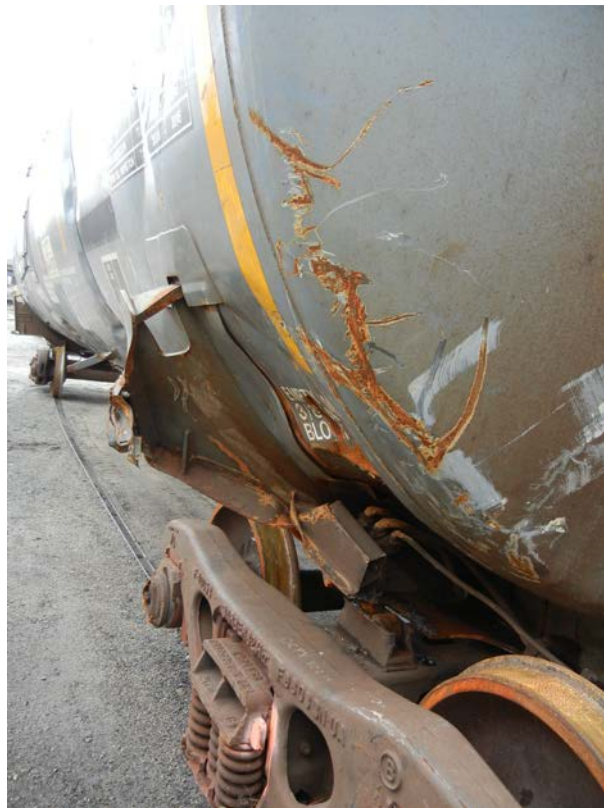
Figure 12: Scrapes on the B-head shield and damage to the B-Left side jacket of tank car OCPX 80323.

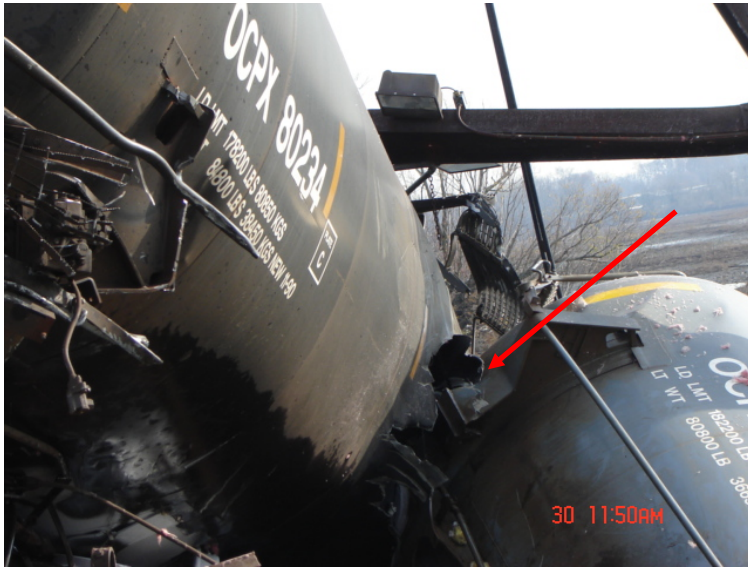
*Figure 13: Breach in OCPX 80234 on November 30, 2012. (Photograph courtesy of the FRA)*

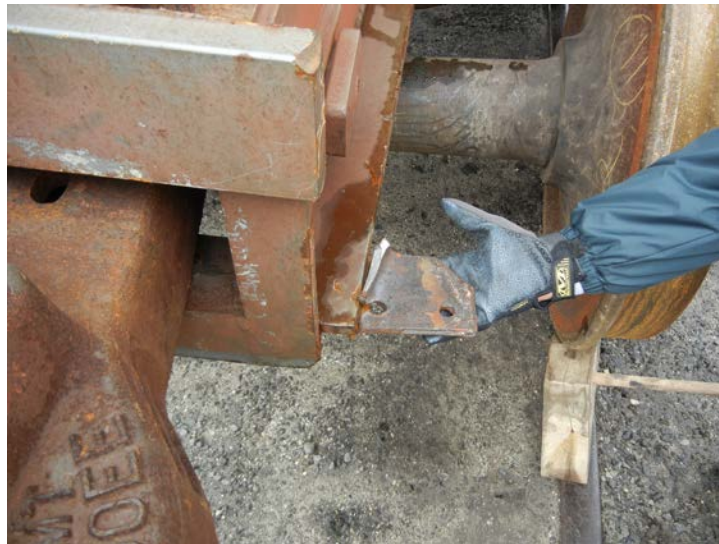
*Figure 14: Recovered mounting plate that is ordinarily welded to tank car sill.*

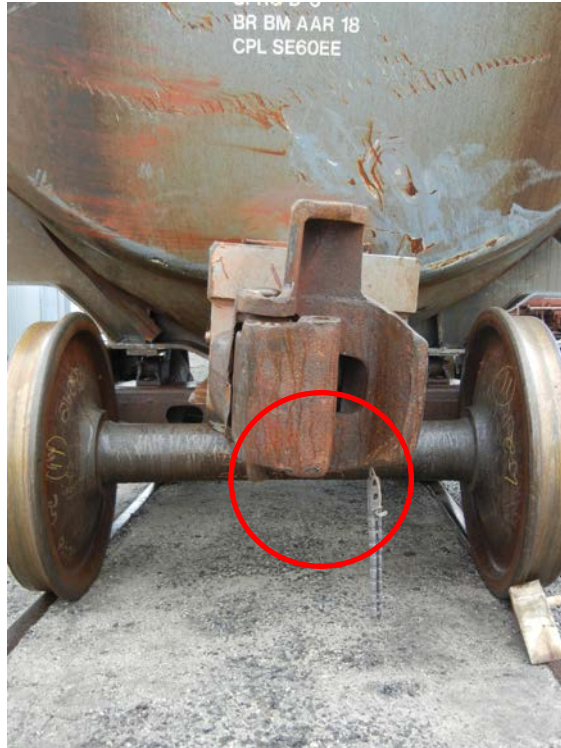
*Figure 15: Broken bottom shelf (highlighted in red) of A-end SE60EE double-shelf coupler on tank car OCPX 80323.*

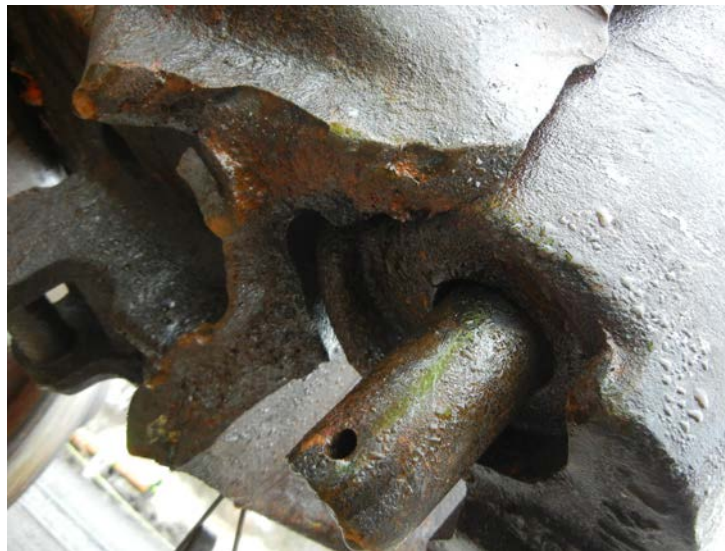
*Figure 16: Another view of broken bottom shelf of A-end SE60EE double-shelf coupler on tank car OCPX 80323.*

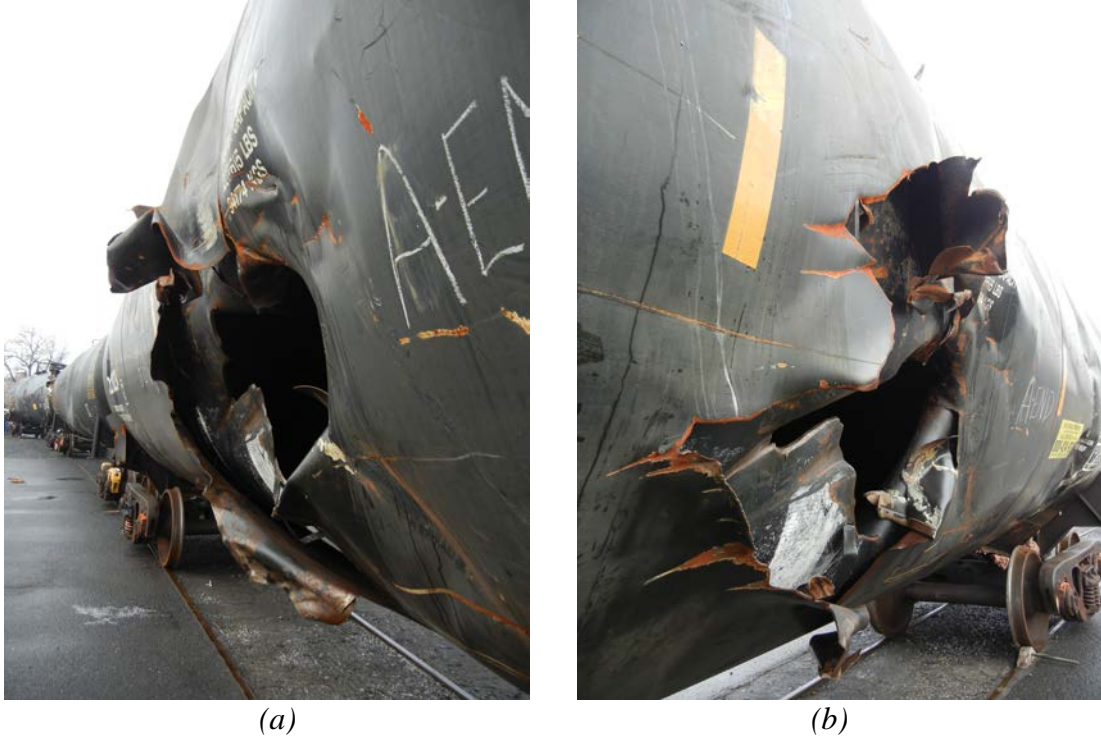
Tank car OCPX 80234 (line number 10) released vinyl chloride in this accident. A breach in the tank shell approximately 50 inches by 33 inches wide was produced during the accident. The breach occurred in the middle of the right side of the tank car at approximately the centerline. See figure 17. The examination of the breach shows that an object, about the size of a coupler, scraped against the outer jacket, then tore through it contacting the shell. The

*Figure 17: Breach in tank car OCPX 80234. Image (a) taken from the A-end and image (b) taken from the B-end.*

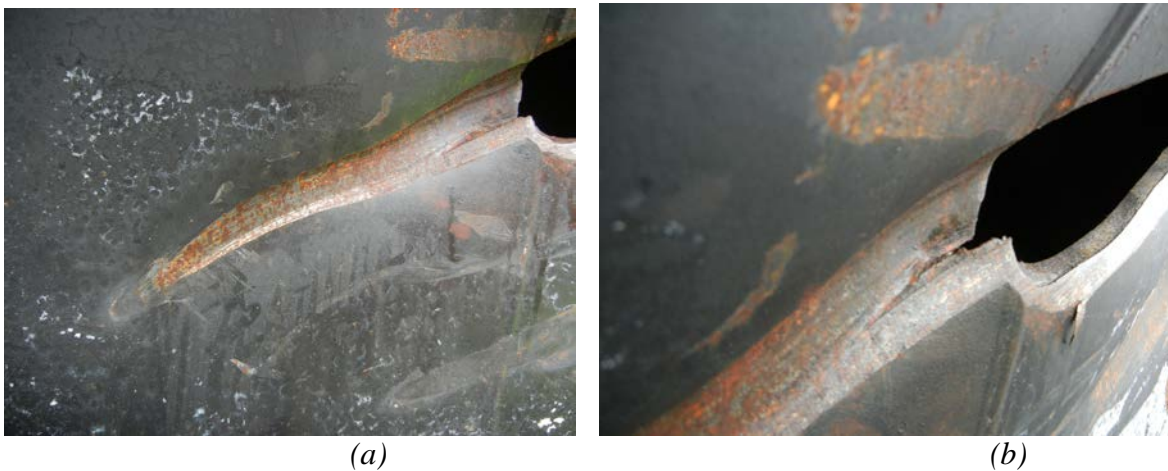
object gouged the shell before digging in and puncturing the tank shell at or near the longitudinal seam weld between two shell rings. See figure 18. The tank shell was torn and curled into the tank car. There was a 22 inch folded piece of the shell rolled back into the tank.

*Figure 18: Gouges and initial breach in tank car OCPX 80234. Image (a) shows the entire gouge and image (b) shows the longitudinal seam weld and cracking.*

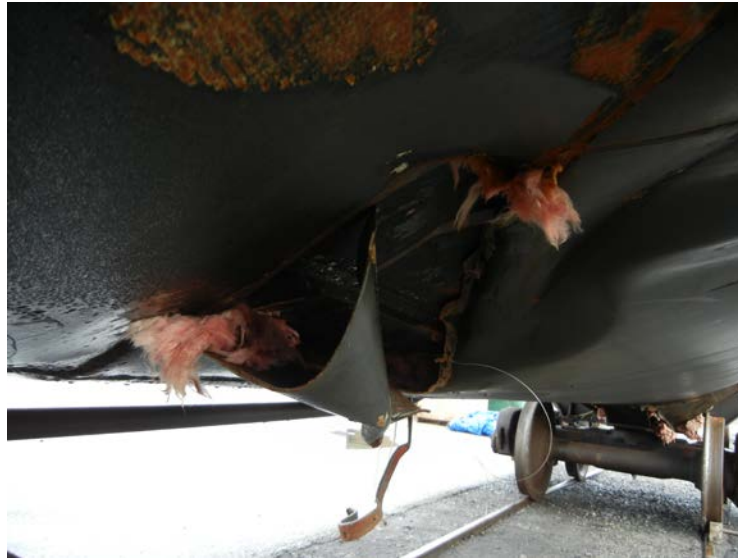
triangular tear in the jacket occurred on the bottom of the A-right side (near the bottom centerline) approximately one-third the length of the tank car (from A-end). See figure 19. Its dimensions were 25 inches long by 15 inches wide.

*Figure 19: Triangular tear in the jacket at the bottom of the tank car OCPX 80234.*

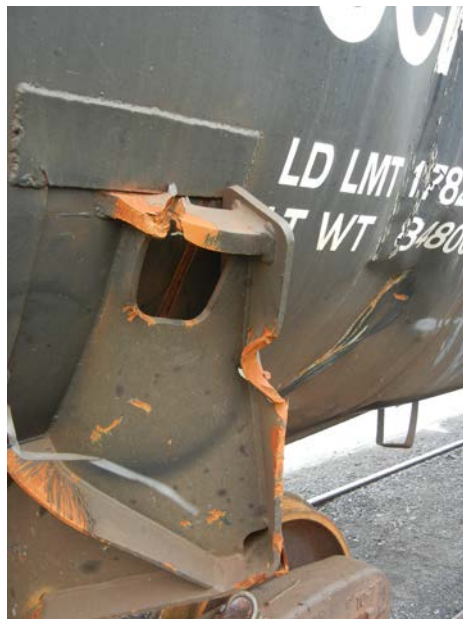
The B-right body bolster web experienced almost 90 degrees of inboard deformation and was torn. See figure 20. Next to this body bolster, there was a large crescent-shaped dent in the jacket.

*Figure 20: Inboard deformation of B-right body bolster on tank car OCPX 80234.*

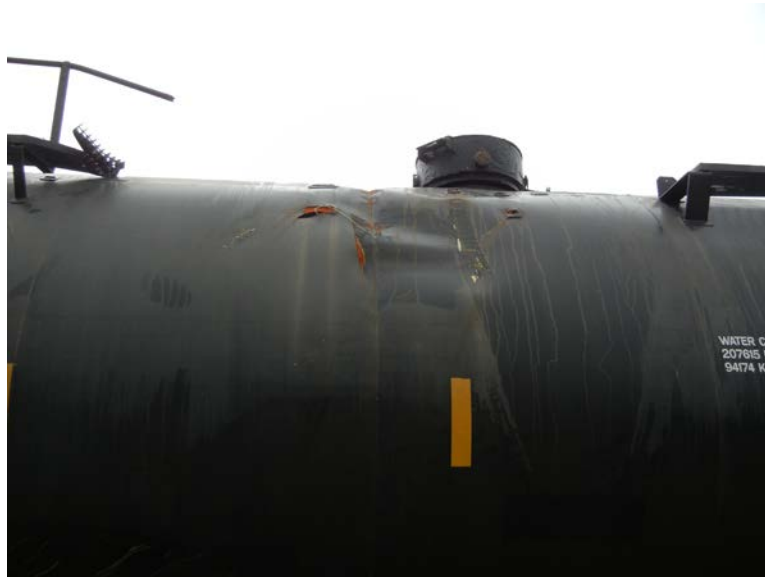
At the B-left mid-top, there was a rectangular shaped dent where the bridge's A-frame was in contact with the tank car. On each side of this rectangular dent, there was a hole in the jacket at the point where the torn-off running board pads were attached. See figure 21. There was

*Figure 21: Damage to the top of tank car OCPX 80234 caused by the bridge A-frame.*

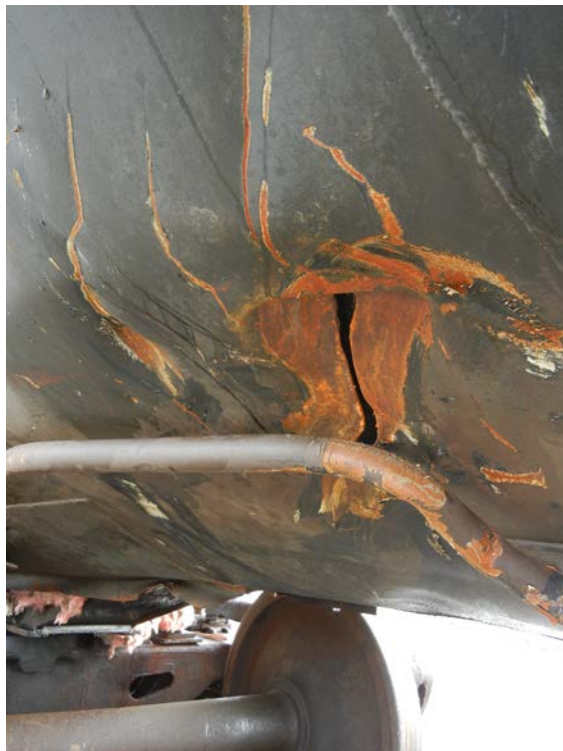
also a 14 inch transversely oriented jacket puncture on the A-left side located approximately one-third the length of the tank car (from A-end). See figure 22.

*Figure 22: Line-shaped puncture of the jacket of OCPX 80234.*

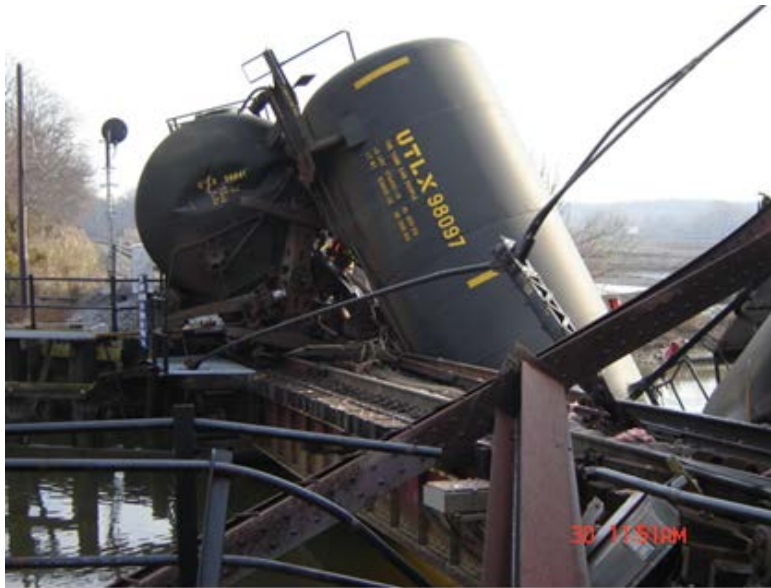
After the accident, tank car UTLX 98097 (line number 11) was found standing almost vertically in the creek with its B-end in the water and A-end on the bridge. See figure 23. Its A-end stub sill was in contact with UTLX 98041.

*Figure 23: Final resting position of tank cars UTLX 98097 and UTLX 98041 after the accident.*

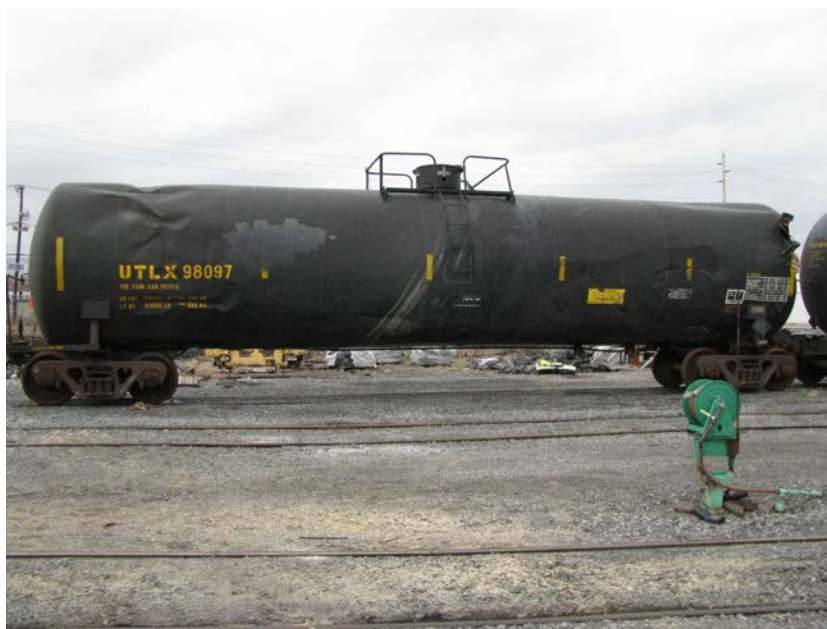
*Figure 24: B-left side of tank car UTLX 98097.*

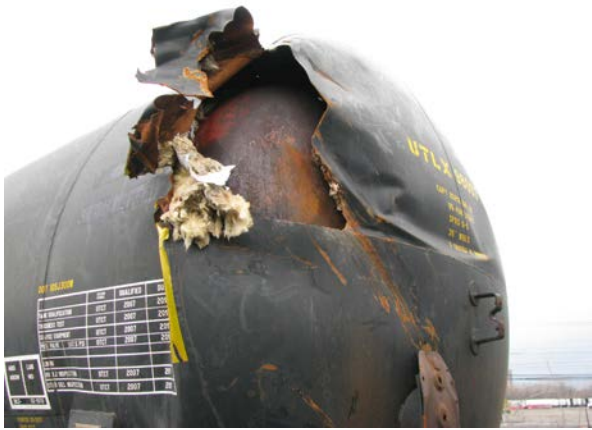
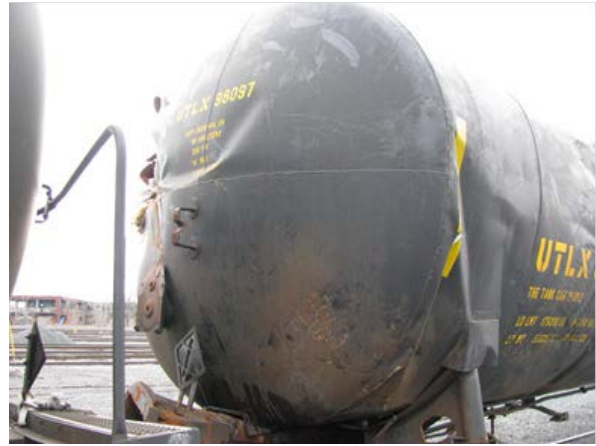
The inspection at Conrail's Camden Yard showed that the B-head of tank car UTLX 98097 sustained impact damage during the accident. On the upper left-side quadrant of the B-head above the half-height head shield, the jacket was torn in a triangular shape (approximately 39 inches in length and 24 inches in width). See figures 24 and 25. The shell was not punctured. The upper half of the B-head had a u-shaped dent centered on the head's center. The B-end stub sill was twisted clockwise and the striker plate was torn. See figure 26. The A-right end there was a crescent shaped tear in the jacket that was approximately 20 inches in length. See figure 27.

Figure 25: Images (a) and (b) of damage to B-head of tank car UTLX 98097.

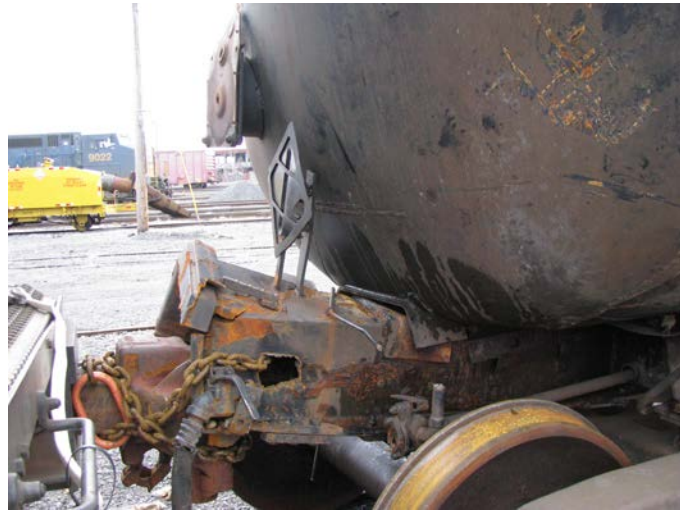
Figure 26: Damage to the B-end stub sill and striker plate of tank car UTLX 98097.

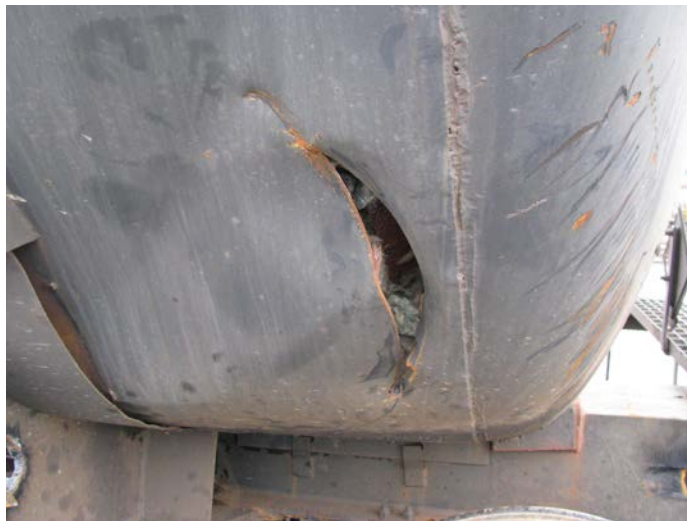
Figure 27: Tear near A-right head of tank car UTLX 98097.

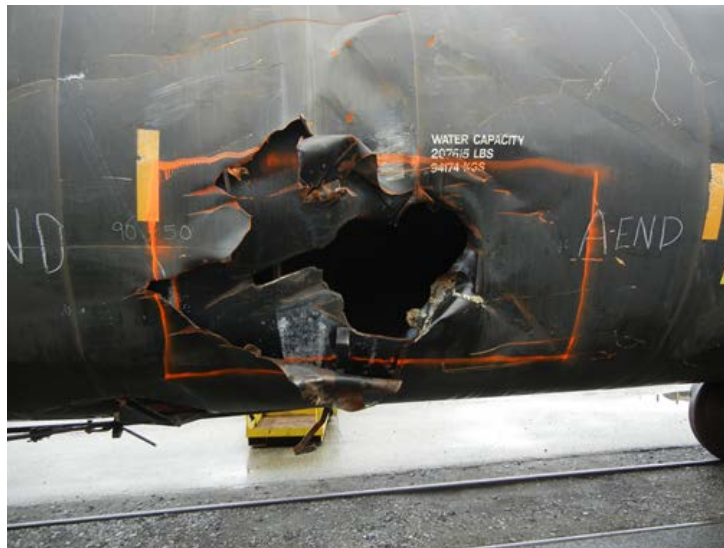
*Figure 28: Portion of tank shell from OCPX 80234 (marked in orange) that was cut and sent to the NTSB Materials Laboratory in Washington, DC.*
