National Transportation Safety Board

Hazardous Materials Group Chairman's Factual Report

Carrier: Consolidated Rail Corporation (Conrail)
Train No.: FC4230
Location: Paulsboro, New Jersey
Date/Time: November 30, 2012, at 6:59 a.m. EST
NTSB No.: DCA-13-MR-002

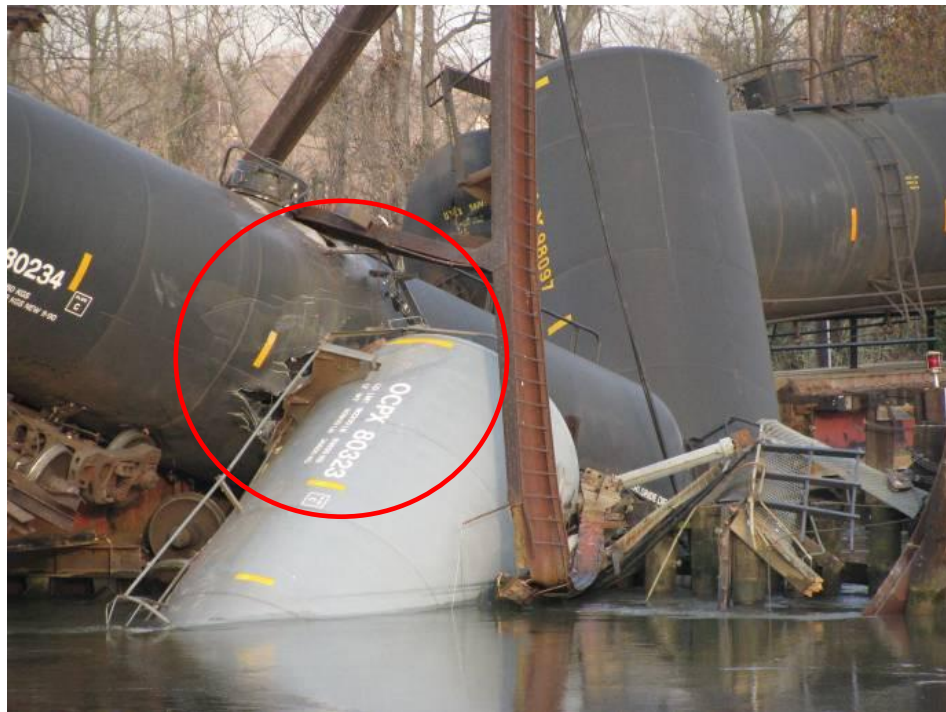
Tank car OCPX 80234 (position 10 in the train) containing vinyl chloride was breached during the accident, releasing approximately 20,000 gallons of product into the environment. A large vapor cloud was produced that blanketed the Mantua Creek basin and traveled into the Borough of Paulsboro, New Jersey. The breach in OCPX 80234 was in contact with the body bolster of tank car OCPX 80323, which was ahead of it in the train (position 9). While separating these two tank cars, the coupler and coupler shaft of OCPX 80323 were found inside the OCPX 80234 tank car. Examination of the derailed cars confirmed only one tank car was breached. None of the other tank cars released product during or after the accident.

Figure 2 – Close-up photograph of tank car OCPX 80323 and the breach in tank car OCPX 80234 on November 30, 2012.

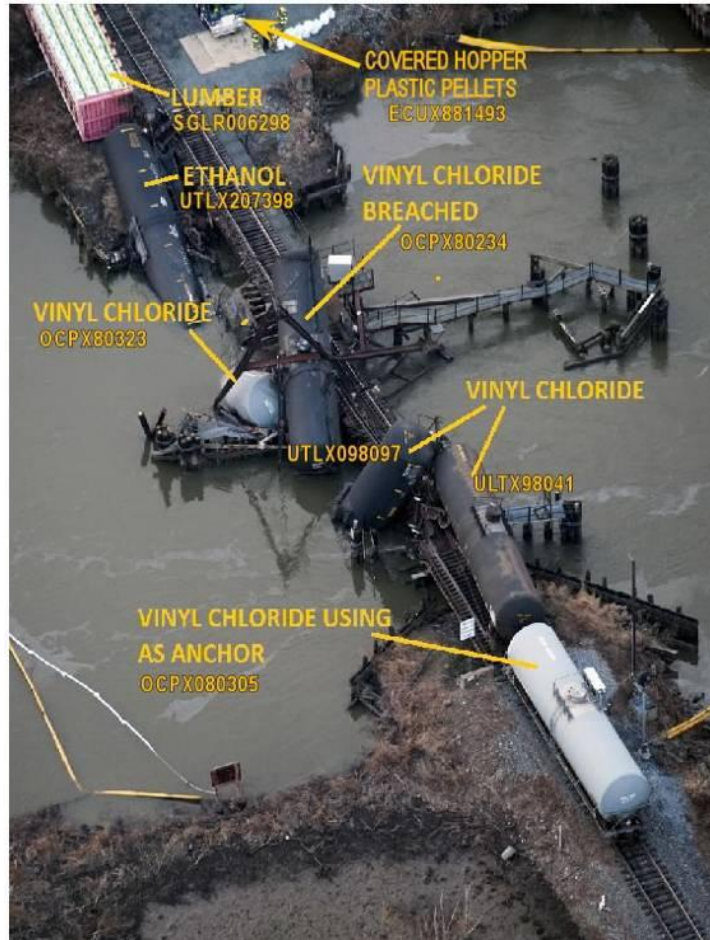
Figure 4 - Aerial image (from the East) of the train derailed on the Paulsboro movable bridge. (Photograph courtesy of the United States Coast Guard)

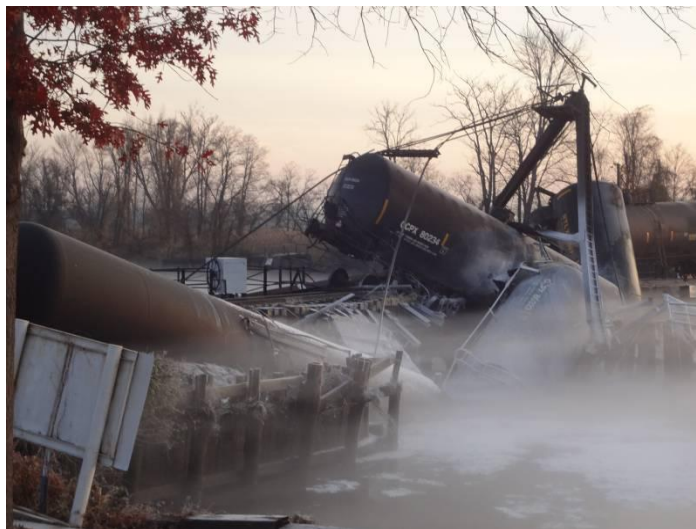
Figure 9 – View of derailed tank cars (at approximately 7:11 a.m. on November 30, 2012) in a fog or cloud with visible ice on the tank cars and in the water.³⁷ (Photograph courtesy of the wife of the Paulsboro Assistant Fire Chief)

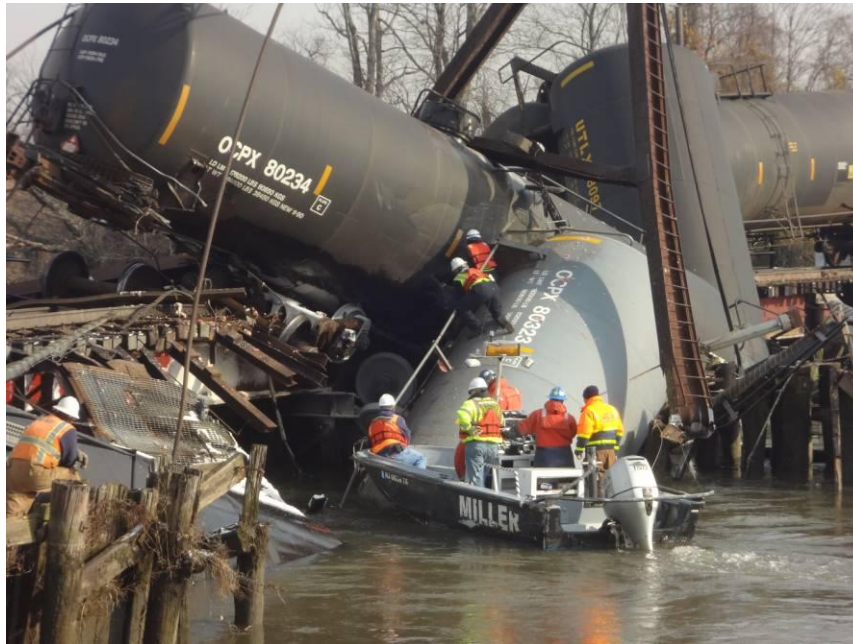
[CSX Hazardous Materials Representative]⁴⁵...checked all the valves, opened up some of the dome lids, indicated there was no additional leakage, [and] assessed the one car that was breached. We noticed that there was snow [on] everything...so we know we definitely had a release. It was obvious. At that point, the [air monitoring] meter did go in[to] alarm. So we ... back[ed] off and ...re-approached in a different area. But we weren't getting alarms or anything on the meters, [we] completed the tank car assessment...

Figure 12 - Image of emergency responders climbing on tank car OCPX 80323 to inspect the breach in tank car OCPX 80234 at 10:49 a.m. on the morning of the accident.⁴⁶ (Photograph courtesy of the wife of the Paulsboro Assistant Fire Chief)

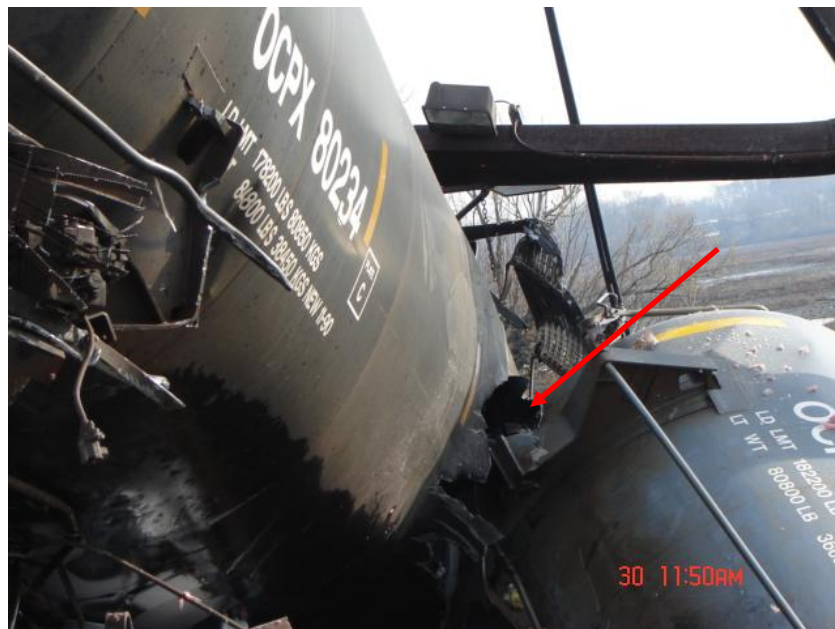
Figure 15 - Image of breach in OCPX 80234 on November 30, 2012. (Photograph courtesy of the FRA)
