National Transportation Safety Board
Washington, D.C. 20594

Hazardous Materials Group Factual Report

Carrier: BNSF Railway Company
Train No.: U-FYNHAY4-05T
Location: Casselton, North Dakota
Date/Time: December 30, 2013, at 2:11 p.m. Central Standard Time
NTSB No.: DCA14MR004

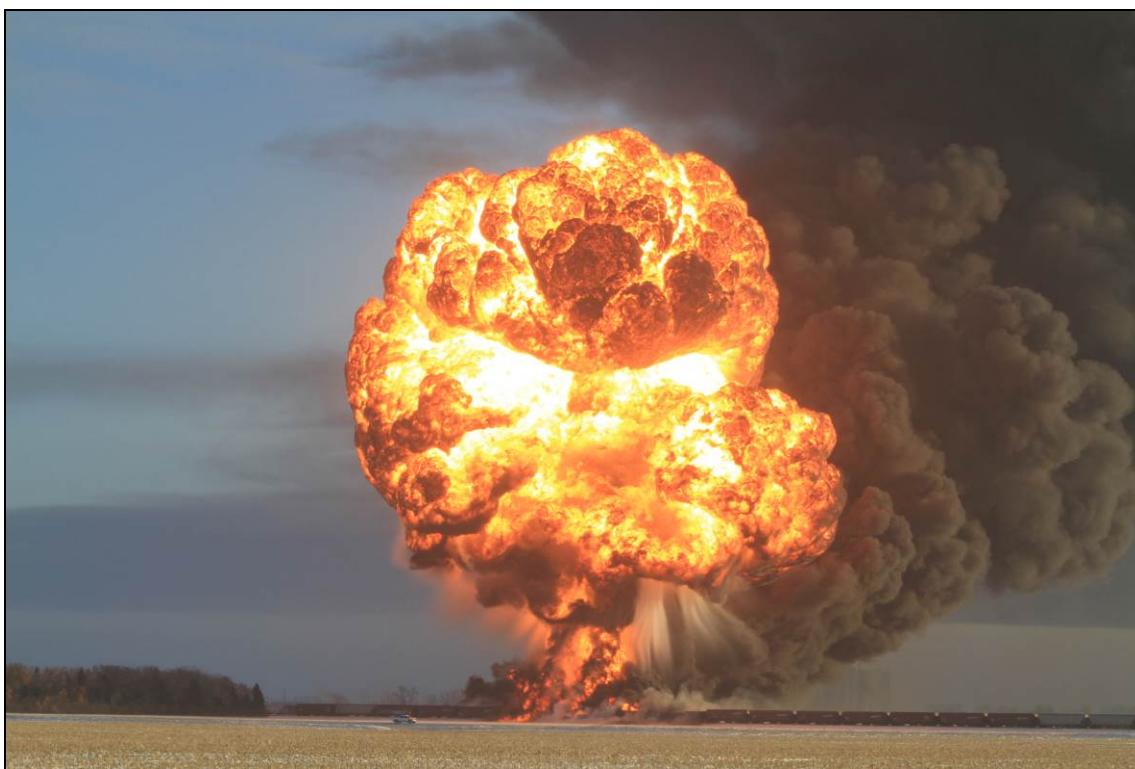
During the incident, several of the derailed tank cars experienced thermal tears that resulted in energetic thermal releases.

Figure 7: Image of a violent energetic release from a tank car in Casselton, North Dakota. (Courtesy of Dawn Faught)

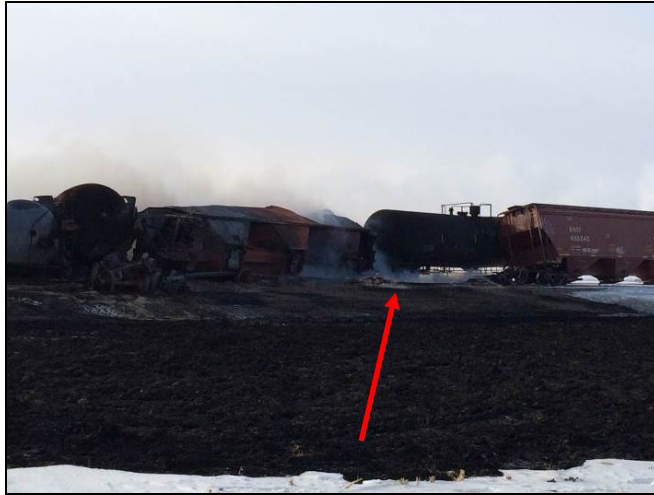
Figure 10: Tank car TAEX 1582 was partially derailed (arrow pointing to derailed truck).

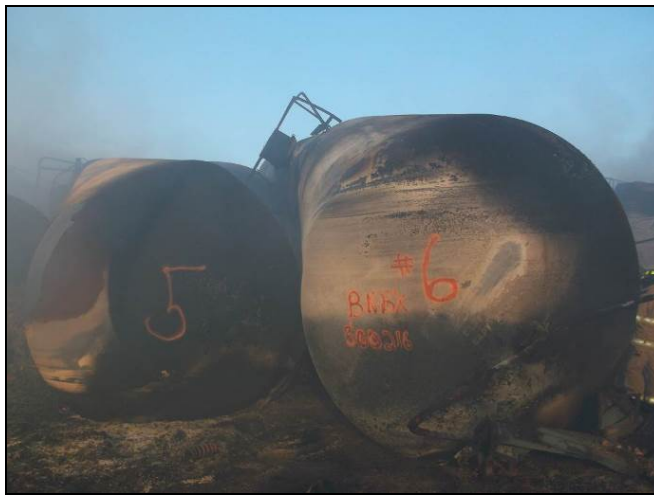
Figure 11: Tank cars SHPX 206708 (field wreckage index #5) and TAEX 1528 (field wreckage index # 6) after derailment.

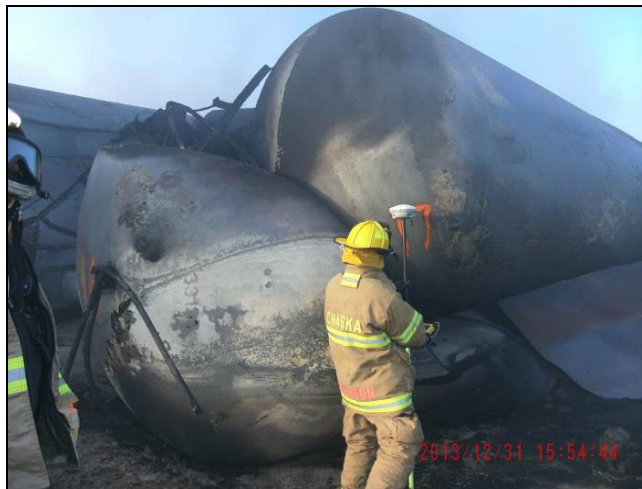
Figure 12: Tank car GATX 33119 (field wreckage index #17) on top of tank car GATX 33123 (field wreckage index # 16) after derailment.

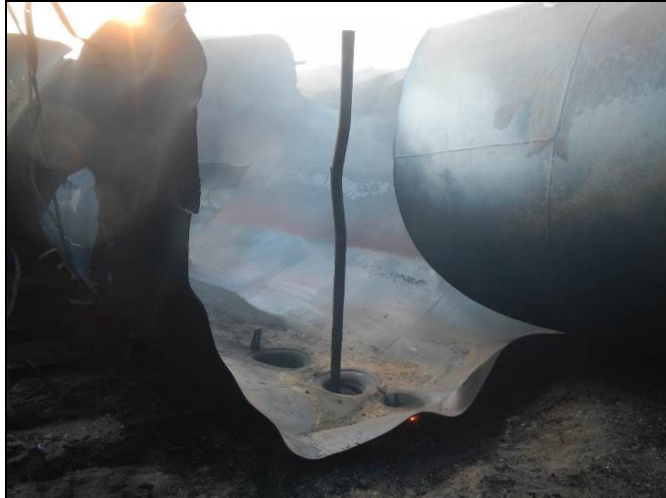
Figure 13: Thermal tear in tank car GATX 33119 (field wreckage index #17).

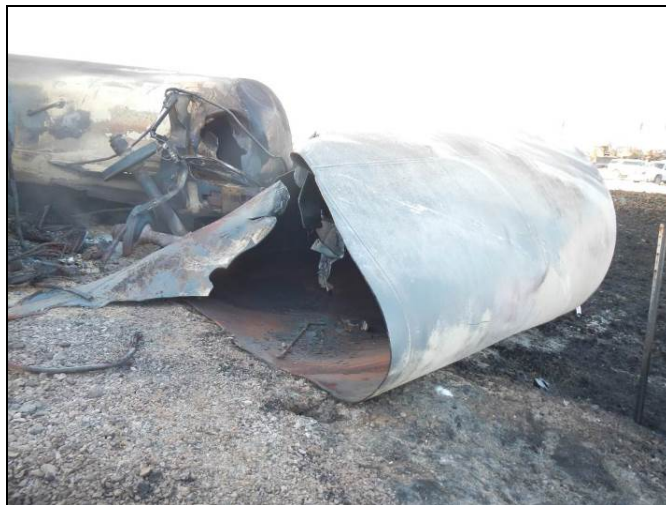
Figure 14: Half of tank car SHPX 208536 (field wreckage index #7) which was located north of the derailment.

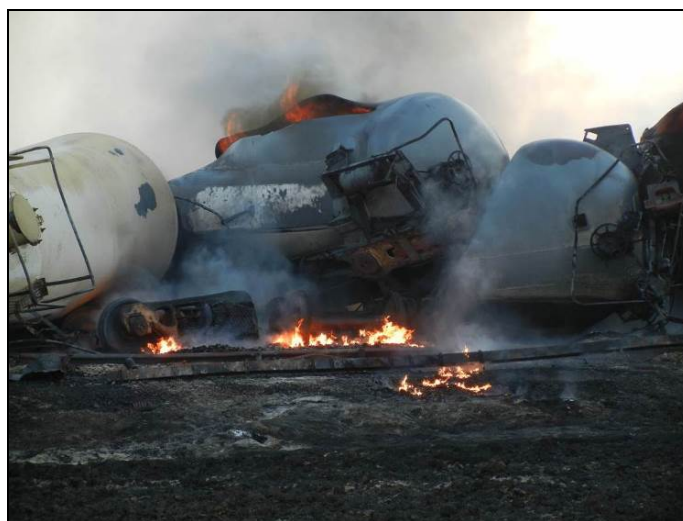
Figure 15: Fire coming out of thermal tear in tank car GATX 33125.

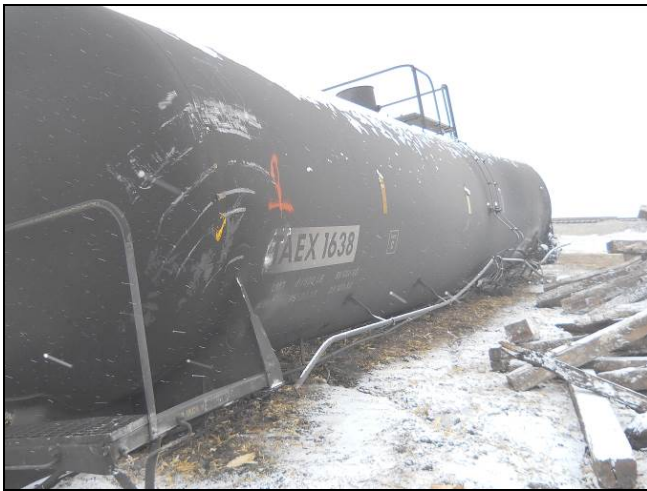
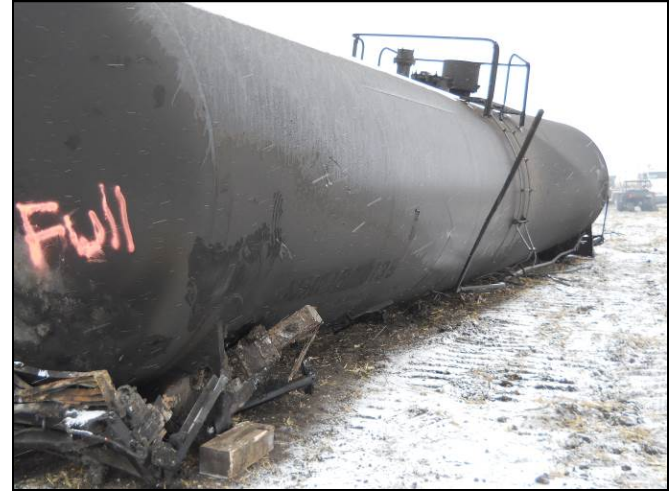
Figure 17: Image of TAEX 1638 (Field Wreckage Index#1) (a) Left side (b) Right side.

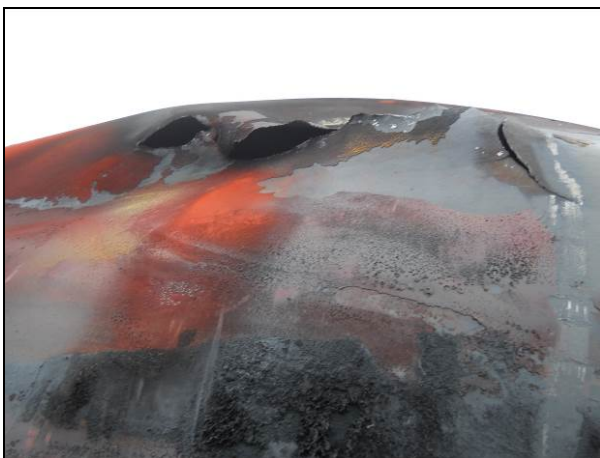
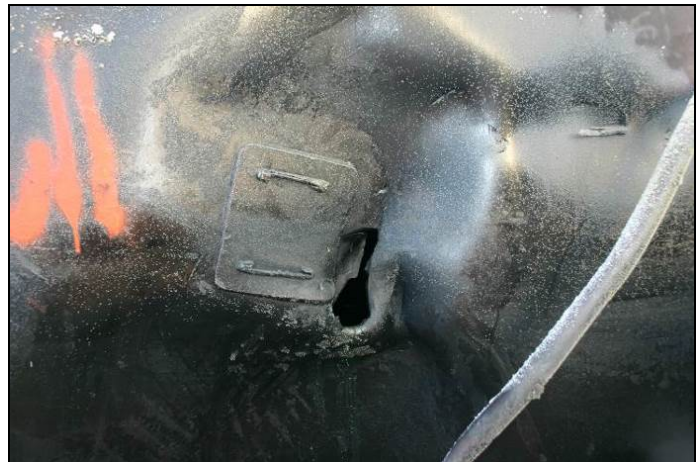
Figure 18: Breaches in TAEX 1630 (Field Wreckage Index#2): (a) Tears in bulging on A-left side; (b) Hole in A-end head.

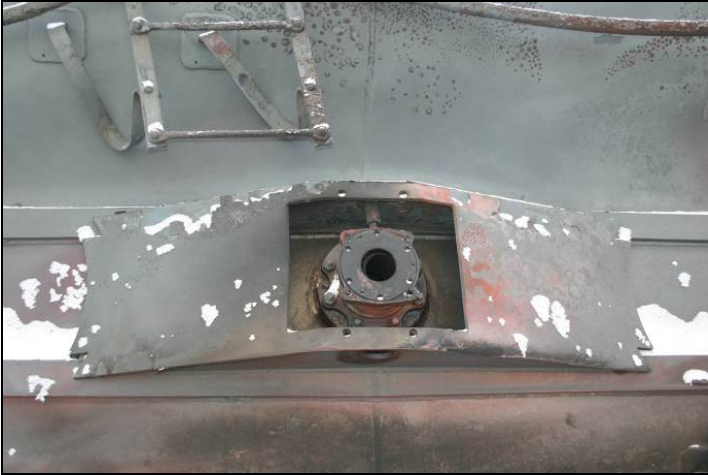
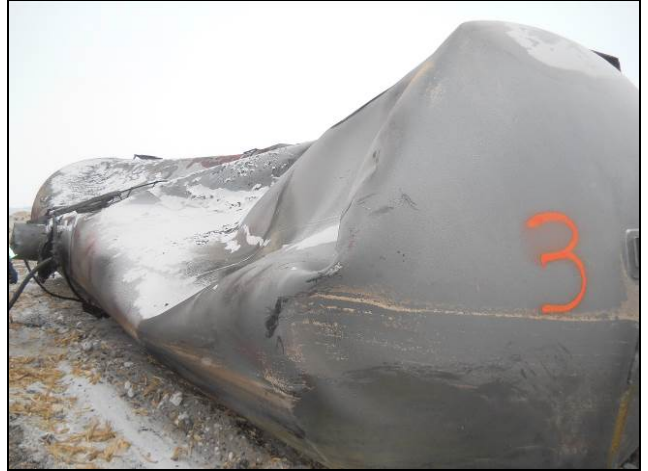
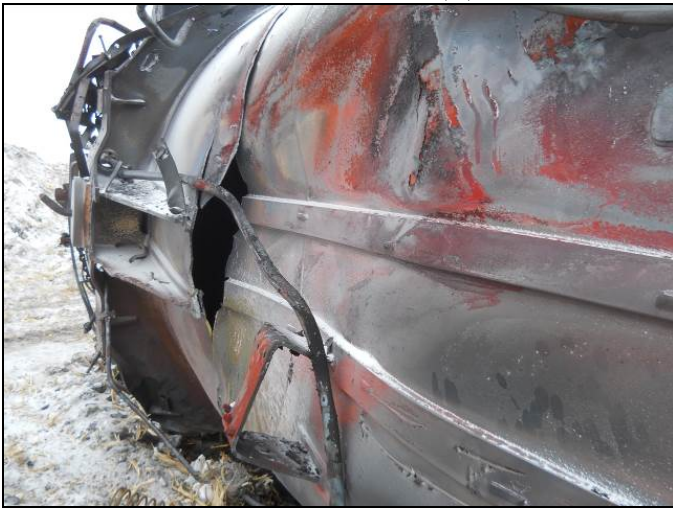
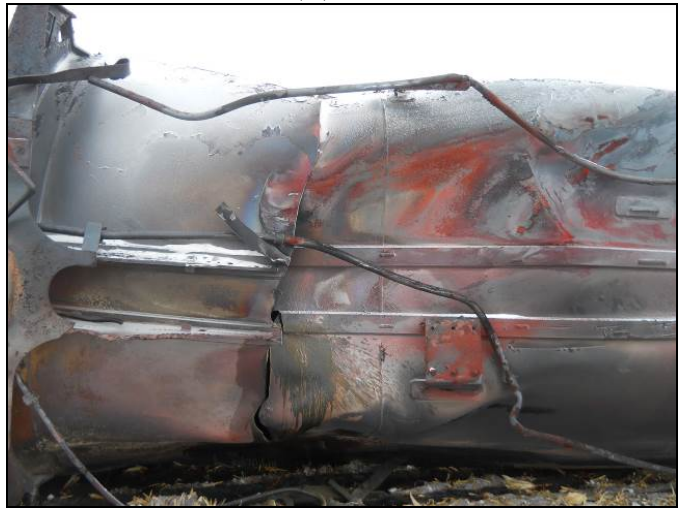
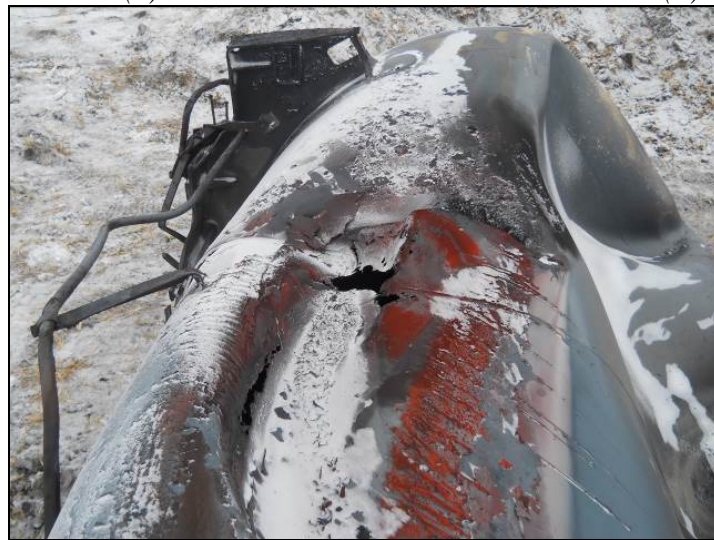
Figure 19: GATX 33139 (Field Wreckage Index#3): (a) Open BOV; (b) Deformation to right-side of tank car; (c) Ring fracture; (d) Ring fracture (alternate view); (e) Melted Shell/burn through on right side.

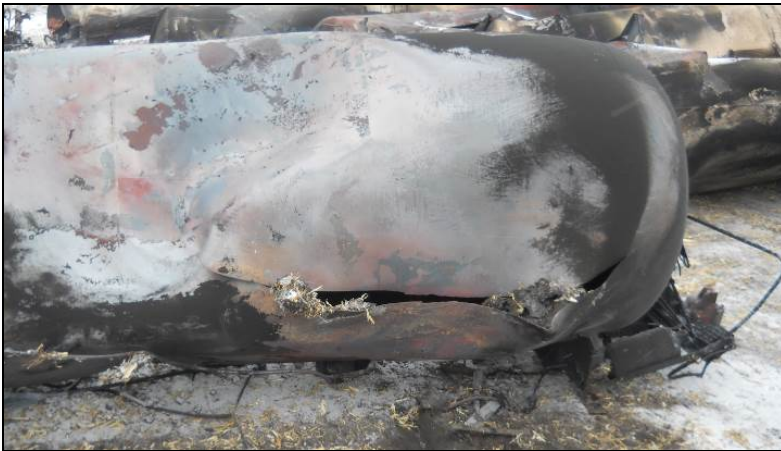
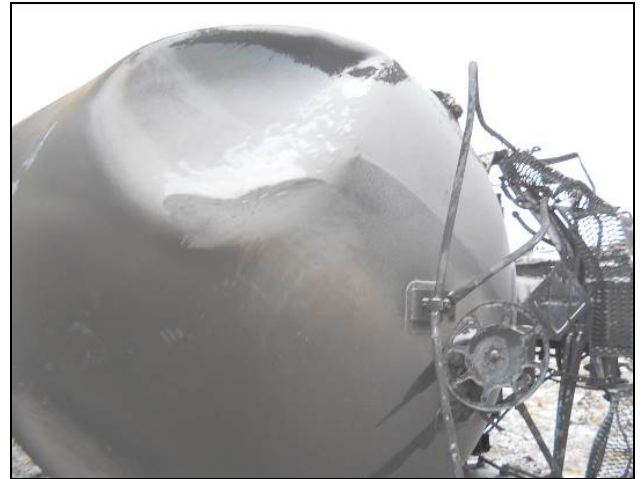
Figure 20: GATX 33125 (Field Wreckage Index#4): (a) Tear in B-left side through rings 1 and 2; (b) Dent on B-end head.

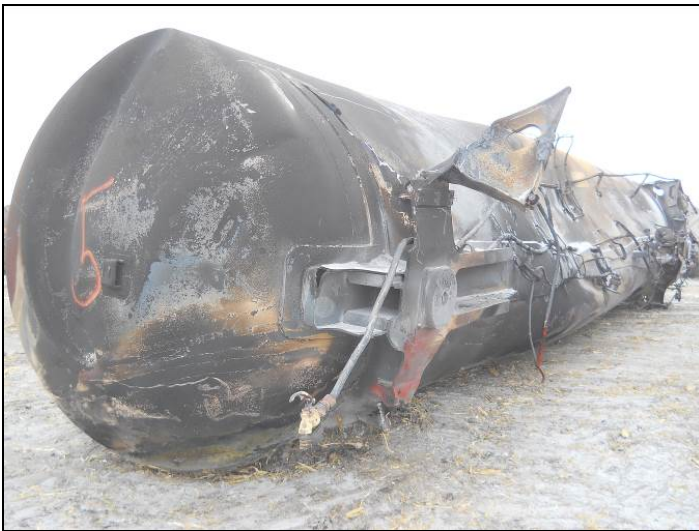
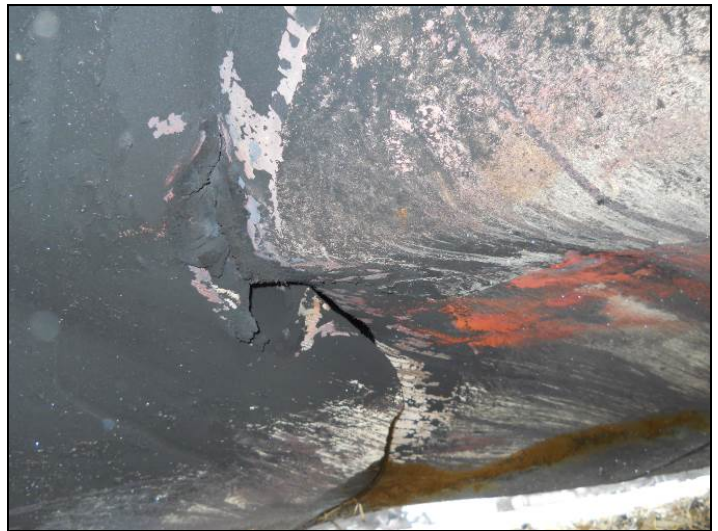
Figure 21: SHPX 206708 (Field Wreckage Index#5): (a) Damage to A-end head and bottom of tank car; (b) Fracture and mechanical tear in B -right side.

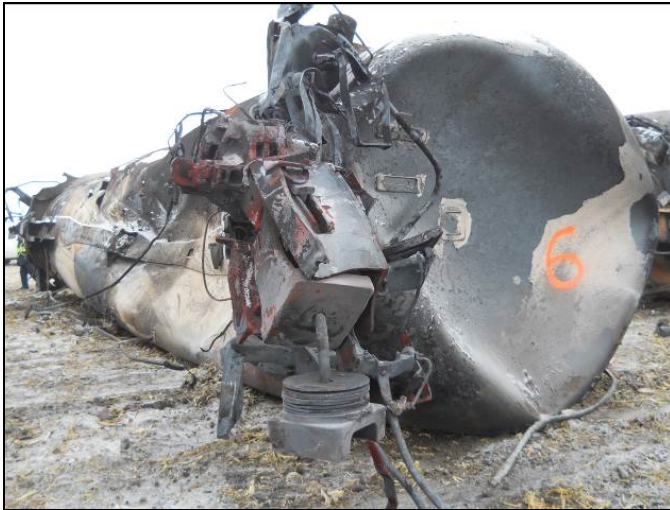
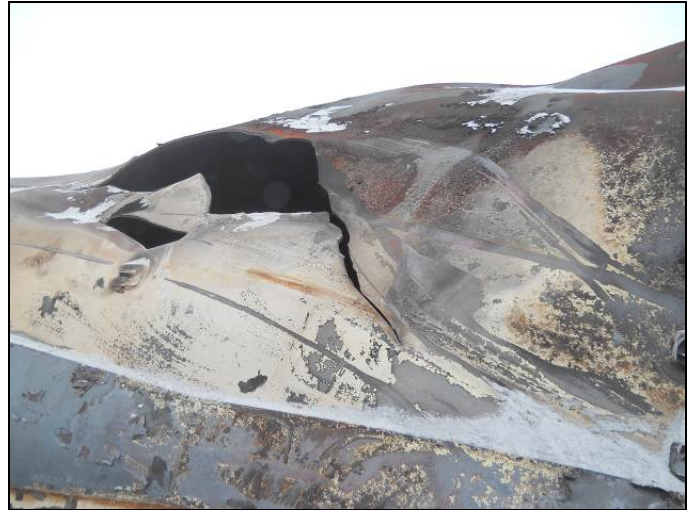
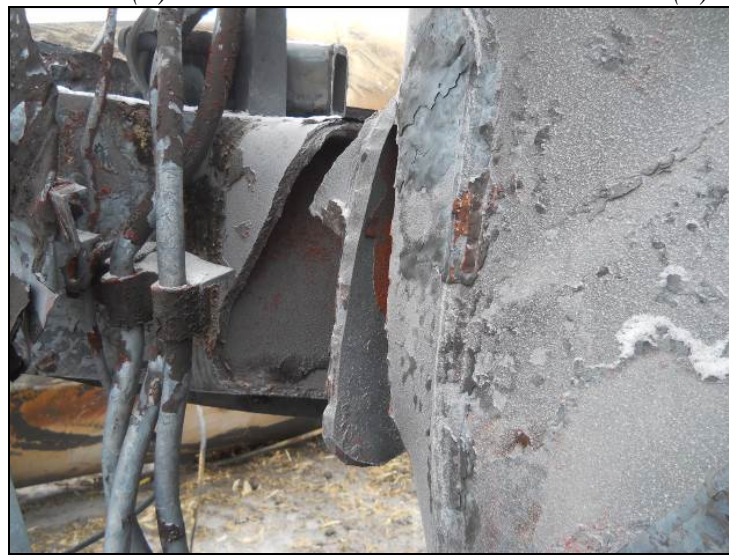
Figure 22: TAEX 1528 (Field Wreckage Index#6): (a) Damage to A-end and bottom of tank car; (b) Breaches in left side of tank (rings 2 and 3); (c) Damage to B-end head pad.

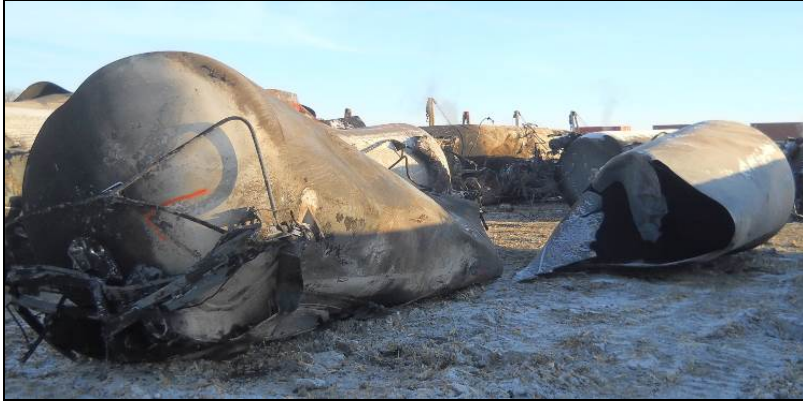
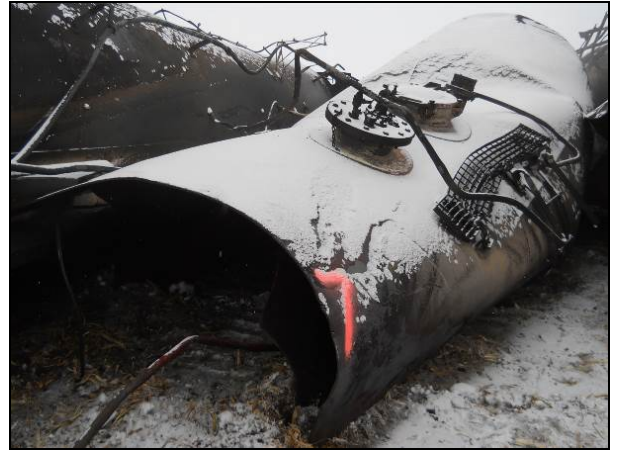
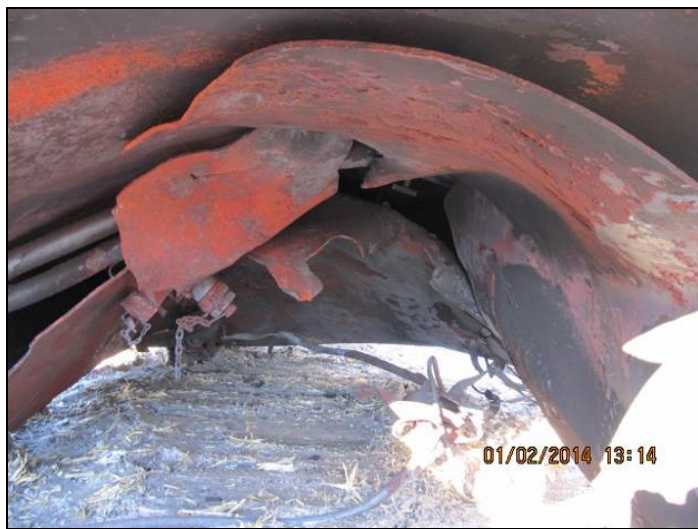
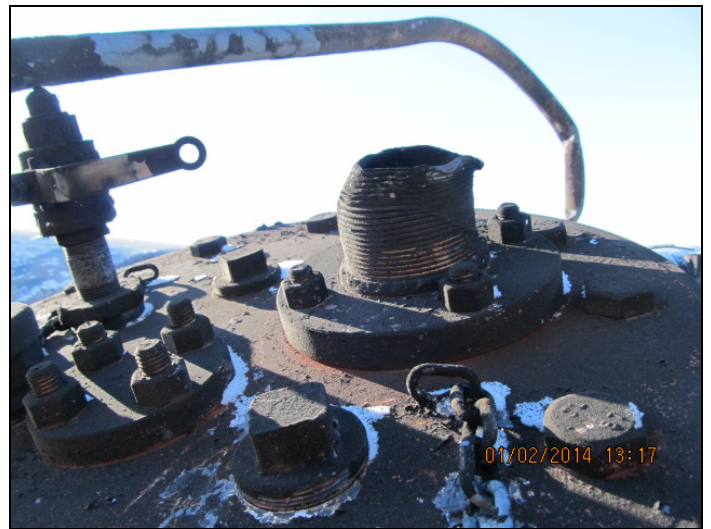
Figure 23: SHPX 208536 (Field Wreckage Index#7): (a) Two halves of tank car; (b) B-end piece of tank car; (c) B-end half collapsed on itself with BOV nozzle against top of tank; (d) Sheared off valve under missing multi-housing.

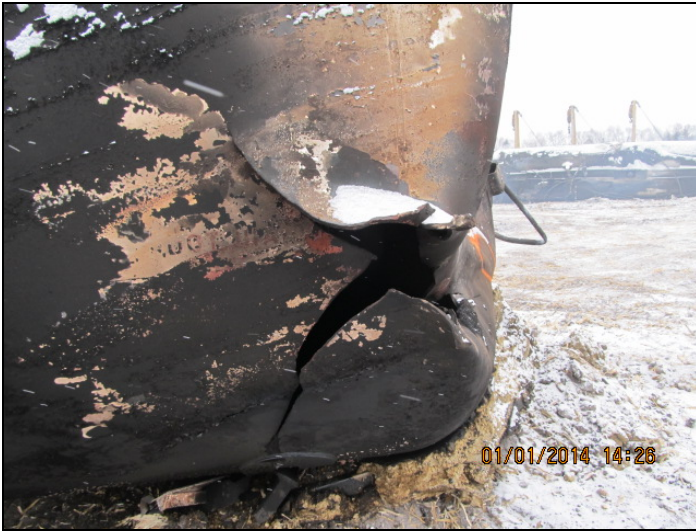
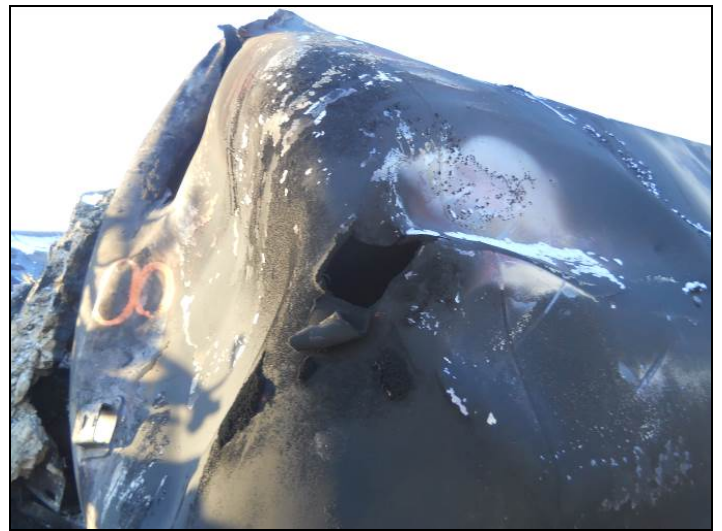
Figure 24: SHPX 206670 (Field Wreckage Index#8): (a) Multi-directional tear in A-right side and A-end head; (b) Dent in center of A-end head and tears at 9:00 and 12:00 positions.

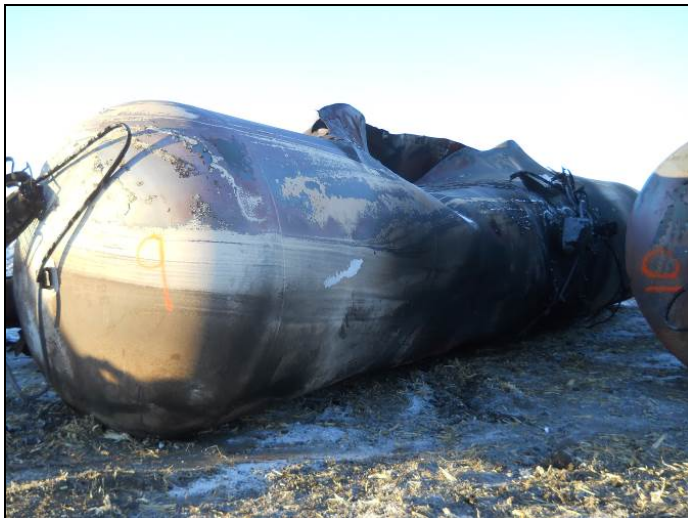
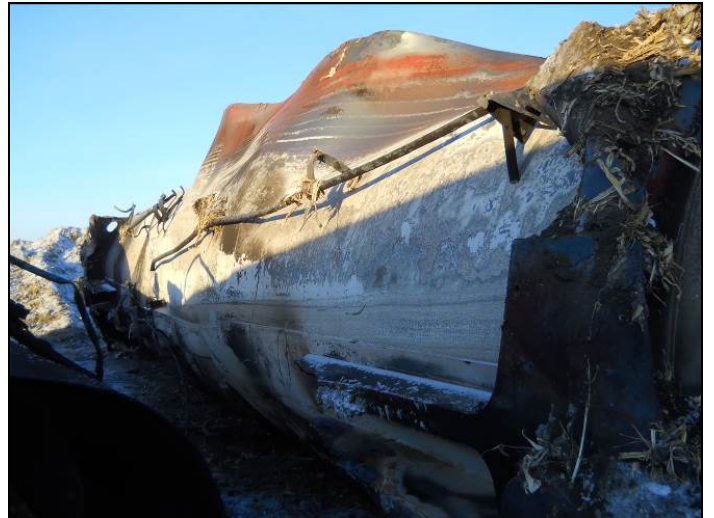
Figure 25: SHPX 208638 (Field Wreckage Index#9):(a) Large tear in right side of tank car; (b) Alternate view of tear.

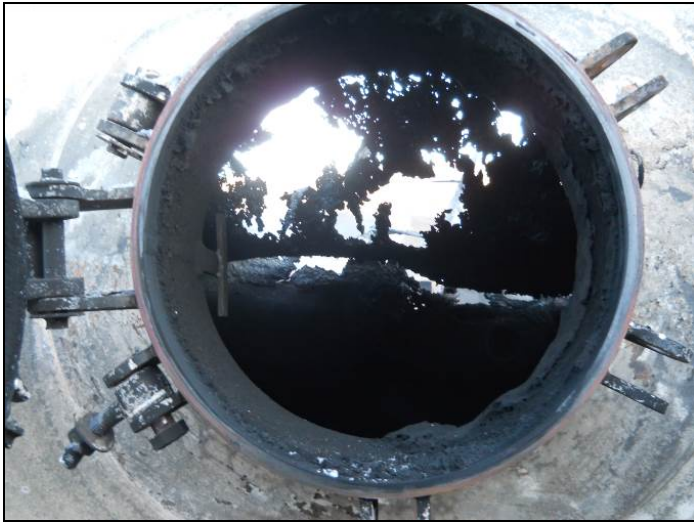
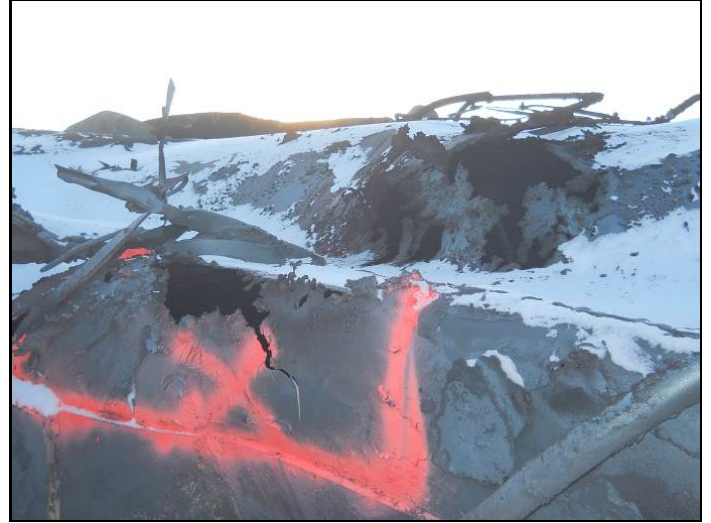
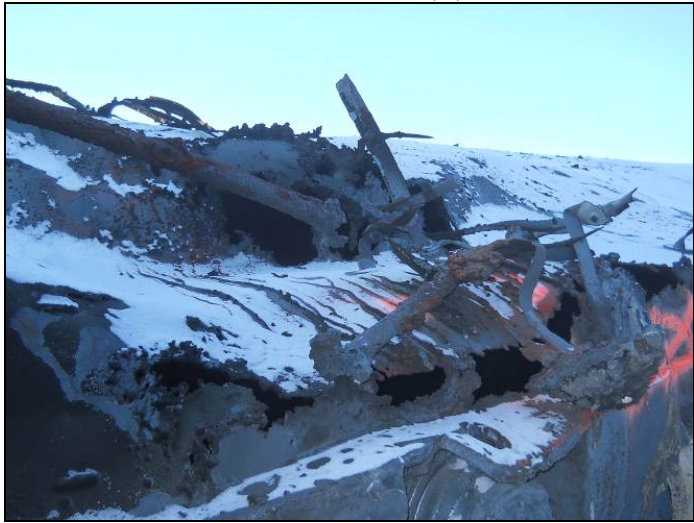
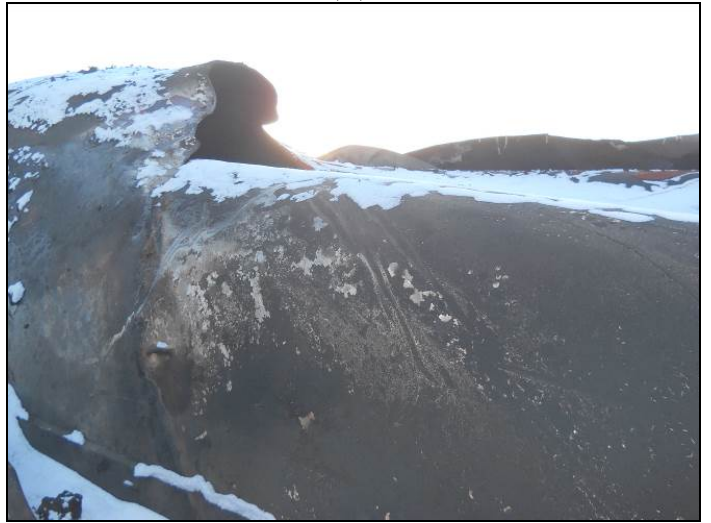
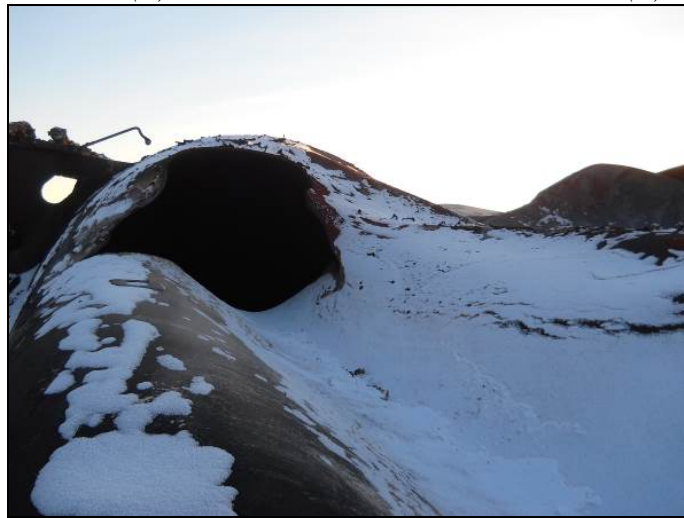
Figure 26: SHPX 208541 (Field Wreckage Index#10):(a),(b),and (c) Images of tank car shell burn through; (d) and (e) Images of shell tear in rings 5 and 6 in A-left.

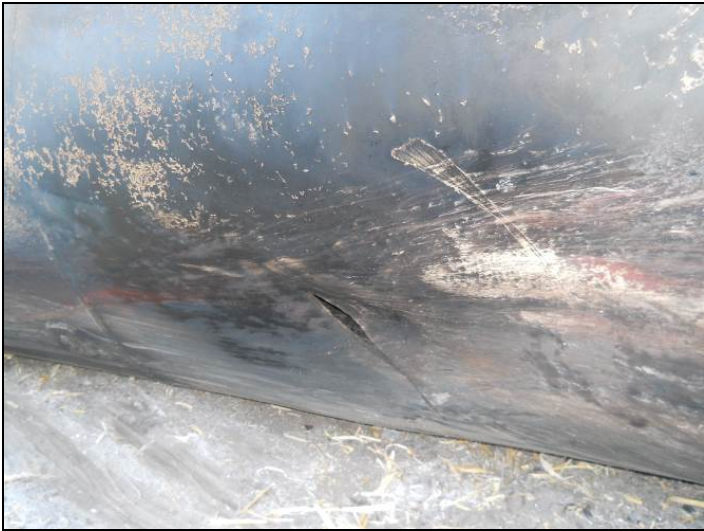
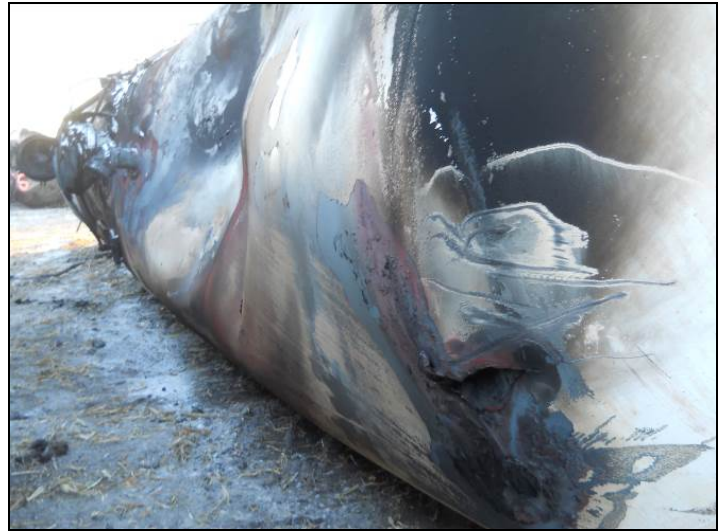
Figure 27: SHPX 206675 (Field Wreckage Index#11): (a) Tear in right side of tank car; (b) Breach in A-end head and deformation of top of tank car.

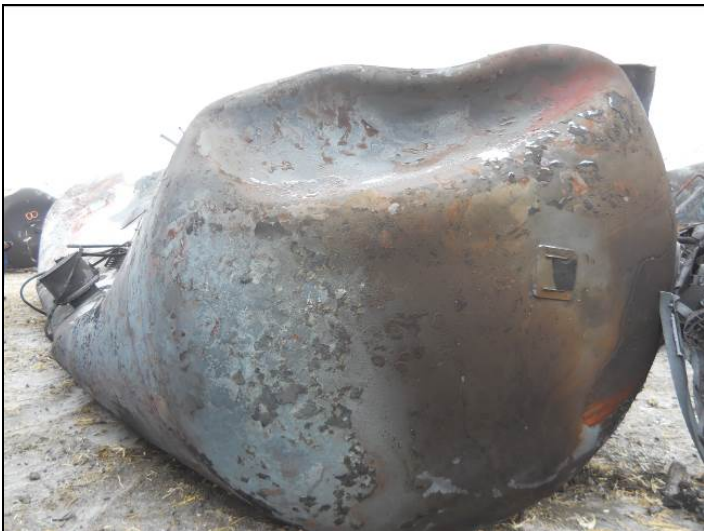
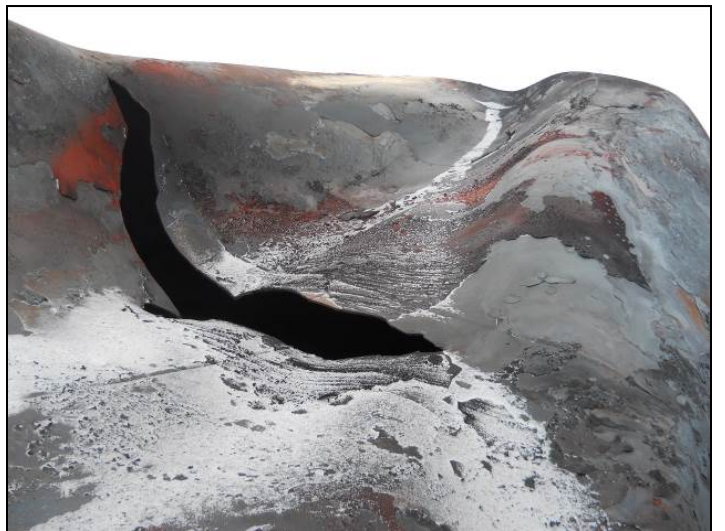
Figure 28: TAEX 1472 (Field Wreckage Index#12): (a) A-end head dent and damage to top of tank car; (b) Tear in ring 5 on A-left side.

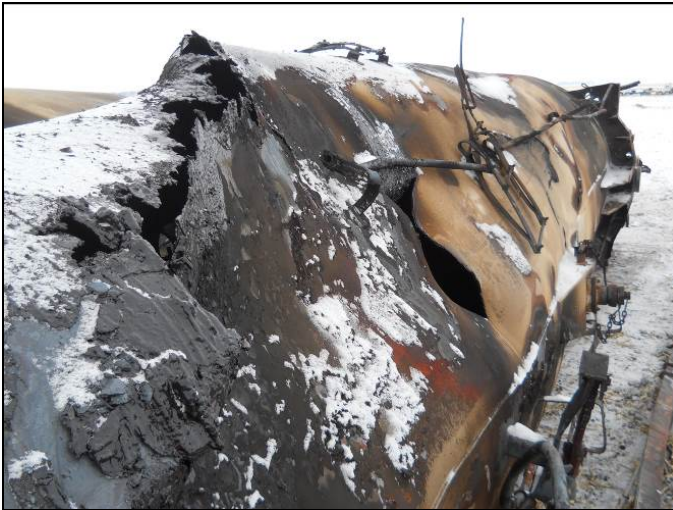
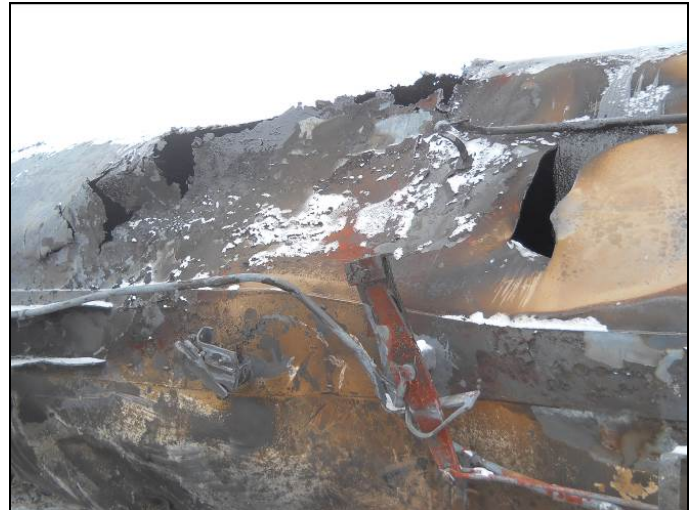
Figure 29: ADLX 500176 (Field Wreckage Index#13): (a) and (b) Burn through and tear in shell on right side of tank car.

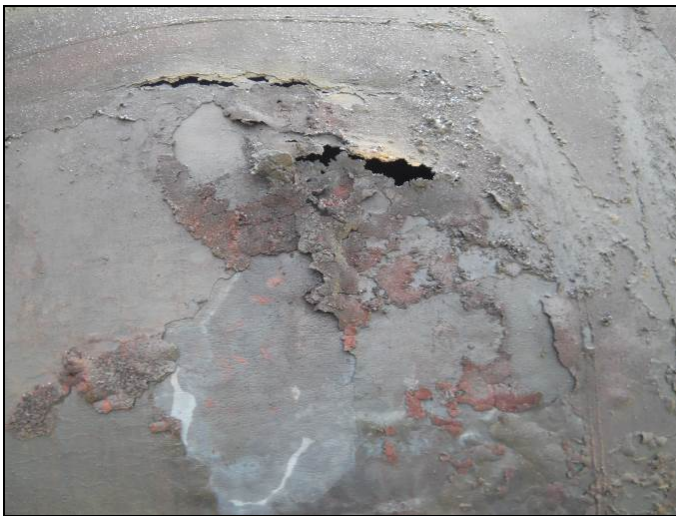
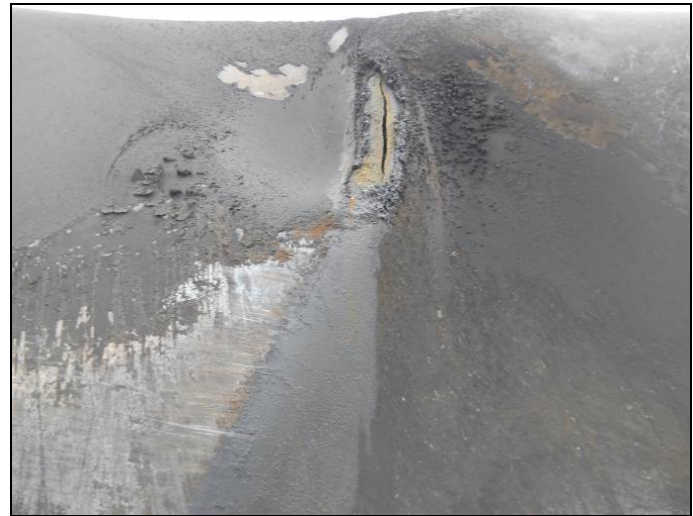
Figure 30: TAEX 1475 (Field Wreckage Index#14): (a) Burn through and tear in shell on B-left side right side of tank car; (b) Crack/tear in tank shell on A-right side.

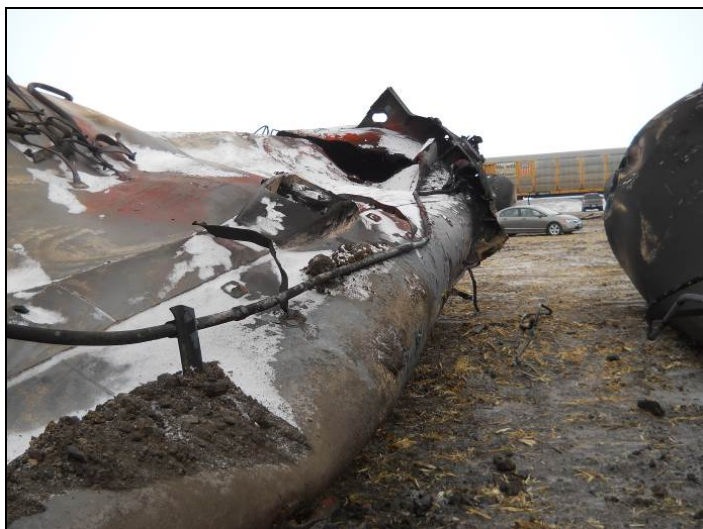
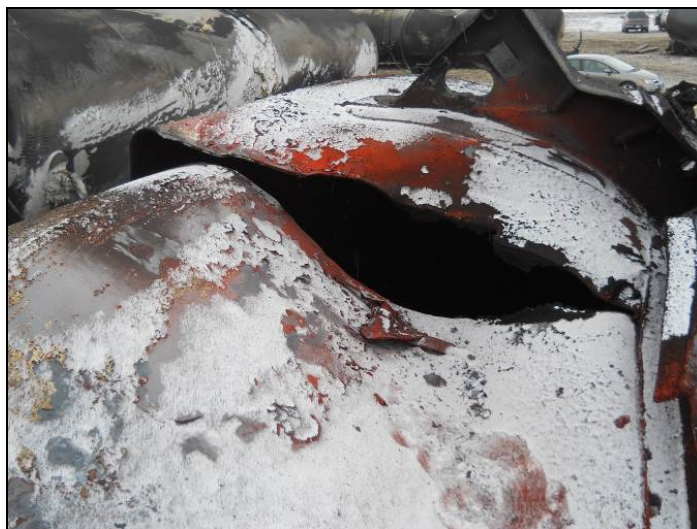
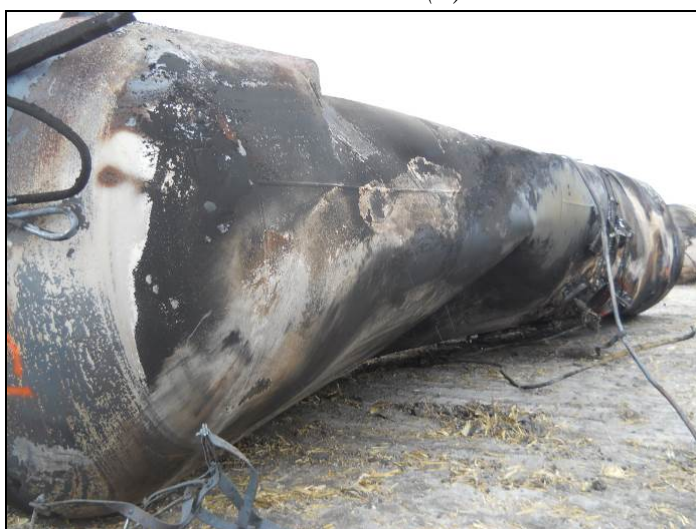
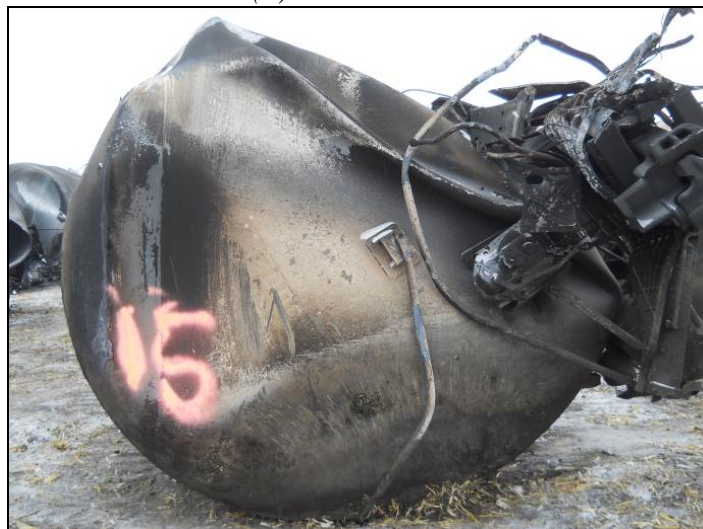
Figure 31: TAEX 1549 (Field Wreckage Index#15): (a) and (b) Damage to bottom of tank car and large tear in A-right side; (c) Dents and damage to the top of the tank car; (d) Dents and large fold on B-end head.

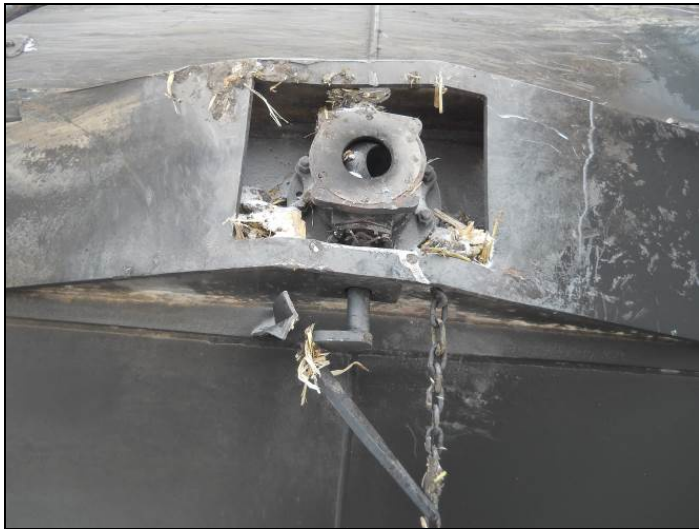
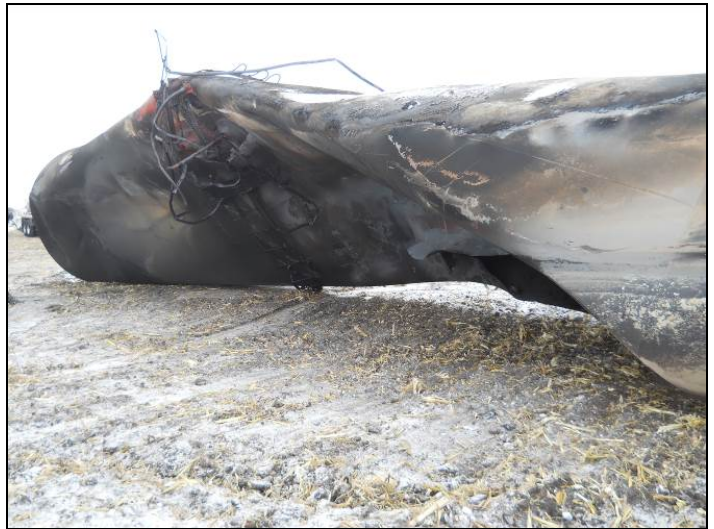
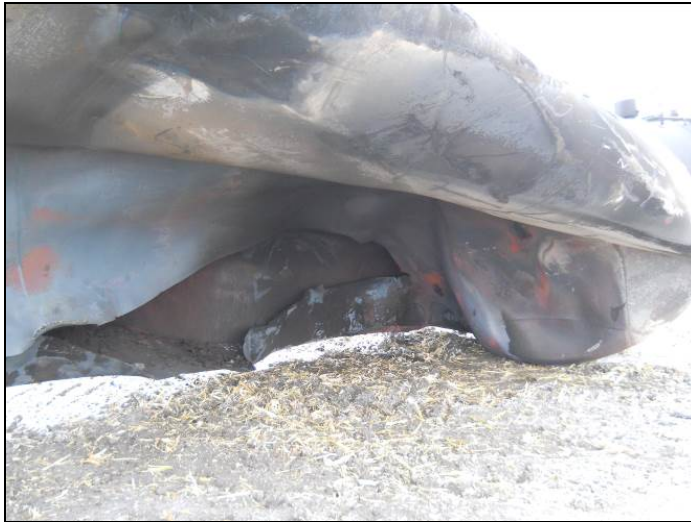
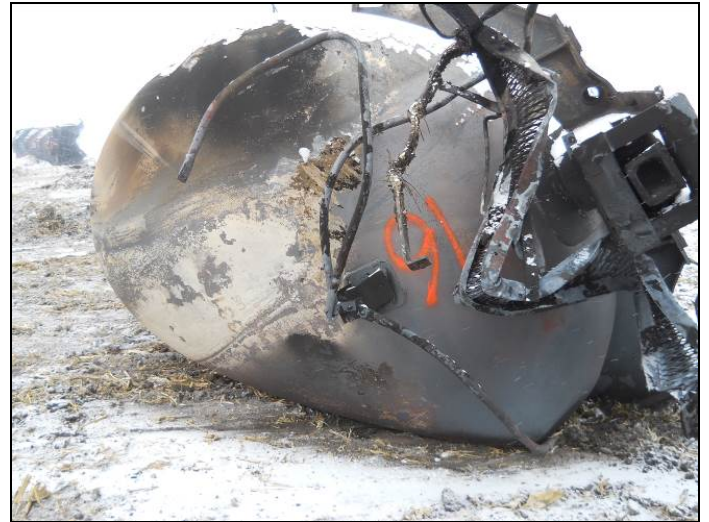
Figure 32: GATX 33123 (Field Wreckage Index#16): (a) Damage to BOV and partially open ball; (b) Tank car crushed; (c) Tear in A-right side of tank car; (d) A-end head deformed to an oval shape.

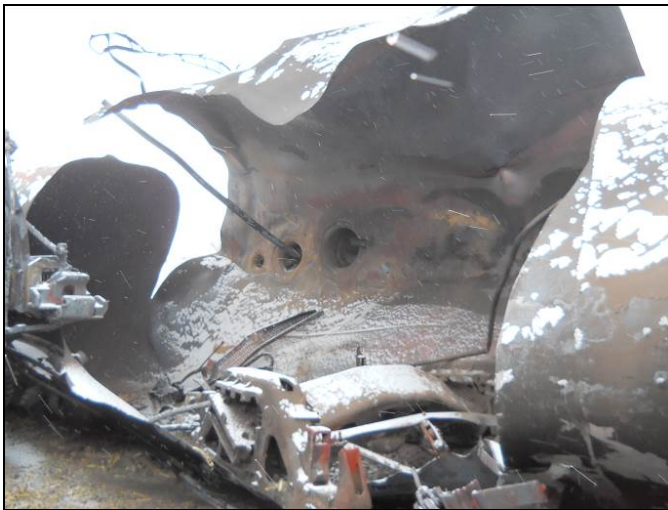
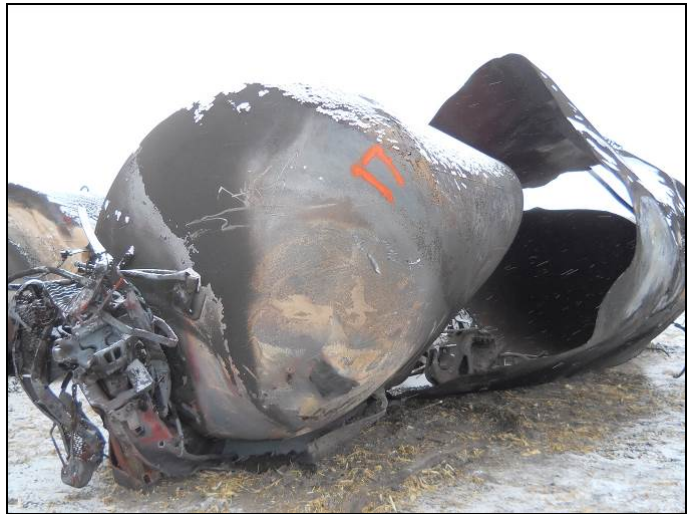
Figure 33: GATX 33119 (Field Wreckage Index#17): (a) and (b) Large tear in middle section of tank car.

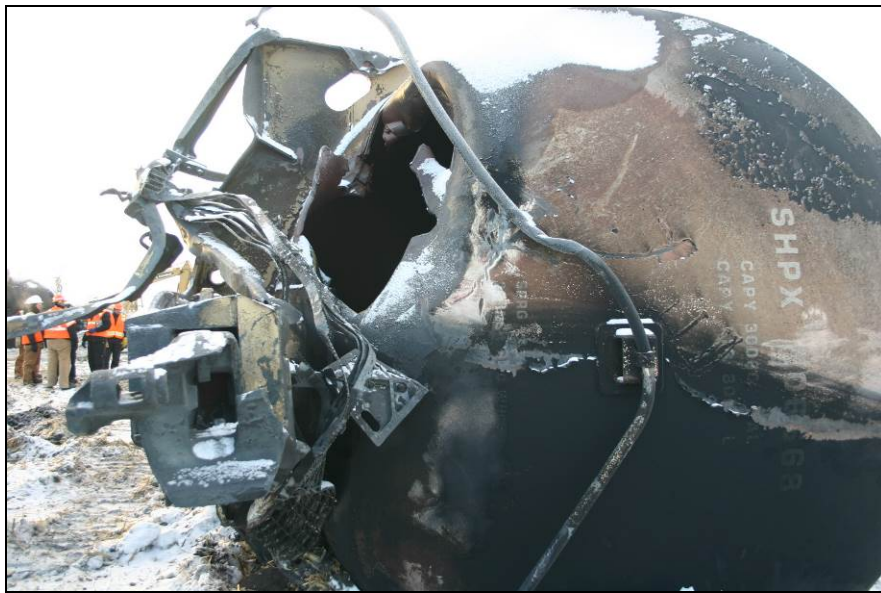
18	16	SHPX 206668	Yes	Deformation full length of the car. B-right had dent estimated at 6' x 20'. PRD, BOV, BOV handle, manway. Multi-housing intact. B-end head had two small holes. A-end head had two dents and a hole that was 5'x3'.	No	No	No	No	No	No	No	No	No	Yes

Figure 34: SHPX 206668 (Field Wreckage Index#18): Large puncture in A-end head.

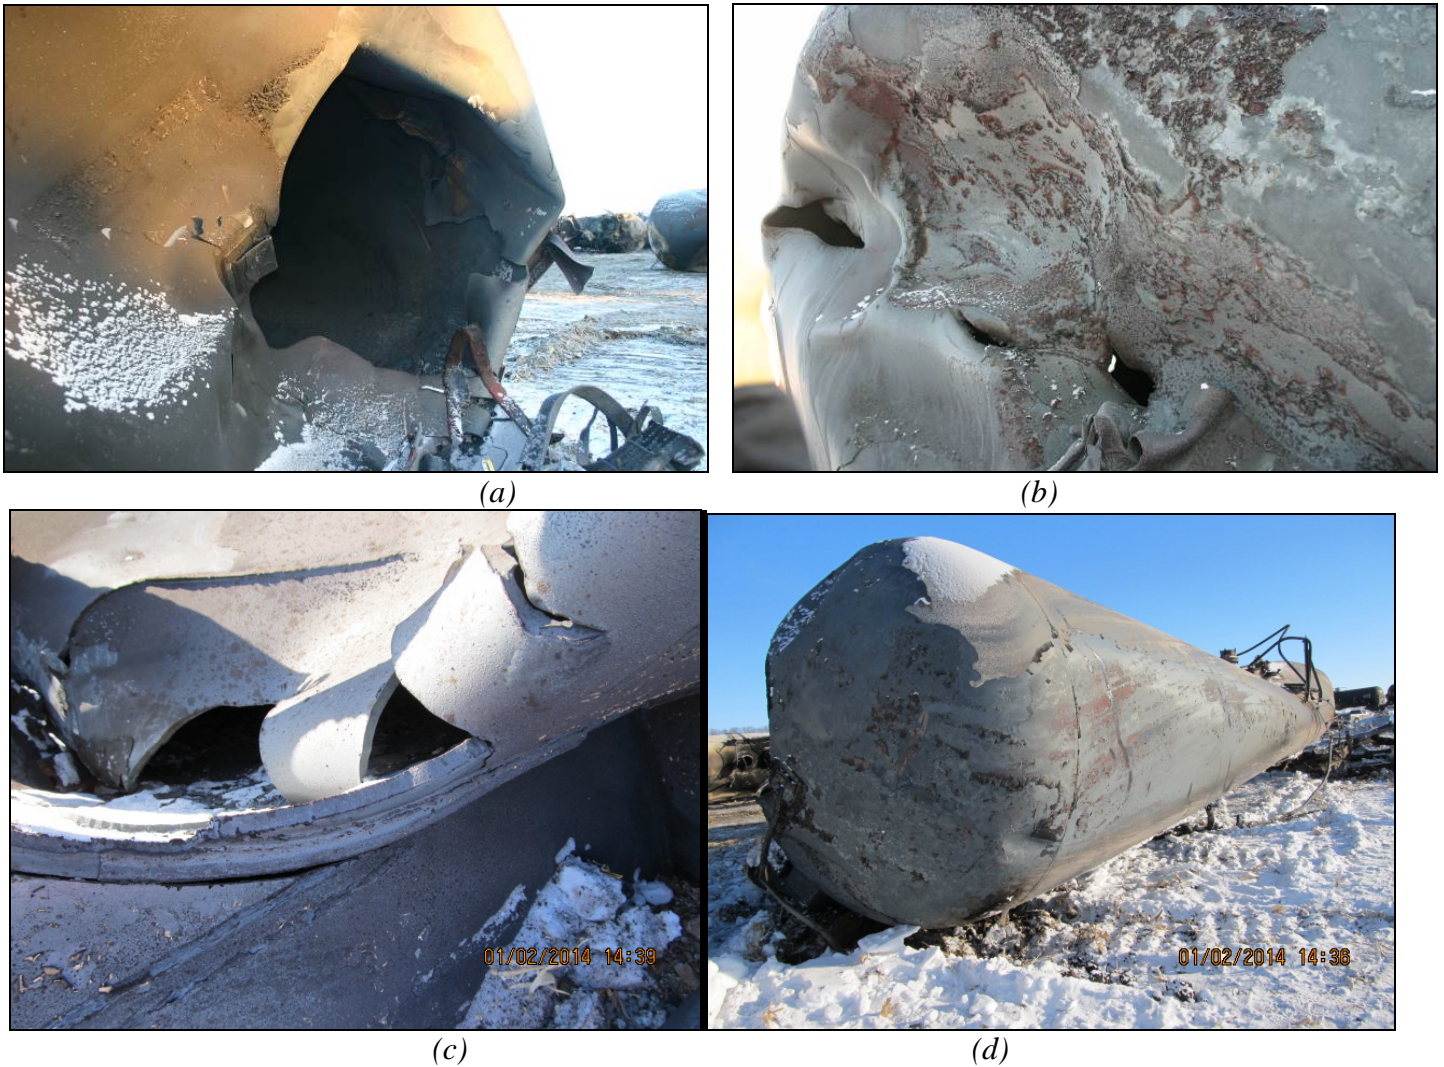
Figure 35: TAEX 1602 (Field Wreckage Index#19) (a) Large puncture in A-end head; (b) Three punctures in B-end head; (c) Head pad damage and separation; (d) Center of tank car crushed.
