**HAZARDOUS MATERIALS GROUP
FACTUAL REPORT**

**Derailment of Union Pacific Railroad Train UEGKOT 09 with
Subsequent Hazardous Materials Release
Graettinger, Iowa, March 10, 2017**

DCA17MR007

Report Date: August 9, 2017

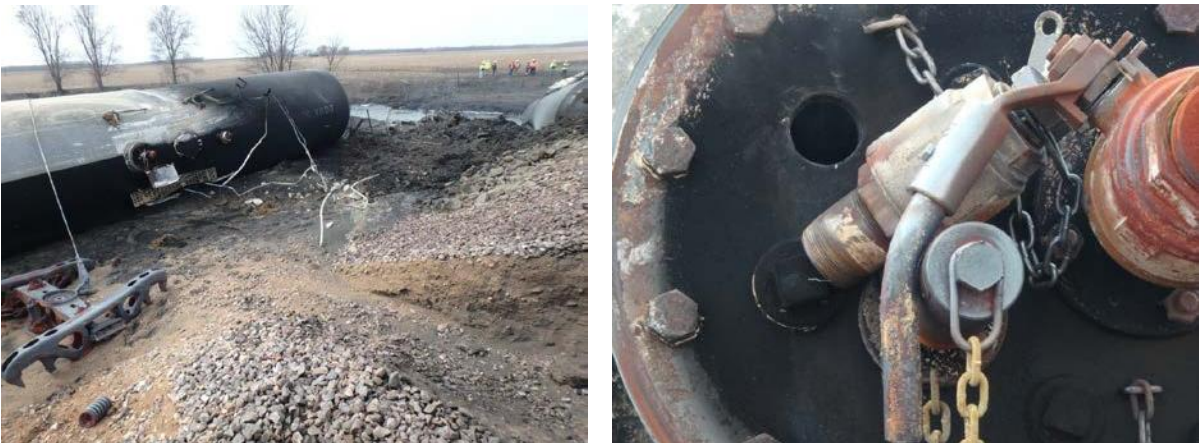
Line 80: DBUX 301674

- The car came to rest on the south side of the trestle, about one car length west of the track. The car was resting on its left side, about 9 o'clock with its A-end leading;
- The left side of the tank was scorched about half the tank diameter leaving a ring residue in the paint;
- The top fittings housing cover was broken away, but still attached to the hinge;
- The vapor valve was detached from the threaded hole in the multihousing fittings flange but it was still chained to the plate. The vapor valve pipe threads were mashed (Figure 6);
- The right of way bank was eroded opposite of the multihousing missing valve opening;
- The pressure relief device throat was caked with mud;
- The right side of the shell was buckled about 3 o'clock in Rings 2 and 3.

Figure 6: DBUX 301674, in-situ (left), multihousing flange with missing vapor valve (right), March 11, 2017.

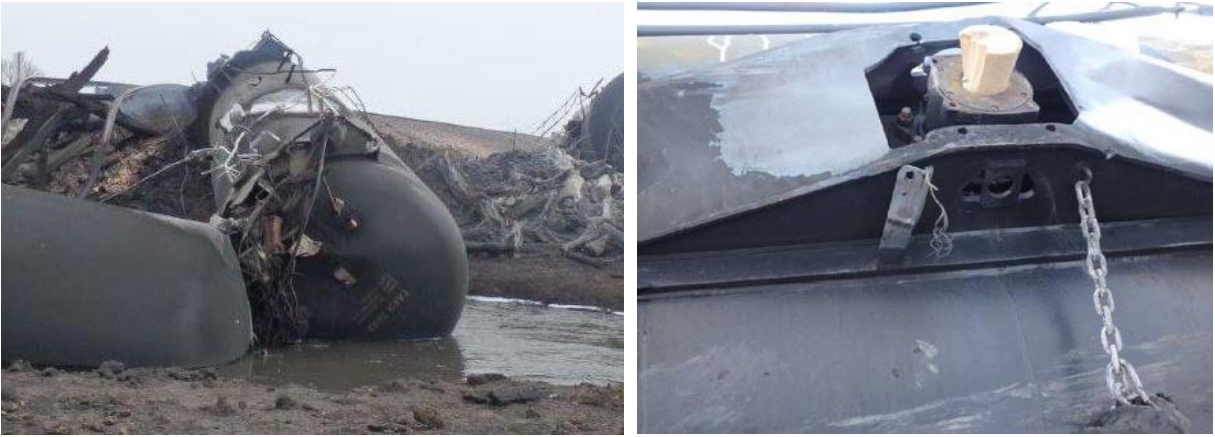
Line 79: TAEX 2893

- The car came to rest on its right side, with the B-end in the creek (Figures 7 and 8);
- Bottom outlet nozzle extension was torn off and the bottom outlet valve was open. First responders used a wooden plug to seal the valve;
- The B-end draft sill was bent to the right more than 90 degrees.

Figure 7: TAEX 2893, in situ (left), and in staging area (right) with plugged bottom outlet nozzle, March 11, 2017.

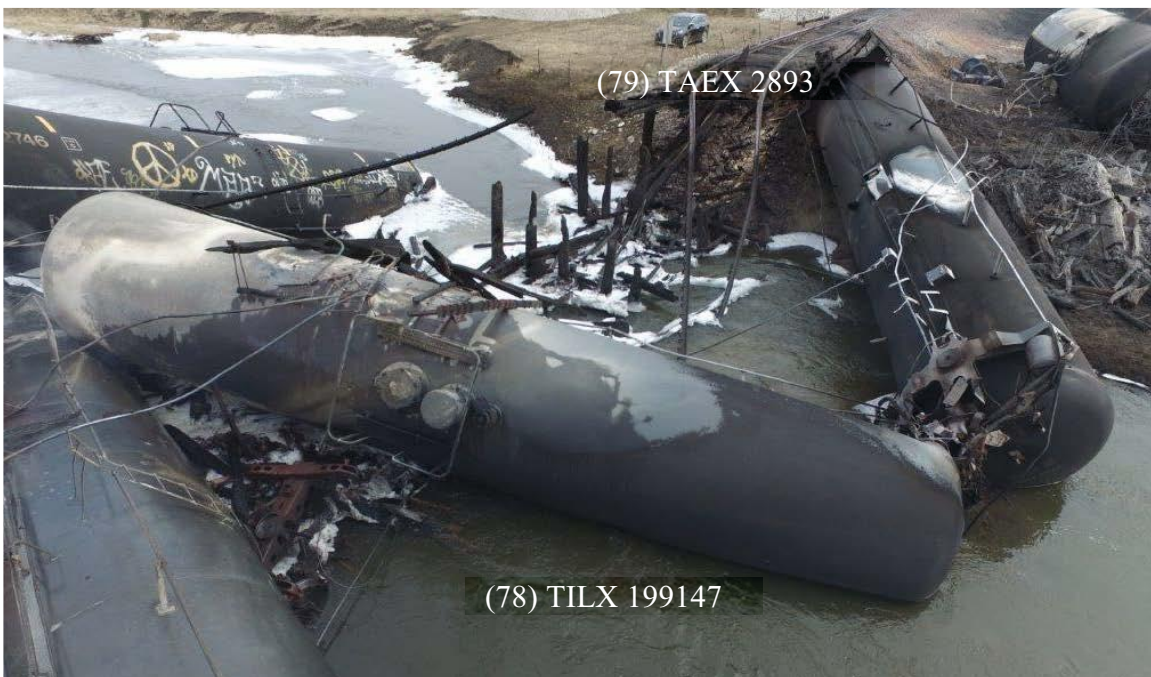
Figure 8: TAEX 2893 and TILX 199147, in situ, March 11, 2017.

- The car came to rest on its right side, with the A-end in the creek, B-end elevated and resting on CTCX 732108;
- A gouge and dent lead to a rectangular puncture in the A-end head. The A-end head sustained two punctures about 4 o'clock. The gouge originated from the head pad area. The punctures were about the size and shape of a coupler (Figure 9);
- The B-end head sustained a rounded dent covering the entire head surface;

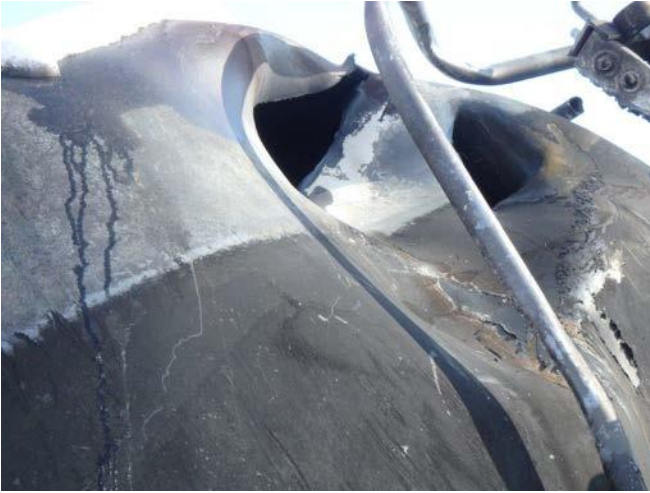
Line 78: TILX 199147

- The bottom outlet valve nozzle was sheared away, the operating handle was missing, the valve was found closed.

Figure 9: TILX 199147 A-end head puncture, March 11, 2017.

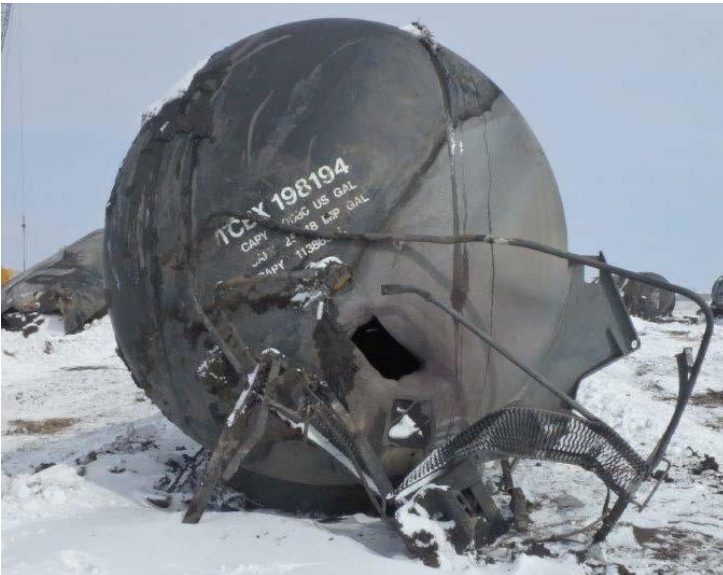
Line 77: TCBX 198194

- The car came to rest on its right side, parallel to the north side of Jack Creek;
- The A-end head sustained a rectangular 8x22-inch puncture between the center line and draft sill (Figure 10).

Figure 10: TCBX 198194, A-end head puncture, staging area, March 13, 2017.

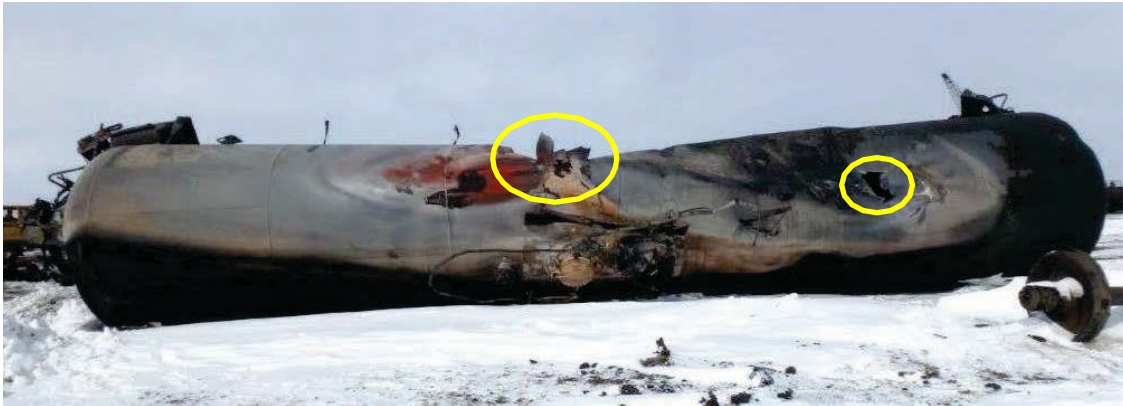
Line 76: CTCX 732108

- The car came to rest on its right/top side as the B-end was leading (Figure 11). The car was resting parallel to and on the north bank of Jack Creek;
- The tank shell sustained an irregular hole about 28x16 inches, A-L, Ring 5, about 11 o'clock;
- The tank shell sustained an irregular 10 ft. tear/hole in Ring 3 below the longitudinal seam;
- The vapor valve was missing. The liquid valve was broken away from the multihousing fittings flange, but remained attached to a chain.

Figure 11: CTCX 732108 in staging area, breaching damage circled March 13, 2017.

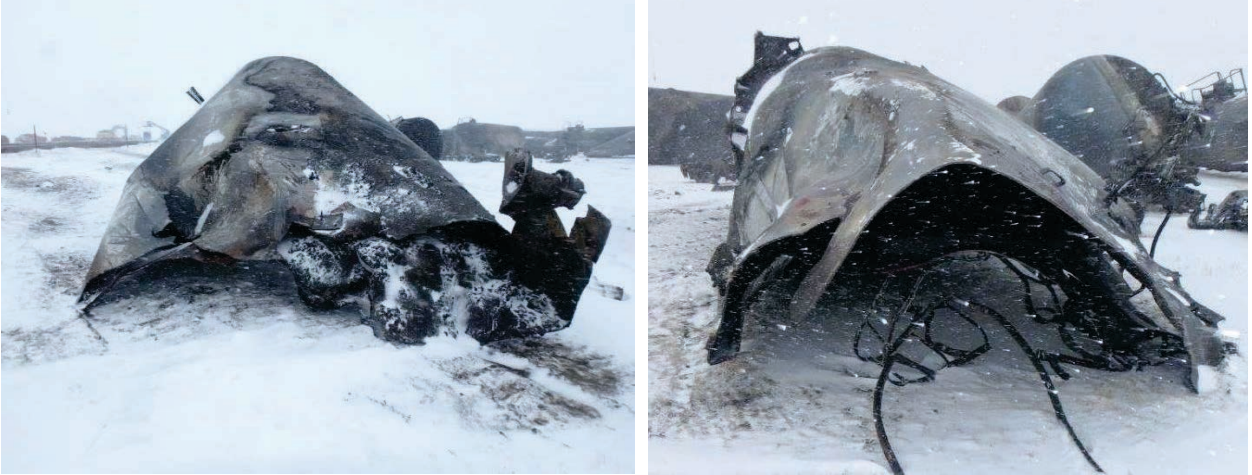
Line 74: DBUX 302834

- The tank fractured in two pieces and flattened about mid-section releasing all contents (Figures 12 and 13);
- A flap of shell material projecting outward from one fractured tank segment contained the pressure relief device;
- The B-end head sustained a 12 x 6-inch puncture about 3 o'clock.

Figure 12: DBUX 302834, two halves of fractured tank car, staging area, March 12, 2017.

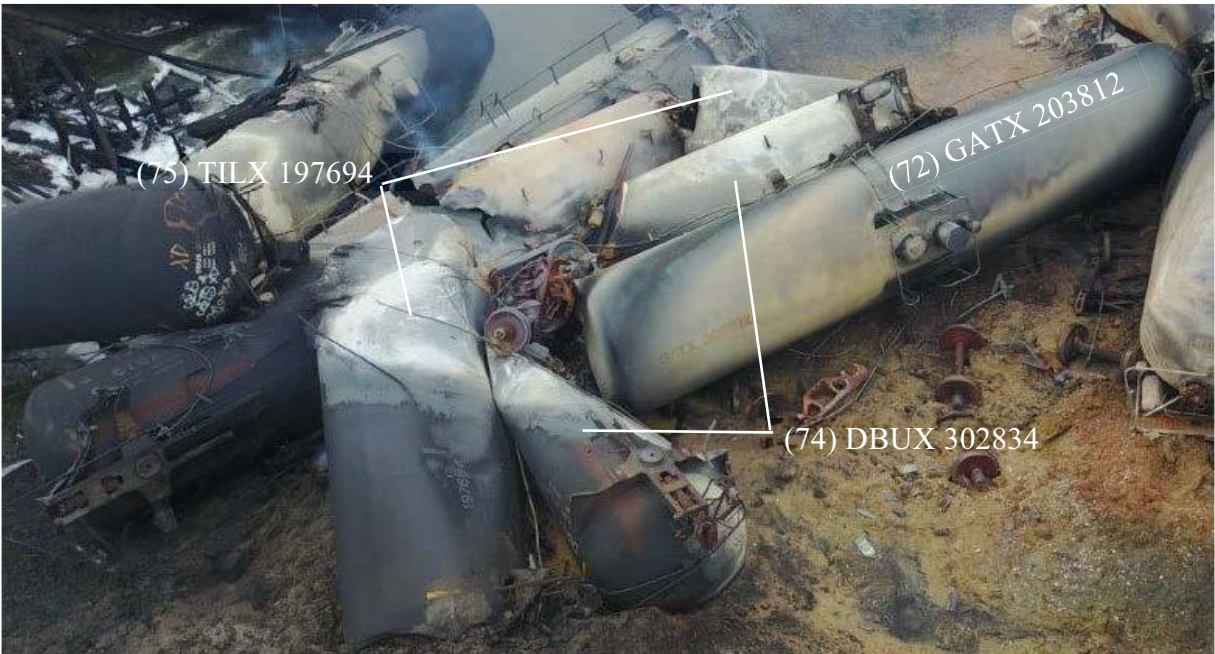
- The tank fractured in two pieces about mid-section and released all contents (see Figure 13). The fractured tank sections were separated about 20-feet in the pileup.

Figure 13: TILX 197694 and DBUX 302834 in situ, March 11, 2017.

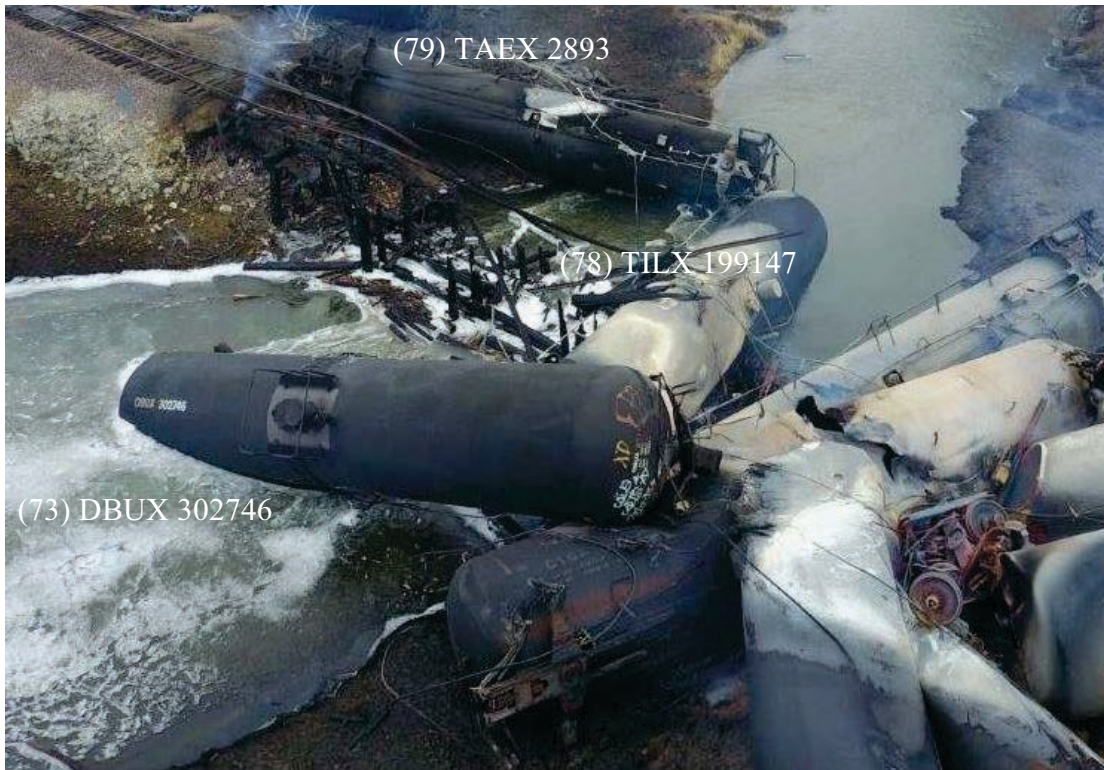
Line 73: DBUX 302746

- No point of release or breaching damage was observed;
- The car came to rest on its right side with the B-end in the creek and A-end elevated 45 degrees and resting upon CTCX 732108 (Figure 14).

Figure 14: DBUX 302746, in situ, March 11, 2017.

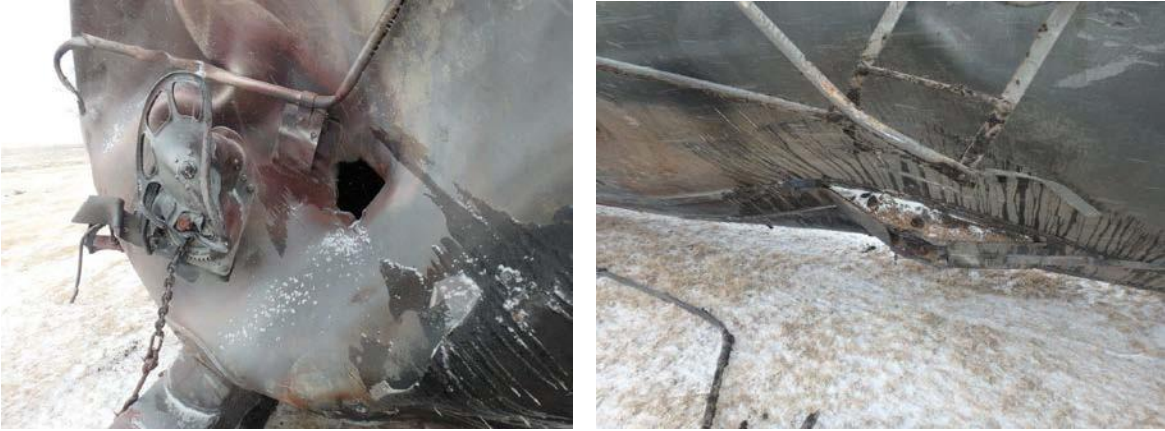
Line 72: GATX 203812 (TAEX 2909)

- The car came to rest on its right side with the B-end leading and in contact with DBUX 302834;
- The B-end head sustained an 8 x 8-inch square puncture right of the brake wheel within a rounded dent (Figure 15);
- The B-end coupler top shelf was broken off;
- An upward dent in the tank bottom was centered on the bottom outlet valve. Skid protection structure was bent upward exposing the bottom outlet valve;
- The bottom outlet valve nozzle was sheared away and the operating handle was missing. The valve was found in the closed position;
- The A-end head sustained a rounded dent, with the head pad fillet weld cracked at edge of the dent.

Figure 15: GATX 203812 / TAEX 2909, punctured B-end head (left) and bottom dent over the bottom outlet valve (right), staging area, March 12, 2017.

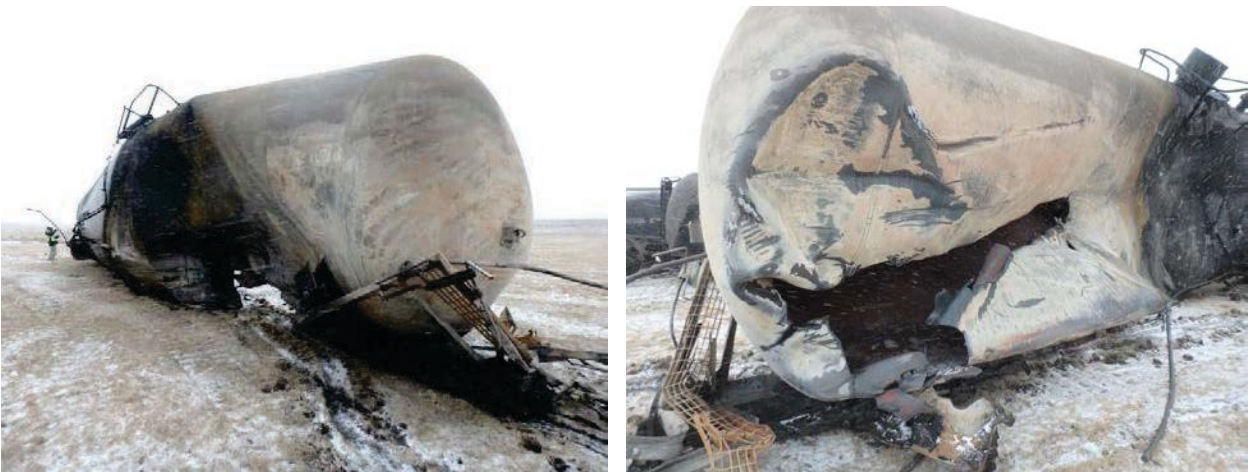
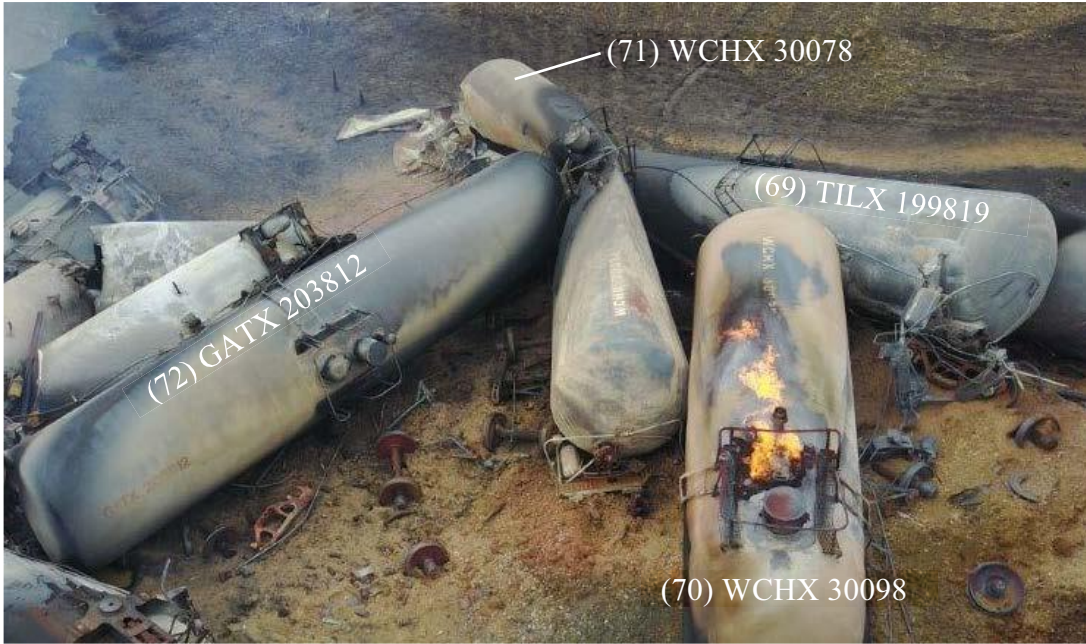
Line 71: WCHX 30078

- The car came to rest between the A-end head of GATX 203812 and the A-end of TILX 199819;
- The tank shell was crushed inward on the left and right sides of Ring 5, with both sides of tank nearly touching;
- The shell sustained a tear in the belly of the tank, 18 feet by 8 feet;
- The shell sustained a 1 to 2 ft. wide rectangular longitudinal shell tear at the left side length of Ring 6, extending into 5 o'clock region of A-end head (Figures 16 and 17).

Figure 16: WCHX 30078 shell fracture (left) and head-shell tear (right), staging area, March 12, 2017.

Figure 17: WCHX 30078 in situ, March 11, 2017.

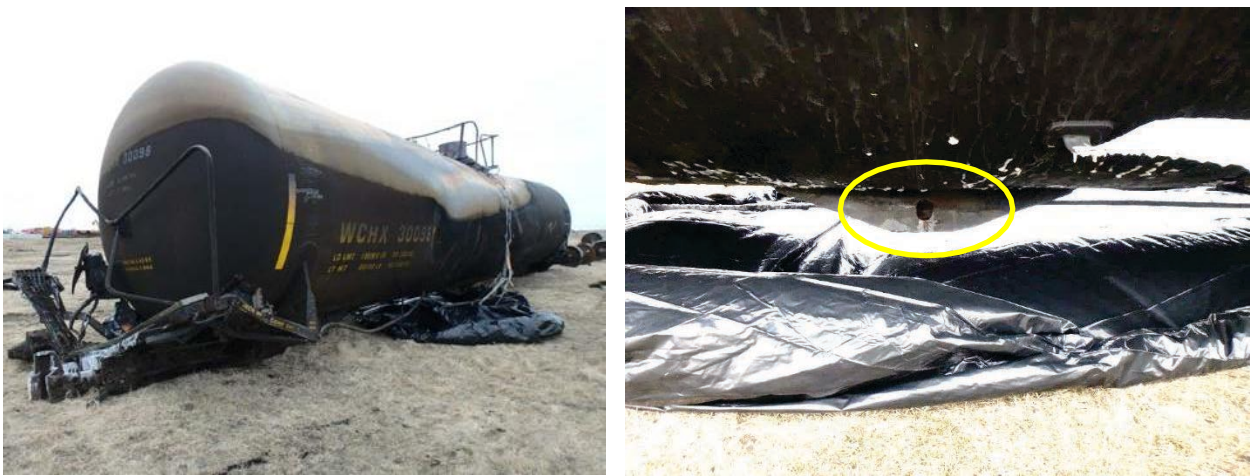
Line 70: WCHX 30098

- The car came to rest upright with B-end facing west and A-end head plowed into the soil;
- On March 11, flame continued to burn from the pressure relief valve and manway. The multihousing cover was not mechanically damaged;
- The bottom outlet valve was leaking, nozzle was sheared off, and the operating handle did not open;
- Paint on the top half of car was scorched, leaving a ring pattern in the paint (Figure 18);
- One manway I-bolt was missing and two button rivets were missing;
- The 8 o'clock edge of B-end head was gouged, but head was not penetrated.

Figure 18: WCHX 30098 staging area (left), leaking bottom outlet (right), March 12, 2017.

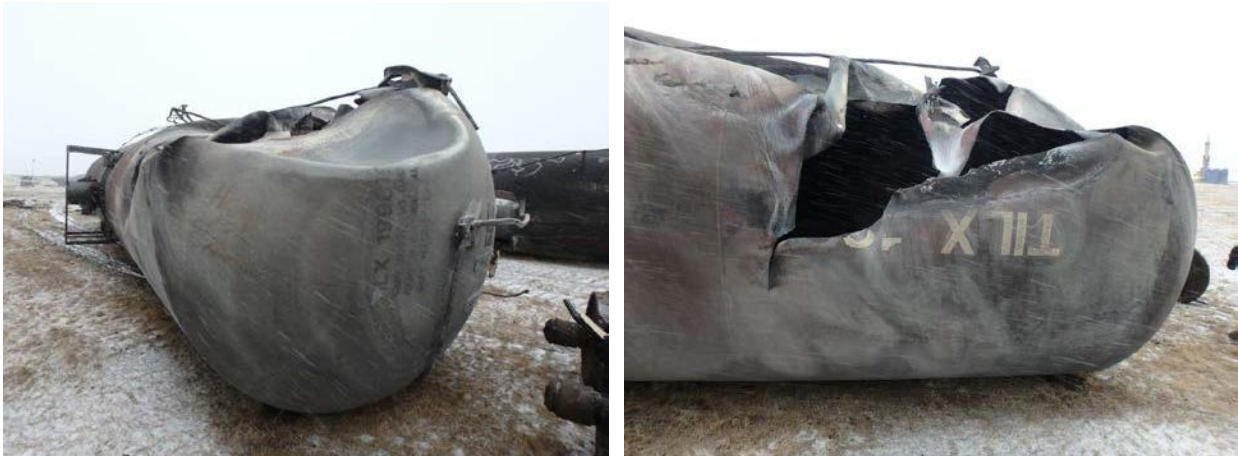
Line 69: TILX 199819

- The car came to rest upright;
- The left side A-end head sustained a deep rounded dent;
- The shell at Ring 6 sustained a cut about 96 inches by 120 inches from contact with the head of adjacent tank car CTCX 731383. Shell deformation adjacent to the hole and extending into Ring 5 was about 6 ft. by 10 ft. (Figure 19);
- The bottom outlet valve nozzle sheared off, the operating handle was missing, and the valve was sealed. The bottom skid protection structure was damaged leaving the bottom outlet valve exposed;
- The B-end draft sill fractured at the head brace and was missing from car, along with the coupler;
- Parent metal stress cracking occurred in the head right of the B-end head pad. The head pad fillet weld did not fracture.

Figure 19: TILX 199819 A-end shell tear, staging area, March 12, 2017.

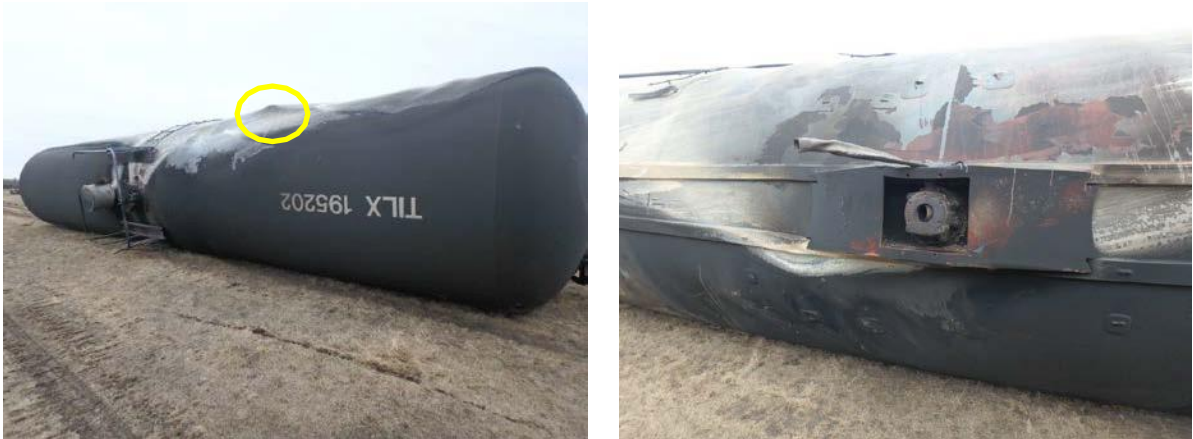
Line 68: TILX 195202

- The A-end was leading and the car came to rest with the head plowed into soil and the tank tilted to the left side;
- The shell in Ring 1 was buckled;
- A small 18-inch thermal tear was centered within a 12-inch outward bulge in Ring 2 (Figure 20);
- The bottom outlet valve operating handle was damaged, the bottom outlet valve was open. Investigators were uncertain whether the valve was manipulated during wreckage movement, since the valve packing was thermally damaged leaving the valve handle free to move easily;
- Paint was scorched across the left side and around top fittings and bottom outlet valve area leaving a ring pattern in the paint.

Figure 20: TLX 195202 Thermal tear (left circled) and open bottom outlet (right), staging area, March 12, 2017.

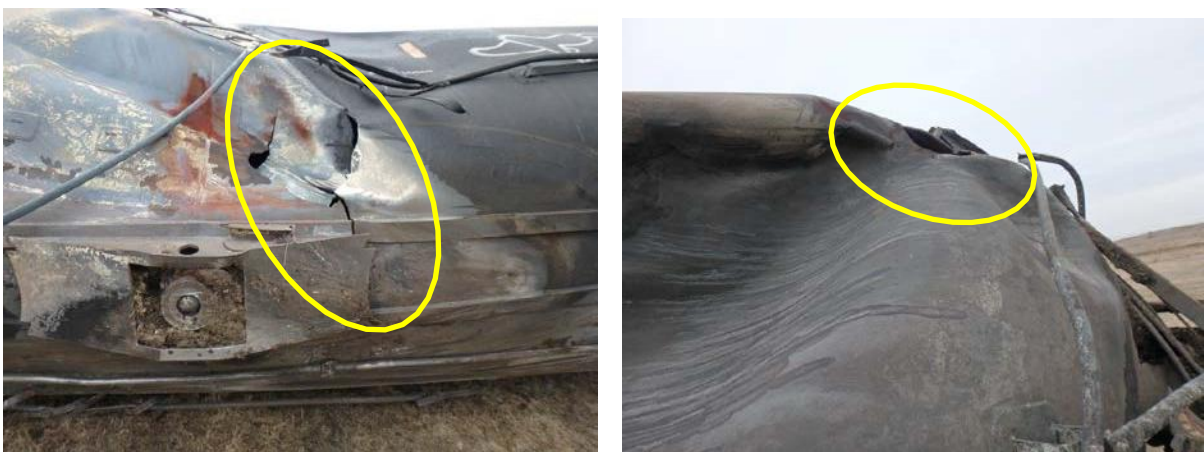
Line 67: CTCX 731383

- The car came to rest vertical with the A-end leading;
- The shell sustained a rectangular puncture on left side, with flap of steel pushed inward above the bottom outlet valve. The shell fracture ran about 24 inches along the bottom of car on the A-end side of the skid protection (Figure 21);
- The right half B-end head sustained a severe rounded dent with a 12-16-inch fracture on knuckle radius, about 3 o'clock;
- The bottom outlet valve was partly open and the operating handle was missing;
- A-end head from impact with TILX 165386 resulted in stencil transfer;
- The bottom third of A-end head was creased.

Figure 21 CTCX 731383 shell puncture (left circled) and B-end head fracture (right circled), staging area, March 12, 2017.

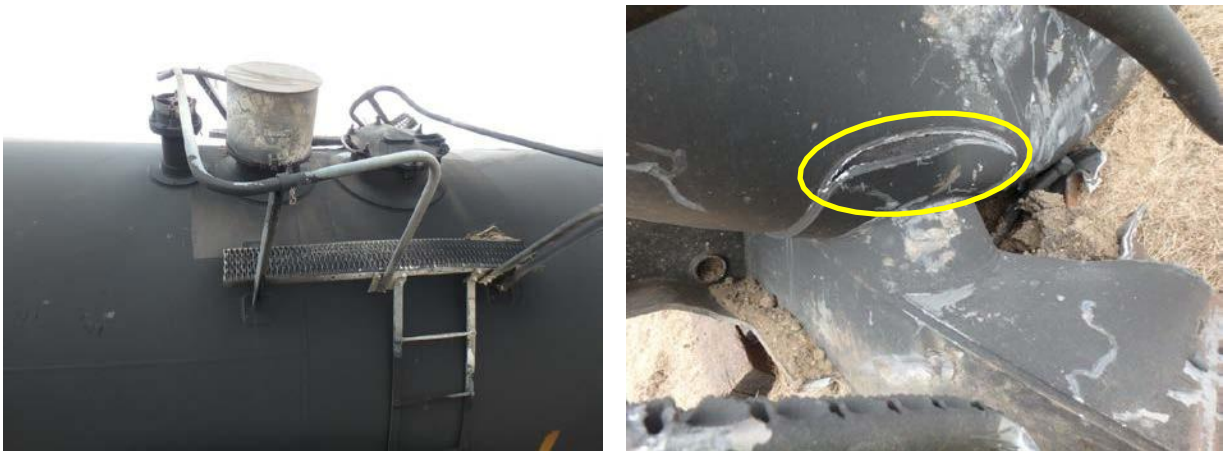
Line 66: TILX 195386

- The car came to rest on its right side, B-end down;
- No product was released from this car;
- The bottom outlet valve nozzle was undamaged. The operating handle was damaged but pinned in place;
- The lower half of the A-end head sustained a rounded dent;
- A-end head pad fillet weld separated across outboard end of the headpad adjacent to a deep dent in the head. No crack was observed in head parent metal;
- Stencil transferred from impact with CTCX 731383 to the left side of the A-end head;
- The top fittings housing cover was thermally damaged and the throat of pressure relief valve showed signs of heat exposure.

Figure 22: TILX 195386, top fittings (left) and A-end head pad separation (right circled), staging area, March 12, 2017.

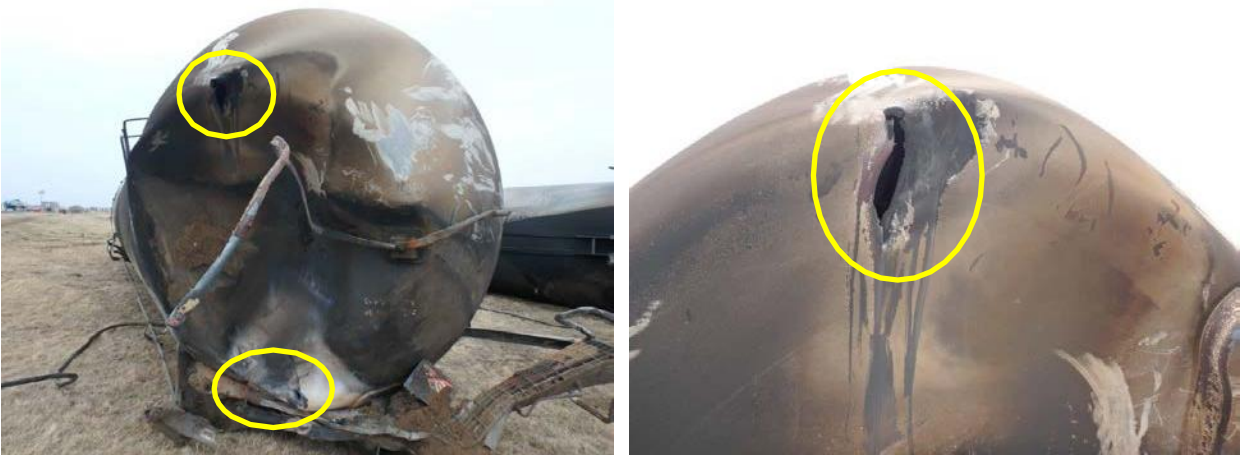
Line 65: CTCX 731997

- The AEI report indicates the A-end was leading as the car came to rest on its right side with the A-end plowed into soil;
- A gouge led to a 2-inch tear on the A-end head about 6 o'clock;
- The A-end head sustained an 8-inch tear about 10 o'clock.
- The A-end head sustained an 8-inch crack across the head-to-shell weld underneath deeply folded head material, about 7 o'clock;
- The right half of the A-end head sustained a 3-4 ft. deep dent;
- The B-R bolster was bent toward the A-end;
- The B-end head sustained a rounded dent in the lower center about 6 o'clock;
- The bottom outlet valve operating handle was closed and pinned in place. The nozzle adaptor was sheared off and the valve was closed.

Figure 23: CTCX 731997 A-end head breaching damage (left and right circled), staging area, March 12, 2017.

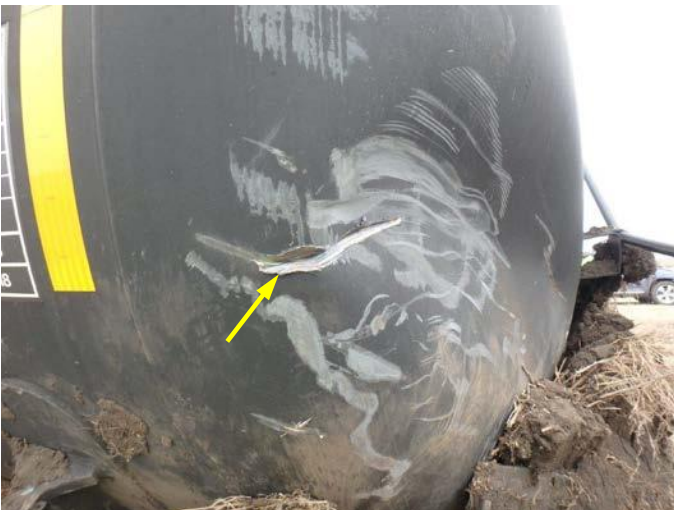
Line 64: TILX 197615

- The car came to rest upright with the A-end downhill and leading;
- No product released from this car;
- The A-end head sustained a deep 24-inch long gouge and rounded dent about 8 o'clock;
- The bottom outlet valve operating handle was broken away. The valve remained closed.

Figure 24: TILX 197615 gouge to A-end head (arrow), March 12, 2017.
