# **NATIONAL TRANSPORTATION SAFETY BOARD**

## **STRUCTURES STUDY** **11 imbedded photographs**

Location: Norfolk, VA  
Date: March 4, 2015  
Time: 0413 EST  
Aircraft: Mooney M20F, N66BB

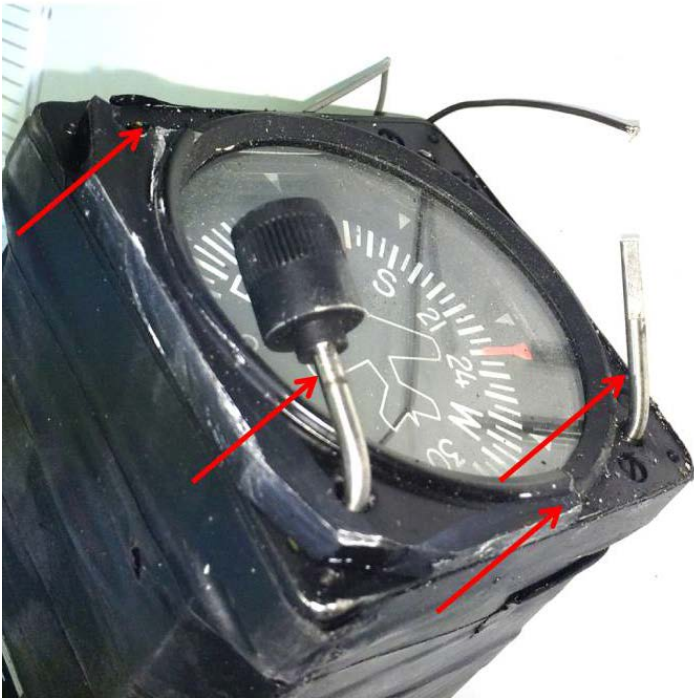
**External observations:** The instrument compass card was free to rotate, indicating that the caging mechanism was not engaged. The cage knob was bent upward. The bug setting knob was bent upward with the bug set at 232 degrees. The aftermarket bezel light fixture was broken, with half remaining attached to the instrument. Damage from a shallow dent and scrap partially obscured the data plate located on top of the instrument. The vacuum pressure switch attached to the back of the instrument was broken free.

Photo 1 – The arrows point to the damage to the knobs and aftermarket lighted bezel.

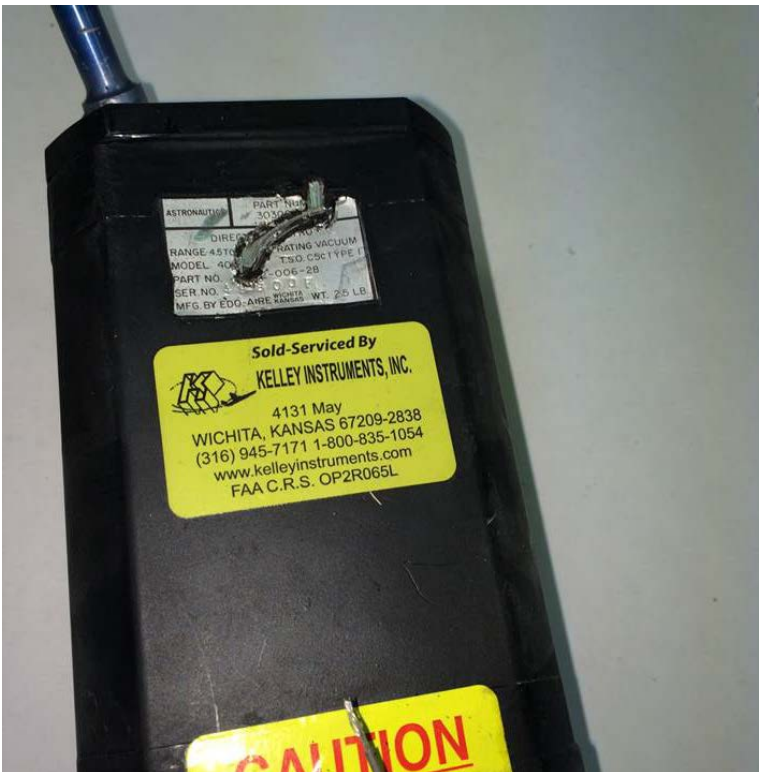
Kelly Instruments - Wichita, KS overhauled the instrument with a date stamp of June 14, 2014.

Photo 2 – Instrument data plate and repair sticker.

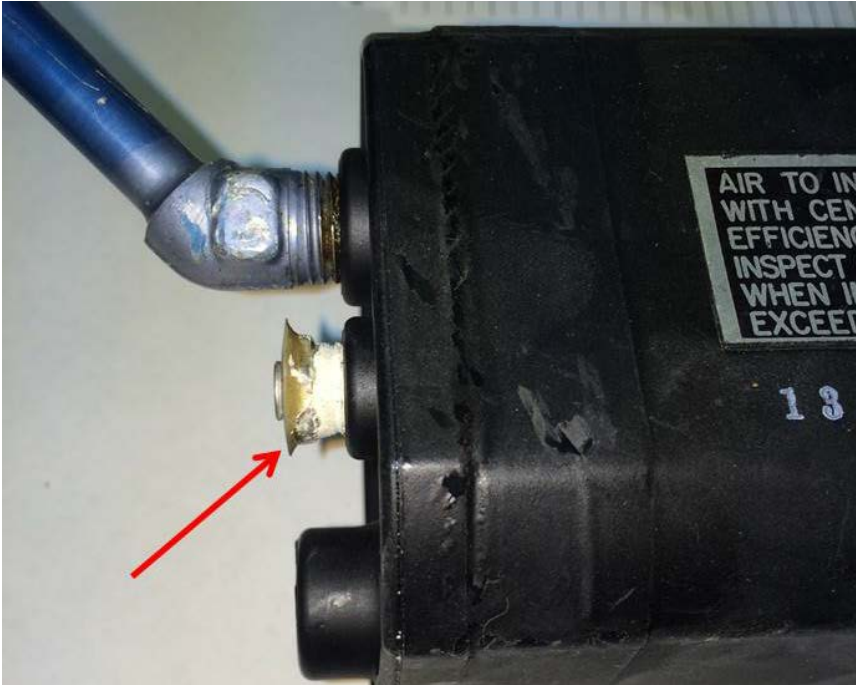
**Photo 3 - Broken vacuum switch**

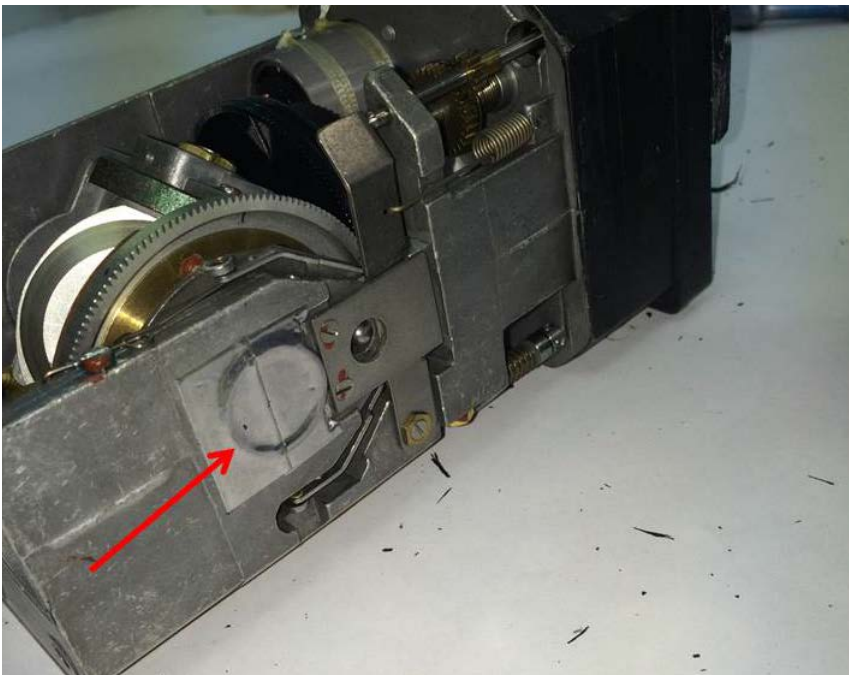
The upper portion of the instrument frame was deformed very slightly in a downward direction. The lower portion of the instrument frame was bent downward in the center, in the area of the lower pivot bearing. The lower pivot bearing would carry the vertical loads imposed by the gyro. The pivot bearing left an imprint on the inner surface of the bottom side of the instrument case.

**Photo 4 - Position of lower pivot bearing at bottom of frame.**

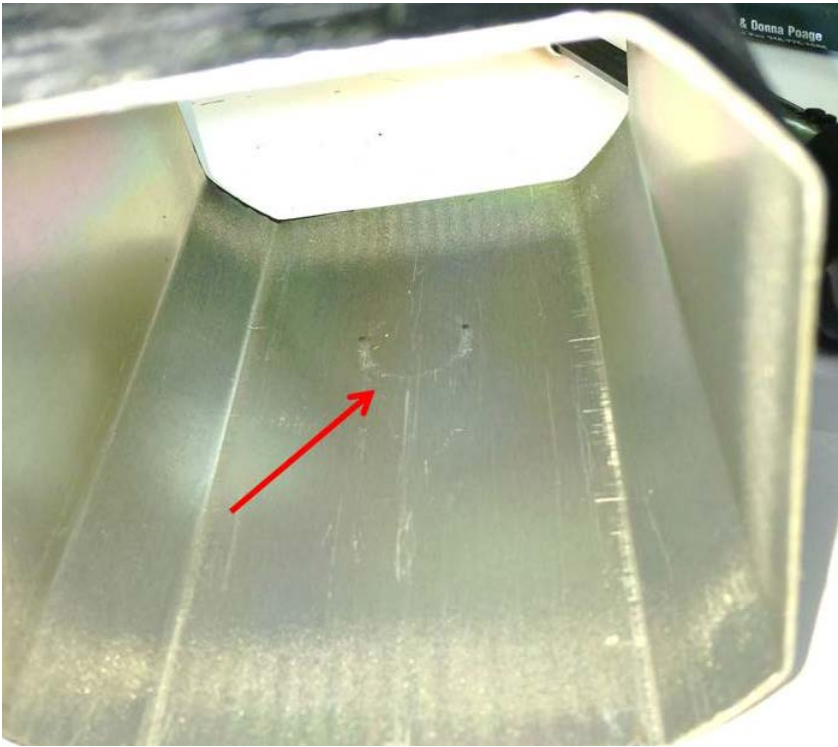
**Photo 5 - Imprint left by lower pivot bearing on bottom of the case.**

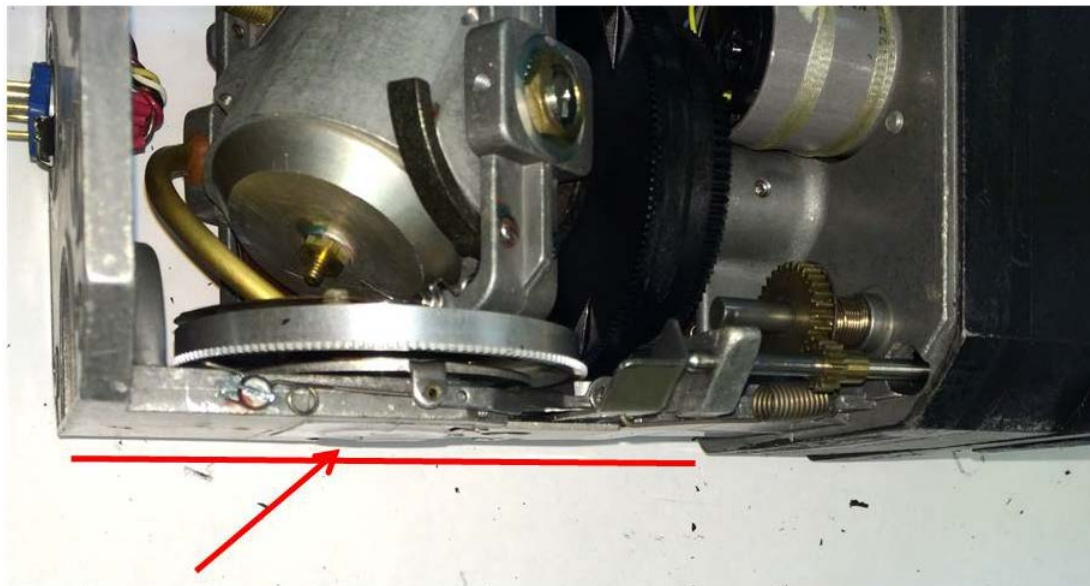
**Photo 6 - Downward bending of bottom case structure.**

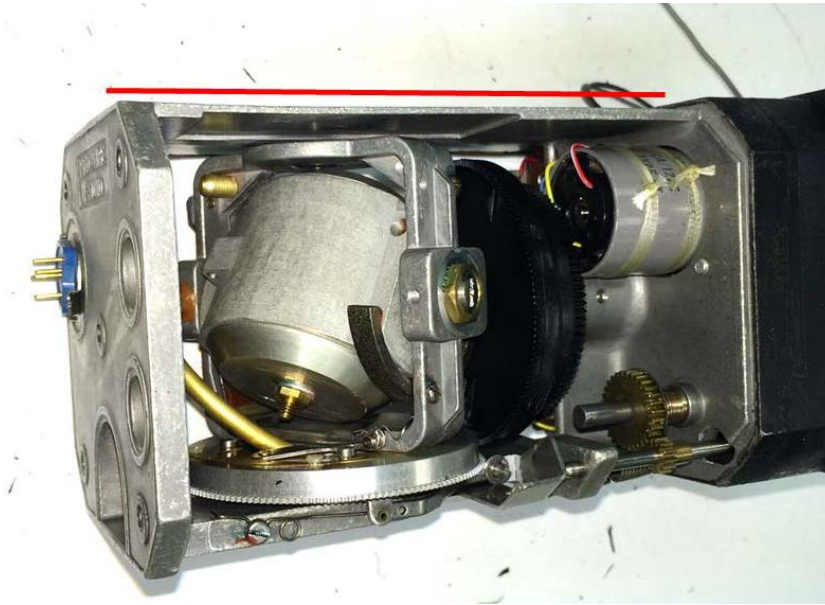
**Photo 7 - Very slight downward bending of upper case structure.**

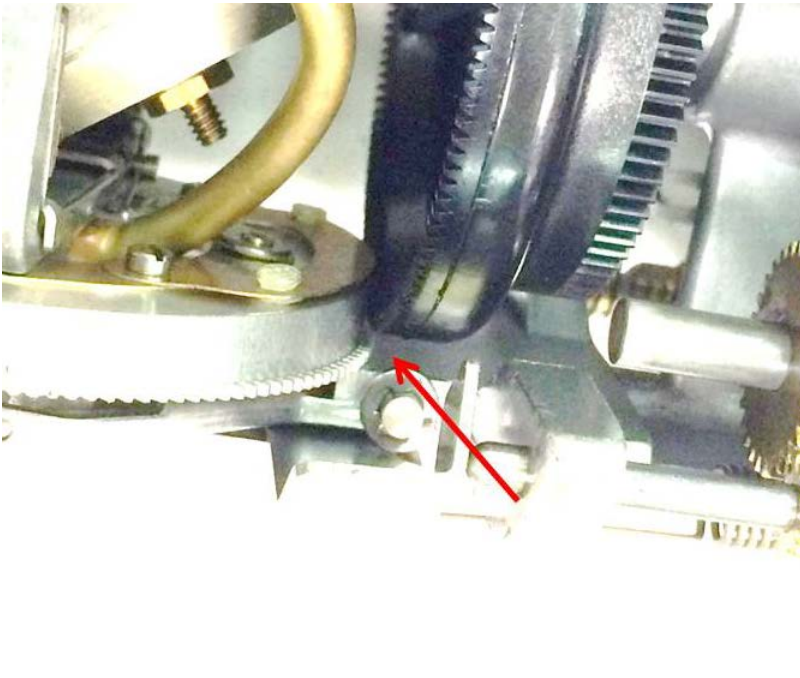
**Internal examination:** The instrument case was removed. The spur gear<sup>2</sup> was not engaged with the dial gear<sup>3</sup>. Each gear rotated freely, independent of the other. The spur gear was displaced downward to disengage from the dial gear.

**Photo 8 - Separation of spur gear (horizontal gear) from dial gear (vertical gear).**

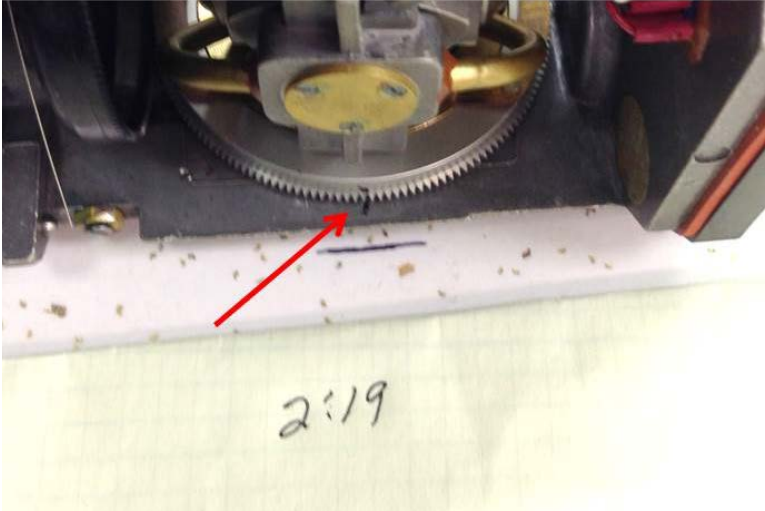
**Second test:** A second test was accomplished by applying 5 In. Hg. pressure to the “AIR INLET” port of the instrument<sup>4</sup>. The gyro spin rate appeared normal and motion about the vertical axis was stable. Index marks were placed on a spur gear tooth and nearby frame. There was no observable movement between the index marks for 11 minutes<sup>5</sup>. The case was rotated slightly clockwise. Observation and relative change of the index marks showed that the gyro remained stationary as the case was rotated about the vertical axis. The case was rotated to the original position and the index marks were again in alignment.

**Photo 9 - Initial alignment of spur gear and case index marks.**

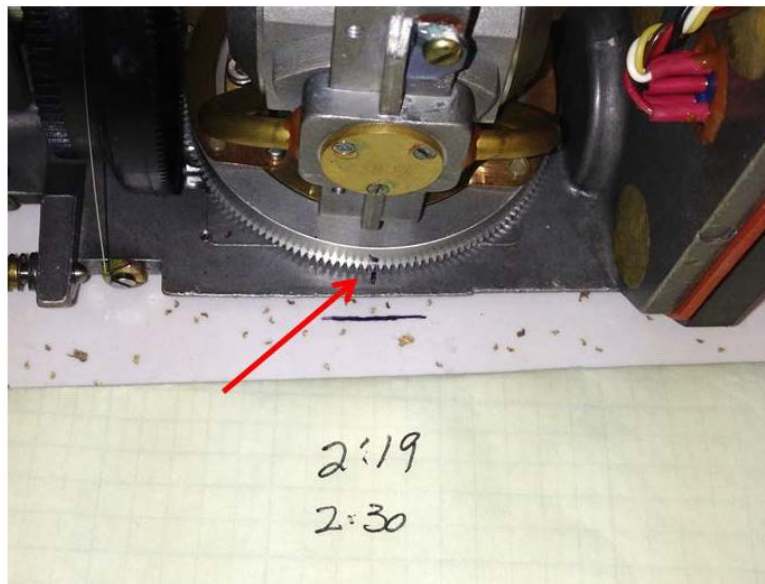
**Photo 10 - Final alignment of spur gear and case index marks after the 11-minute test.**

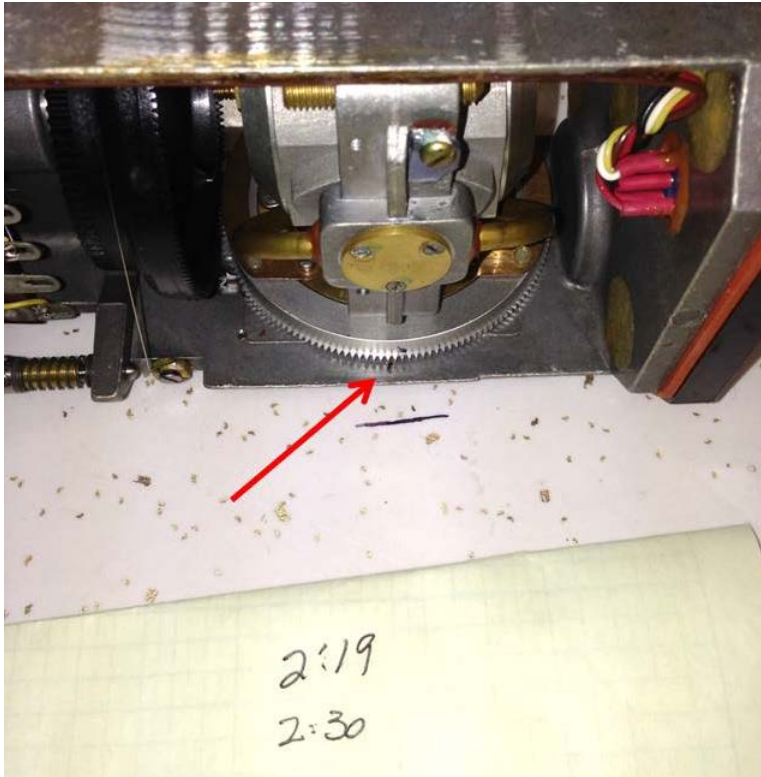
**Photo 11 - Alignment of index marks after case was rotated slightly clockwise about the vertical axis.**
