NATIONAL TRANSPORTATION SAFETY BOARD
Investigative Hearing

Managing Safety on Passenger Railroads: Amtrak Overspeed Derailment – DuPont, Washington; and CSX and Amtrak Train Collision – Cayce, South Carolina.

GROUP	G
EXHIBIT	
10

Safety Alert

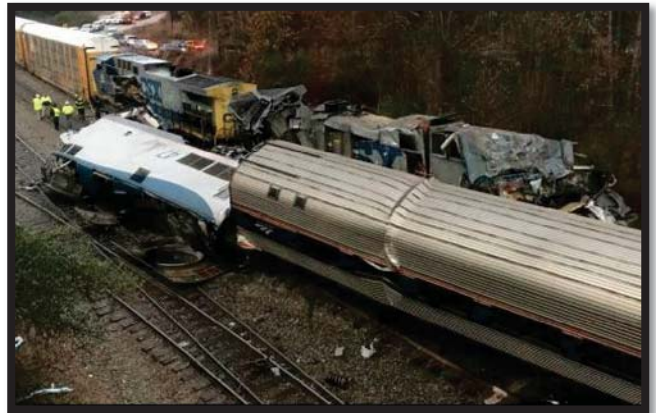
On February 4, 2018, both the engineer and conductor of National Railroad Passenger Corporation (Amtrak) Train P09103 were killed and 115 passengers injured, when their train collided head-on with a CSX Transportation, Inc. freight train (Train F77703). The collision occurred at approximately 2:27 a.m. in Cayce, South Carolina when the Amtrak train, traveling south from New York City, New York, to Miami, Florida, and operating on a track warrant, was diverted from the main track through a misaligned switch. The misaligned switch sent the Amtrak train into the siding where the CSX train was parked, resulting in a head-on collision with an impact speed of 50 miles per hour (mph). The lead locomotive and six of the seven cars in the Amtrak train derailed. At the time of the accident, eight Amtrak crew members and 139 passengers were on board the train.

CSX has implemented changes to the following Operating Rules:

Operating Rule 401.14: Employees must remain at the hand-operated main track switch until verbally confirming with each crewmember the switch was restored and locked in normal position. SPAF completed in ink.

Operating Rule 505.11: All crewmembers must agree it is safe to release an authority or report by a specific location. All crewmembers must be present and hear the authority being released.

Operating Rule 505.12: If any crewmember has doubt or uncertainty about the position of a hand-operated main track switch, the authority must not be released and the crew must immediately contact the train dispatcher.
