HIGHWAY GROUP CHAIRMAN'S FACTUAL REPORT

**RAILROAD INTERSECTION AT GRADE COLLISION INVOLVING
UNION PACIFIC RAILROAD TRAIN (UPRR) 2ASMAR-2 AND
BURLINGTON NORTHERN SANTA FE TRAIN (BNSF) UKCKHKMO-
05T FOLLOWED BY DERAILMENT AND IMPACT INTO AND PARTIAL
COLLAPSE OF THE MISSOURI HIGHWAY BRIDGE A4376 SPANNING
MISSOURI STATE ROUTE M
NEAR CHAFFEE, MISSOURI
MAY 25, 2013 ABOUT 2:30 A.M.**

DCA-13-MR-004

NATIONAL TRANSPORTATION SAFETY BOARD

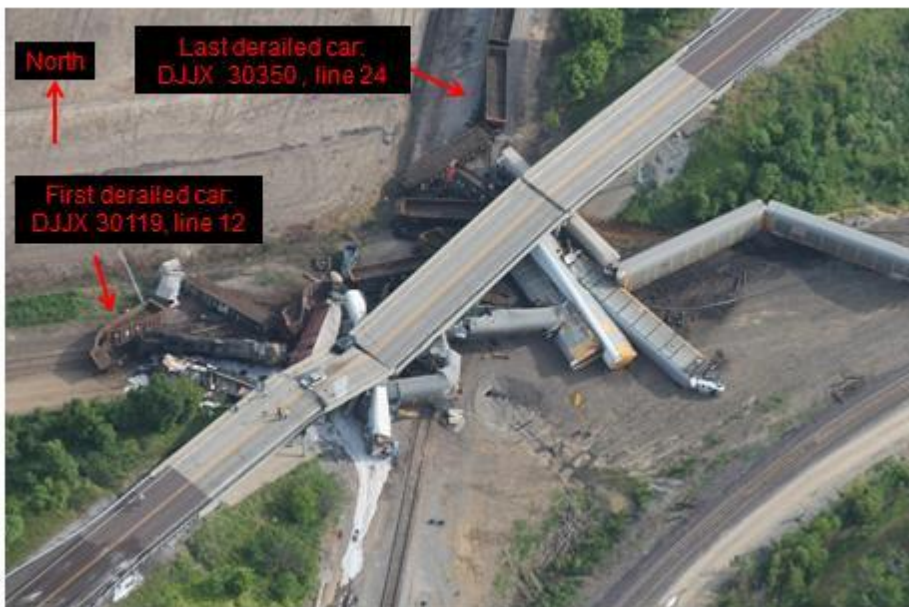
On May 25, 2013 at approximately 2:30 a.m., central daylight time, near Chaffee, Missouri, Union Pacific (UP) southbound freight train, 2ASMAR-2 collided with BNSF southbound freight train U-KCKHKMO-O5T, where UP and BNSF tracks cross at Rockview interlocking. The BNSF train was occupying the interlocking when the UP train struck the 12th

car behind the locomotives of the BNSF train. As a result of the collision, 13 cars of the BNSF train were derailed. Two locomotives and 11 cars on the UP train were derailed. Spilled diesel fuel from the derailed UP locomotives caught fire. Missouri State Highway M bridge is above the Rockview interlocking and collision forces resulted in the collapse of portions of the highway bridge. The engineer and conductor on the UP train were the only crew members that were injured and they were transported to a local hospital. Subsequent to the bridge collapse, two motor vehicles struck damaged highway elements and were involved in fires. Five occupants of the motor vehicles were transported to a local hospital. It was clear and 48° F at the time of the accident. (See Photograph 1 below)

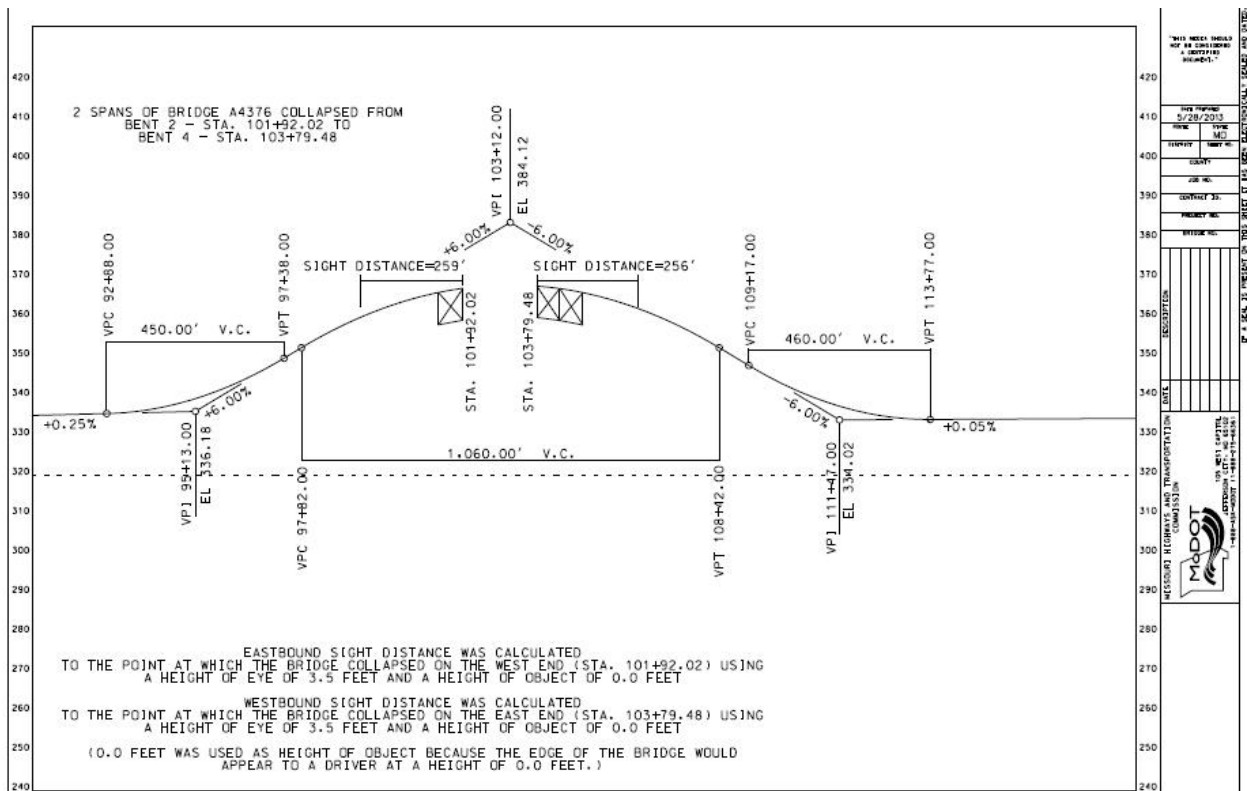
Figure 1

In the accident area, the roadway had two 12-foot-wide travel lanes, one in each direction. On the approach to the bridge the pavement had a double yellow pavement stripe designating it as a no passing zone. The approach roadway had 10-foot wide shoulders that narrowed to three-feet-wide on the bridge. On the westbound approach the roadway was tangent or straight. On the eastbound approach the bridge was preceded by a 955-foot-long, 5-degree or 1146-foot radius curve that had a superelevation of .08 ft/foot. Both east and westbound approaches had vertical sag curves of 460 feet long and 450 feet long respectively. Then the vertical grade changed to 6 percent to form a 1060-foot-long crest vertical curve in the center of the bridge that had a design stopping sight distance of 350 feet in 1988, the design year. The calculation procedures changed for stopping sight distances in more recent versions of the AASHTO Policy on Geometric Design of Highways and Streets. The current stopping sight distance for a curve of these

dimensions is 440 feet.¹ The approach guard rails were 27-inch-high blocked-out W-beam guard rails with turned down end-treatments.² The bridge had 32-inch high, NCHRP 350 test-level 4 concrete railings. See diagram below for sight distance diagram.

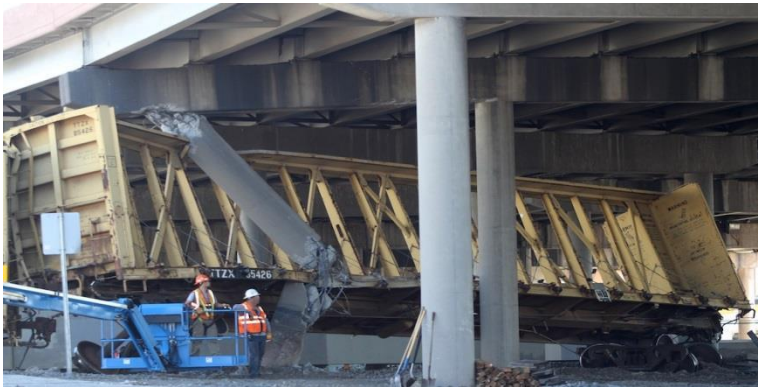
Approximately 4% of U.S. Highway bridges or 24, 103 bridges span railroad tracks. BNSF provided the NTSB with information on their system indicating that they had seven other diamond interlocking at grade intersections underneath or in close proximity to highway bridges. On the UPRR system they had 27 at grade crossings within .125 miles of a highway bridge. The FRA provided a computerized list of Railroad incidents with damage from February through May of 2013. Only one other incident with a highway bridge was found and it resulted in only minor damage. For more information see (Highway Attachment 3 FRA Incident Reports). Additionally, one other railroad accident occurred in October 2013, near El Paso, Texas where a bridge pier was substantially damaged, resulting in the closure of Interstate Highway 10 until repairs could be performed. See photo below.
