National Transportation Safety Board

Highway Accident Brief

Passenger Vehicle/School Bus Collision and Roadway Departure

Accident Number:	HWY15FH010
Accident Type:	Passenger vehicle/school bus collision and roadway departure
Location:	Eastbound Interstate 610 (I-610) overpass above Telephone Road, Houston, Harris County, Texas
Date and Time:	September 15, 2015; about 7:03 a.m.
Vehicles:	47-passenger 2009 International school bus 2004 Buick LeSabre passenger vehicle
Fatalities:	2
Injuries:	3

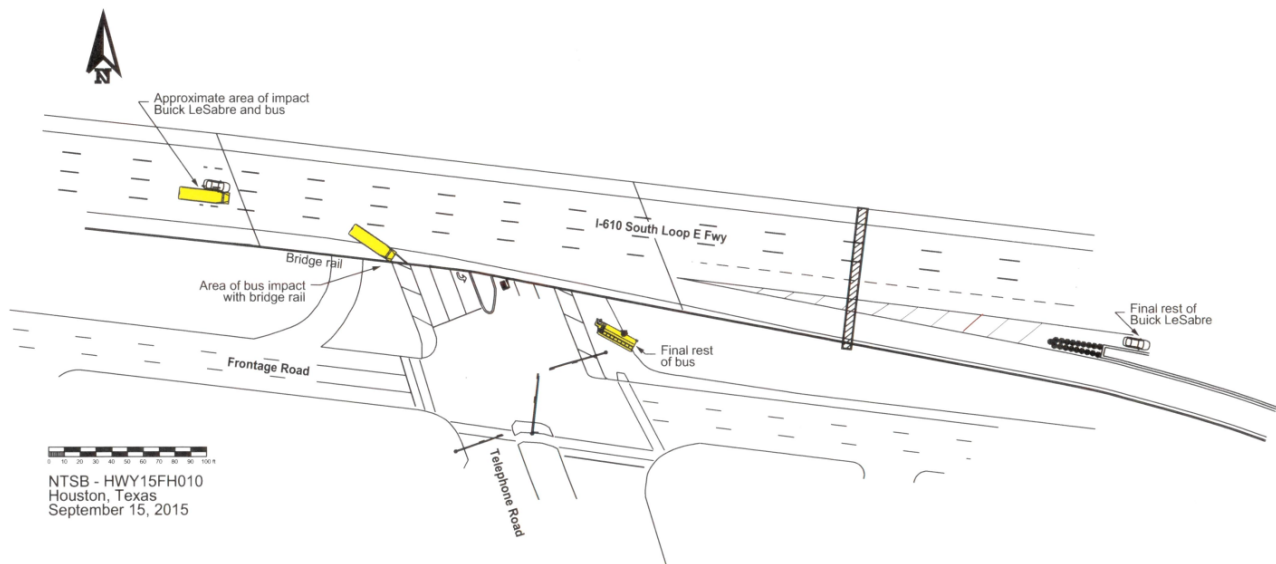
Figure 2 is a crash scene diagram showing the following features of this crash: approximate area of impact between the Buick LeSabre and the HISD school bus; approximate point of the school bus’s impact with the bridge rail; and final rest positions of the school bus and the Buick.

Figure 2. Diagram showing the crash events that involved the school bus (in yellow) and Buick LeSabre.

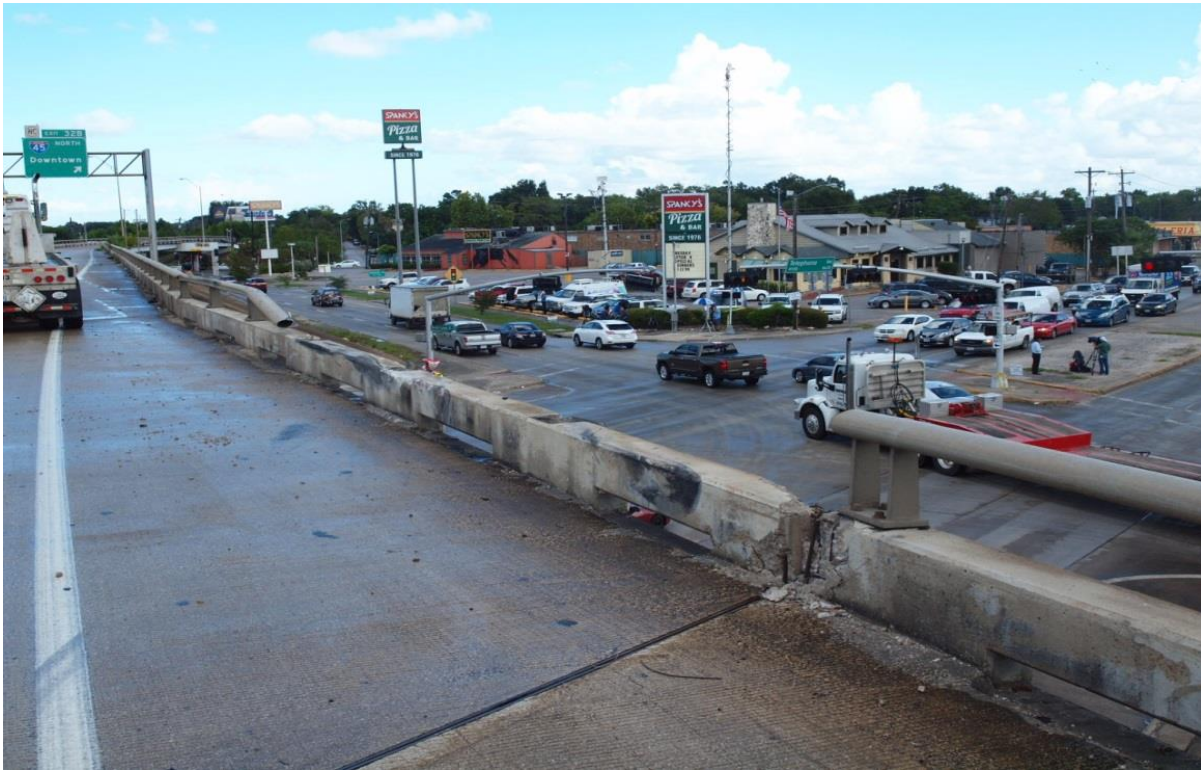
The total weight of the HISD school bus in the crash was approximately 16,300 pounds.⁹ In addition to the bus’s weight being almost 12,000 pounds above the TL-3 test protocol, the angle of impact with the barrier was slightly above the thresholds for the TL-3 test criteria. Given these factors, the Type C4 (modified) bridge railing, in its designed condition, would not have been expected to redirect a collision by a school bus. (Figure 3 provides a view of the bridge rail after being struck by the HISD school bus.)

Figure 3. Bridge rail after being struck by the HISD school bus (view is to the southeast).

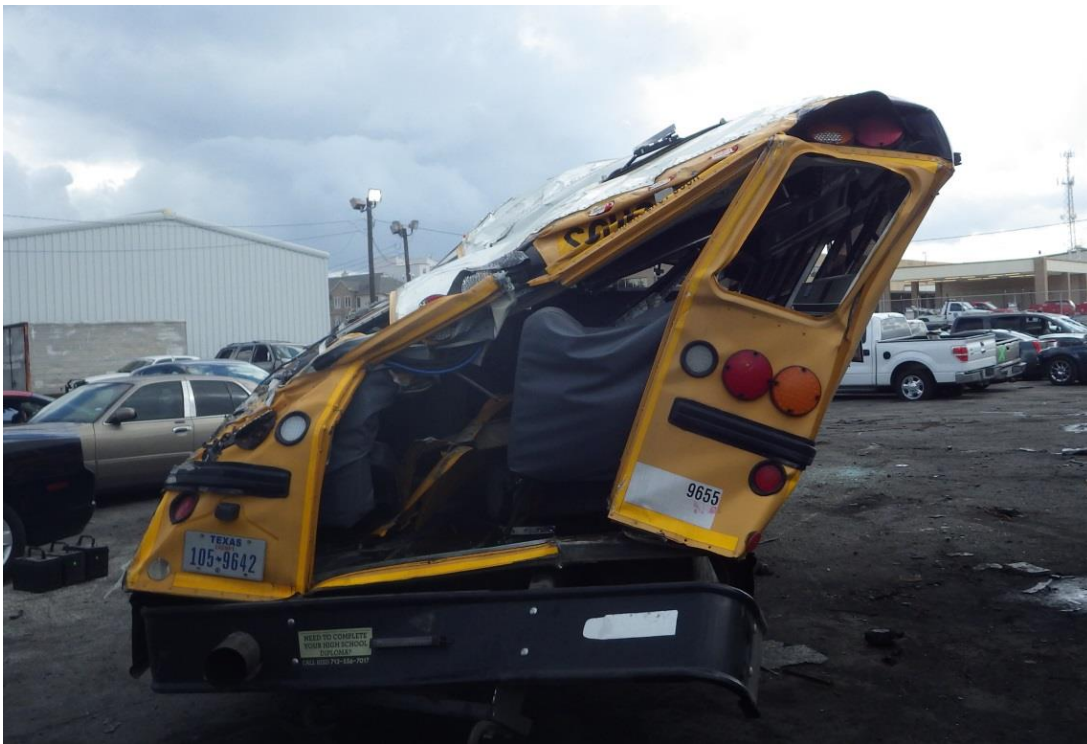
The right side of the school bus, from the boarding door rearward, had little damage and all of the windows were intact. The entire body of the bus was shifted to the right due to the impact damage on the left side. The left side of the bus had extensive contact damage, with crush damage concentrated at the left rear corner near the roofline. The roof was crushed to the top of the left side seats, with several seatbacks projecting out of the windows. Crush at the left rear corner measured approximately 48 inches, as well as an additional 24 inches due to the shift of the bus body to the right from impact. (Figure 5 shows the rear of the damaged school bus.) The crush decreased from the rear of the bus to the front, with little crush at the left front roofline. The rightward shift of the bus body at this location measured approximately 12 inches. There was intrusion into the interior of the bus at the firewall and floorboard near the driver's seat.

Figure 5. View of the rear of the HISD bus showing contact damage to the top left corner.

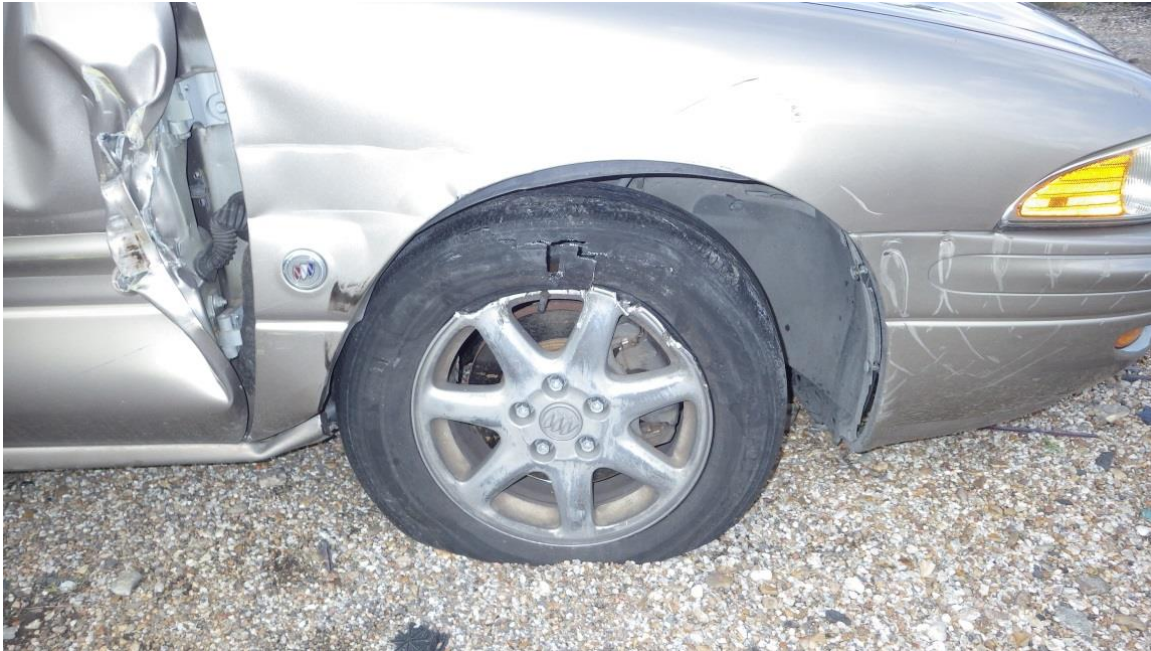
Buick LeSabre. The damage to the Buick LeSabre was limited to the right side of the vehicle. There were pattern scratches in the paint on the right front fender near the wheel well. Portions of the outside flange of the right front wheel rim were broken away. There was a tear measuring approximately 3 x 3 inches in the right front sidewall near the valve stem, and the tire was deflated. The pattern scratches and the tear were caused by contact with the wheel studs on the rotating left front wheel of the bus. Figure 6 shows the damage to the Buick LeSabre caused

by the wheel studs. A portion of the steering system's right side control arm was fractured through at a fitting near the frame.

Figure 6. Pattern scratches and damage to the front right tire on the Buick LeSabre from contact with the HISD bus.

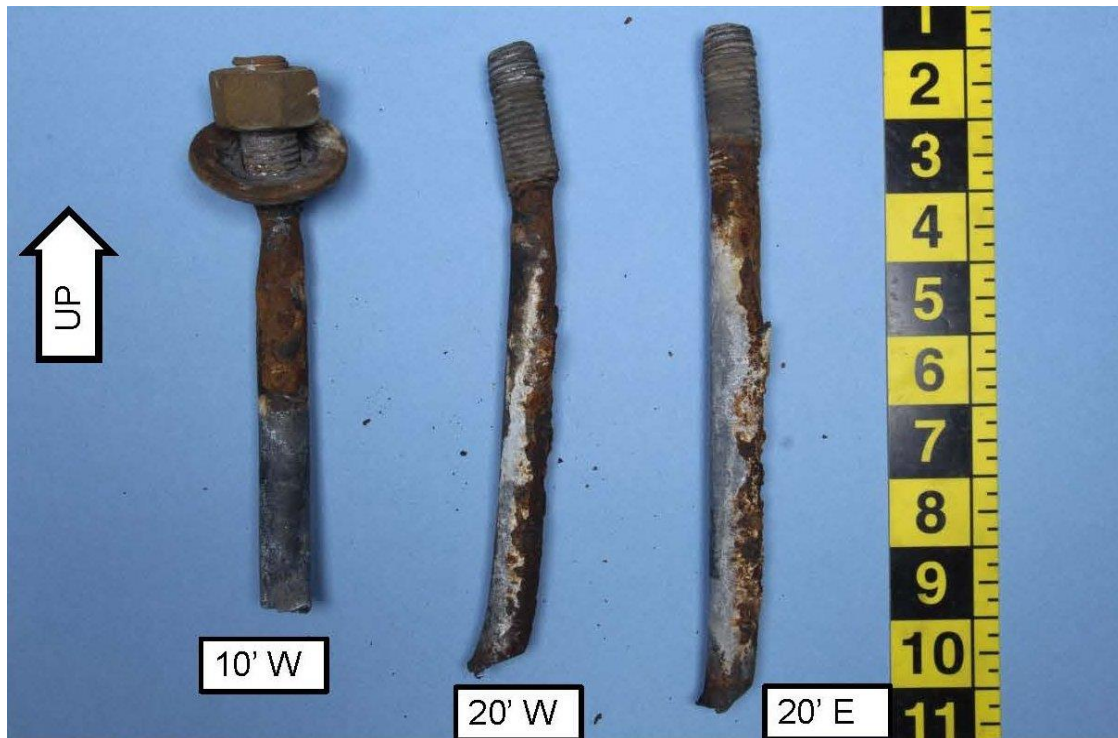
Three U-bolt anchors were removed from the concrete parapet in the approximate location where the HISD school bus surmounted the bridge rail. Figure 7 shows the U-bolt pieces taken from the side facing the outer edge of the traffic rail. The pieces were labeled 10' W, 20' W, and 20' E. The piece labeled 10' W came from the west U-bolt (the first post east of the expansion joint in span 2). The pieces labeled 20' W and 20' E came from the west and east U-bolts, respectively, which anchored the second rail post east of the same expansion joint.

Figure 7. Pieces of U-bolt removed from the concrete parapet near where the HISD school bus surmounted the bridge rail.

According to the design plans provided by TxDOT, the U-bolts had a nominal diameter of 0.75 inch. The pieces removed postcrash showed substantial corrosion, including reduced diameter, particularly in the area near the lower end of the threads. Corrosion on the surface of piece 10' W was observed around the circumference up to 4.51 inches from the upper end of the piece. On pieces 20' W and 20' E, corrosion was observed along the entire length of the pieces on the side to the outside of the bend, up to 8.30 inches from the upper end of piece 20' W and 9.04 inches from the upper end of piece 20' E. At the inside of the bend, corrosion was present up to 4.35 inches from the upper end of piece 20' W and up to 2.79 inches from the upper end of piece 20' E.

Examination showed that each of the U-bolt pieces had a zinc coating that was compromised, resulting in corrosion and loss of section near the lower ends of the threads. The corrosion and loss of section would have resulted in substantial reduction in the metal strength, particularly in pieces 10' W and 20' W. In areas where the thickness of the zinc coating was measured, it varied from 0.005 to 0.048 inch on piece 10' W, from 0 to 0.042 inch on piece 20' W, and from 0 to 0.029 inch on piece 20' E.
