Collapse of the Interstate 5 Skagit River Bridge  
Following a Strike by an Oversize Combination Vehicle  
Mount Vernon, Washington  
May 23, 2013

**Accident Report**

NTSB/HAR-14/01  
PB2014-106399

NTSB/HAR-14/01  
PB2014-106399  
Notation 8509A  
Adopted July 15, 2014

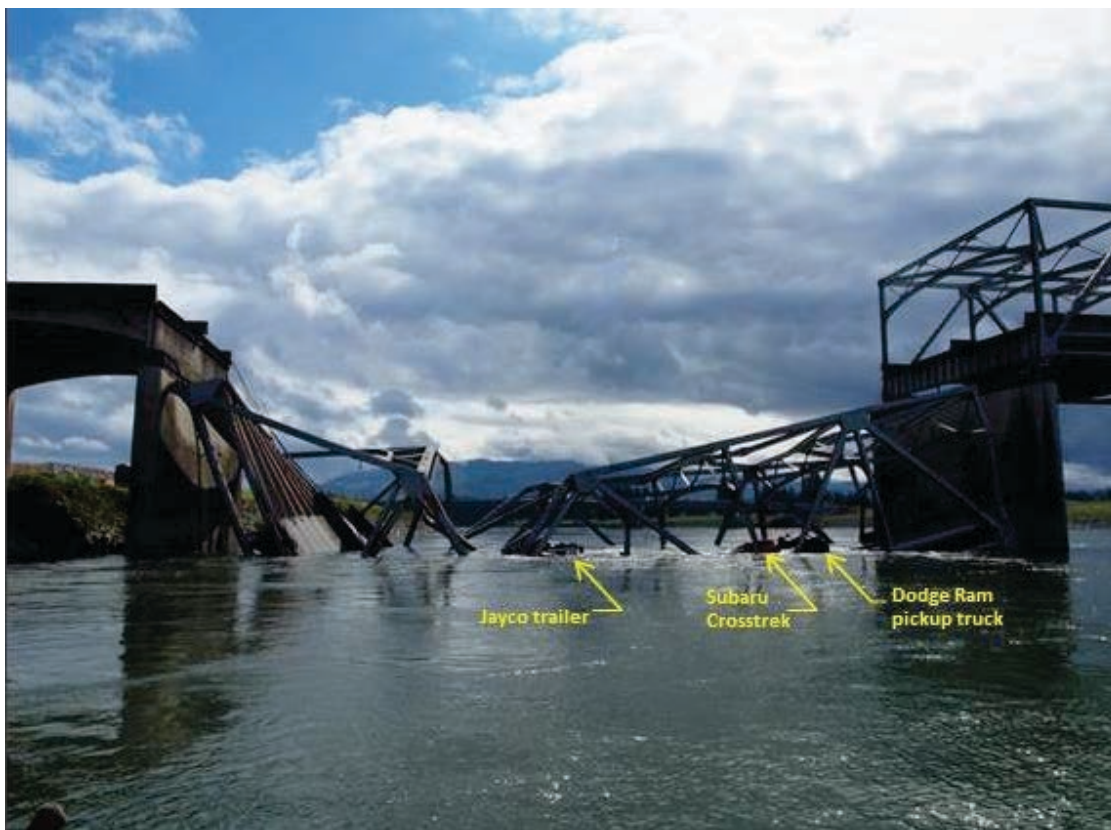
Two other passenger vehicles, a southbound 2010 Dodge Ram pickup truck towing a Jayco travel-trailer and a northbound 2013 Subaru XV Crosstrek, fell with the collapsing bridge span into the Skagit River. A driver and a passenger occupied the Dodge pickup, and a driver occupied the Subaru. First responders rescued these three people from their vehicles and transported them to local hospitals for treatment of minor injuries. Their vehicles were later retrieved from the river when the collapsed span was recovered. (See figure 6 below.)

**Figure 6.** Bridge span 8 in the Skagit River.

<sup>7</sup> The collapsed section, span 8, was 160 feet long. Bridge geometry is described in section 1.6 of this report.

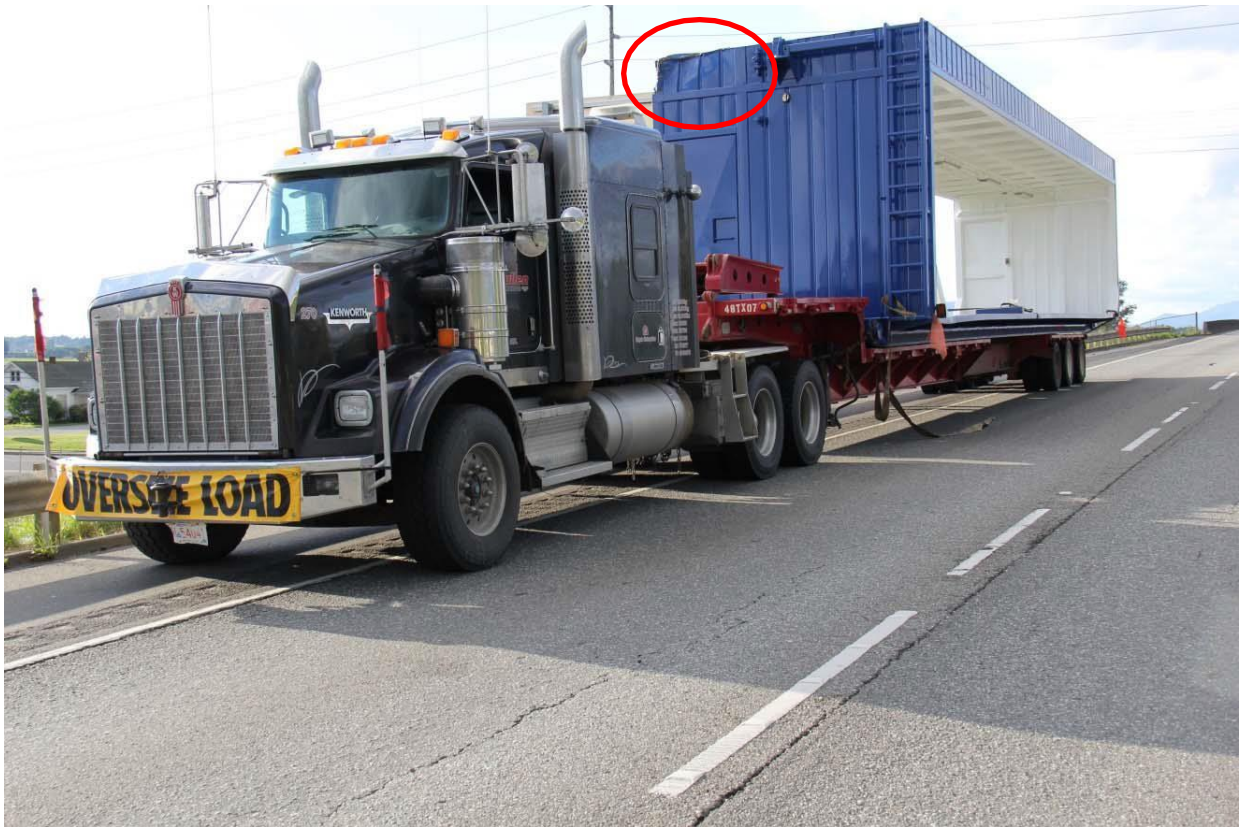
**Oversize combination vehicle.** The 2010 Kenworth truck-tractor showed no signs of damage. The oversize load—the casing shed section—sustained deformation damage to its upper right front corner. Scratches and dents were present along the entire length of the right top edge of the load. Scratches were also found on the upper left front side of the casing shed. The overall frame of the load was distorted rearward, most noticeably at its top right corner, where slight buckling had occurred. The entire load had shifted to the left on the semitrailer. (Figures 7 and 8 show the damage to the upper right front corner of the load. Note: Figure 7 is a facing view of the vehicle, so the right corner of the load is on the left in the photo. The same is true for the photo in figure 8.)

**Figure 7.** The oversize load, with the area of damage circled.

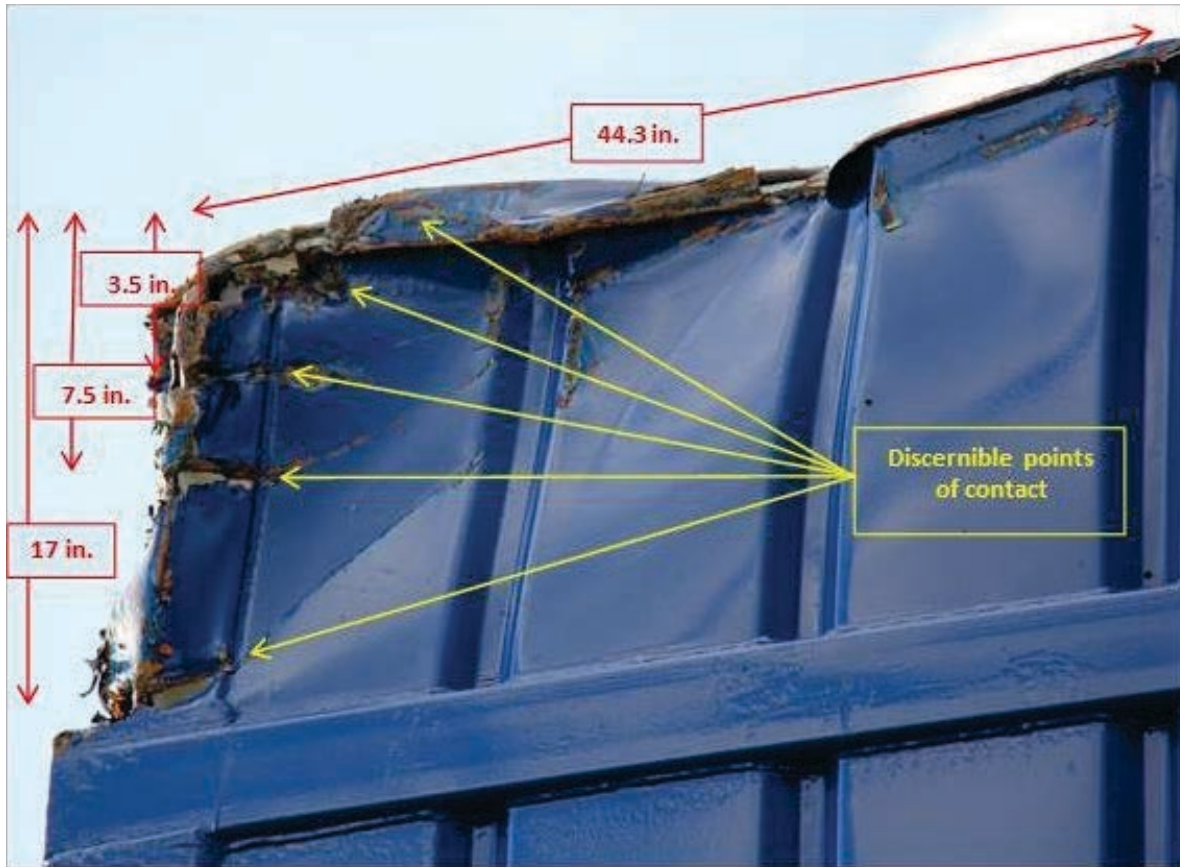
**Figure 8.** The upper right corner of the oversize load, with damage dimensions.

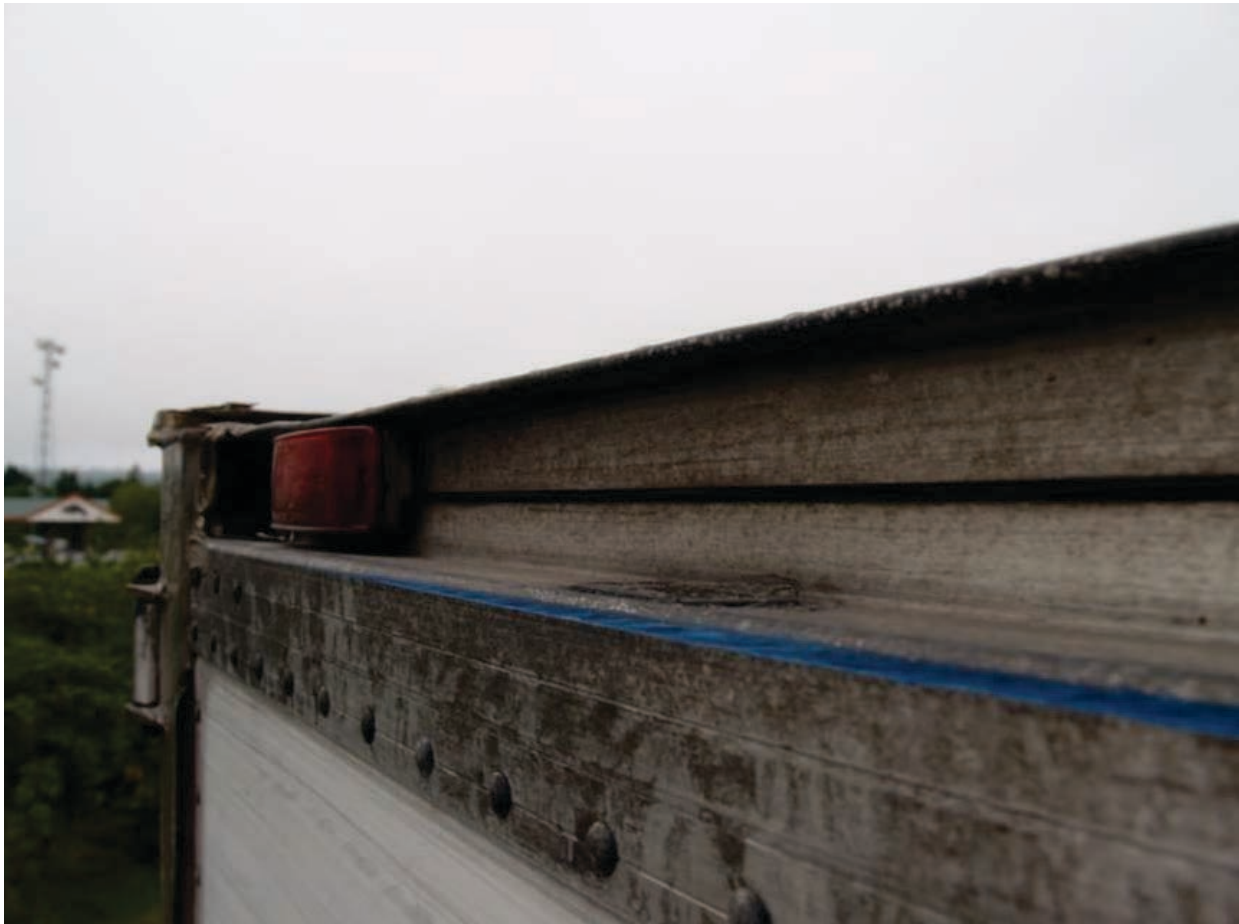
**2000 Kenworth truck.** The 2000 Kenworth truck-tractor with a 1996 Utility refrigerated semitrailer was in the left lane passing the oversize combination vehicle at the time of the bridge strike. This vehicle left the scene of the bridge span collapse but was later identified from video evidence. When investigators located the 2000 Kenworth truck, they found evidence of contact with the oversize vehicle's casing shed section on the upper right side of the refrigerated

semitrailer. (See figure 9.) Although his vehicle was on the bridge as it was collapsing and was struck by the oversized load, the driver of the 2000 Kenworth truck told investigators he had not realized that he had been involved in the event and had continued driving.

**Figure 9.** Blue transfer paint from the oversized load found postcrash on the upper right side of the refrigerated semitrailer of the 2000 Kenworth truck.

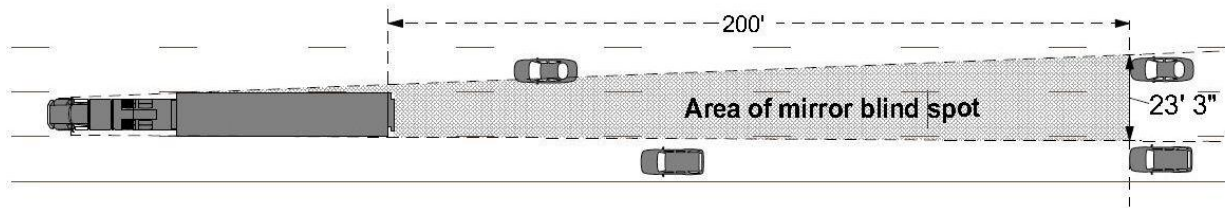
Investigators used 3D scans of the accident truck-tractor when it was coupled to a very similar casing shed and semitrailer to analyze the mirrors on the vehicle. The left and right side flat (plane) mirrors located inboard of the casing shed each had a substantial blind spot in the driver's rearward field of view.<sup>16</sup> This rearward blind spot, with a span of more than 23 feet at a distance of 200 feet behind the vehicle, would have made lane changes hazardous without a trailing pilot/escort vehicle. (See figure 10.)

<sup>16</sup> The blind spots on the right and left extended laterally outward at angles of about 3° and 2°, respectively. Extension of the obstructed sight line revealed that for a 12-foot-wide lane, the adjacent right and left lanes could be completely obscured at distances of about 248 feet and 260 feet, respectively.

**Figure 10.** Diagram showing the blind spot in the rearward field of view through the flat mirrors on the crash tractor.

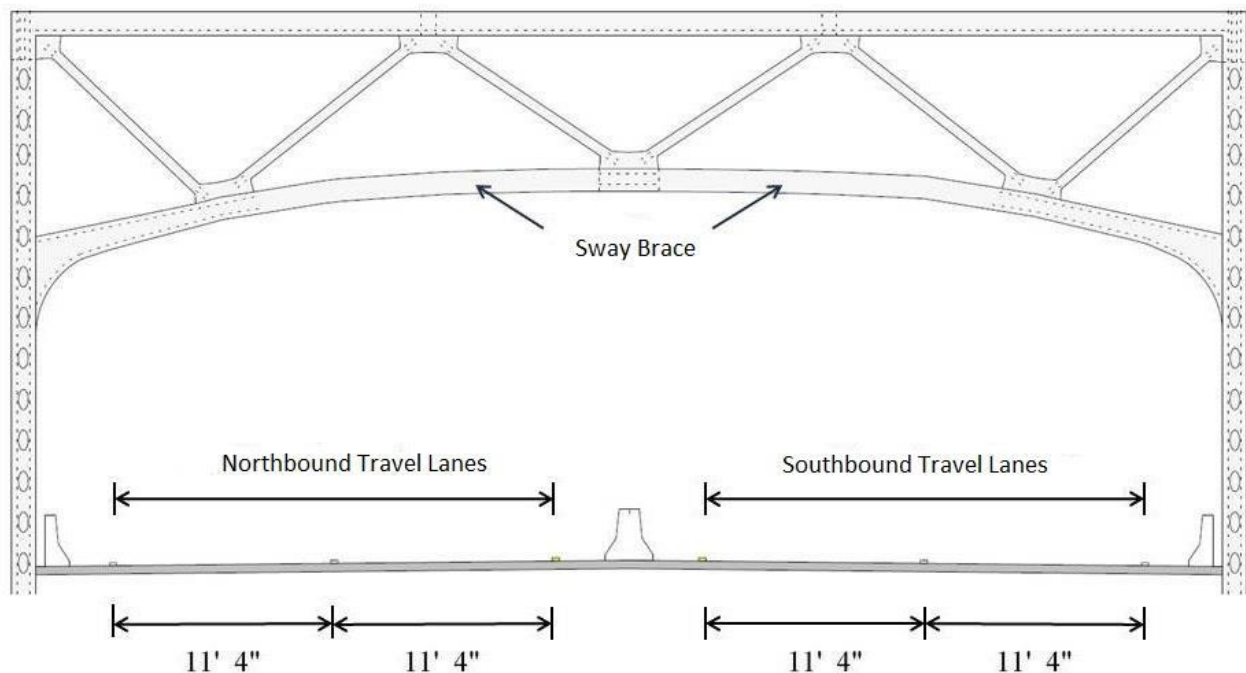
As the roadway traversed the Skagit River Bridge structure, the travel lanes narrowed from 12 feet to 11 feet 4 inches.<sup>34</sup> Adjacent to the right lanes were 26-inch-wide paved right shoulders, extending from the edge lane markings to the barriers on the outsides of the bridge deck.<sup>35</sup> Adjacent to the left travel lanes were 30-inch-wide median shoulders. There were 32-inch-tall concrete traffic barriers at the outside edges of the bridge deck and in the center median. (See figure 13.)

**Figure 13.** Cross section diagram of the Skagit River Bridge, showing the elliptical shape of the sway braces of the through-truss structure.

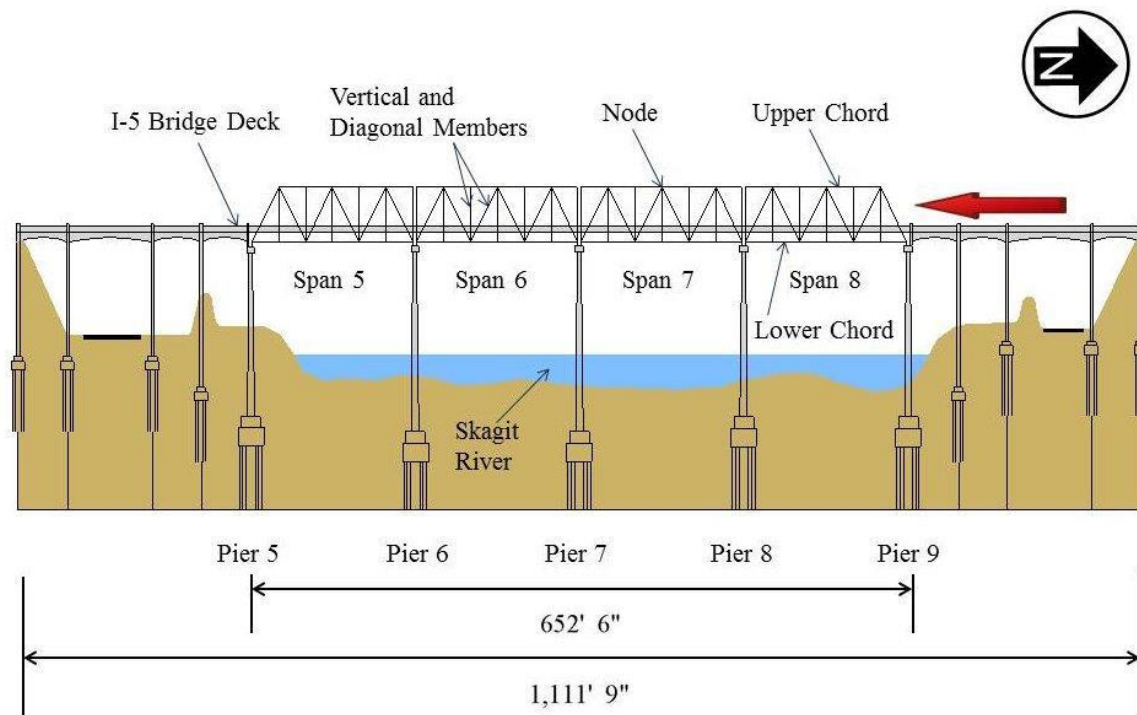
The east and west trusses were connected by riveted plate floor beams at the lower chords (below the roadway) and by sway braces at and below the upper chords (above the roadway). The sway braces were themselves truss structures made up of riveted structural shapes. The lower chords of the sway braces were elliptically curved to form archways across the traffic lanes. The load on the oversize combination vehicle struck the north portal, all of the sway braces in span 8, and five of the sway braces in span 7.<sup>41</sup>

**Figure 14.** Components and layout of the Skagit River Bridge. (The red arrow shows the southbound direction of travel of the oversize combination vehicle.)

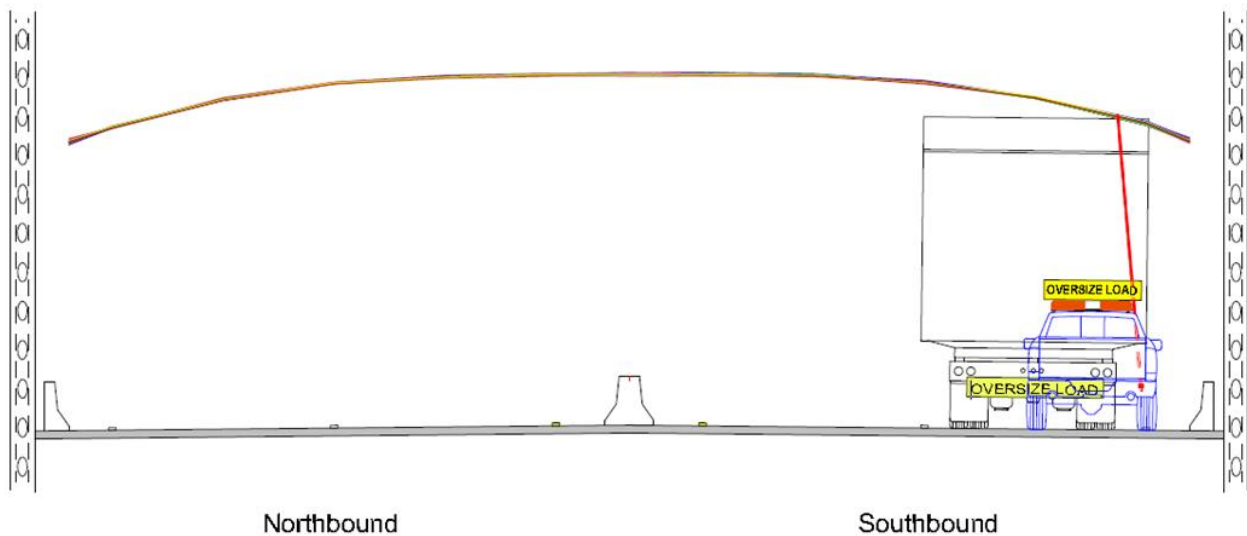
Based on the measured geometries of the bridge and the height pole, the right tire of the pilot/escort vehicle would have to have traveled atop the right lane edgeline for the pole to have made contact with the sway brace. (See figure 19.)

**Figure 19.** Image of the approximate position of the pilot/escort vehicle in the roadway necessary to ensure contact with the low-clearance sway braces.
