HIGHWAY CONSTRUCTION FACTORS FACTUAL REPORT
HWY-07-MH-024
Minneapolis, MN

HIGHWAY FACTORS DRAFT FACTUAL INVESTIGATION REPORT

Type of Accident: Bridge Collapse
Date and Time: August 1, 2007 at 6:10 pm CDT
Location: Interstate Highway 35W Bridge over the Mississippi River,
Minneapolis, Hennepin County, MN
Fatalities: 13
Injuries: 145

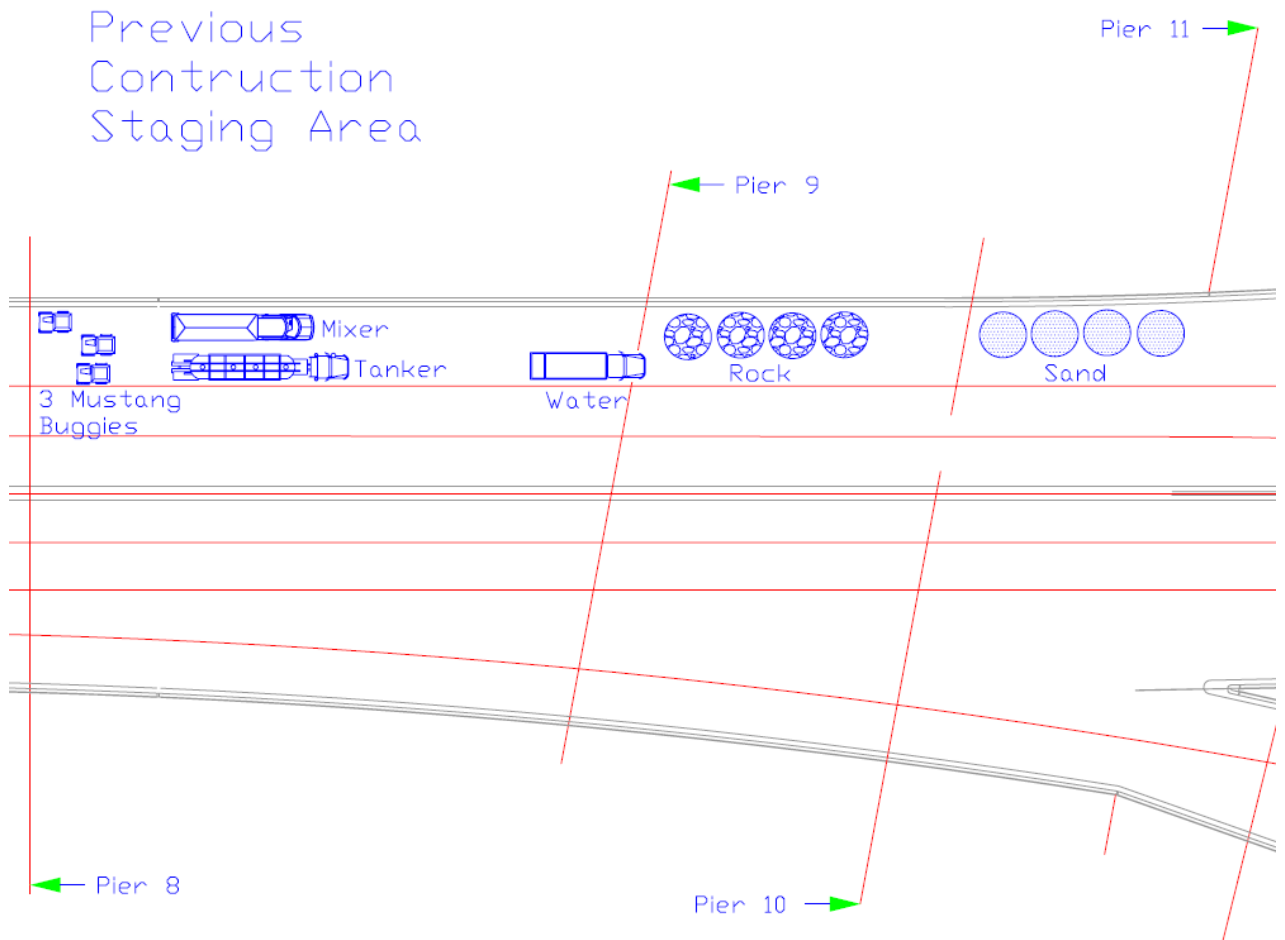
See Attachment 3 for diagrams of the overlays and staging areas. The weight of the equipment and materials of this overlay was similar to the weight of materials on the deck at the time of the collapse.

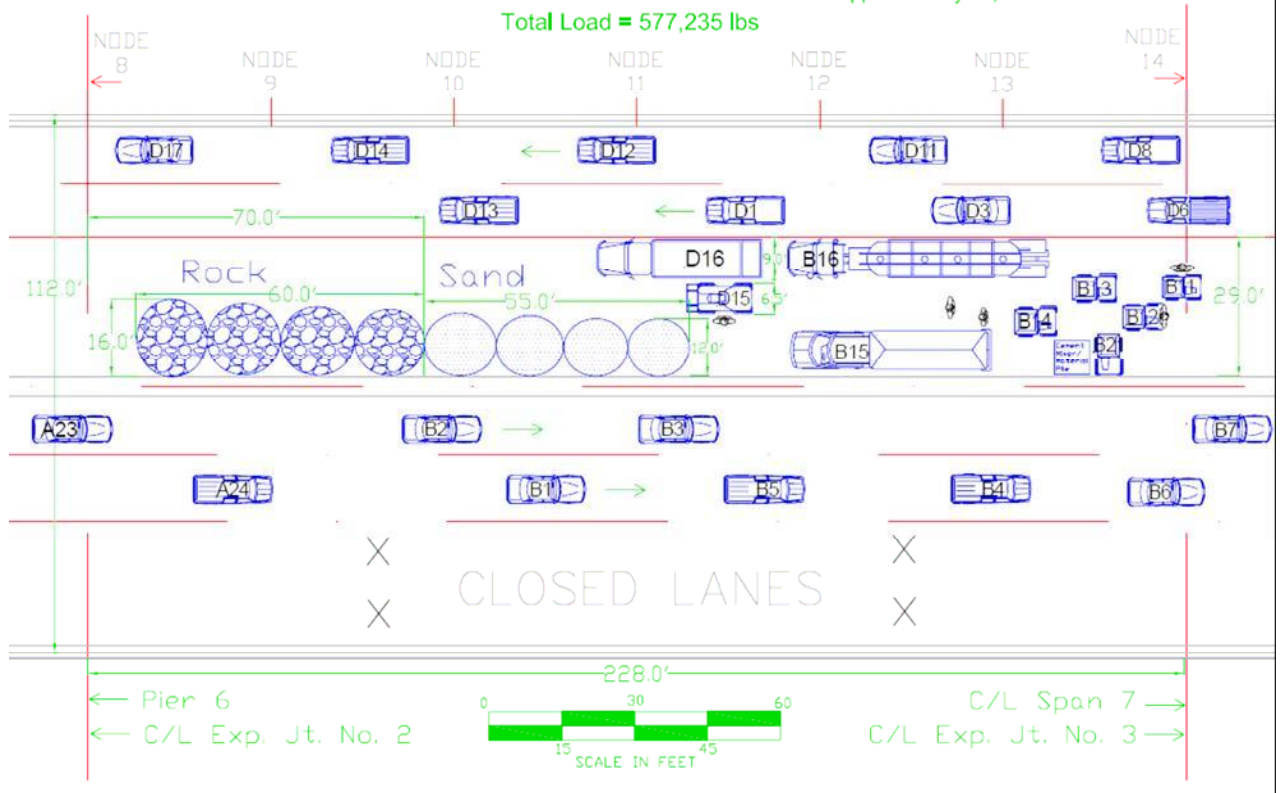
Construction Material Staging on Center Span Truss

4 Loads of Rock (184,380 lbs) 4 Loads of Sand (198,820 lbs) = 383,200 lbs
 3 Loaded Commercial Construction Vehicles, Water Truck D16 (48,200 lbs), Cement Tanker B16 (72,780 lbs), and Concrete Mixer B15 (51,400 lbs) = 172,380 lbs
 1 Skidsteer and 5 Scootcretes with associated material and workers = approximately 21,655 lbs
Total Load = 577,235 lbs

The positions of the materials and vehicles were changed after the 3:30 p.m. photograph was taken. Construction workers from PCI used a skidsteer to move the materials closer to the median barrier to make room for the movement of construction vehicles and traffic moving in the outside lanes. (See Photo 1 in Highway Construction Factors Group for Details)

In the right center of this photograph the plastic covering can be seen over previously repaired areas that had not yet cured. For that reason the length of the material staging area was reduced to what can be seen here. The gray colored material is the load of rock and the brown colored material is the sand. In the photograph the edge of the rock is over pier 6 and the center of the aggregate piles of sand and rock is located over structural truss node U-10.
