**NATIONAL TRANSPORTATION SAFETY BOARD  
OFFICE OF HIGHWAY SAFETY  
WASHINGTON, D.C.**

**HIGHWAY FACTORS & RAILROAD GRADE CROSSING  
GROUP CHAIRMANS' FACTUAL REPORT**

Location: Lanetown Road and Buckingham Branch Grade Crossing near Crozet, Albemarle County, Virginia

NTSB #: **HWY18MH005**

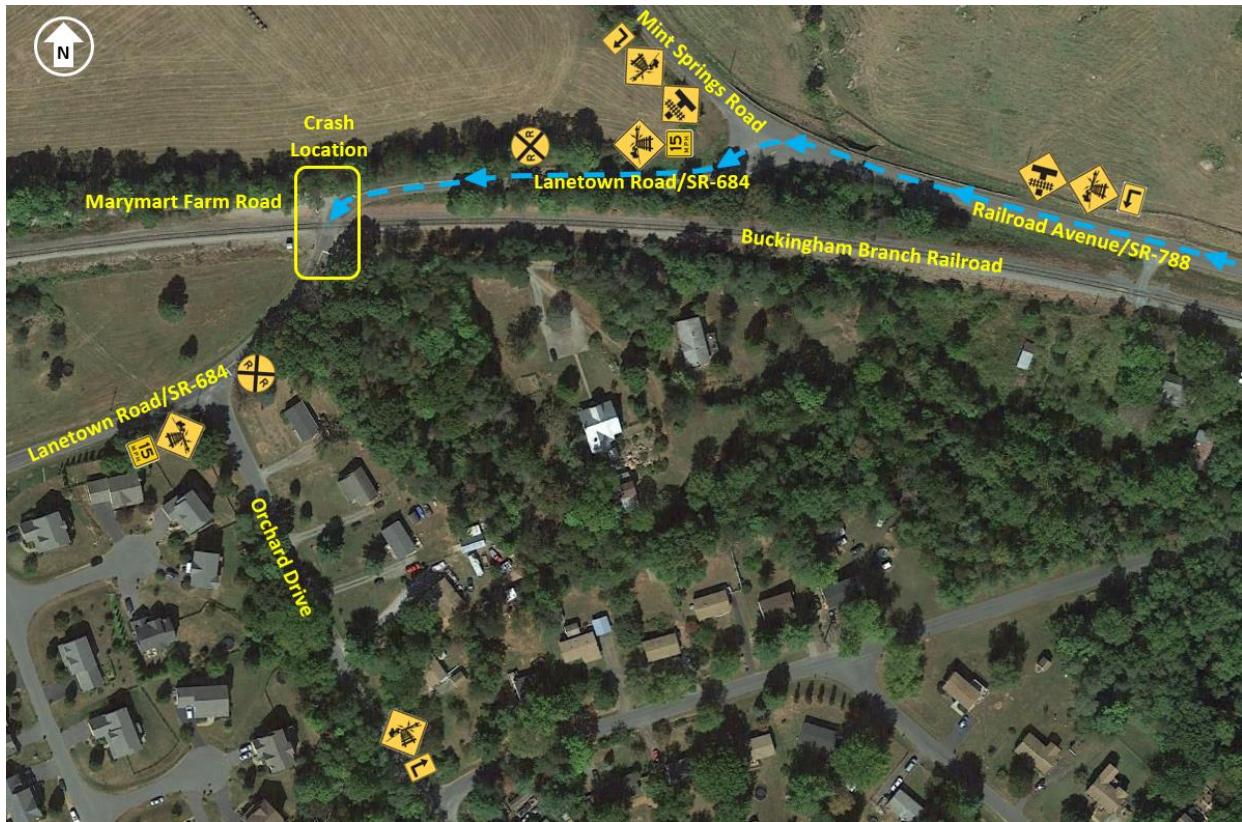
**Figure 3:** Crossing Related Advanced Warning Signs Near the Lanetown Road Grade Crossing (modified from: Google Earth)

A Parallel Grade Crossing and Intersection warning sign, in combination with a Low Ground Clearance Grade Crossing warning sign, accompanied by a Supplemental Arrow plaque,<sup>3</sup> were posted on both Mint Springs Road and Railroad Avenue, approximately 33-feet and 142-feet prior to their intersections with Lanetown Road respectively. On Lanetown Road, along the southbound approach to the crossing, a Low Ground Clearance Grade Crossing warning sign, accompanied by a 15 mph Advisory Speed plaque, was located approximately 449-feet prior to the crossing.<sup>4</sup> A grade crossing advanced warning symbol was located approximately 280-feet from the nearest rail. A grade crossing pavement-marking symbol was located in the southbound travel lane of Lanetown Road adjacent to the grade crossing advanced warning symbol.<sup>5</sup> A 2-foot wide white stop line was located approximately 33-feet from the automatic gate arm, and 46-feet from the nearest rail. The signal mast, warning devices, and attached Grade Crossing (Crossbuck) sign were located approximately 13-feet from the nearest rail. A summary of the signs found along the refuse truck's southbound approach to the grade crossing on Railroad Avenue and Lanetown Road can be found in **Table 1**.

On Lanetown Road, along the northbound approach to the crossing, a Low Ground Clearance Grade Crossing warning sign accompanied by a 15 mph Advisory Speed plaque was located approximately 340-feet prior to the crossing. A grade crossing advanced warning symbol was located approximately 198-feet from the nearest rail. A grade crossing pavement-marking symbol was located in the northbound travel lane of Lanetown Road adjacent to the grade crossing advanced warning symbol. A 2-foot wide white stop line was located approximately 18-feet from the automatic gate arm, and 32-feet from the nearest rail. The signal mast, warning devices, and attached Grade Crossing (Crossbuck) sign were located approximately 14-feet from the nearest rail. A fifth Low Ground Clearance Grade Crossing warning sign, accompanied by a Supplemental Arrow plaque, was posted on Orchard Drive approximately 550-feet prior to its intersection with Lanetown Road. A satellite image of the area surrounding the Lanetown Road grade crossing is shown in **Figure 3**, and has been annotated to show the crossing related advanced warning signs. **Figure 3** also shows the refuse truck's approximate approach route highlighted in blue.

Type	MUTCD Code	Symbol	Condition	Size	Distance to Crossing
Parallel Grade Crossing and Intersection Warning	W10-3

Good	36-inch x 36-inch	940-feet (on Railroad Ave.)
Low Ground Clearance Grade Crossing Warning	W10-5

Good	36-inch x 36-inch	940-feet (on Railroad Ave.)
Supplemental Arrow Plaque	W16-6P

Good	24-inch x 18-inch	940-feet (on Railroad Ave.)
Low Ground Clearance Grade Crossing Warning	W10-5

Good	36-inch x 36-inch	449-feet (on Lanetown Rd.)
15 mph Advisory Speed Plaque	W13-1P (15)

Good	18-inch x 18-inch	449- feet (on Lanetown Rd.)
Grade Crossing Advanced Warning	W10-1

Good	36-inch diameter	280-feet (on Lanetown Rd.)
Grade Crossing (Crossbuck)	R15-1

Good	36-inch x 36-inch	13-feet (on Lanetown Rd.)
