**HIGHWAY FACTORS GROUP CHAIRMAN FACTUAL REPORT**  
(61 pages)

**NATIONAL TRANSPORTATION SAFETY BOARD  
OFFICE OF HIGHWAY SAFETY  
WASHINGTON, DC 20594**

LOCATION: Interstate 95 (I-95) New England Thruway, at Mile Marker 3.2, in New York City, Bronx County, New York  
VEHICLE 1: 1999 Prevost Motorcoach  
OPERATOR: World Wide Travel of Greater New York Ltd.  
DATE: March 12, 2011  
TIME: Approximately 5:37 a.m. EST

**NTSB #: HWY-11-MH-005**

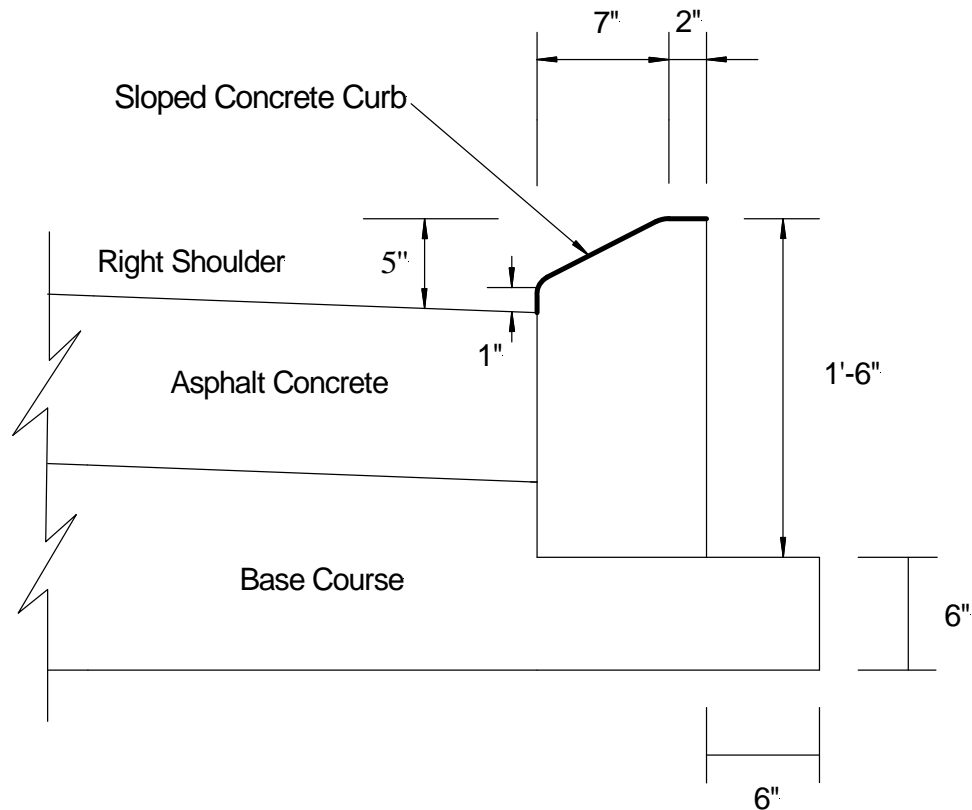
**Figure 3 – View of sloped curb (mountable concrete curb, Type AB)**

The primary purpose of the mountable curb, when originally constructed in the 1950's, was to convey storm water runoff from the travel lanes of I-95 to a closed drainage system. Closed drainage systems employ catch basins located at the left and right pavement edges that connect to storm drain pipes located underneath the roadway which empty into existing wetlands or drainage channels. Closed drainage systems are typically designed for developed urban areas due to the built up nature of the area and limited space to drain storm water runoff into an open drainage system of roadside ditches. In contrast, open drainage systems are generally employed in rural and suburban areas, due to the ample space available for constructing open drainage ditches adjacent to the roadway.

When the mountable curb was constructed in the vicinity of the accident as part of the original construction of I-95 in the 1950's (construction contract FANETC 54-13), the mountable curb was located at the edge of the travel lane (between the travel lane and shoulder). After a period of time, the pavement area adjacent to the catch basins located at periodic locations along the curb began to fail due to repeated loadings of heavy vehicular traffic. The design report for construction contract TANE 84-25<sup>17</sup> (see Attachment 7 - Design Report for Construction Contract TANE 84-25) indicated the following:

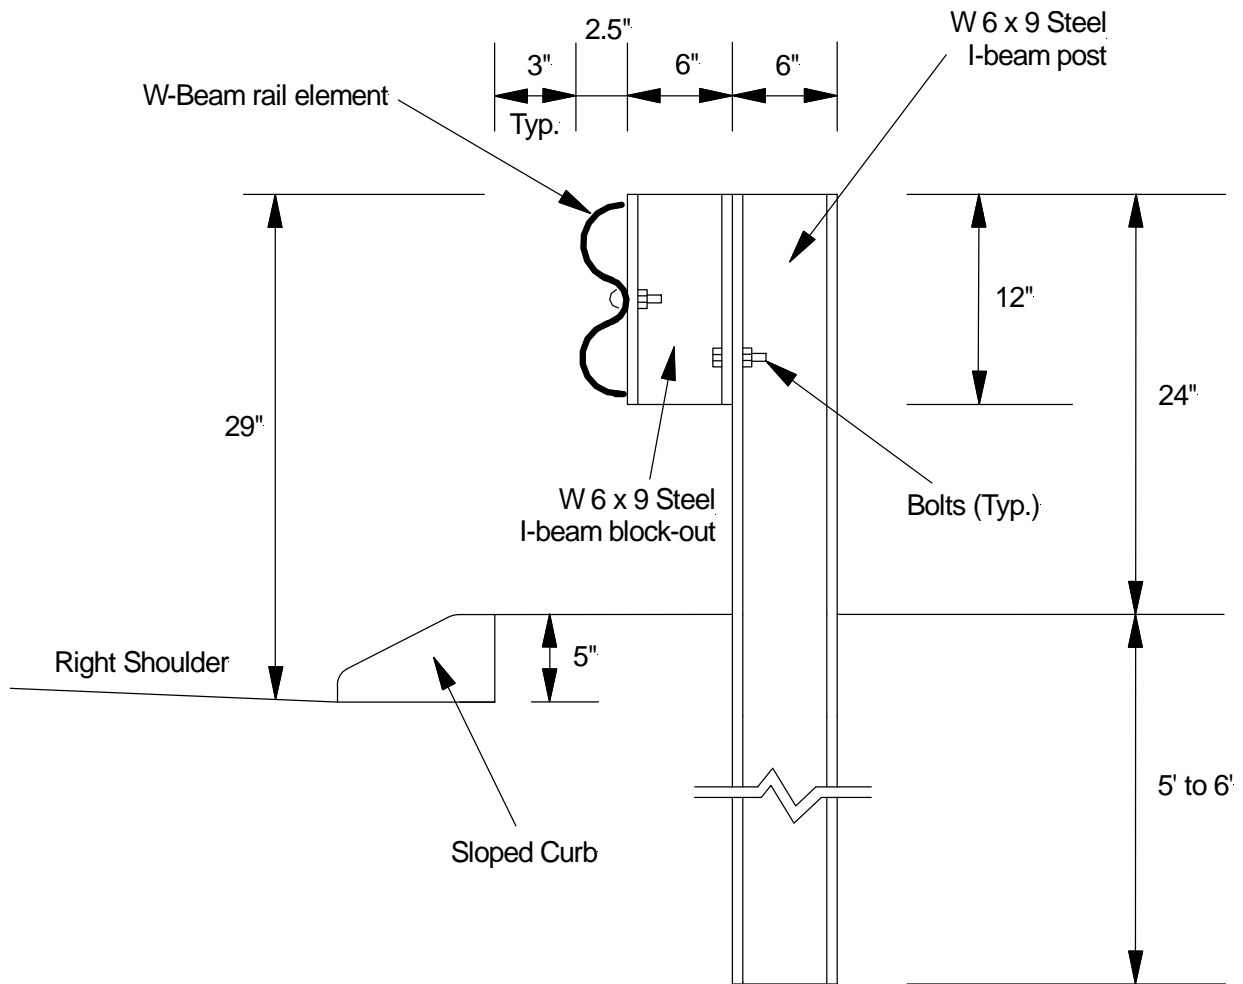
**Figure 4 – View of strong post blocked-out W-beam guiderail**

The strong posts that connected to the W-beam rail element consisted of W 6 x 9 steel I-beam posts that were spaced 6 feet and 3 inches apart. The W 6 x 9 steel I-beam posts were embedded in the ground approximately 5 to 6 feet.

The strong post blocked-out W-beam guiderail was initially constructed as part of the 1984 reconstruction project (construction contract TANE 84-25). In the vicinity of the accident, the new strong post blocked-out W-beam guiderail shielded the vertical poles supporting the overhead sign structure support and was not continuous along the right side of the southbound lanes. The W-beam guiderail extended for approximately 300 feet (see Attachment 8 – NYS Thruway Authority Plans for strong post blocked-out W-beam guiderail as part of Construction Contract TANE 84-25).

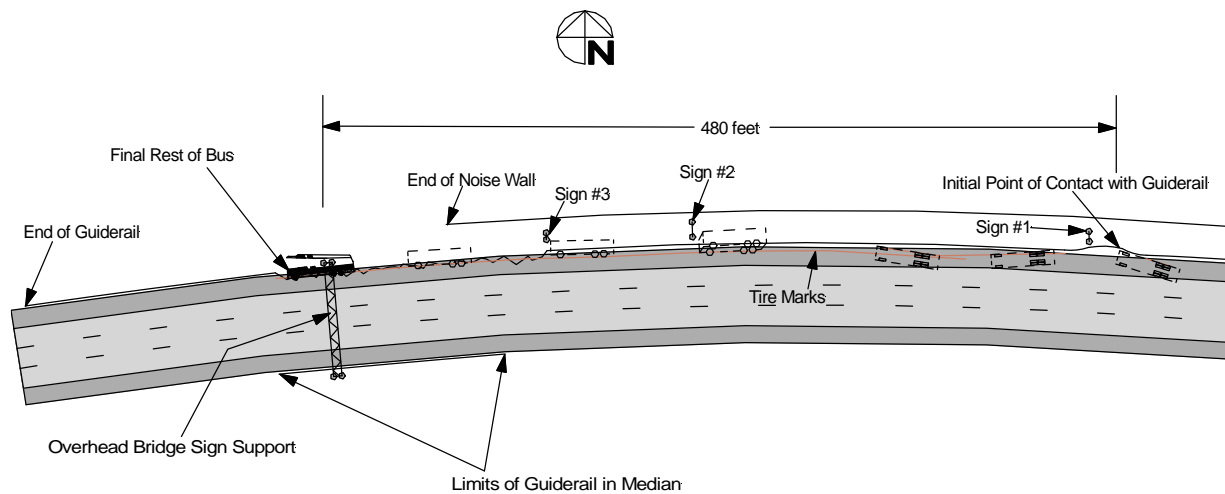
**Figure 6 – Overall scene diagram**

NTSB investigators documented the evidence of tire marks on the paved right shoulder as a result of the bus being redirected onto the shoulder of the roadway after collision with the strong post blocked-out W-beam guiderail. The initial point of contact with the guiderail was approximately 480 feet from the final rest of the bus (see Highway Factors Photograph (HWY Photo-06) illustrating the initial point of contact with the guiderail). Figure 6 illustrates the overall scene diagram showing the tire marks on the paved right shoulder and the progression of the bus from the initial point of contact with the guiderail to final rest.

<b>Distance from Final Rest of the Bus</b>	<b>Comments</b>
480 feet	Initial point of contact with the guiderail.
460 feet	Deformation of the guiderail measured to be approximately 18 inches. Posts moved perpendicular to the direction of traffic. Applied force created a moment about the strong axis of the posts.
453 feet	Location of Sign #1 (damage to lower left hand corner of sign) (see Highway Factors Photograph (HWY Photo-11) illustrating the damage to lower left hand corner of Sign #1).
439 feet	End of initial impact with guiderail.
430 feet	Beginning of continuous tire mark offset 0.5 feet from curb line.
403 – 407 feet	4 foot gouge mark in right shoulder offset 2 foot from curb line.
380 feet	Continuous tire mark offset 3 foot from curb line. Beginning of multiple tire marks offset 4 foot, 4.5 foot, and 5 foot from curb line.
331 feet	Second point of contact with the guiderail. Continuous tire mark offset 1 foot from curb line. End of multiple tire marks offset 1.5 foot, 2.5 foot, and 3 foot from curb line.

300 feet	Start of bus tilting on guiderail. Continuous tire mark offset 1 foot from curb line. Guiderail being pushed down to 20 inch height <sup>37</sup> .
217 feet	Location of Sign #2 (damage to lower left hand corner of sign) (see Highway Factors Photograph (HWY Photo-12) illustrating the damage to lower left hand corner of Sign #2). Continuous tire mark offset 1.5 foot from curb line. Guiderail being pushed down to 18 inch height.
130 feet	Location of Sign #3 (damage and removal of left post) (see Highway Factors Photograph (HWY Photo-09) illustrating the damage and removal of left post supporting Sign #3). Continuous tire mark offset 1.5 foot from curb line. Guiderail being pushed down to 12 inch height. Guiderail element separates from posts. Posts deformed and turned down 45 degrees. All turned down posts were in the direction of travel, about the weak axis of the posts.
100 feet	Continuous tire mark offset 1.5 foot from curb line. Guiderail being pushed down to 10 inch height. Guiderail element separates from posts. Posts deformed and turned down 90 degrees. All turned down posts were in the direction of travel, about the weak axis of the posts (see Highway Factors Photograph (HWY Photo-13) illustrating the rail element completely separated from the posts and the posts deformed and turned down 45 degrees and 90 degrees).
