**NATIONAL TRANSPORTATION SAFETY BOARD
OFFICE OF HIGHWAY SAFETY
WASHINGTON, D.C.**

**HIGHWAY FACTORS GROUP CHAIRMAN'S
FACTUAL REPORT**

Location: Northbound US Highway 83 (US-83) near milepost 553.4 in Uvalde County, 6.5 miles north of Concan, Texas

NTSB #: **HWY17MH011**

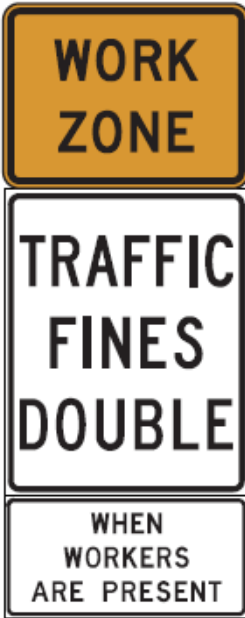
Good	48 inch X 60 inch	3000 feet south of impact area
Begin work Zone Traffic Fines Double When Workers Are Present	G20.5AP R20-5T R205aTP

Good	24 inch X 24 inch 24 inch X 30 inch 24 inch X 12 inch	1,500 feet south of impact area
