**HIGHWAY FACTORS GROUP CHAIRMAN'S  
FACTUAL REPORT**

**Collapse of a Bridge Span  
Mount Vernon, WA; 05/23/2013**

**HWY13MH012**

**NATIONAL TRANSPORTATION SAFETY BOARD  
OFFICE OF HIGHWAY SAFETY  
WASHINGTON, D.C. 20594**

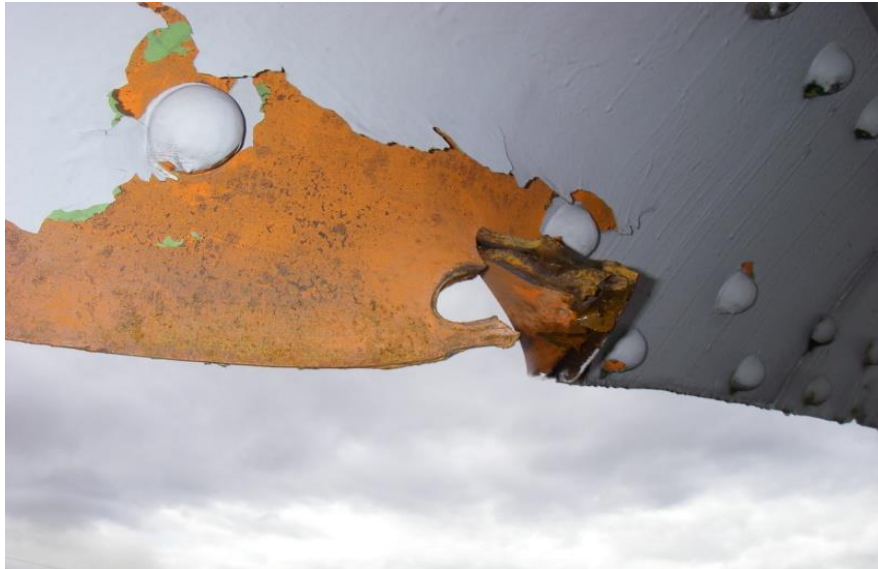
*Over height load traveled in the right lane traveling northbound and damaged the first portal in Span 5 and the following two sway braces.*

**Photograph 3** illustrates the damage to the U1 portal in Span 5 above the right lane in the northbound direction to the I-5 Bridge over the Skagit River as a result of the high load bridge hit on November 29, 2012<sup>7</sup>.

**Photograph 3** – Damage to the U1 portal in Span 5 above the right lane in the northbound direction to the I-5 Bridge over the Skagit River as a result of the high load bridge hit on November 29, 2012

*Straighten the damaged angles at U1 portal and splice the tear in the steel. Paint all locations where damage has occurred.”*

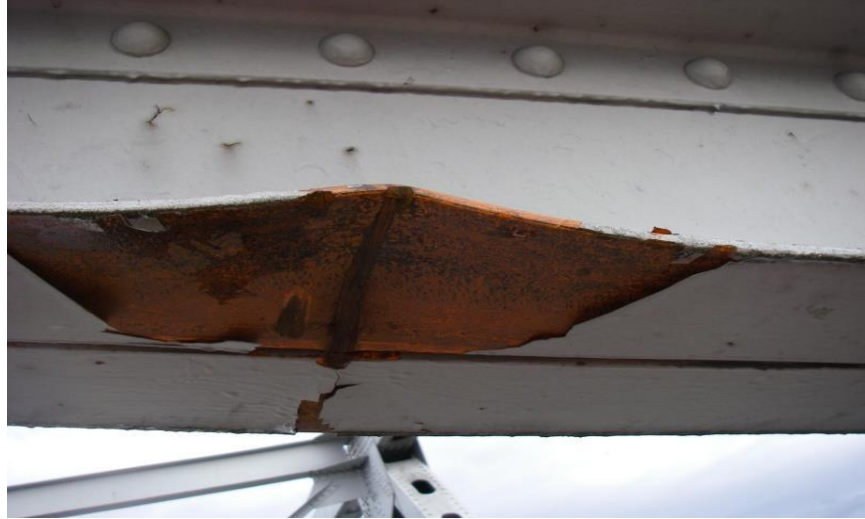
**Photograph 4** illustrates the damage to the U2 sway brace in Span 5 above the right lane in the northbound direction to the I-5 Bridge over the Skagit River as a result of the high load bridge hit on November 29, 2012<sup>8</sup>.

**Photograph 4** – Damage to the U2 sway brace in Span 5 above the right lane in the northbound direction to the I-5 Bridge over the Skagit River as a result of the high load bridge hit on November 29, 2012

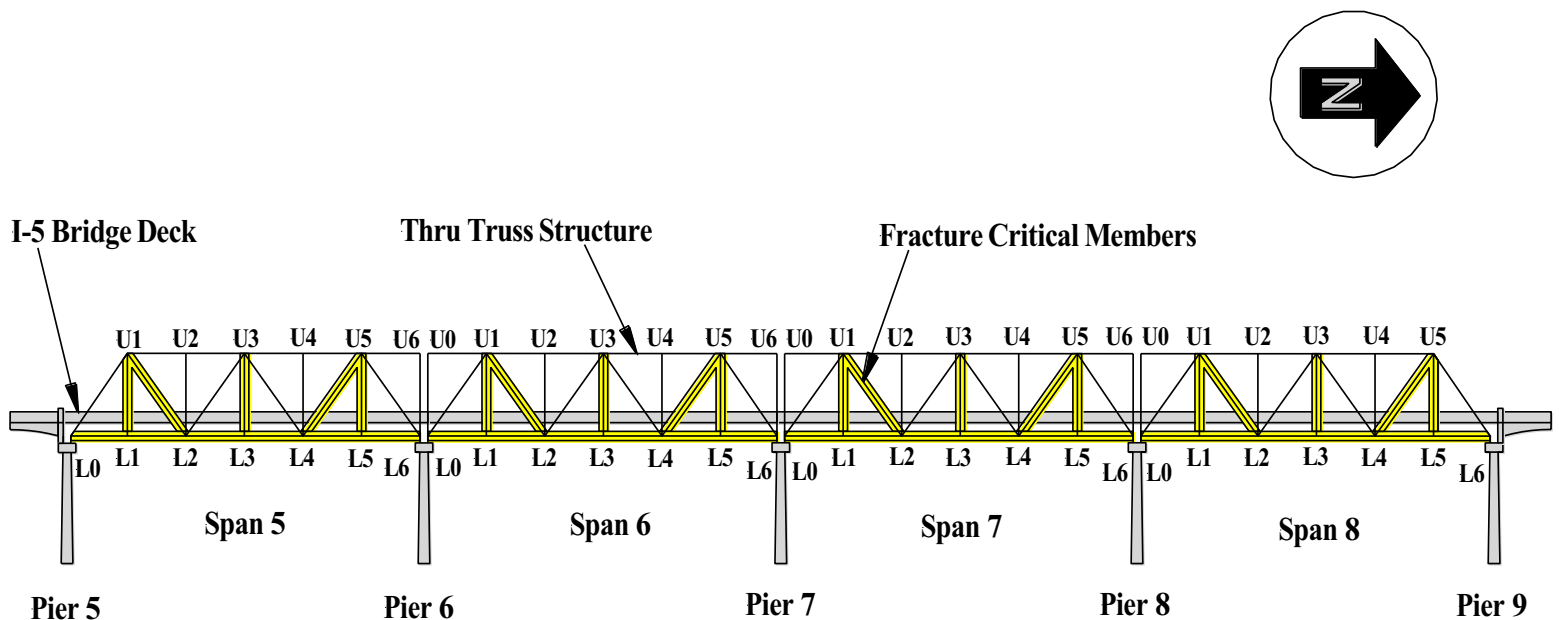
**Figure 4** – Location of the Fracture Critical Members of the I-5 Bridge over the Skagit River

**Figure 4** illustrates the location of the fracture critical members of the I-5 Bridge over the Skagit River. The fracture critical members are shown in yellow highlight. A fracture critical bridge is a bridge that contains one or more steel members in tension, or with a tension element, and arranged in such a manner that, if one fails, a portion or the entire bridge could collapse. The nomenclature of the truss nodes are broken into the upper chords and lower chords. The upper chords of the truss are numbered sequentially from south to north for each span (U1, U2, U3, and so on). The lower chords of the truss are numbered in a similar fashion (L0, L1, L2, L3, and so on). The fracture critical members are identified from node to node, for example, L0 to L1, U1 to L1, U1 to L2, and so on.

The total number of fracture critical members on the thru truss was 88 members. Each span had 22 fracture critical members or 11 members on each side.

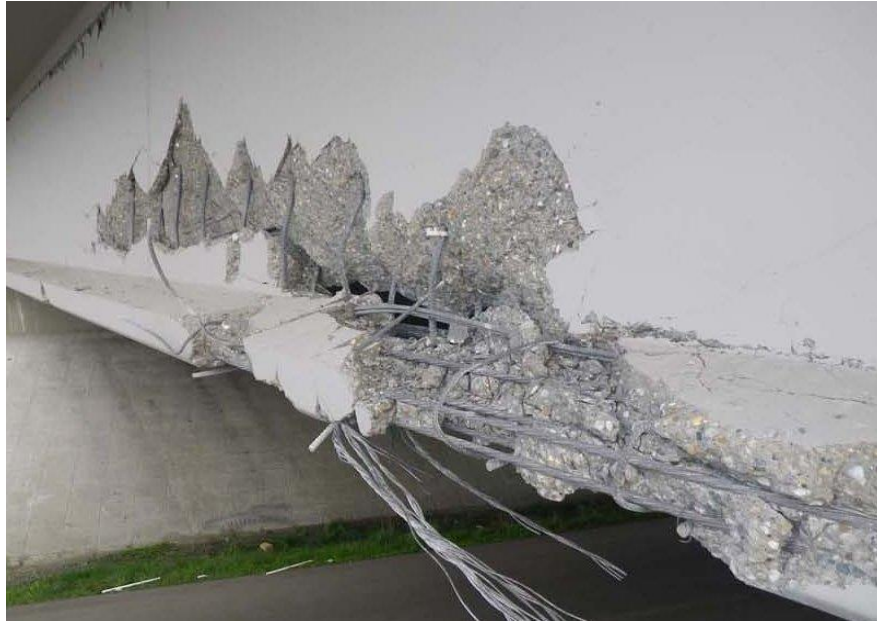
**Photograph 5** illustrates the damage to the State Road 16 and the Olympic Drive Overpass as a result of the high load bridge hit on March 17, 2013<sup>10</sup>.

**Photograph 5** – Damage to the State Road 16 and the Olympic Drive Overpass as a result of the high load bridge hit on March 17, 2013

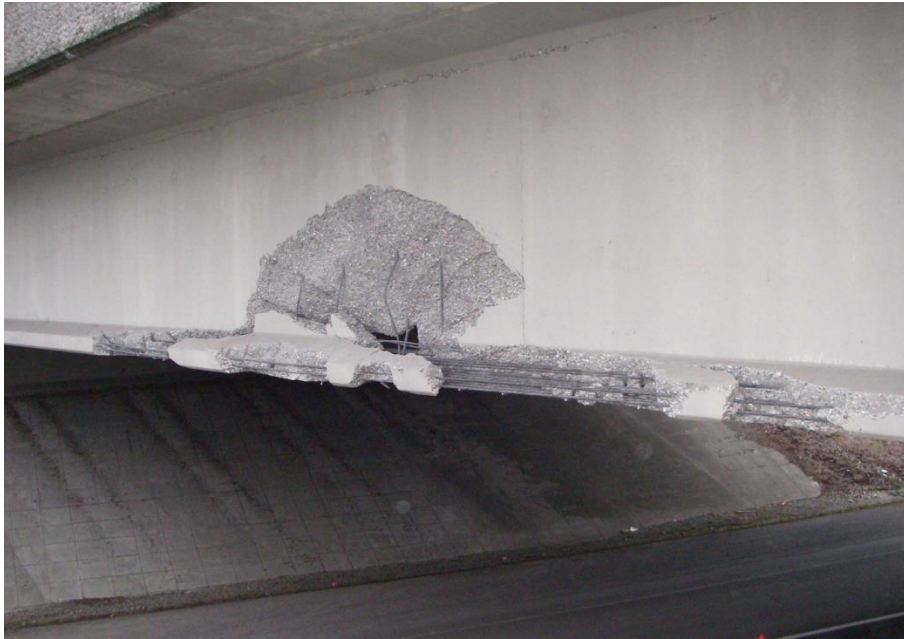
**Photograph 6** illustrates the damage to the State Road 16 and the Olympic Drive Overpass as a result of the high load bridge hit on January 4, 2011<sup>11</sup>.

**Photograph 6** – Damage to the State Road 16 and the Olympic Drive Overpass as a result of the high load bridge hit on January 4, 2011

The cost of replacement to the girder that was damaged as a result of the high load bridge hit on 1/4/2011 was the following:
