**HIGHWAY FACTORS GROUP CHAIRMAN'S
FACTUAL REPORT**

HWY15FH010

**NATIONAL TRANSPORTATION SAFETY BOARD
OFFICE OF HIGHWAY SAFETY
WASHINGTON, D.C.**

Location: Eastbound Interstate 610 (I-610) overpass above Telephone Road, Houston, Harris County, Texas

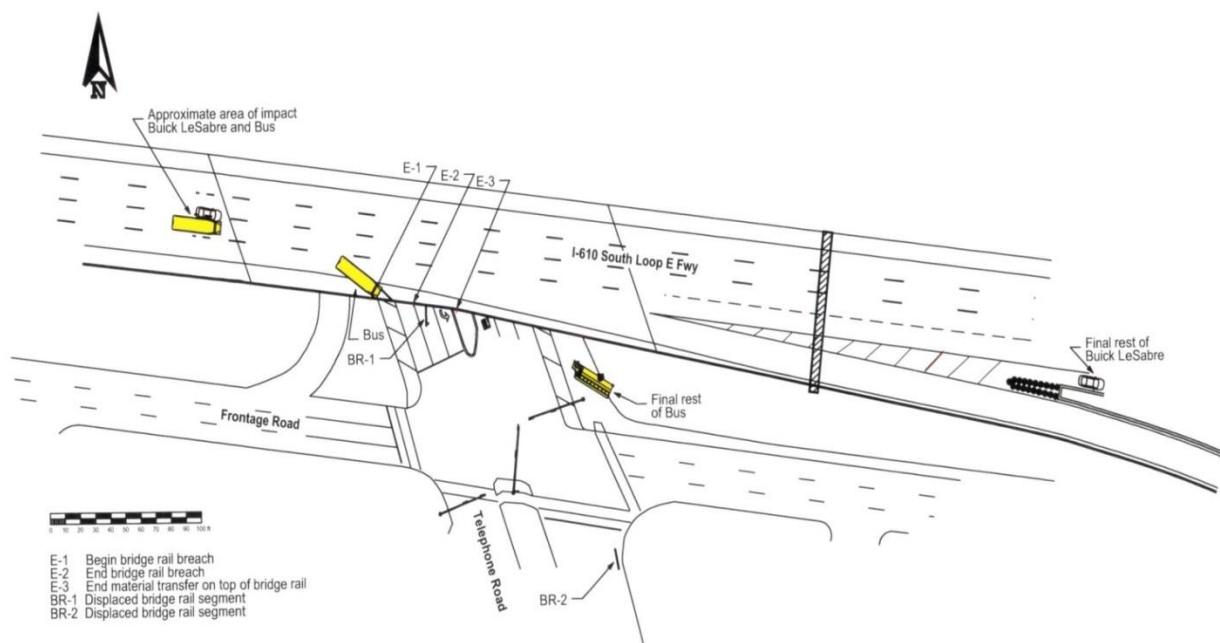
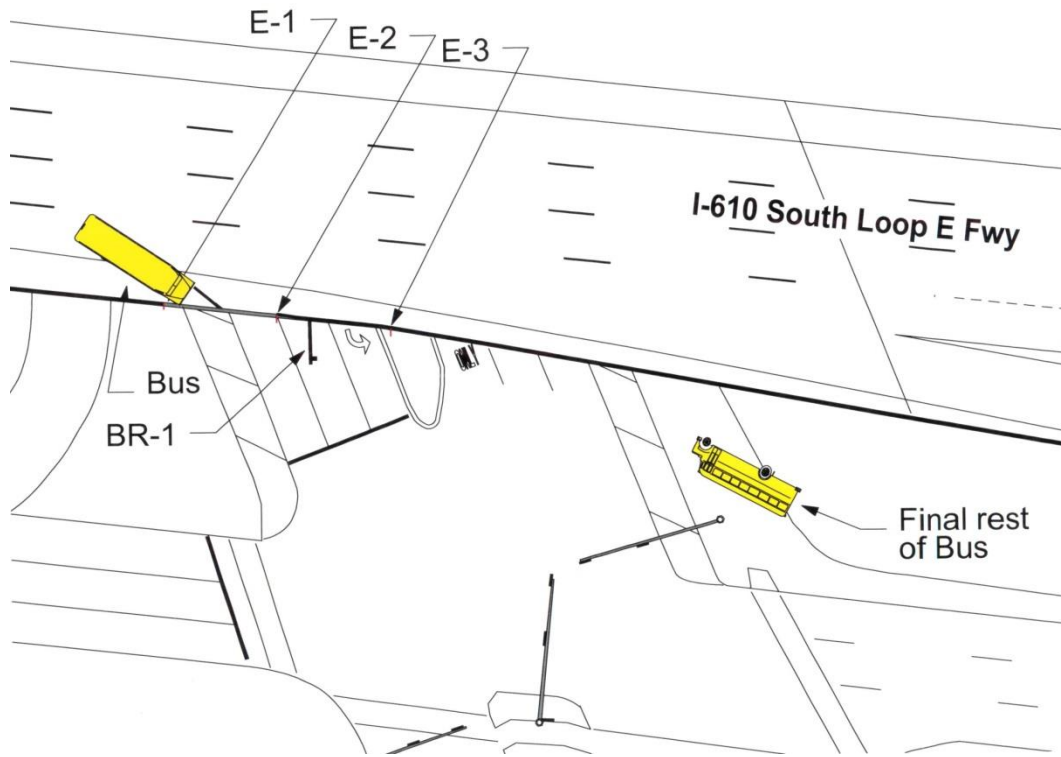
Figure 2 – Crash scene diagram

eastbound on IH-610 in the left center lane⁴ at an estimated speed of 69 mph.⁵ As the Buick overtook the school bus, the Buick departed its lane of travel to the right and collided with the school bus in the vicinity of the left front wheel. The school bus moved to the right, traversed the right travel lane⁶ and shoulder, and impacted the bridge rail⁷ at an approximate 28 degree angle⁸. The bus overrode the concrete portion of the bridge rail; and breached the metal railing along the top of the concrete parapet leaving an approximate 30 foot long opening in the metal rail before falling approximately 21 feet onto Telephone Road. The bus came to rest on its left side facing westward on the east side of Telephone Road. The Buick came to rest on the right shoulder of IH-610 beyond the overpass.

Figure 2 illustrates a crash scene diagram showing the approximate area of impact between the passenger vehicle and the bus, the approximate point of impact in which the bus impacted the bridge rail, and the final rest positions of the bus and passenger vehicle. **Figure 2** also illustrates the approximate beginning and end points of the bridge rail breach, the approximate end of material transfer on top of the bridge rail, and the final rest positions of the displaced bridge rail segments.

⁸The 28 degree angle is the angle turned from a line parallel with the bridge rail to a line parallel with the tire friction marks. The tire friction marks were left by the HISD school bus and found on the right shoulder.

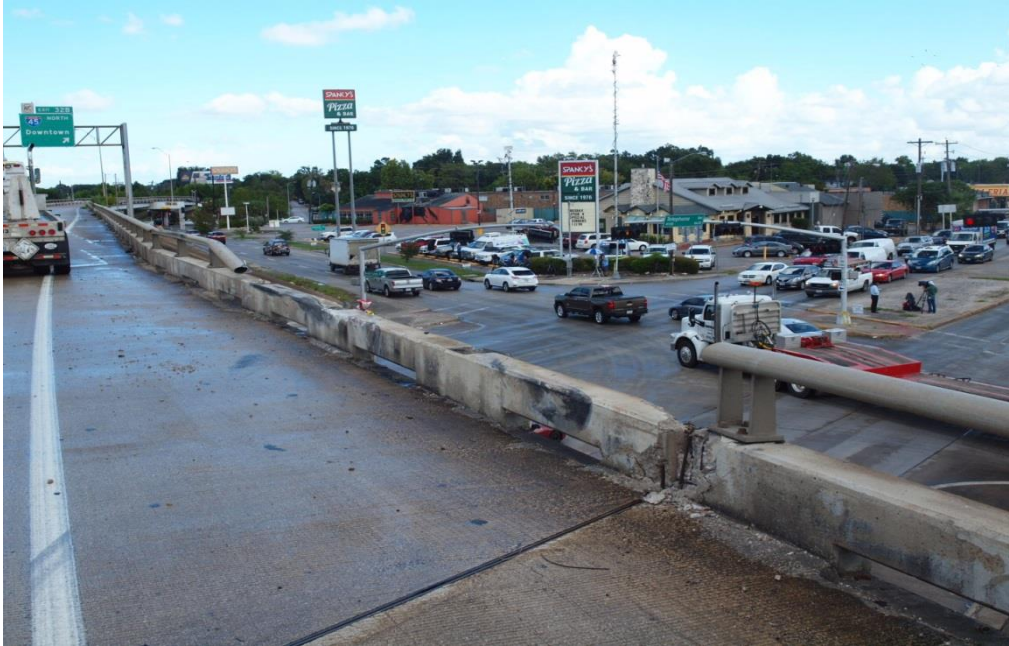
Figure 3 – View of the bridge rail after impact by the HISD school bus looking to the southeast

The total weight of the HISD school bus involved in the crash was approximately 16,300 pounds¹¹. The Type C4 (modified) bridge railing in its designed condition would not be expected to be able to perform adequately to withstand a collision of the HISD school bus weighing approximately 16,300 pounds.

Figure 3 illustrates a view of the bridge rail after impact by the HISD school bus looking to the southeast.

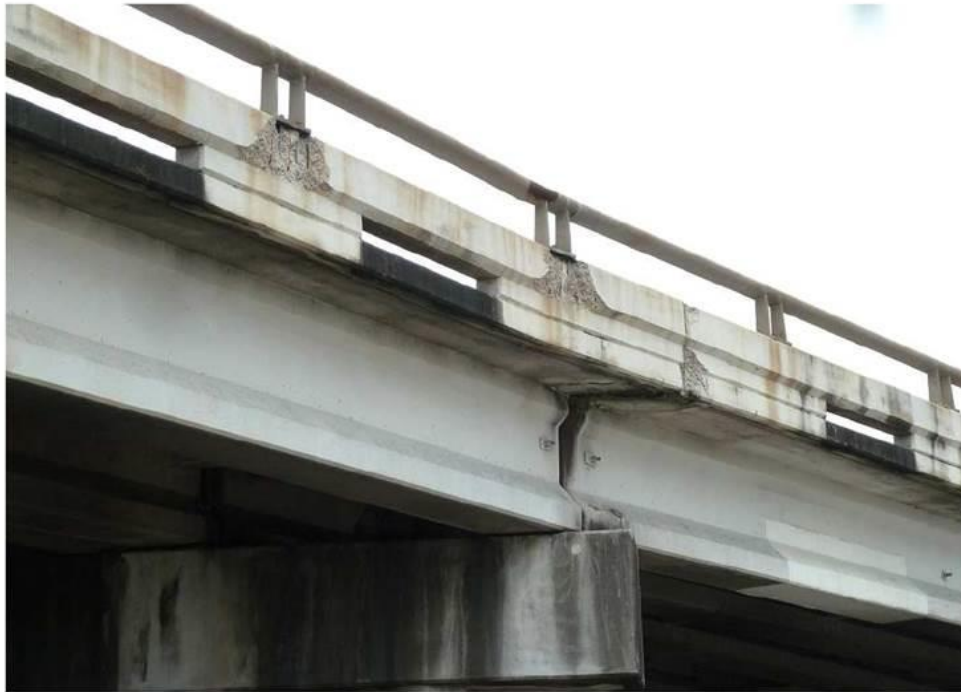
NTSB investigators reviewed the bridge inspection reports of the IH-610 overpass above Telephone Road and found a photograph taken on December 27, 2012. The photograph is shown in **Figure 4** and depicts severe spalling with exposed reinforcing steel at the anchor bolt connections. The location of the severe spalling and exposed reinforcing steel is located along the south edge of eastbound IH-610 immediately east of where the HISD bus surmounted the bridge rail on September 15, 2015.

Impact Damaged Bridge Rail

NOTE: Several areas of moderate to severe impact damage to Bridge Railing. Severe spalling with exposed reinforcing steel @ anchor bolt connections.

Figure 4 – Photograph taken on December 27, 2012 depicting severe spalling with exposed reinforcing steel at the anchor bolt connections

Based on existing repairs, TxDOT found there had been a previous severe impact to the bridge rail in the same location of where the HISD school bus had surmounted the bridge rail on September 15, 2015. TxDOT could not determine when the previous severe impact occurred because the TxDOT Districts (a total of 25 Districts statewide) do not keep maintenance records that document prior bridge railing improvements and cost of repair. The previous severe impact resulted in significant damage to the concrete parapet and the anchor bolts. There was evidence

that the bolts were bent over by the impact, then bent back and reused rather than being replaced. The previous severe impact also resulted in significant damage at the posts. Repair mortar had been used to patch spalls at the posts due to the impact. The quality of the repair mortar was inferior in overall quality to the original concrete and was completely carbonated in some locations, which significantly increased the corrosion potential for the embedded steel. The combination of compromised galvanizing, poor quality spall repair material, and contaminants ponding around the anchor bolts within the slotted holes resulted in severe corrosion and section loss in the exact location that the HISD school bus hit on September 15, 2015.

TxDOT concluded that they believe there was no systemic deterioration issues associated with the Type C4 (modified) bridge rail or other similar rail types where the components had been galvanized, even where contaminants pooled around anchor bolts in slotted holes. TxDOT intends to provide direction to all 25 Districts that the proper procedure for repairing damaged rail is to install new anchor bolts as opposed to bending back and re-using damaged bolts.
