**NATIONAL TRANSPORTATION SAFETY BOARD
OFFICE OF HIGHWAY SAFETY
WASHINGTON, D.C.**

**HIGHWAY FACTORS GROUP CHAIRMAN'S
FACTUAL REPORT**

Location: Rail crossing, Main Street, Biloxi, Harrison County, Mississippi
Vehicle #1: 2016 Van Hool CX45 Motorcoach
Operator #1: Echo Transportation of Dallas, Texas
Vehicle #2: CSX Freight Train, consisting of 3 locomotives, 27 loaded cars, and 25 empty cars
Operator #2: CSX Transportation
Date: Tuesday, March 7, 2017
Time: 2:12 p.m. CST
NTSB #: **HWY17MH010**

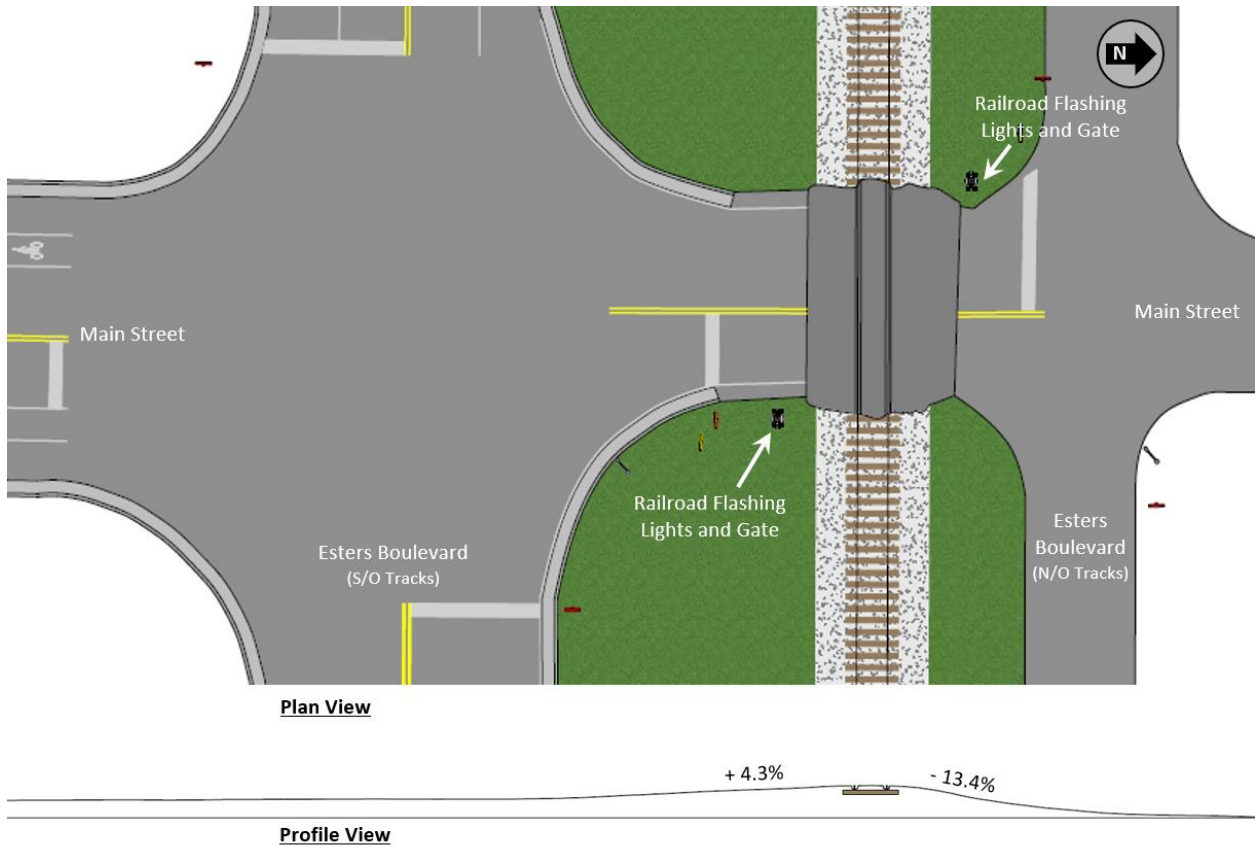
Figure 6: Plan and Profile Views of Main Street Grade Crossing

The vertical grade for northbound traffic as it approached the railroad tracks on Main Street was an average +4.2% (uphill) slope (+7.5% maximum). The vertical grade for northbound traffic as it departed from the railroad tracks was an average -13.3% (downhill) slope (-24.4% maximum). **Figure 6** shows a plan and profile overview of the Main Street grade crossing. **Figure 7** shows a detailed view of the northbound approach grade for approximately 50-feet south of the tracks, with approximate slope measurements shown at 5-foot intervals. **Figure 8** shows a detailed view of the northbound departure grade for approximately 35-feet north of the tracks, with approximate slope measurements shown at 2-¹/₂-foot intervals. A photograph showing both the northbound approach and departure slopes is shown in **Figure 9**.¹⁴

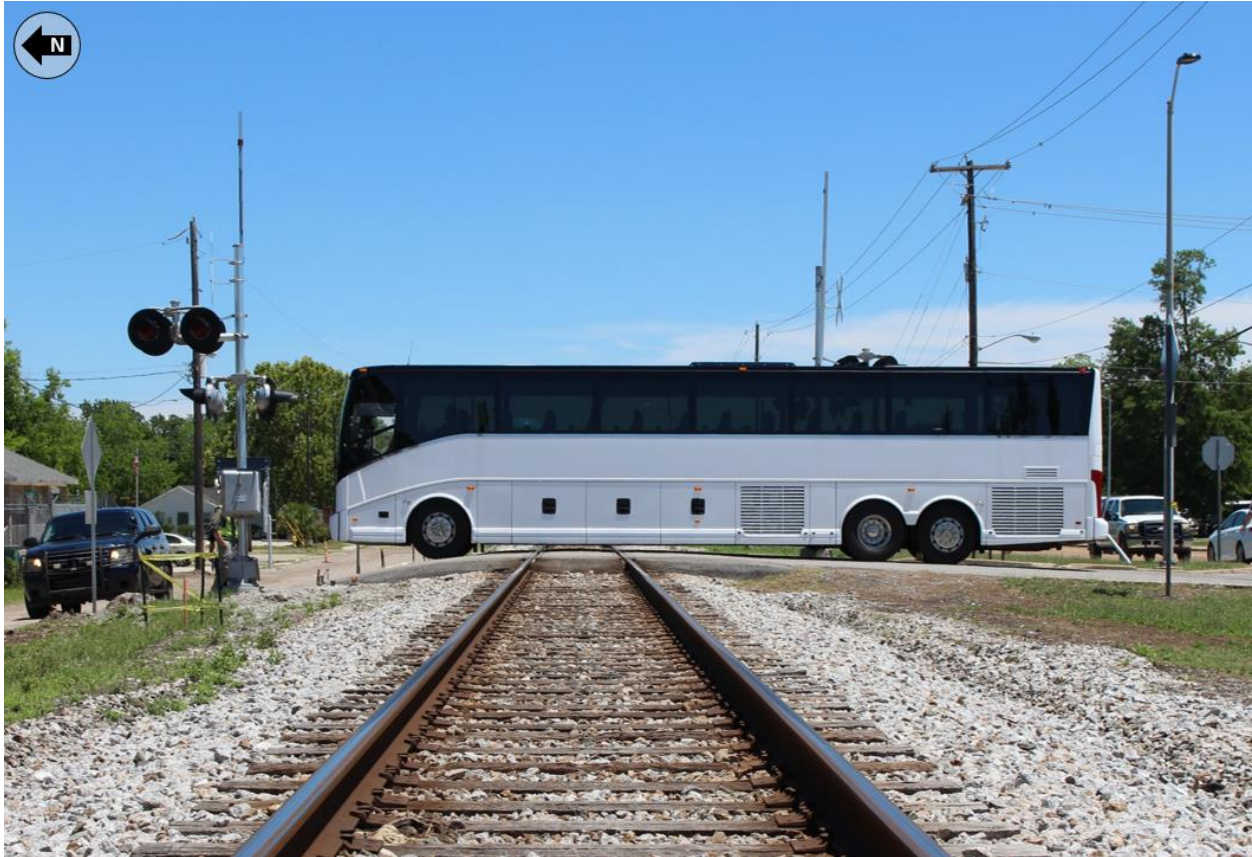
Figure 10: Exemplar Motorcoach Positioned on the Main Street Grade Crossing – Looking East

Using an exemplar motorcoach with an experienced driver and a spotter, NTSB investigators conducted a series of tests under controlled circumstances.¹⁵ These tests including capturing video of the motorcoach’s approach to the crossing, acceleration testing, and ground clearance measurements as the motorcoach drove up and onto the crossing. During this testing, the motorcoach was slowly moved forward onto the crossing, and was stopped when it was in a position just short of bottoming out, as shown in **Figure 10**.¹⁶ In this position, the exemplar motorcoach would have been close to the position that the collision involved motorcoach was in when it became immobilized on the crossing.

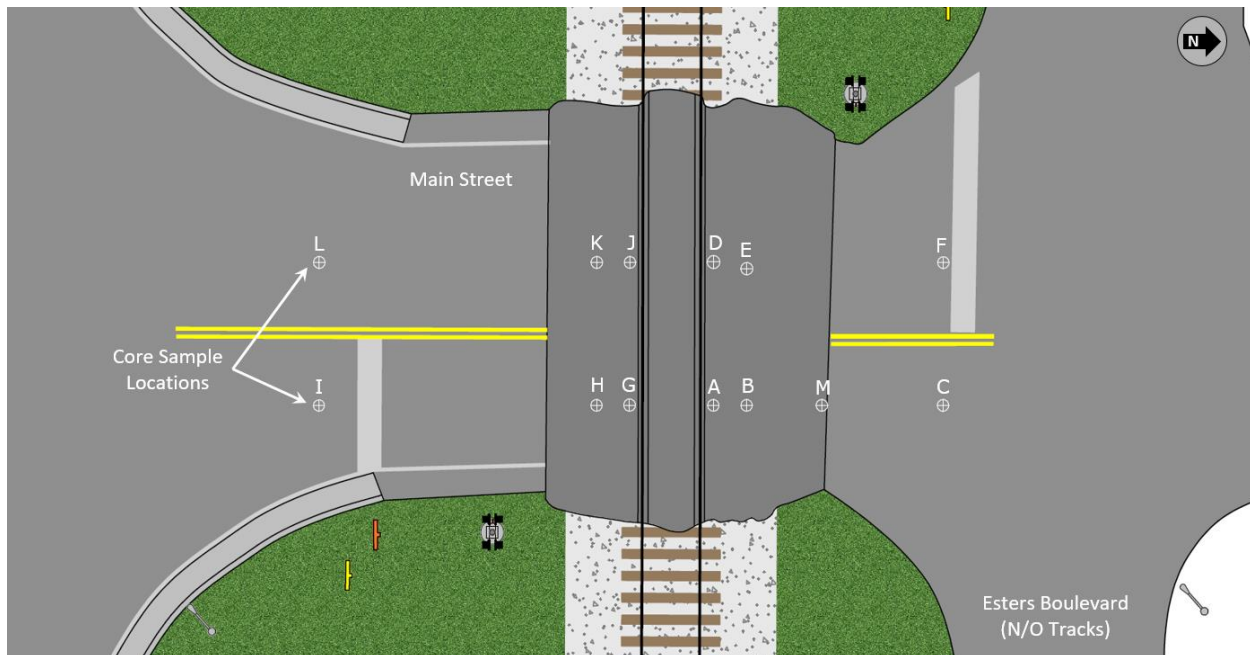
Figure 13: Approximate Asphalt Core Sample Locations

were left in the possession of the APL staff for them to conduct a more thorough examination.⁴⁰ The detailed examination of the core samples that were collected relatively close to the tracks (samples A, B, D, E, G, H, J, and K) revealed that each of these samples consisted of a single layer with multiple lifts,⁴¹ and had similar aggregate types. The APL examination found that:

According to the APL, the detailed examination of the core samples that were collected relatively far from the tracks (samples C, F, I, L, and M) contained clearly different pavement layers, and showed variability in aggregate type, size, abundance, and distribution. These core samples were thicker than the samples collected closer to the tracks, and contained between four and ten layers. The APL examination found that samples “I” and “L” appeared to have a similar placement/construction history based on the similarities found in the observed layers and their aggregate types. For the same reasons, the APL found that samples “C” and “F” also appeared to have a similar placement/construction history.
