**NATIONAL TRANSPORTATION SAFETY BOARD
OFFICE OF HIGHWAY SAFETY
WASHINGTON, D.C.**

**HIGHWAY FACTORS GROUP CHAIRMAN'S
FACTUAL REPORT**

Location: Intersection of Northern Boulevard and Main Street, Flushing, NY
Vehicle #1: 2015 Motor Coach Industries Motorcoach
Operator #1: Dahlia Group Inc., of Flushing, NY
Vehicle #2: 2015 New Flyer Transit Bus
Operator #2: New York City Transit
Vehicle #3: 2009 Honda Odyssey
Operator #3: Parked at curb, not running, unoccupied
Vehicle #4: 2002 Toyota Sequoia
Operator #4: Parked at curb, not running, occupied by two passengers (one in the driver's seat, and one in the right-front passenger seat)
Date: Monday, September 18, 2017
Time: 6:16 a.m. Eastern Daylight Time (EDT)
NTSB #: **HWY17MH015**

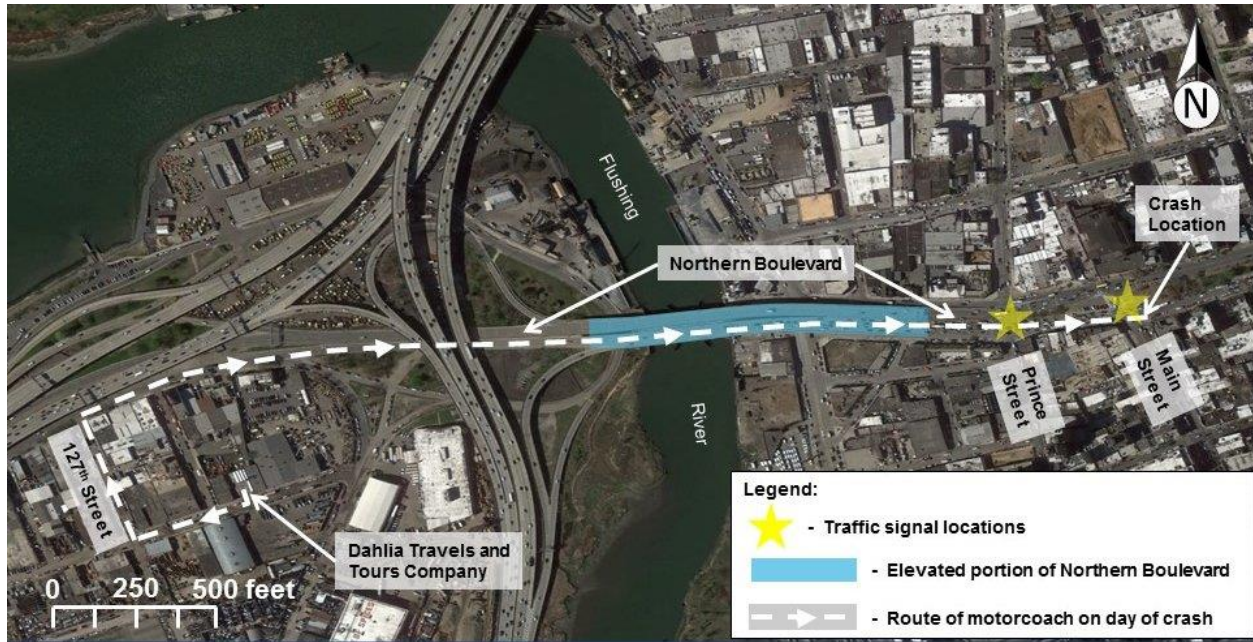
Figure 3 – Traffic signal locations and elevated portion of Northern Boulevard (Source: Google Earth Maps revised)

Figure 3 illustrates an aerial view of Northern Boulevard with Dahlia Travels and Tours Company office located in the lower left corner.¹ The blue color denotes the elevated portion of Northern Boulevard over the Flushing River. The yellow stars denote the locations of traffic signals at the intersections of Northern Boulevard and Prince Street, and Northern Boulevard and

Main Street. The crash occurred at the intersection of Northern Boulevard and Main Street located to the far right. The white dashed line denotes the route the motorcoach took on the day of the accident. The driver pulled out onto 127th Street from the Dahlia parking lot and turned right onto Northern Boulevard. From there, the driver proceeded eastbound on Northern Boulevard until colliding with the New York Metropolitan Transit Administration bus at the intersection of Northern Boulevard and Main Street.

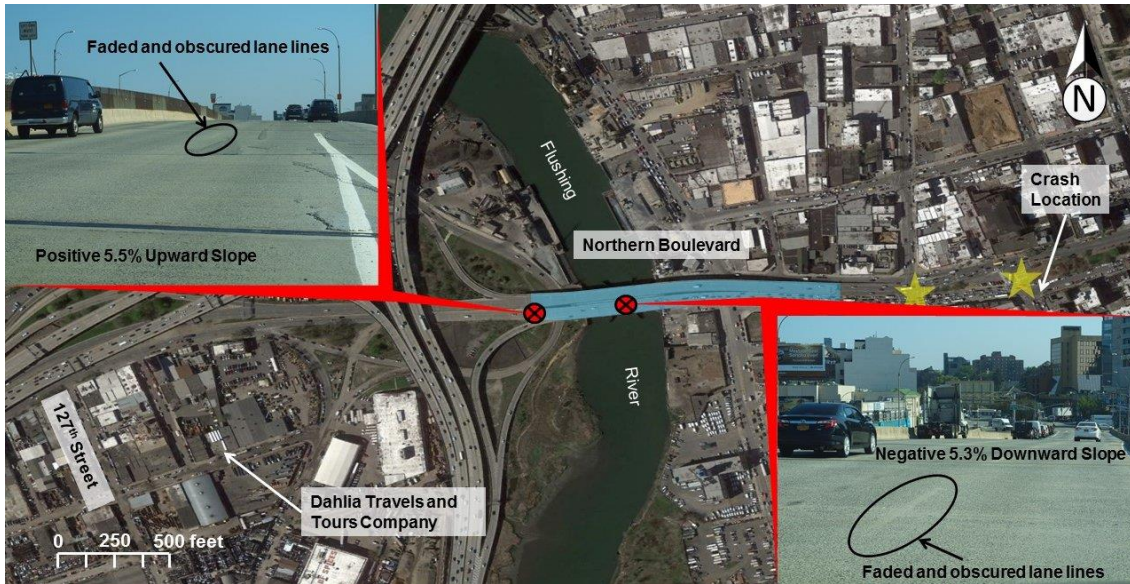
Figure 4 – Vertical grades on elevated portion of Northern Boulevard (Source: Google Earth Maps revised)

The upper left corner of **Figure 4** shows a view of the positive 5.5% (upward) slope on the elevated portion of Northern Boulevard over the Flushing River. Notice the lane lines were faded and obscured on the positive 5.5% (upward) slope. The lower right corner of **Figure 4** shows a view of the negative 5.3% (downward) slope on the elevated portion of Northern Boulevard looking toward the crash location. The lane lines were also faded and obscured on the negative 5.3% (downward) slope.

The lane lines were refreshed by the NYCDOT on January 4, 2018.

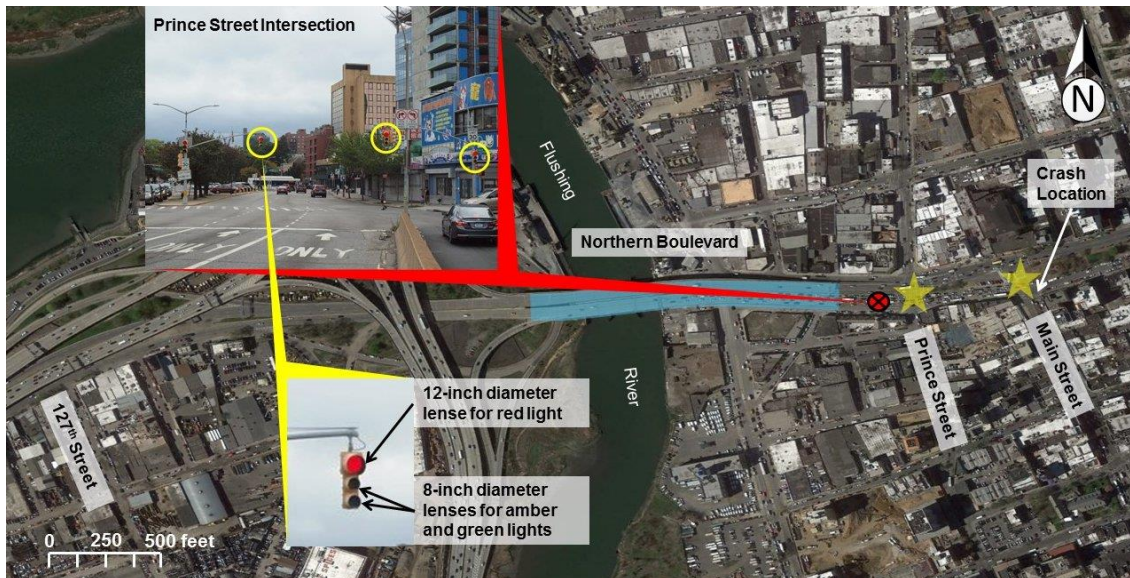
Figure 5 – View of the Prince Street intersection looking in the eastbound direction of Northern Boulevard toward the crash location (Source: Google Earth Maps revised)

Figure 5 shows a view of the Prince Street intersection looking in the eastbound direction of Northern Boulevard toward the crash location. There were 3 red signal light indications facing eastbound traffic at the Prince Street intersection at the time of the crash. Video evidence shows that the motorcoach travelled through the Prince Street intersection when the 3 red lights were activated. The 3 red lights consisted of 12-inch diameter lenses versus the 8-inch diameter lenses for the amber and green indications.

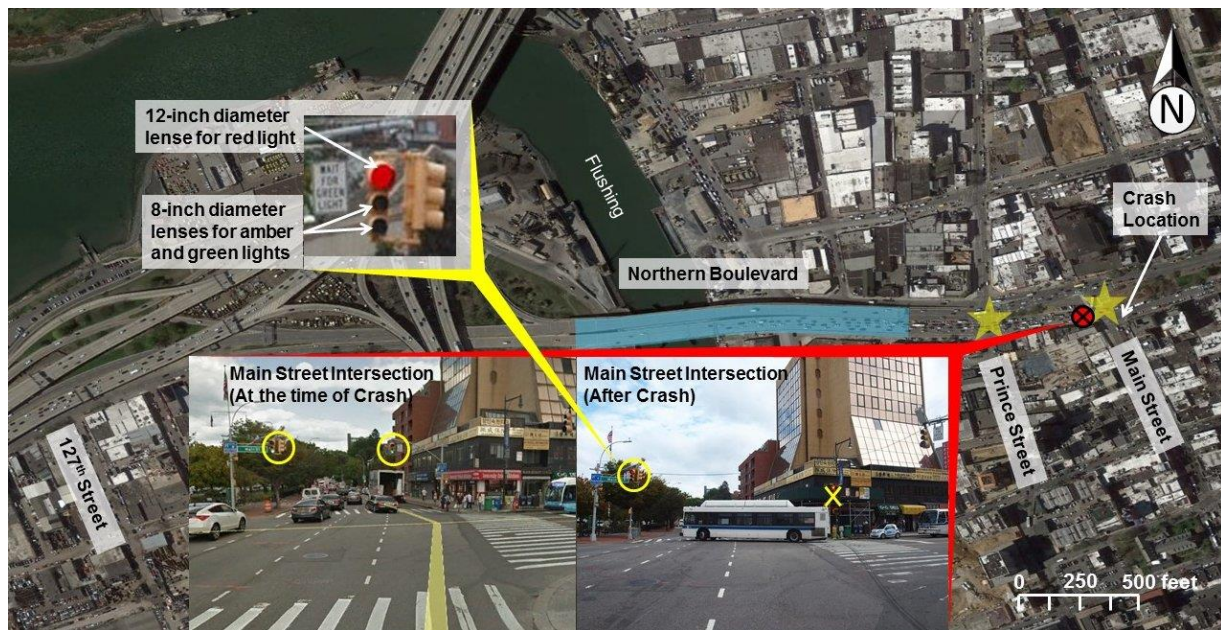
Figure 6 – View of the Main Street intersection looking in the eastbound direction of Northern Boulevard toward the crash location (Source: Google Earth Maps revised)

Figure 6 shows the approximate location of the New York Metropolitan Transit Administration bus turning right from Main Street onto Northern Boulevard at the time of the crash. The far right slide only shows 1 traffic signal over the travel lanes after the crash. However, at the time of the crash, there were 2 traffic signals over the travel lanes as shown in the far left slide. One signal was demolished as a result of the crash and a temporary signal was installed by the NYCDOT as shown by a yellow X mark in the right slide. Video evidence shows that the motorcoach travelled through the Main Street intersection when the 2 red lights were activated. The 2 red lights consisted of 12-inch diameter lenses versus the 8-inch diameter lenses for the amber and green indications.

The traffic signals at the Prince Street / Northern Boulevard and Main Street / Northern Boulevard intersections were coordinated signals (or timed together) for traffic proceeding eastbound on Northern Boulevard. The signals operate with a separate controller, however, they are coordinated using offsets that are timed by a central management system.

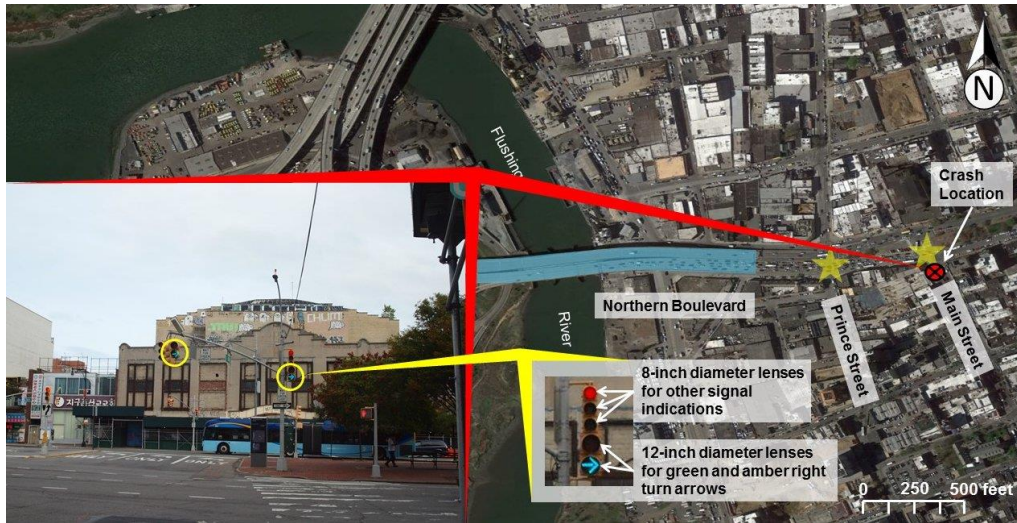
Figure 7 – View of the Northern Boulevard intersection looking in the northbound direction of Main Street toward the crash location (Source: Google Earth Maps revised)

Figure 7 shows a view that the driver of the New York Metropolitan Transit Administration bus would have had while turning right from Main Street onto Northern Boulevard at the time of the crash. The driver would have seen the 2 green right turn arrow signal indications. The green and amber right turn arrows were 12-inch diameter lenses versus the 8-inch diameter lenses for the other signal indications.

The driver of the of the New York Metropolitan Transit Administration bus proceeded correctly turning right from Main Street onto Northern Boulevard after receiving 2 green right turn arrow indications according to provisions outlined in New York State Vehicle and Traffic Law Section 1111²:

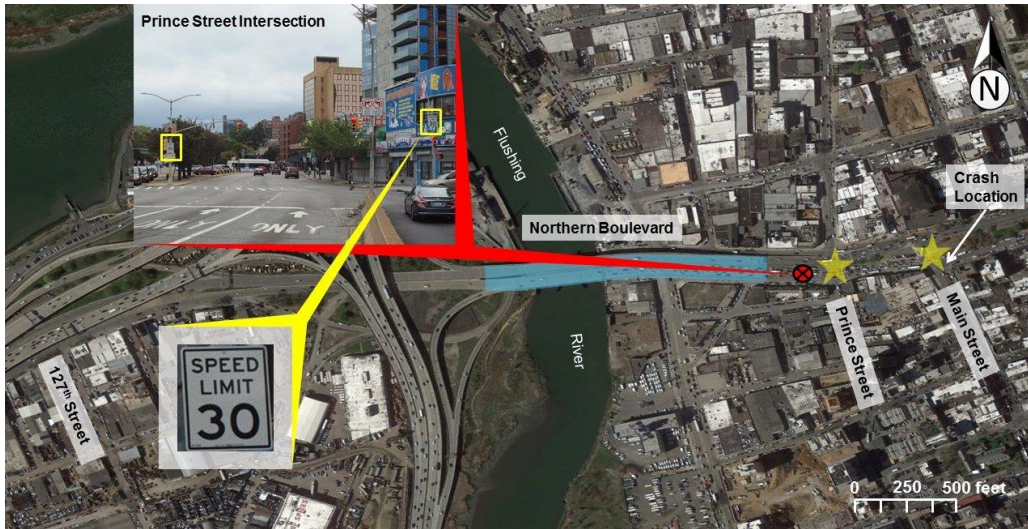
Figure 8 – View of the Prince Street intersection looking in the eastbound direction of Northern Boulevard toward the crash location indicating the speed limit was 30 miles per hour (mph) (Source: Google Earth Maps revised)

Figure 8 shows a view of the Prince Street intersection looking in the eastbound direction of Northern Boulevard toward the crash location indicating the speed limit was 30 miles per hour (mph). There were 2 signs that indicated the speed limit was 30 mph.

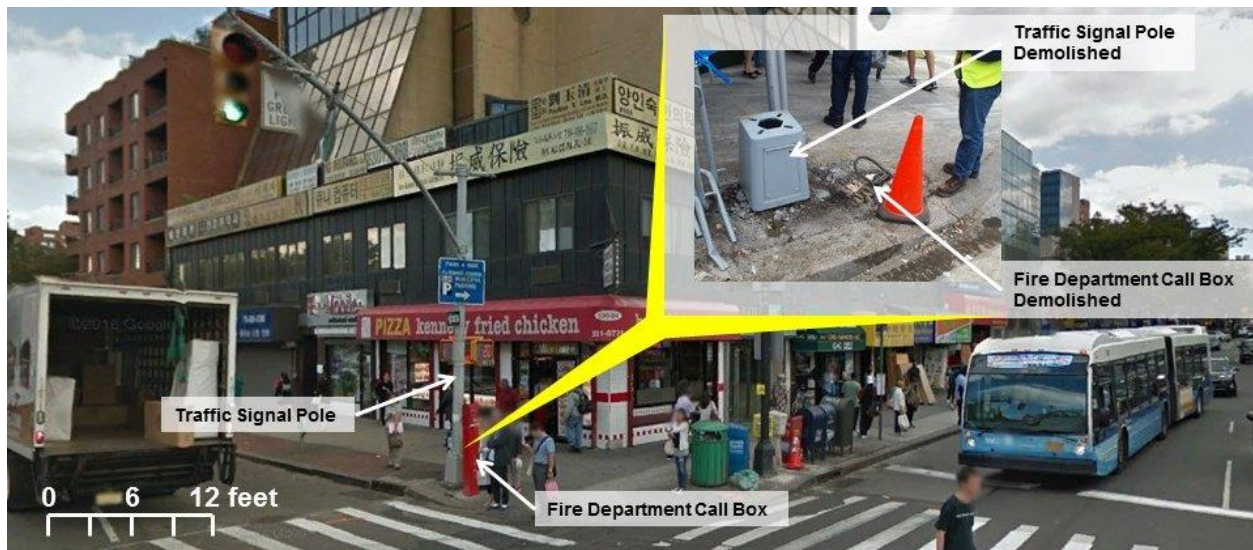
Figure 9 – View of the traffic signal pole and fire department call box demolished as a result of the crash (Source: Google Earth Maps revised)

Figure 9 shows a view of the traffic signal pole and fire department call box before and after the crash. Both the traffic signal pole and fire department call box were demolished as a result of the crash.
