Highway Factors Photographs

Tempe, Arizona

HWY18MH010

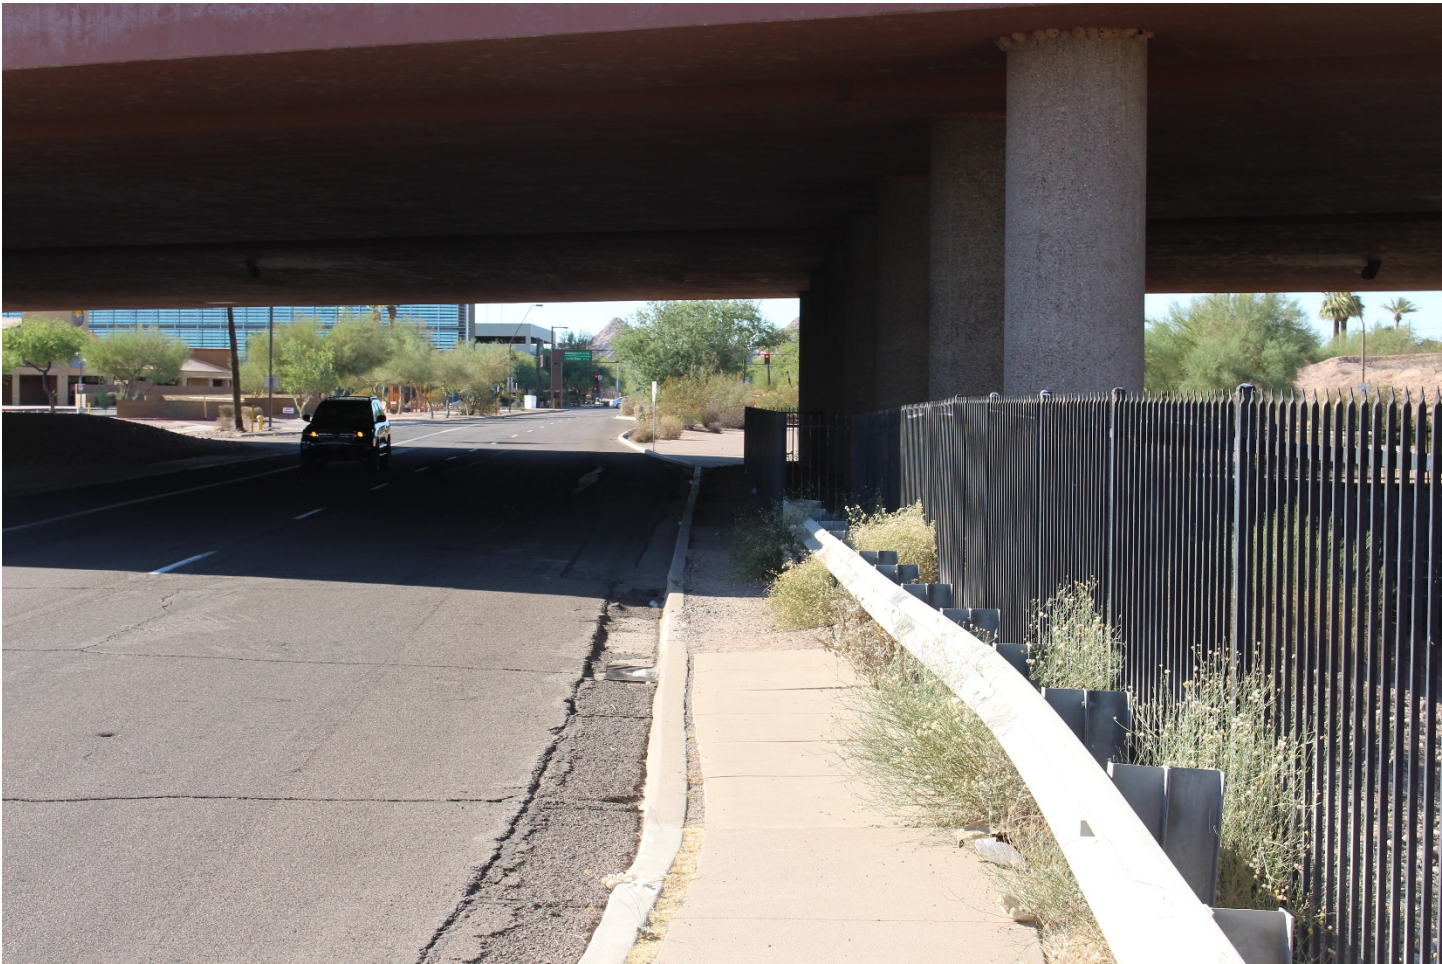
Highway Photo 1 – View of the pedestrian’s travel path into the median separating North and South Mill Avenue. Note the concrete sidewalk changes to a dirt path where the shadow of the overhead bridge begins in the photo.

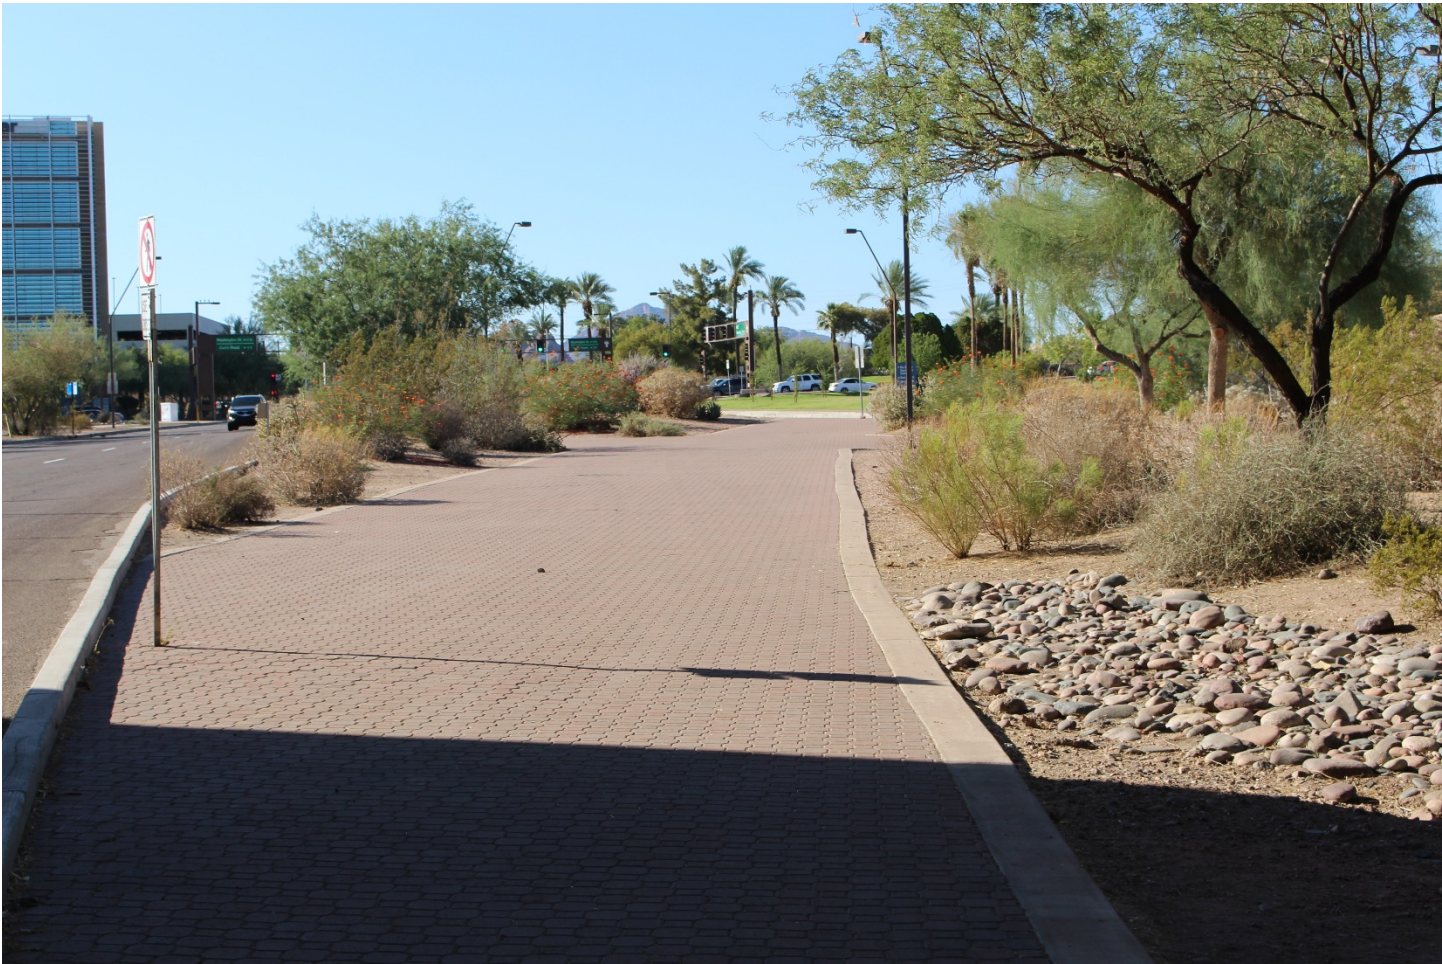
Highway Photo 2 – Continued view of pedestrian’s path in the median toward N. Mill Avenue. Note the sign facing outward in the left side of the photo that prohibits pedestrians from crossing S. Mill Avenue into the median area.

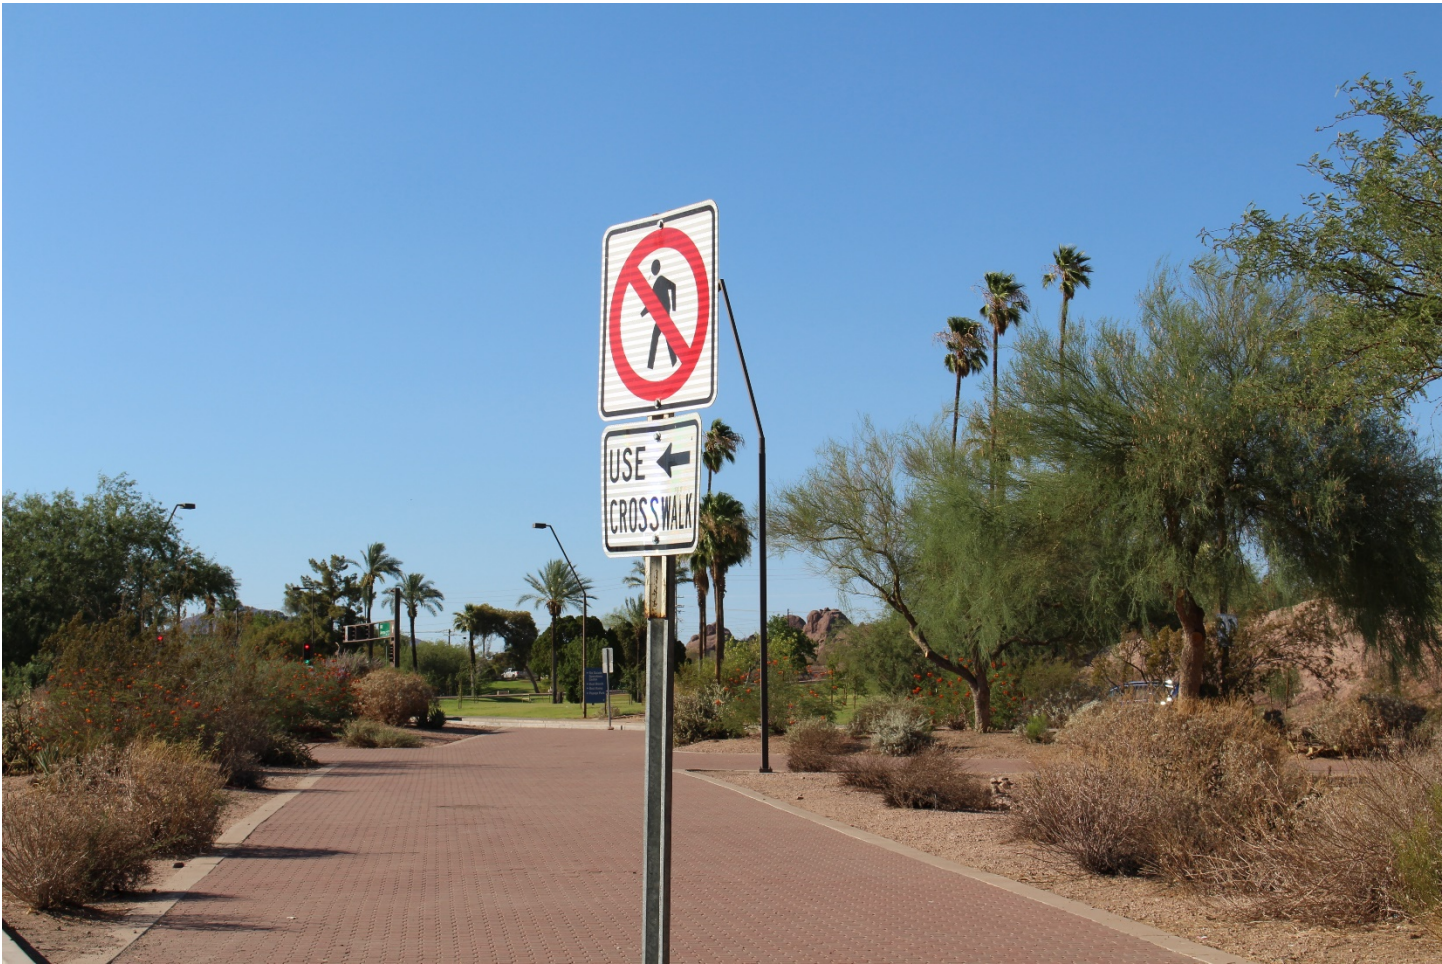
Highway Photo 3 – Close-up view of the wording on the sign.

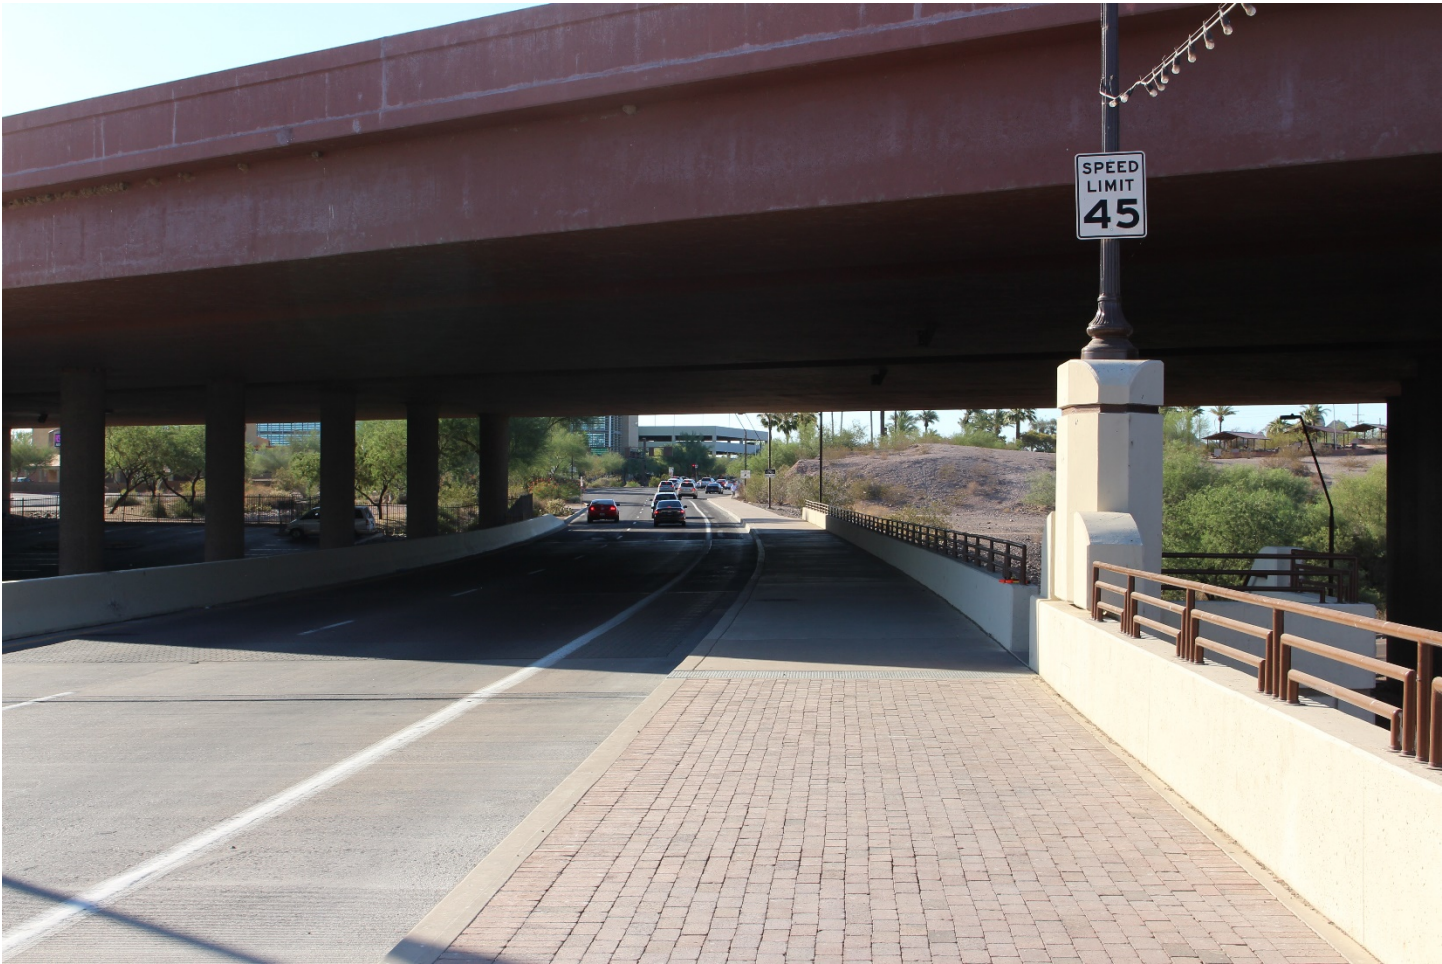
Highway Photo 4 – View of Uber Vehicle’s approach path to the accident area.

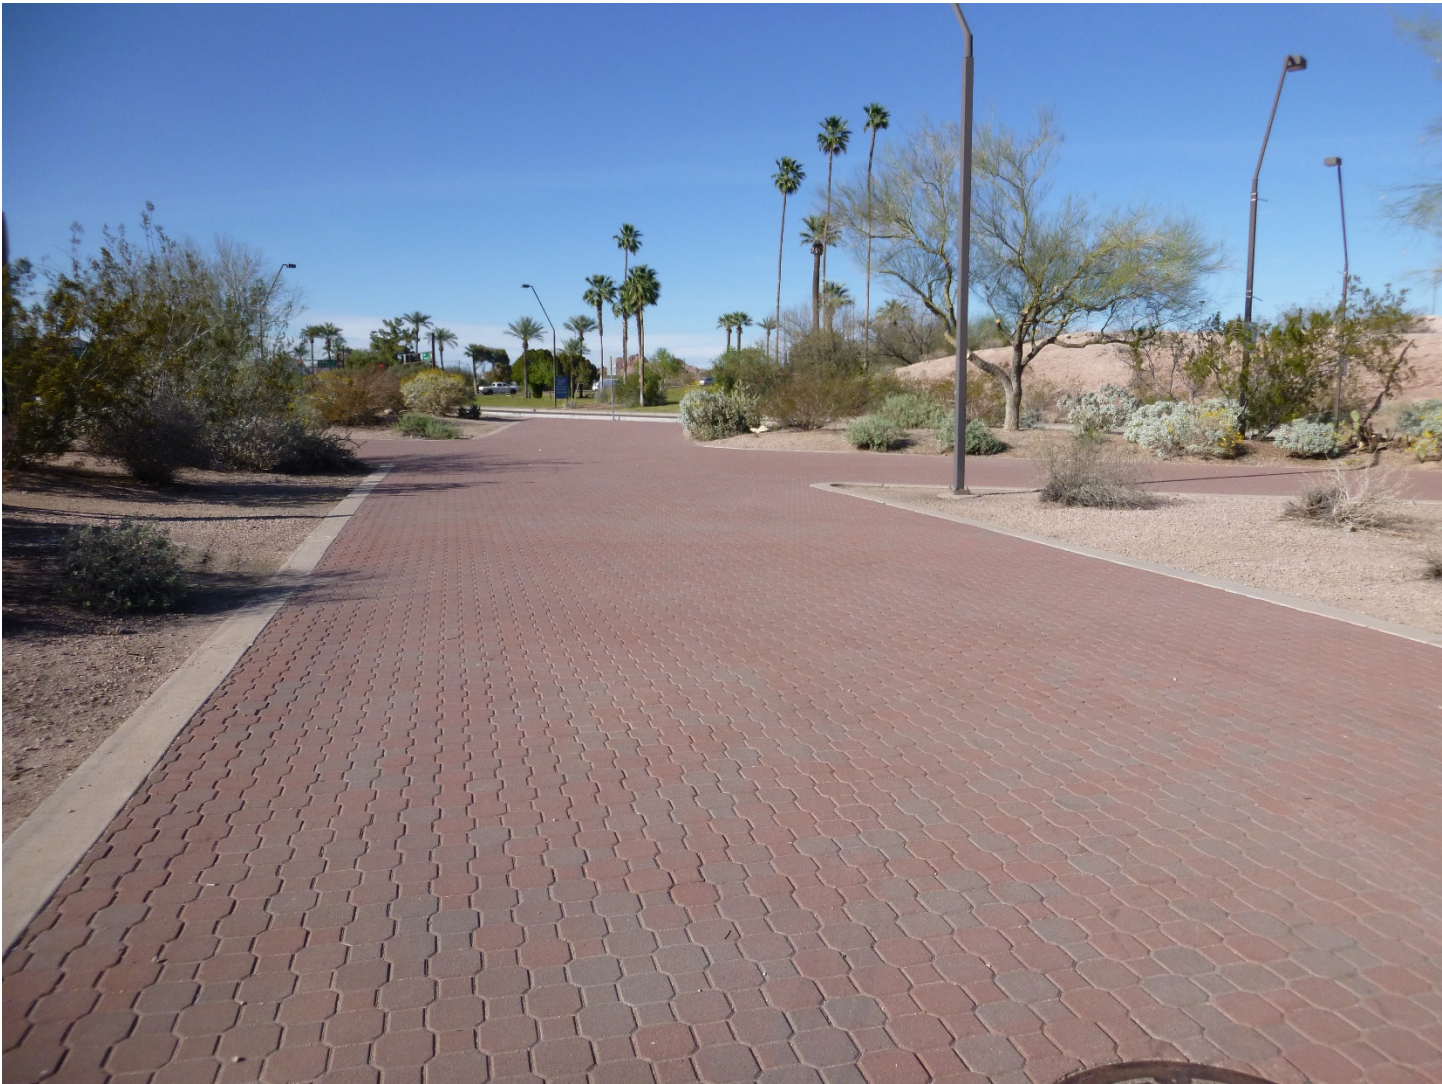
Highway Photo 5 – Pedestrian’s path through the landscaped median to where she crossed into N. Mill Avenue.

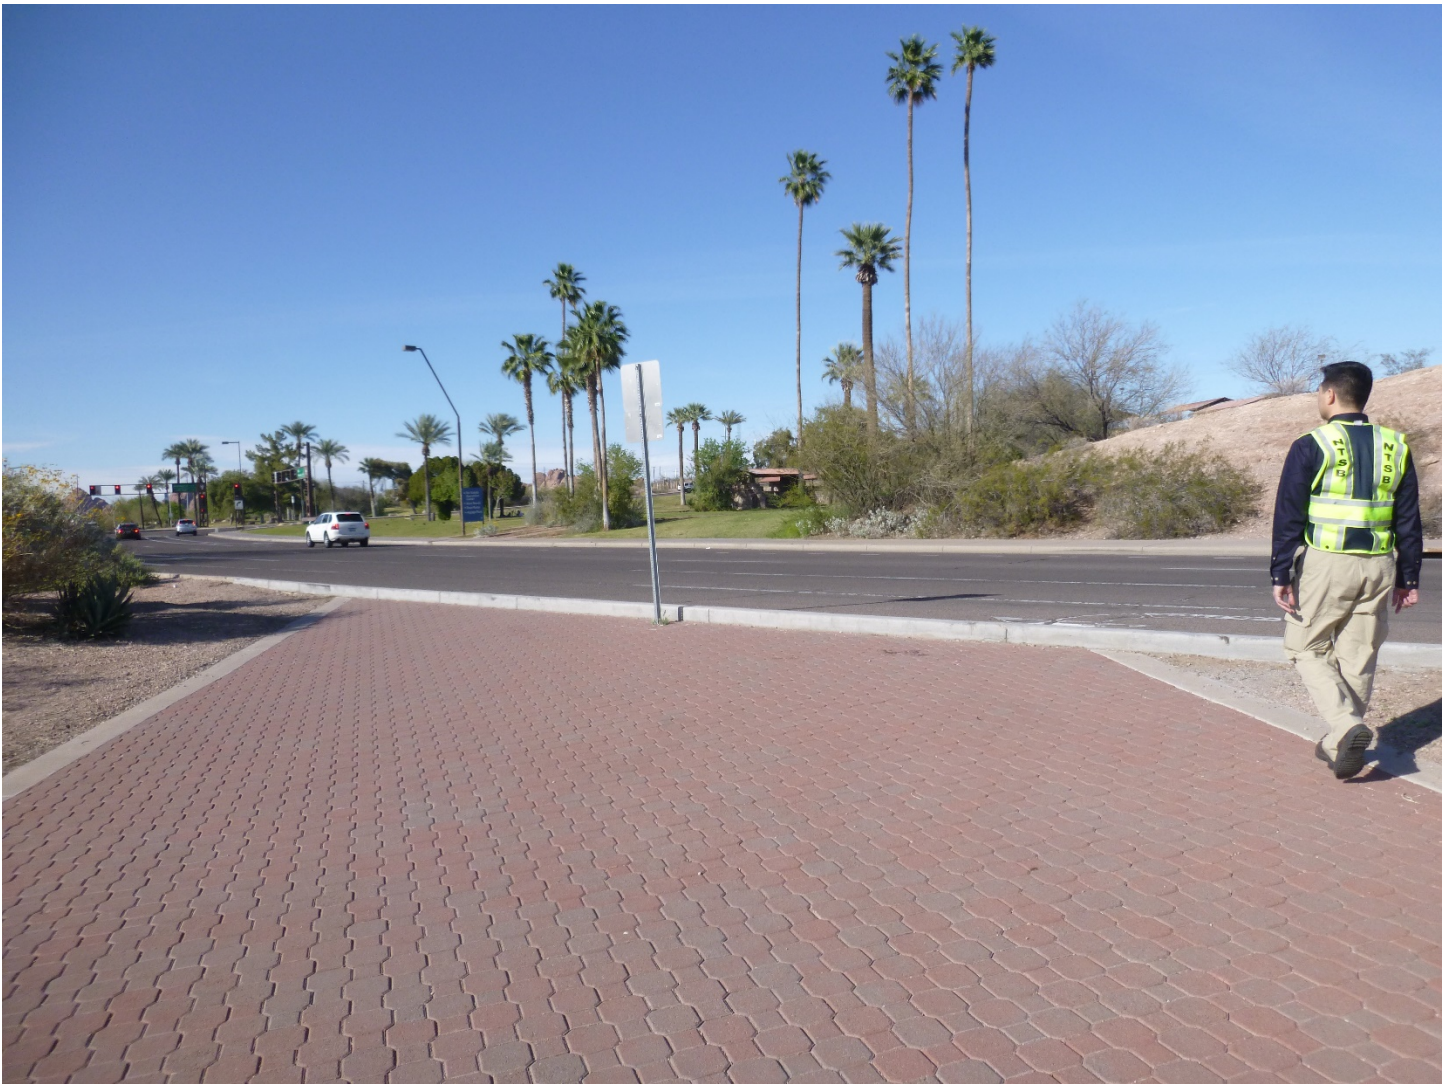
Highway Photo 6 – View of where the pedestrian exited the median to cross N. Mill Avenue. Note the sign prohibiting pedestrian crossing in the area is facing the opposite direction. Tempe Public Works will be adding double side signs so that pedestrians coming into the area from under the bridge will have additional signs to guide them to the crosswalk at Washington St./ Curry Road.

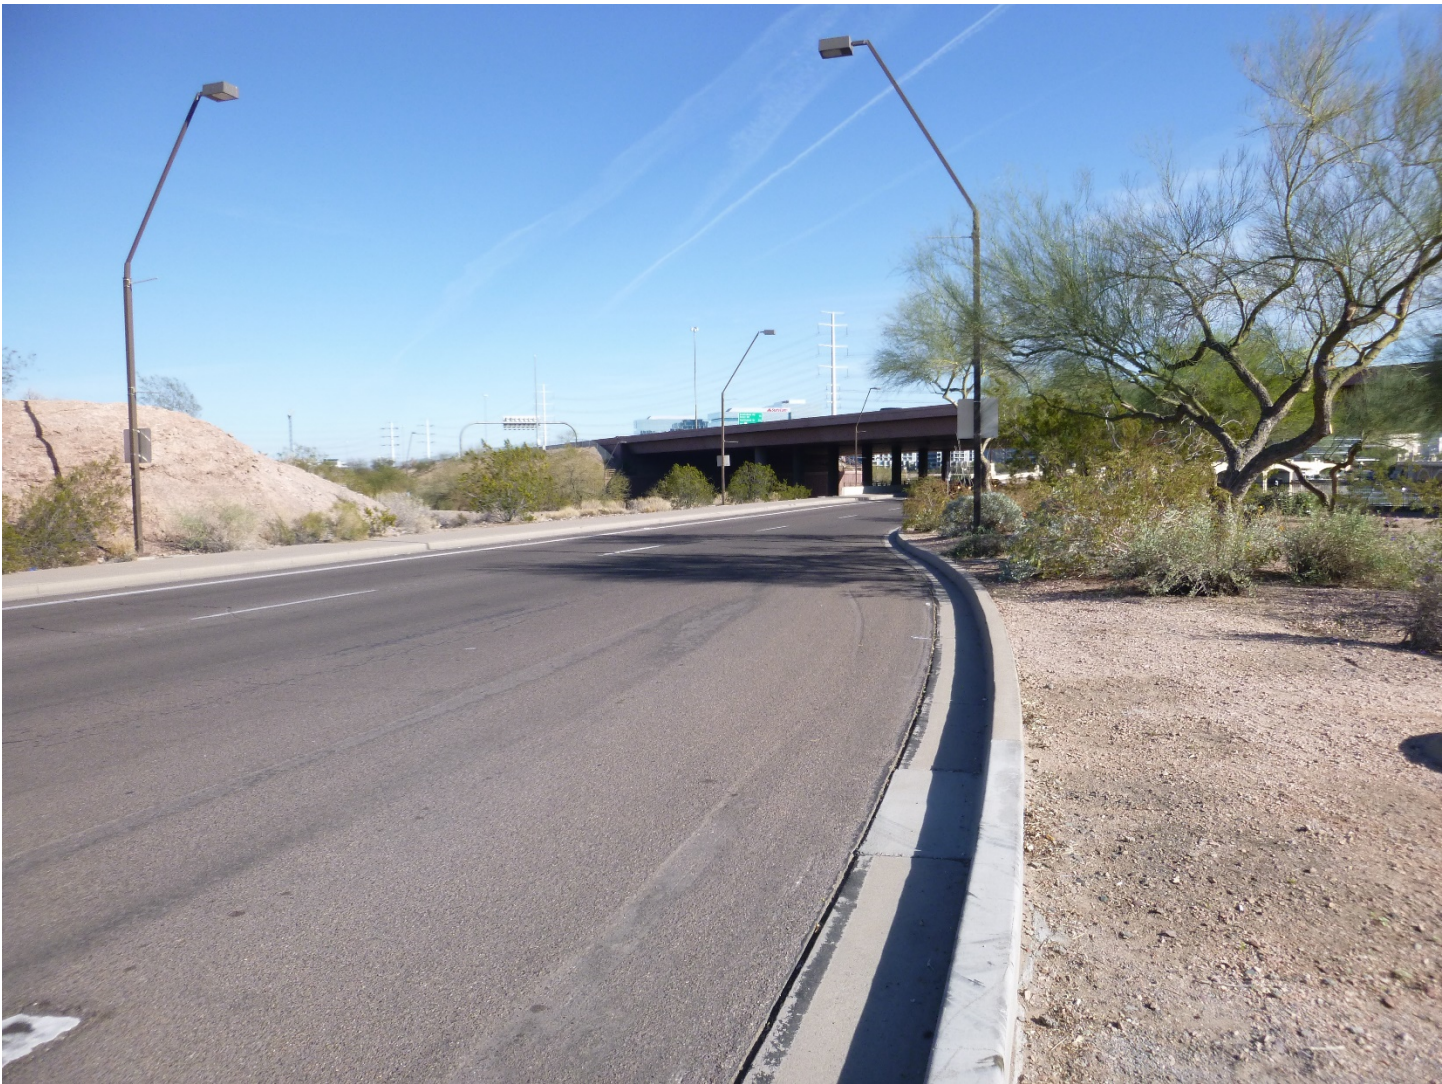
Highway Photo 7 – View to the pedestrians right where the Uber vehicle approached from.

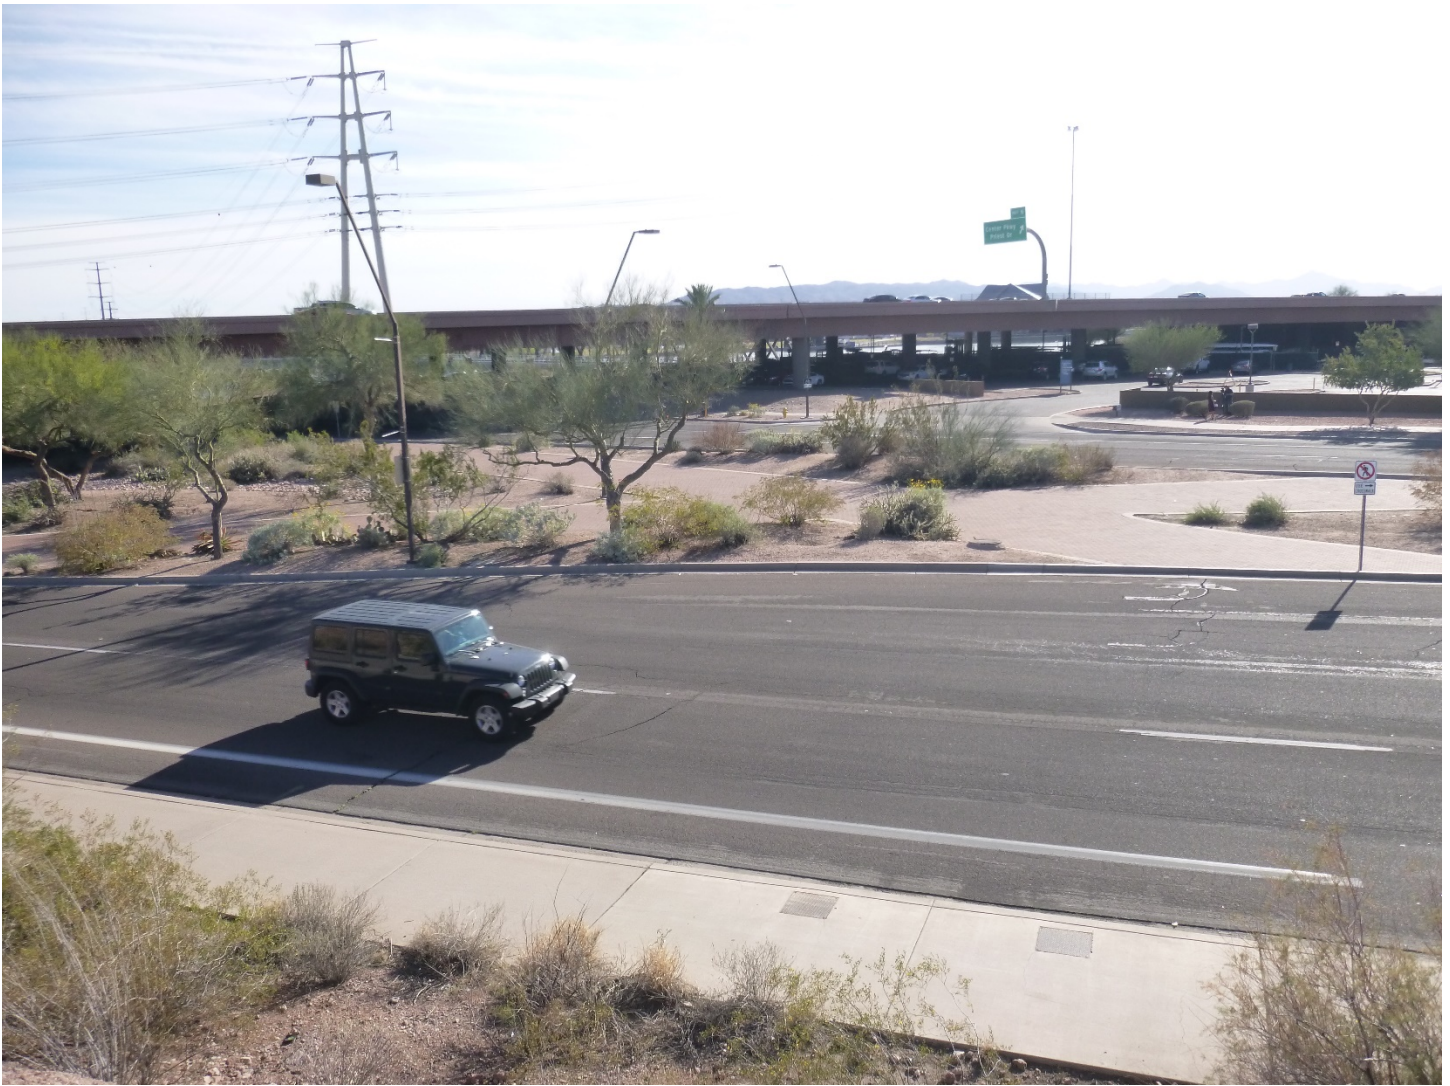
Highway Photo 8 – View looking to the west at North Mill Avenue, showing the median area, and South Mill Avenue. In the bottom of the photo are two squares marking the location of drainage inlets. The impact occurred nearest the inlet on the left in the photo, approximately 5 feet west of the solid white line. Also, the impact was 22.5 feet prior to the end of the solid white bicycle path line shown in the bottom of the photo.

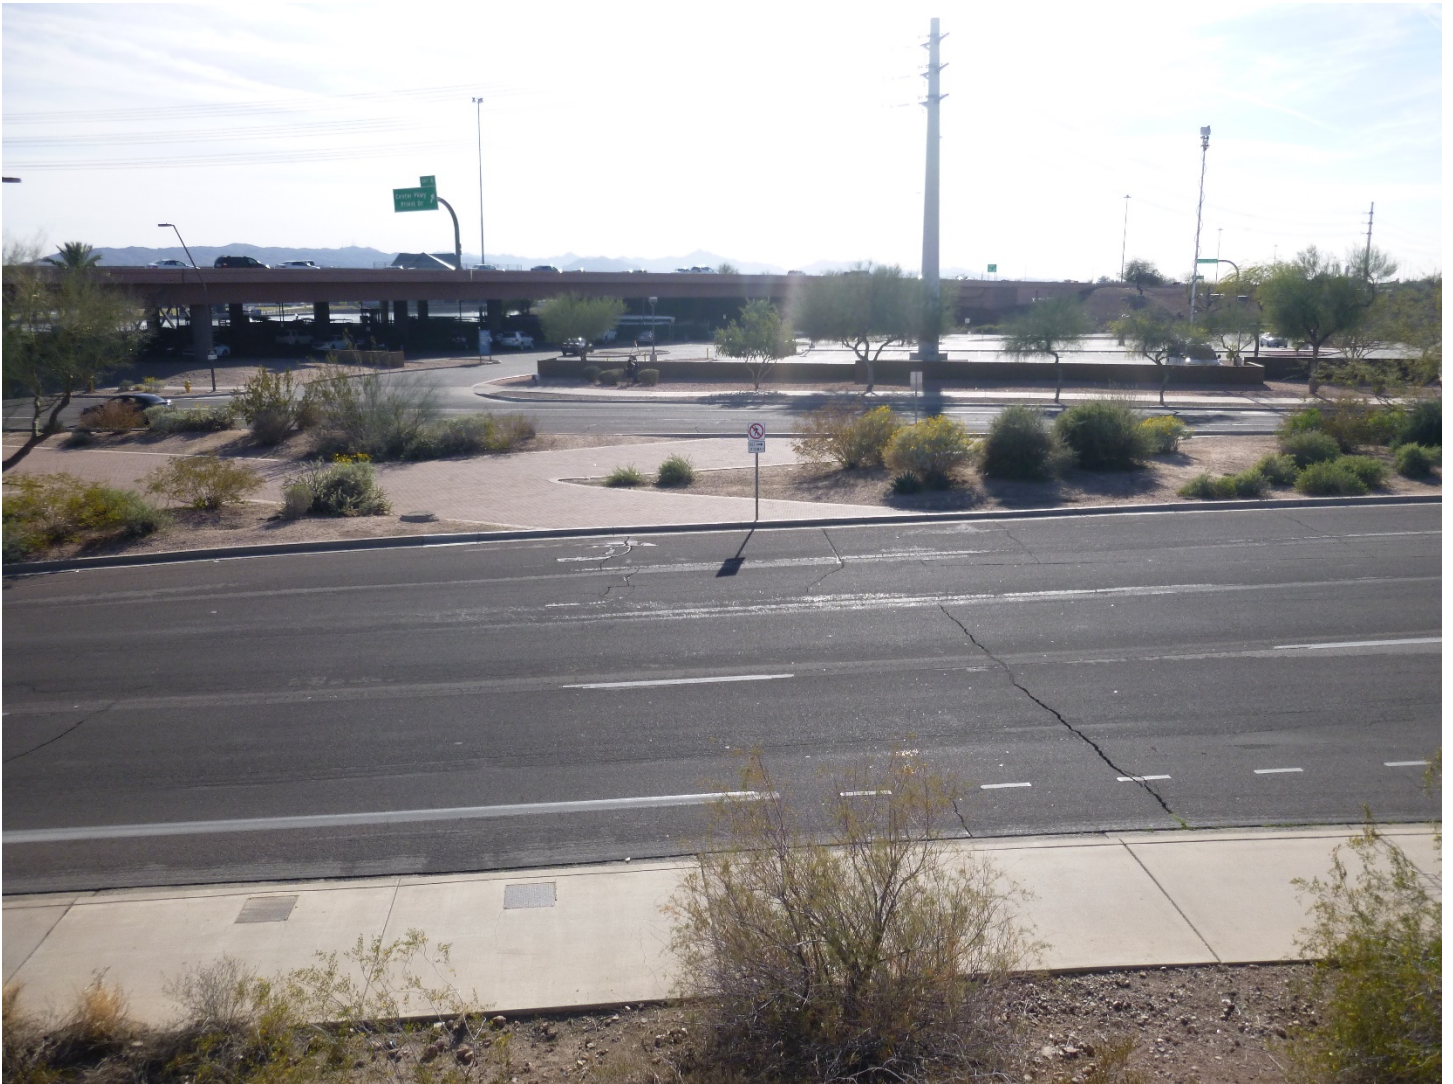
Highway Photo 9 – Additional view of North Mill Avenue looking where the impact occurred in the right-hand lane perpendicular to the drainage inlet on the left in the photo.

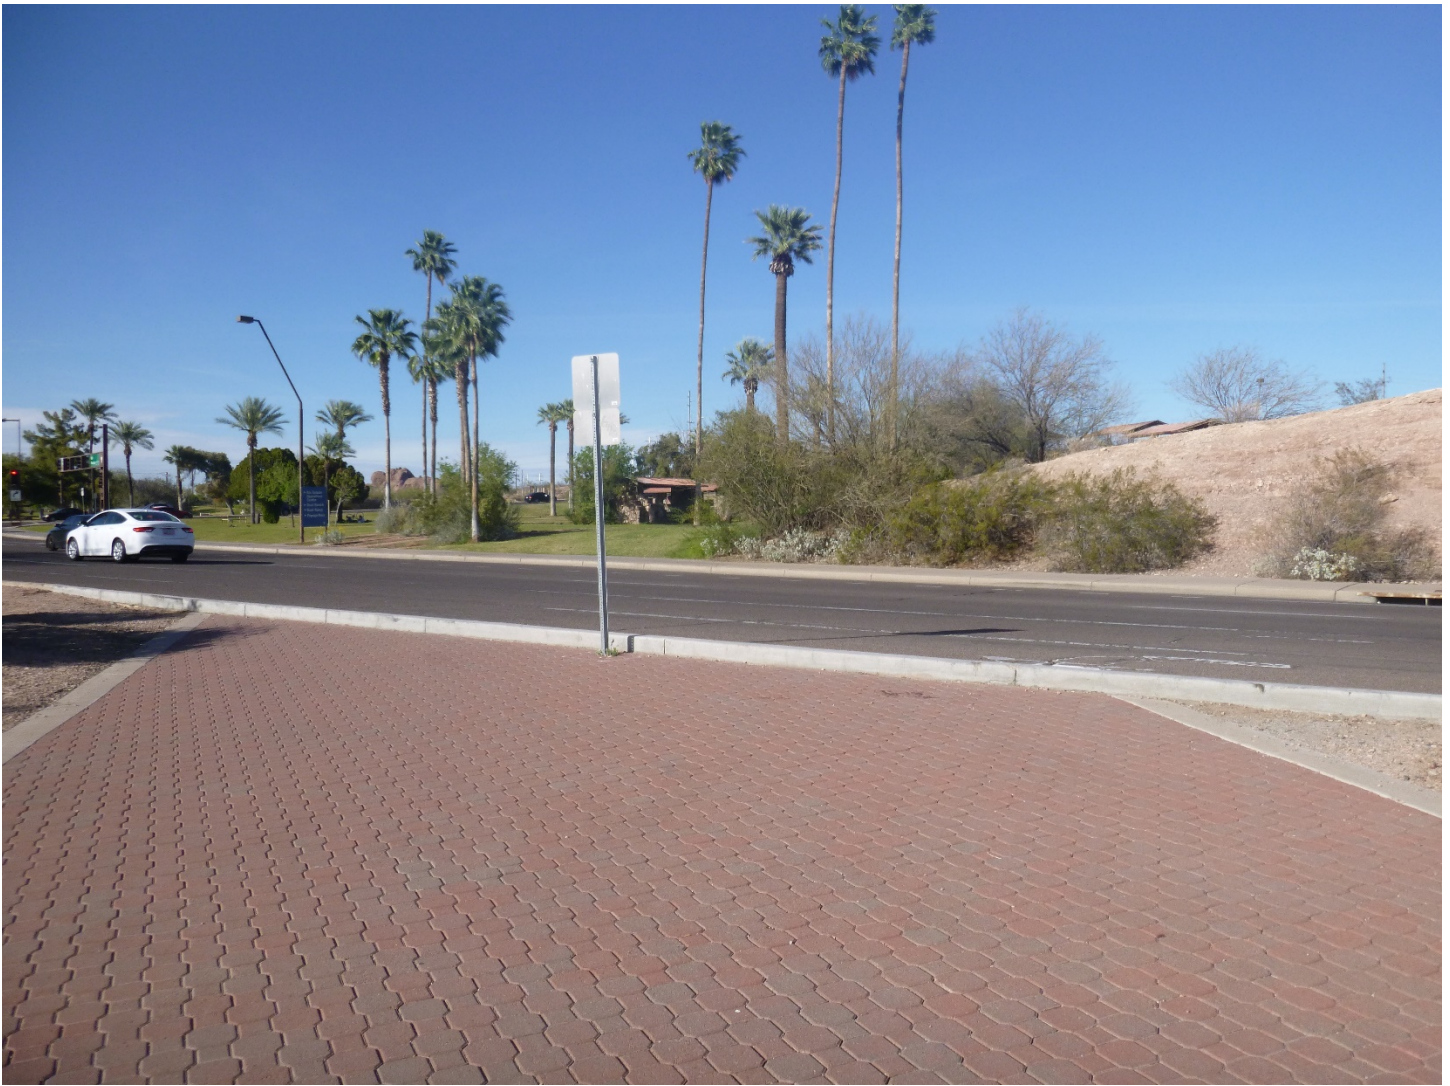
Highway Photo 10 – Area where the pedestrian entered North Mill Avenue moving toward the drainage inlets on the right side of the photo.

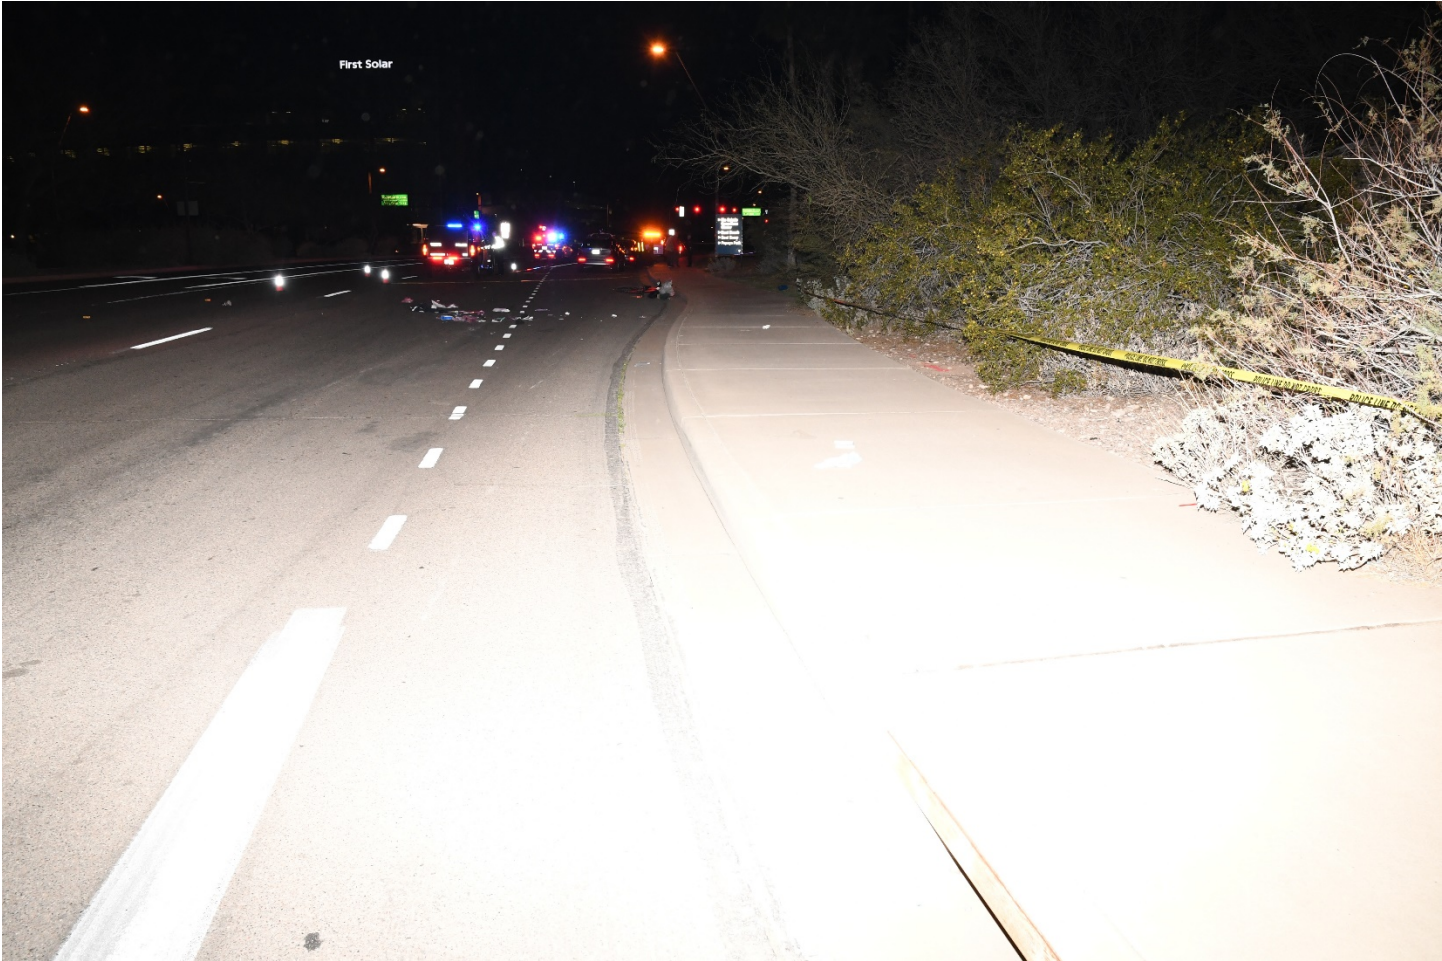
Photo 11 – (Photos 11-20 Courtesy of Tempe Police Department) This photo depicts just north of the impact area with medical debris in the right-hand lane and the bicycle laying where the right turn lane begins.

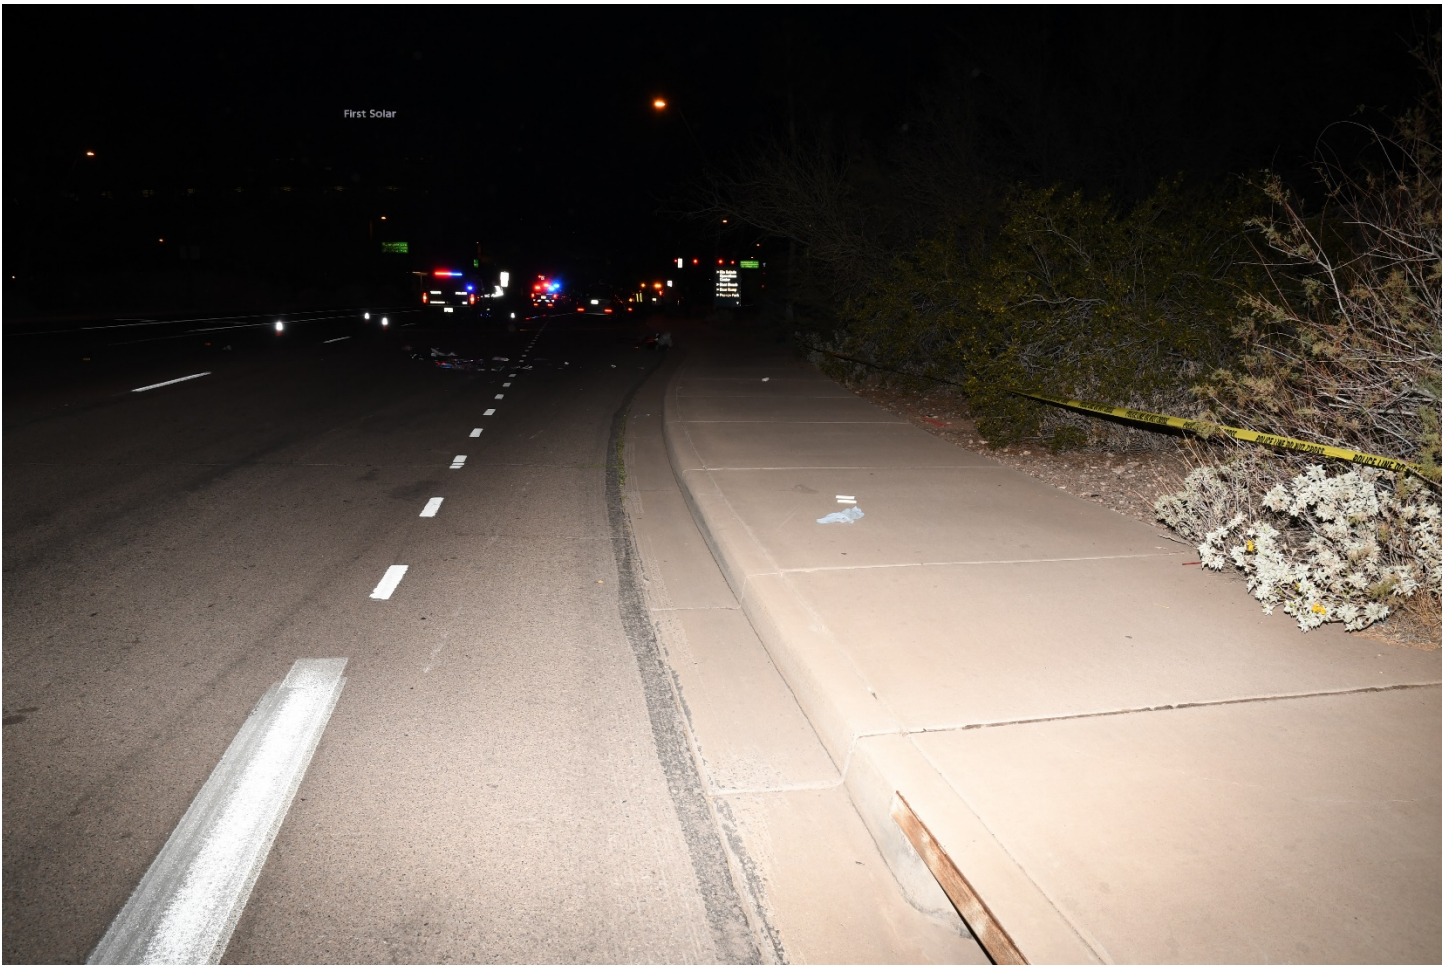
Photo 12 – Additional view of accident scene the night of the accident.

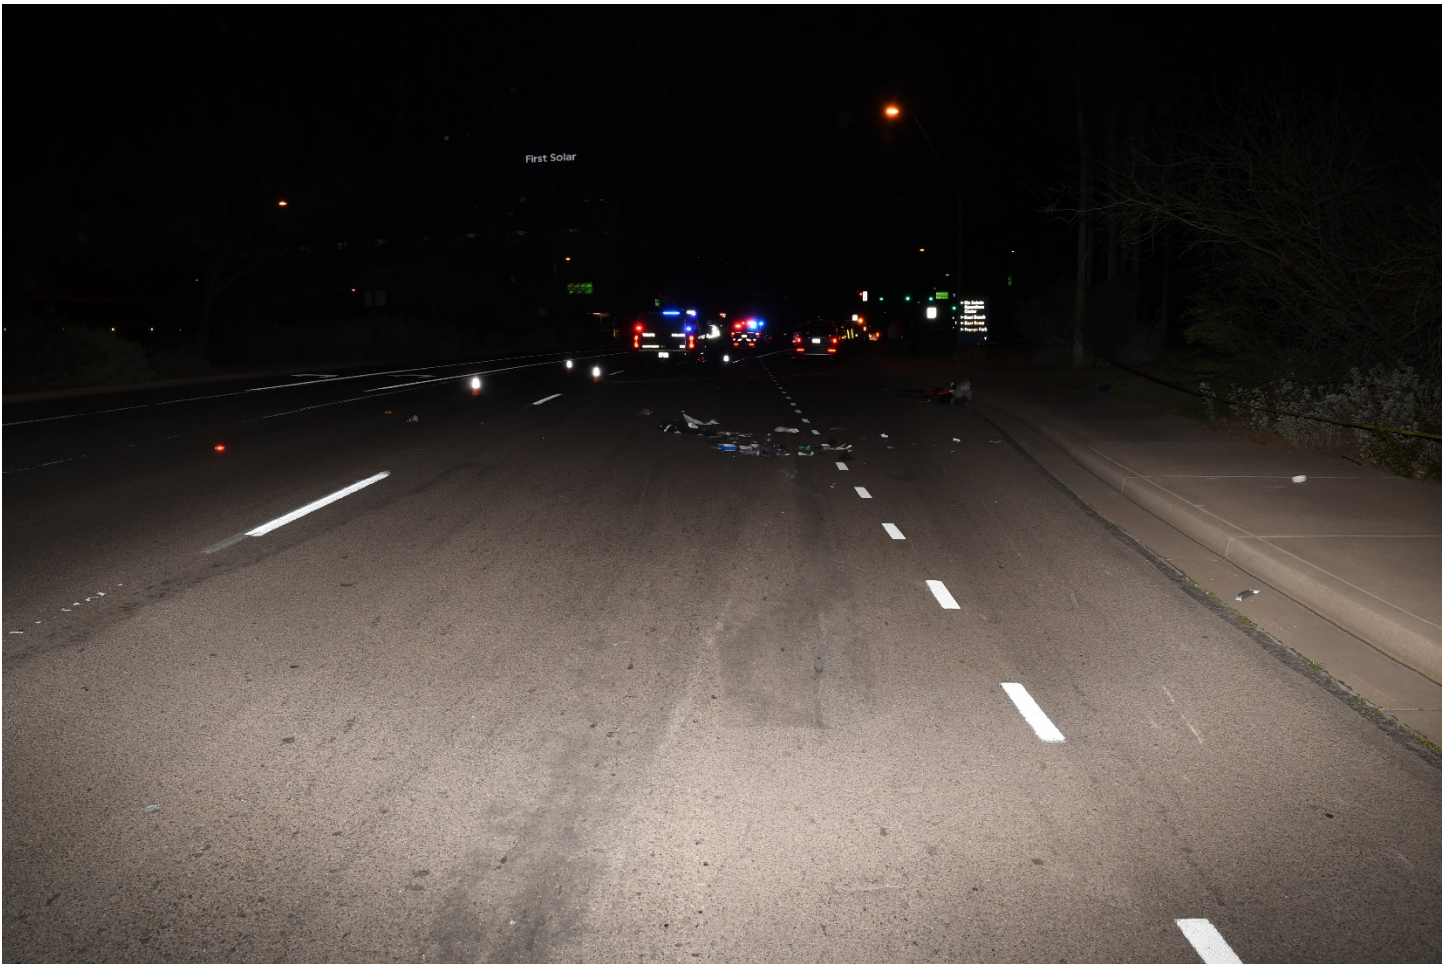
Photo 13 - View of postcrash scratches in the pavement, smear marks from the victims clothing, and medical debris along with the bicycle in the background.

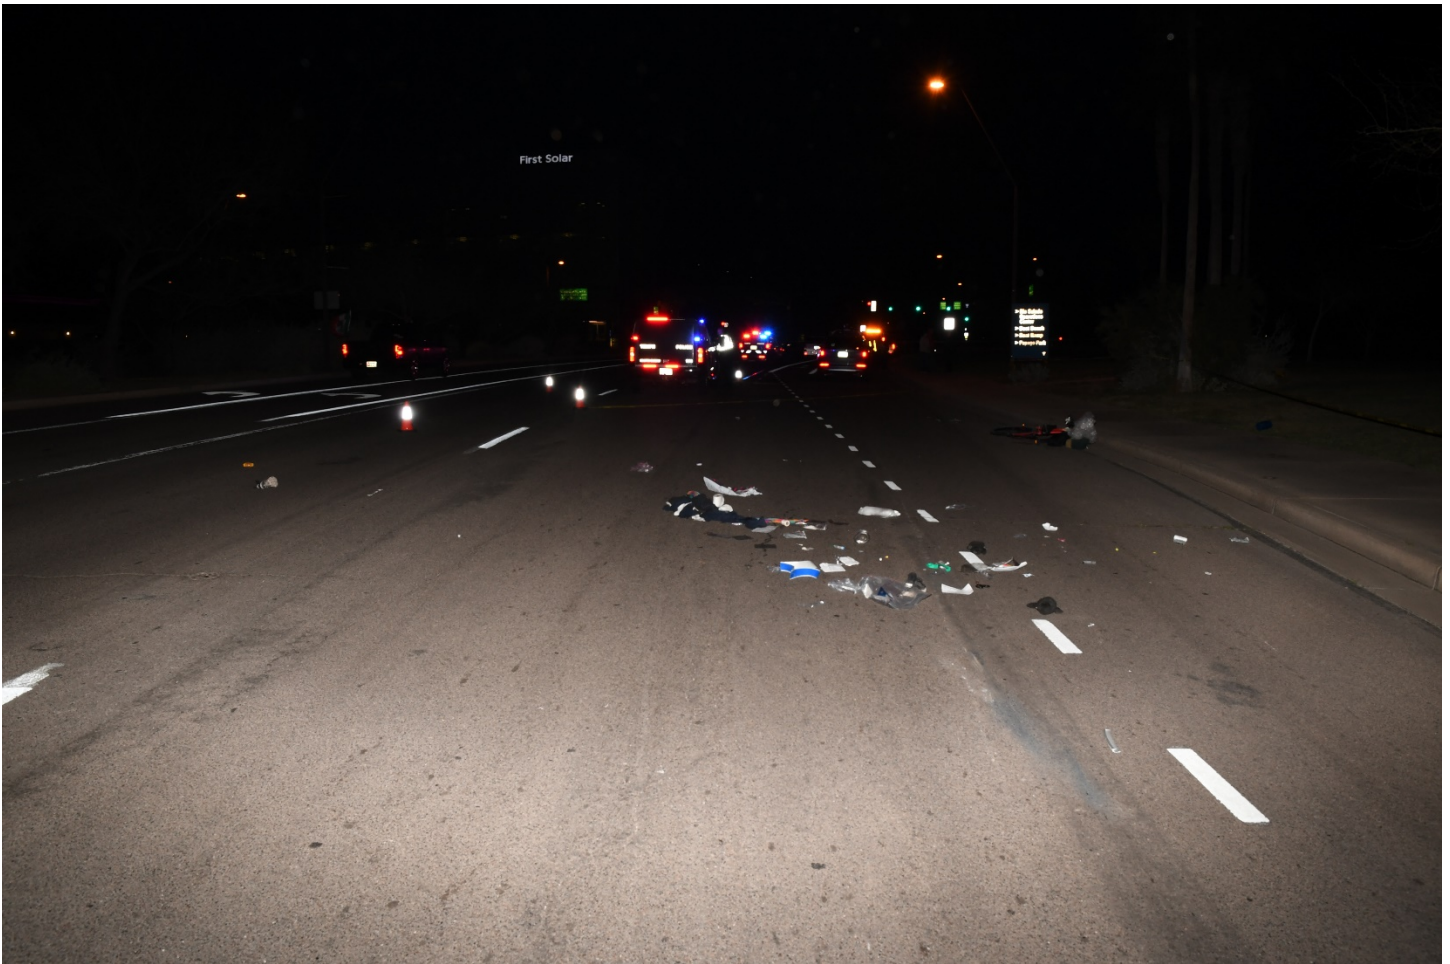
Photo 14 – Closer view of the victims clothing smears in the right-hand lane and the bicycle laying in the right-hand turn lane against the curb.

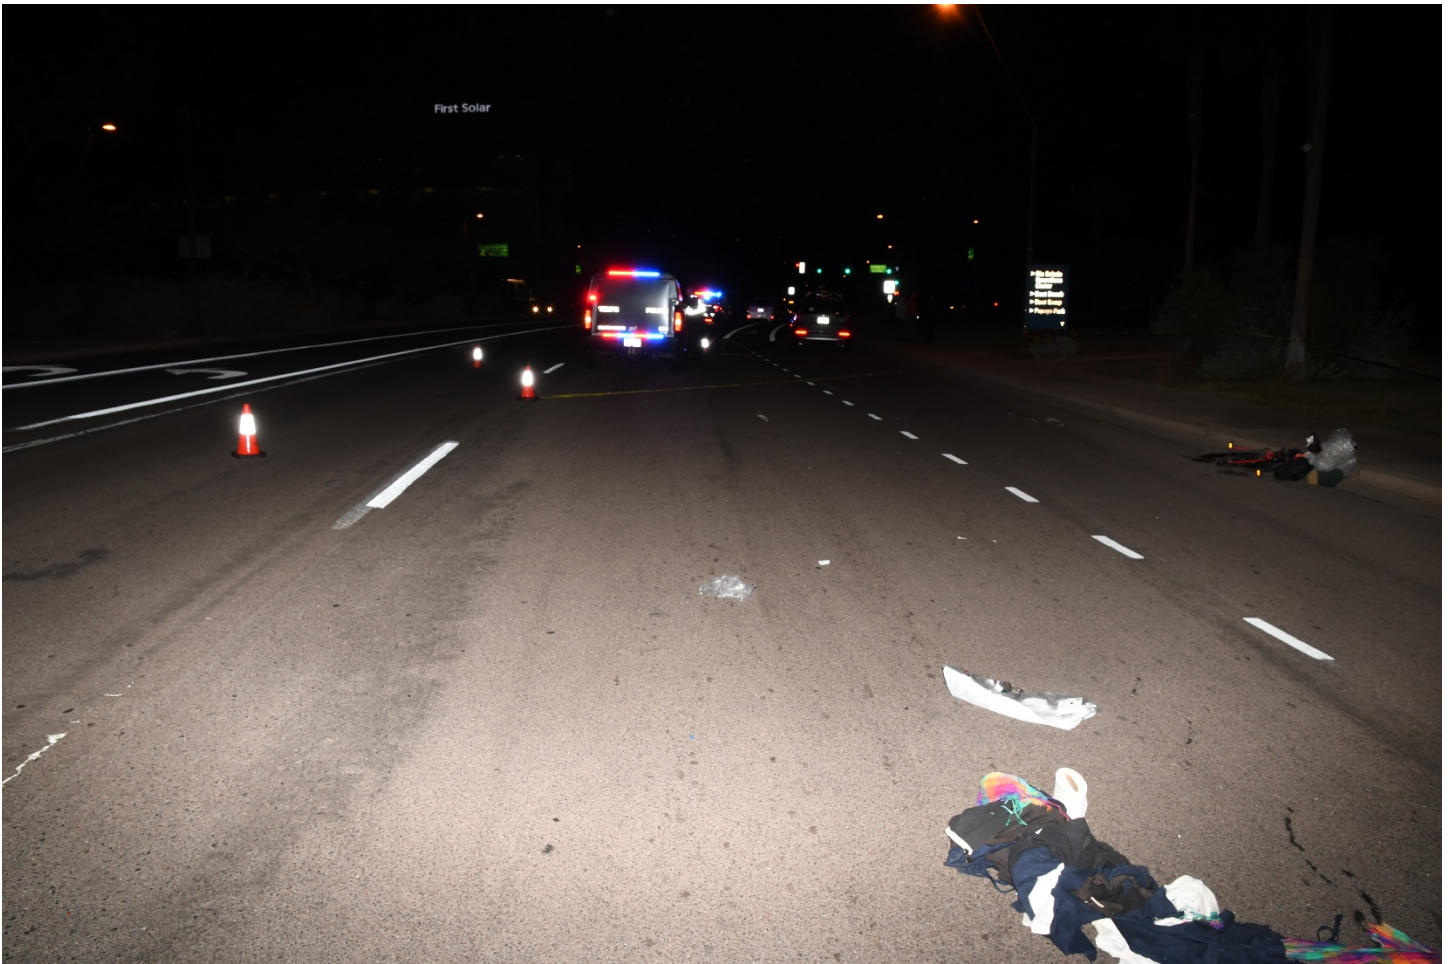
Photo 15 – View of victims clothing and medical debris in the right-hand lane followed by the bicycle and then the Uber vehicle in the right-hand turn lane.
