Highway Factors Photographs

Tempe, Arizona

HWY18MH010

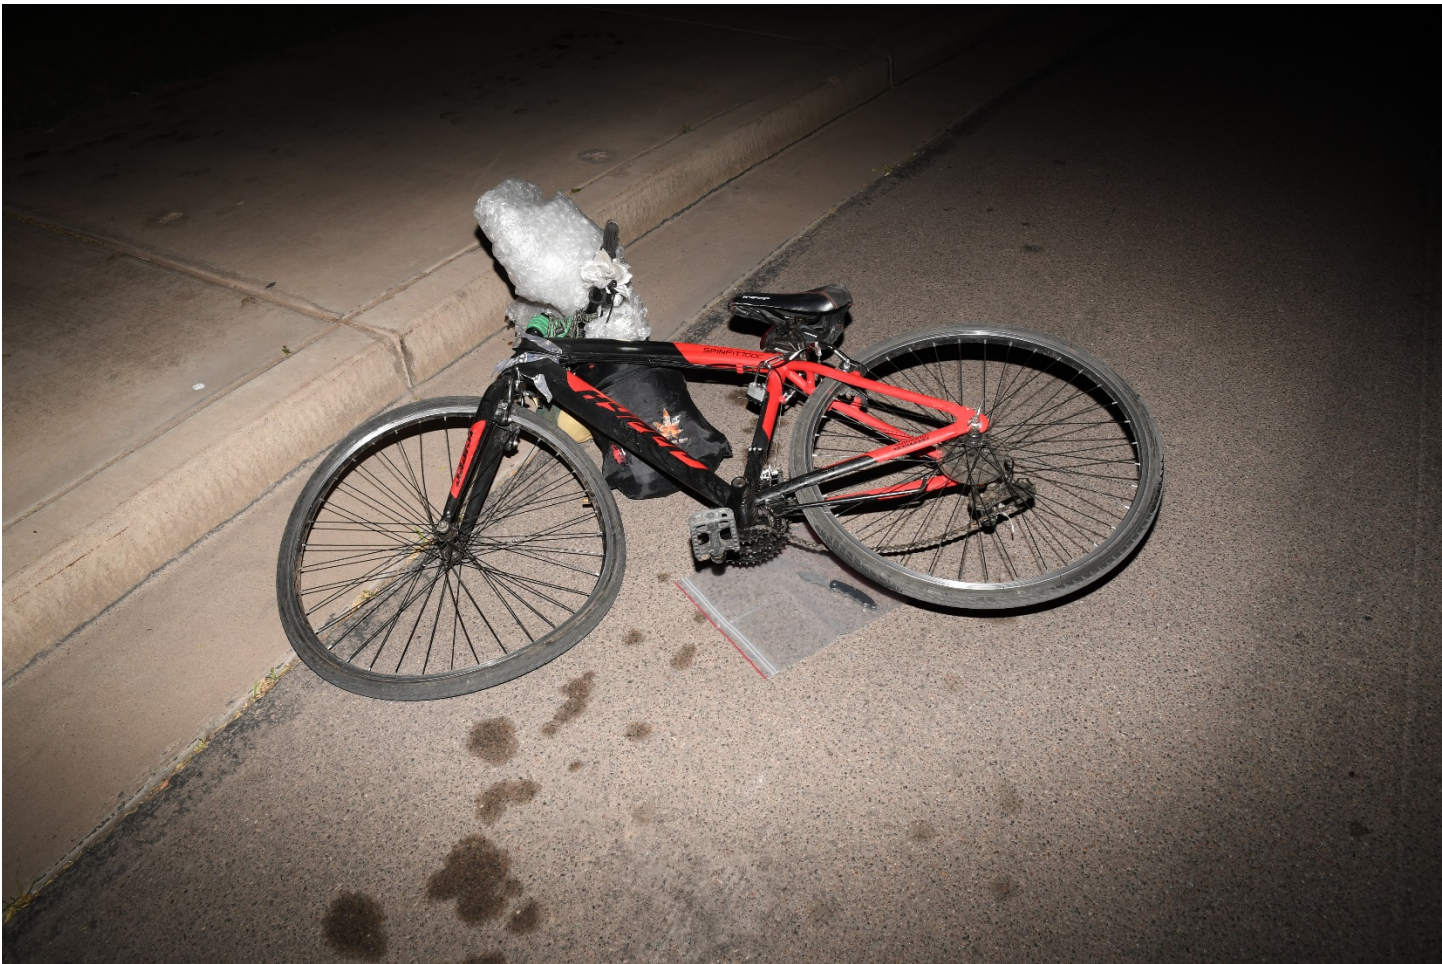
Photo 16 – Close-up view of the black and orange bicycle the pedestrian was walking across the road at impact.

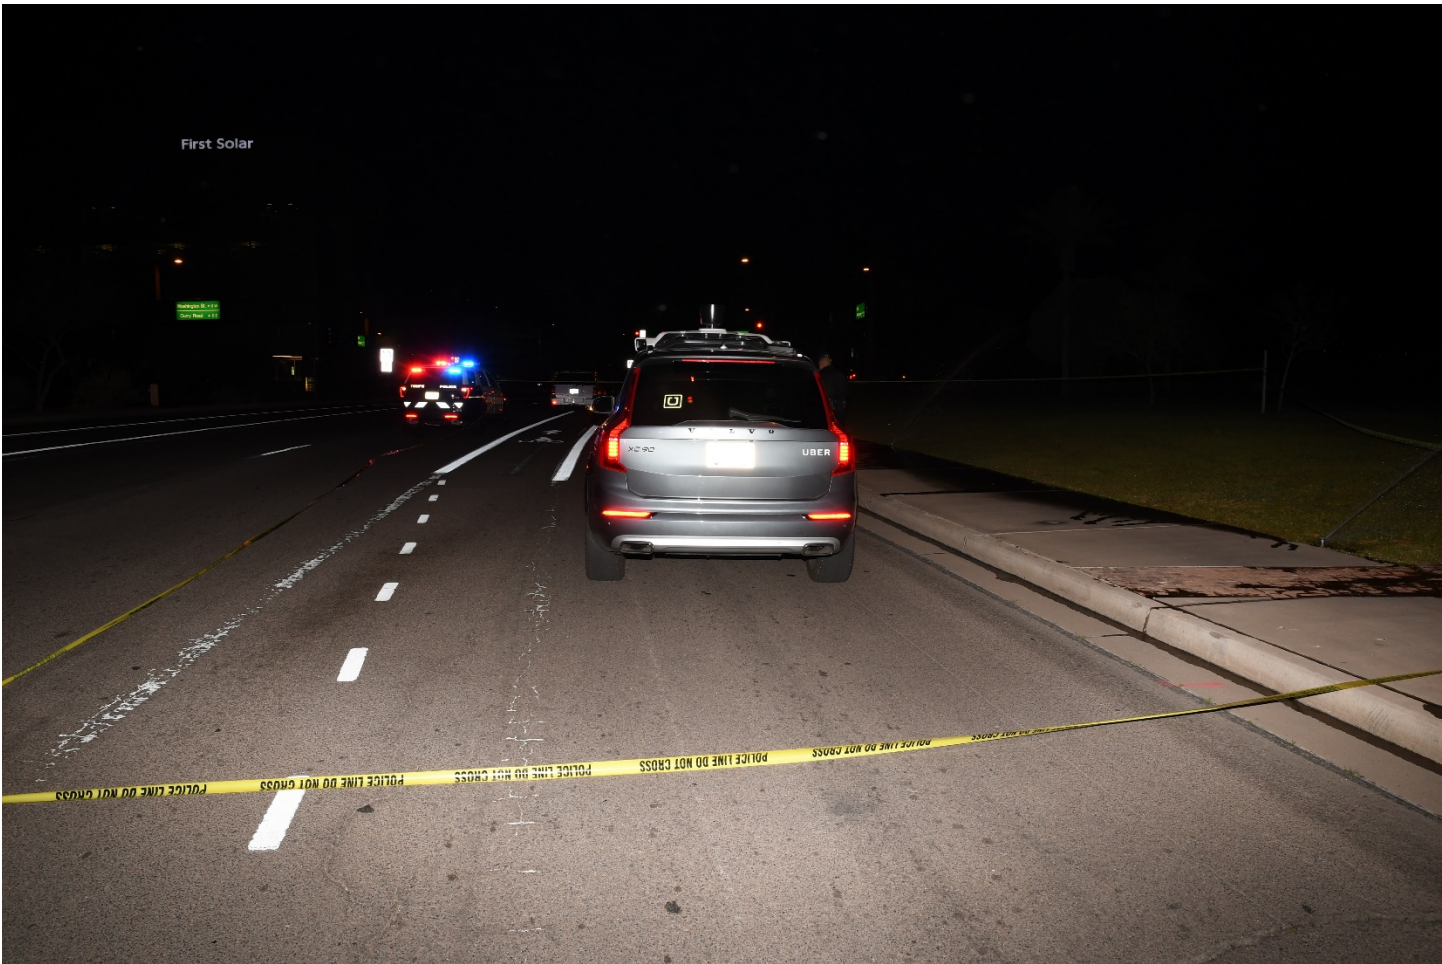
Photo 17 – View of Uber Vehicle at final position following the impact.

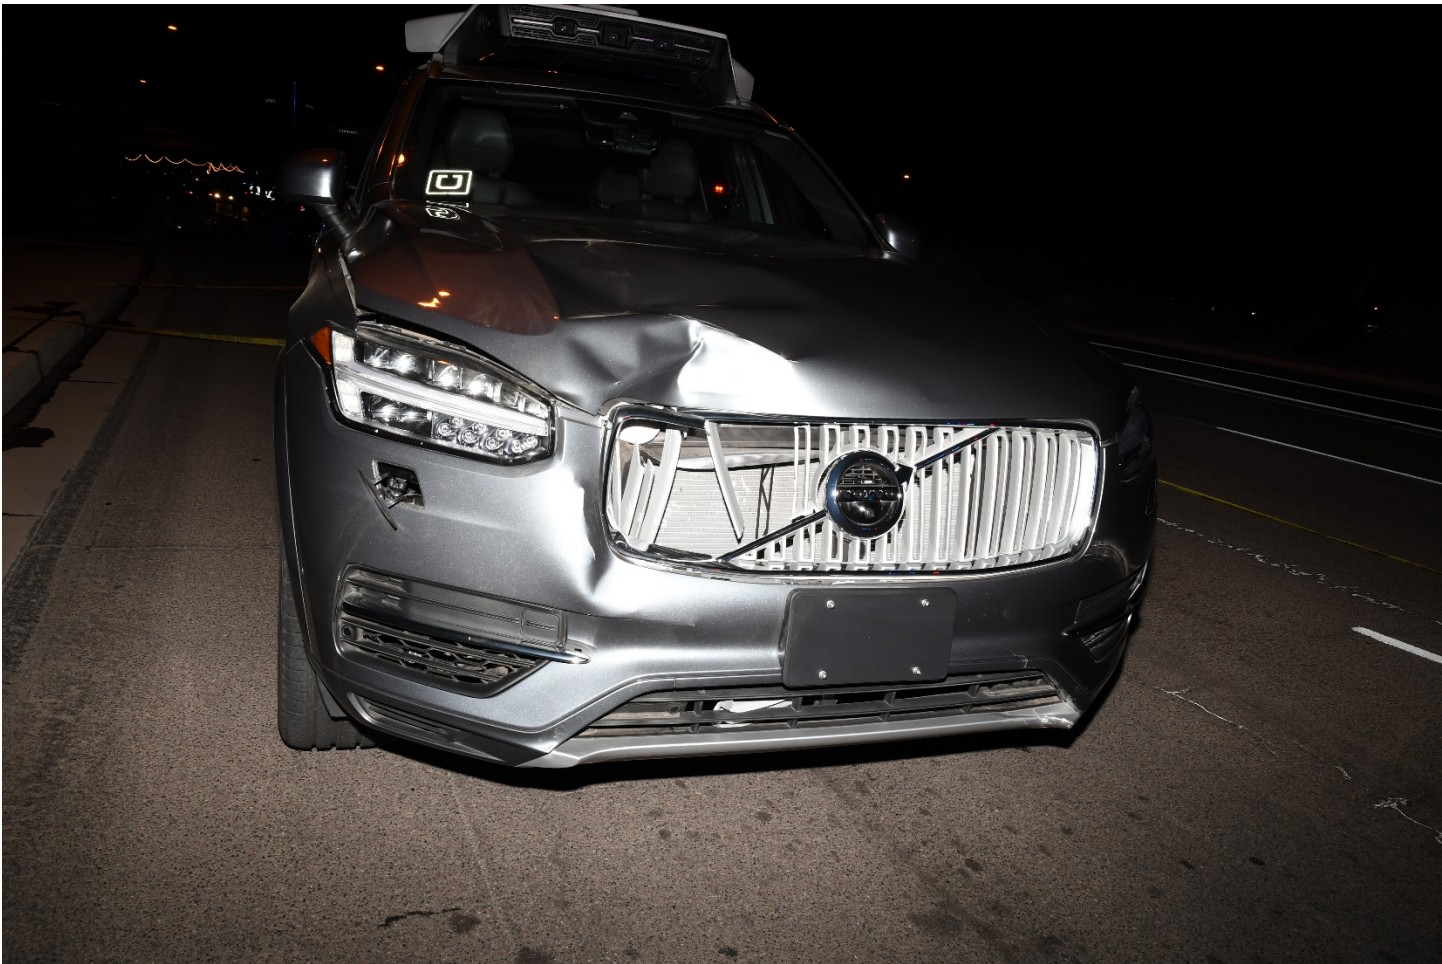
Photo 18 – View of the damage from the impact on the right front of the Uber/Volvo.

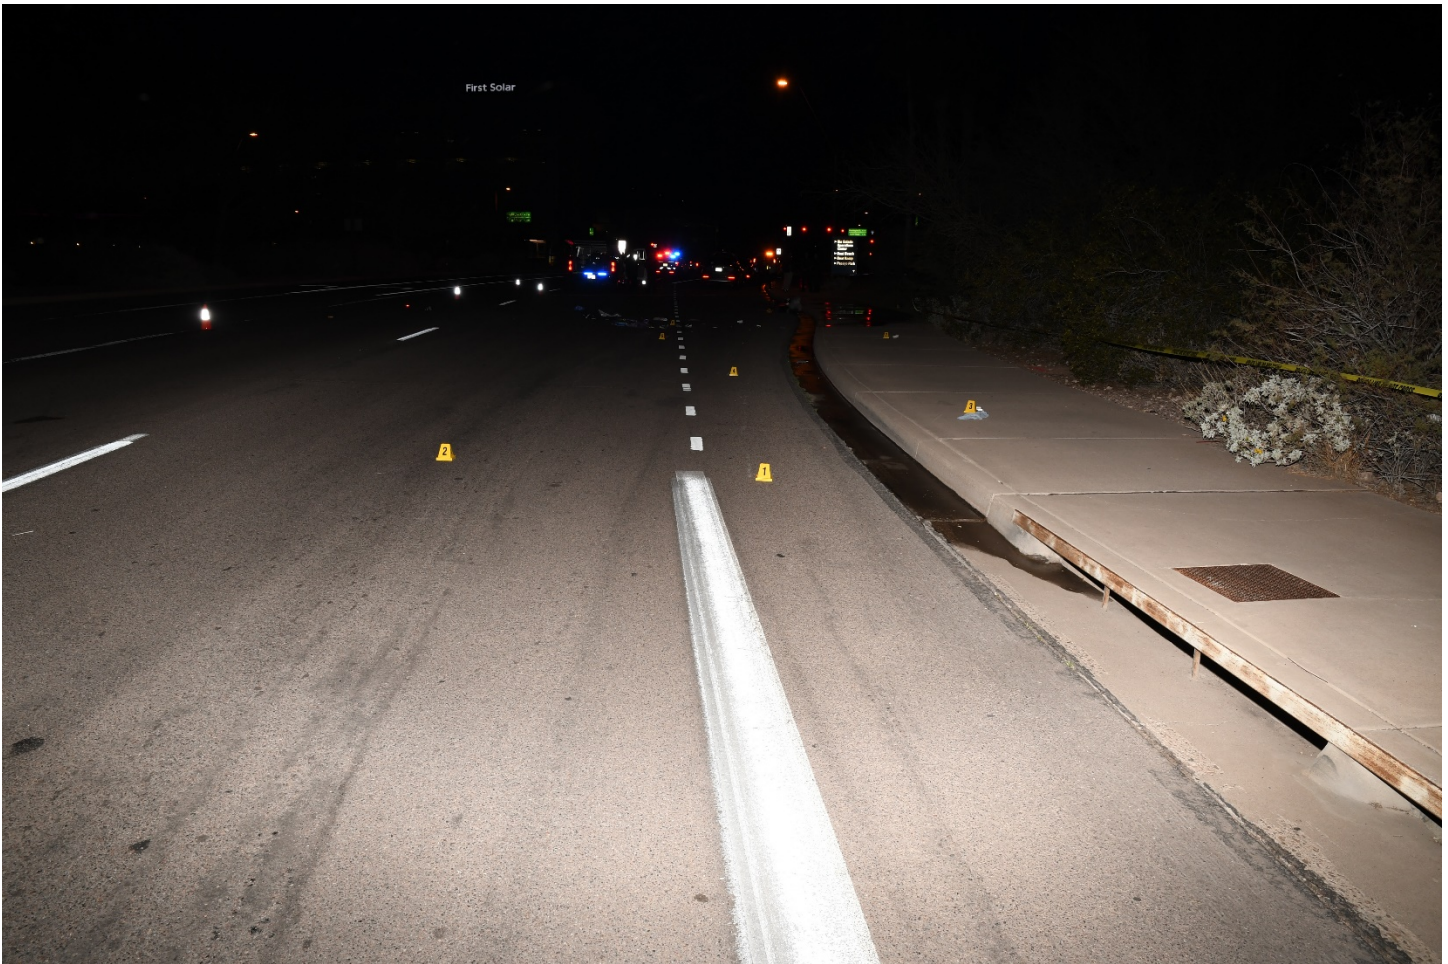
Photo 19 – View of impact area at bottom of photo 5 feet to the left of the solid white bicycle lane line. In the far background evidence tags are placed by debris areas.

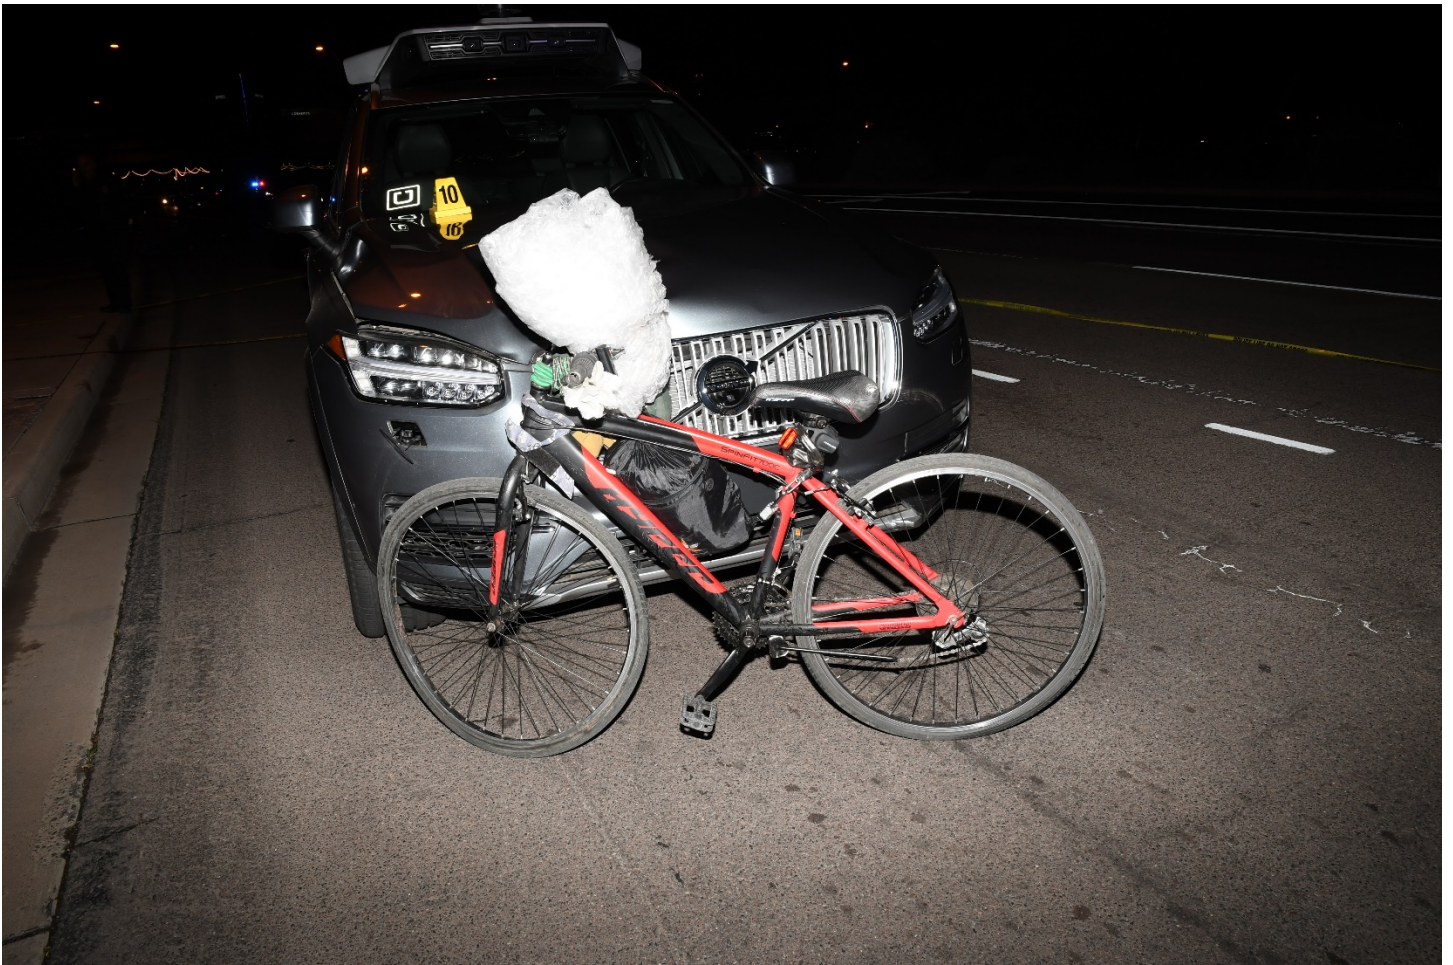
Photo 20 – View showing bicycle matched up to the damaged areas on the Uber/Volvo.
