**HIGHWAY FACTORS GROUP CHAIRMAN'S
FACTUAL REPORT**

Baltimore, MD

HWY17MH007

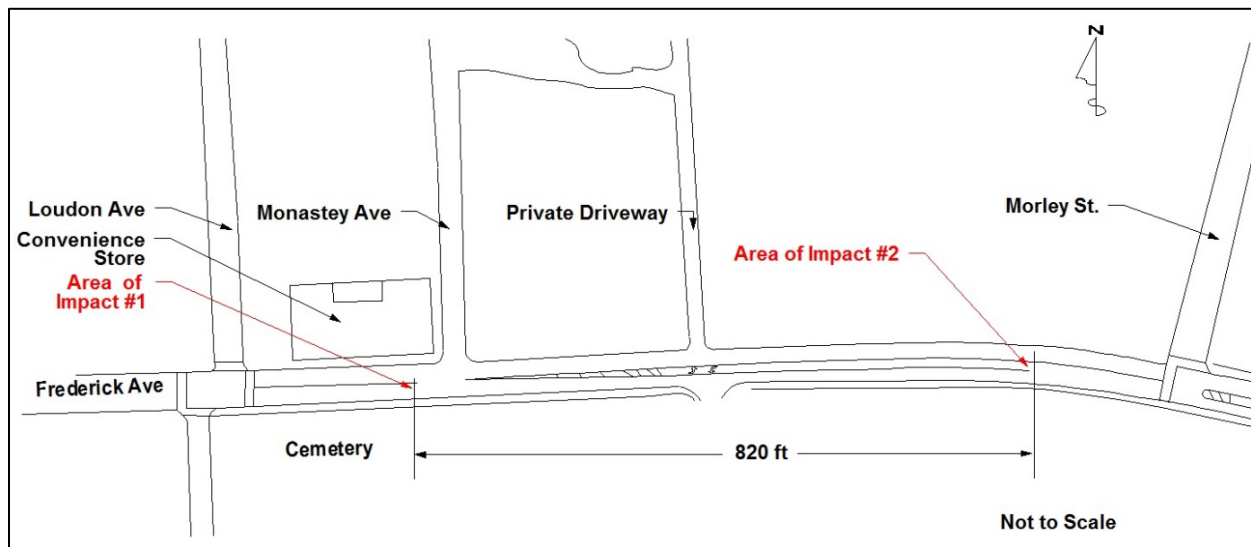
Figure 2. Location of Impact Area #1, Where the School Bus Struck the Mustang and Area #2, Where the School Bus Struck the Transit Bus

The two impacts involved in the crash sequence accident occurred between the 3800 and 3900 blocks of Frederick Avenue (State Route SR 144). The highway facility is owned and maintained by the City of Baltimore. The crash event involved two separate impacts. First, the school bus collided into the rear of a Ford Mustang, and then continued forward eastbound on Frederick, approximately 820 feet to where it collided into the left front side of a Maryland Transit Administration (MTA) transit bus that was traveling west on Frederick avenue. The first impact on Frederick Avenue was approximately 200 feet east of Loudon Avenue, and the second impact on Frederick Avenue was approximately 1000 feet east of Loudon Avenue, and approximately 210 feet west Morley Street. The GPS coordinates for the initial impact was 39 degrees 16 minutes 54.39 seconds north longitude by 76 degrees 40 minutes 52.40 seconds west latitude and the impact with the MTA bus was located at 39 degrees 16 minutes 54.78 seconds north longitude by 76 degrees 40 minutes 42.51 seconds west latitude. See Figure 1 for a map of the crash location and Figure 2 for a detailed view of the crash location showing points of impact and distances between impacts.

The initial impact between the school bus and Ford Mustang was evidenced by scrapes in the pavement and collision scrub, tire-friction marks. The Mustang traveled approximately 74 feet from the initial impact to where it struck the south curb of Frederick Avenue, and then traveled 23 feet to where it collided with a brick wall and metal fence. From there it traveled back into the lane coming to a final position across the eastbound lane of Frederick Avenue. The total distance traveled by the Mustang from the initial impact to its final position was approximately 148 feet.

The impact area between the school bus and transit bus was evidenced by radiator splatter which, was located partially in the center turn lane and in the westbound lane of Frederick Avenue. The splatter fluid marks were approximately 15 feet forward of where the transit bus came to its final rest position. See Highway photographs 1-28 for views of impact areas, pavement markings, and roadway alignment.
