**Highway Factors Photographs**

**Baltimore, Maryland**

**HWY17MH007**

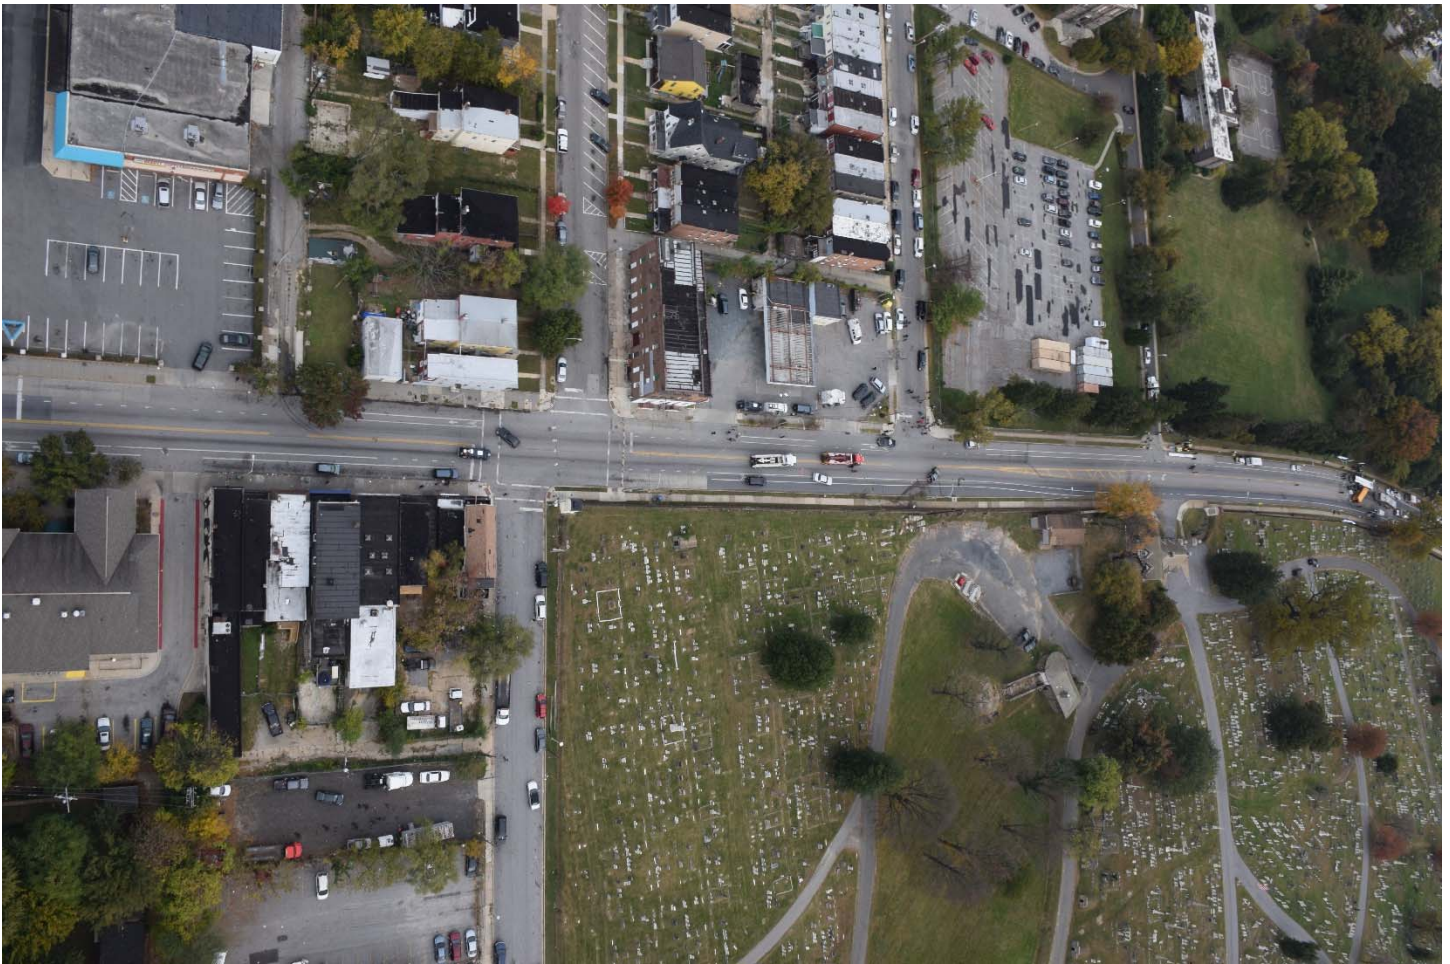
Highway Photo 1 – Aerial view of Frederick Avenue from left to right or eastbound in photo. The Avenue depicted in the left of photo is Loudon Ave. where the Mustang turned right onto Frederick. The initial impact occurred in the center of the photo where the red and white tow trucks are parked. The far right edge of the photo shows the school bus and transit bus at impact location. **Highway photos 1-24 provided courtesy of the Baltimore Police Department (BPD)**

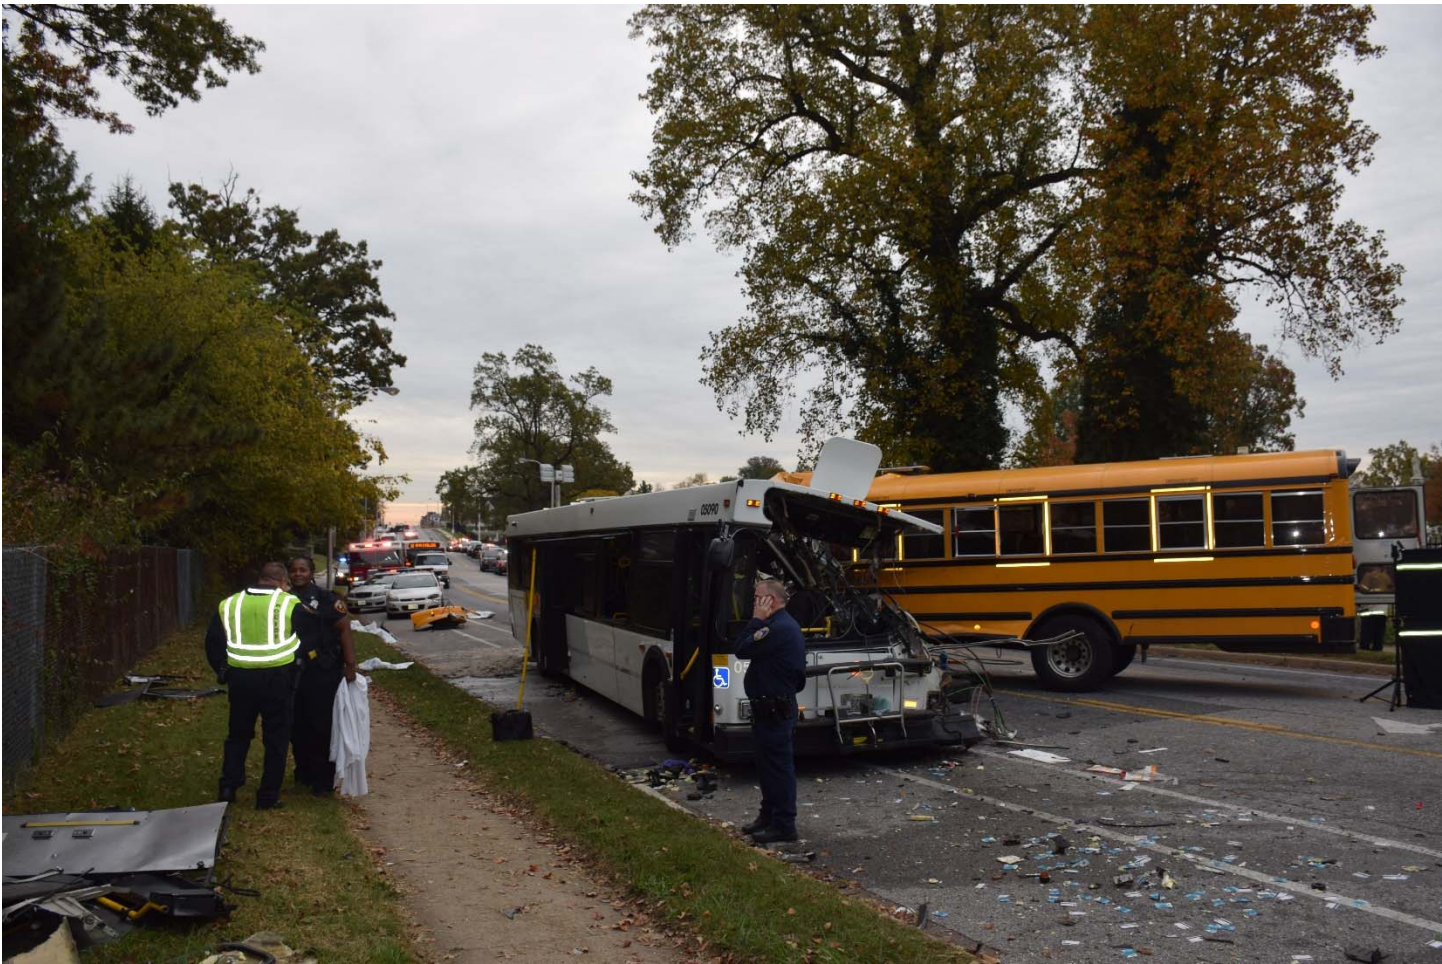
Highway Photo 2 – Eastbound view of Frederick Ave. with impact area and both buses at final positions.

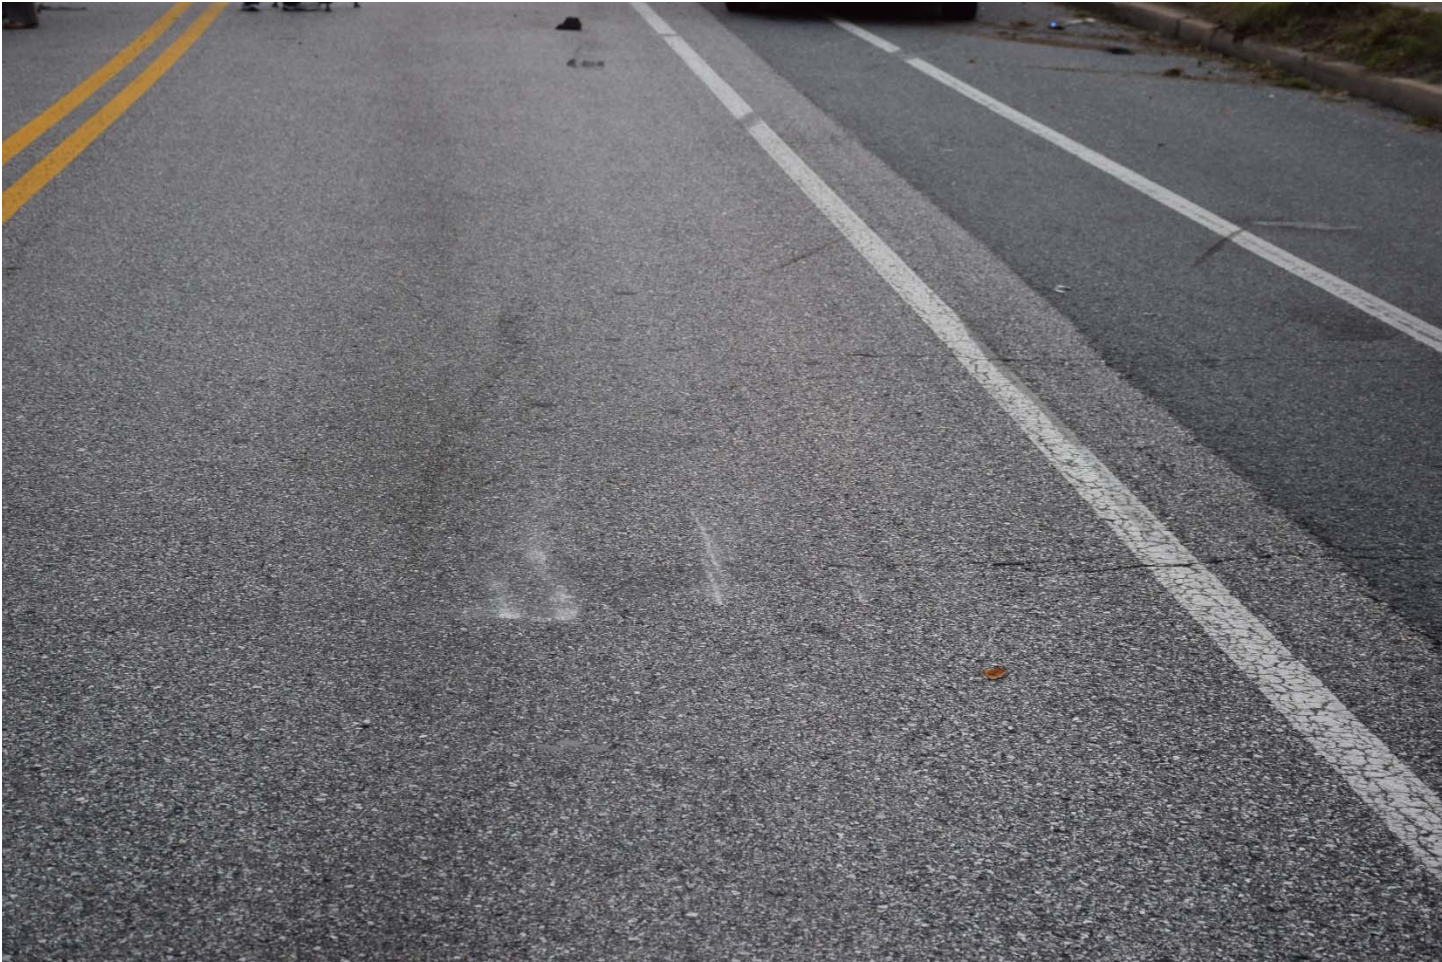
Highway Photo 3 – View of gouges and scrapes in pavement on Frederick Ave. where the school bus struck the rear of the Mustang.

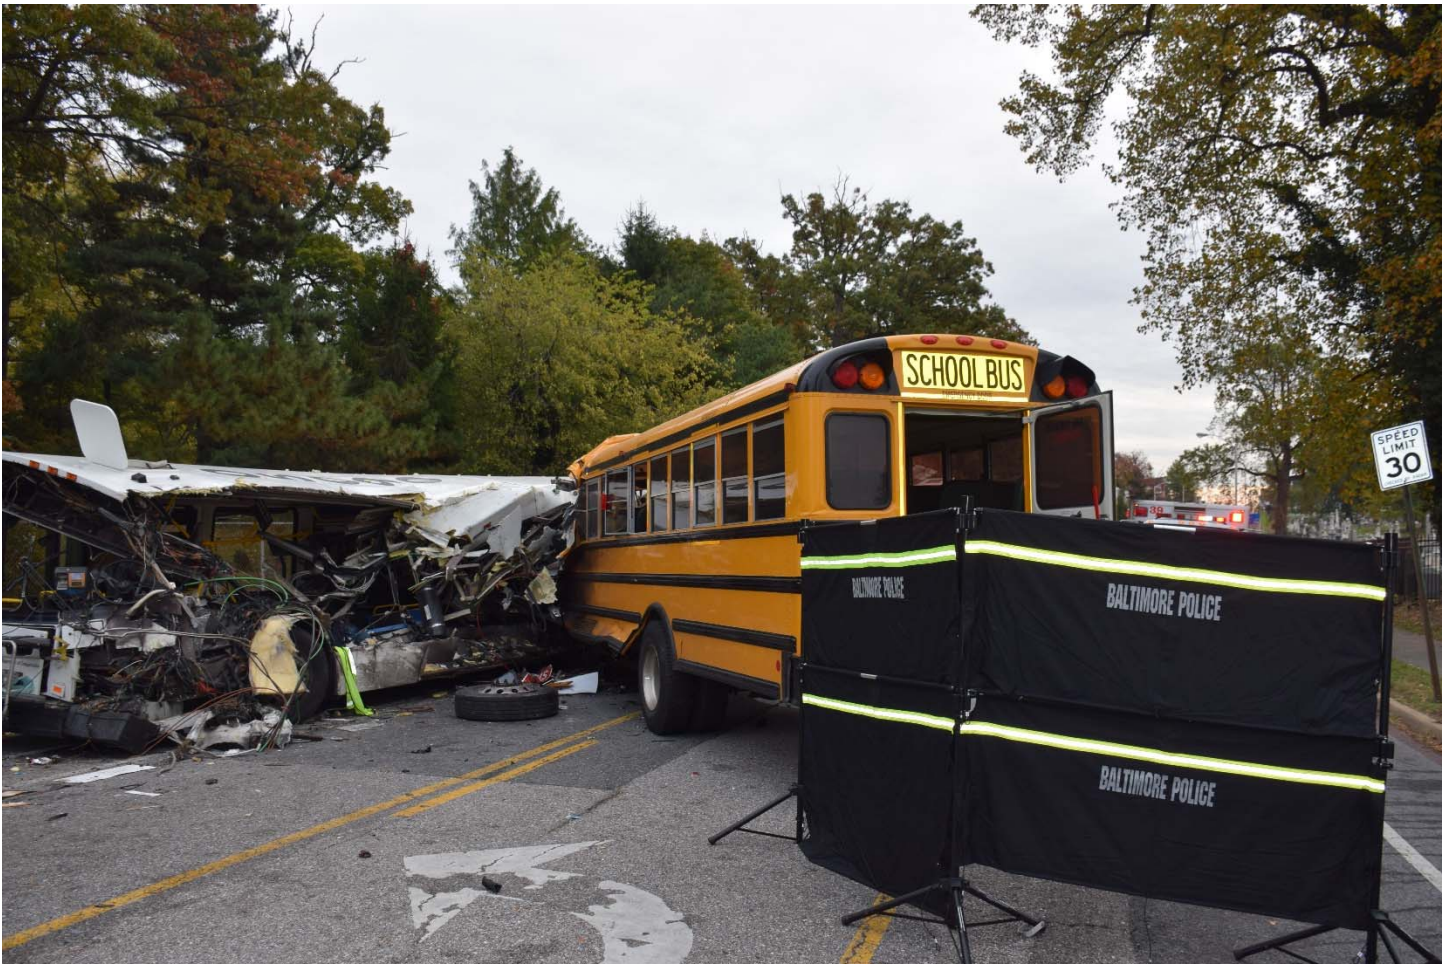
Highway Photo 4 – Eastbound view of school bus and truck at their final positions east of the impact area.

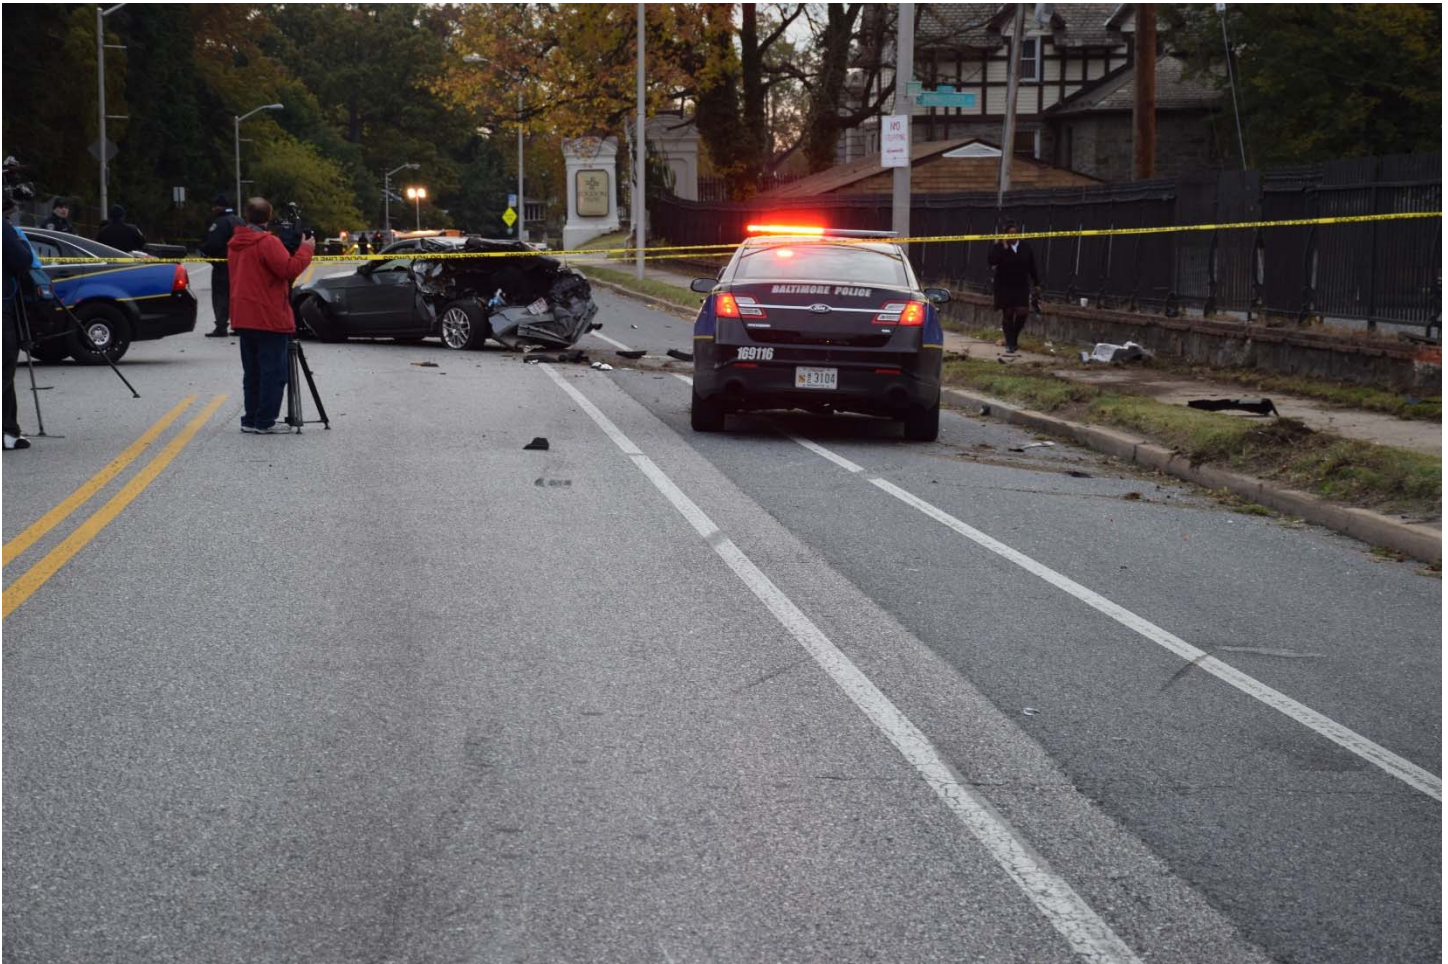
Highway Photo 5 – Eastbound view of Frederick Ave. showing the Mustang’s post-crash tire friction marks, 820 feet west of the school bus-transit bus impact.

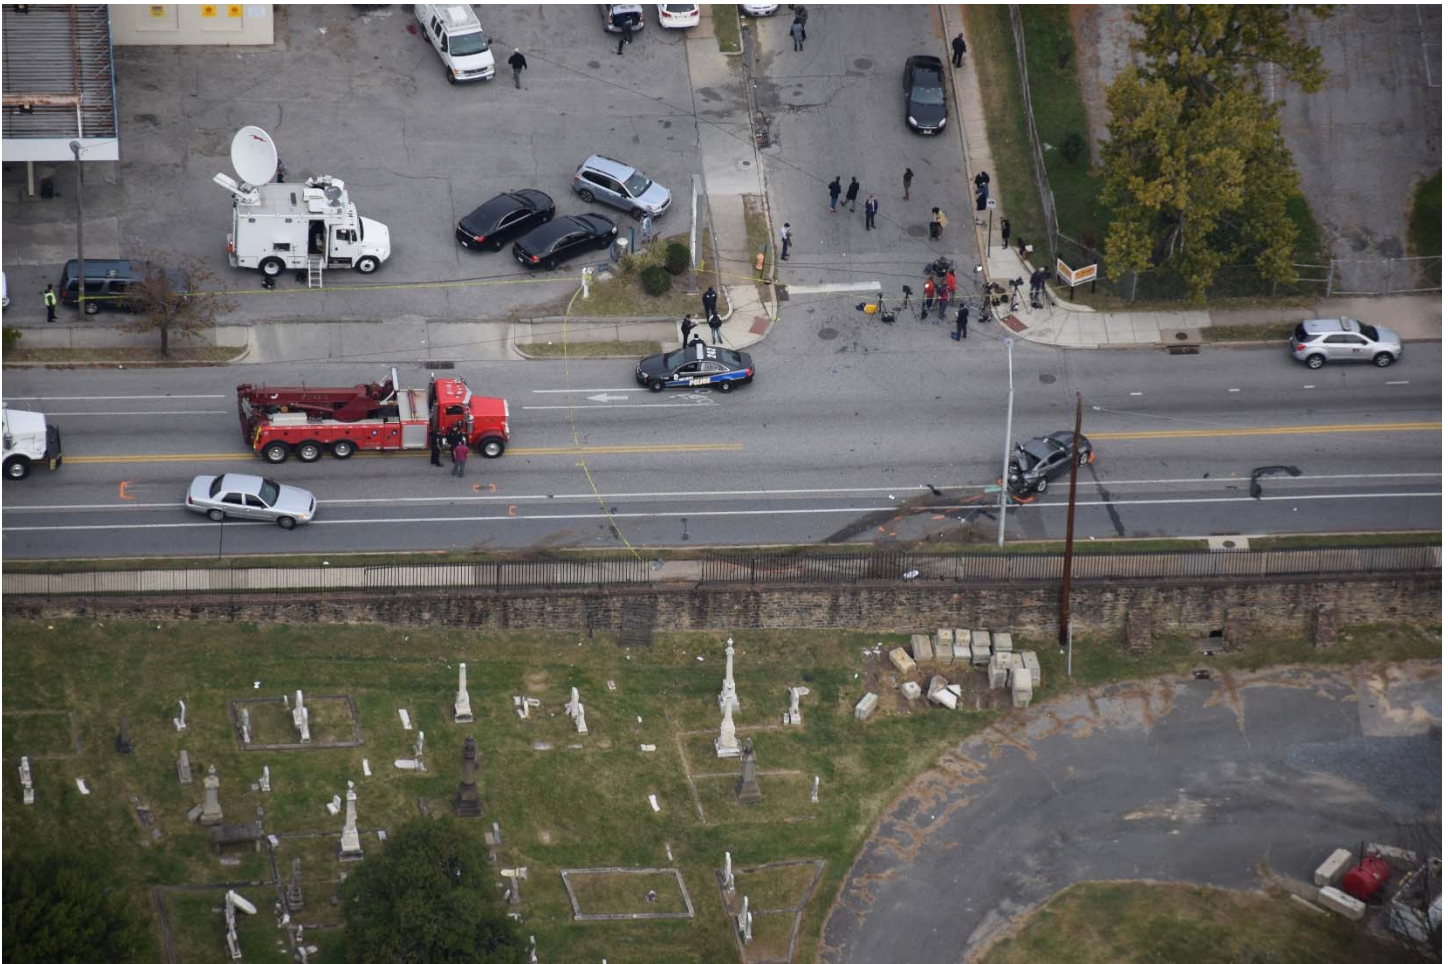
Highway Photo 6 – Aerial view of school bus-Mustang impact area depicted by orange pavement markings with the Mustang post-crash marks leading to the Loudon Cemetery wall and back into Frederick Avenue with the Mustang coming to a final position at Monastery Avenue.

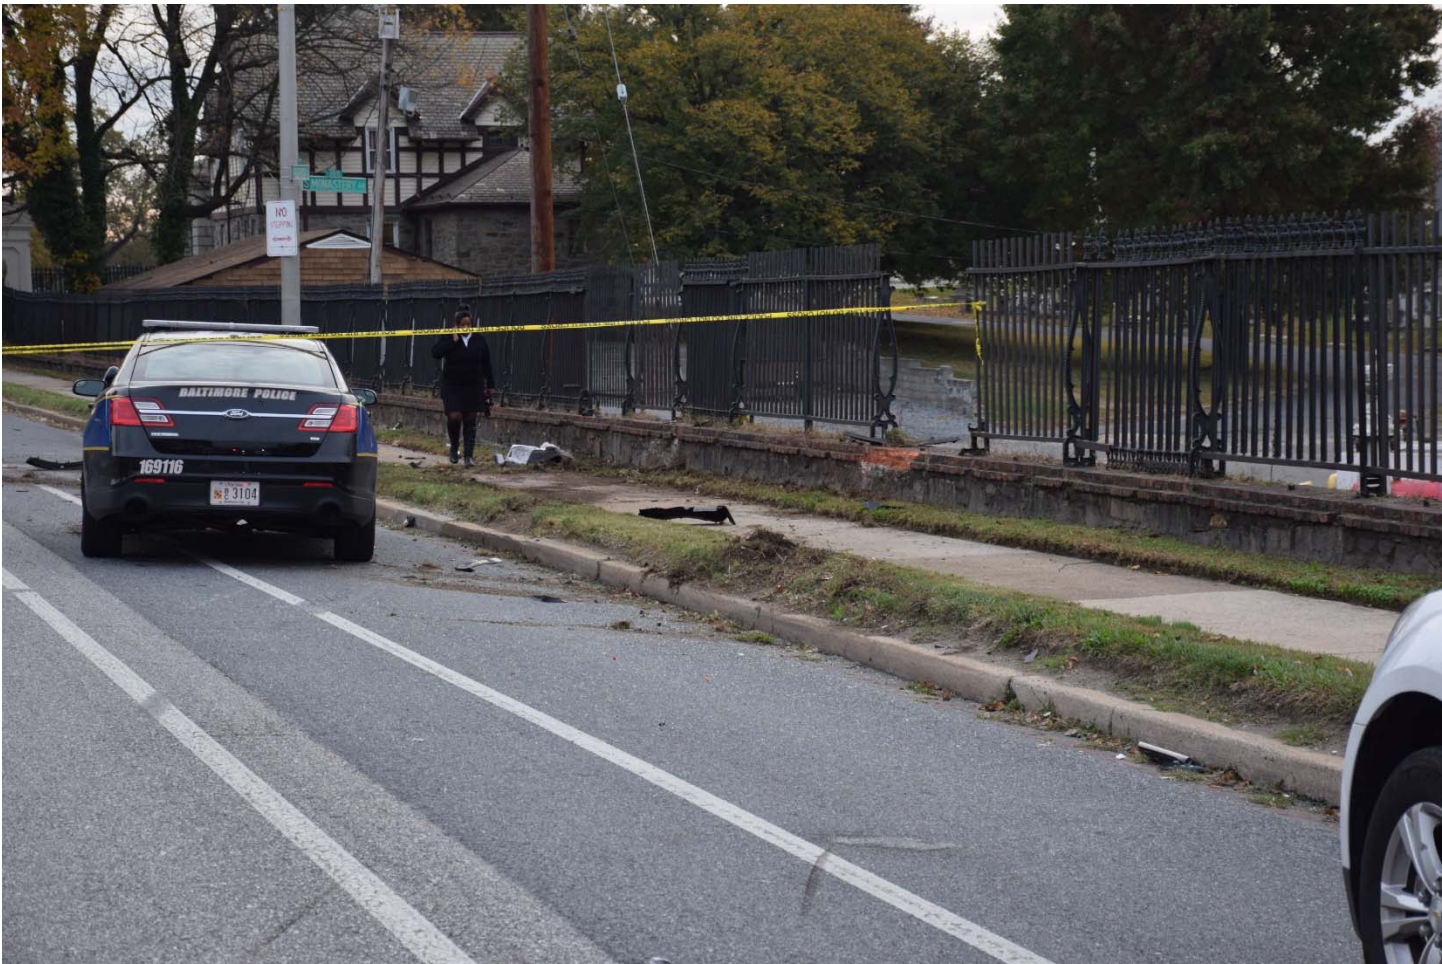
Highway Photo 7 – View of the Mustangs post-crash travel path into the cemetery wall.

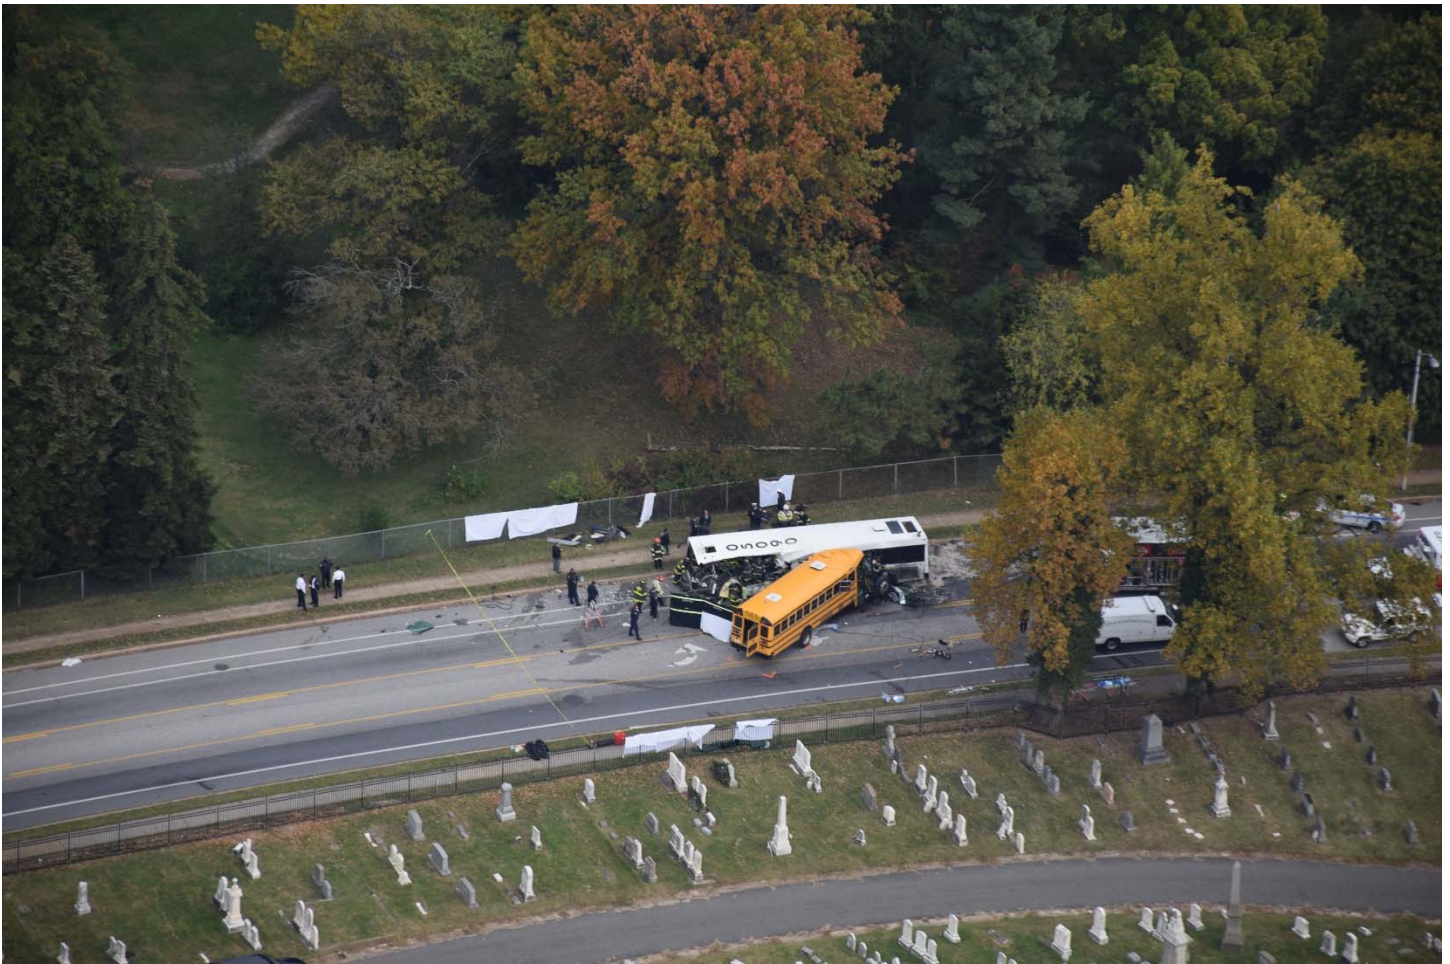
Highway Photo 8 – Closer aerial view of school bus-transit bus impact area with vehicles at their final positions, approximately 200 feet west of Morley Street.

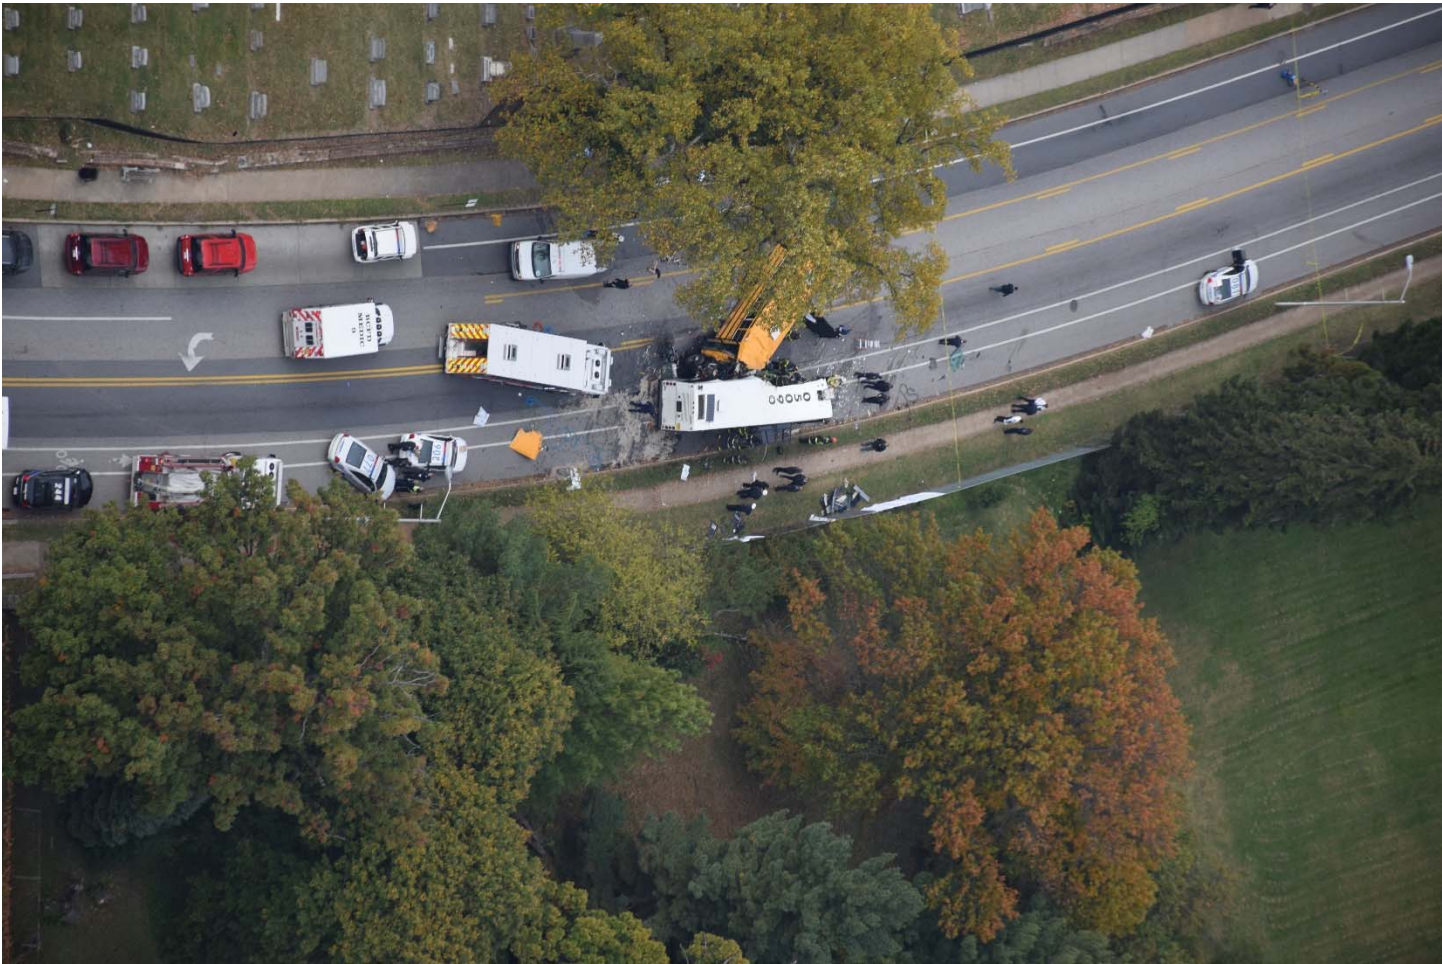
Highway Photo 9 – Additional aerial view showing the depth of penetration by the school bus into the left side of the transit bus

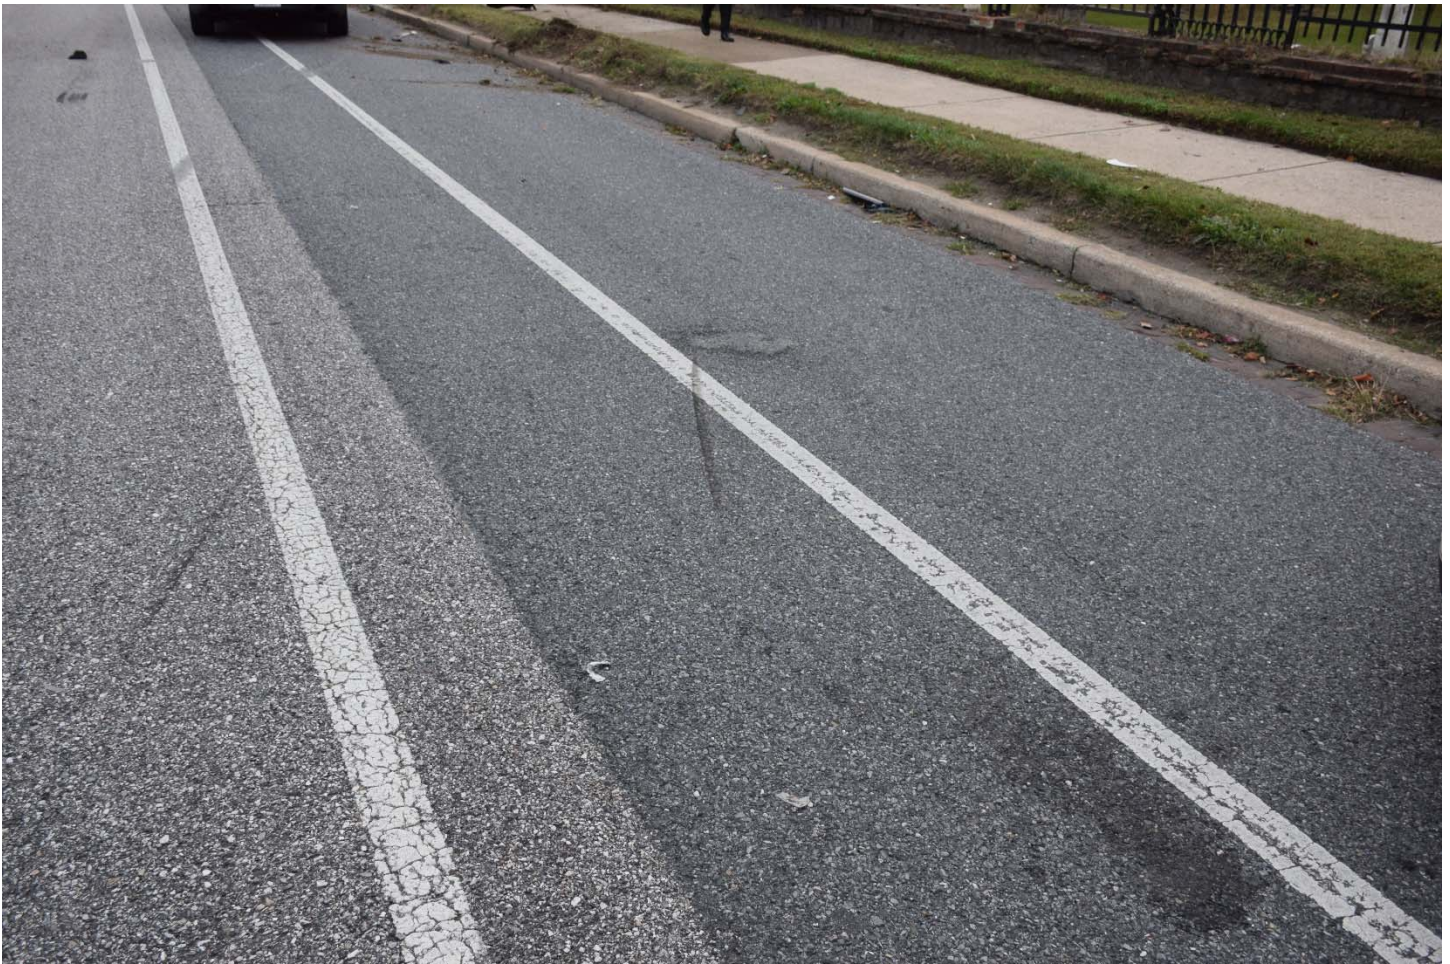
Highway Photo 10 – View of the Mustang’s post-crash pavement gouges leading from the initial impact into the cemetery wall.

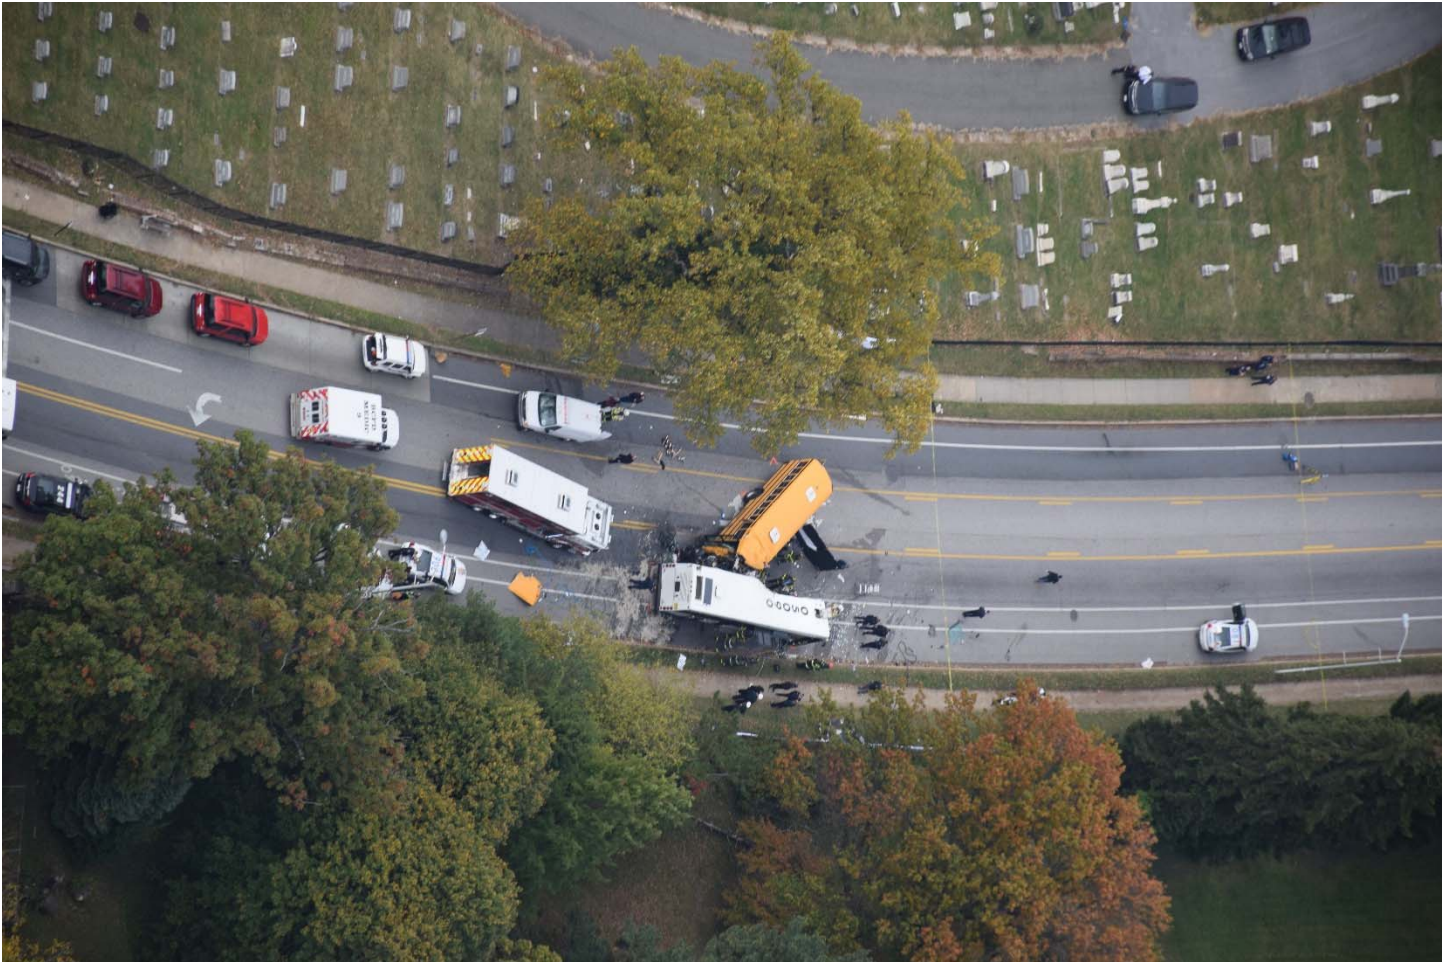
Highway Photo 11 – Aerial view of school bus-transit bus impact area.

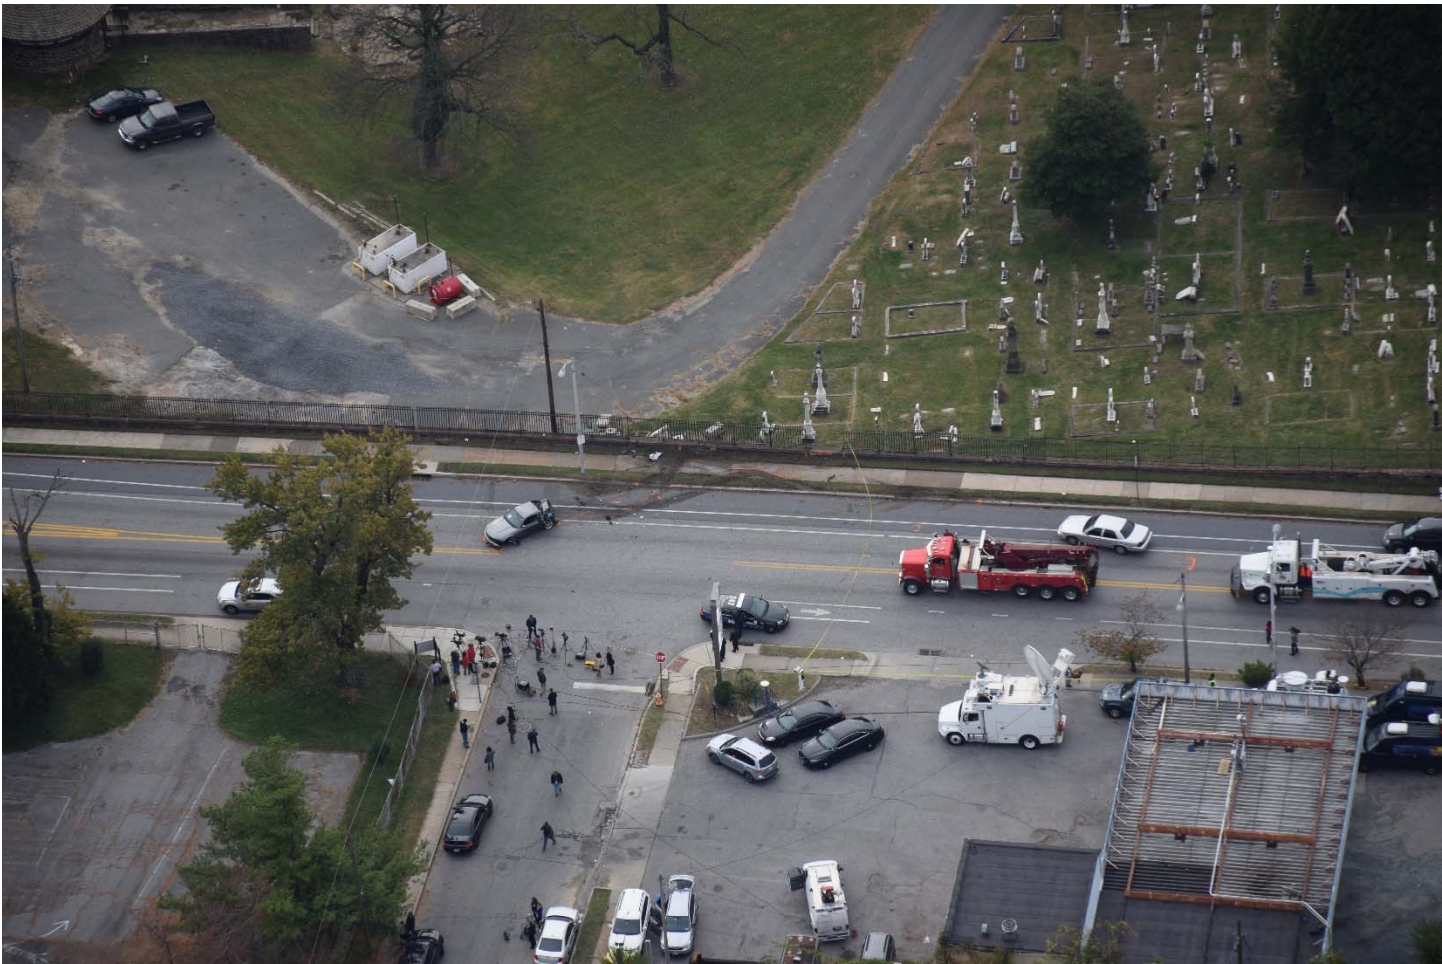
Highway Photo 12 – North to south view of Mustang impact into cemetery wall.

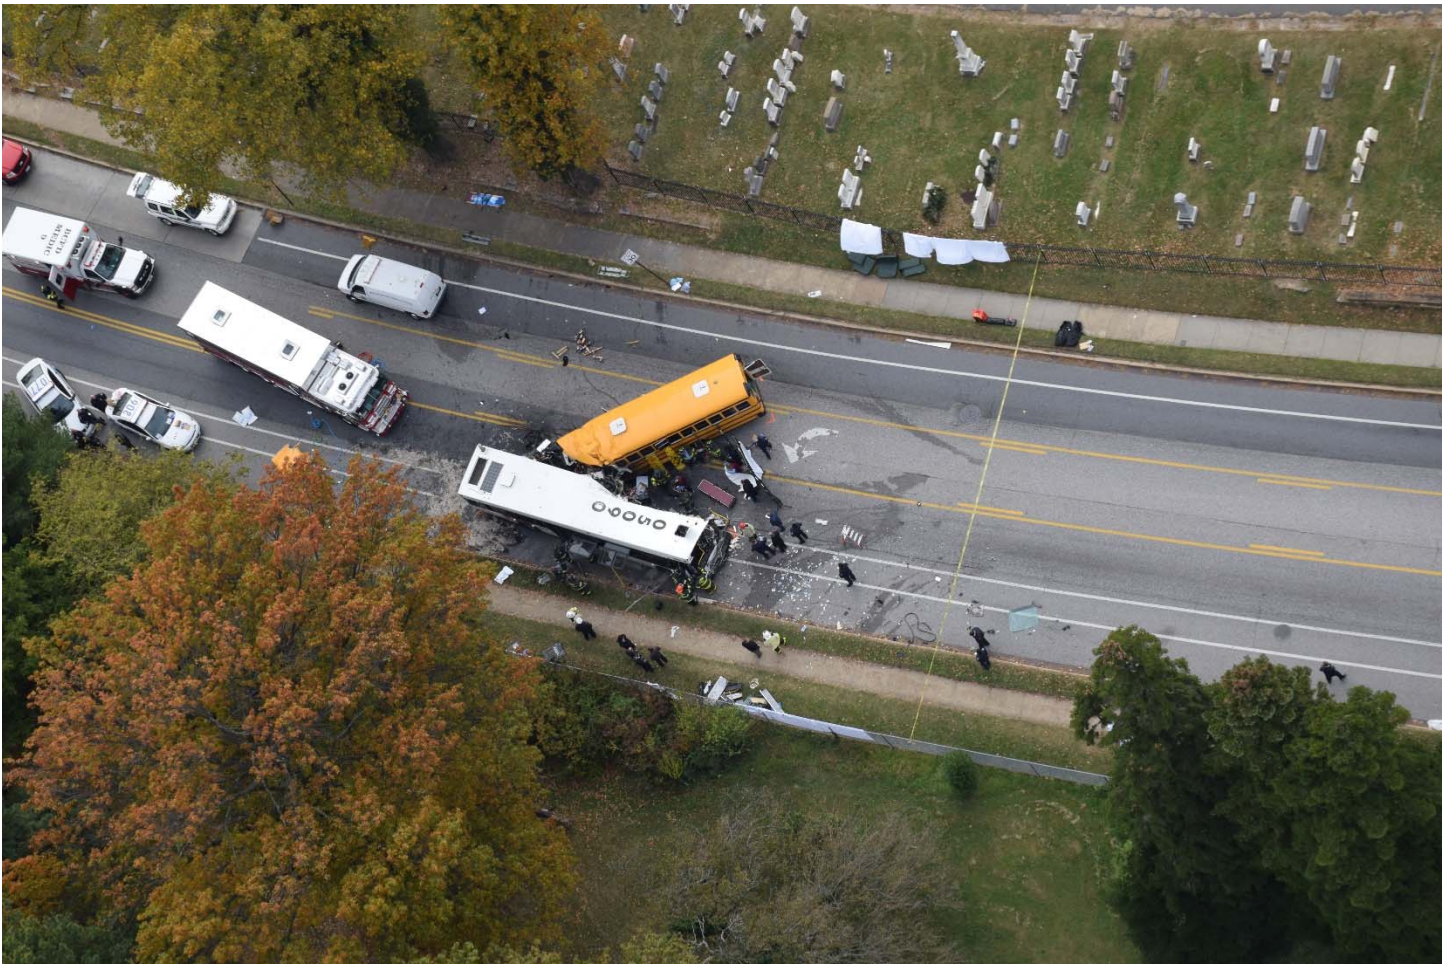
Highway Photo 13 – Aerial view of the school bus-transit bus impact area depicted by fluid spatter and debris forward of the transit bus.

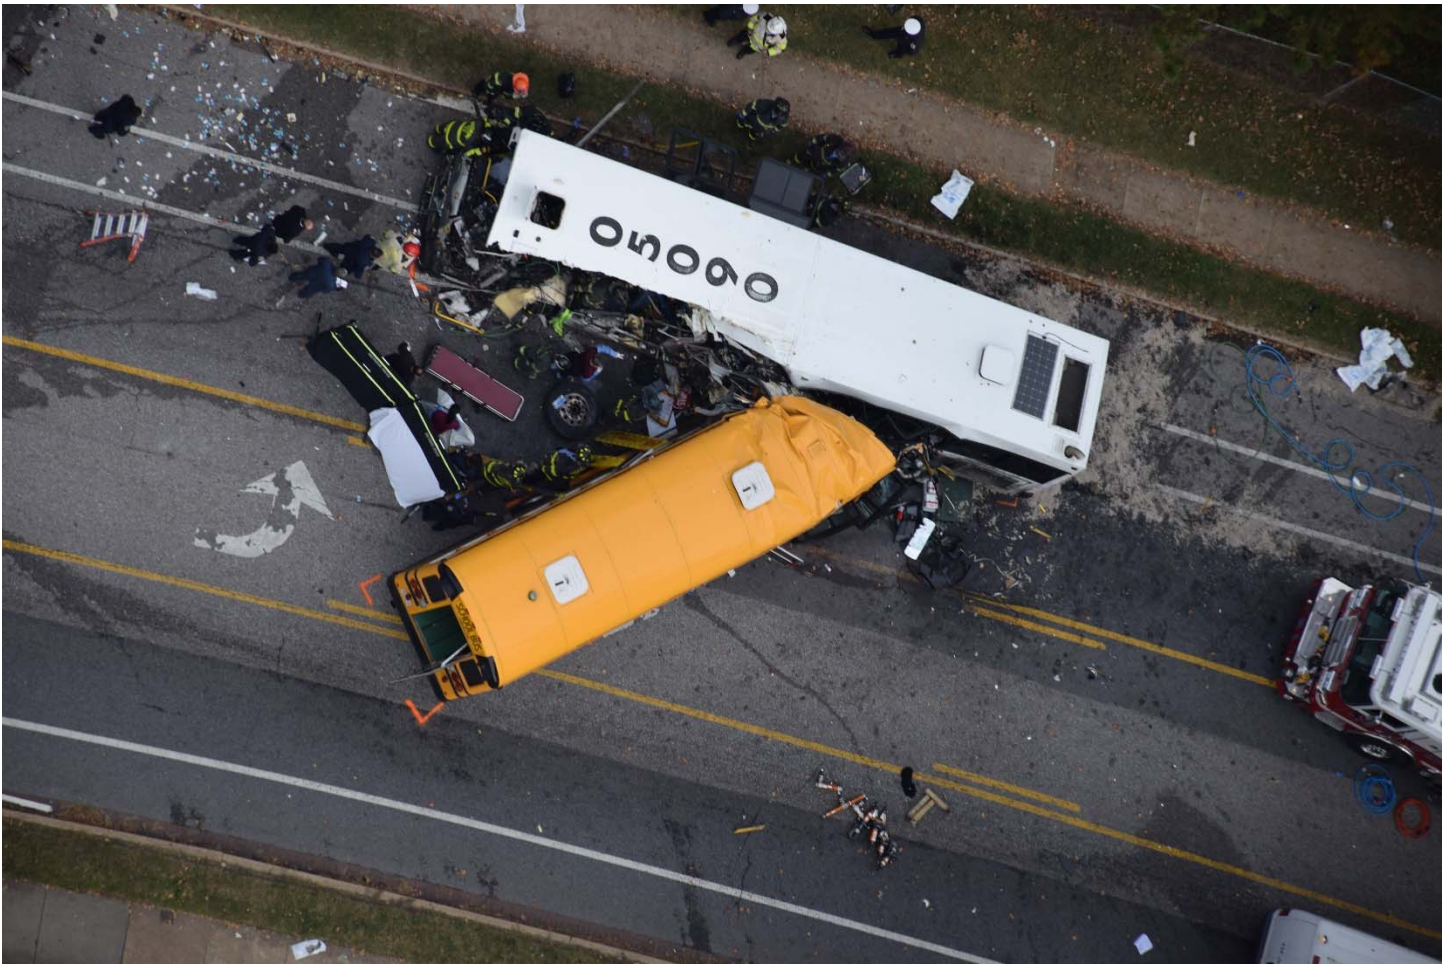
Highway Photo 14 – Close-up aerial view of impact area between the buses and the depth of penetration into the left side of the transit bus.

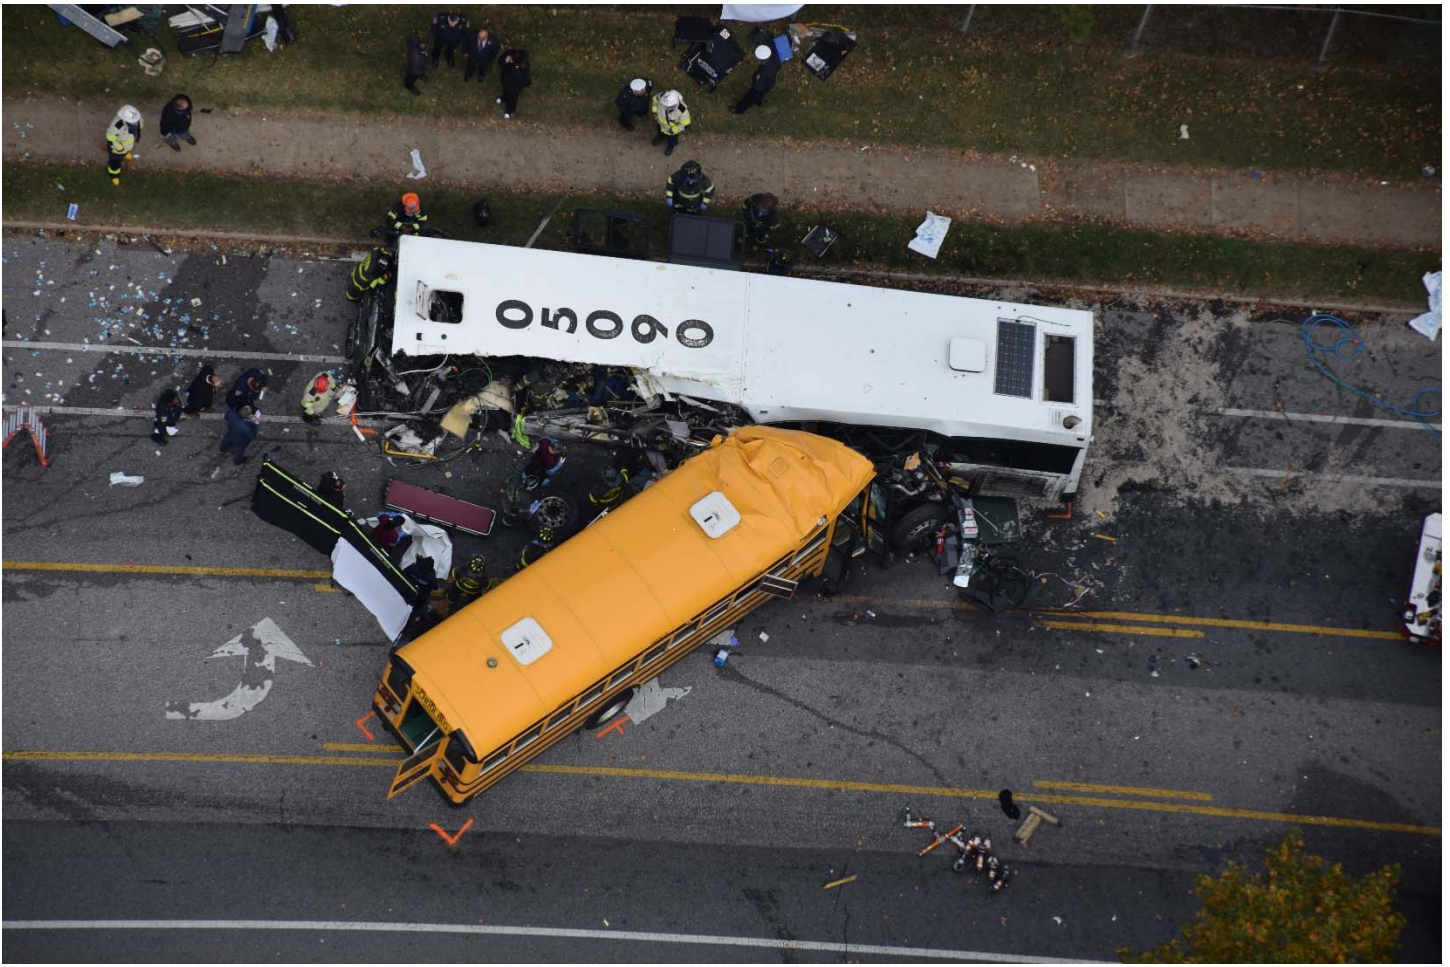
Highway Photo 15 – View of vehicle liquids drainage path from the impact area toward the curb on the upper part of the photograph.

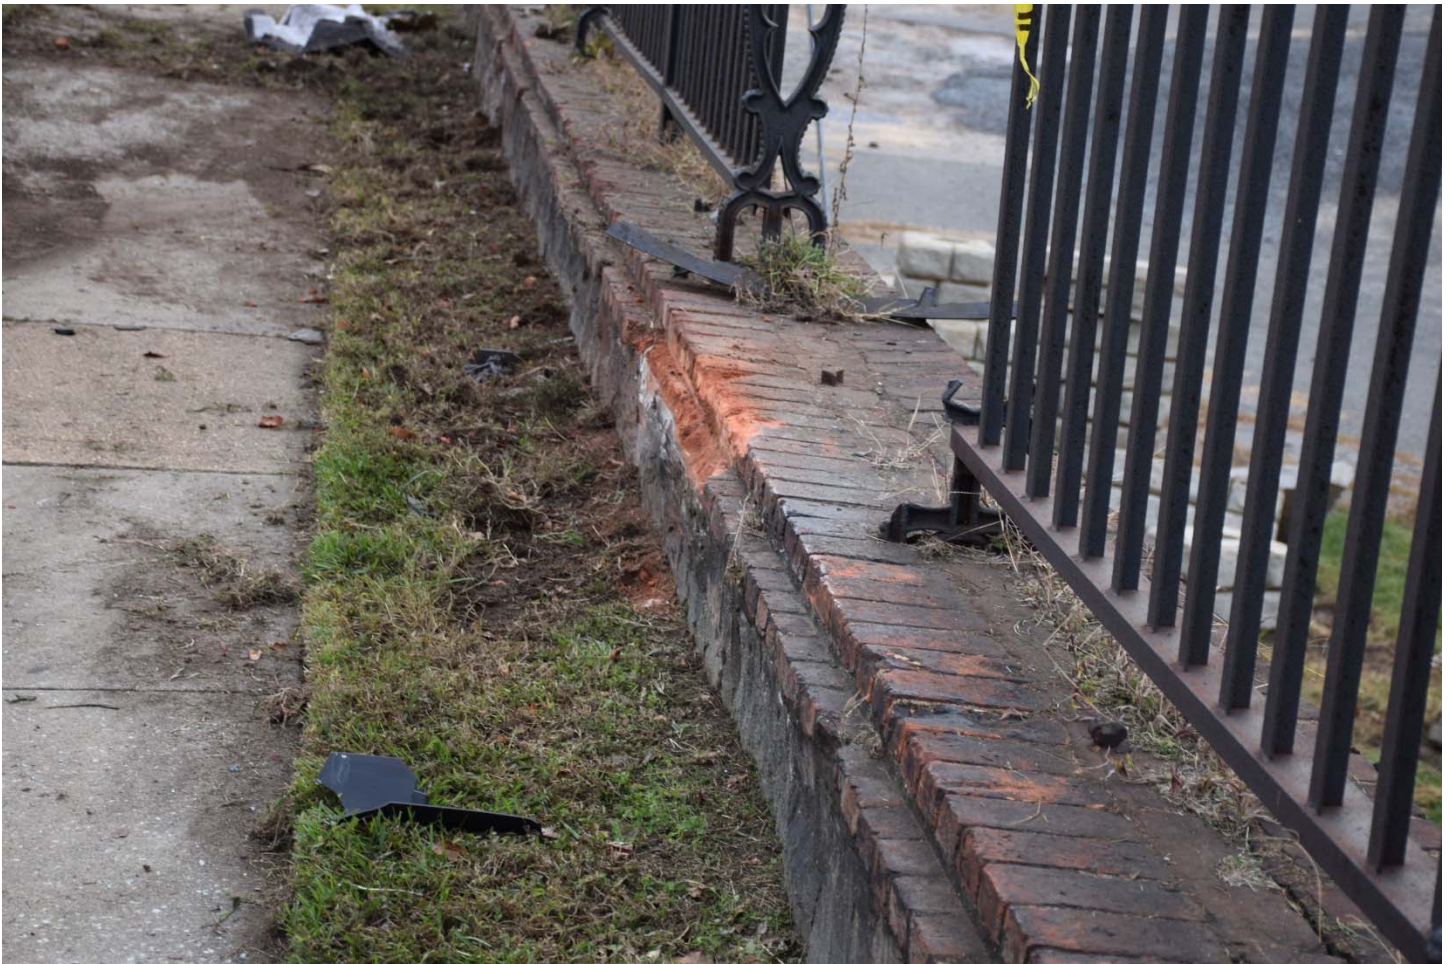
Highway Photo 16 – Close-up view of damage to cemetery wall from the Mustang’s secondary impact into the wall.
