**Highway Factors Photographs**

**Baltimore, Maryland**

**HWY17MH007**

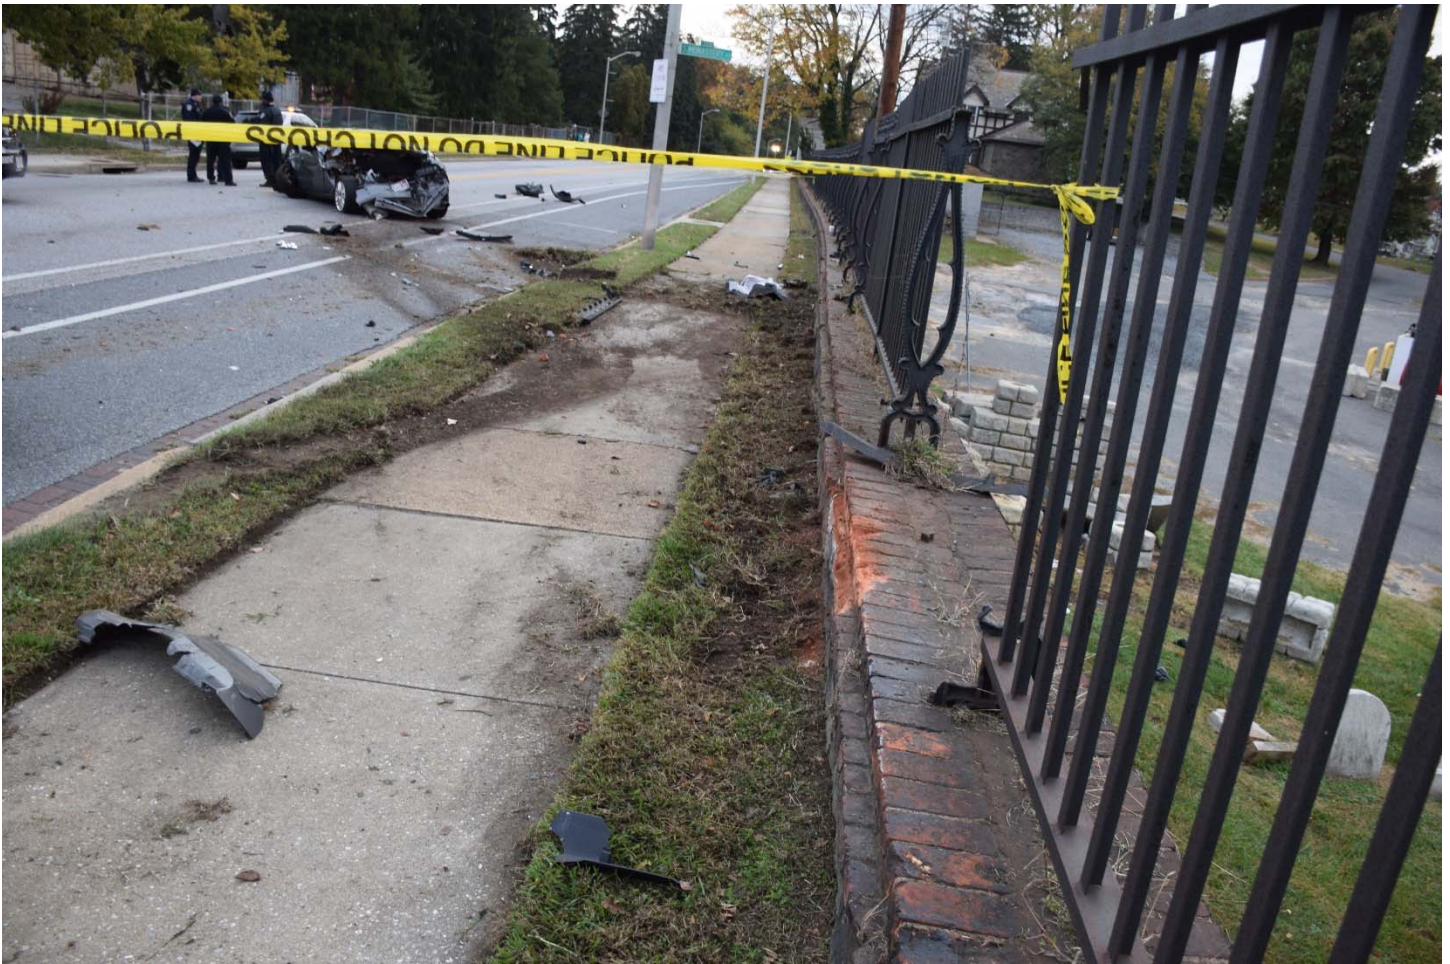
Highway Photo 17 – Continued view of Mustang’s travel path into the wall and back into the street.

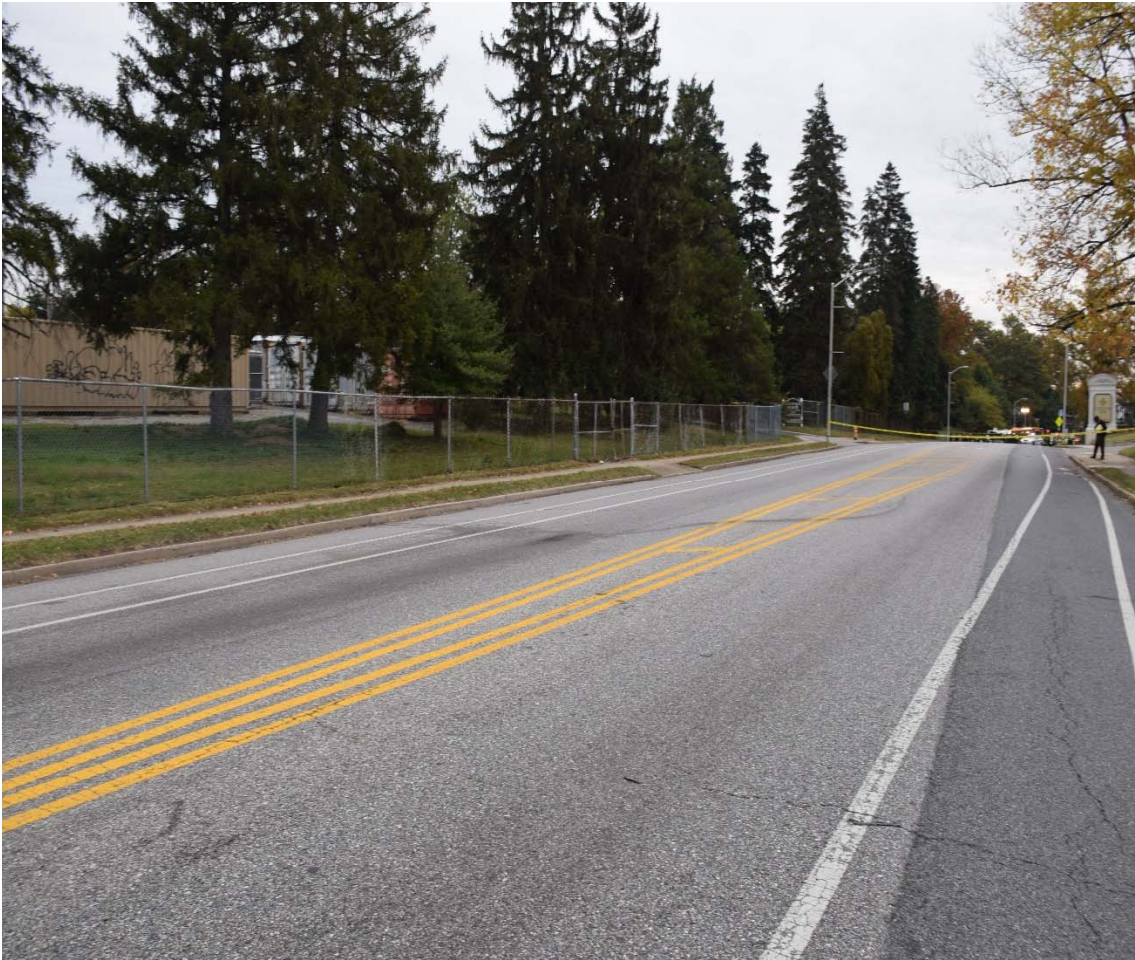
Highway Photo 18 – View standing near the area of final rest of the Mustang, looking eastbound on Frederick Avenue with the school bus and transit bus impact in the far background behind the caution tape.

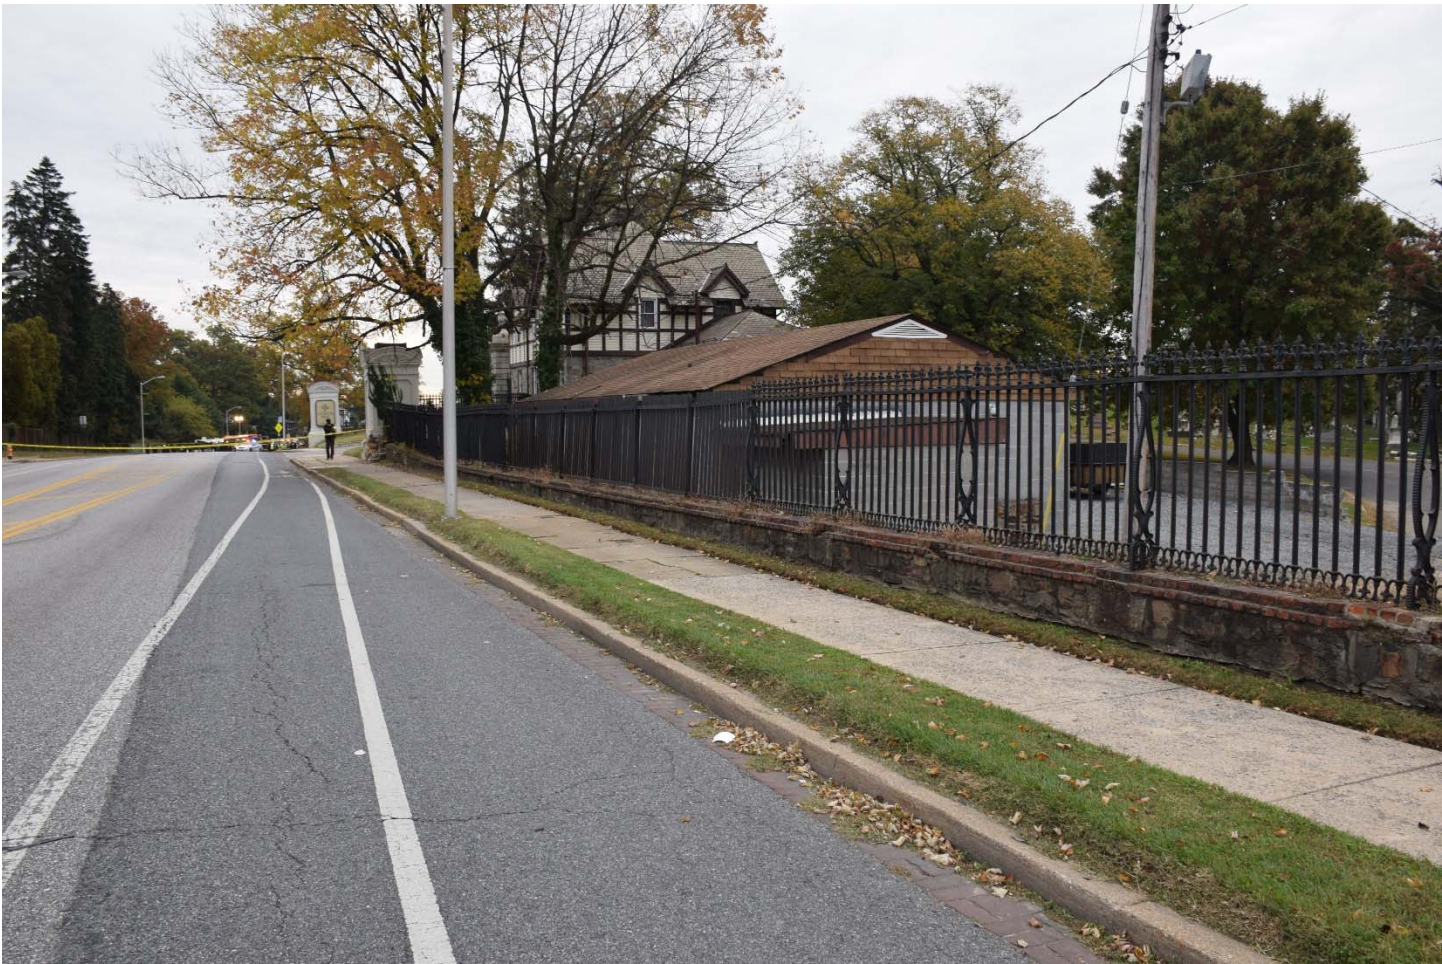
Highway Photo 19 – Continued view looking east on Frederick Avenue showing the buses on the other side of a slight hill crest past the entrance to the cemetery.

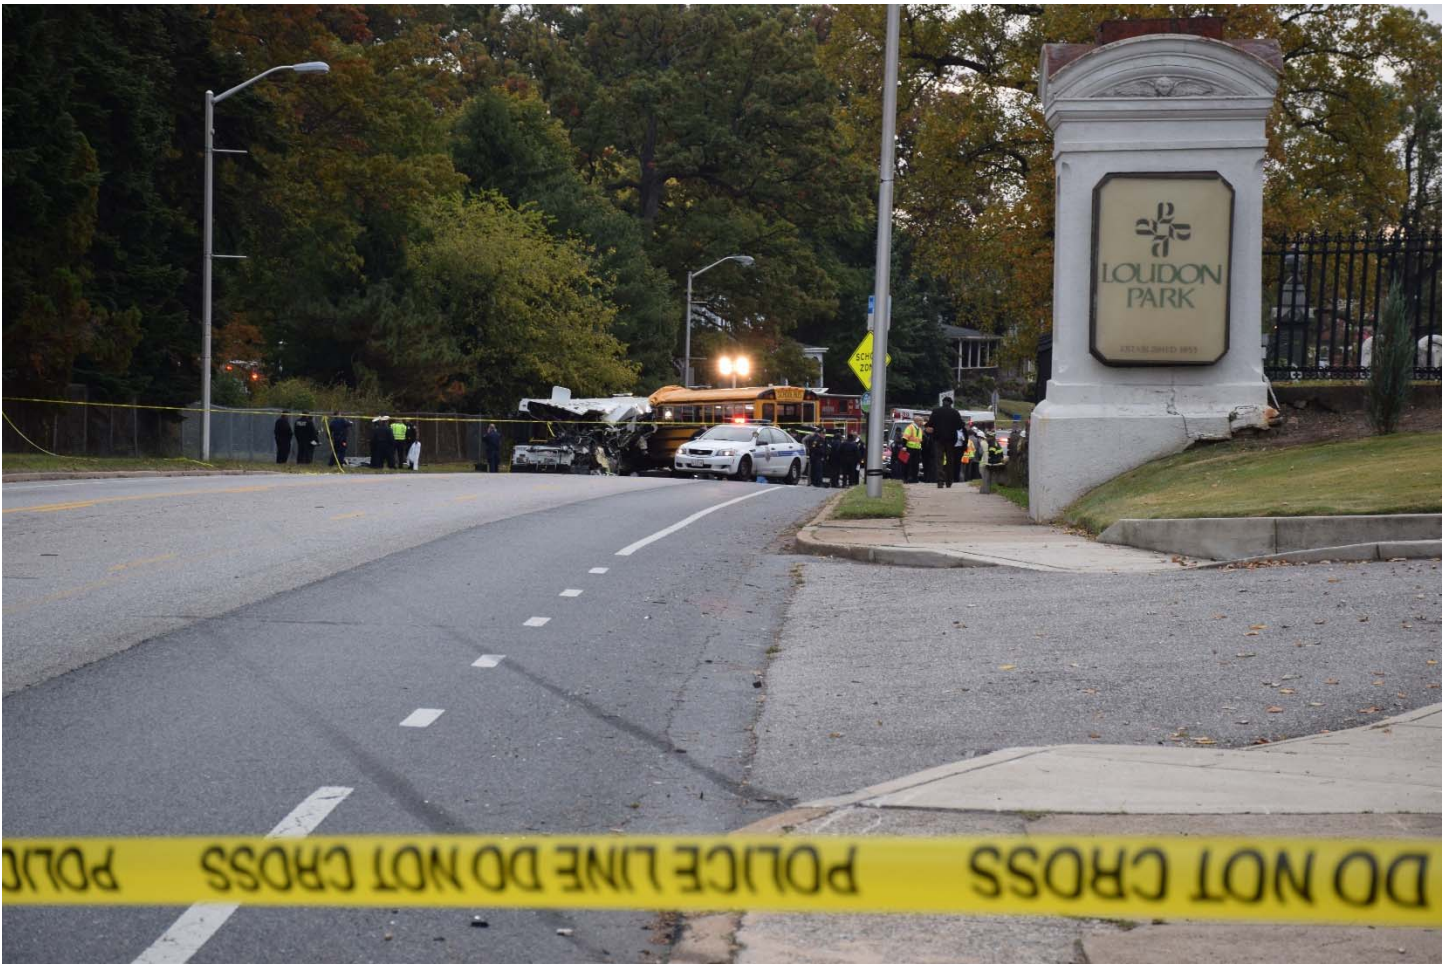
Highway Photo 20 – View of buses at their final positions on the other side of the vertical curve or hill crest. Also note the presence of highway safety lighting on both sides of Frederick Avenue, which was on at the time of the accident.

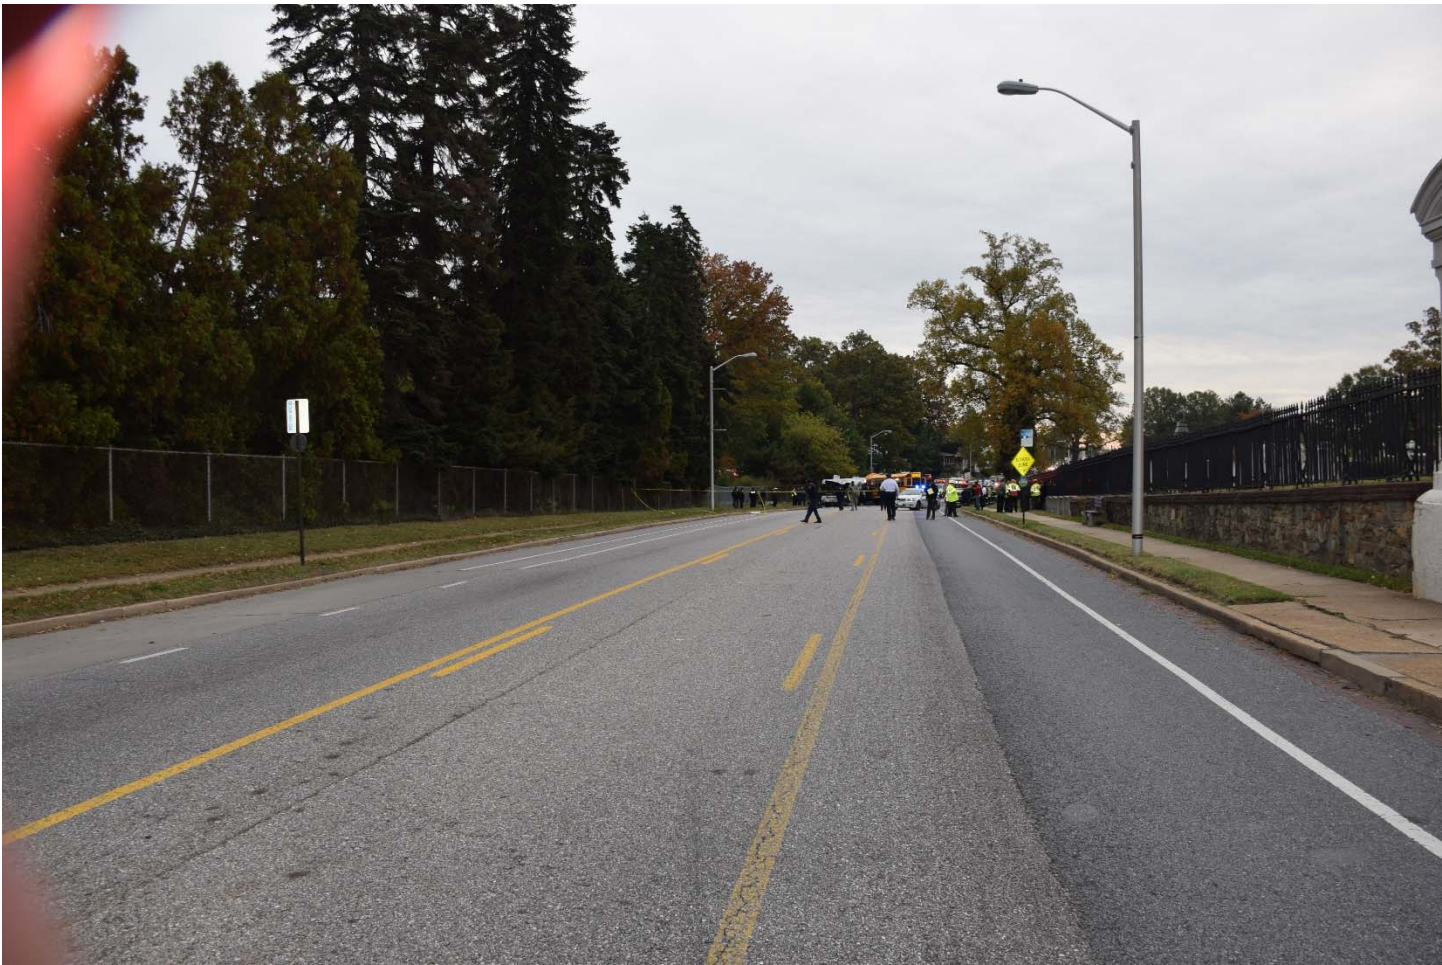
Highway Photo 21 – View showing the center turn lane on the approach to the bus impact location.

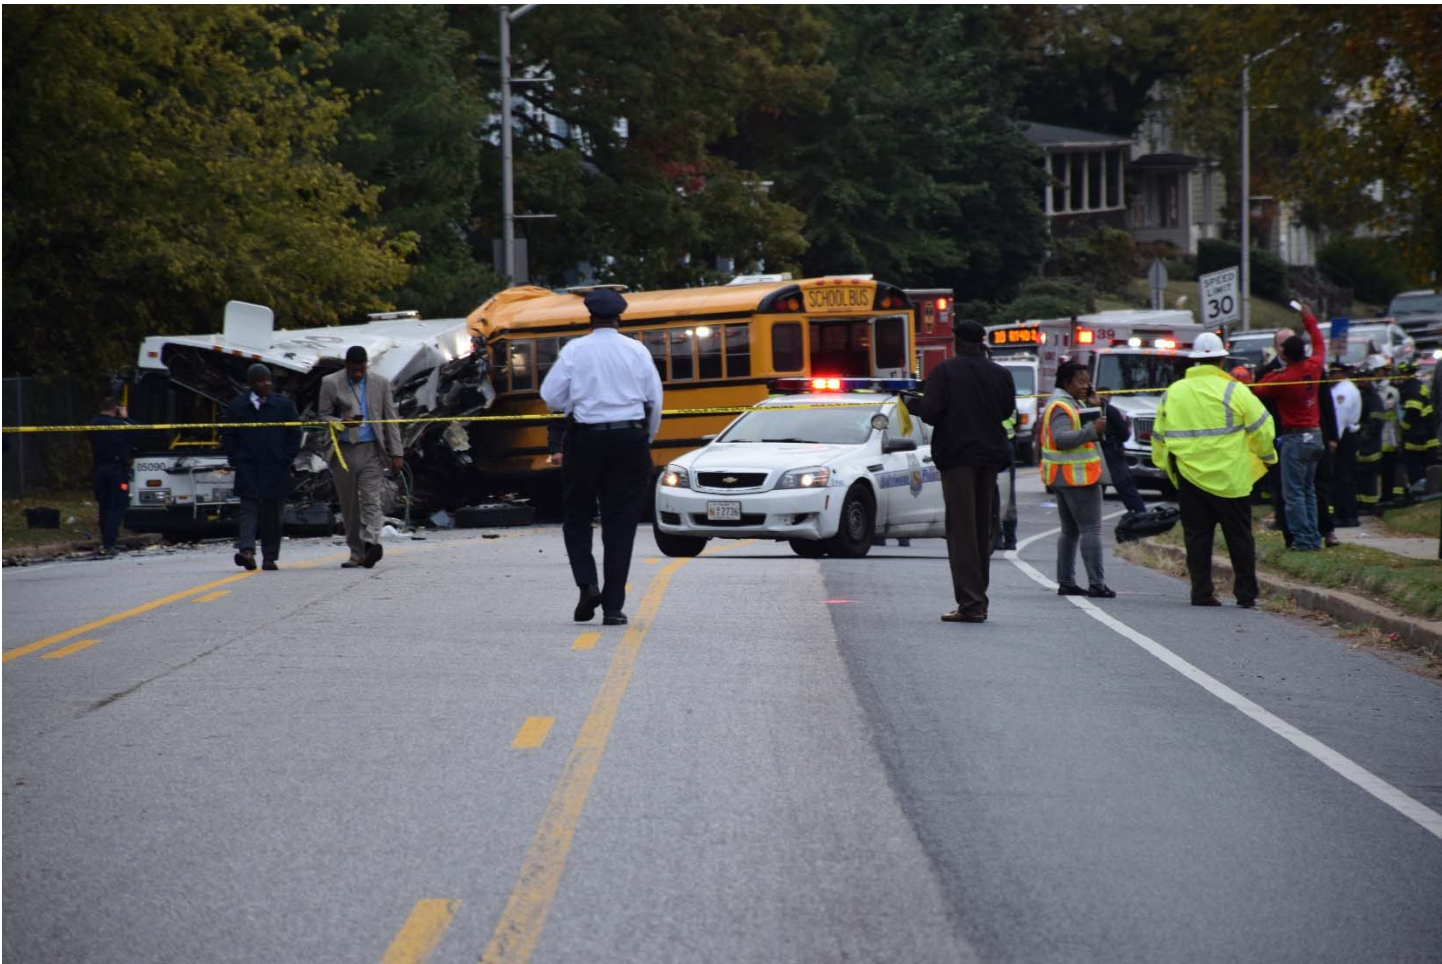
Highway Photo 22 – View showing the eastbound approach to the impact area.

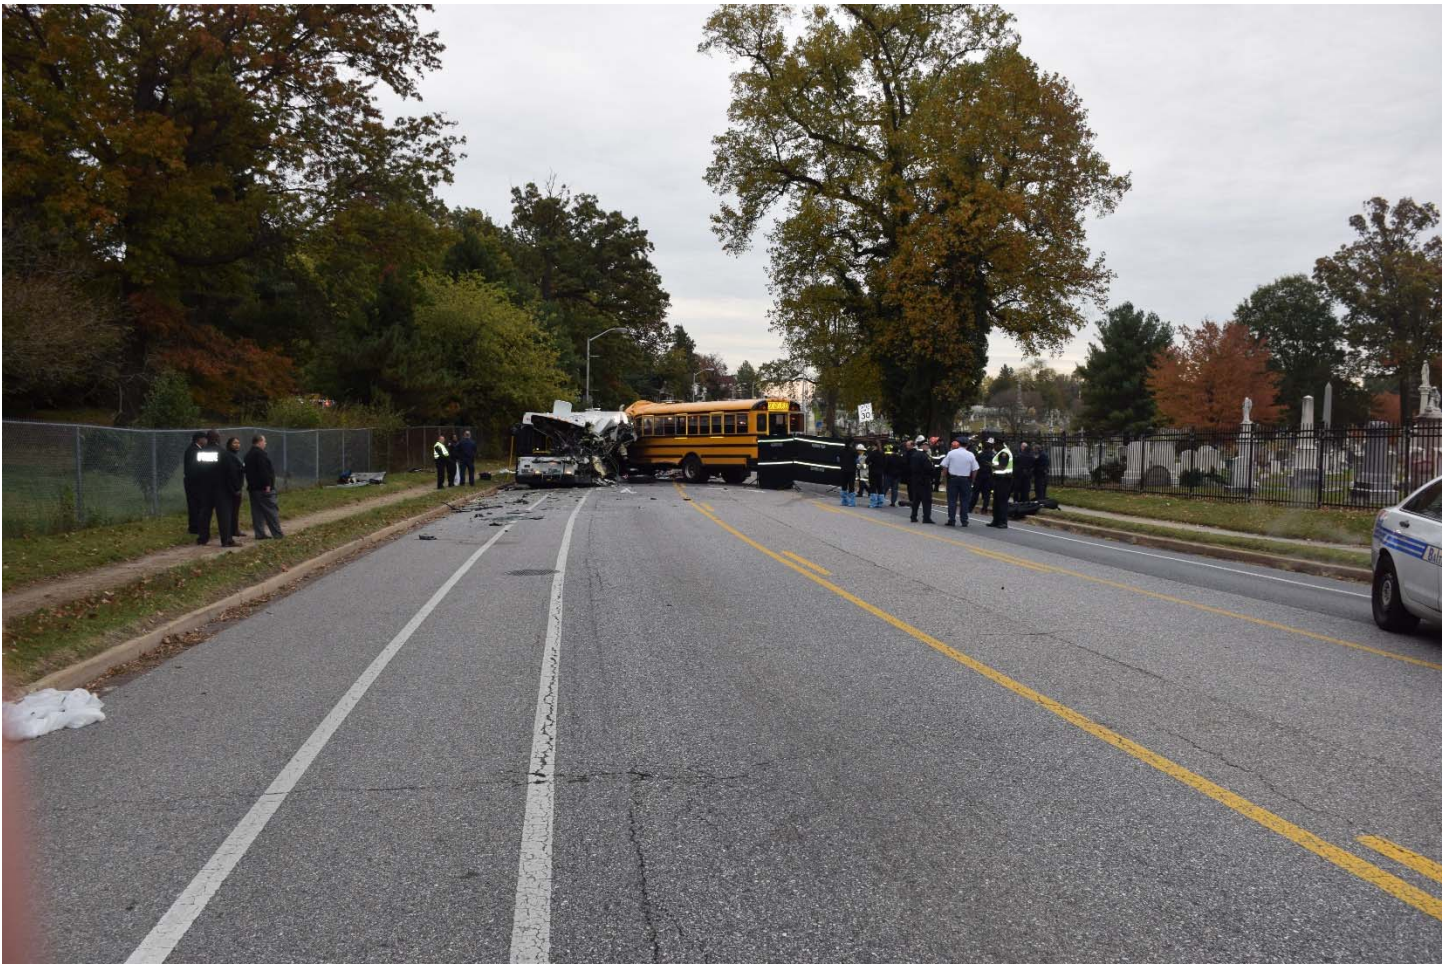
Highway Photo 23 – Additional view of eastbound approach to the accident area.

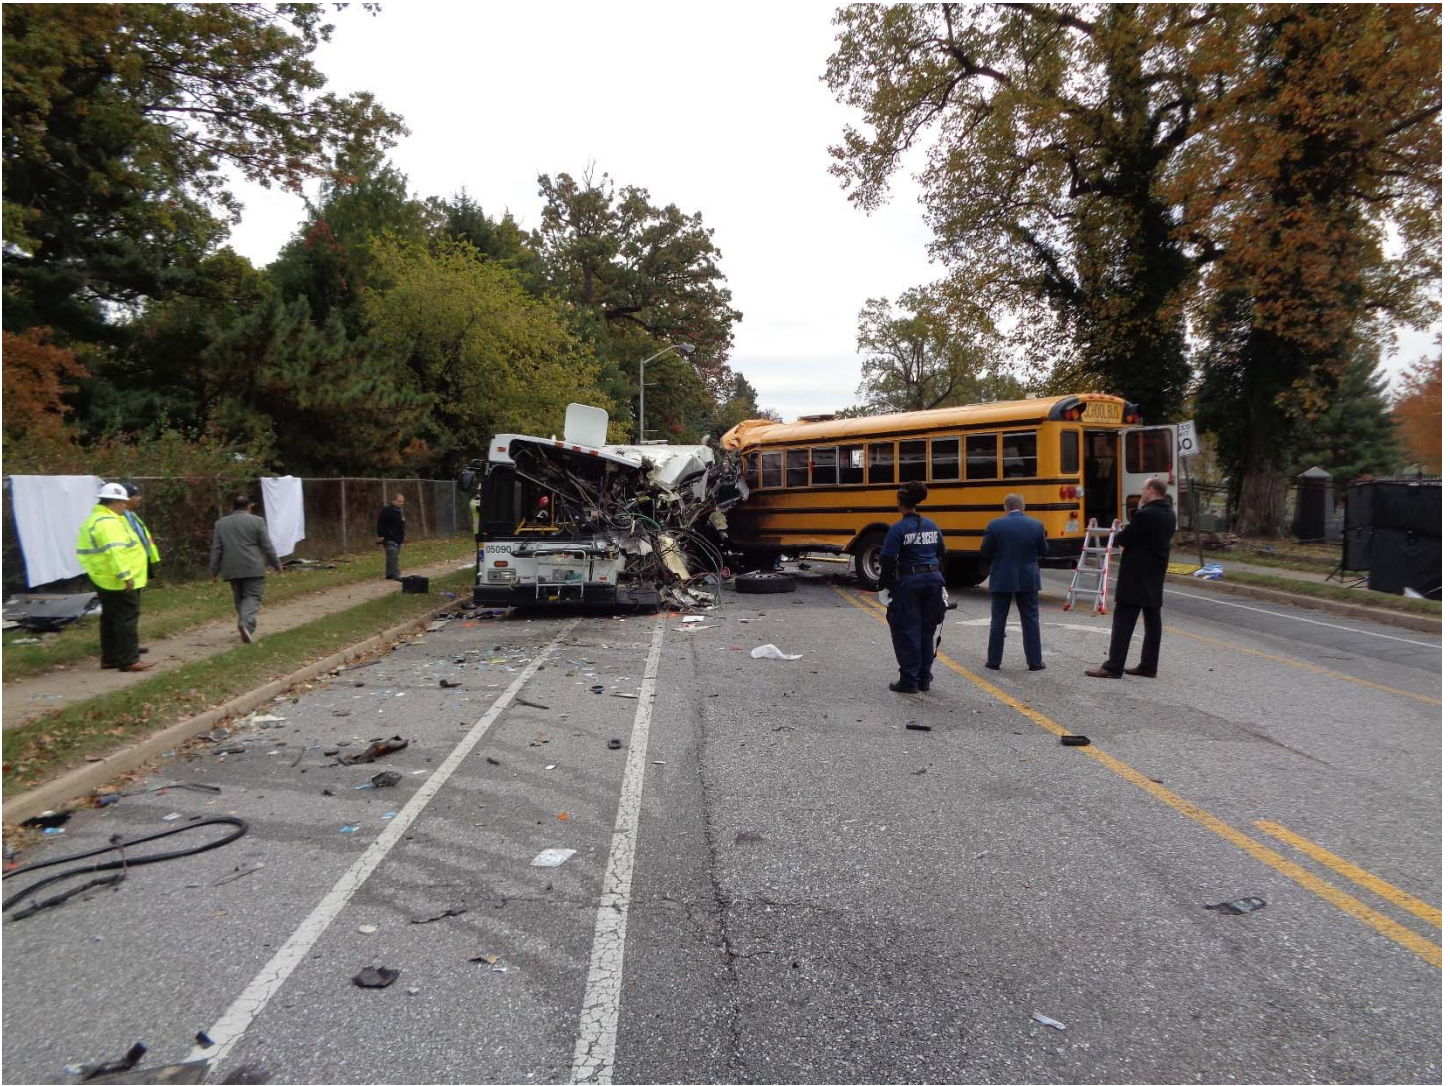
Highway Photo 24 – View of wet pavement from the school bus liquids spattered onto the center turn lane and westbound lane occupied by the transit bus. Area begins where the police officer is standing in the westbound lane near the yellow line of the center turn lane.

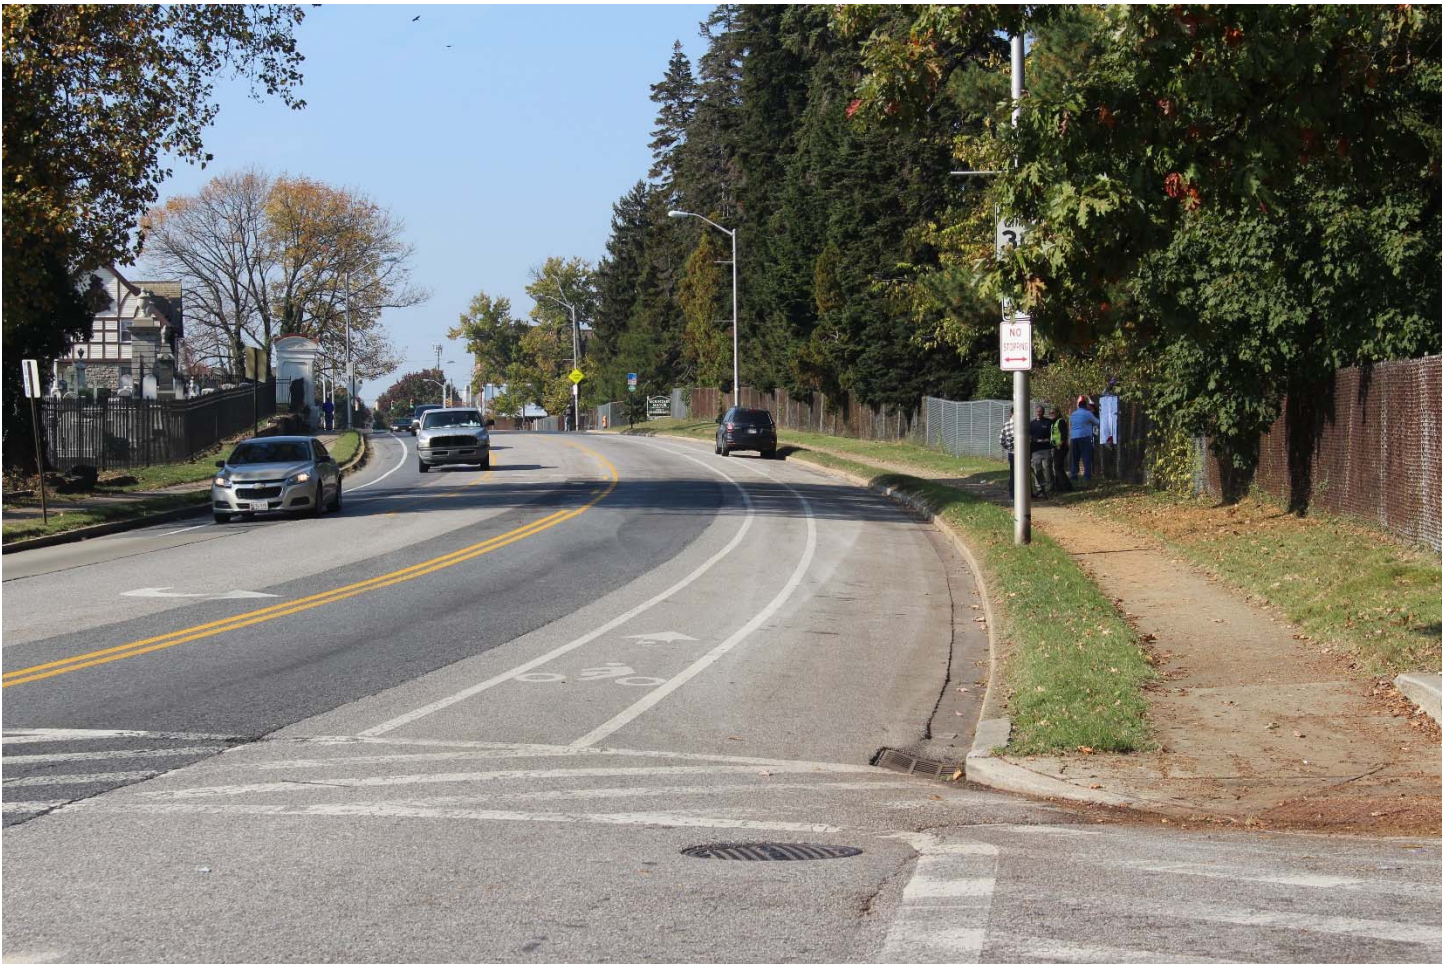
Highway Photo 25 – Westbound view of transit buse’s approach from Morley street. Note the slope and curvature of the roadway. The impact area is near where the curve begins in the area covered by the shade of the trees.

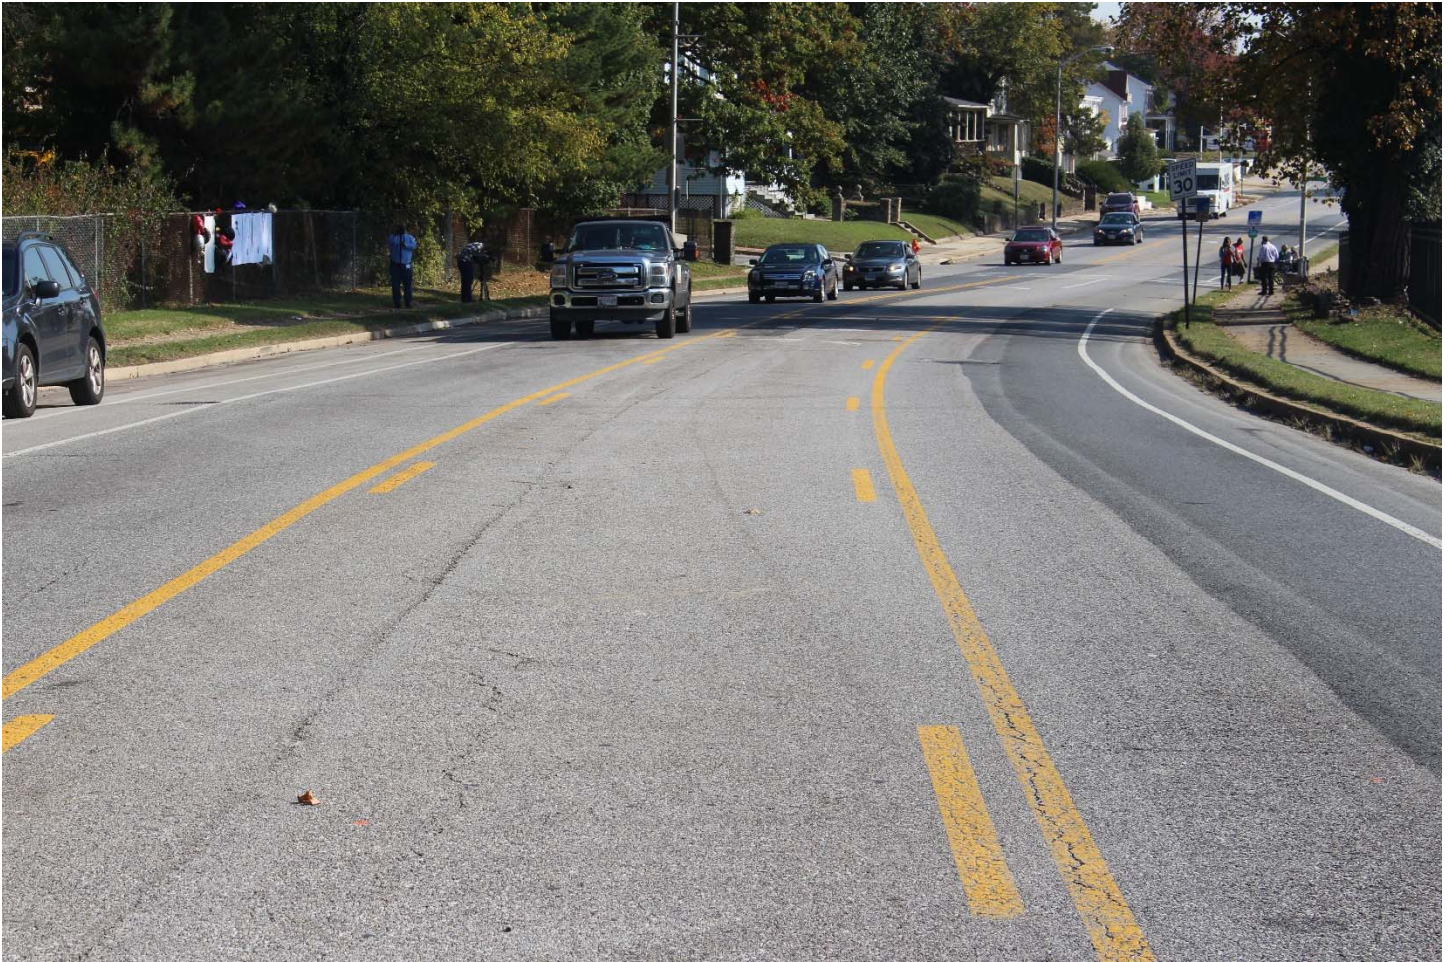
Highway Photo 26 – Eastbound view of School bus driver’s approach taken the day after the accident. Note the downhill slope and curvature of the roadway.

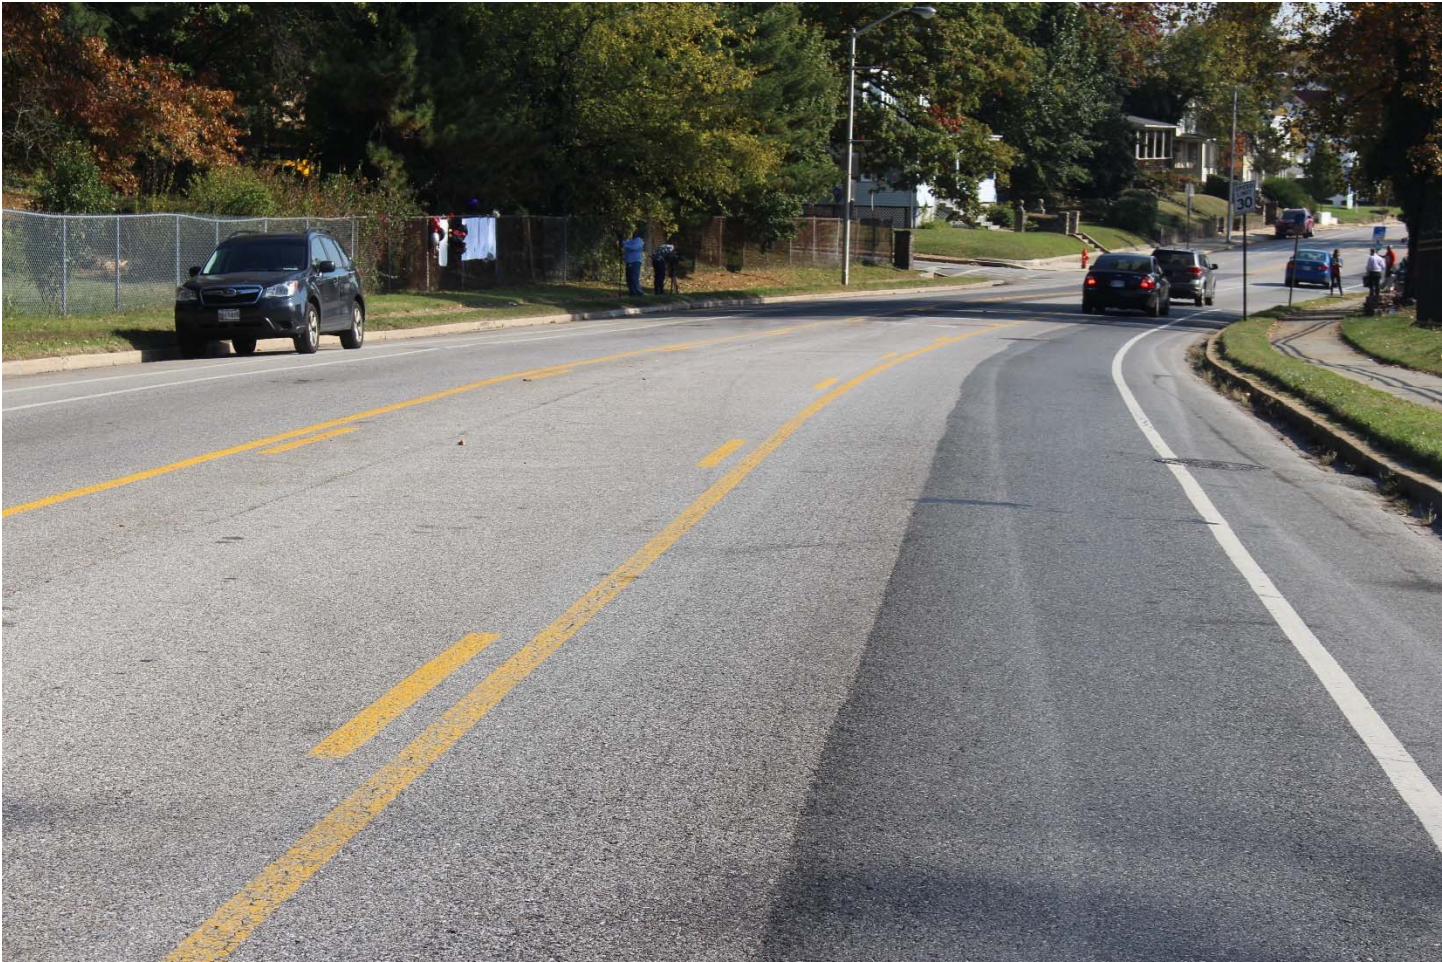
Highway Photo 27 – Additional view of eastbound approach with impact area located in the photo area where the tree shade crosses the pavement adjacent to the 30 mph speed limit sign.

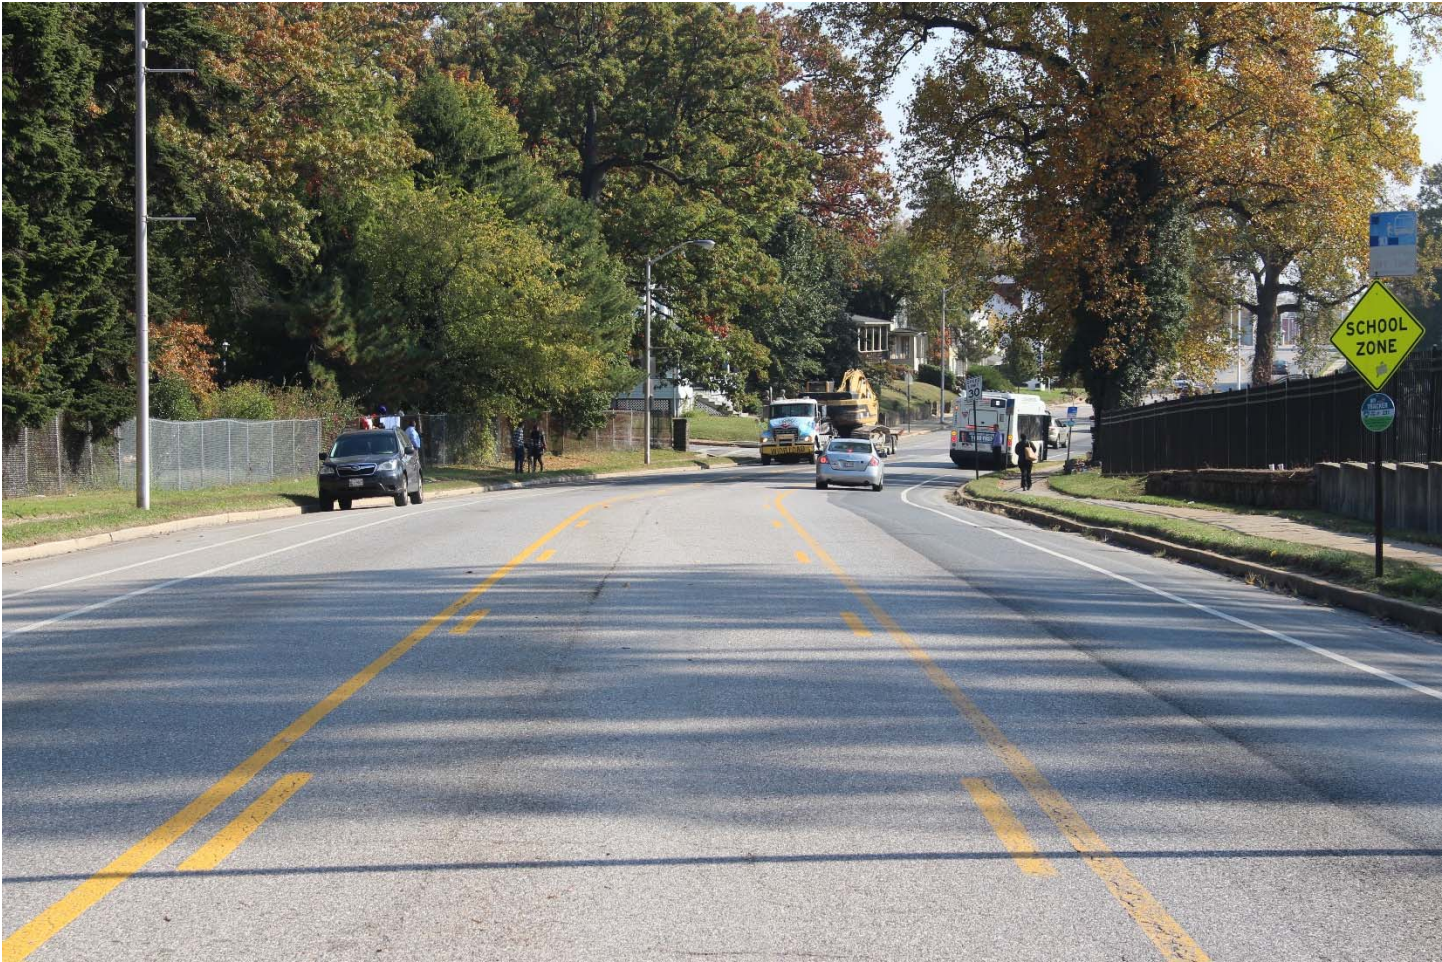
Highway Photo 28 – View of eastbound approach to the curve with the impact area and Morley street in the background.
