Highway Group Chairman
Factual Report

HIGHWAY GROUP CHAIRMAN – FACTUAL REPORT

HWY-00-F-H001

I. ACCIDENT SUMMARY:

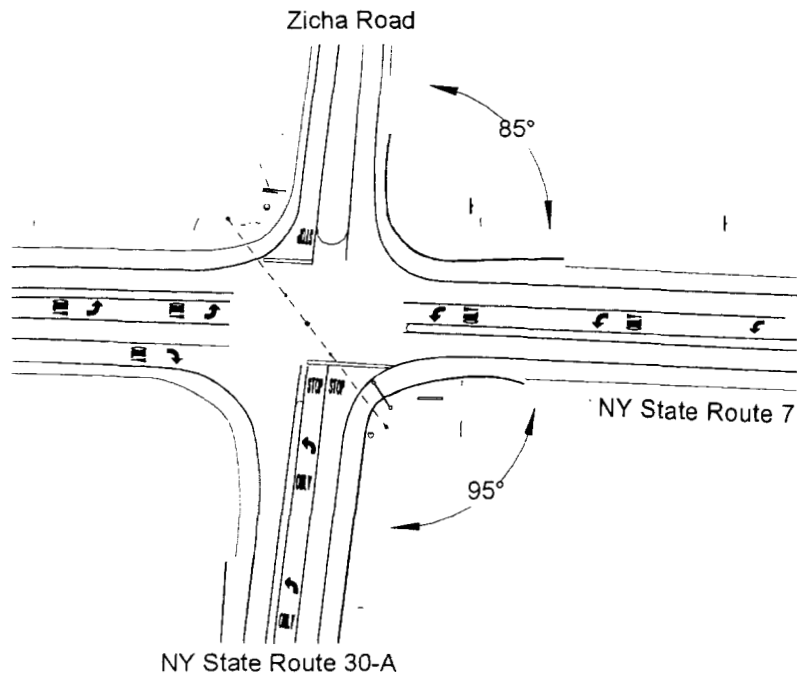
Figure – 1, intersection of SR 7 and SR 30-A

The location where the crash occurred was configured as a channelized³ four-leg intersection. The roadway that traversed the intersection from east to west was identified as State Route (SR) 7, and was assigned a functional classification by the NYSDOT of *Rural, Minor Arterial*⁴. The roadway comprising the north leg of the intersection was identified as Zicha Road, and was assigned a functional classification by the NYSDOT of *Rural, Minor Collector*⁵. The roadway coming into the intersection from the south was identified as State Route (SR) 30-A, and was assigned a functional classification by the NYSDOT of *Rural, Minor Arterial*. The alignment of the intersection was such that the roadways did not cross each other at exactly 90 degrees. Establishing SR 7 as a baseline, and measuring counterclockwise in the northeast quadrant, Zicha Road was found to intersect SR 7 at about an 85 degree angle (see figure 1). The westbound approach of SR 7 had a 1.6 percent downgrade that began about 1 mile east from the intersection.

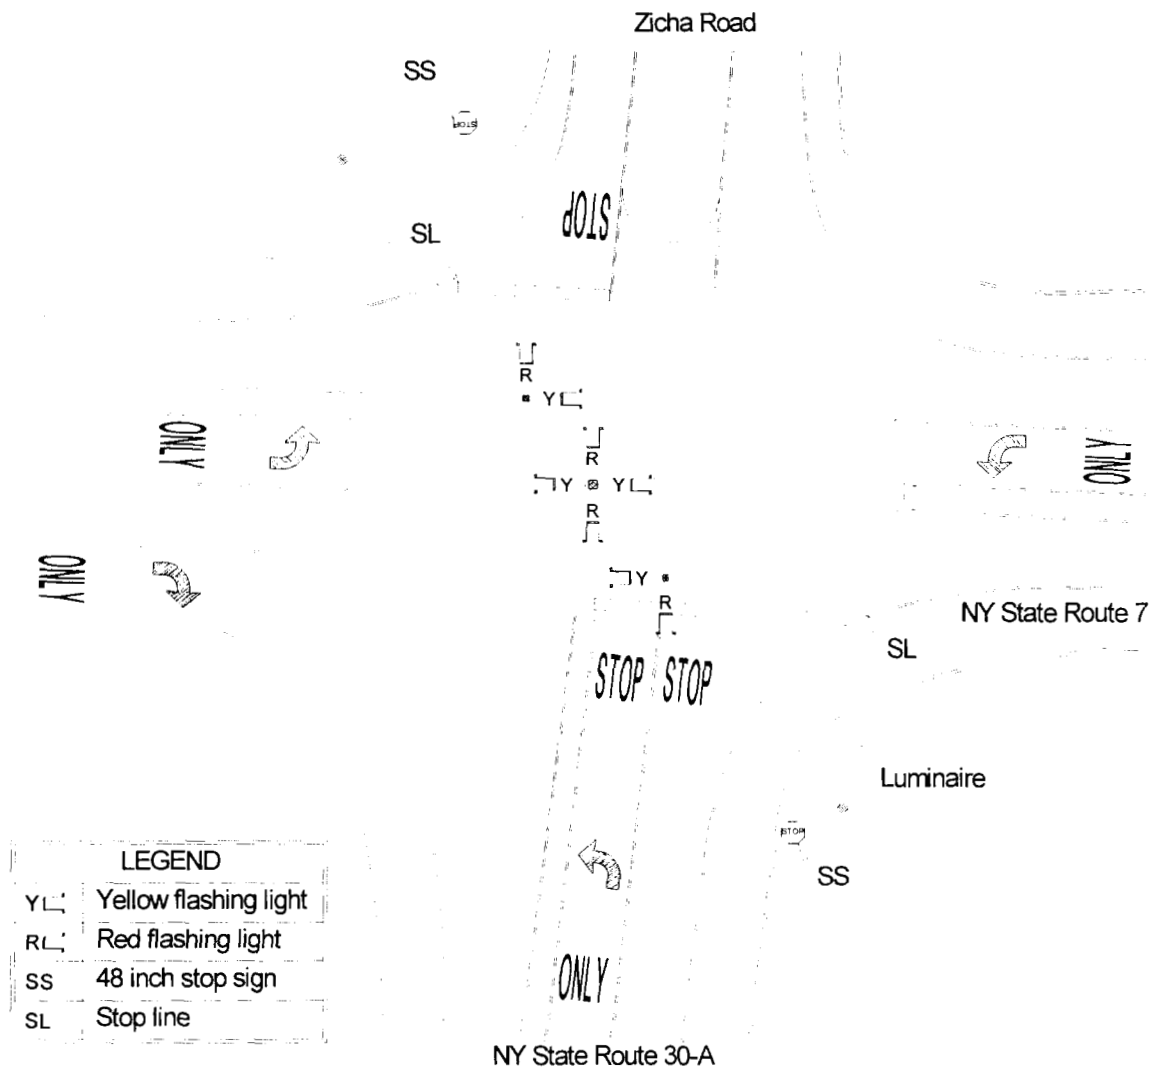
Figure – 2, intersection traffic control devices

In addition to the signs, a set of three, overhead intersection control beacons, as described in section 4E-3 of the MUTCD had been erected within the intersection. The beacons traversed the intersection diagonally from the northwest to the southeast, with the lowest beacon positioned about 19 feet above the pavement. The center beacon consisted of four 12-inch lenses configured so that the north and south approaches faced a red colored lens, and the east and west approaches faced a yellow colored lens. The center beacon was supplemented by two smaller beacons, each having an eight inch lens. The smaller beacons had one red, and one yellow lens, and were positioned to work in conjunction with the center beacon (see figure 2).

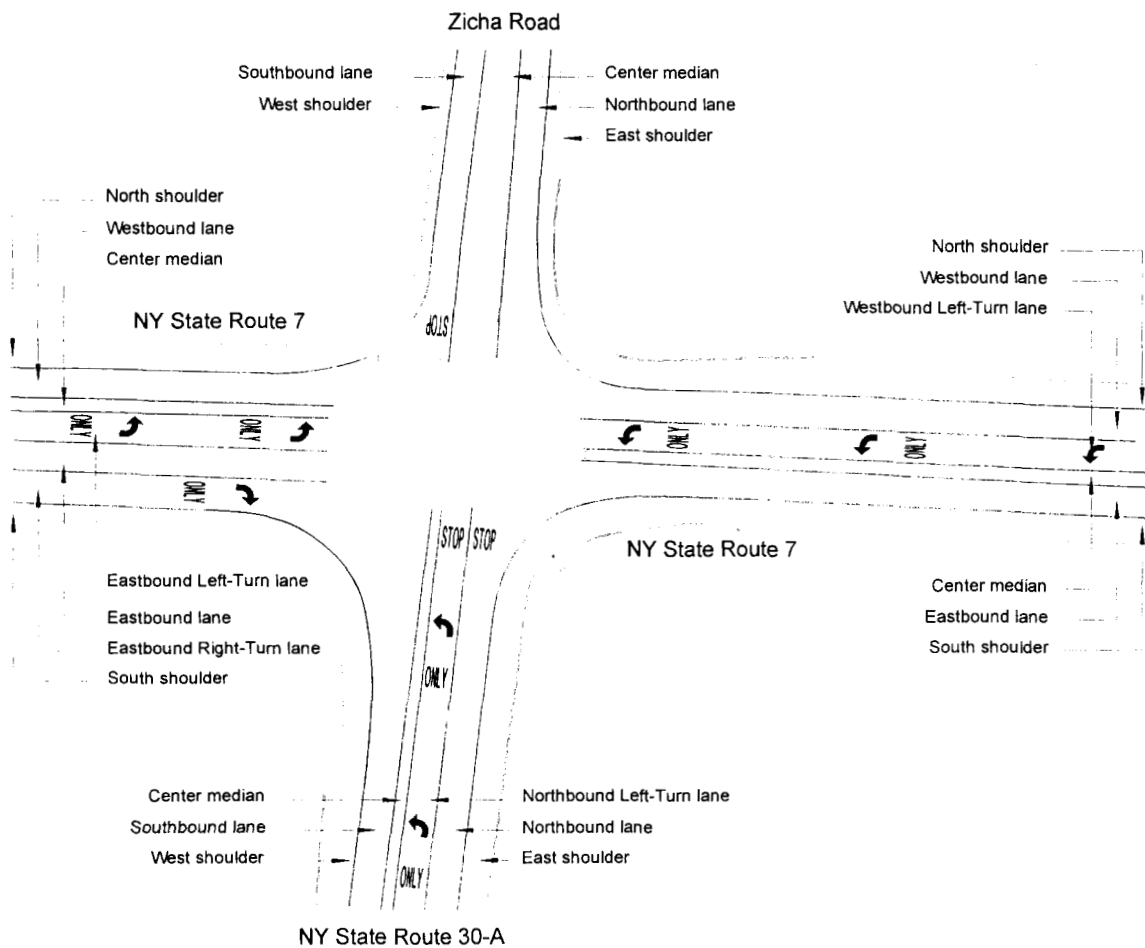
Figure – 3, traffic lane configurations

State Route 7 was a two way, two lane, paved asphalt roadway running east and west through the intersection. Typically, the east and westbound traffic lanes were divided by a painted center stripe. However, at both approaches to the intersection, the roadway was divided by a flush, concrete median, delineated by yellow, painted edge lines. In addition to the inclusion of the center median, the number of lanes at the intersection was increased by the addition of channelized turn lanes. On the east side of the intersection, SR 7 was comprised of one 12-foot wide westbound through lane, one 11-foot wide westbound left-turn-only lane, and one 11-foot wide eastbound through lane. The turn-only lane was identified by painted pavement markings consisting of left turn arrows, preceded by the words “ONLY”. Painted, solid white edge lines delineated the through lanes. The traffic lanes were bordered by 10 foot wide paved shoulders, and the overall width of the roadway’s paved surface was 60 feet (see figure 3).

On the west approach to the intersection, SR 7 was comprised of an 11-foot wide westbound through lane, and a flush, 4 foot wide concrete median. The eastbound lanes consisted of an 11-foot wide left-tun-only lane, an 11-foot wide through lane, and a 12-foot wide right-tun-only lane. The turn-only lanes were identified by painted pavement markings consisting of turn arrows, all of which were preceded by the words "ONLY". The through lanes were delineated by painted, solid white edge lines. The roadway also had a 10 foot wide paved shoulder on the north side, and a 6 foot paved shoulder on the south side. The overall width of the paved surface of the roadway was 68 feet (see figure 3).

State Route 30-A, which comprised the south leg of the intersection was a two way, two lane, paved asphalt roadway running north and south. The north and south bound lanes of the roadway, from the north exit ramp of Interstate 88 to the intersection of SR 7 were divided by a flush, concrete median, delineated by yellow, painted edge lines. The northbound through lane was 12 feet wide, and the width of the southbound lane was 11 feet. Both lanes were delineated by painted, solid white edge lines, and were bordered by 11 foot wide paved shoulders. At the northbound approach to the intersection, the roadway also incorporated an 11 foot wide channelized turn lane to accommodate traffic intending to turn left onto SR 7. The turn-only lane was identified by painted pavement markings consisting of left turn arrows, preceded by the words "ONLY". The overall width of the paved surface of the roadway was 60 feet (see figure 3).

Zicha Road, located at the intersection's north leg was a two way, two lane, paved asphalt roadway running north and south. The northbound lane was 11 feet wide, and the width of the southbound lane was 10 feet. In general, the traffic lanes were divided by a painted center stripe. However, at the southbound approach to the intersection, the roadway widened to incorporate a flush, concrete median. The traffic lanes were separated from the median by yellow, painted edge lines, and from the paved shoulder area by white edge lines. Both paved shoulders were 4 feet wide, and the overall width of the roadway's paved surface was 43 feet (see figure 3).

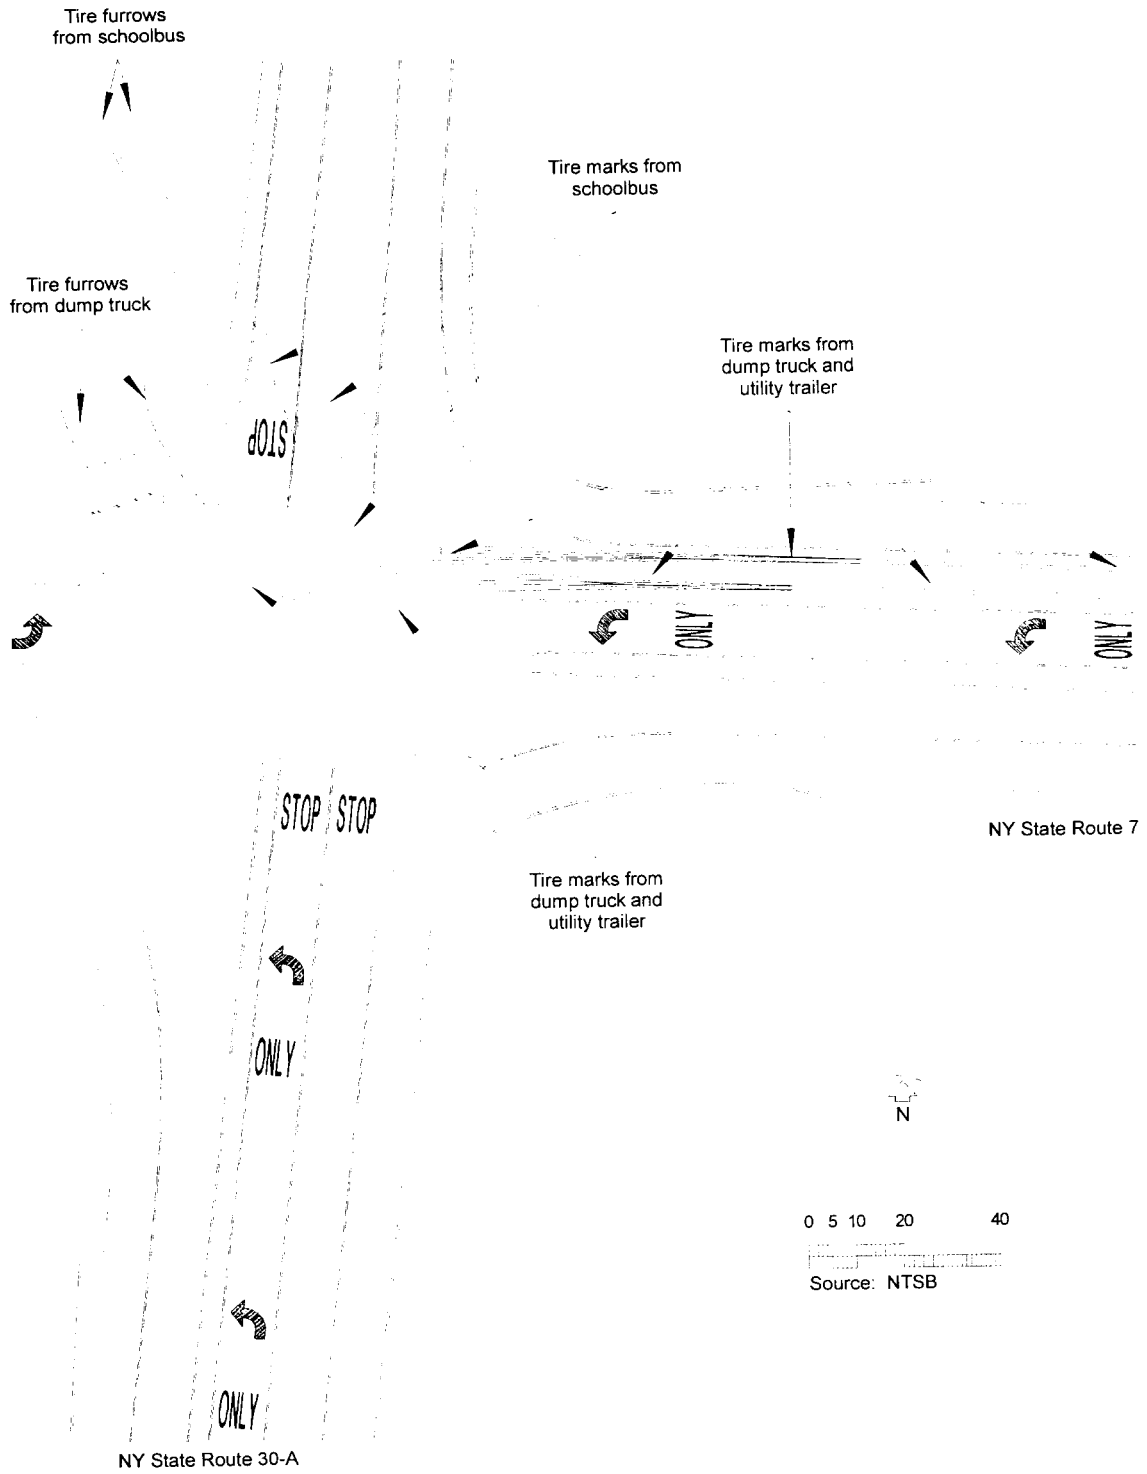
Figure – 4, physical evidence

The accident scene was first documented by NTSB investigators on October 22, 1999. During this time, a detailed mapping was conducted documenting the physical layout of the intersection, lane details, and the existing physical evidence. The physical evidence consisted of tire marks that were found in the westbound lane of SR 7, the north side of the intersection, and off the pavement in the northwest corner of the intersection. The dump truck and utility trailer had left a series of tire marks in the westbound lane of SR 7. The tire marks began about 149 feet east of the intersection and terminated at the intersection. Additional tire marks from both the dump truck, utility trailer, and schoolbus were observed on the north side of the intersection. These tire marks, which led off toward the intersection's northwest corner were about 79 feet in length. Additionally, the dump truck and schoolbus had produced tire furrows in the earthen surface as both vehicles came to rest off the roadway (see figure 4).

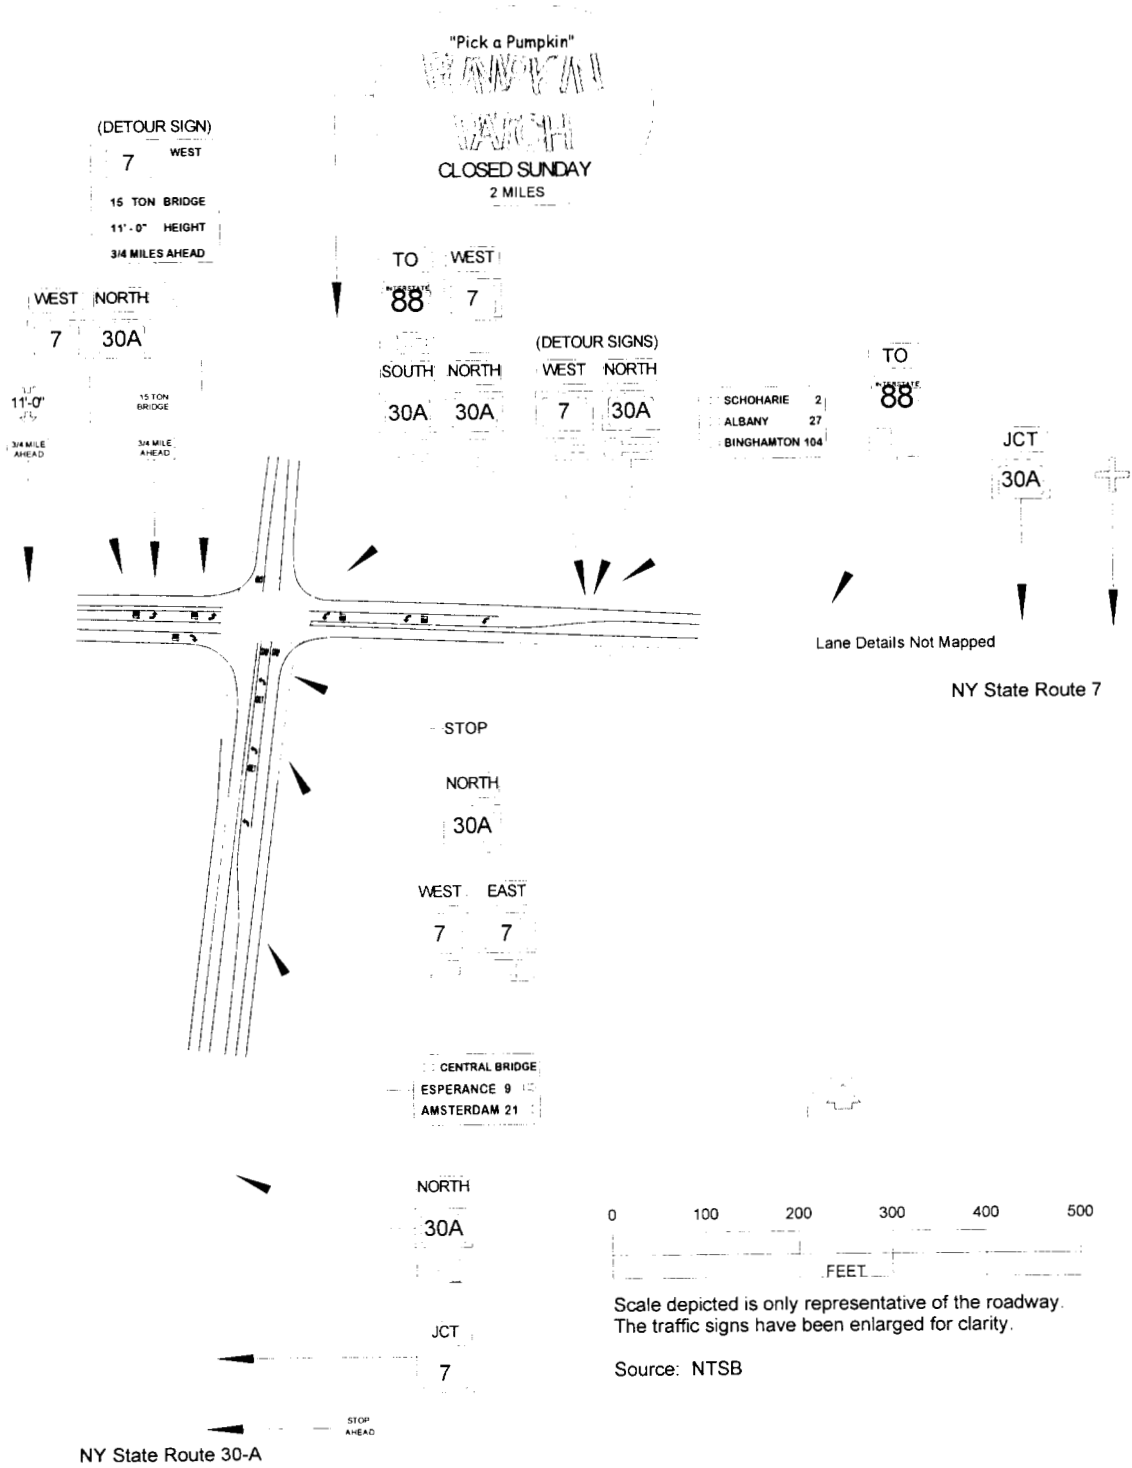
Figure – 5, highway signs located adjacent to vehicle approaches

Investigators returned to the accident scene on October 23, 1999 to document the location of traffic control devices, highway signs, and other environmental features. Of specific interest were the placement and types of road guide signs that would be visible to both vehicle operators as they approached the intersection (see figure 5).
