**HIGHWAY FACTORS GROUP CHAIRMAN'S
FACTUAL REPORT**

PENWELL, TX

HWY15MH004

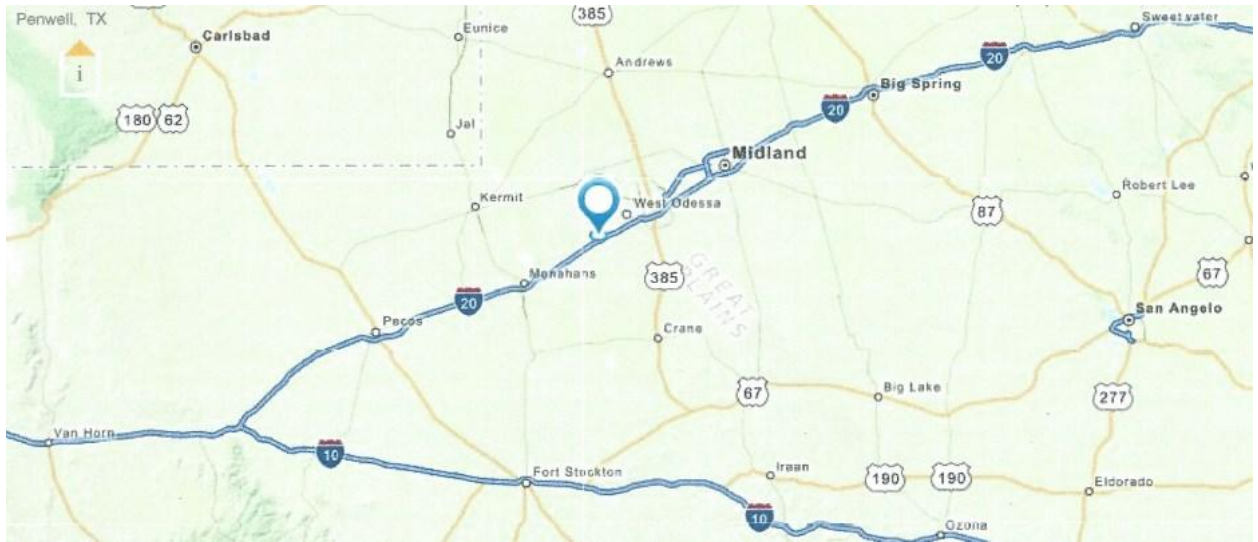
Figure 1

The accident occurred on Interstate 20 (I-20) about 918 feet east of mile marker 103 near Penwell, in Ector County, Texas, in the westbound lanes near station no. 989.00¹. The accident scene was located at latitude 31.751389 degrees and longitude-102.561667 degrees. (See Figure 1.)

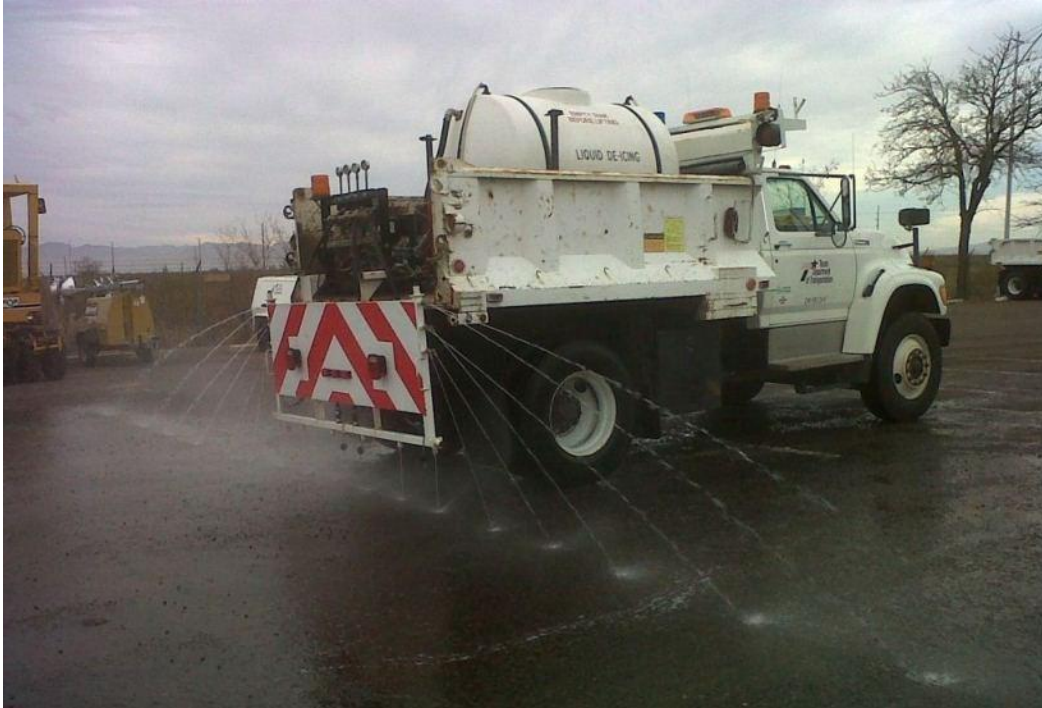
Figure 2 Application of liquid chemical by stream nozzles.

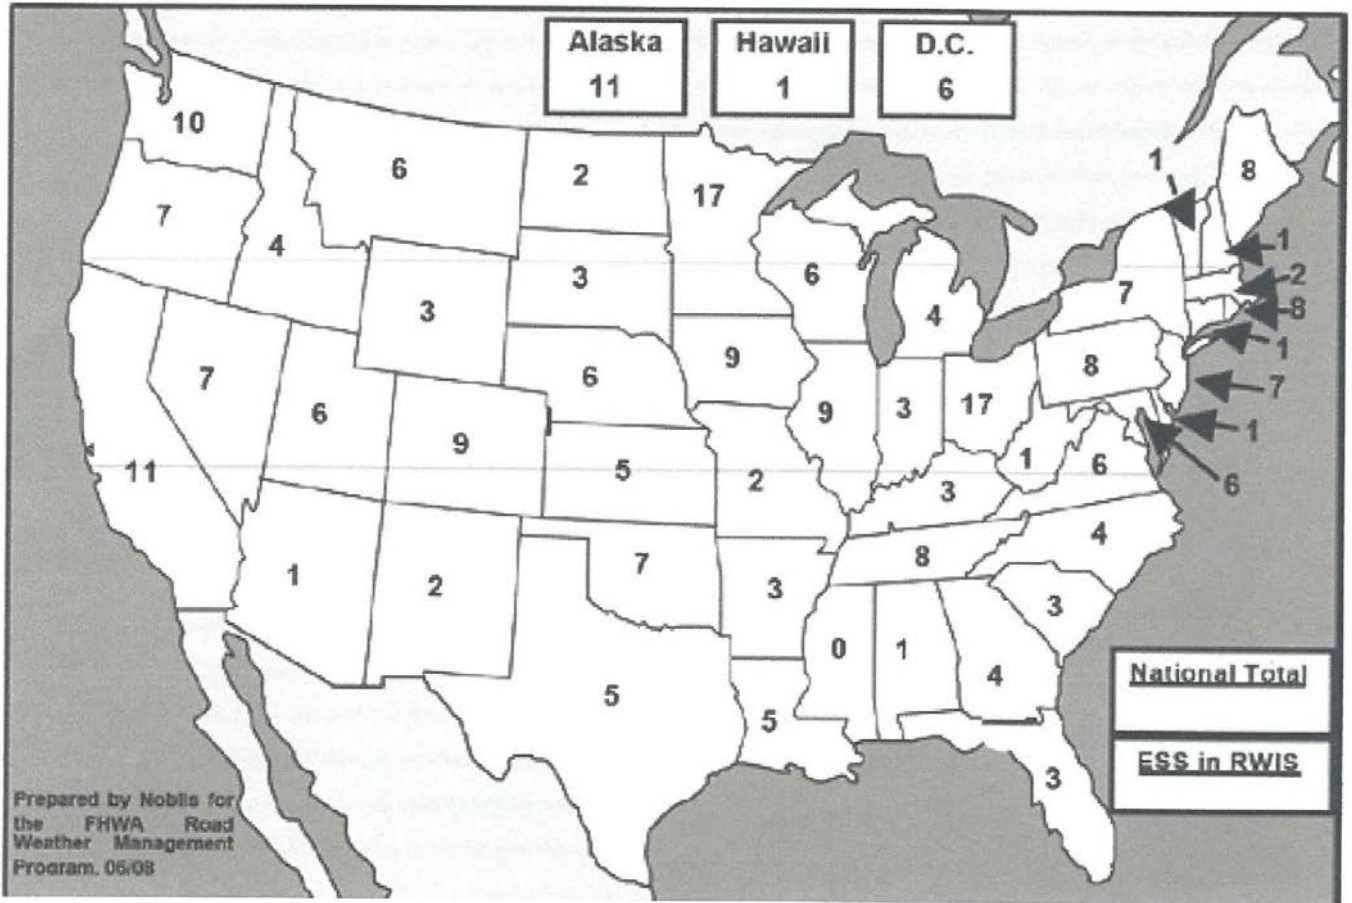
Figure 5

ESS owned by State Transportation Agencies
