**NATIONAL TRANSPORTATION SAFETY BOARD
OFFICE OF HIGHWAY SAFETY
WASHINGTON, D.C.**

**HIGHWAY FACTORS GROUP CHAIRMAN'S
FACTUAL REPORT**

Vehicle: 2017 Volvo XC90, being operated by Uber in autonomous mode

NTSB #: **HWY18MH010**

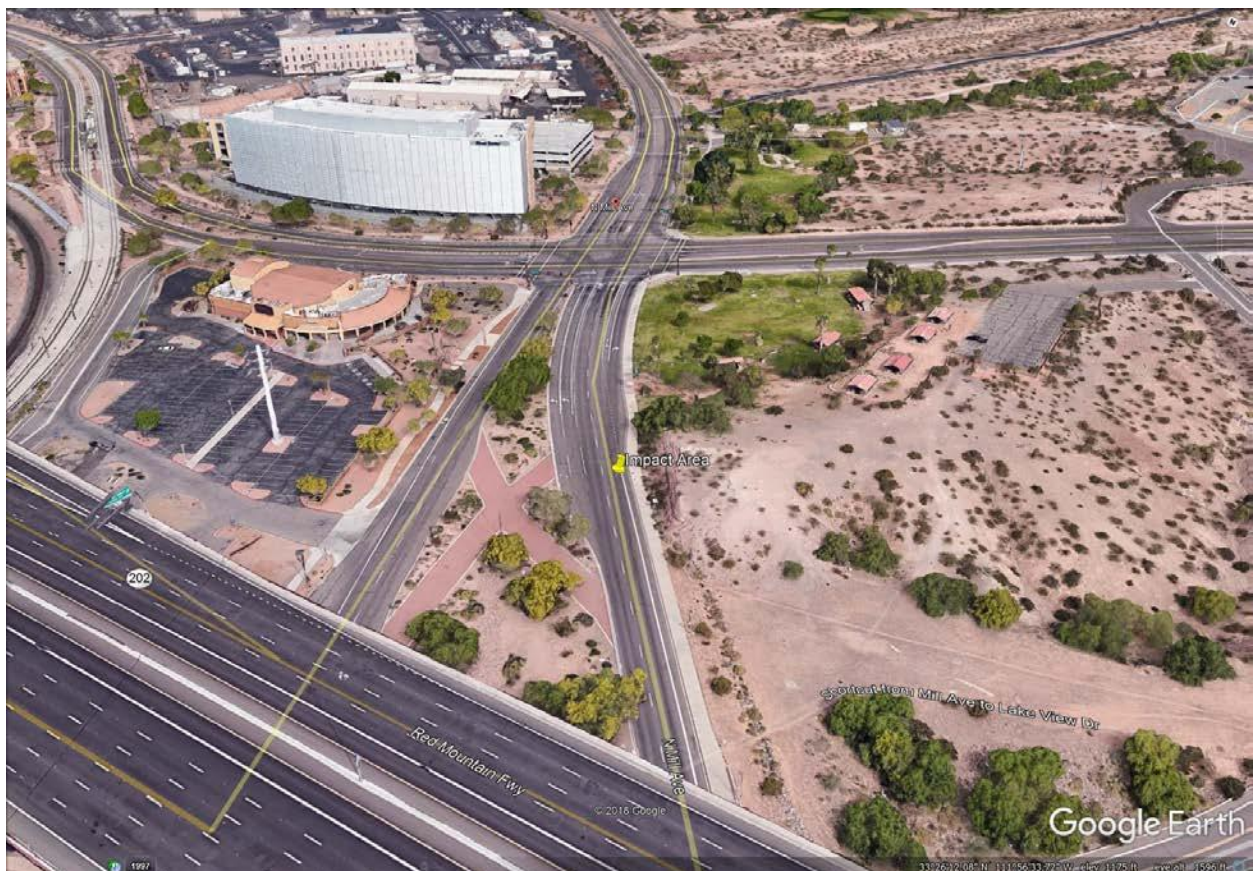
Figure 1 View of impact area on N. Mill Avenue

This accident occurred on North Mill Avenue about 398 feet south of the intersection of Curry Road and approximately 380 feet south of the crosswalk at the intersection. The posted speed limit on North Mill Avenue was 45 mph. **See Figure 1** for a view of the accident area.

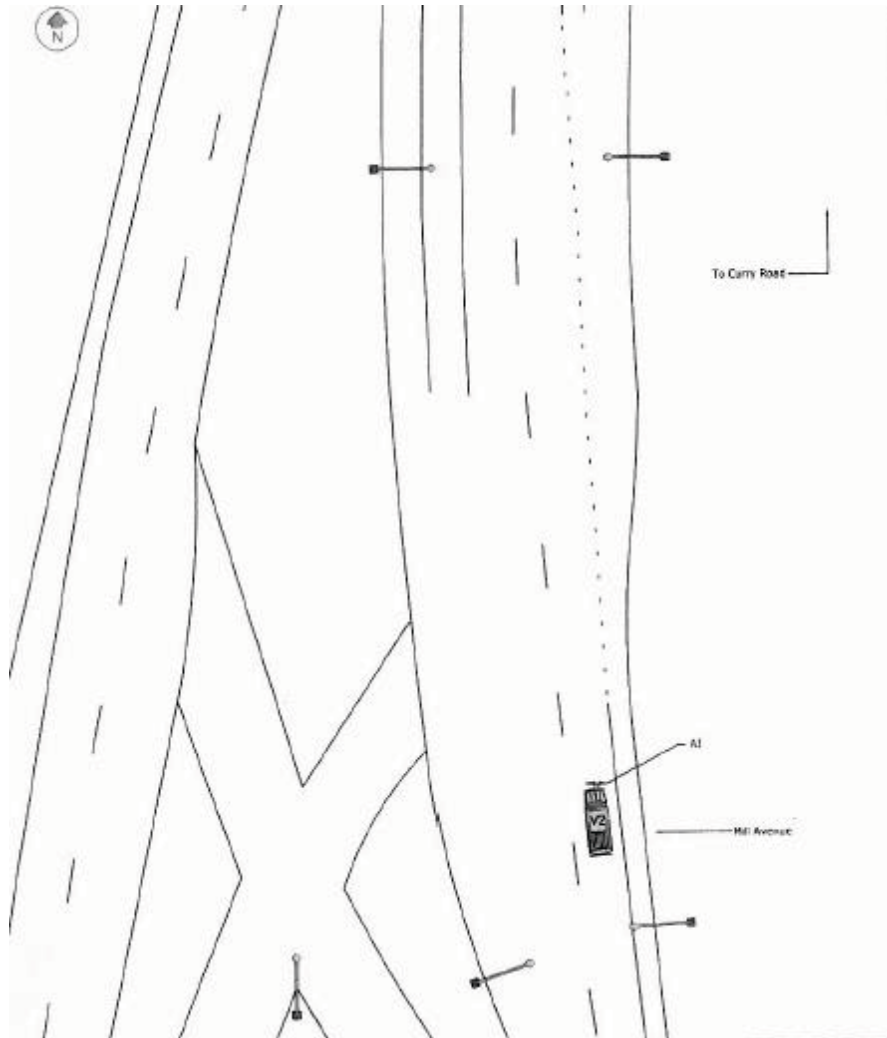
Figure 3 Approximate impact location shown by passenger car and bicycle just north of two street lights. (Drawing courtesy of Tempe Police)

Since there were no marks at the initial impact point Tempe PD used the video file from the Uber vehicle's forward facing dashcam to triangulate to common points visible on the video file. With this information there were able to determine that the center of the Volvos front bumper was 22.5 feet from (south of) the solid white pavement stripe ending for the bicycle lane and five feet to the left of the pavement stripe when the impact occurred.

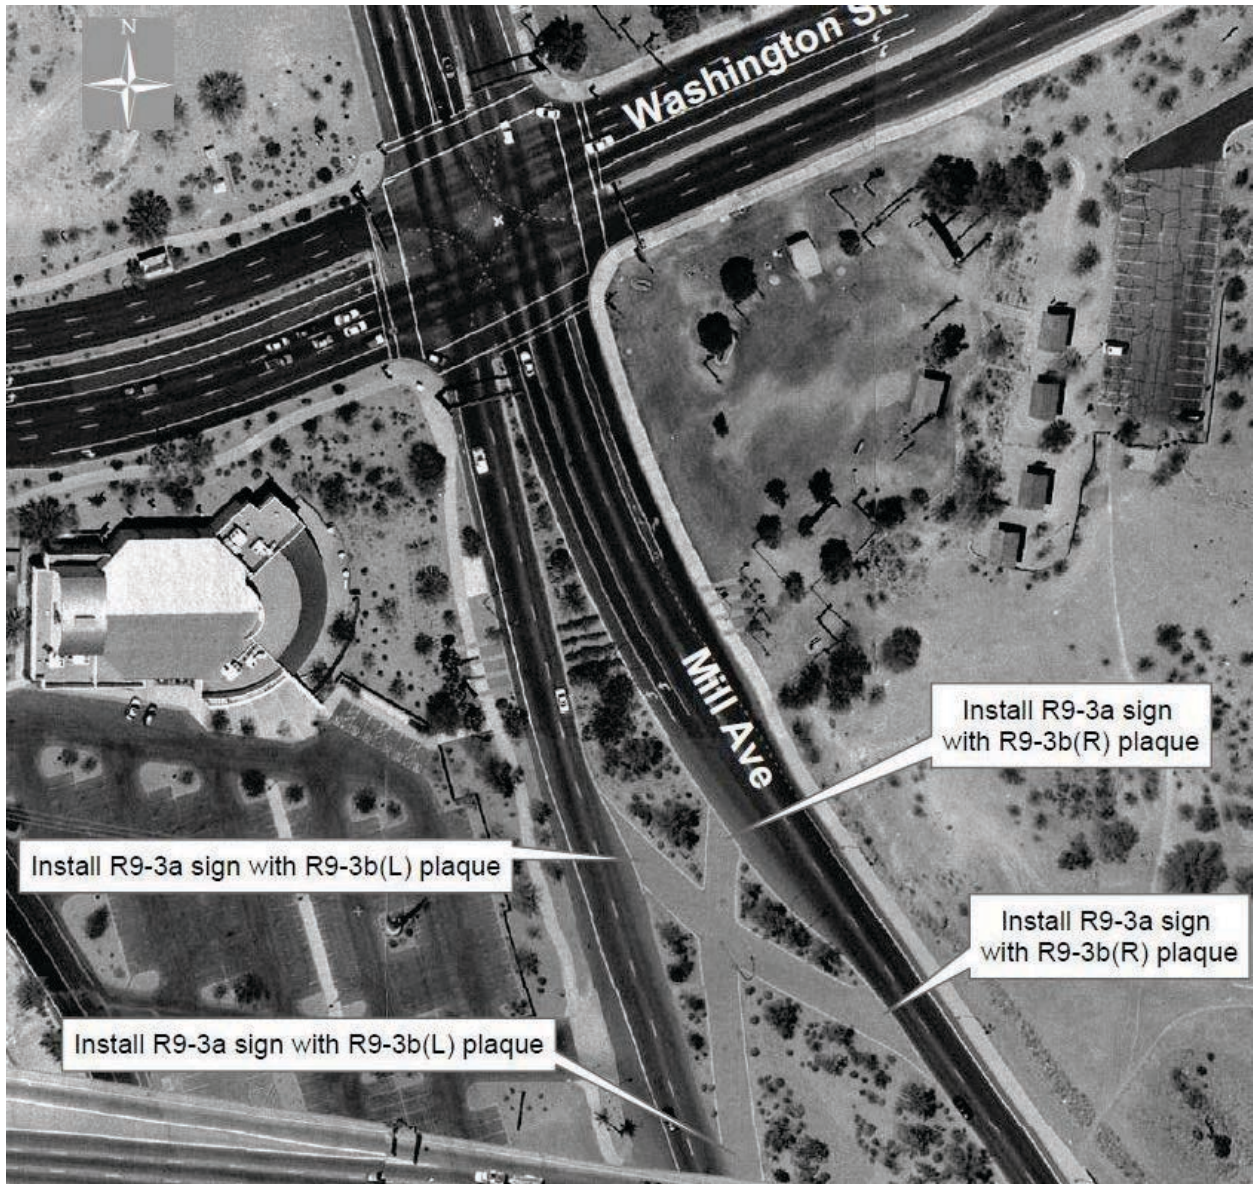
Figure 4 Shows the location of signs prohibiting pedestrians from crossing in the accident area.

In 2009, when the Public Works Department was adding vertical curbs on North Mill Avenue, the Tempe Police Department requested they also add signage in the area to prohibit pedestrians from crossing mid-block in this area. **See Figure 4** below for the locations of the signs added to prohibit pedestrians from crossing in the accident area.

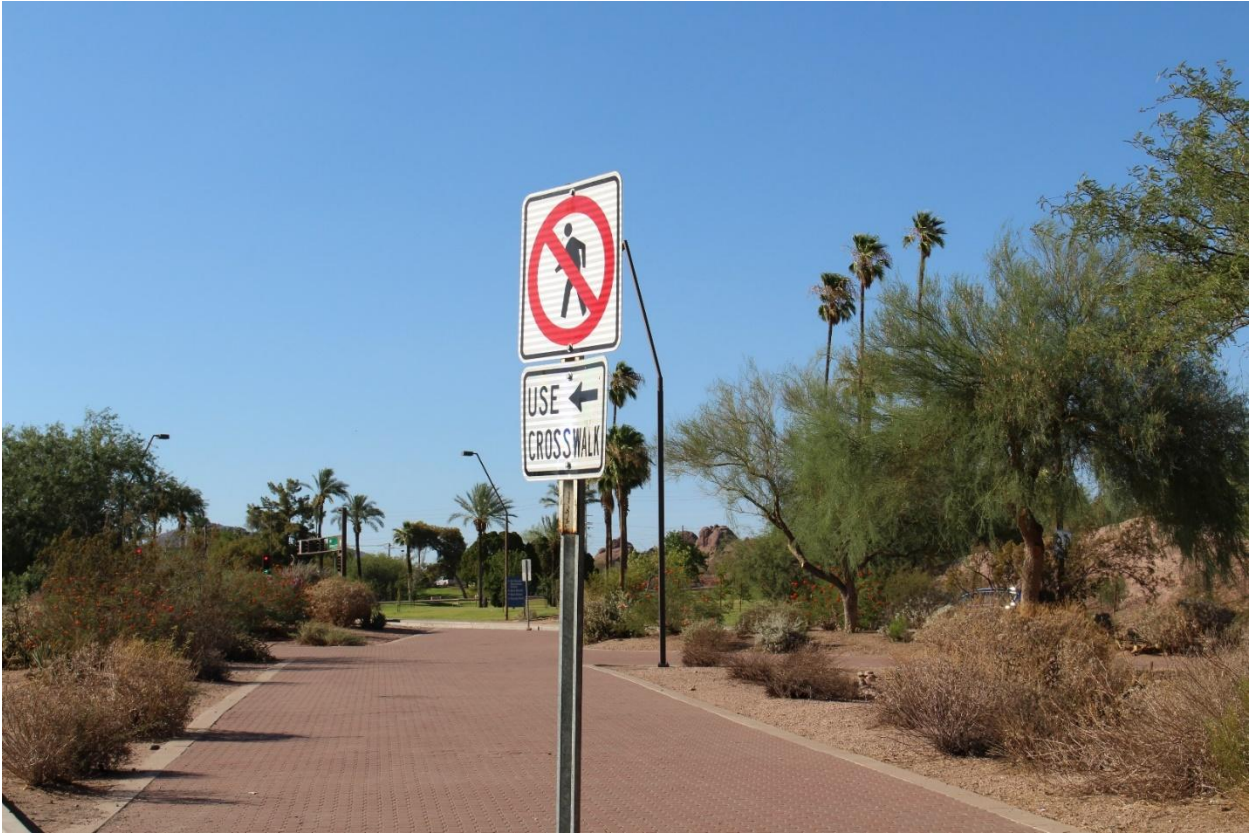
Figure 5 Signs prohibiting pedestrians from crossing South Mill Ave

After this crash, the City of Tempe added additional double-sided signs to prohibit pedestrian crossings in this area. See Highway Photo 3, which shows the wording on the signs placed in 2009. See Figure 5 below of the sign.

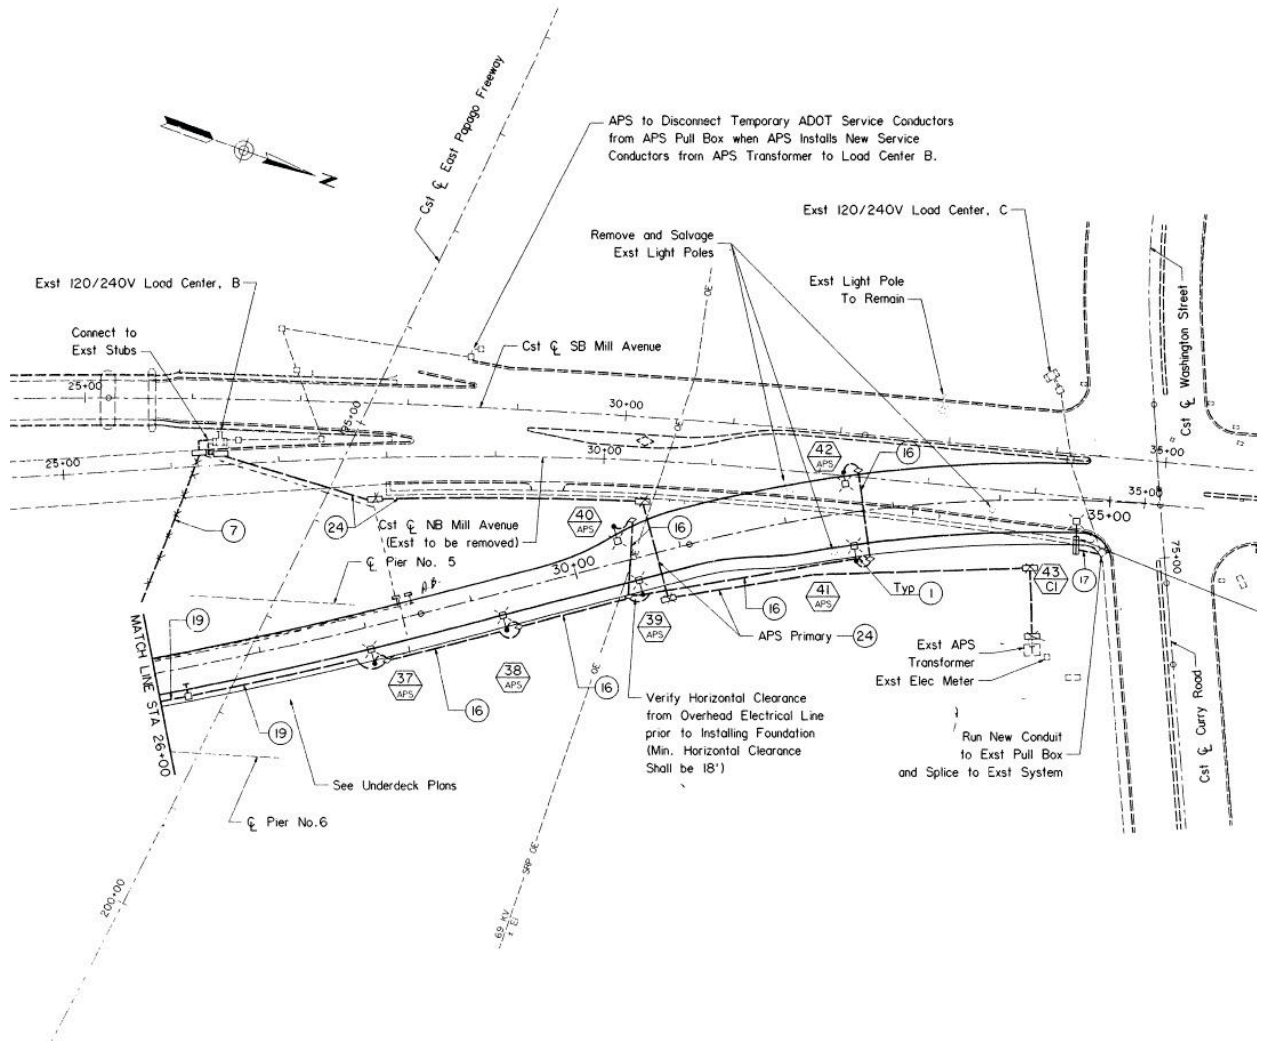
Figure 6 Lighting Fixture locations

Six highway safety lights were installed along North Mill Avenue in the crash area. There were four installations on the right and two installations on the left as a motorist moves northbound on Mill Avenue toward Curry Road. There were additional installations in the landscaped median area. Each lighting fixture was a 250-watt, 240-volt, High Pressure Sodium (HPS) light rated for 30,000-lumen output.⁶ The closest highway safety light to the impact area was fixture No. 39, which was on the right-hand side of the road. Design plans showed it was located at Station No. 30.55 or approximately 47 feet from the impact area at Station No. 31.02. The plans showed the light was installed 33.5 feet right of the roadway centerline on a 32-foot high fixture. The nearest light on the left-hand side of the road was designated on the plans as fixture No. 40. It was located at Highway station No. 30.45, or 57 feet south of the impact area and across the road. This fixture was installed 36.5 feet left of the N. Mill Avenue centerline. The Tempe Police indicated that all of the lights were working except for the farthest light on the left from the impact area. The plans designated this fixture as No. 42. It was located at highway Station No. 32+60, or 158 feet north

of the impact area and across the roadway in the median. This fixture was installed 36.5 feet left of the N. Mill Avenue centerline. See Figure 6 for design plan locations.

Additionally, beginning in the fall of 2017, the City of Tempe began replacing HPS lighting fixtures with LED streetlights in the city, citing increased visibility of pedestrians and cyclists along with substantial cost savings and reduced carbon emissions.⁷
