**HIGHWAY FACTORS GROUP CHAIRMAN'S
FACTUAL REPORT**

Highway Photographs 1 through 15

Palm Springs, CA

HWY17MH005

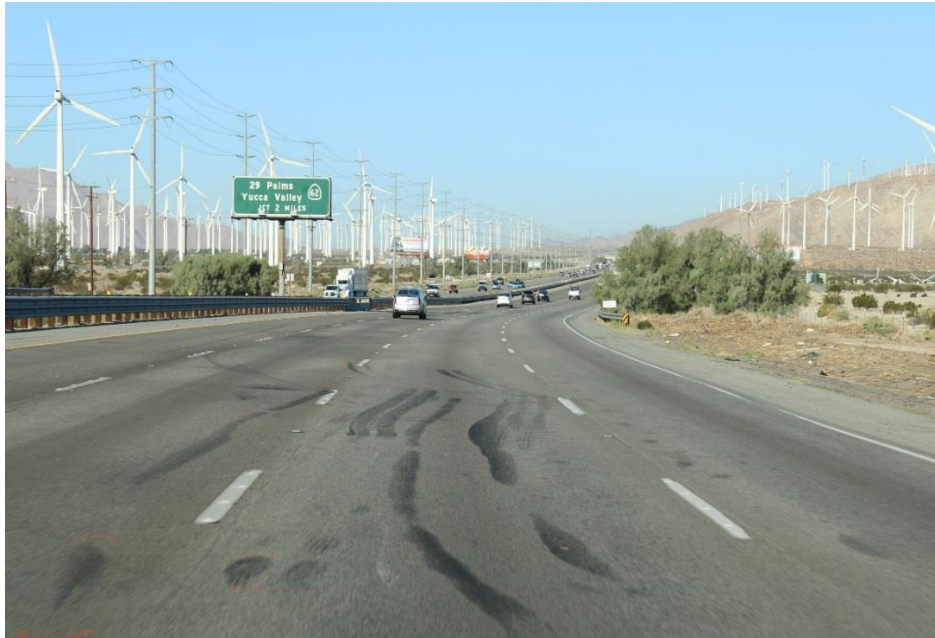
Highway Photograph 1 – View of tire marks and 6,000-foot radius curve to the right in the vicinity of the crash looking in the westbound direction of I-10 in Lane #3

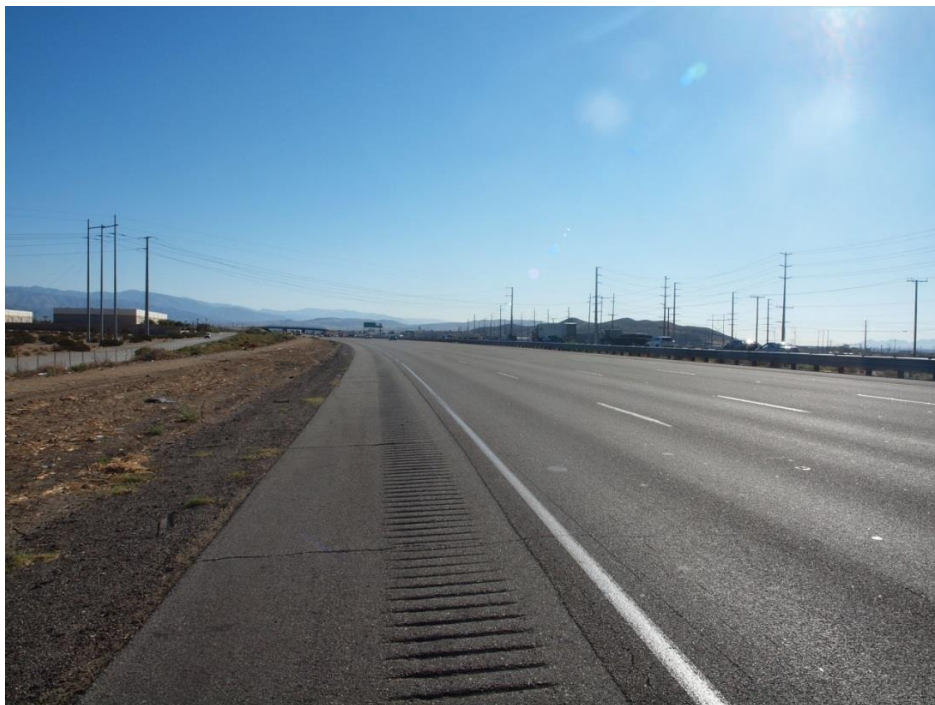
Highway Photograph 2 – View of the westbound travel lanes of I-10 looking to the east from the area of the crash illustrating no obstructions (i.e. shrubbery or signage) were located close to the shoulder that would have obstructed the view of the motorcoach driver as he traversed the 6,000-foot radius curve to the right in the center right lane

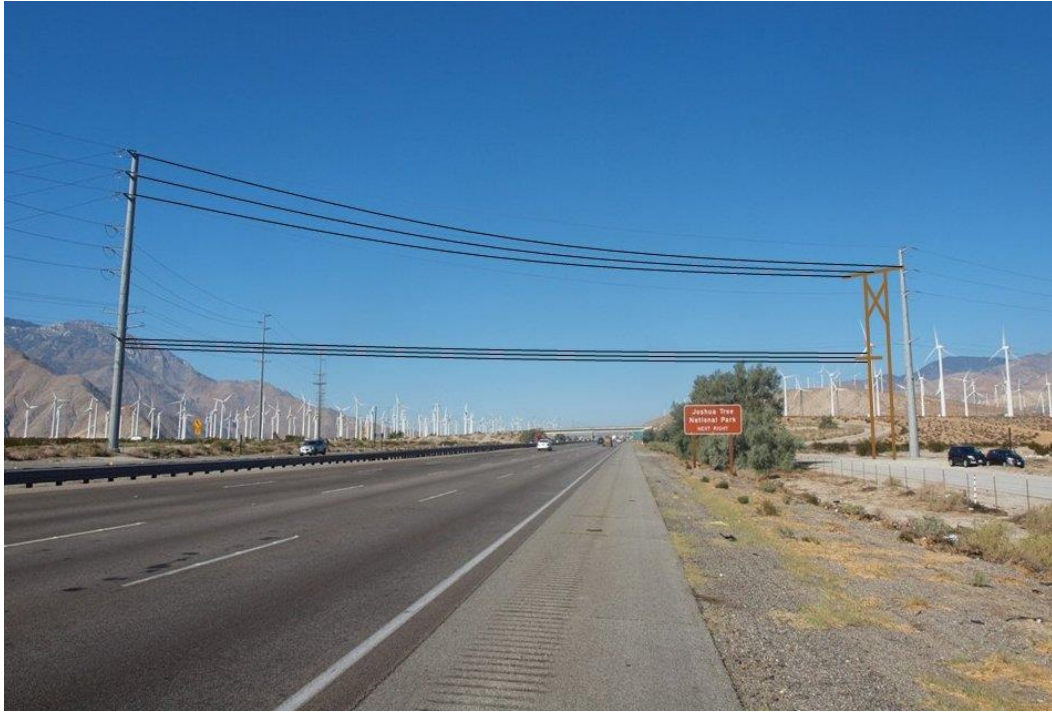
Highway Photograph 3 – Illustration depicting Stage 1 utility work. At the beginning of the utility work, the new tubular steel pole structure has no transmission lines attached to it spanning I-10. The wood structure and new steel pole structure are located side by side.

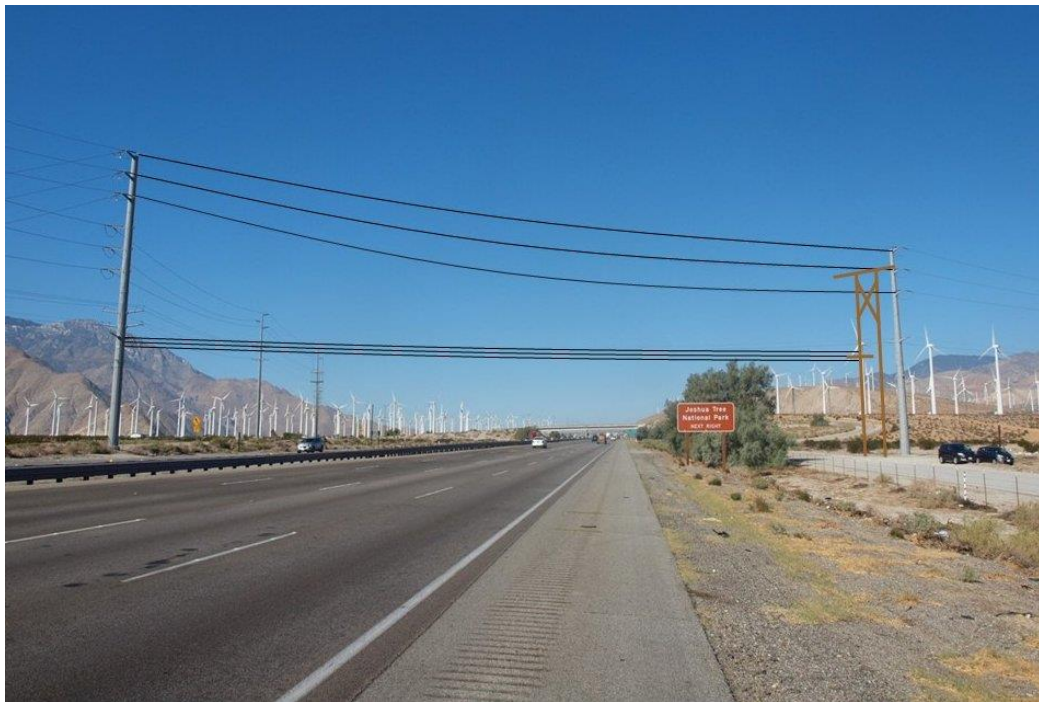
Highway Photograph 4 – Illustration depicting Stage 2 utility work. The top 3 lines are fastened to the new steel pole structure.

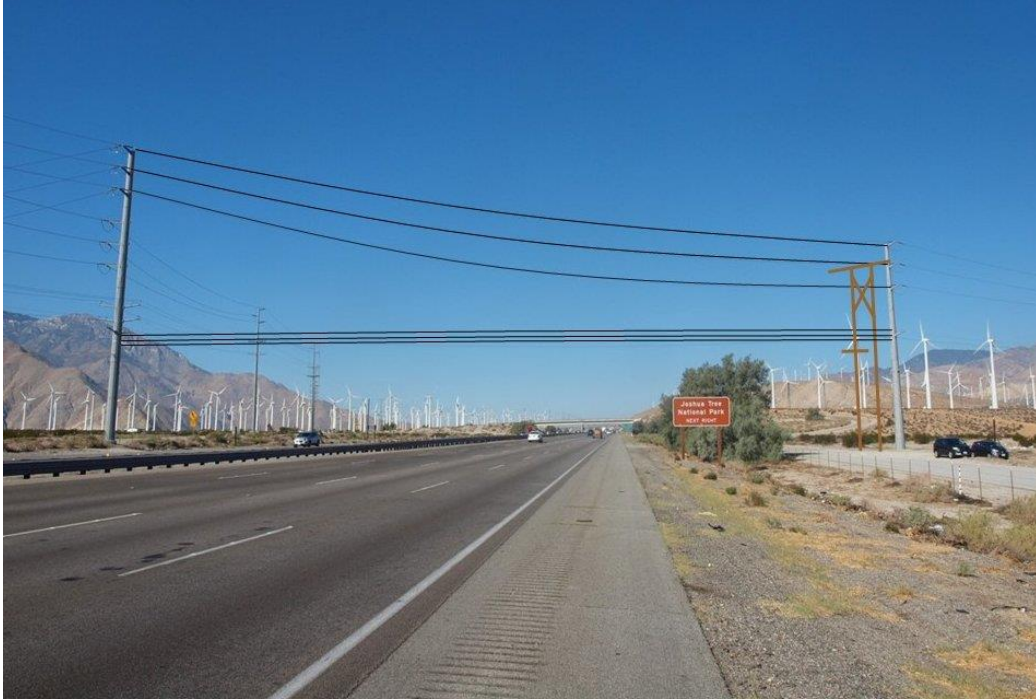
Highway Photograph 5 – Illustration depicting Stage 3 utility work. The bottom 3 lines are transferred to the new tubular steel pole. Safety devices are attached to the bottom 3 lines as an additional measure to secure the transfer.

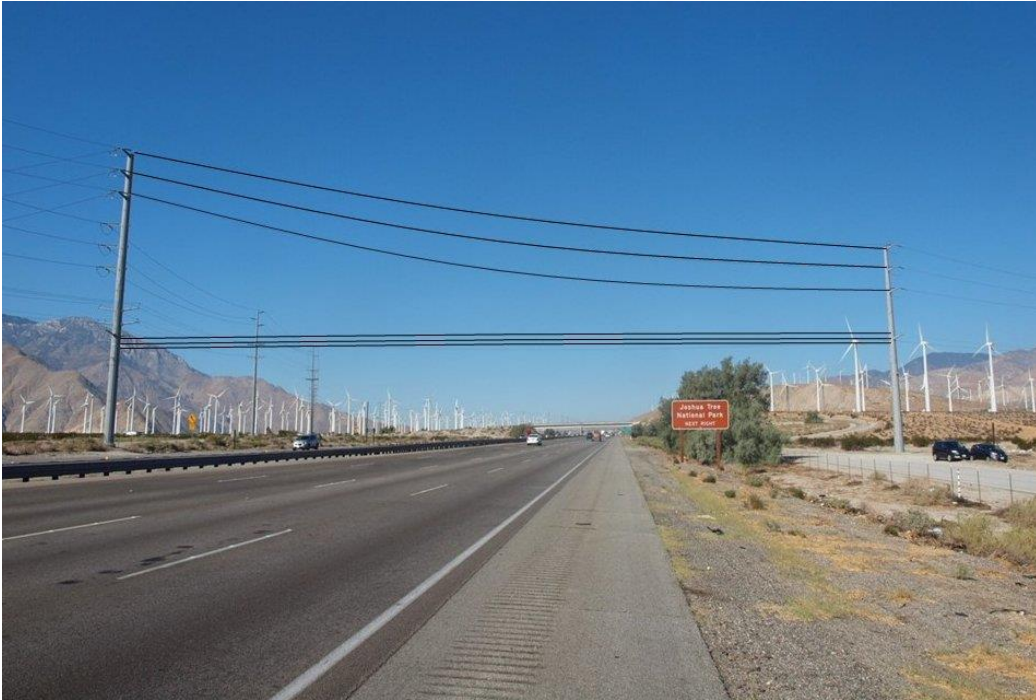
Highway Photograph 6 – Illustration depicting Stage 4 utility work. The existing H-frame wood structure is removed from the jobsite.

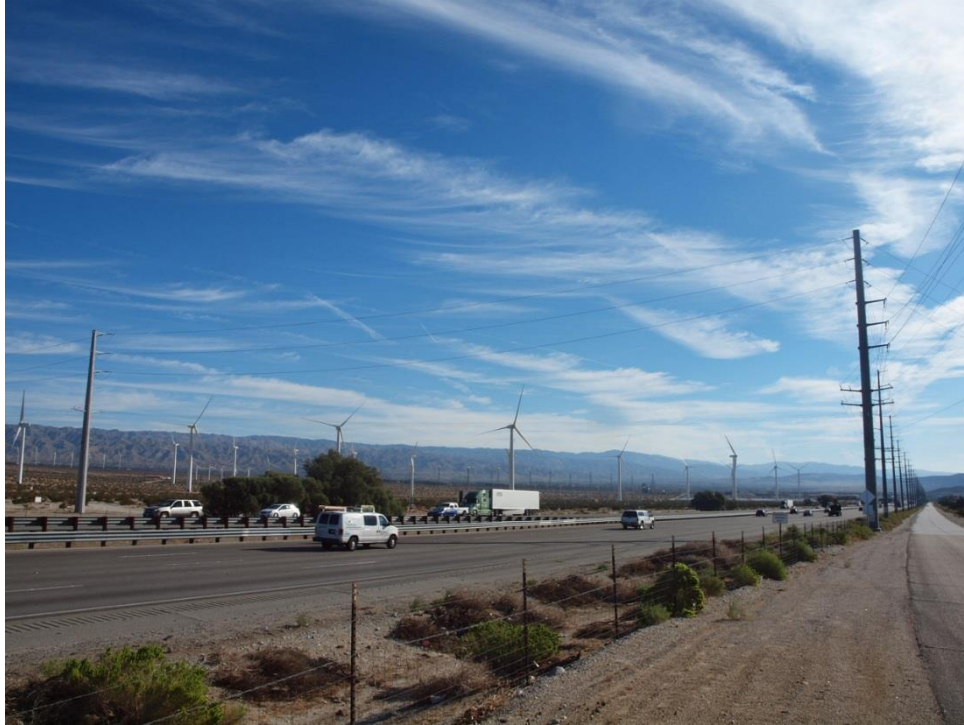
Highway Photograph 7 – View of the completed utility work taken after the crash on October 26, 2016 looking in the eastbound direction and standing on the south side of I-10

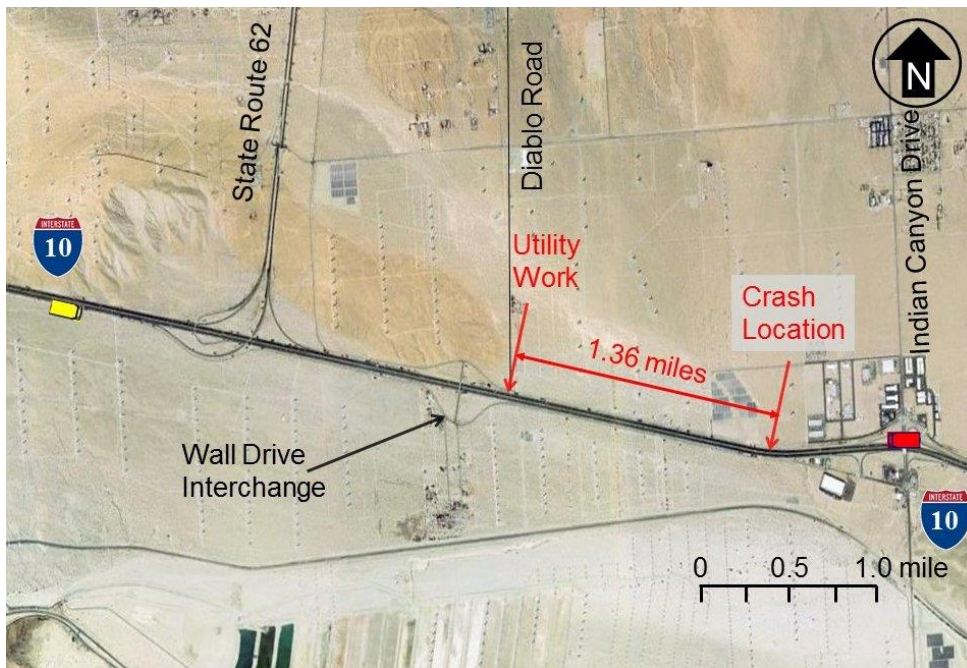
Highway Photograph 8 – Illustration depicting Stage 1 traffic break. The location of the CHP patrol vehicles highlighted in yellow and red are the staging positions before the first traffic break begins according to the MVARs video.

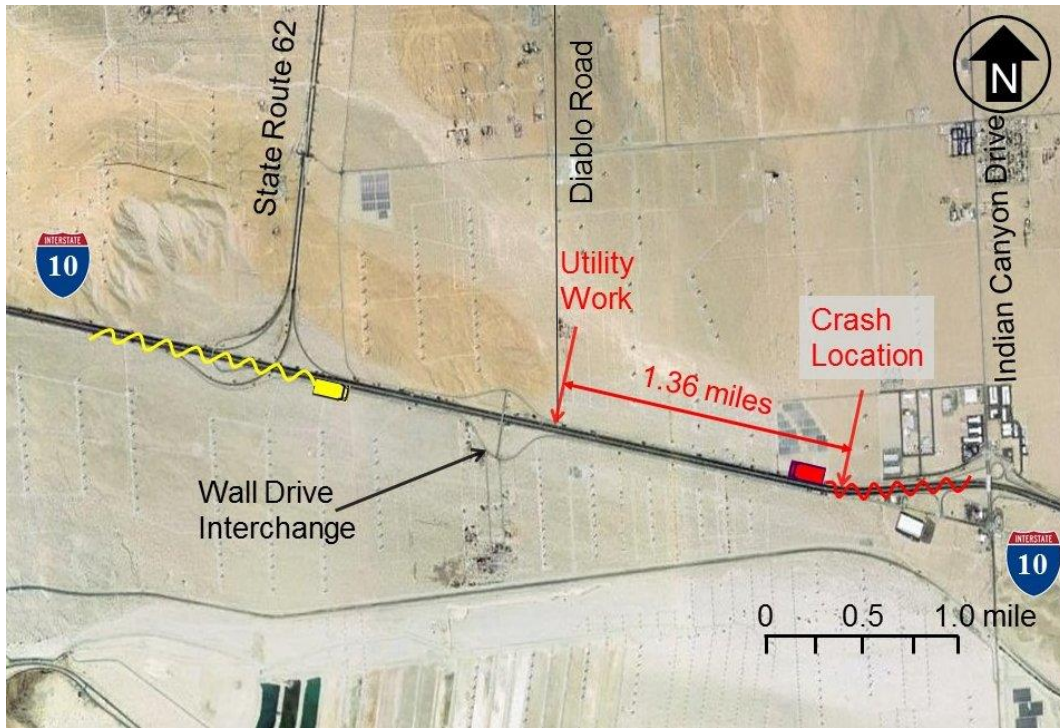
Highway Photograph 9 – Illustration depicting Stage 2 traffic break. The CHP patrol vehicles conduct a serpentine maneuver across all travel lanes before stopping traffic.

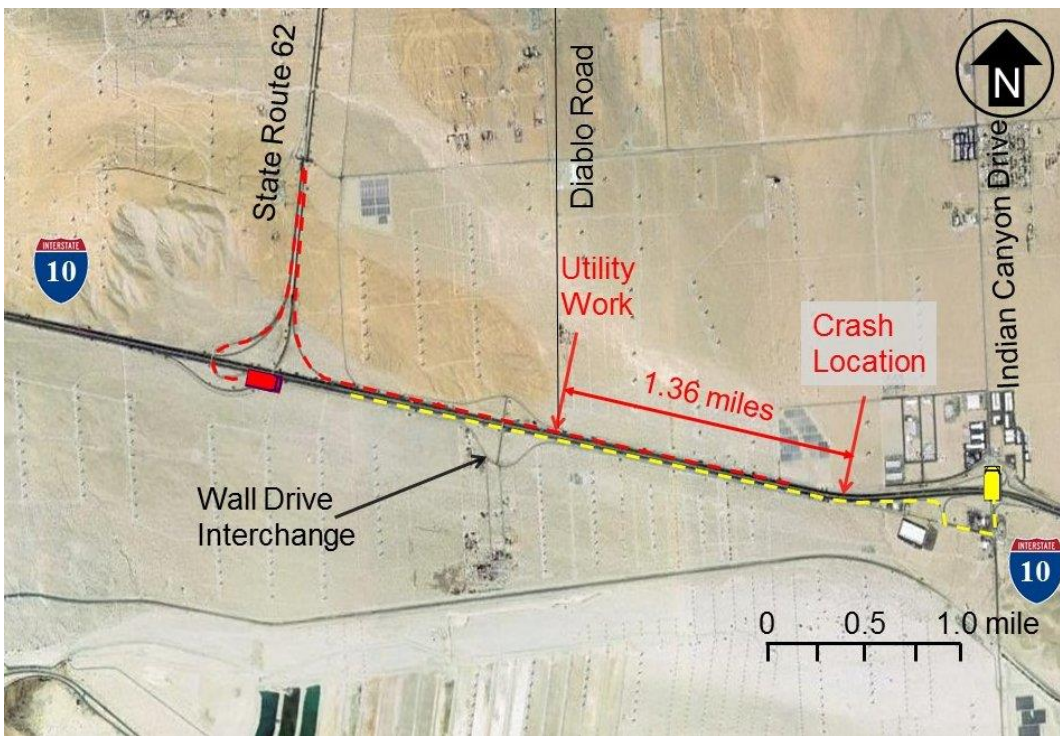
Highway Photograph 10 – Illustration depicting Stage 3 traffic break. The CHP patrol officers release the traffic break and proceed to their next staging positions.

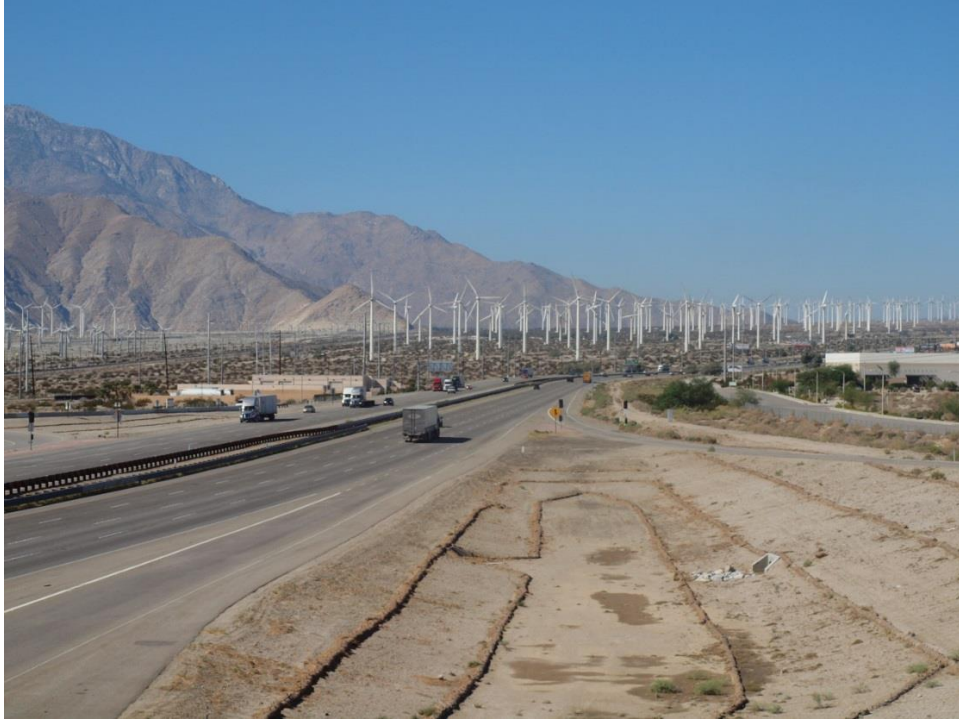
Highway Photograph 11 – View of the westbound lanes of I-10 prior to the crash location standing on the Indian Canyon Drive overpass

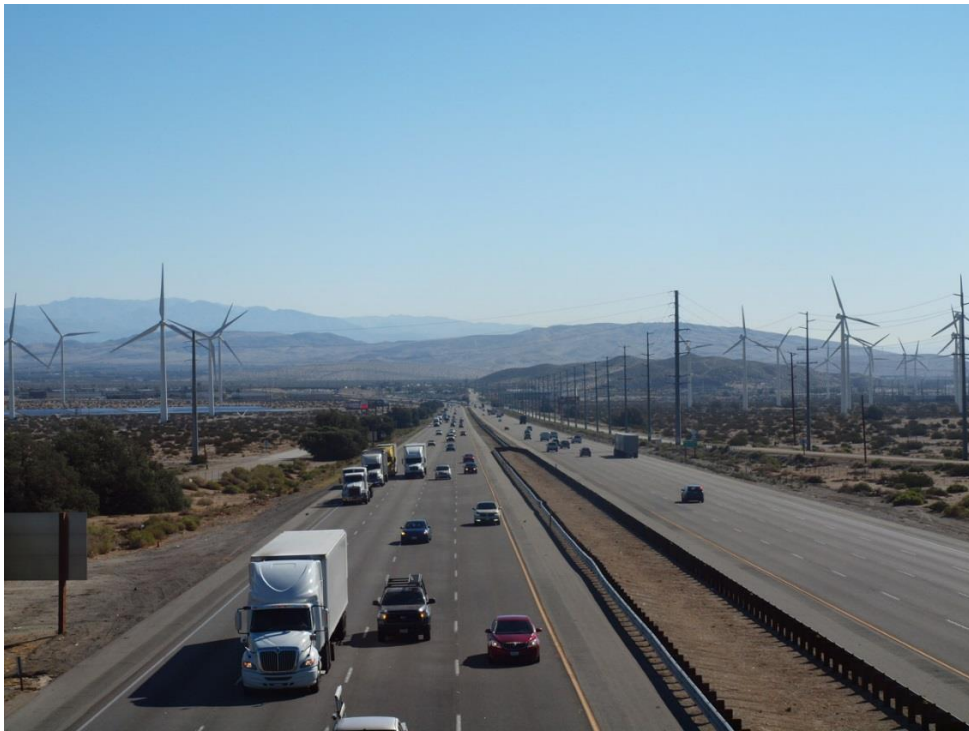
Highway Photograph 12 – View of the westbound lanes of I-10 illustrating the completed utility work in the background standing on the Wall Drive overpass

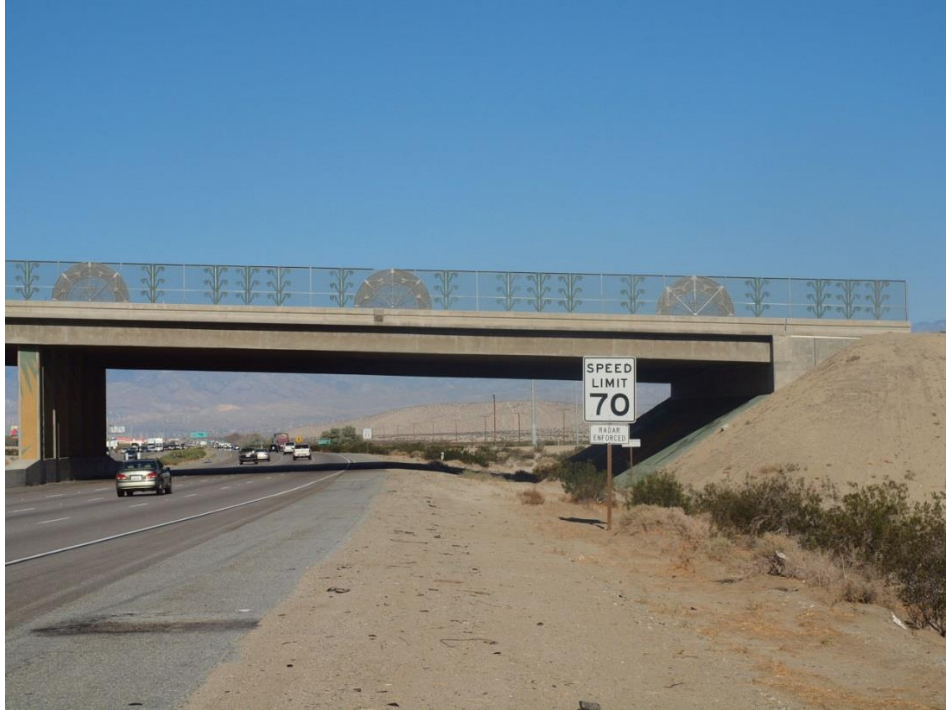
Highway Photograph 13 – View of the posted speed limit sign of 70 miles per hour (mph) in the westbound direction of I-10 prior to the crash location

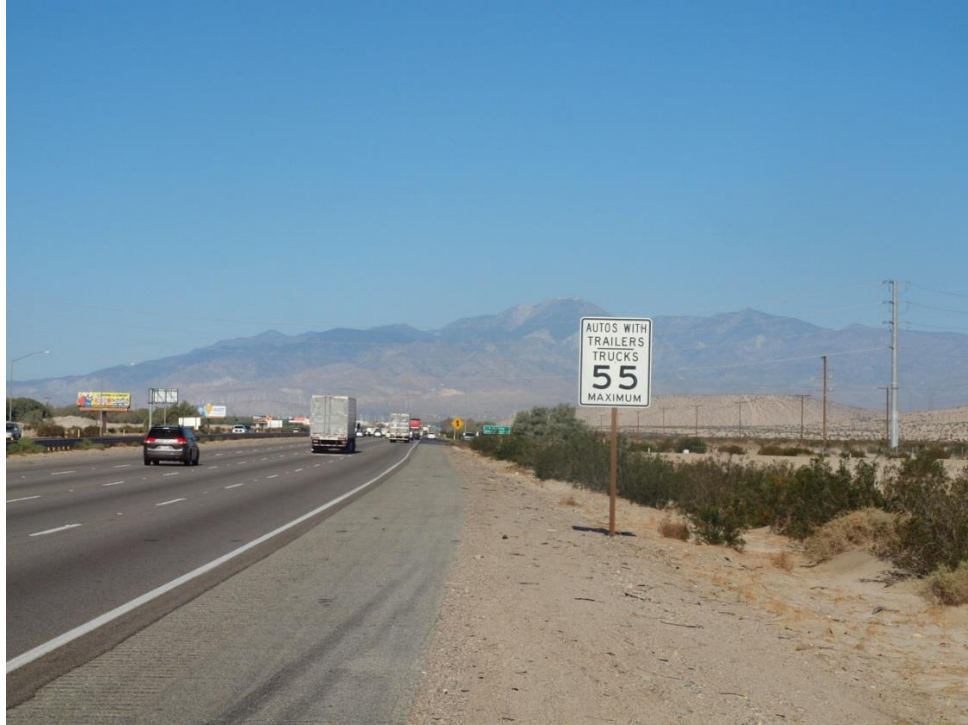
Highway Photograph 14 – View of the maximum speed limit sign for vehicles towing trailers of 55 miles per hour (mph) in the westbound direction of I-10 prior to the crash location

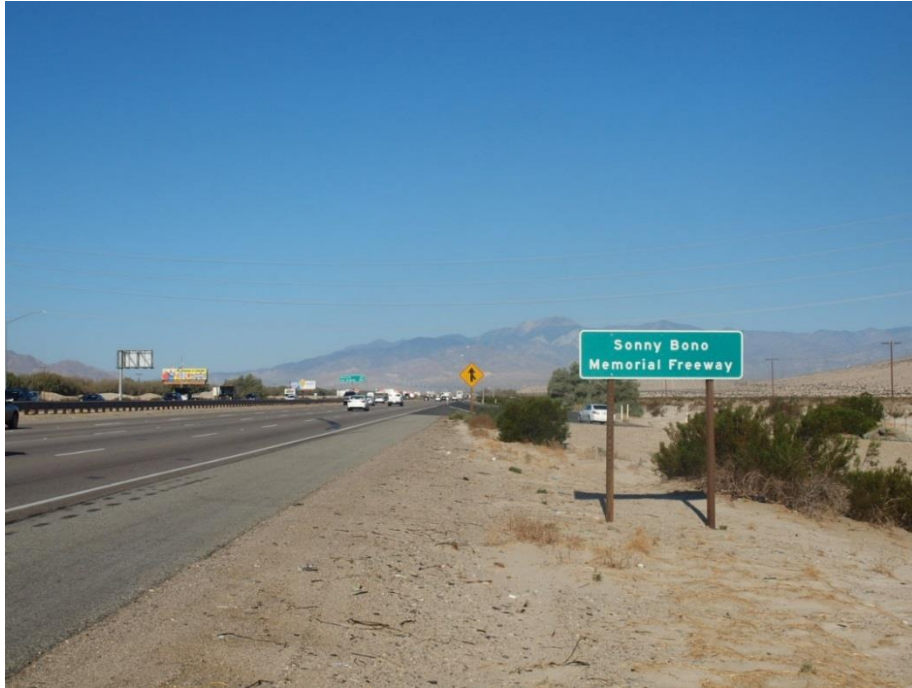
Highway Photograph 15 – View of the “Sonny Bono Memorial Freeway” sign in the westbound direction of I-10 prior to the crash location
