Highway Factors Photographs

Concan, Texas

HWY17MH011

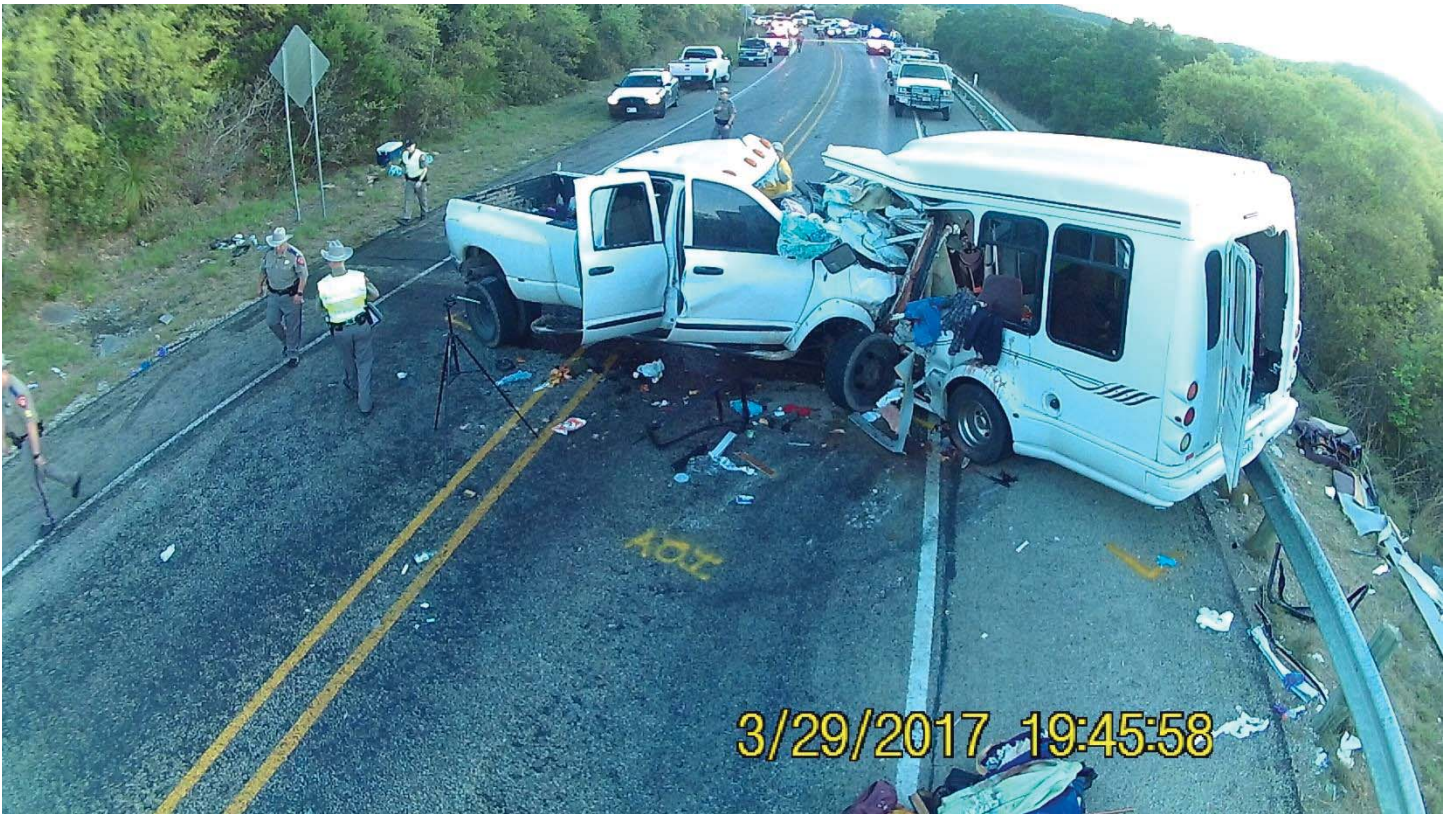
Highway Photo 1 – Southbound view on US 83, showing the final positions of both accident vehicles. Note the scrapes and tire friction marks leading away from the impact area. **Highway photos 1-11 are provided courtesy of the Texas Highway Patrol**

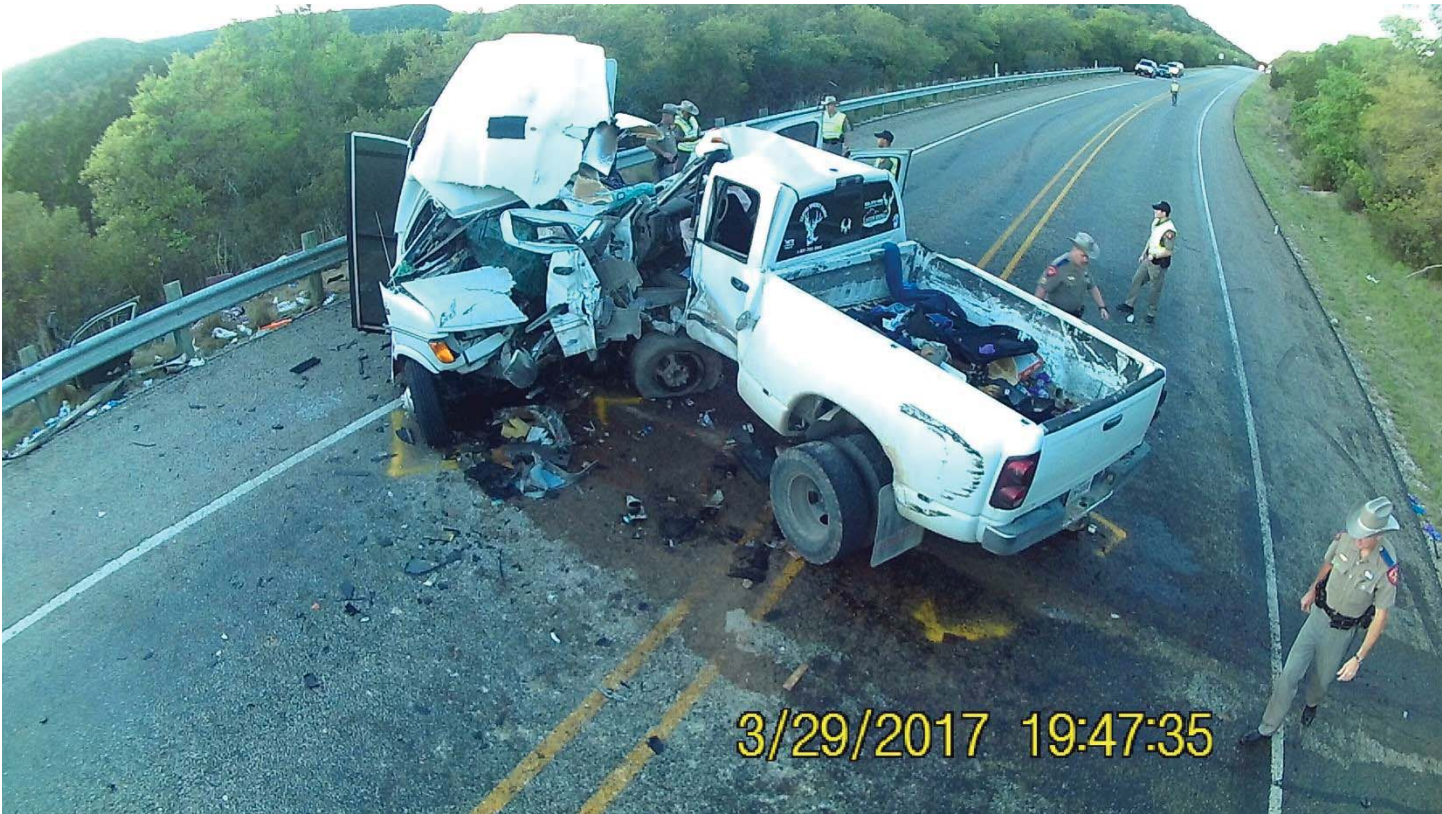
Highway Photo 2 – Northbound view on US 83 show impact area and final vehicle positions.

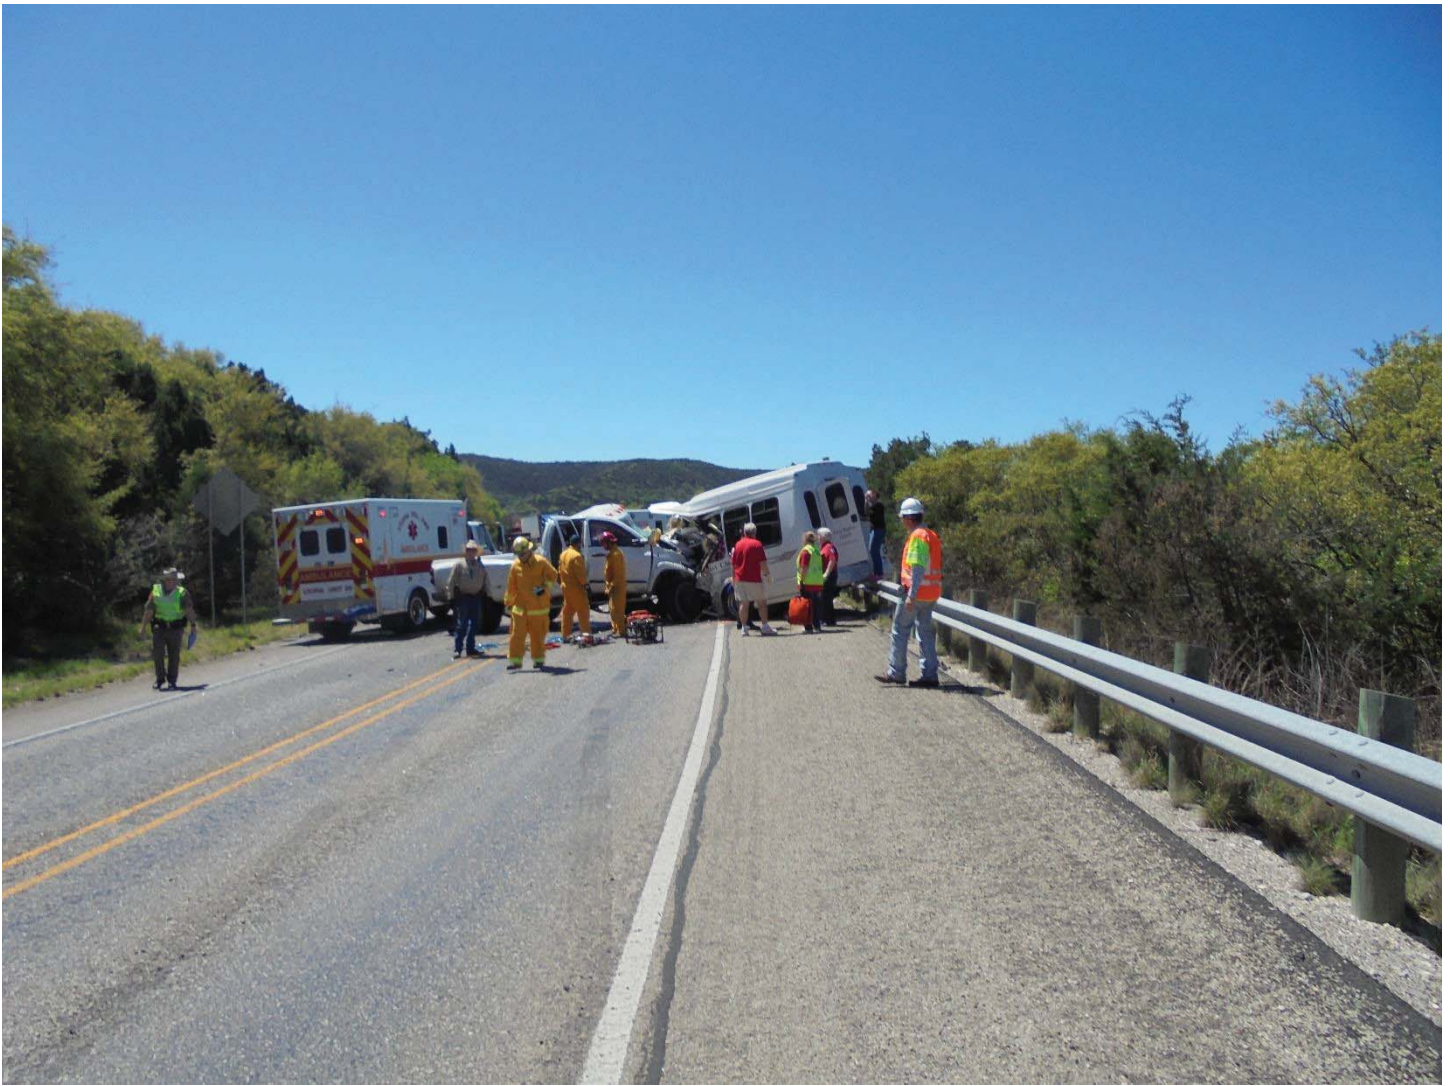
Highway Photo 3 – Southbound view of tire friction marks from a witness vehicle that skidded to a stop behind the bus.

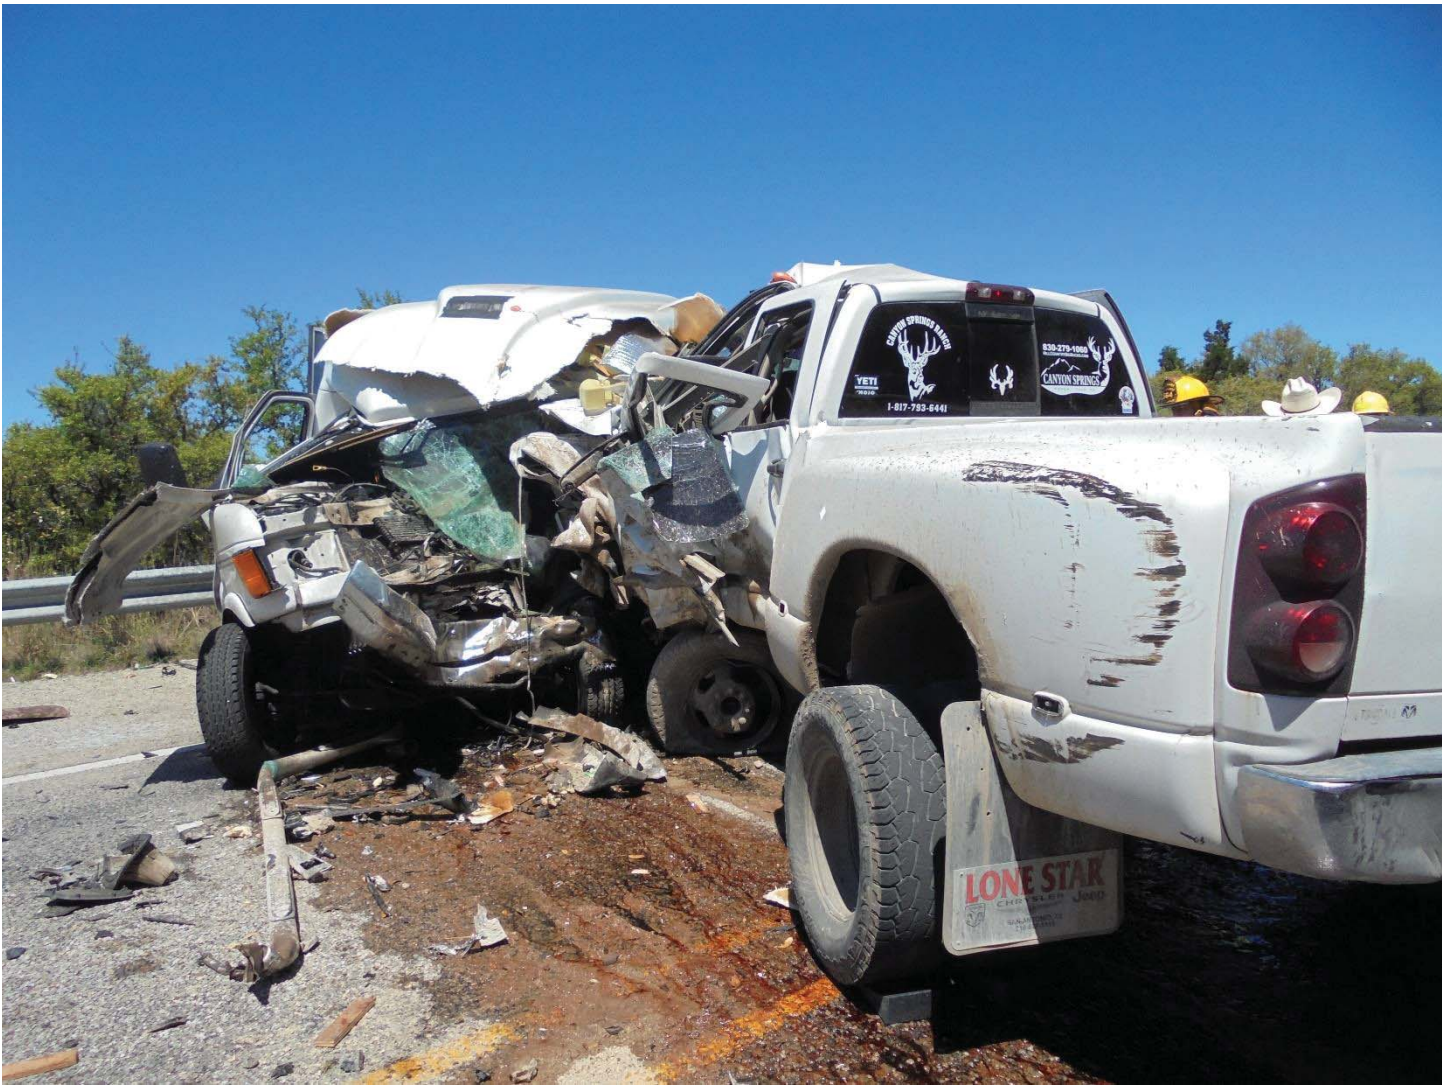
Highway Photo 4 – View of both vehicle’s final positions in the southbound lane.

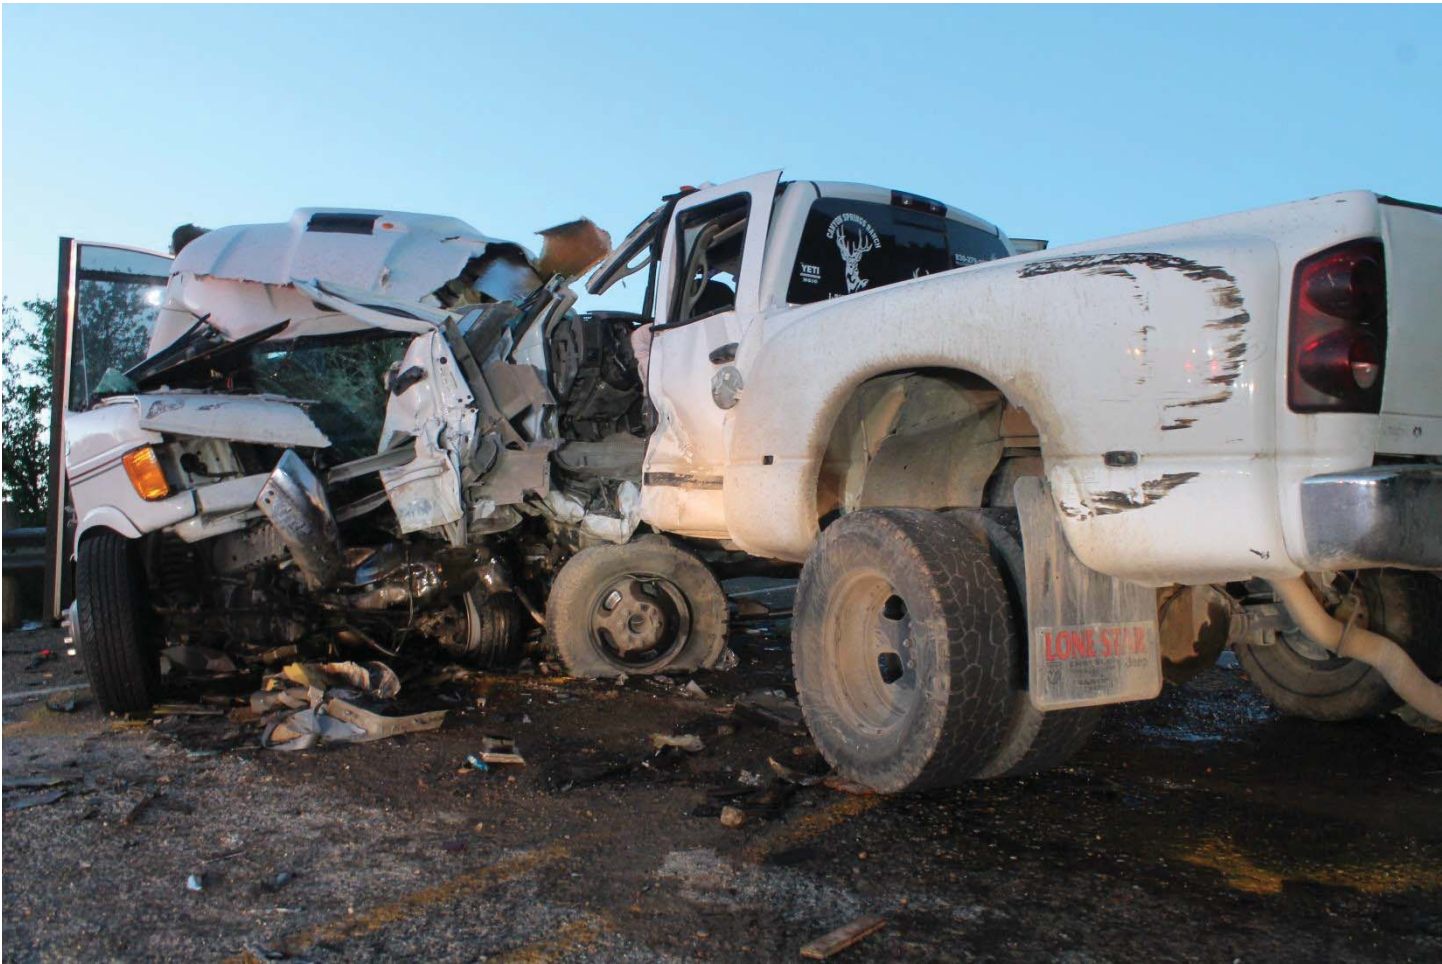
Highway Photo 5 – Additional view of impact area

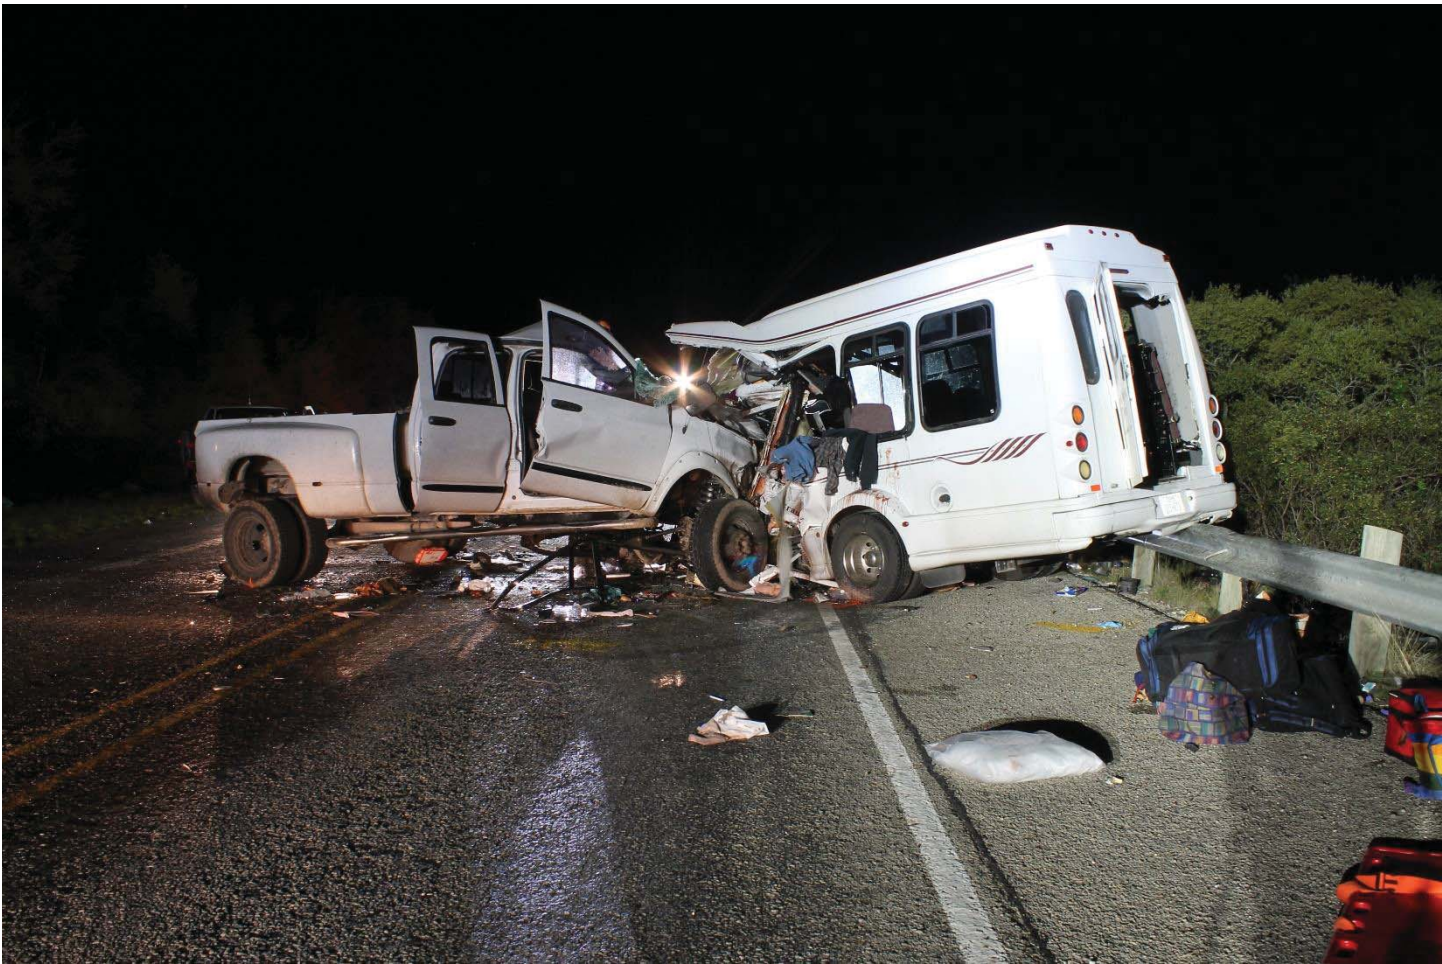
Highway Photo 6 – Additional Southbound view of both vehicles final positions in the southbound lane

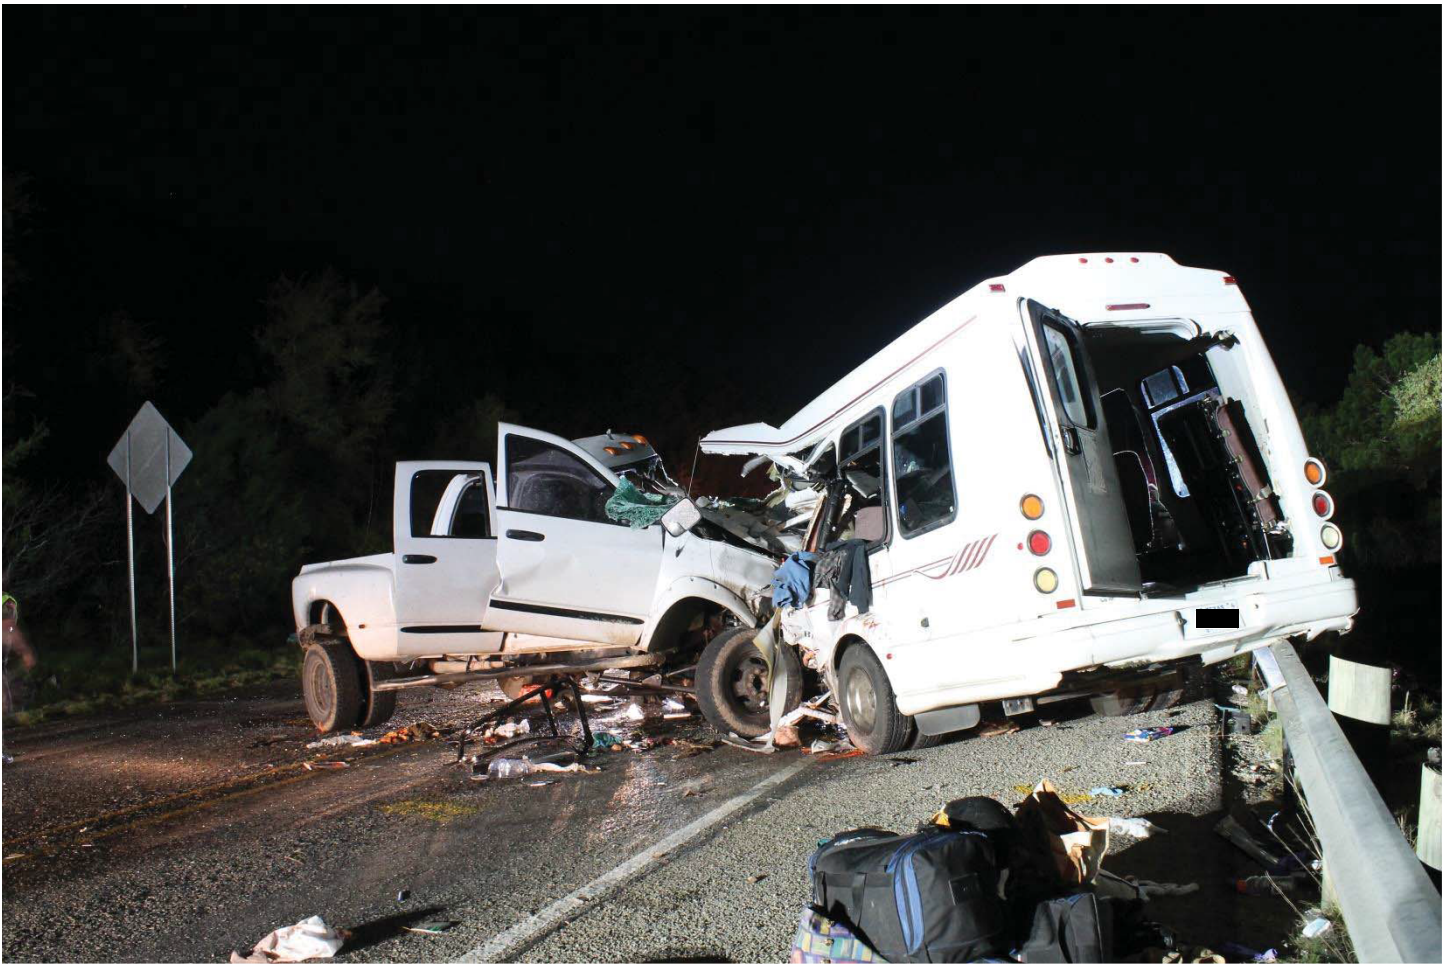
Highway Photo 7 – From of vehicle positions from southbound shoulder, showing the back on the bus on the metal beam guardrail.

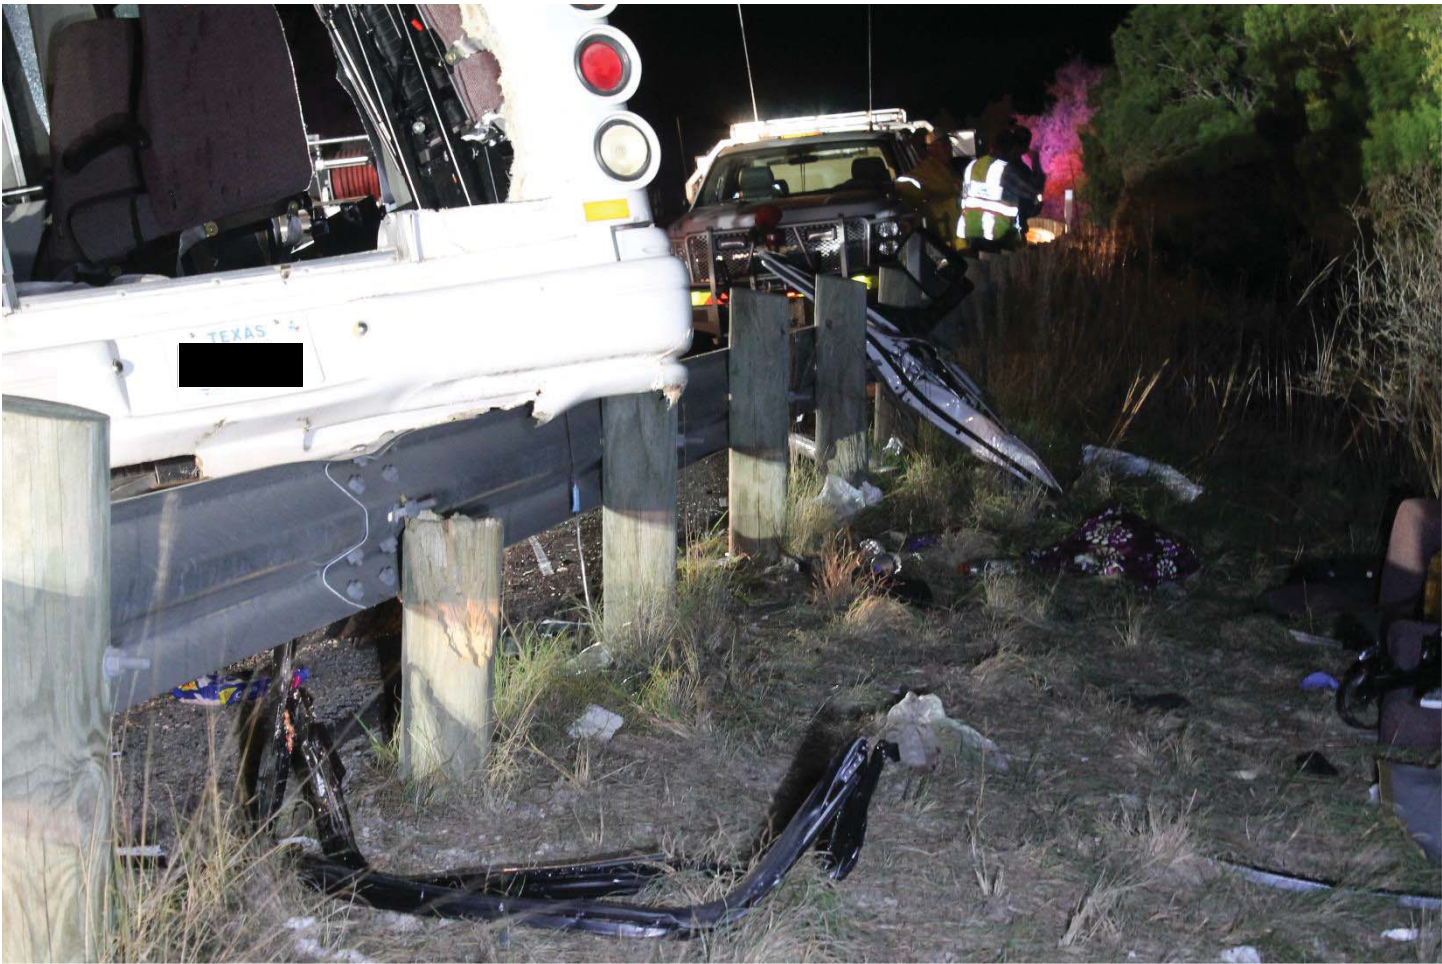
Highway Photo 8 – View of bus impact with wooden guardrail post

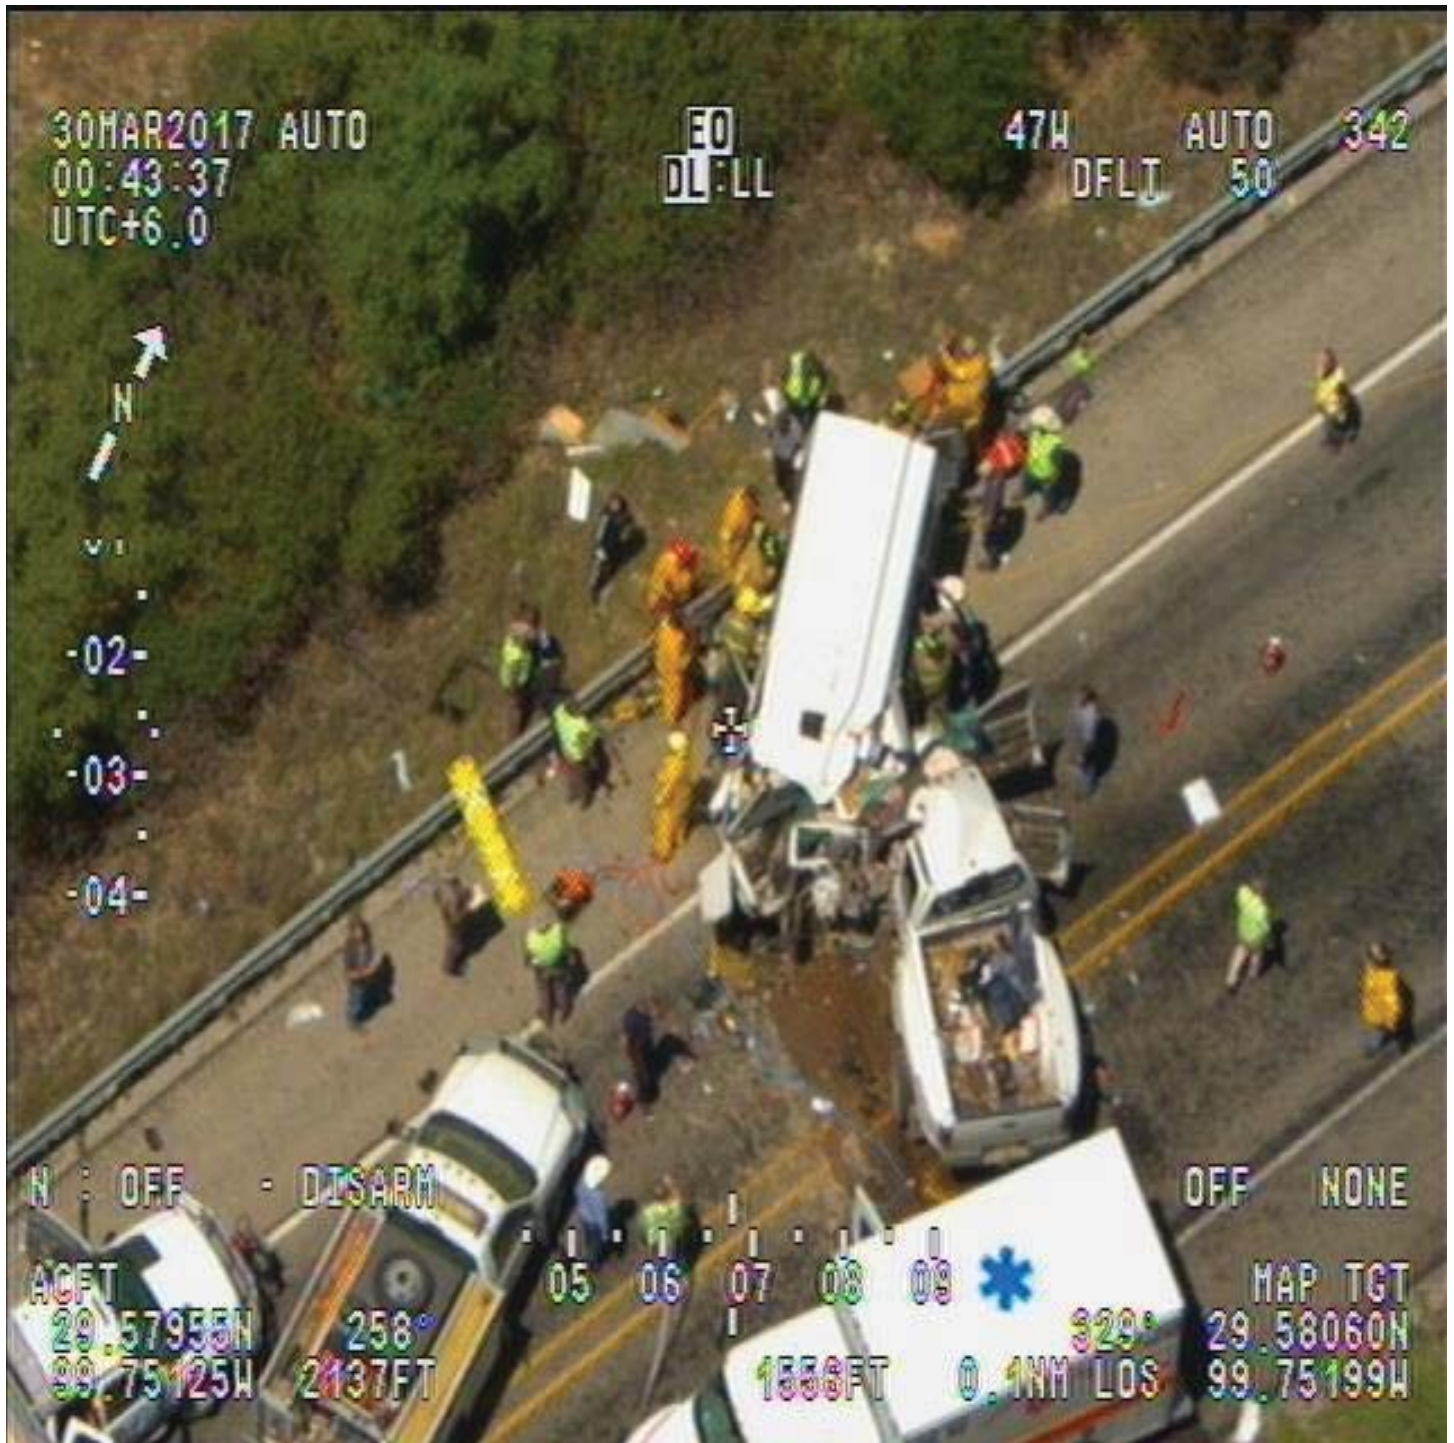
Highway Photo 9 – Aerial view of impact area and vehicle positions

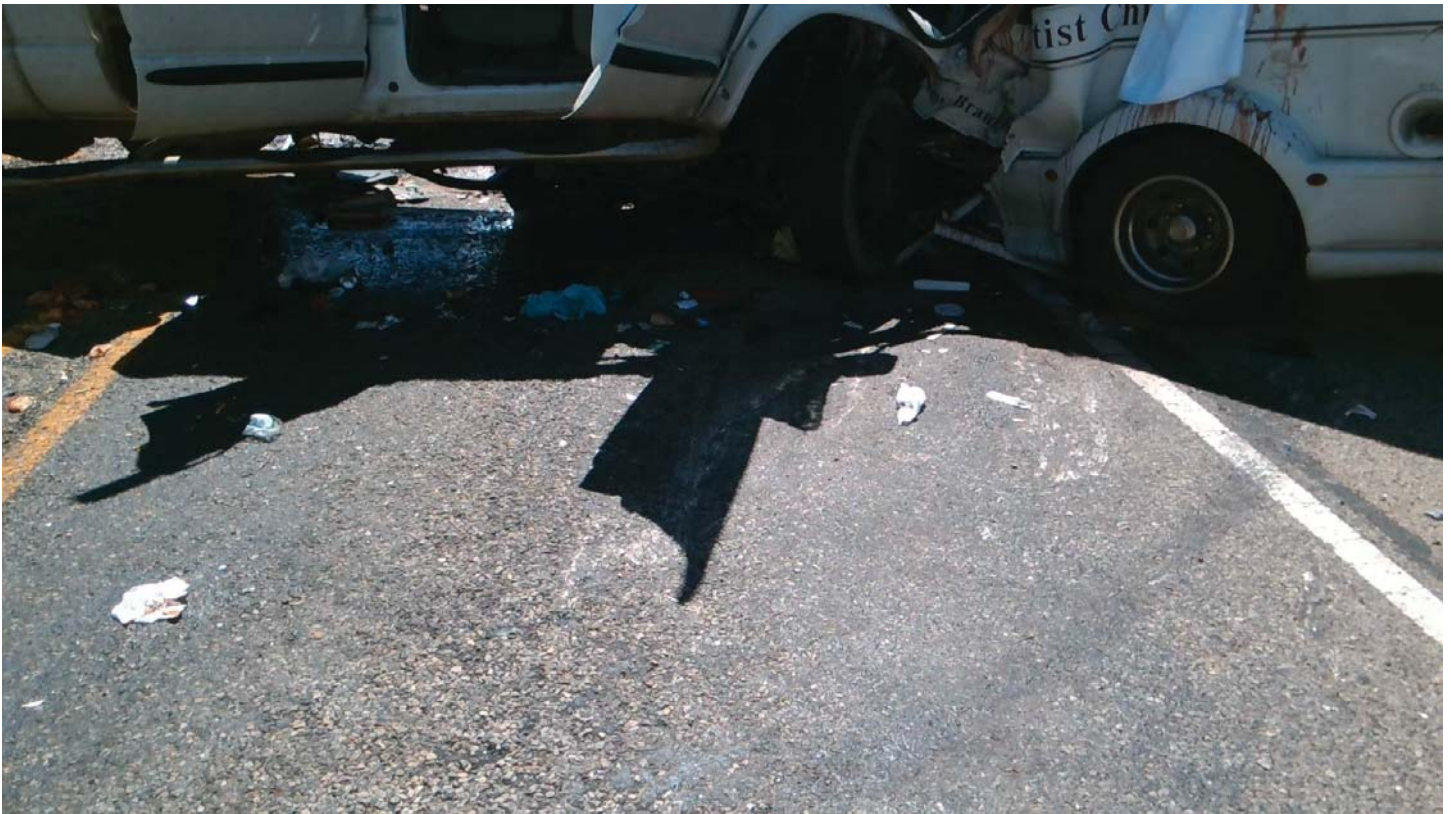
Highway Photo 10 – Closer view of scrapes on the pavement and tire friction marks leading away from the impact area.

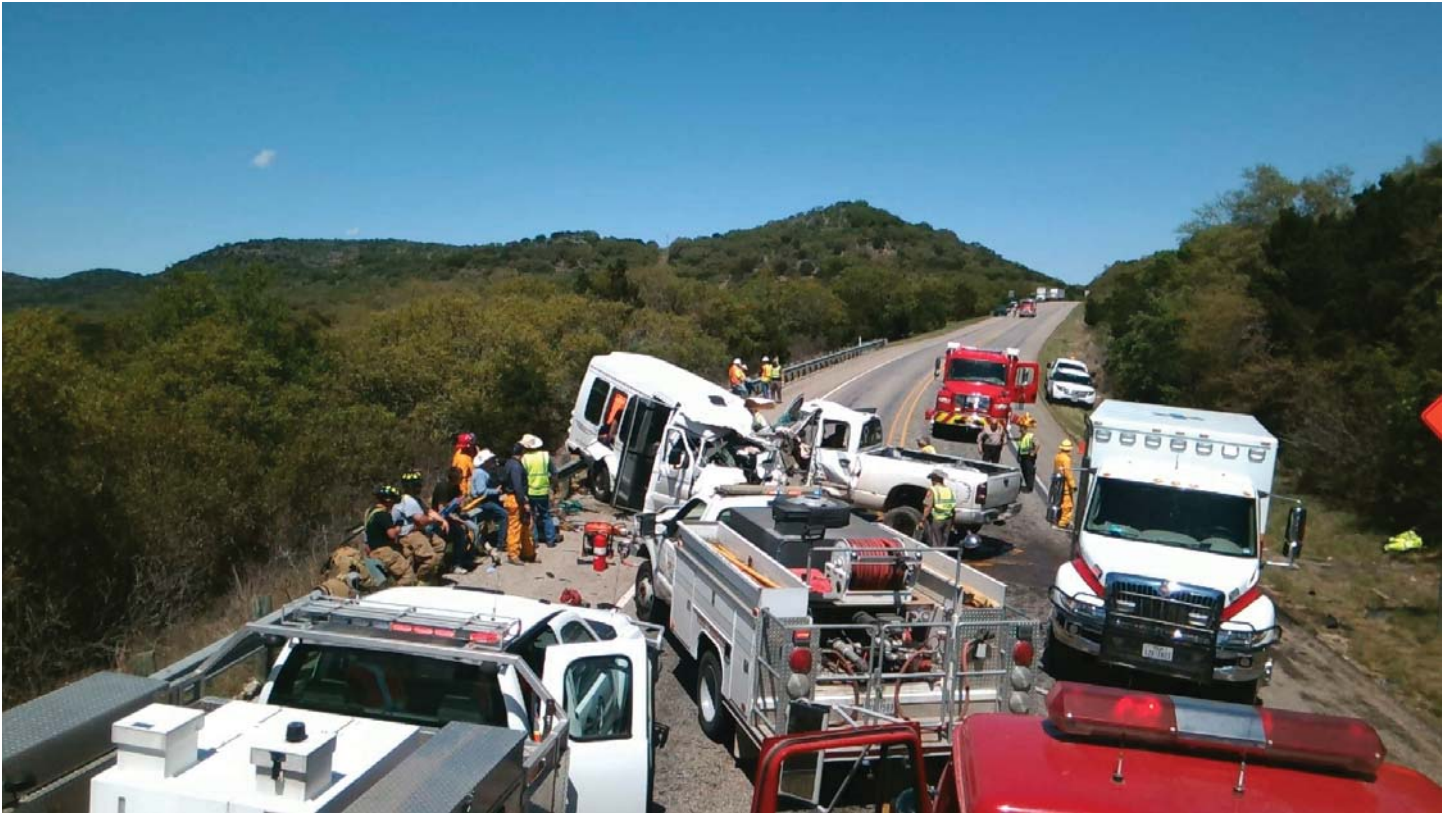
Highway Photo 11 – View of vehicle final positions with the end of the curve in the background.

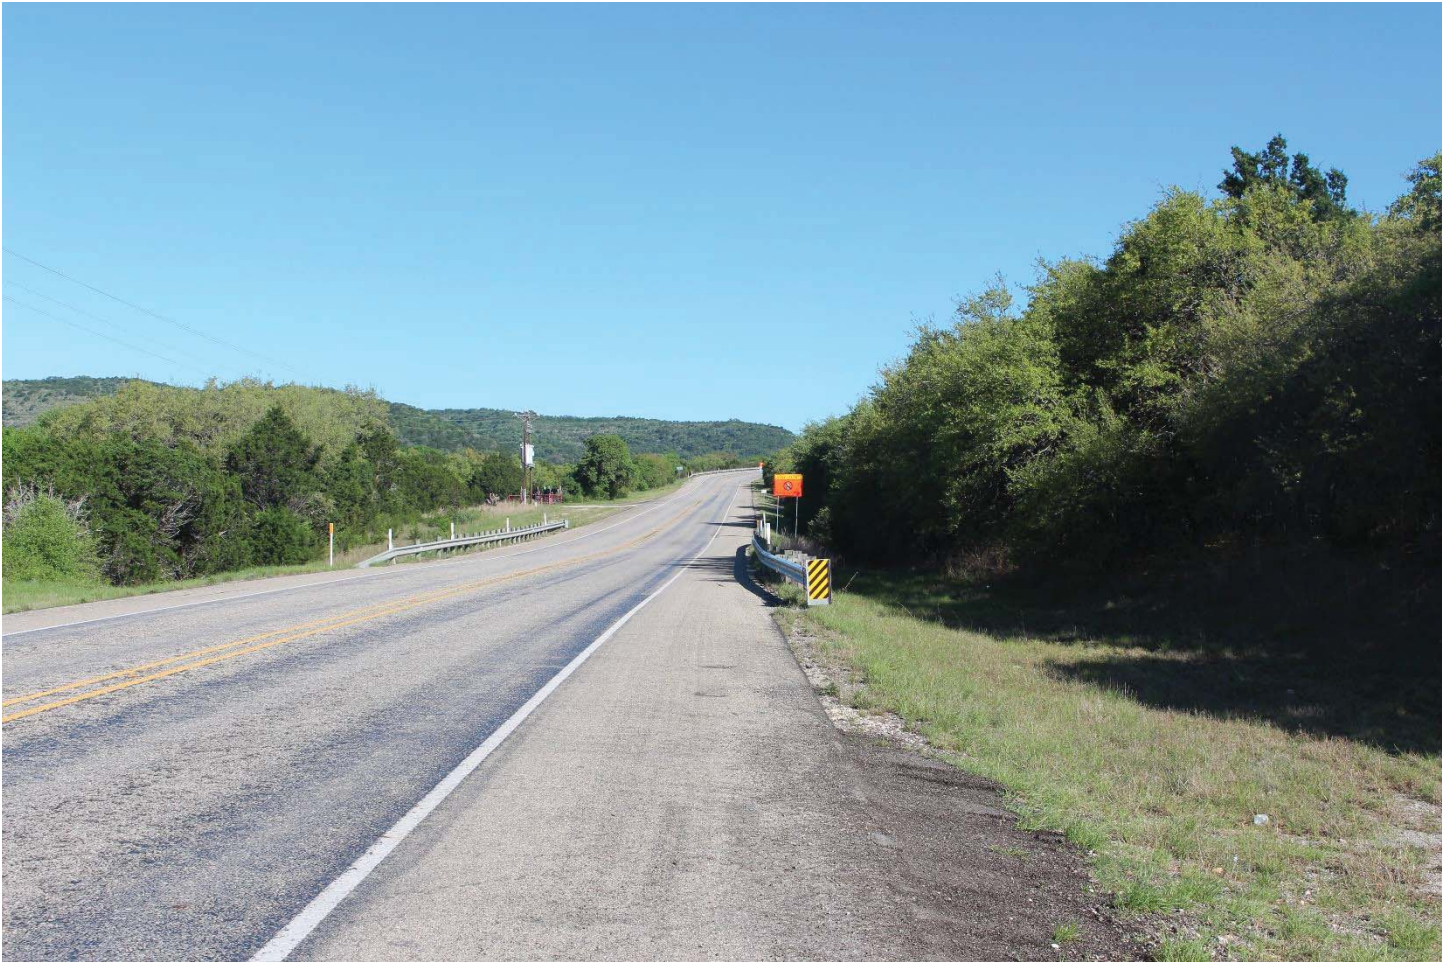
Highway Photo 12 – View of advance work zone warning sign on US 83, approximately 3200 feet from the impact area.

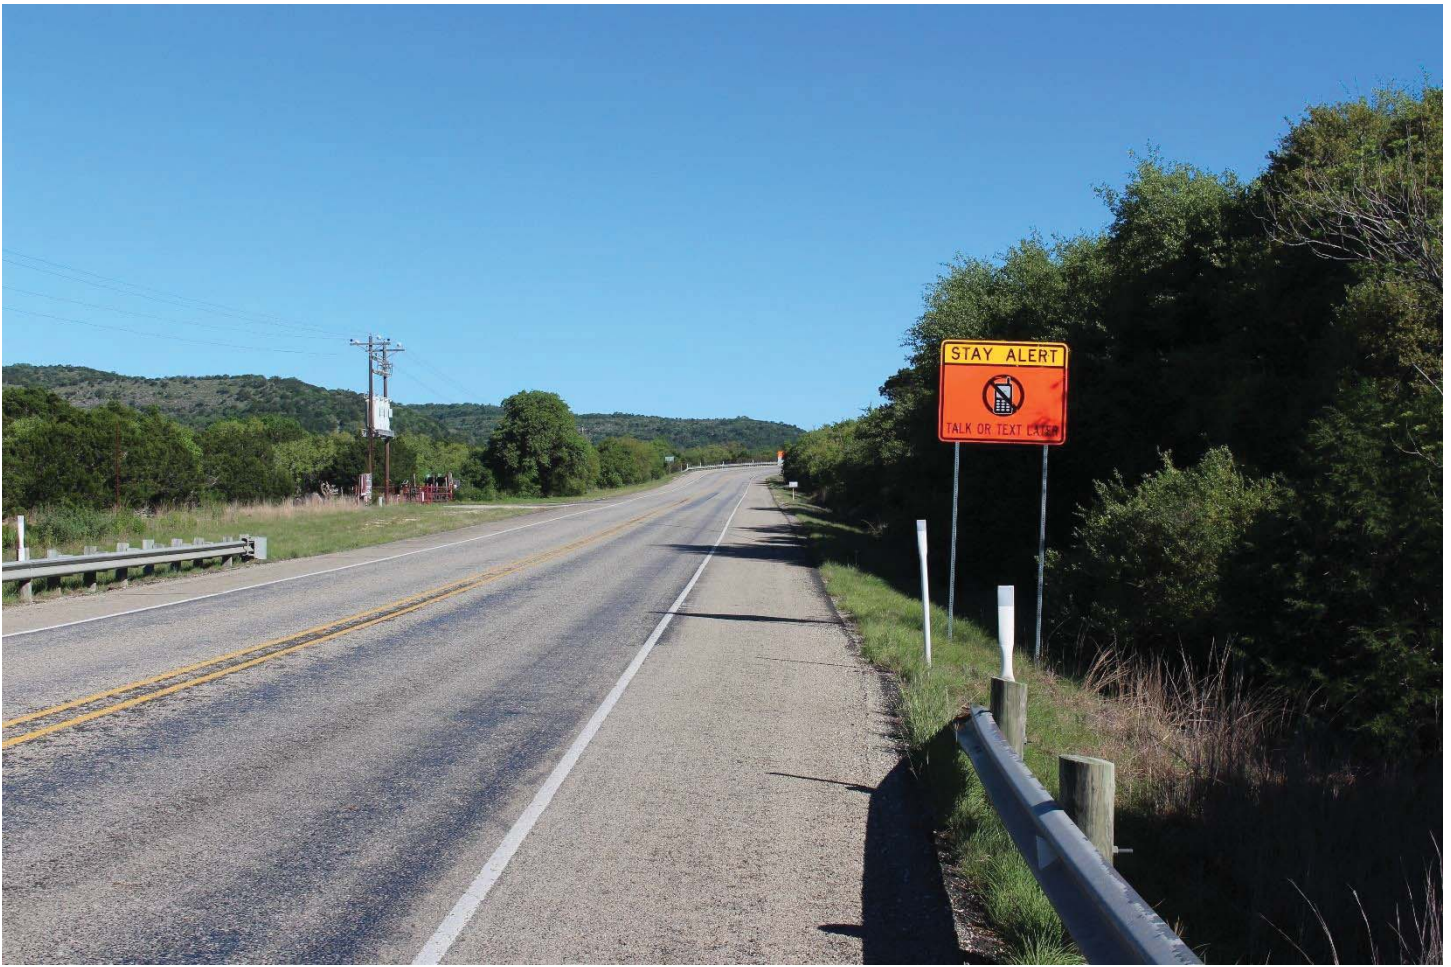
Highway Photo 13 – View of Texas G20.10T sign warning motorist to stay alert and not to text in work zones. The accident curve can be seen beginning approximately 1500 feet away in the photo background.

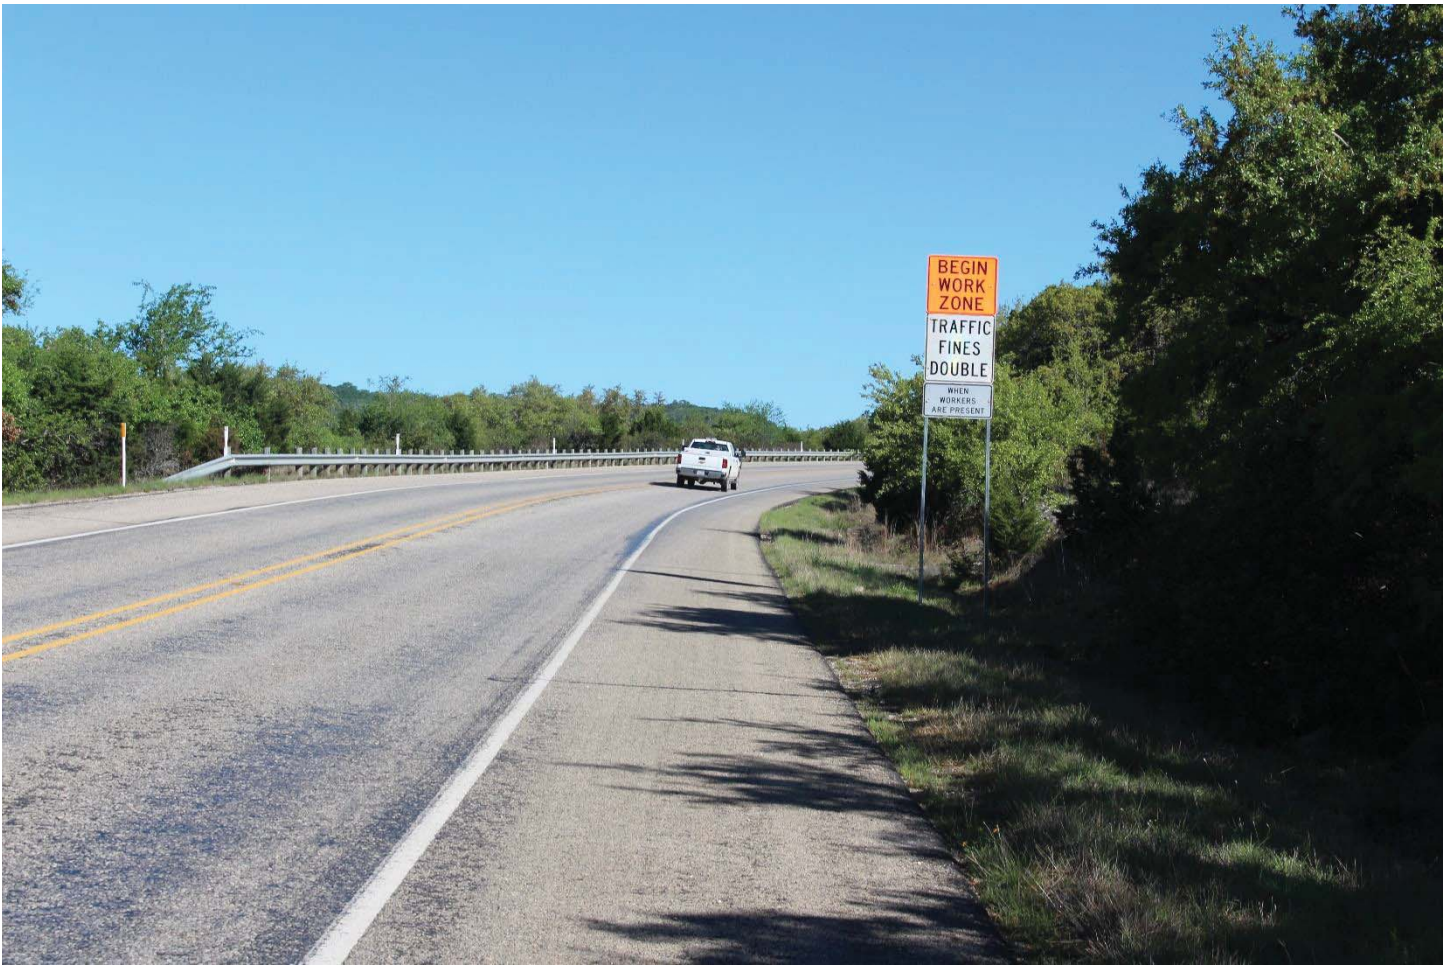
Highway Photo 14 – View of where the work zone began at the beginning of the accident curve

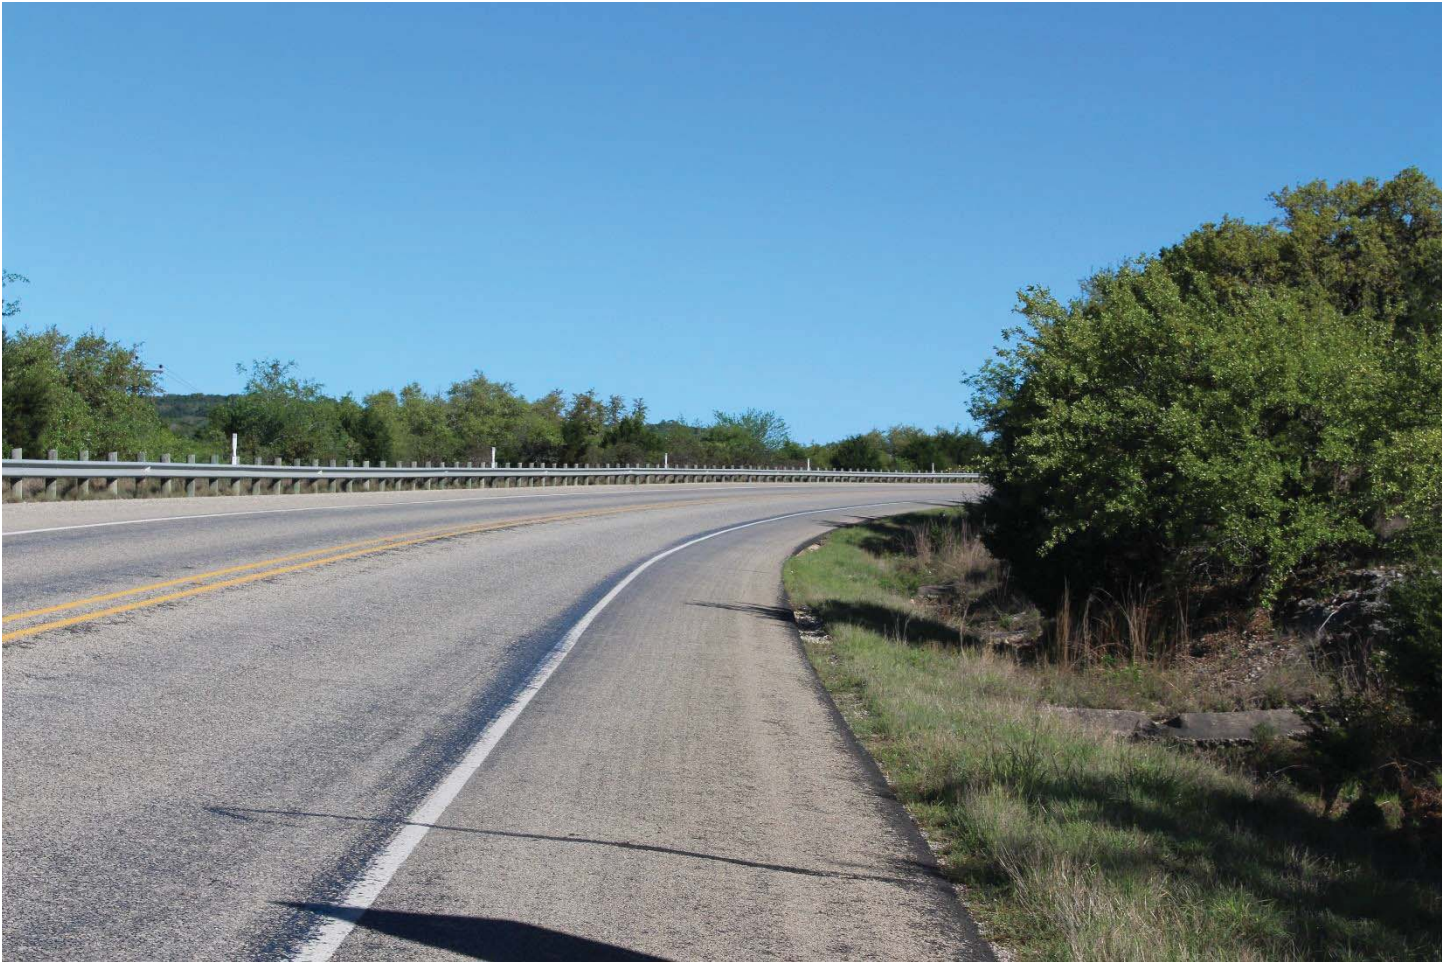
Highway Photo 15 – View of northbound US 83, approximately 1400 feet from the impact area.

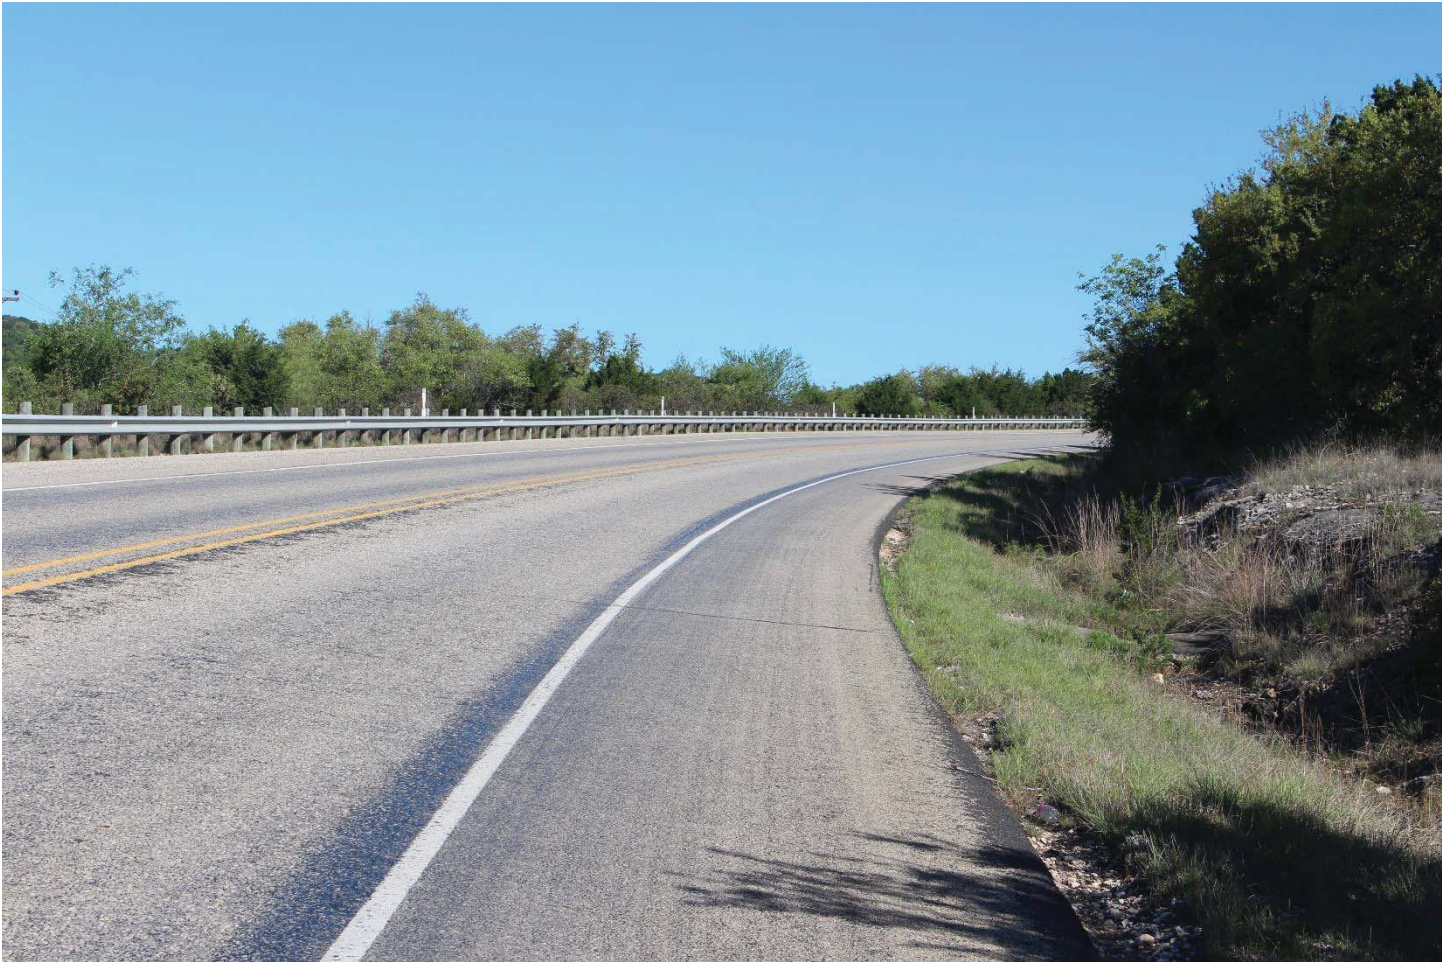
Highway Photo 16 – Continued view of accident curve about 1300 feet from the impact area.
