Highway Factors Photographs

Concan, Texas

HWY17MH011

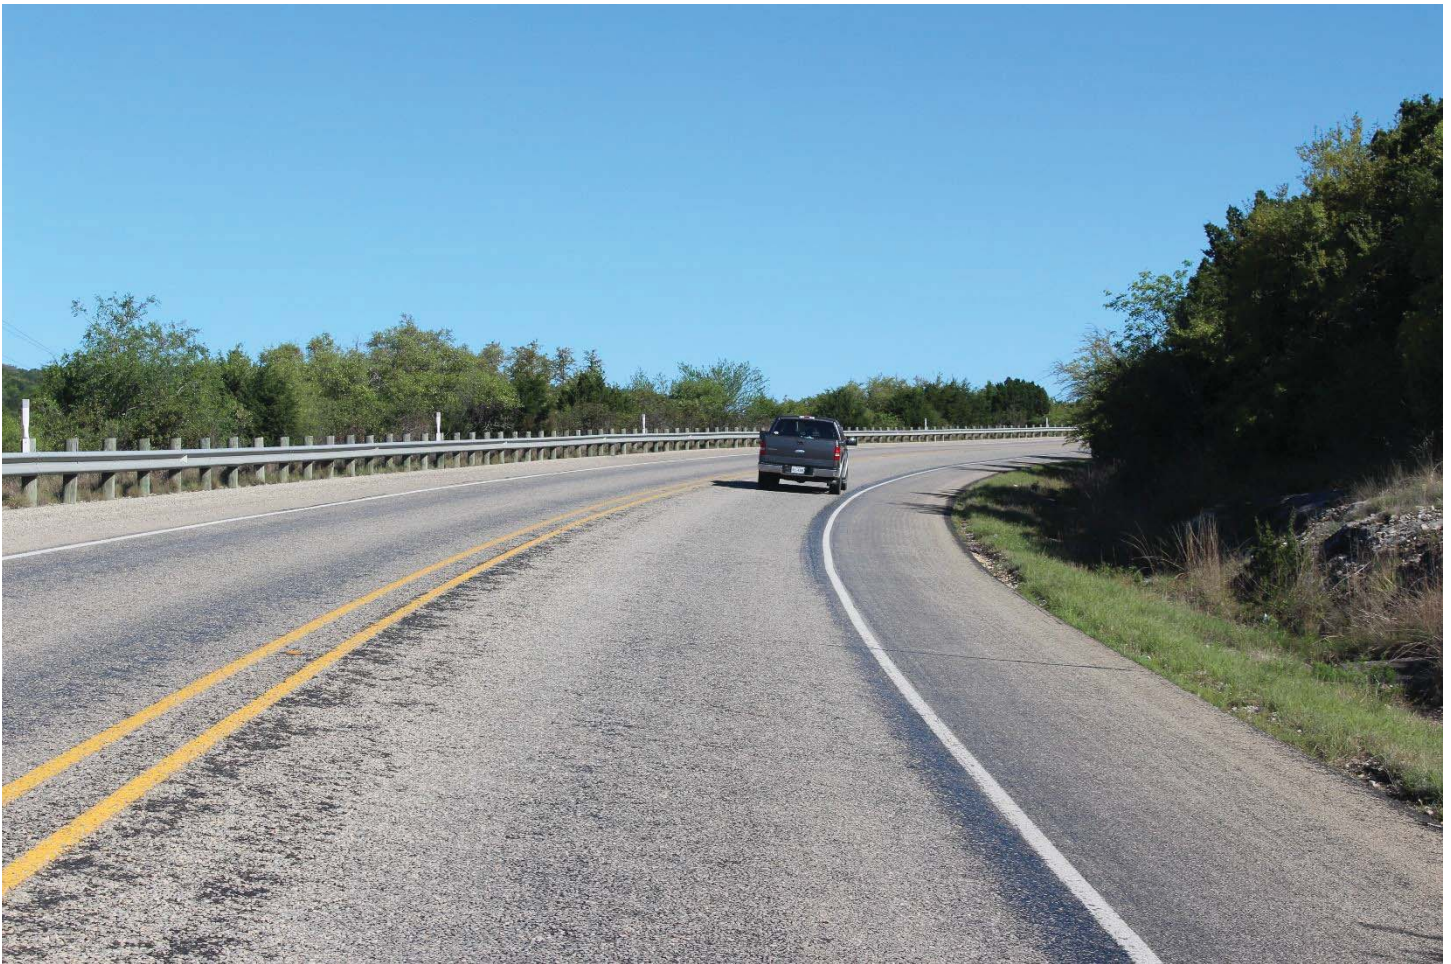
Highway Photo 17 – Note how the forward sight distance in the curve is limited by the cut slope and vegetation on the hill side.

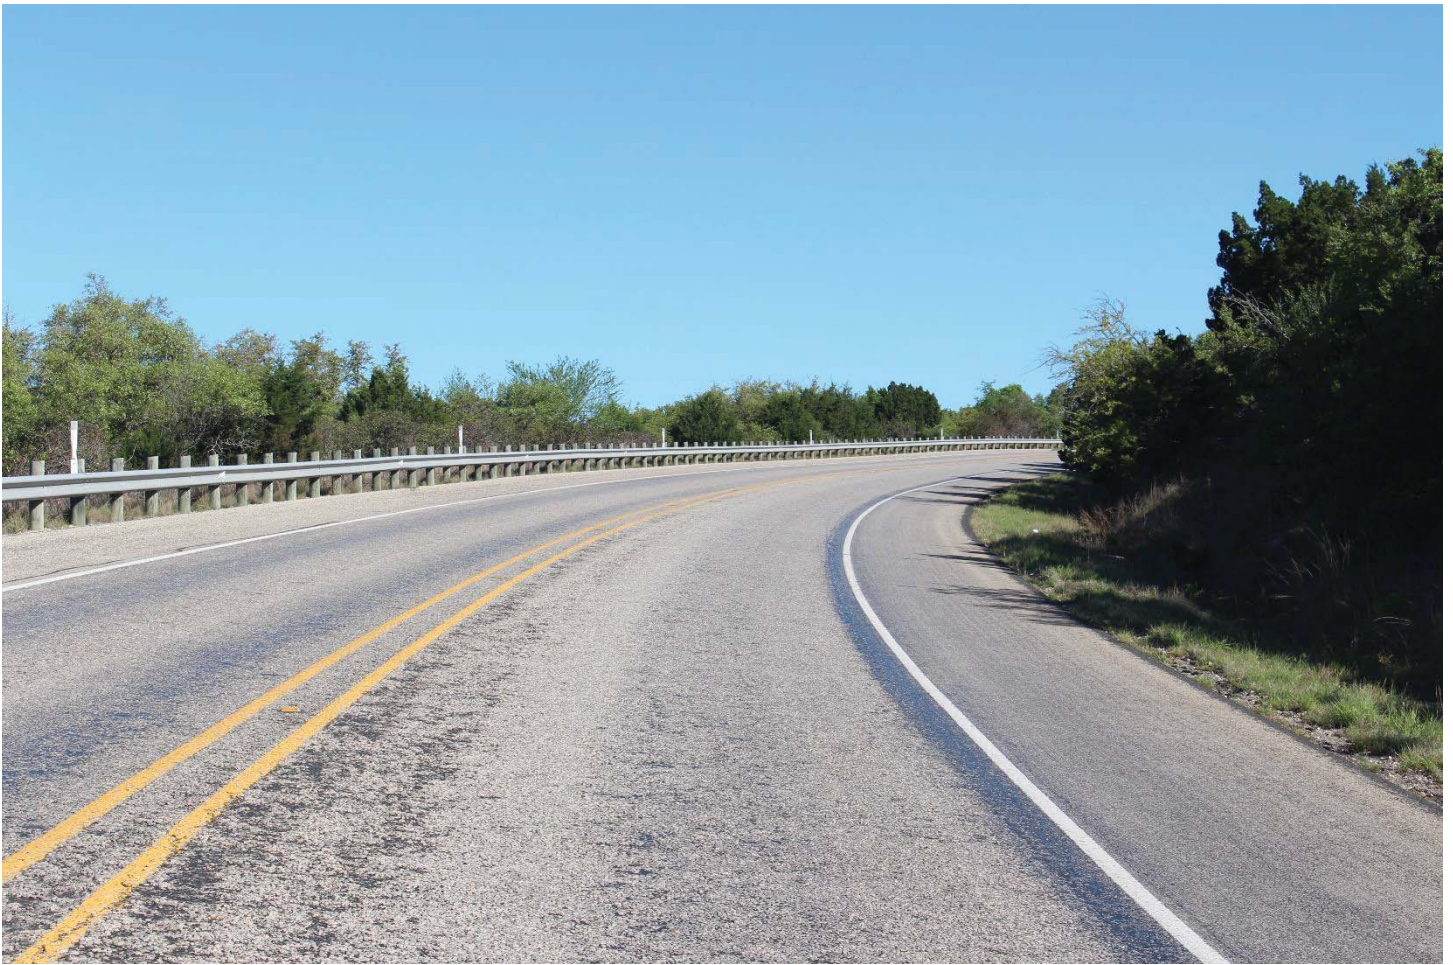
Highway Photo 18 – Continued northbound around the accident curve approximately 1200 feet from the impact area.

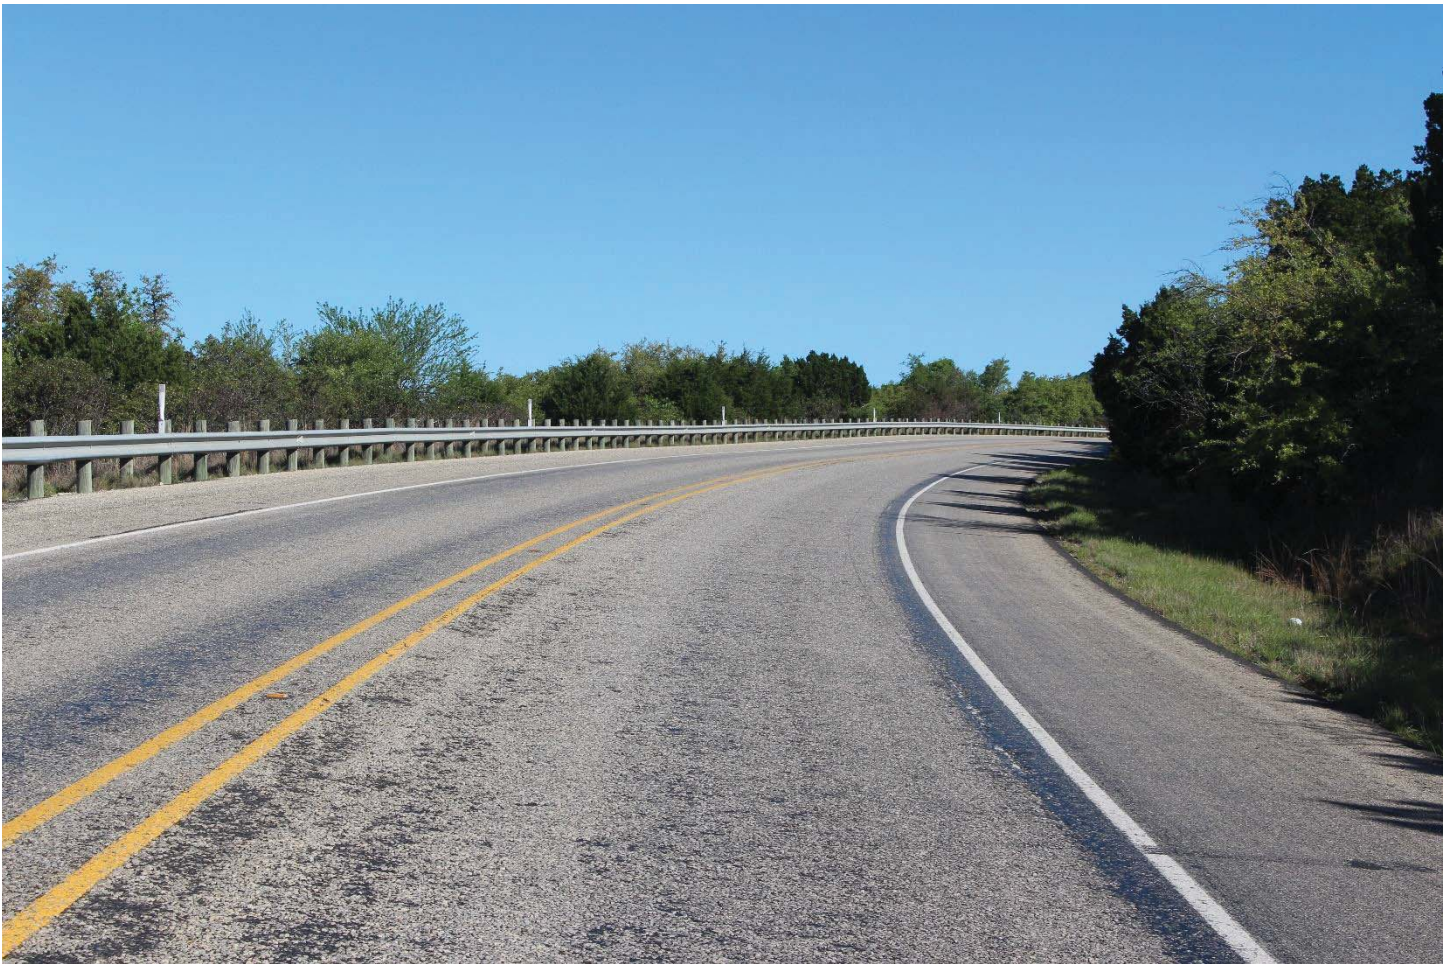
Highway Photo 19 – Continued view approximately 1100 feet from the impact area.

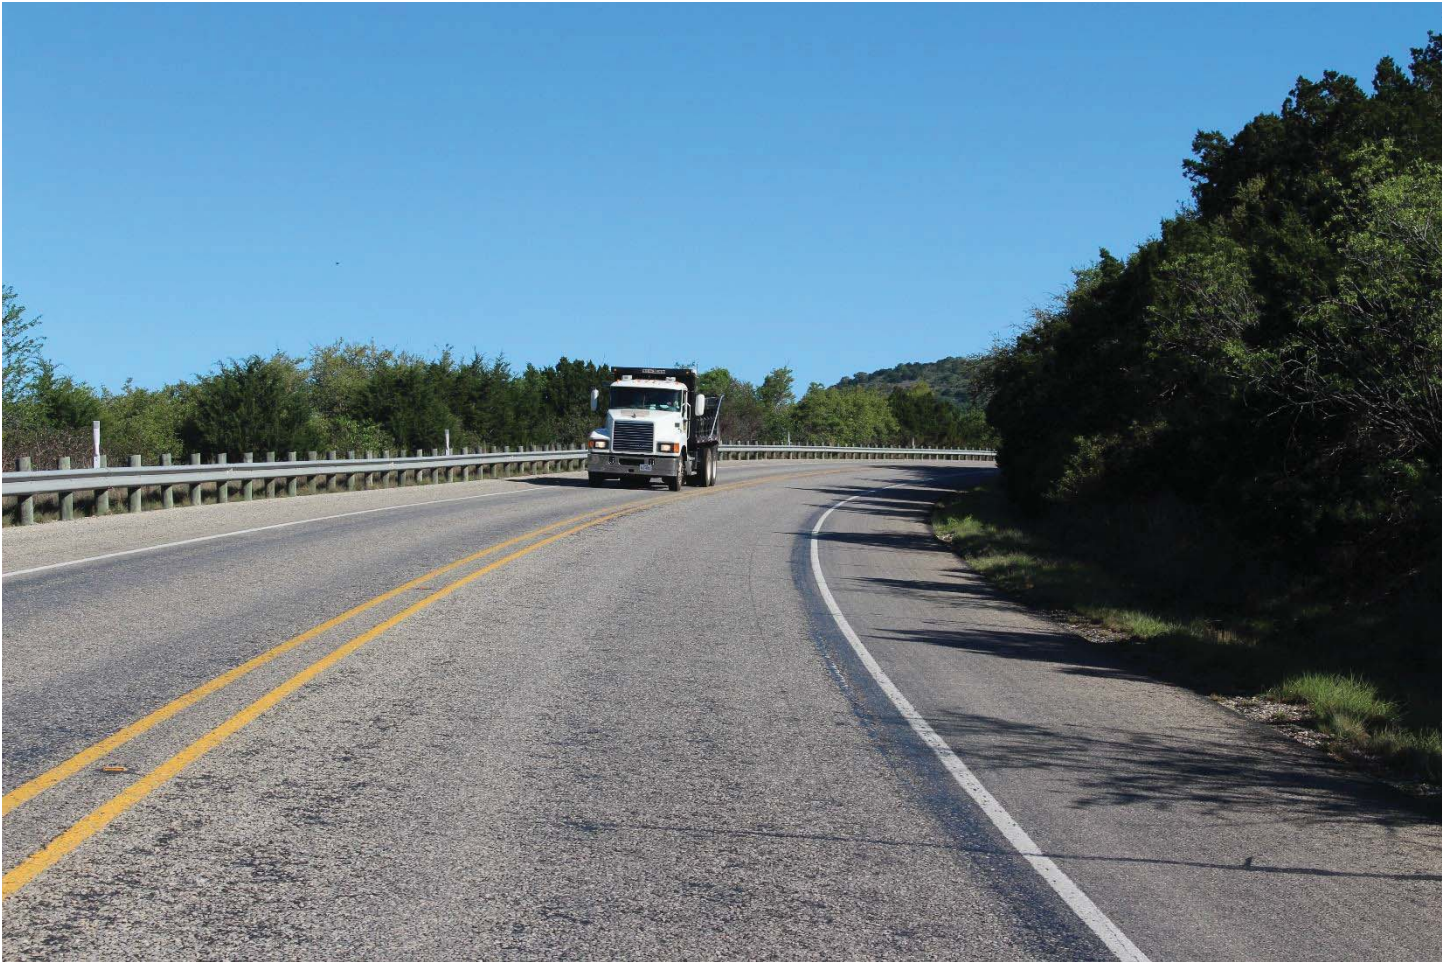
Highway Photo 20 – Northbound view of 4-degree right-hand curve on the uphill grade.

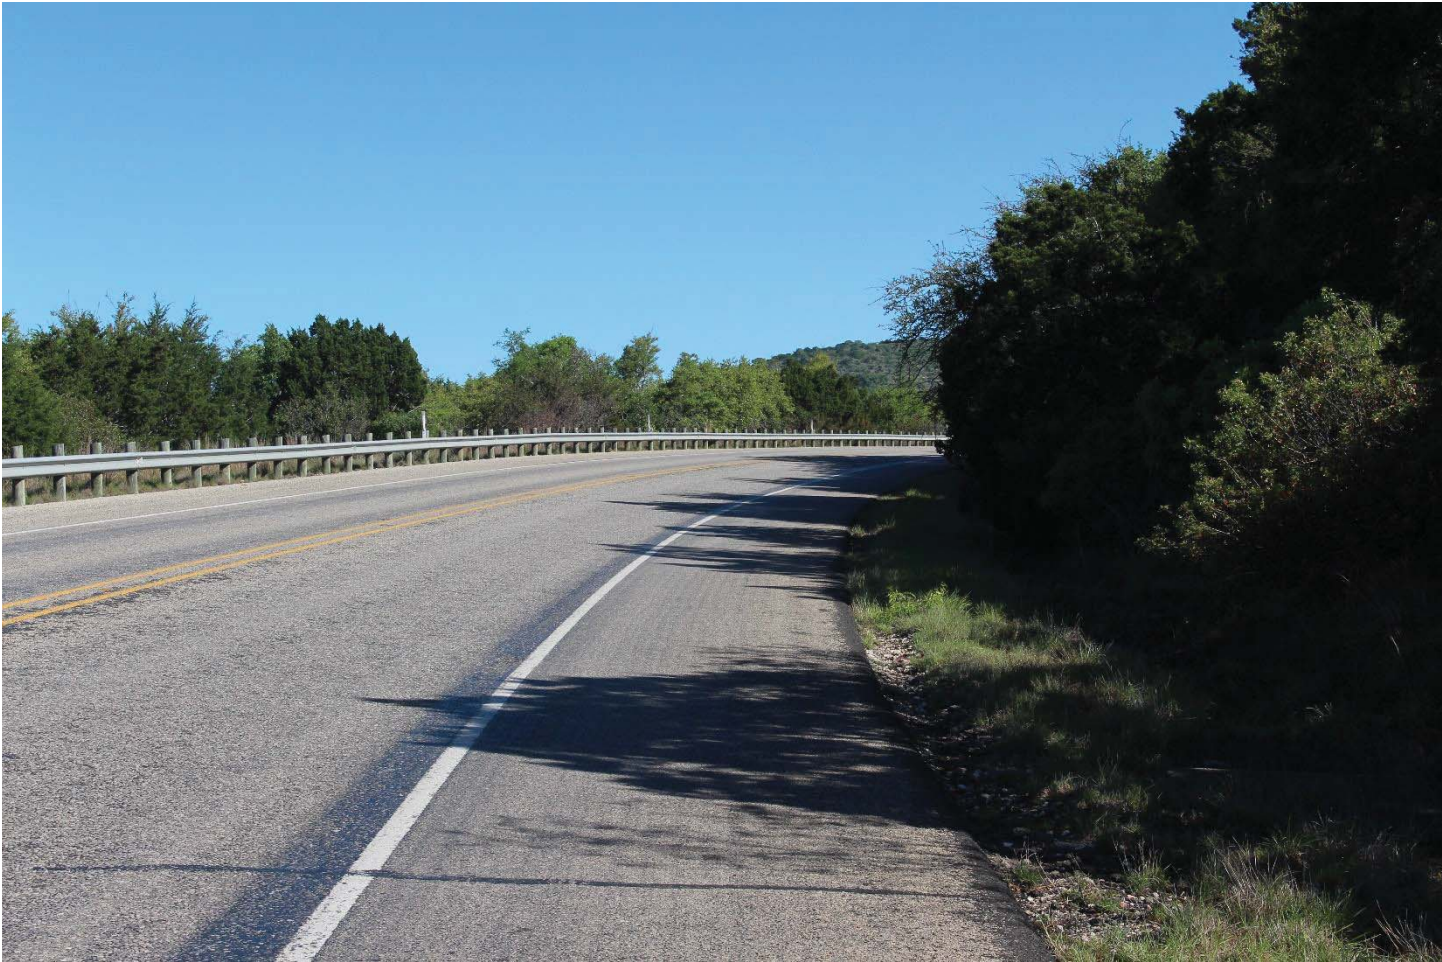
Highway Photo 21 – Continued view of accident curve, approximately 1,100 feet from the impact area.

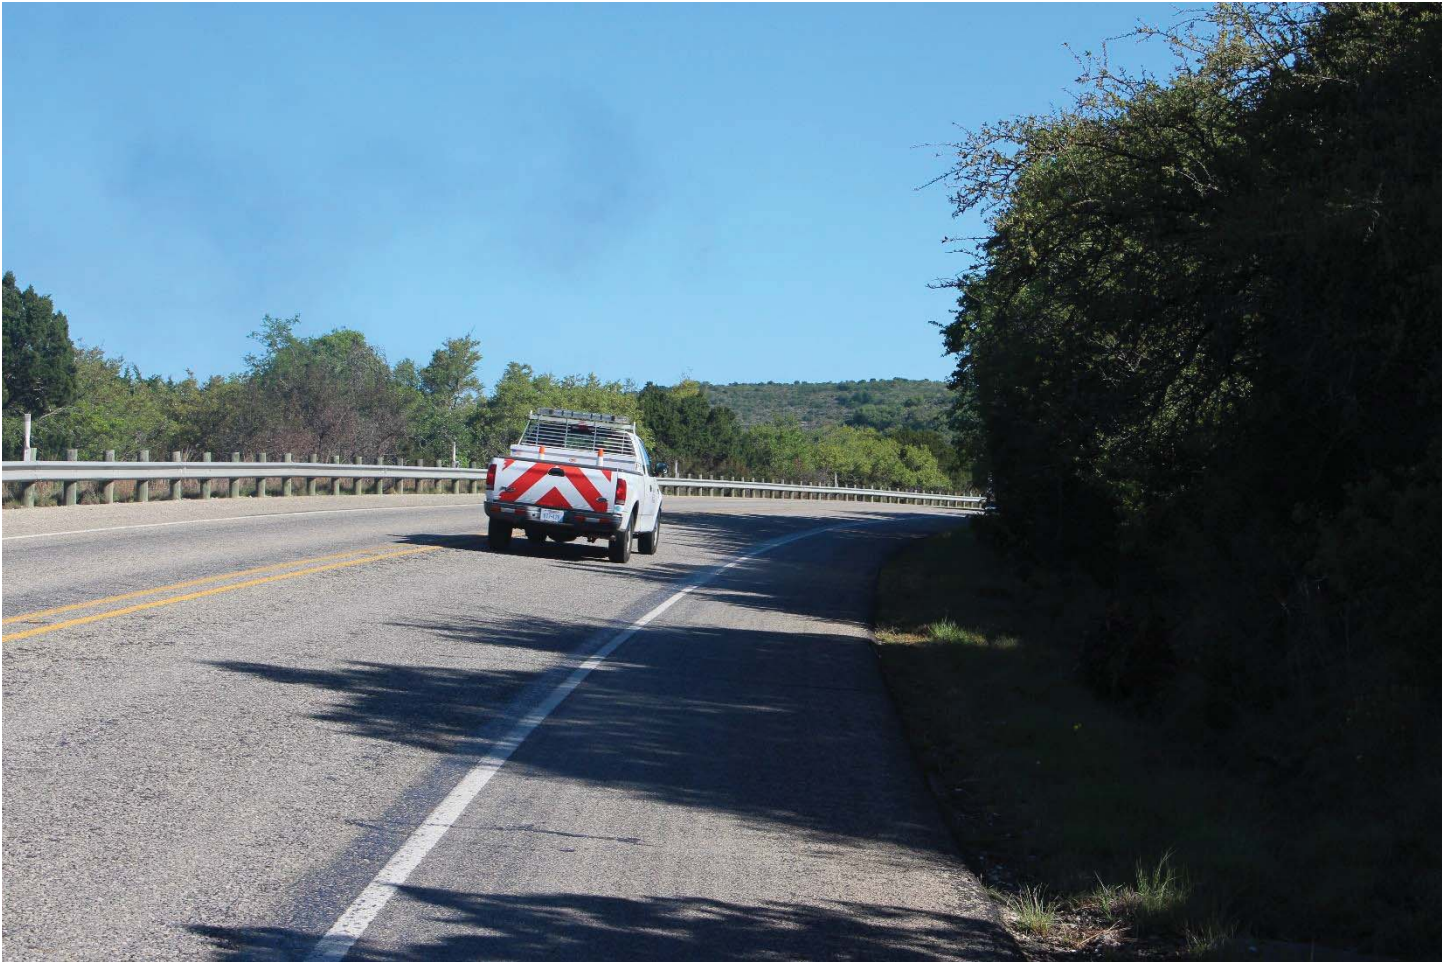
Highway Photo 22 – Continued view of accident curve.

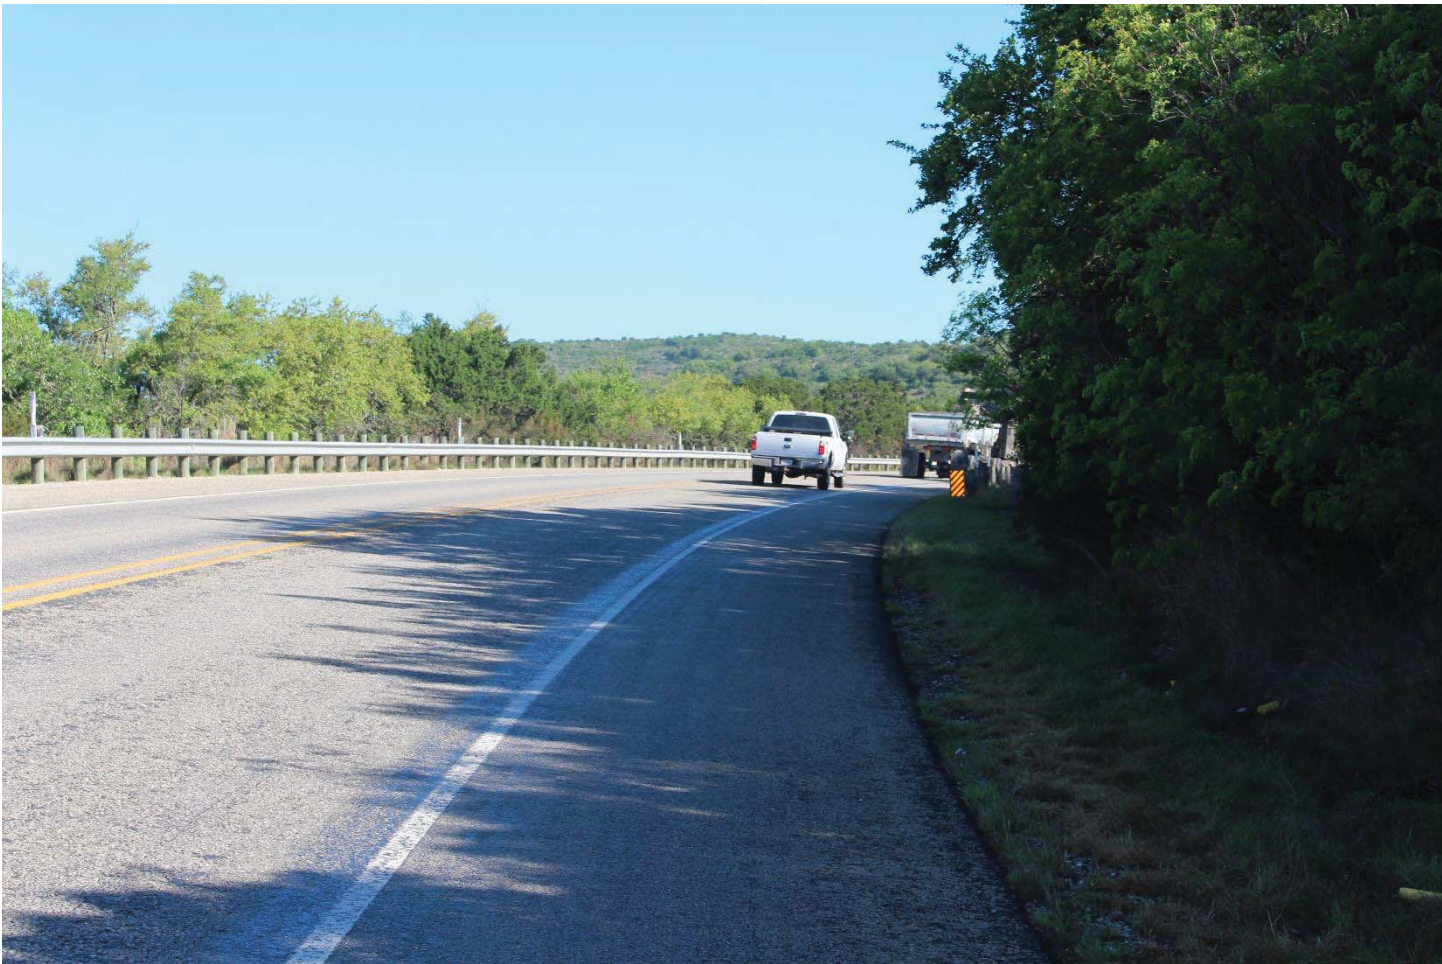
Highway Photo 23 – Northbound view of curve approximately, 900 feet from the impact area.

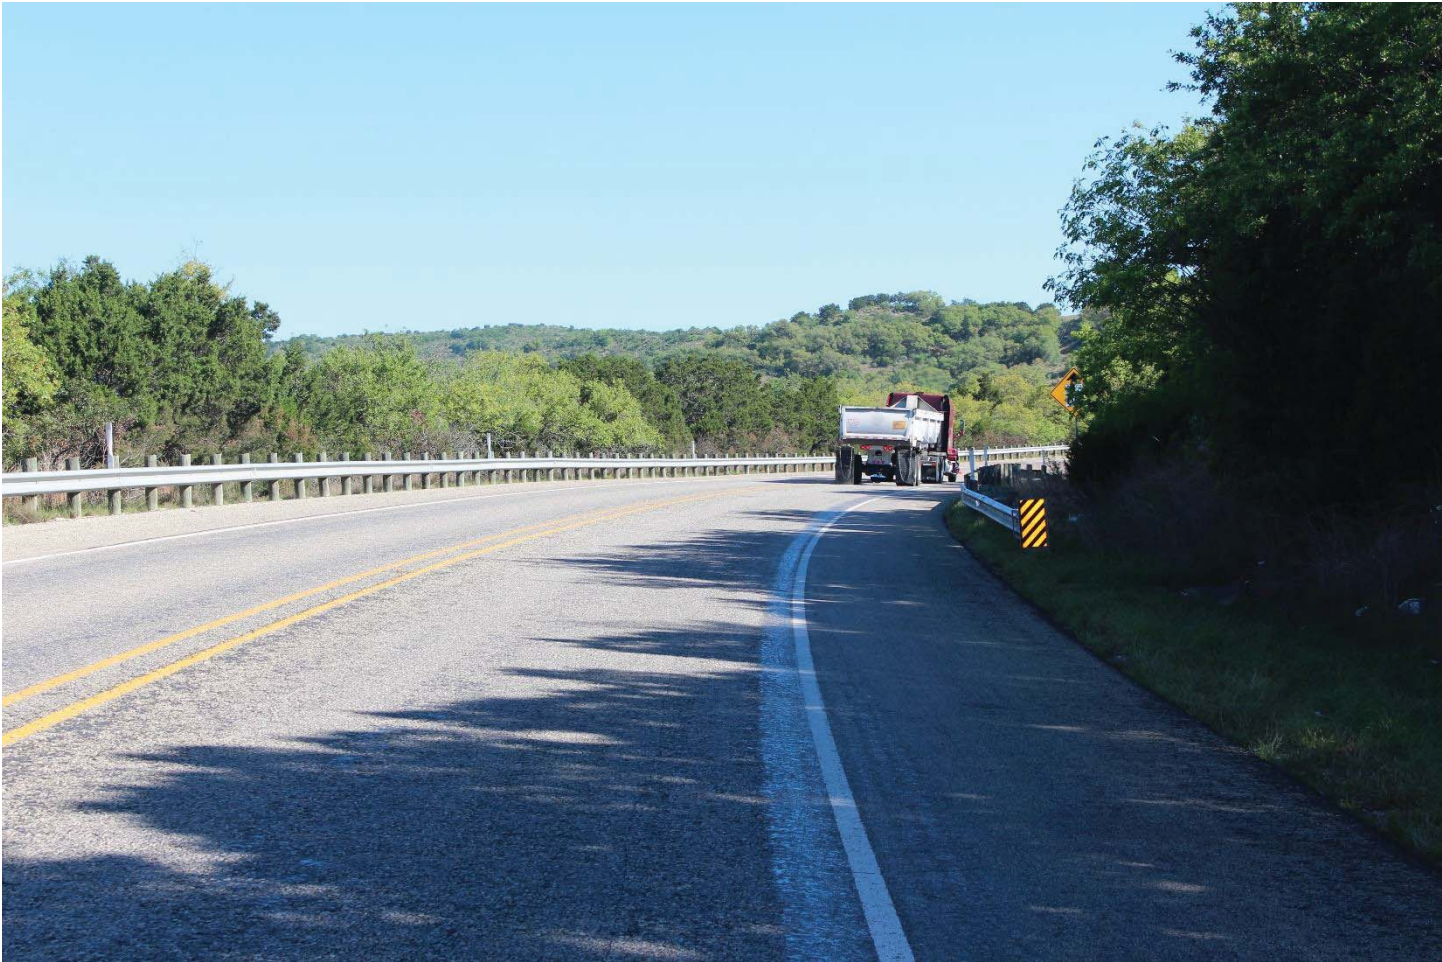
Highway Photo 24 – Continued view of accident curve.

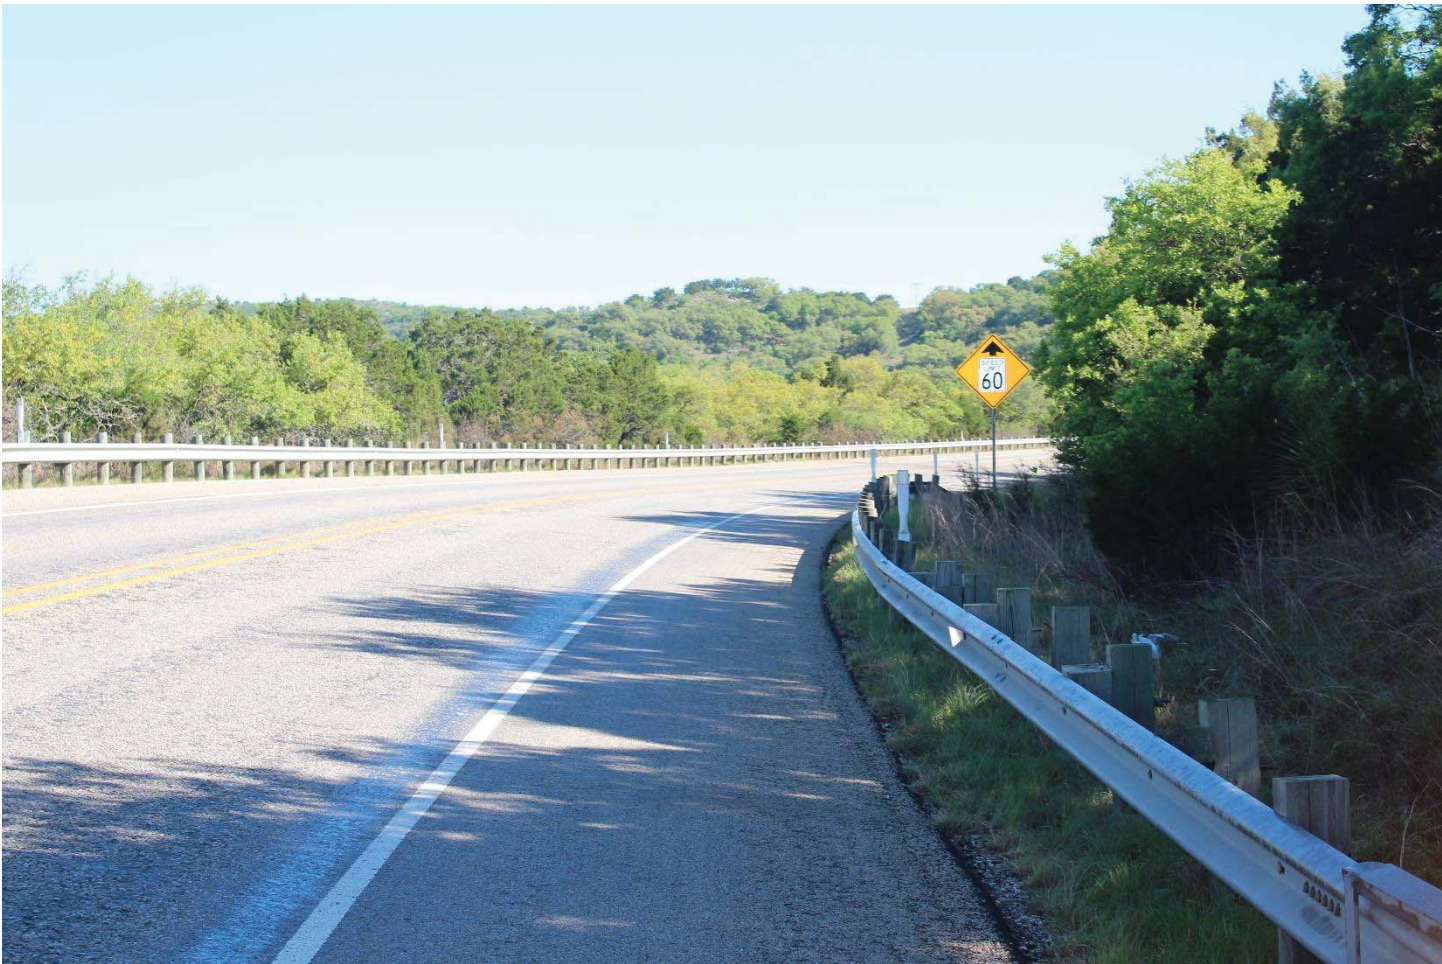
Highway Photo 25 – View of advance warning sign for speed limit change ahead on US 83 from 70 mph to 60 mph.

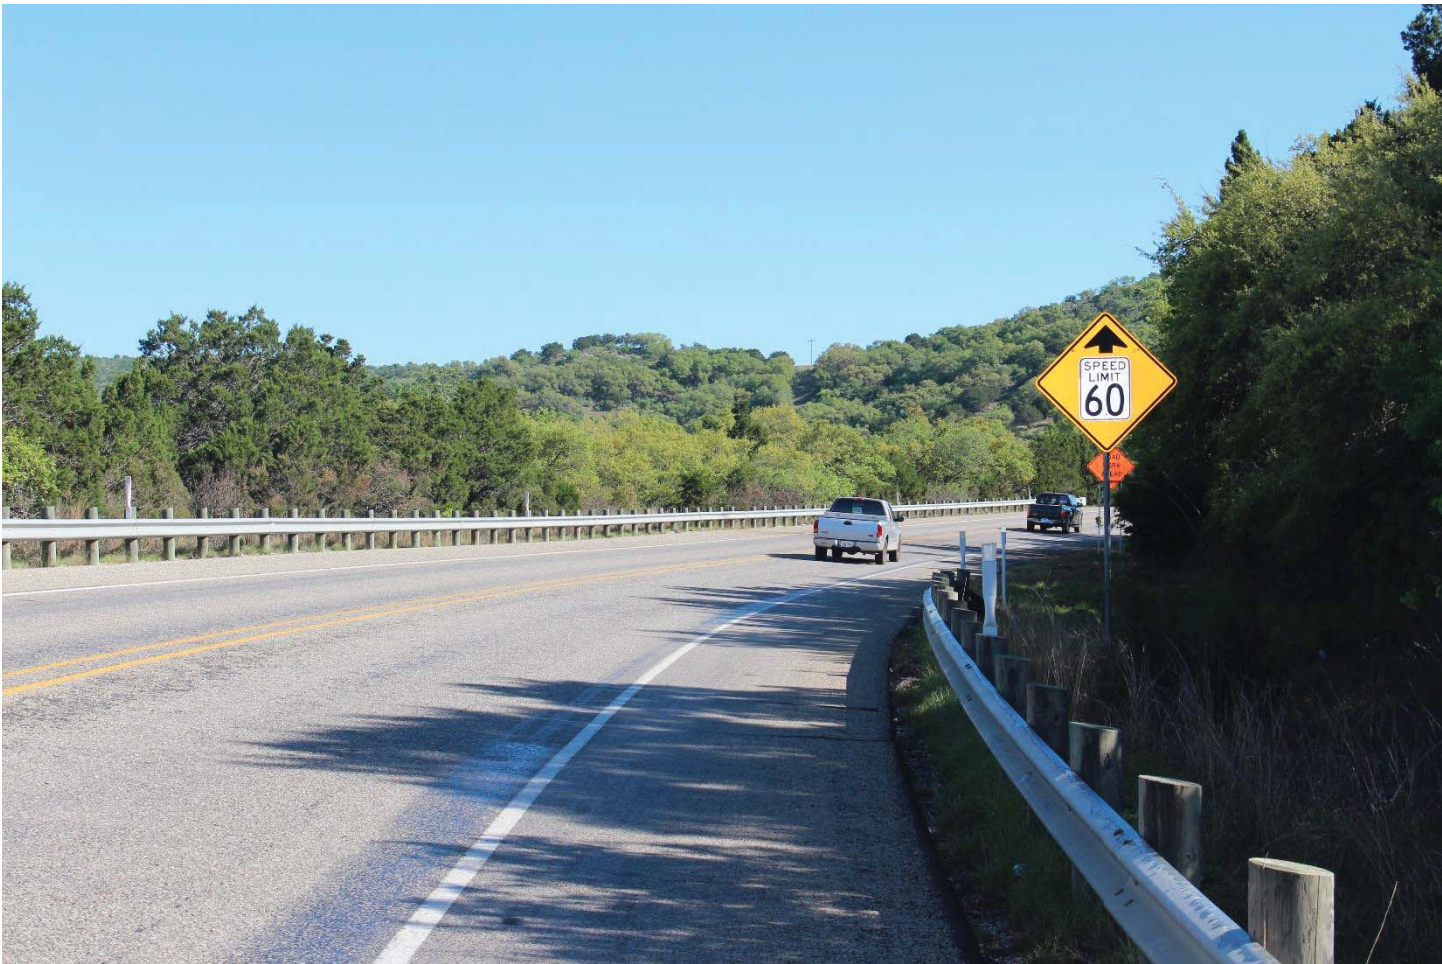
Highway Photo 26 – Closer view of speed limit change warning sign.

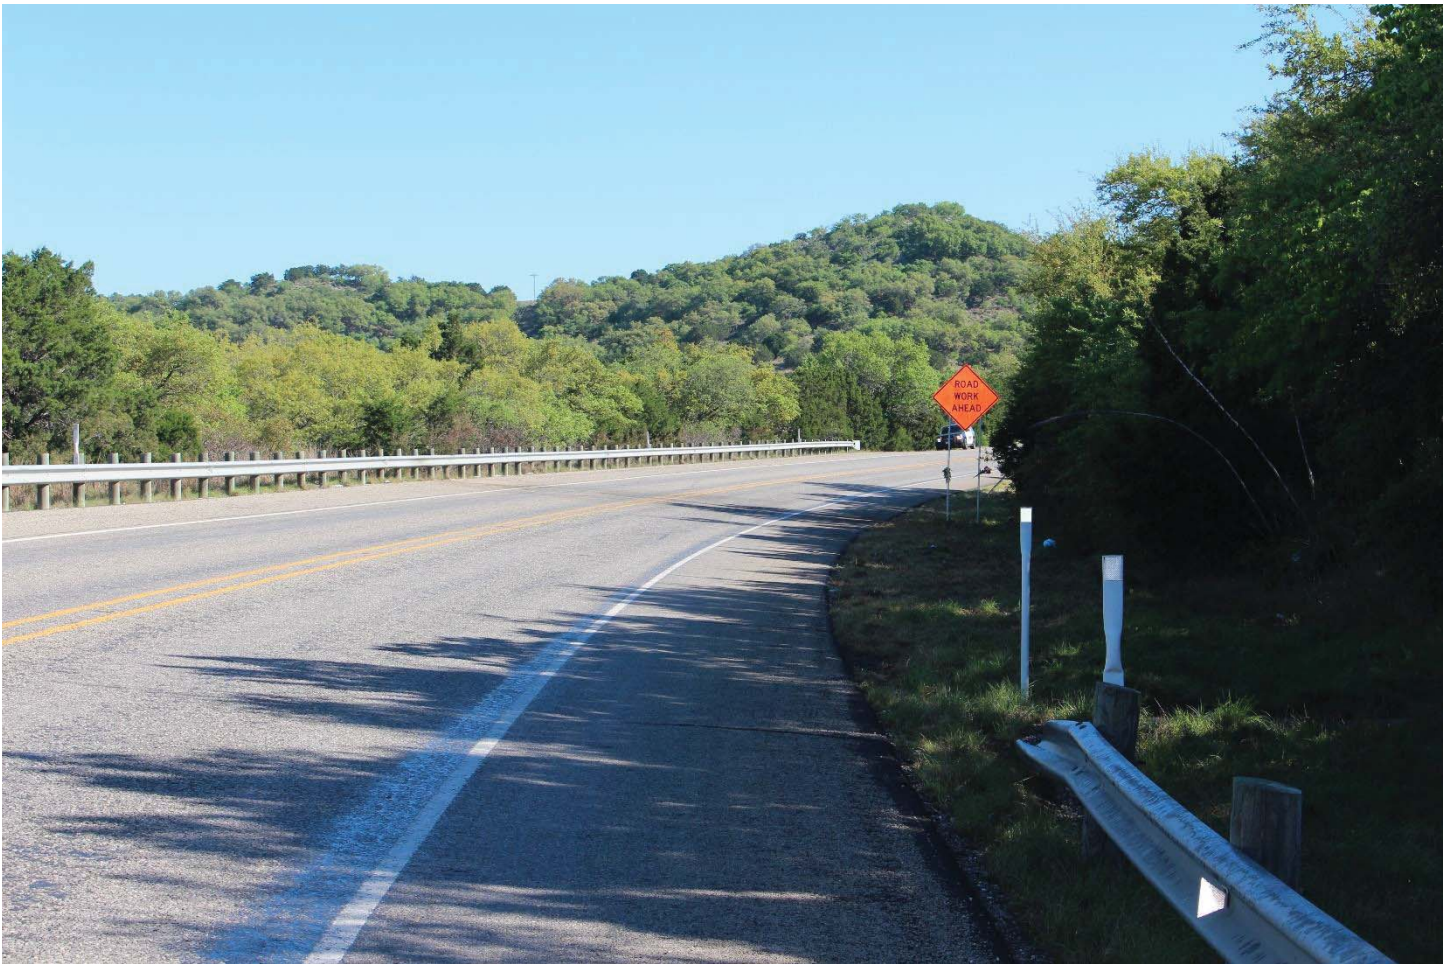
Highway Photo 27 – View of work zone warning sign. Note the impact area can be seen by the pavement discolored by fluid debris on the opposite side of the road across from the sign.

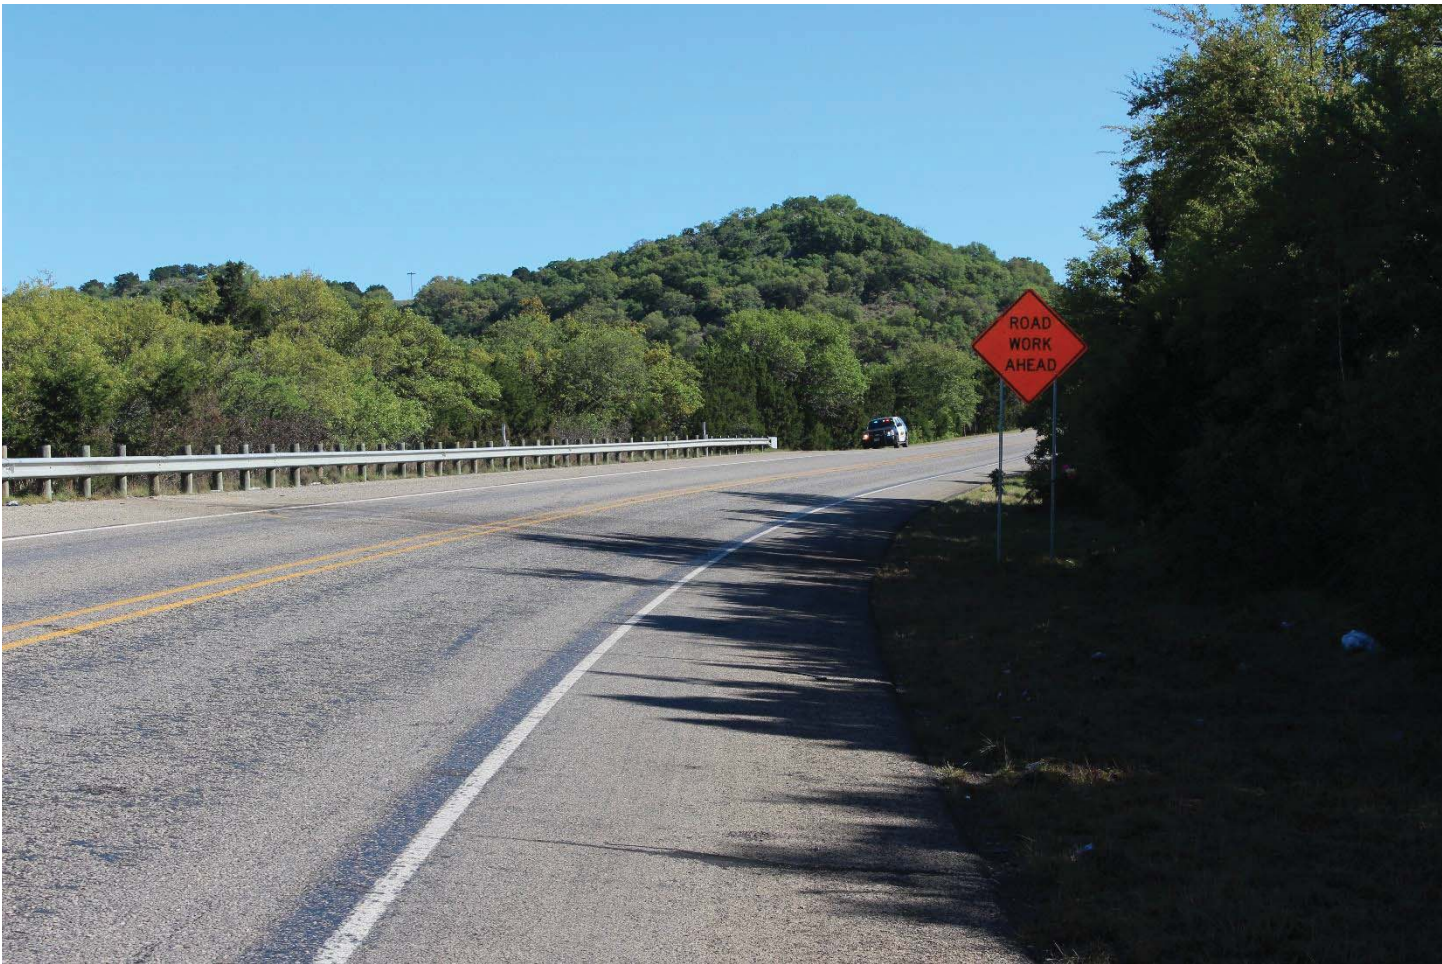
Highway Photo 28 – Northbound view of impact area in the southbound lane.

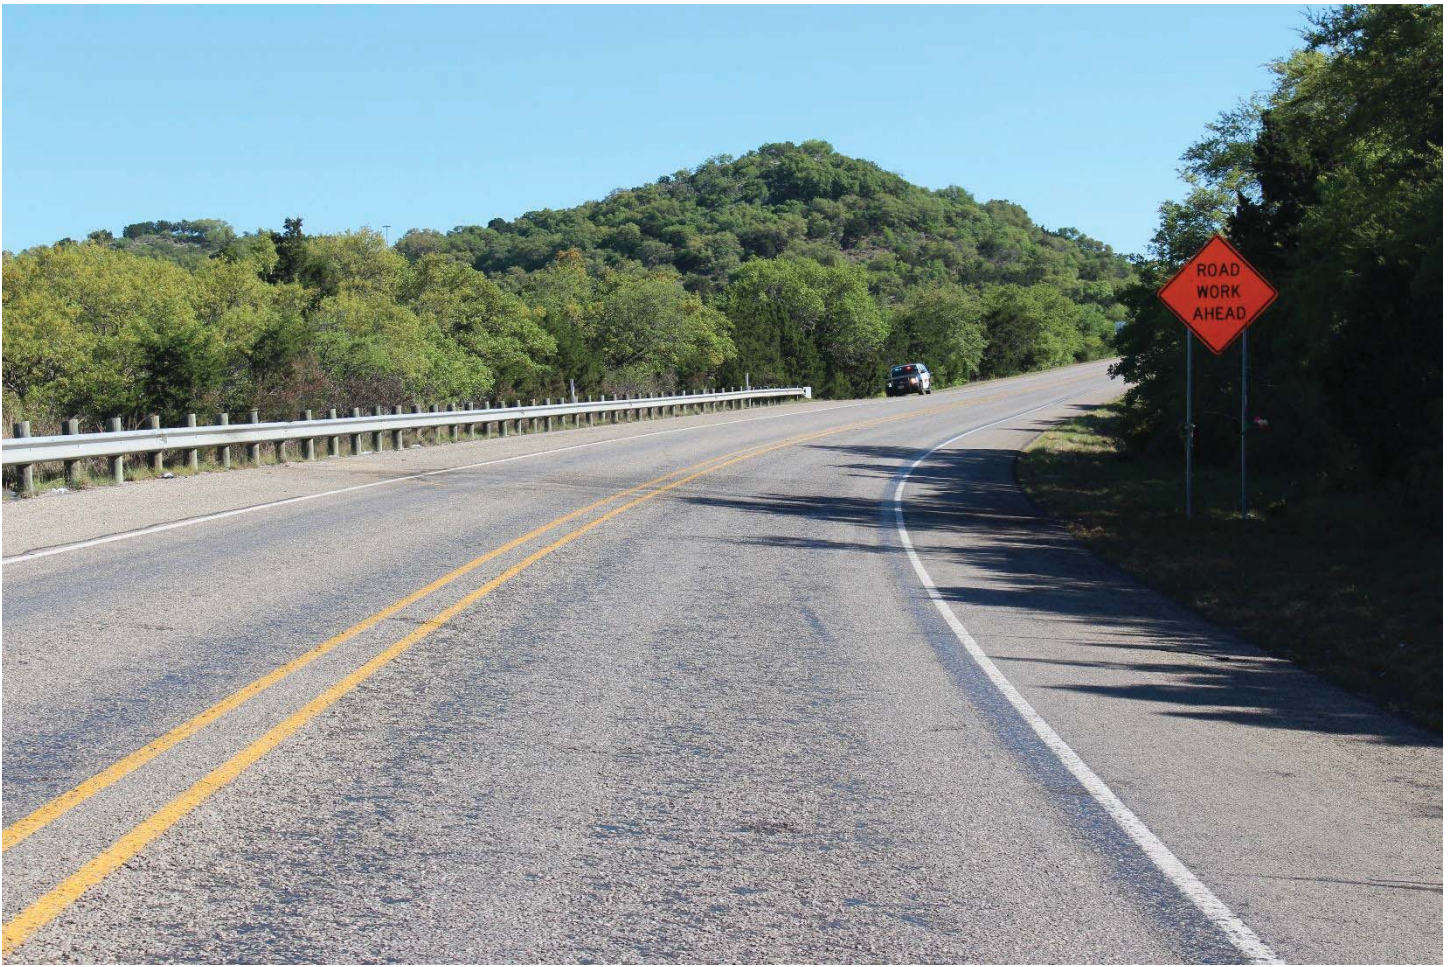
Highway Photo 29 – Closer view of the impact location.

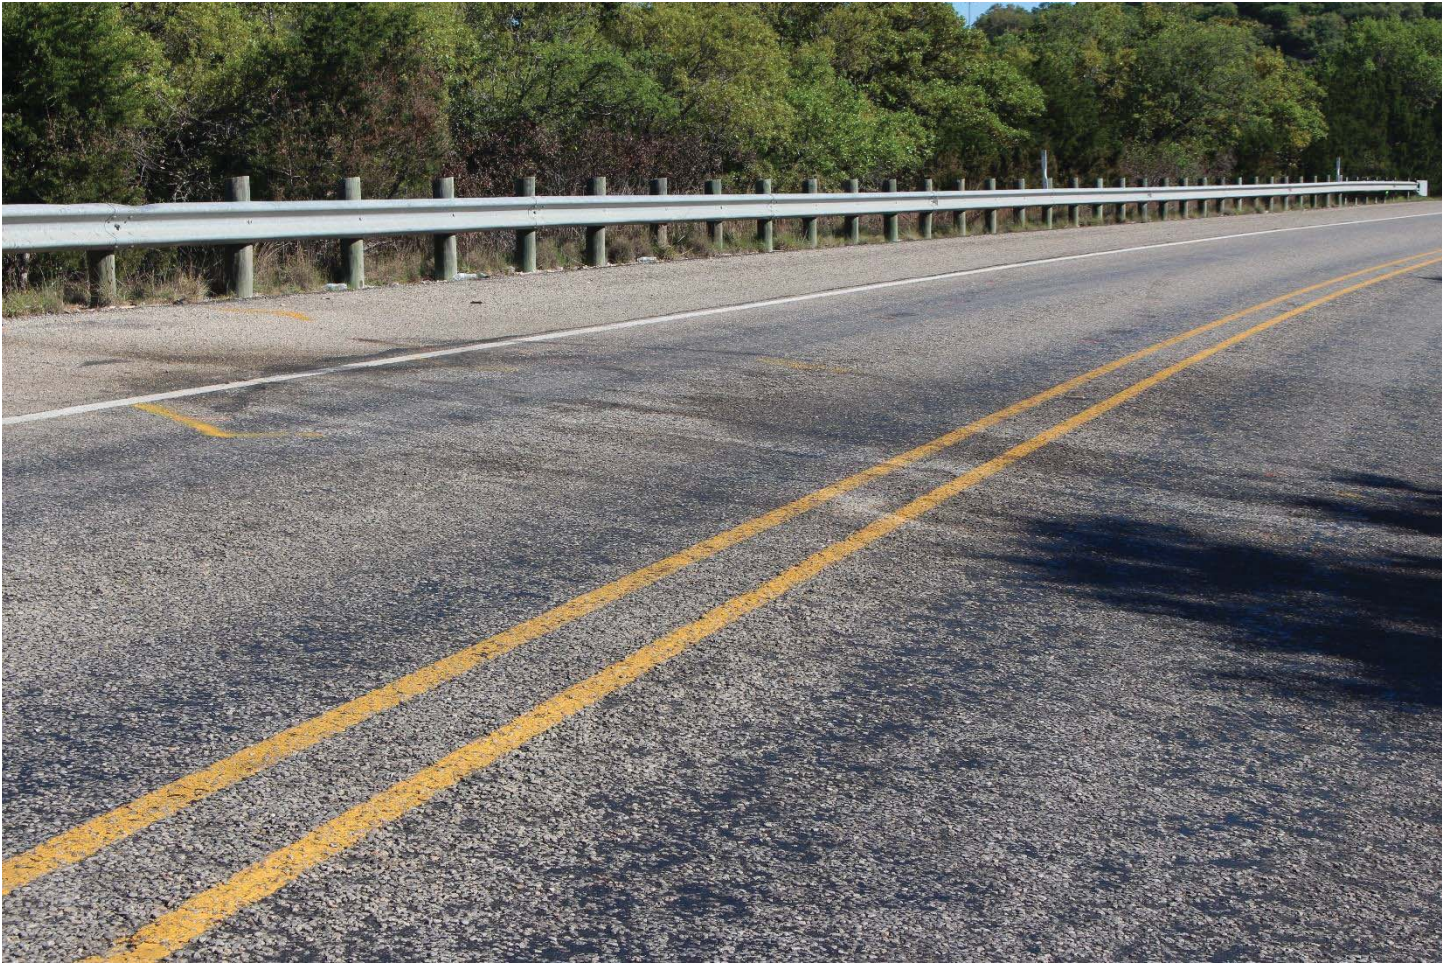
Highway Photo 30 - View of impact area marked by fluid stains and paint markings.

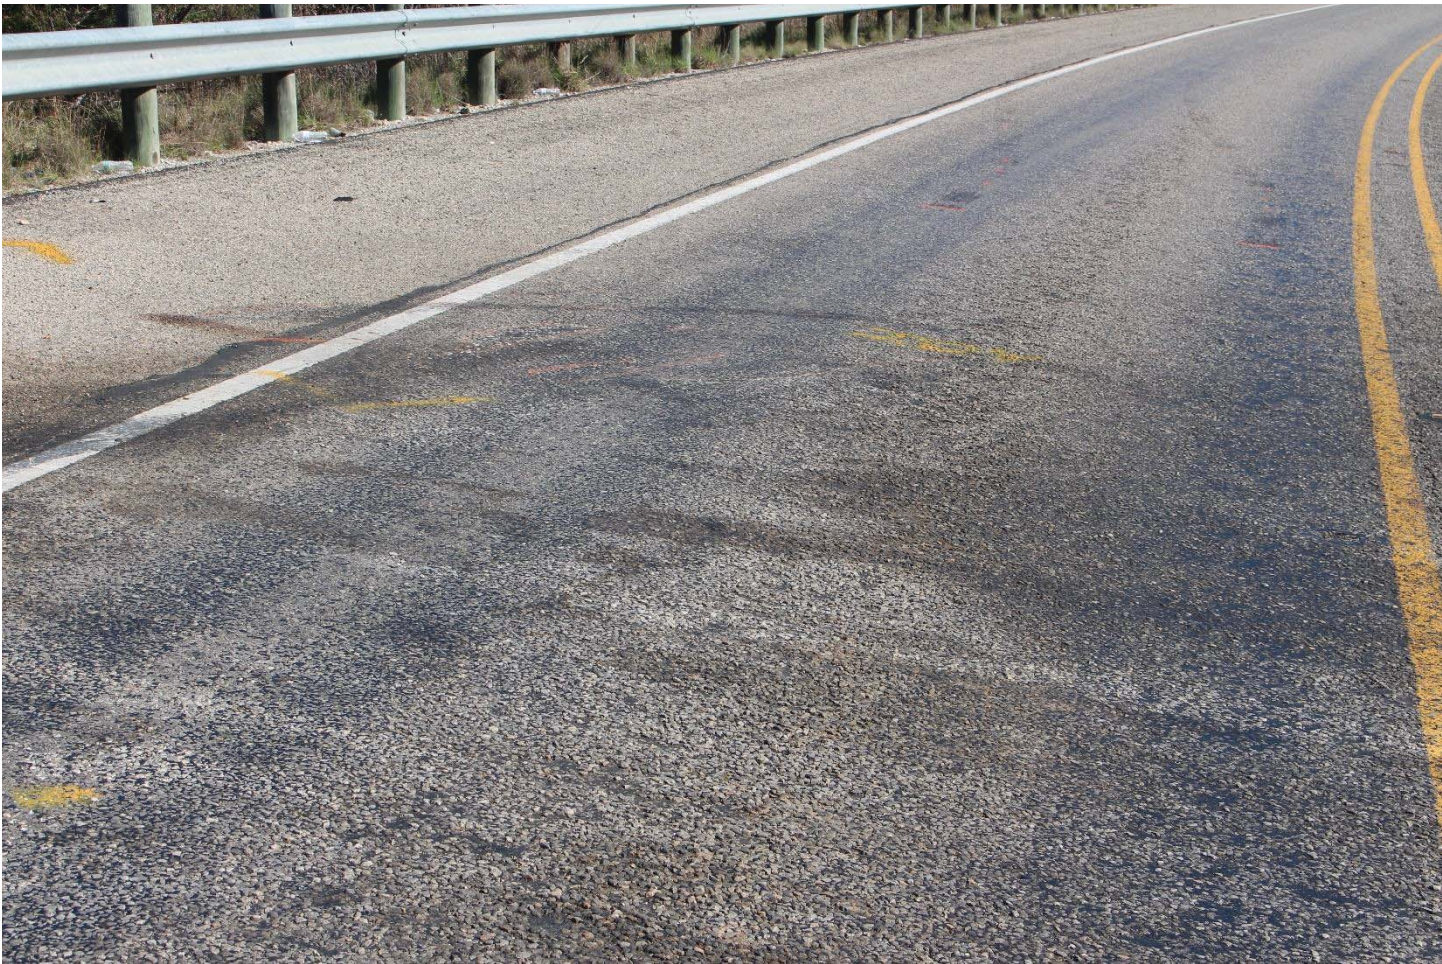
Highway Photo 31 – Close-up view of impact area in the southbound lane of US 83.

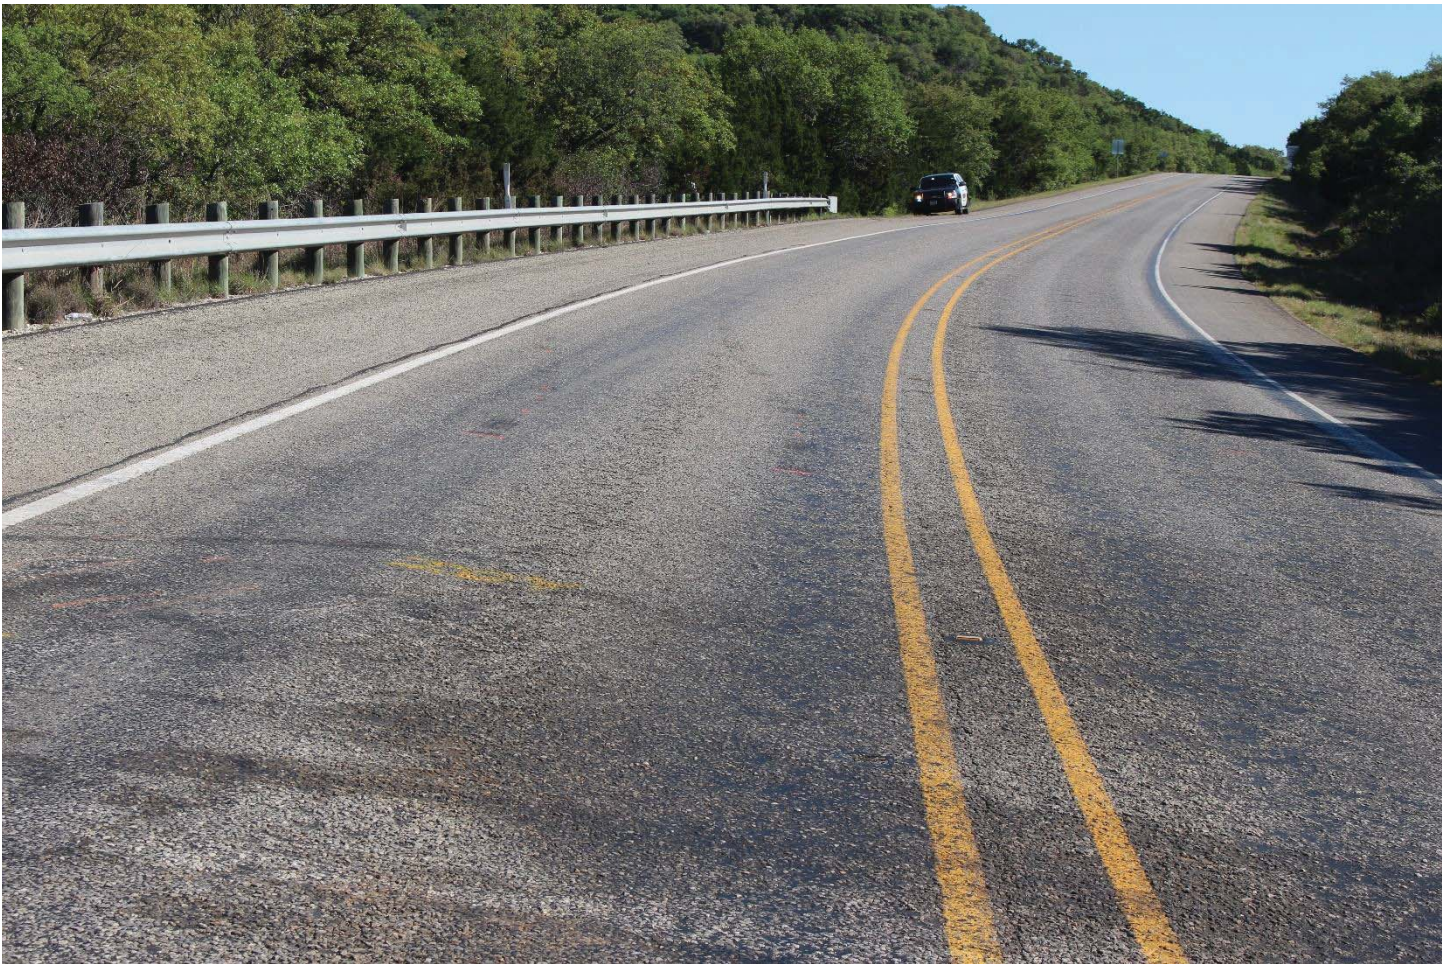
Highway Photo 32 – View of northbound curve ending in the photo background.
