Highway Factors Photographs

Concan, Texas

HWY17MH011

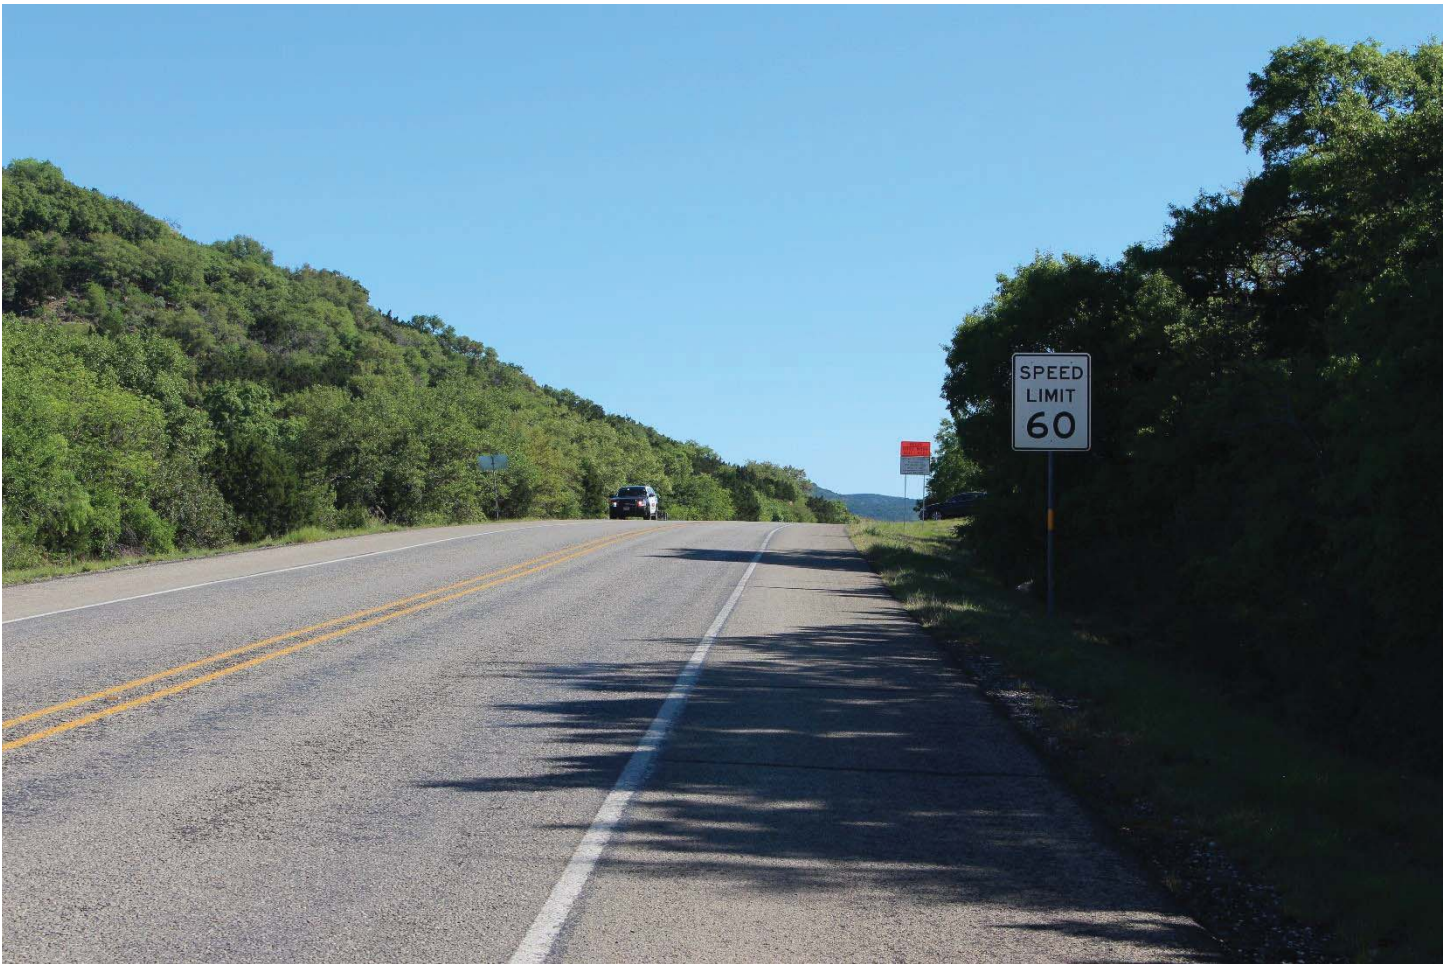
Highway Photo 33 – Continued view on northbound US 83 where the speed limit changes to 60 mph, approximately 750 feet past the impact area.

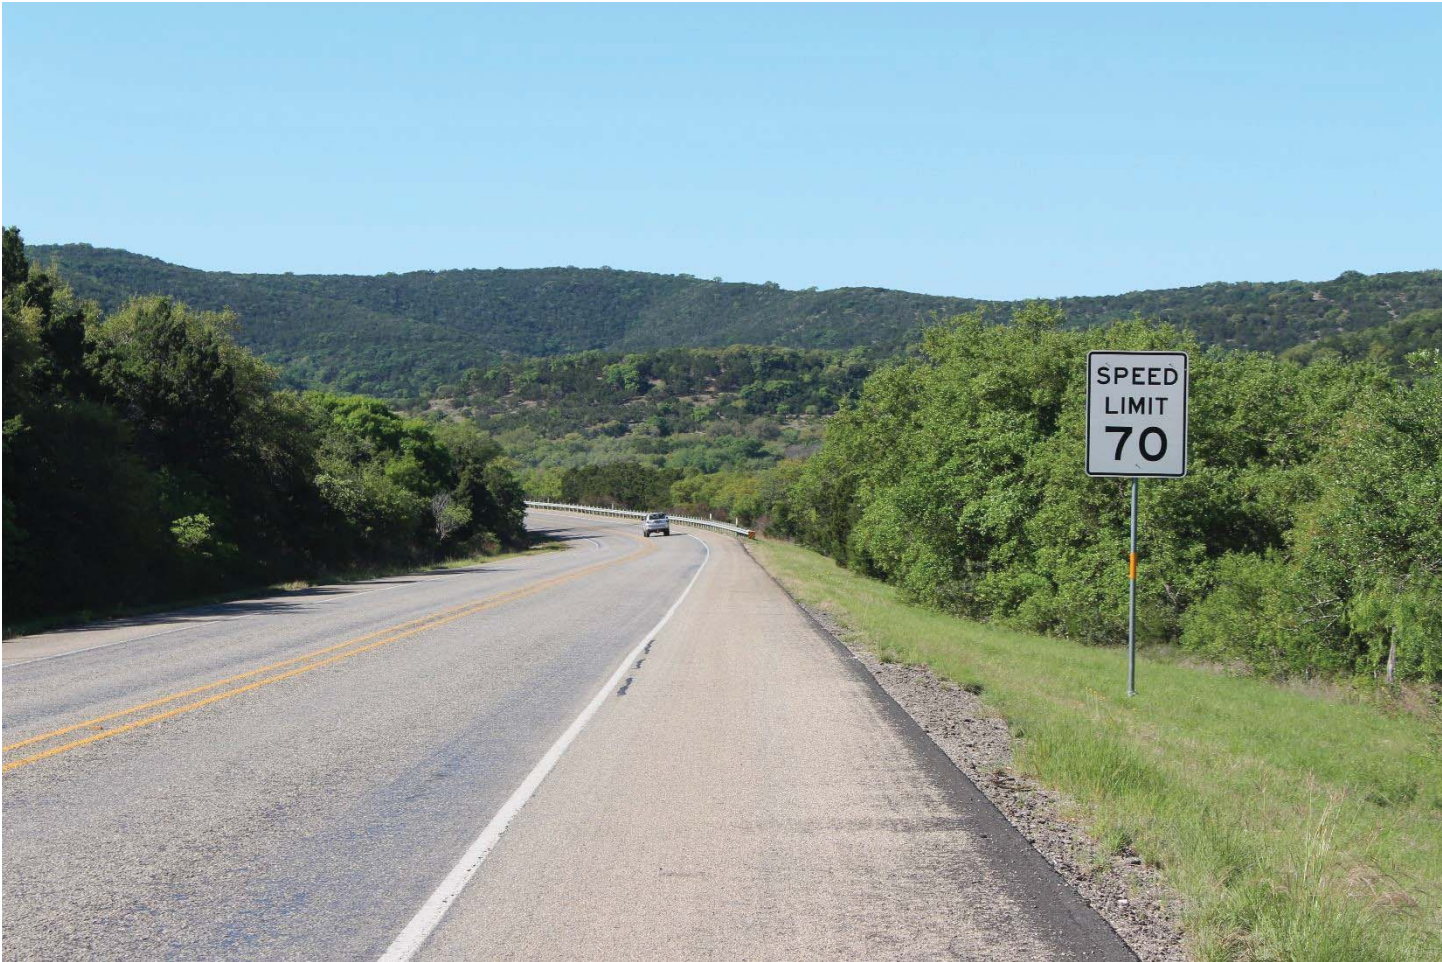
Highway Photo 34 – Southbound view (direction of bus) of US 83 where the speed limit in the southbound direction changes from 60 mph to 70 mph for the bus.

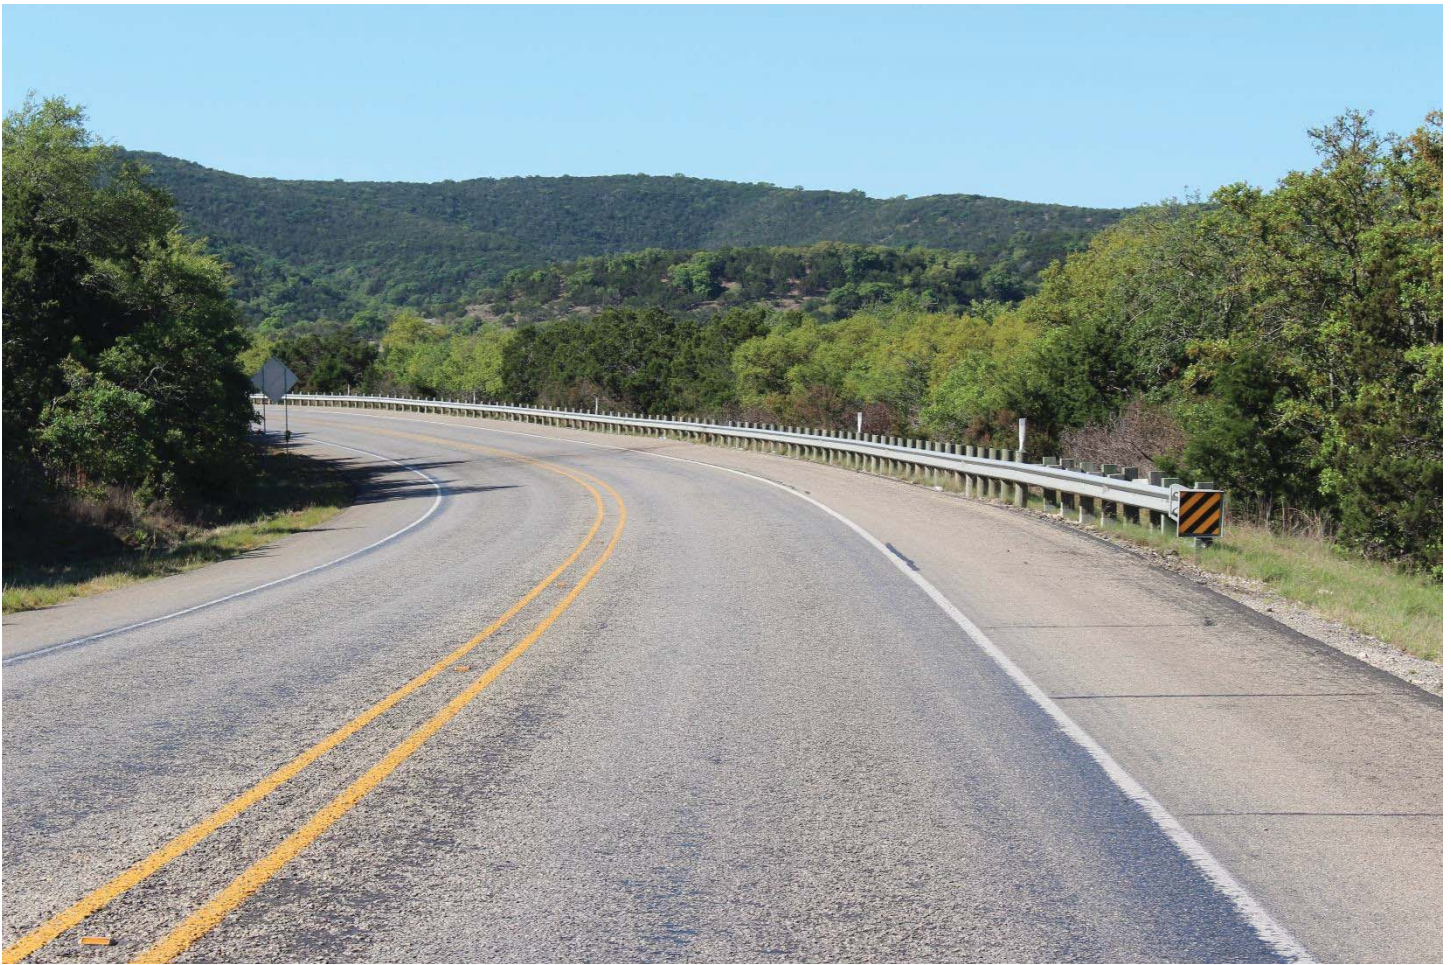
Highway Photo 35 – Beginning of the accident curve in the southbound direction. The impact area is approximately 350 feet ahead.

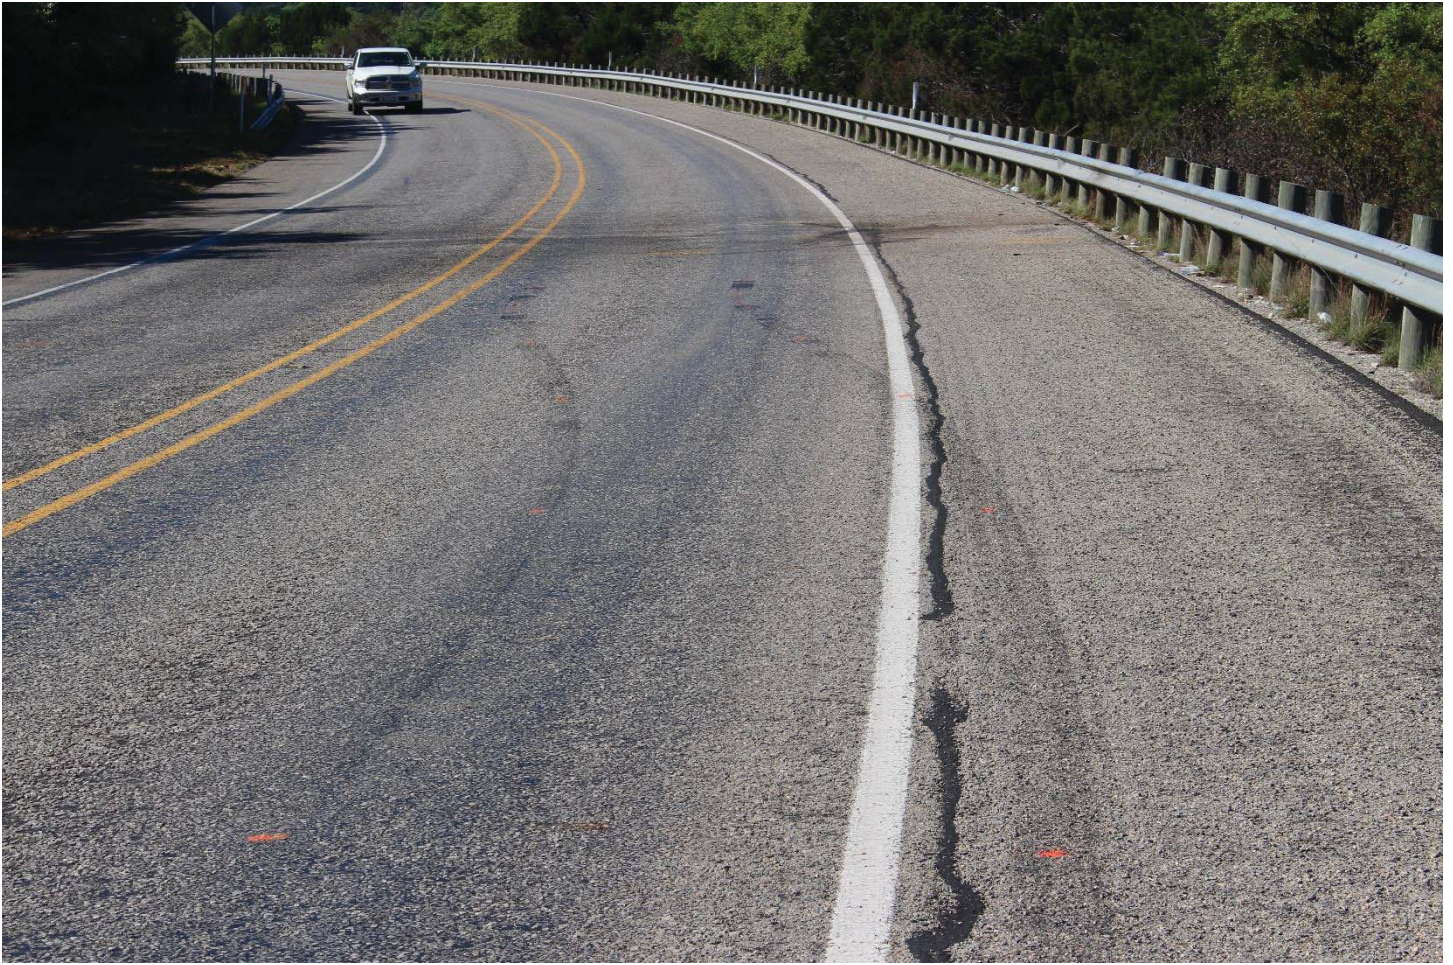
Highway Photo 36 – View of witness vehicle tire friction marks in the southbound lane that skidded to a stop behind the accident bus. Flid stains marking the impact area are just ahead of the tire marks in the photo.

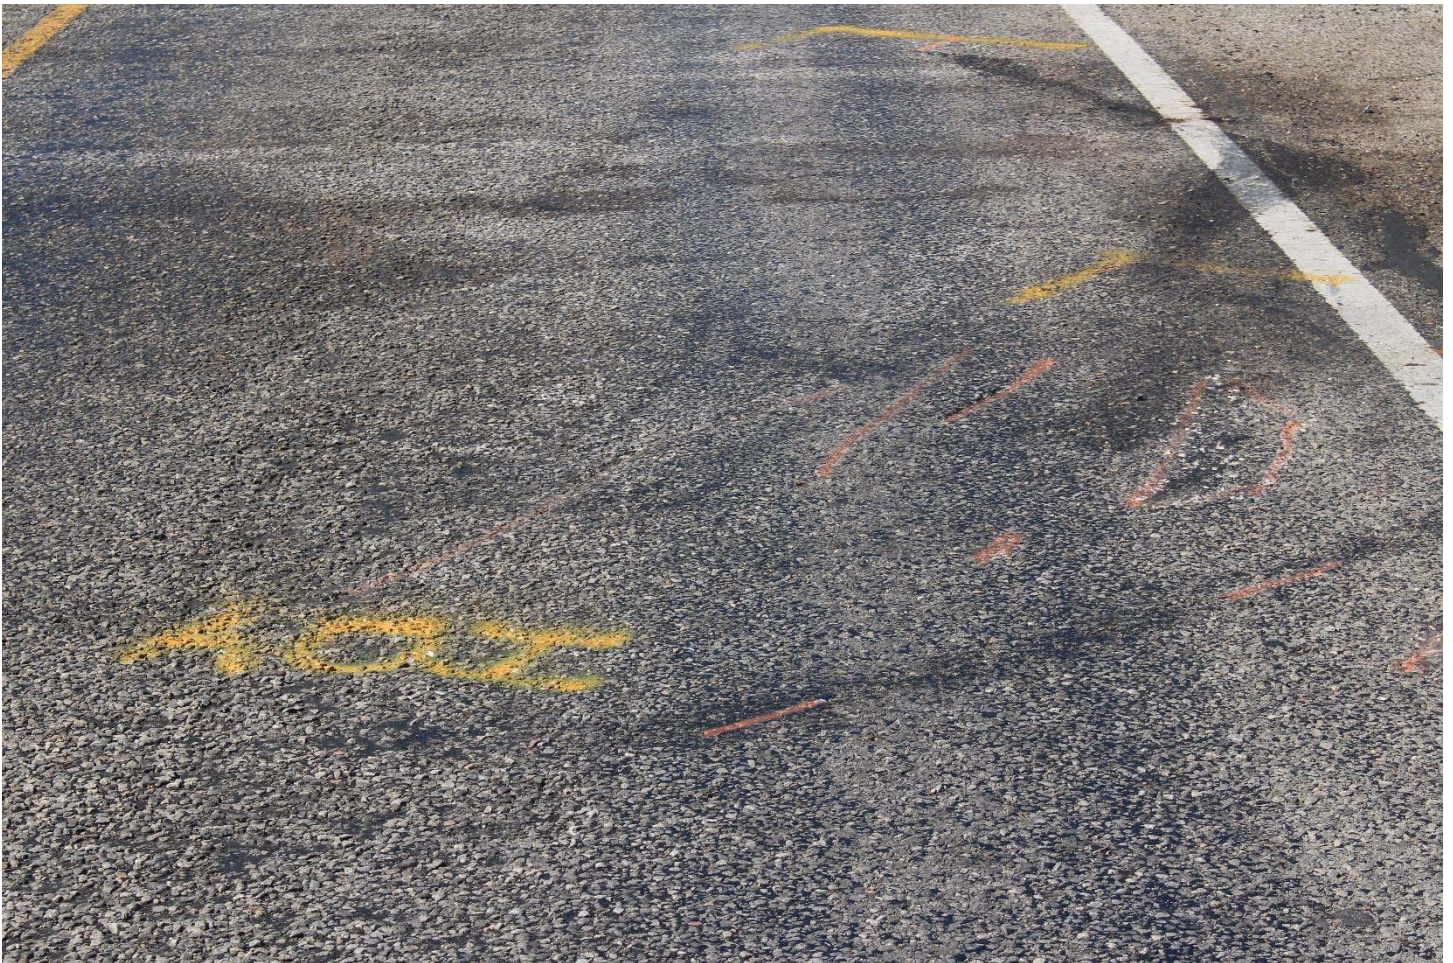
Highway Photo 37 – Southbound view of the impact area in the southbound lane.

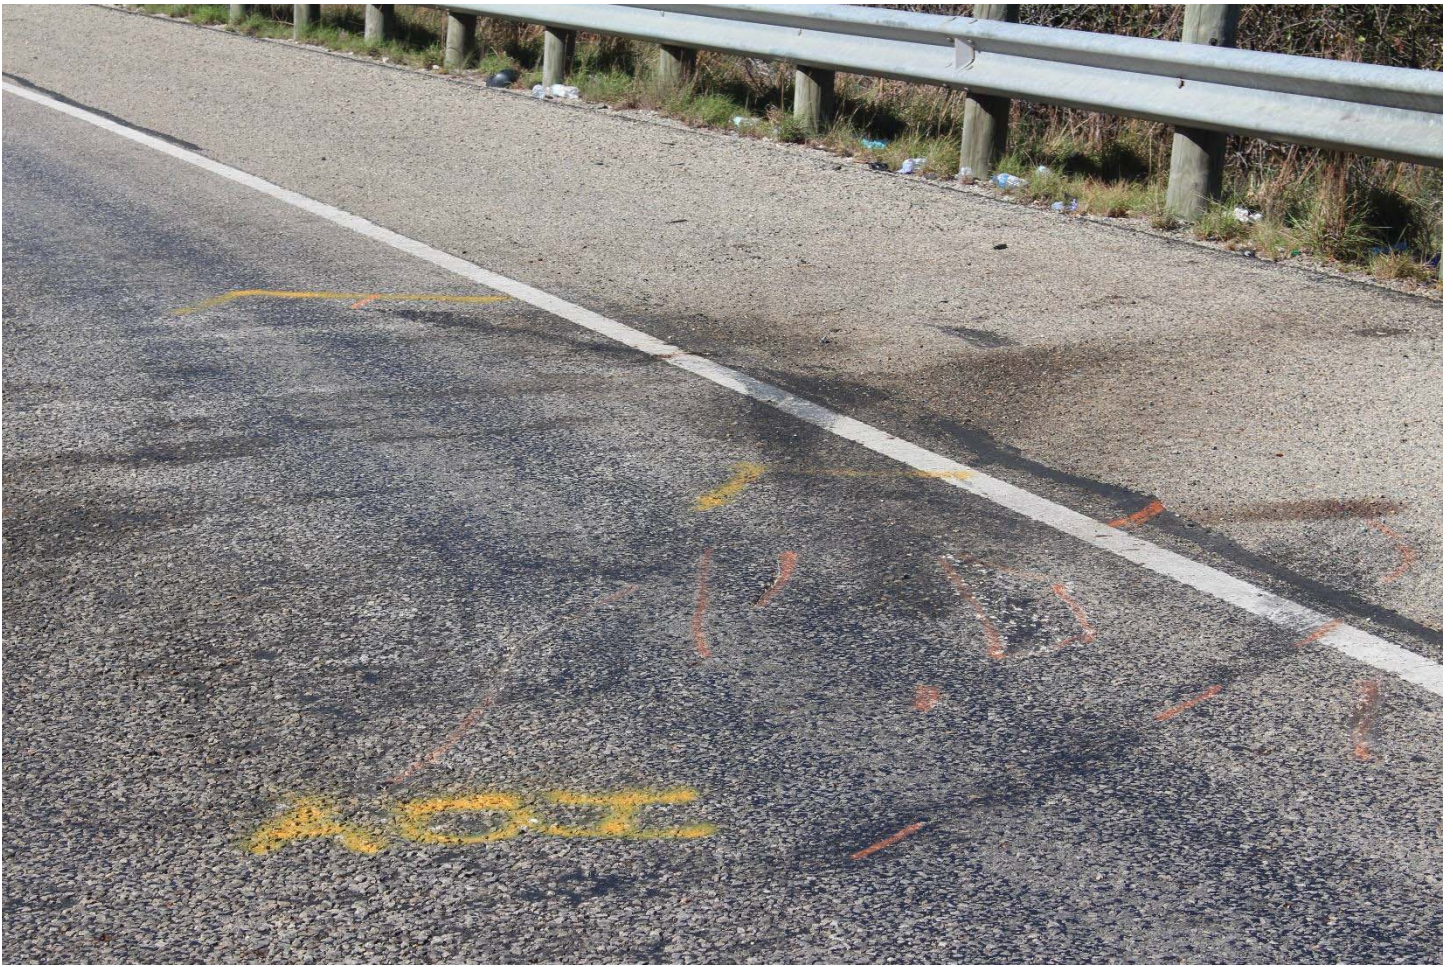
Highway Photo 38 – Additional close-up view of pavement gouges and tire friction marks in the impact area.
