## **Engine Wreckage Examination Notes June 25-26, 2015 Pleasant Grove, California**

NTSB Identification Number: WPR15FA195

Accident Aircraft: Shorts Brothers Tucano S312 T Mk1

Accident Aircraft Registration: N206PZ

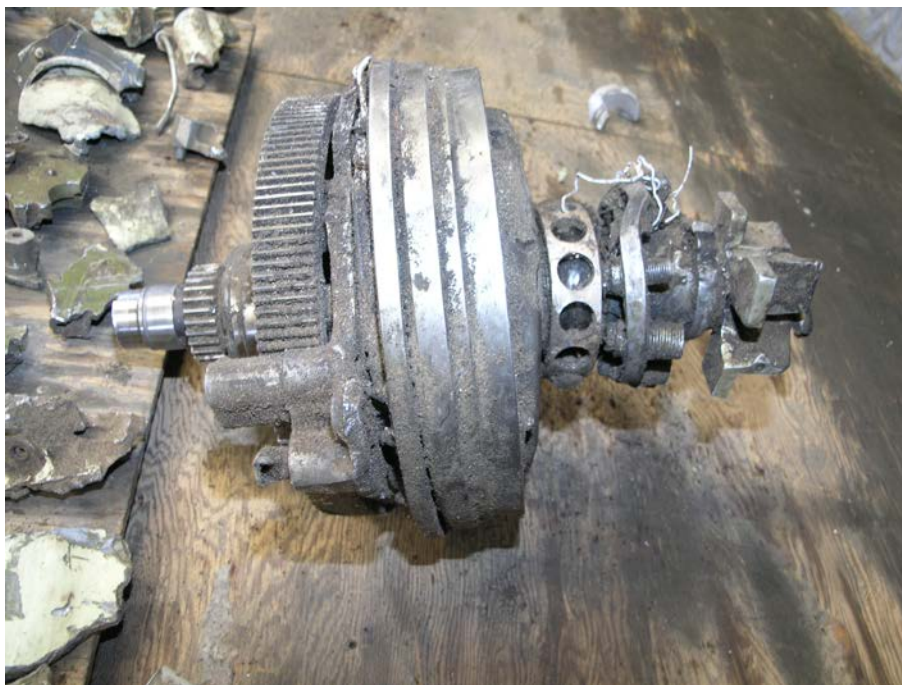
**Figure 1. Bull Gear, Ring Gear, Engine Propeller Shaft, and Propeller Fork.**

Three interconnected sections of the engine were recovered: (1) the bull gear, ring gear, engine prop shaft, and propeller fork (**Figure 1**). (2) The second-stage compressor housing and impeller, plenum, combustion liner, and the first- and second-stage turbine stator outer vane supports (**Figure 2 and Figure 3**). (3) The first-, second-, third-stage turbine rotors, and turbine bearing support housing (**Figure 4**). The remainder of the engine was recovered as individual loose items (**Figure 5**).

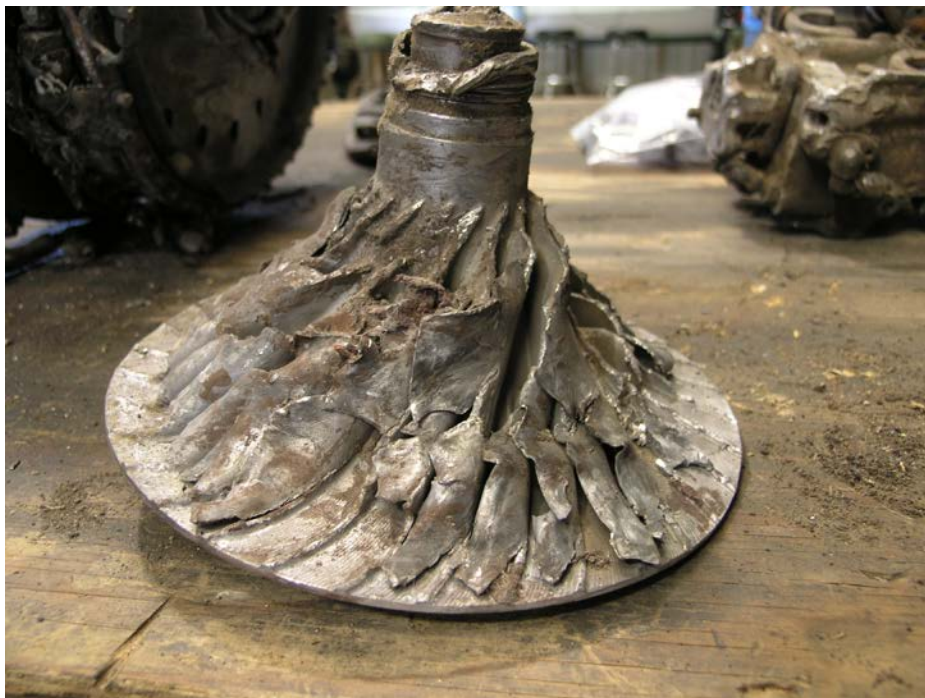
**Figure 6. First-Stage Compressor Impeller.**

The first-stage compressor impeller was recovered as an individual loose item. All blades on the first-stage compressor impeller were folded (bent) opposite the direction of rotation (**Figure 6**). The curvic of the first-stage compressor was smeared (**Figure 7**). The mating forward curvic of the second-stage compressor impeller was also smeared (**Figure 8**). The shroud and compressor housing were crushed in and around the second-stage compressor impeller blades (**Figure 2**). Second-stage compressor impeller blades were bent both opposite and in the direction of rotation (**Figure 8**). The aft curvic of the second-stage compressor impeller was smeared (**Figure 9**).

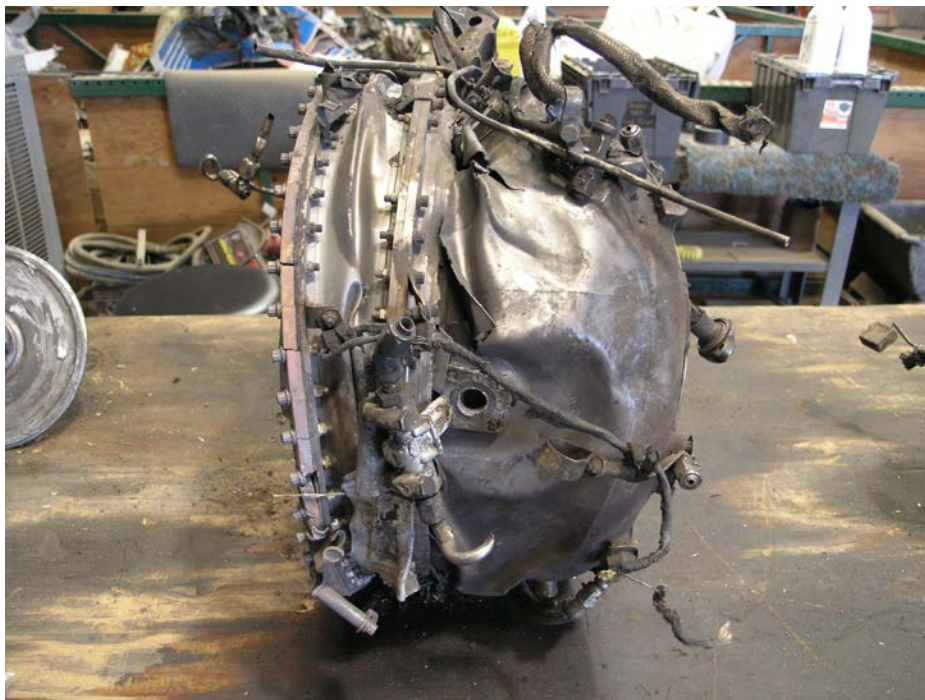
**Figure 10. Second-Stage Compressor Housing and Plenum.**

The plenum had deformation damage (Figure 10), but there was no evidence of a high energy radially outward penetration. The turbine disks were intact and held together by a deformed segment of the main shaft (Figure 11).

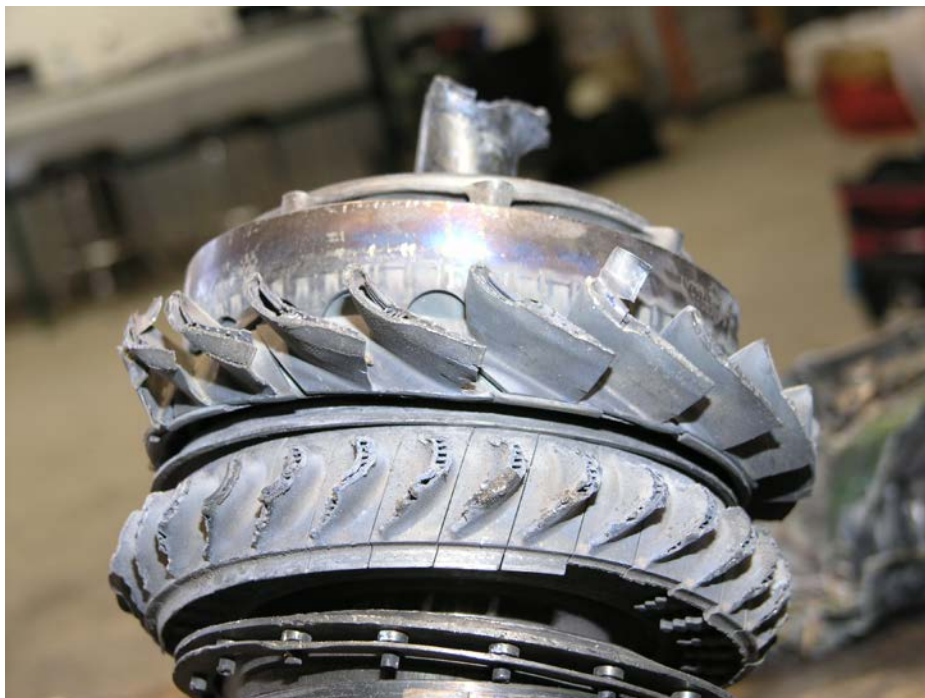
**Figure 12. First-Stage Turbine Stator Vanes and Rotor Blades.**

The first-stage turbine stator vanes were separated from the outer diameter support (Figure 12). There was metal spray on the aft side of the first-stage turbine stator vanes (Figure 13). All first-stage turbine rotor blades were present. The first-stage turbine rotor blades were separated approximately 3/8" above the blade platforms (Figure 12).

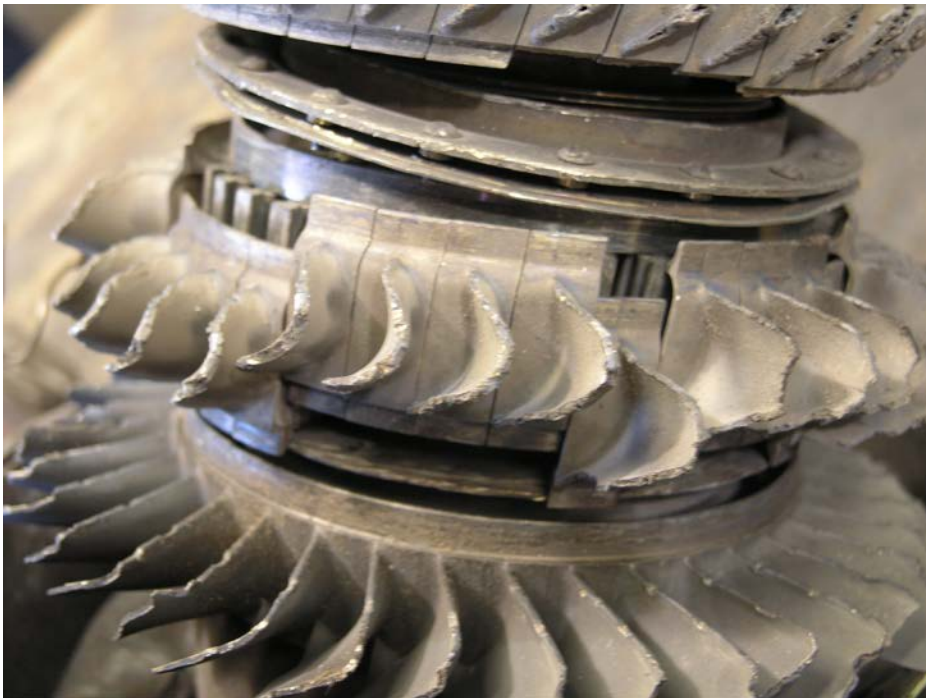
**Figure 14. Second-Stage Turbine Rotor.**

The outer diameter support of the second-stage turbine stator remained in the turbine housing. The second-stage turbine stator vanes were missing. All second-stage turbine rotor blades were present. The second-stage turbine rotor blades were separated approximately 7/8" above the blade platform (Figure 14). Seven second-stage turbine rotor blades were moved aft approximately 3/8".

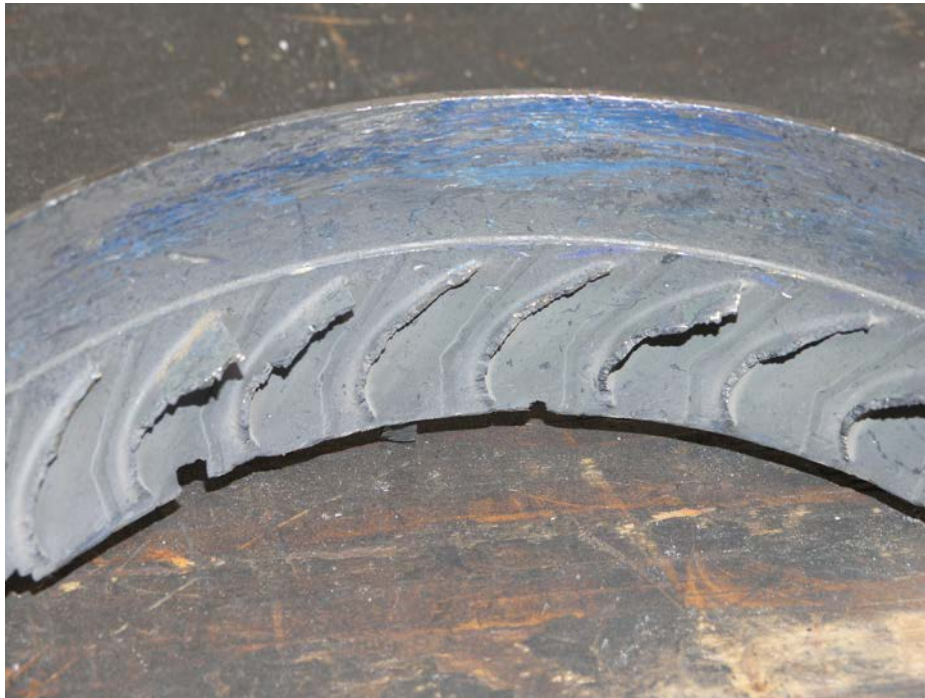
**Figure 15. Third-Stage Turbine Stator.**

The outer diameter support of the third-stage turbine stator was out of the turbine housing. There was intermittent rotational scoring on the third-stage blade tip shroud (Figure 15). All third-stage turbine rotor blades were present. There was leading edge damage to the third-stage turbine rotor blades (Figure 16). There was metal spray on the pressure side of the third-stage turbine rotor blades (Figure 17).

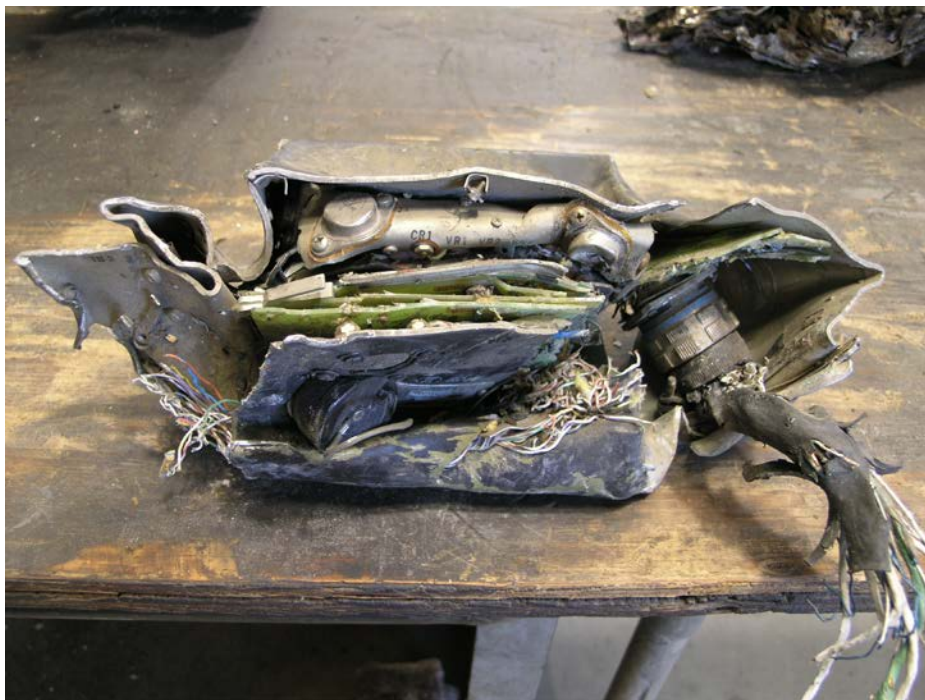
**Figure 18. Engine Control.**

- Engine Control, Part Number 897821-1, Series 1, Serial Number 108-1347, There was impact damage to the engine control (Figure 18). The electrical connector was attached with the blue strip indicated.

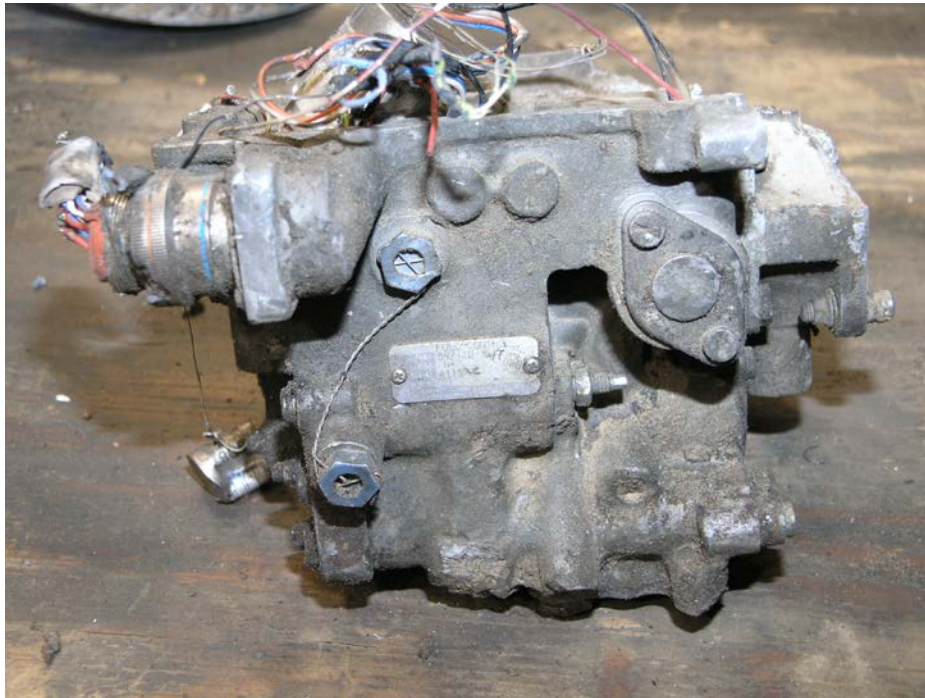
**Figure 19. Fuel Control.**

- Fuel Control, Part Number 897110-17, Series 4, Serial Number A1157C, There was impact damage to the fuel control (Figure 19).
- Fuel Flow Divider, Part Number 394408-8-1, Series 4, Serial Number 9590, The inlet fitting was removed during the June 25, 2015 examination to facilitate examination of the inlet fuel screen. There was no visible debris on the outside of the screen (Figure 20) or when viewed thru light to reveal the inside of the screen.

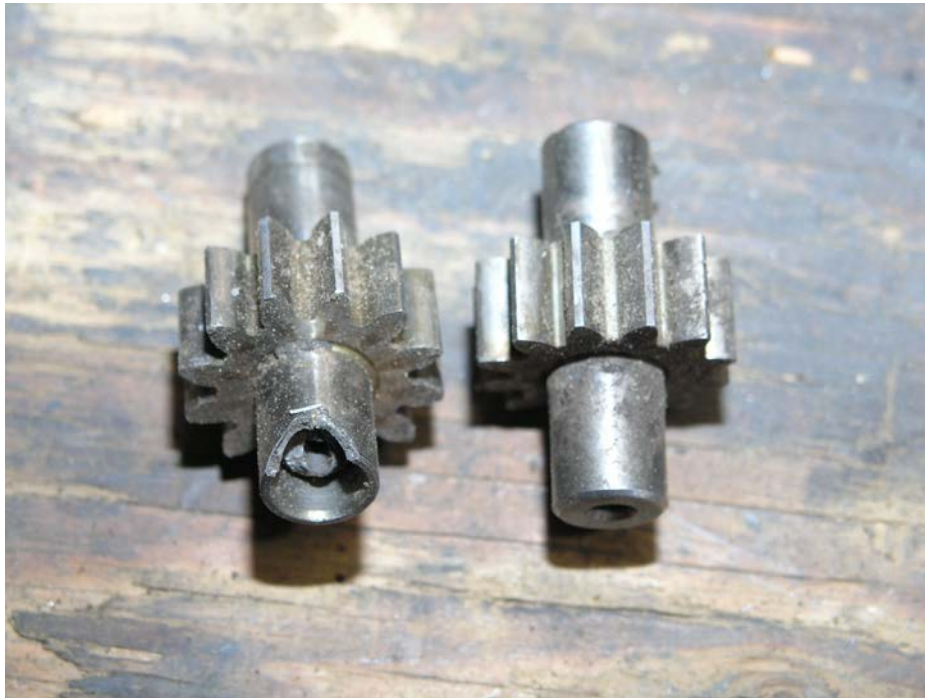
**Figure 21. High Pressure Fuel Pump Elements.**

- Fuel Pump, A portion of the housing was recovered. The high pressure pump elements were intact (Figure 21). The low pressure element was not identified in the wreckage.

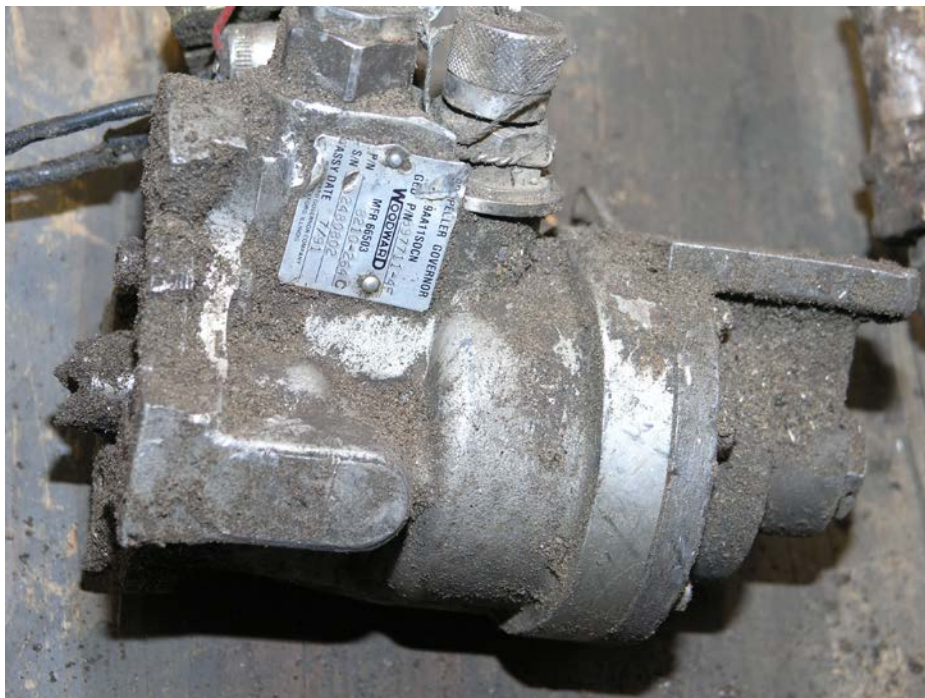
**Figure 22. Propeller Governor.**

- Propeller Governor, Part Number 897711-4F (Woodward 8210-264C), Serial Number #2480802, the mounting flange was fractured and the drive shaft was missing (Figure 22).

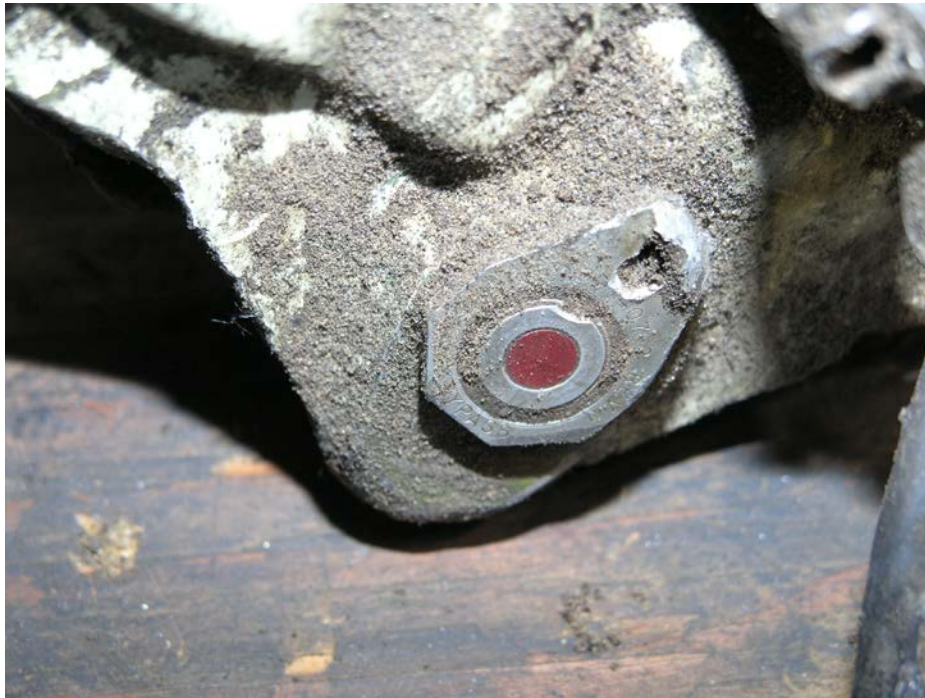
**Figure 23. Oil Pressure Impending Bypass Indicator.**

- The oil pressure bypass was not extended (Figure 23).
- The gearbox oil scavenge pump.
- The oil filter housing cap was fractured, deformed and portions were missing exposing a deformed filter element.

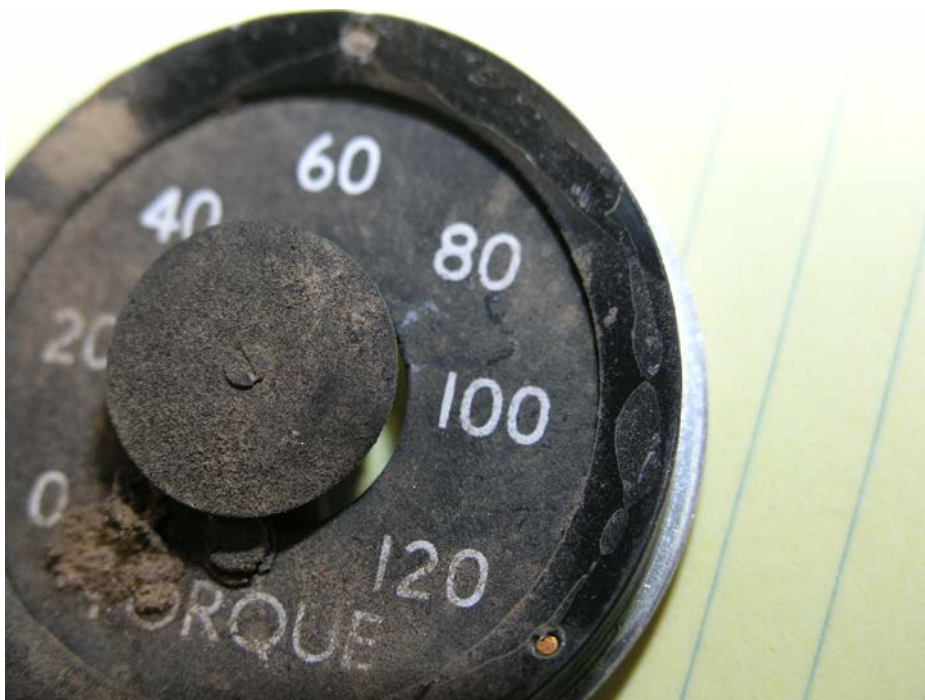
**Figure 24. Engine Cockpit TORQUE Gauge Dial.**

The engine TORQUE cockpit gauge dial had a witness mark just past 80% and a second witness mark just prior to 100% (Figure 24). The RPM cockpit gauge dial had a witness mark just past 100% (Figure 25).
