NTSB Identification: ERA14FA045
14 CFR Non-US, Non-Commercial
Accident occurred November 19, 2013 in Ft Lauderdale, FL
Aircraft: Learjet 35, registration: XA-USD
Injuries: 4 Fatal

Engines: A wreckage review was performed on Wednesday, January 22, 2013 and Thursday, January 23, 2013 and Atlanta Air Recovery in Griffin, GA with oversight provided by the NTSB.

Left Engine:

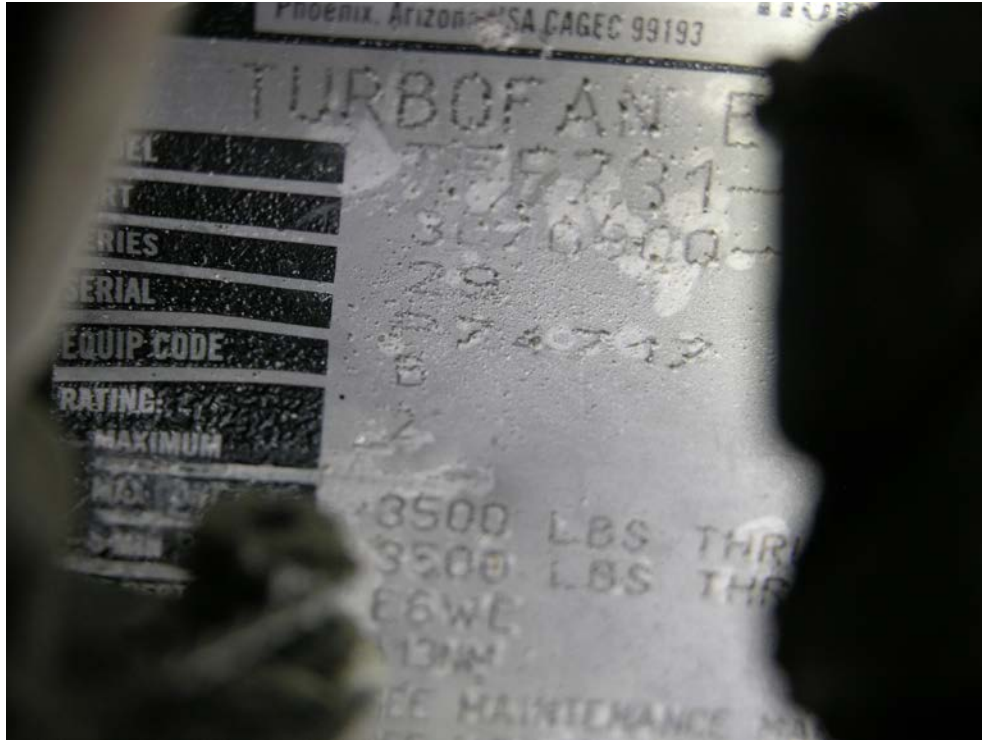
Figure 1. Left Engine, P-74717, Dataplate

- The dataplate identified the engine as follows: (Figure 1)
 - Model Number: TFE731-2
 - Part Number: 3070300-9
 - Serial Number P-74717
- The aircraft engine mounting structure remained with the engine, enabling the team to identify the side of the aircraft to which the engine was physically installed.

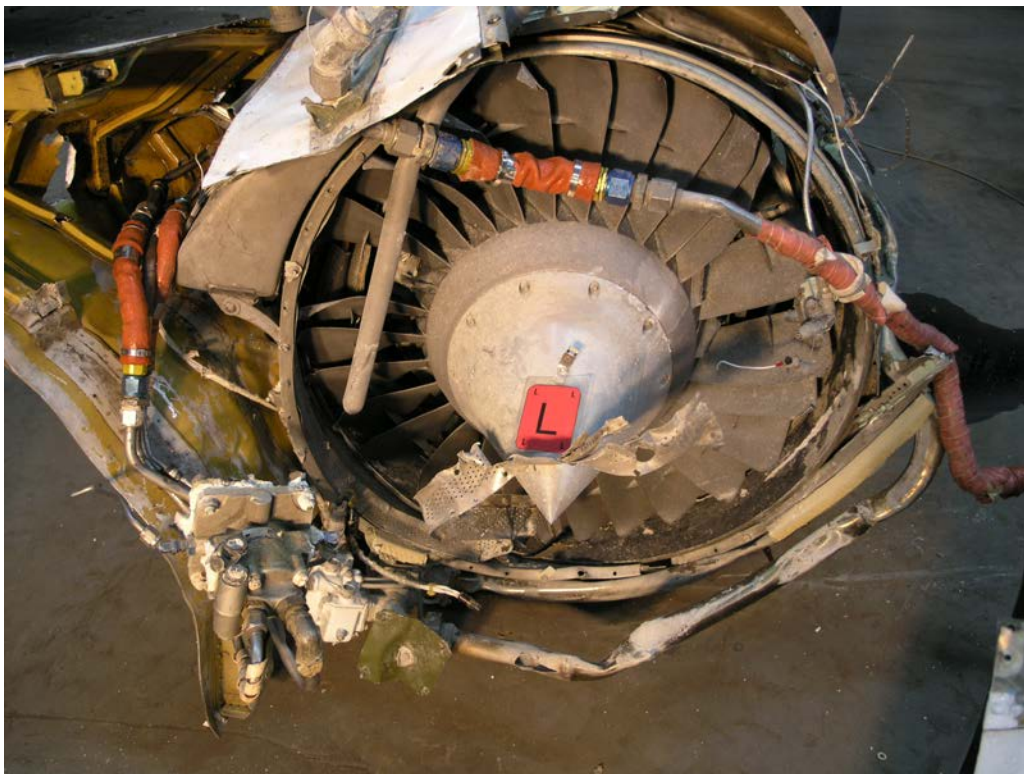
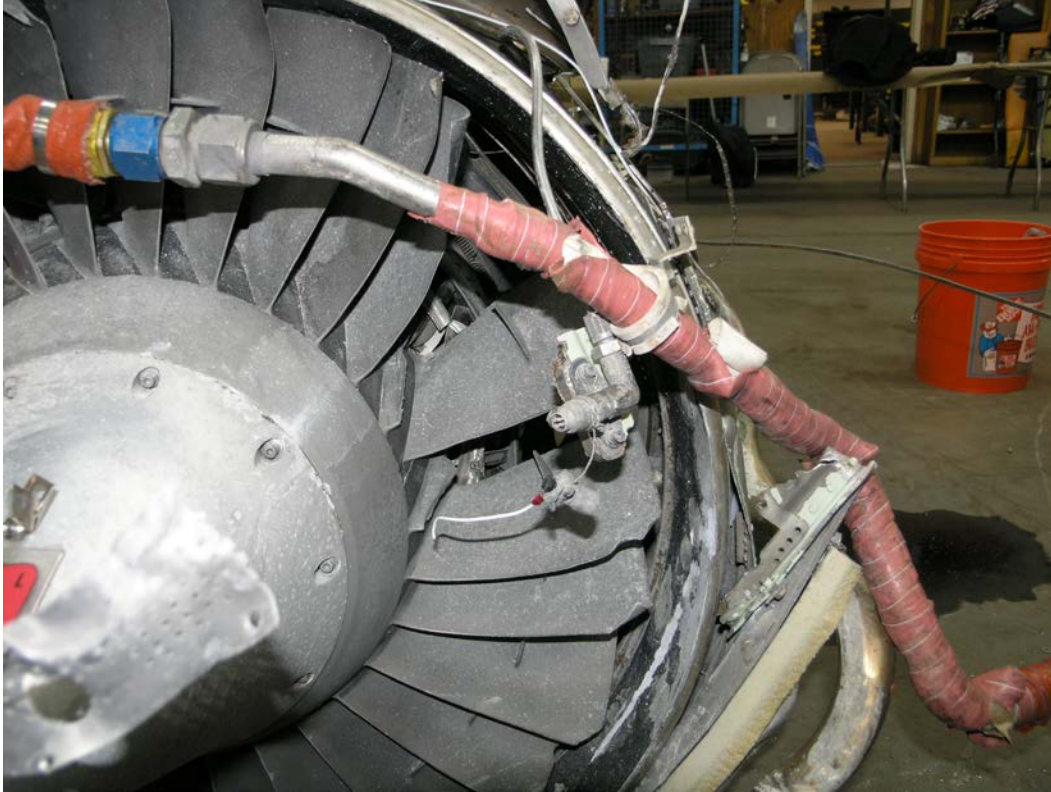
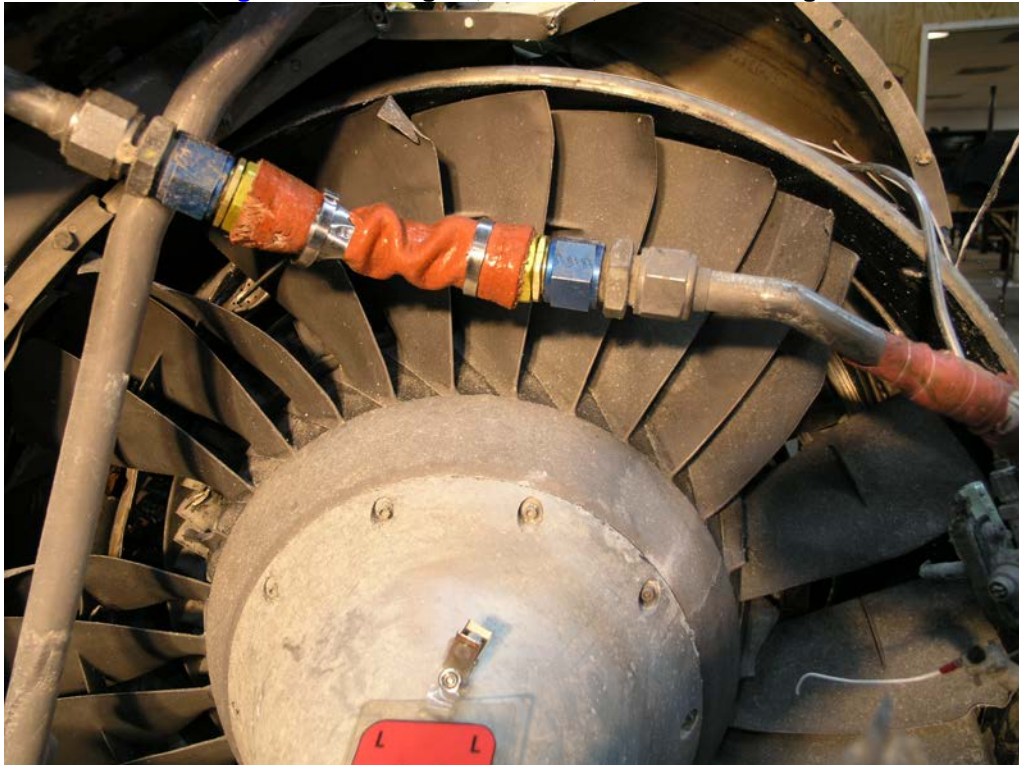
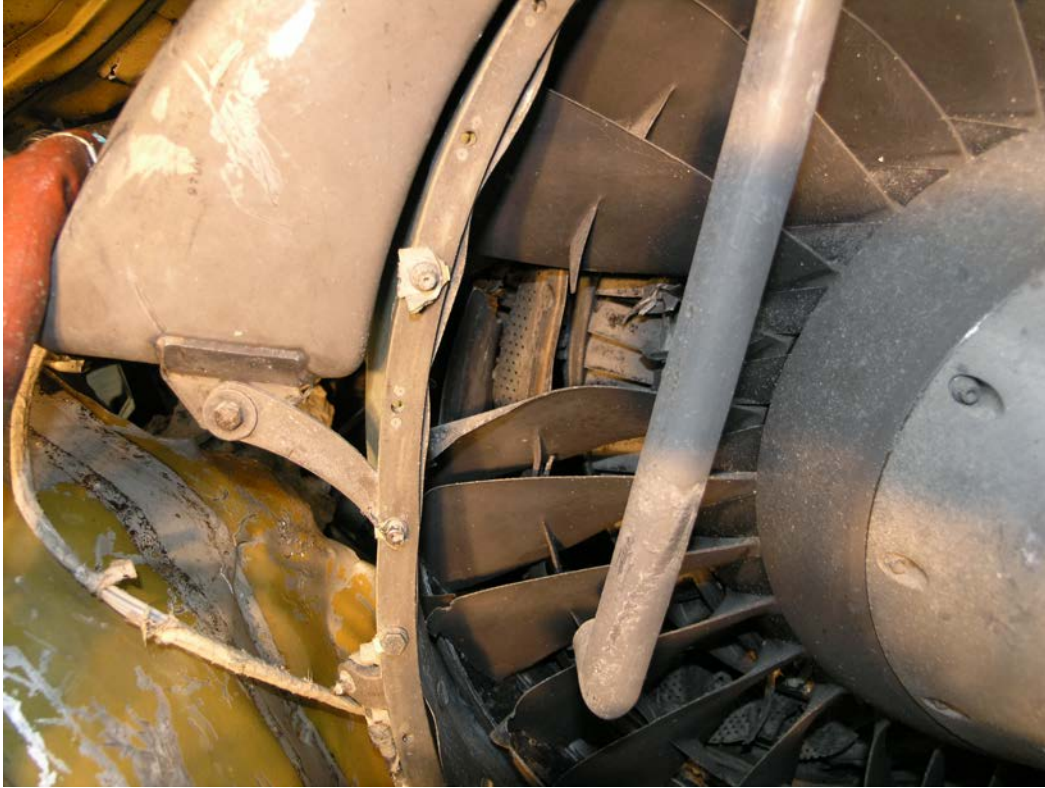
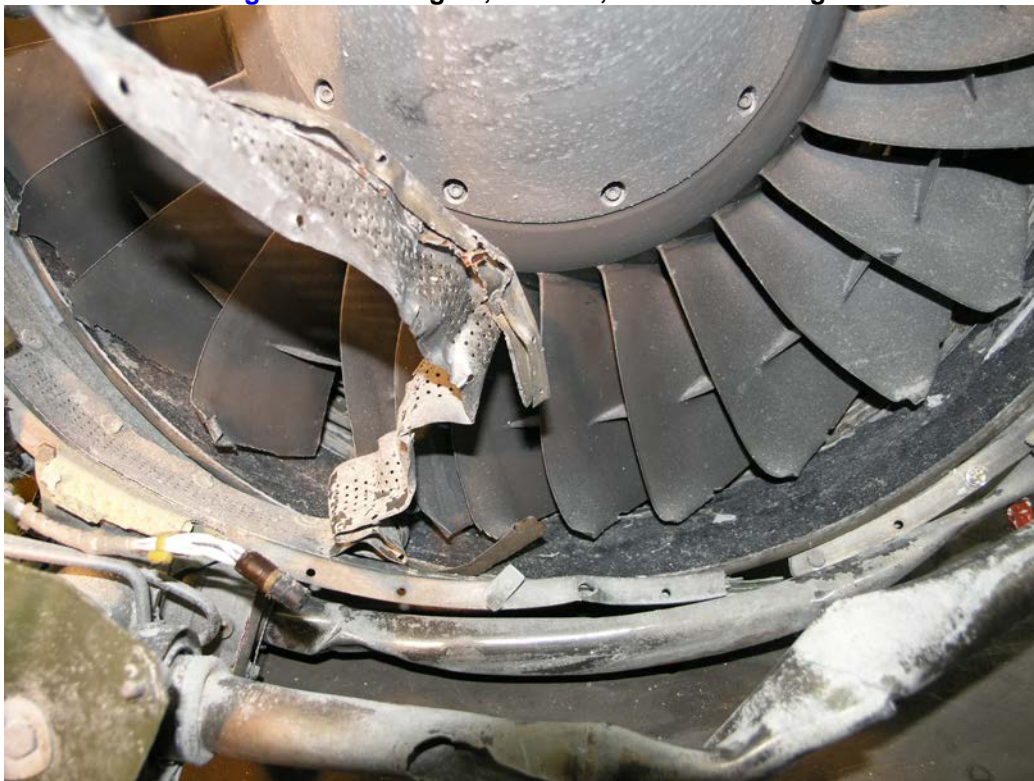
- The engine mounts were intact.
- The engine displayed crushing all around the outside of the engine and the associated engine nacelle.
- Three main fan blades were separated from the fan assembly just above the platform and were located just aft of the main fan. (Figure 2 through Figure 6)

- All of the main fan blades displayed soft bending opposite the direction of rotation. (Figure 2 through Figure 6)
- All of the main fan blades displayed leading edge damage typically associated with hard body impact damage. (Figure 2 through Figure 6)

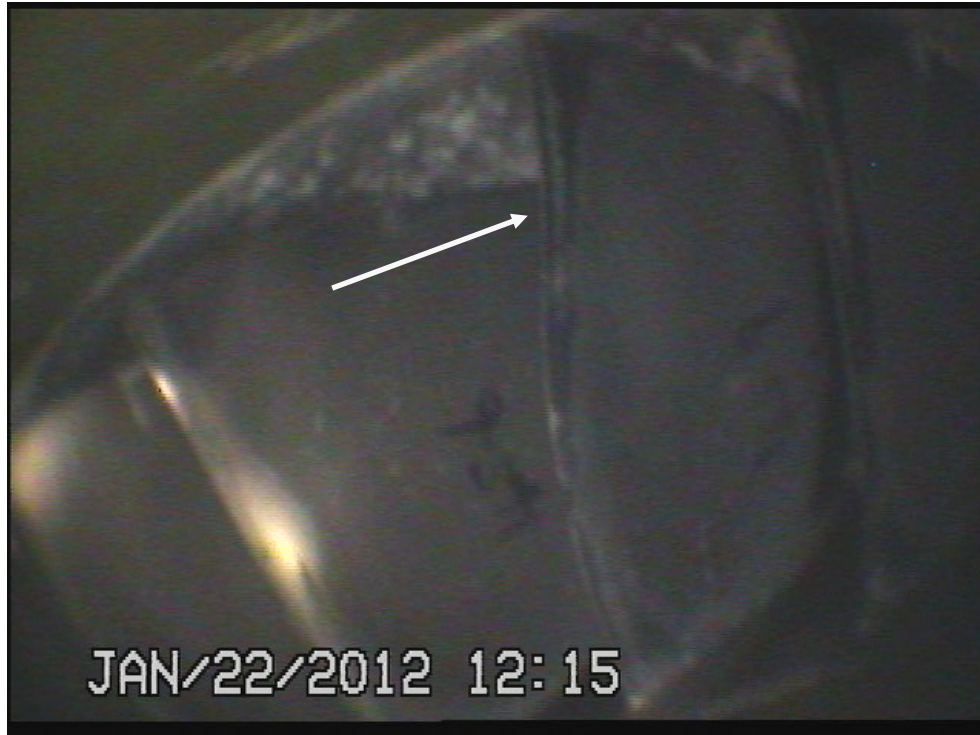
Figure 7. Left Engine, P-74717, 1st Stage LP Axial Compressor

- With the use of a boroscope, the following engine observations were made:
 - Soft bending, opposite the direction of rotation, was noted on the 1st stage low pressure compressor blades. (Figure 7)

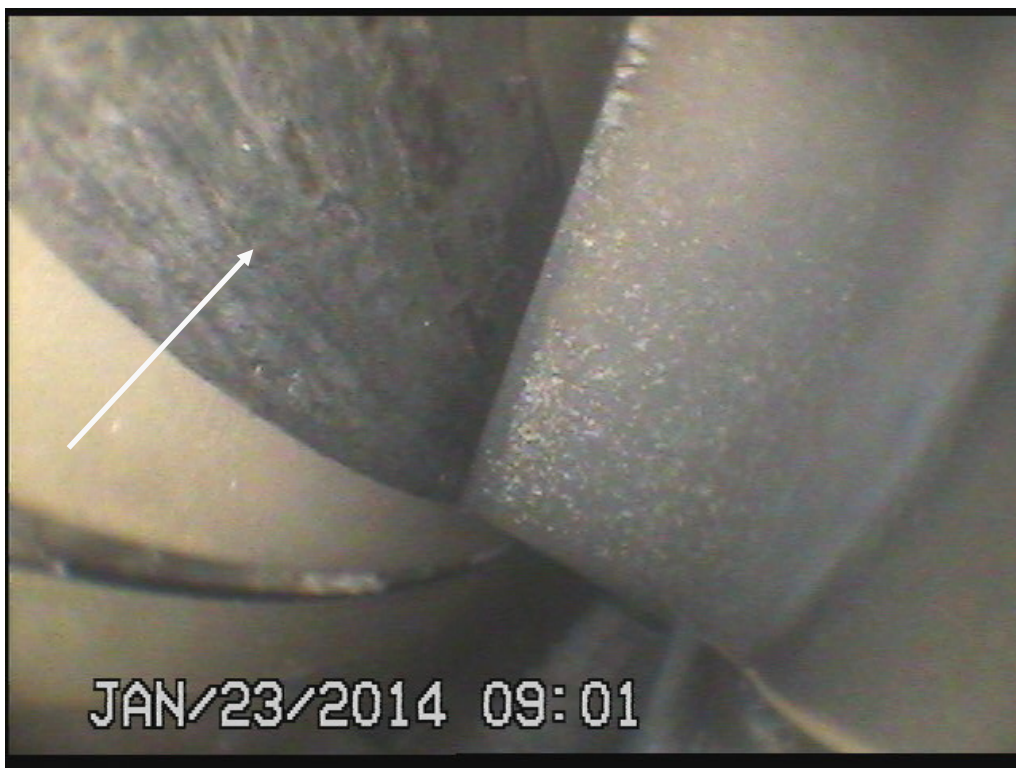
Figure 8. Left Engine, P-74717, High Pressure Impeller Rotational Scoring

- The high pressure impeller displayed evidence of corrosion but otherwise appeared to be undamaged.
 - The high pressure impeller and corresponding shroud displayed signs of rotational scoring. (Figure 8)

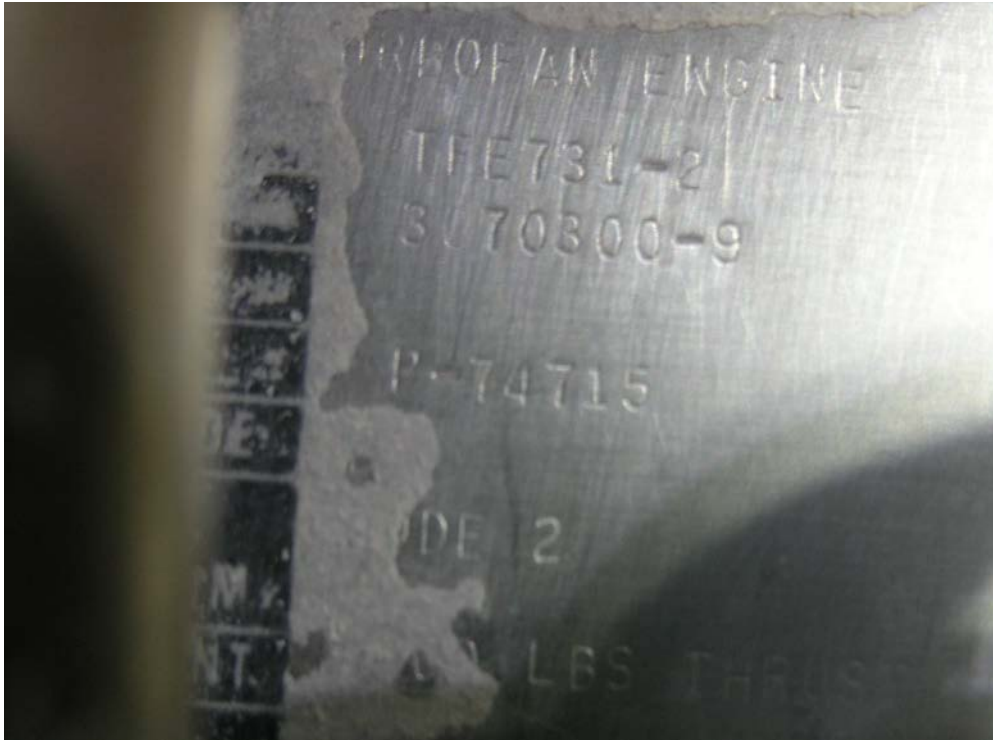
Figure 9. Right Engine, P-74715, Dataplate

- The dataplate identified the engine as follows: (Figure 9)
 - Model Number: TFE731-2
 - Part Number: 3070300-9
 - Serial Number P-74715
- The aircraft engine mounting structure remained with the engine, enabling the team to identify the side of the aircraft on which the engine was physically installed.

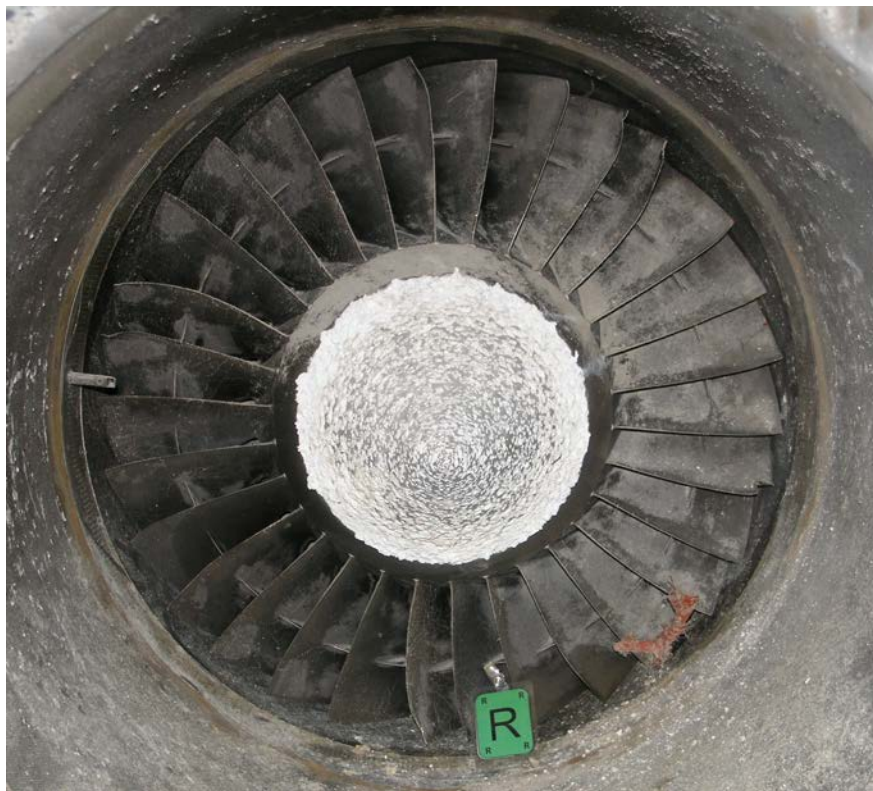
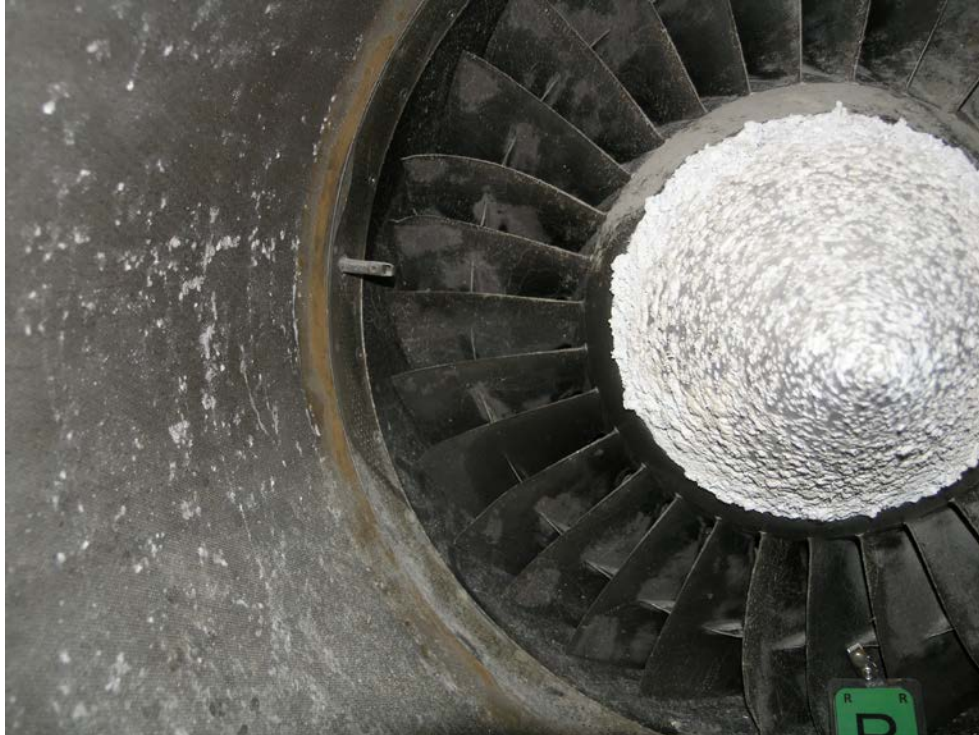
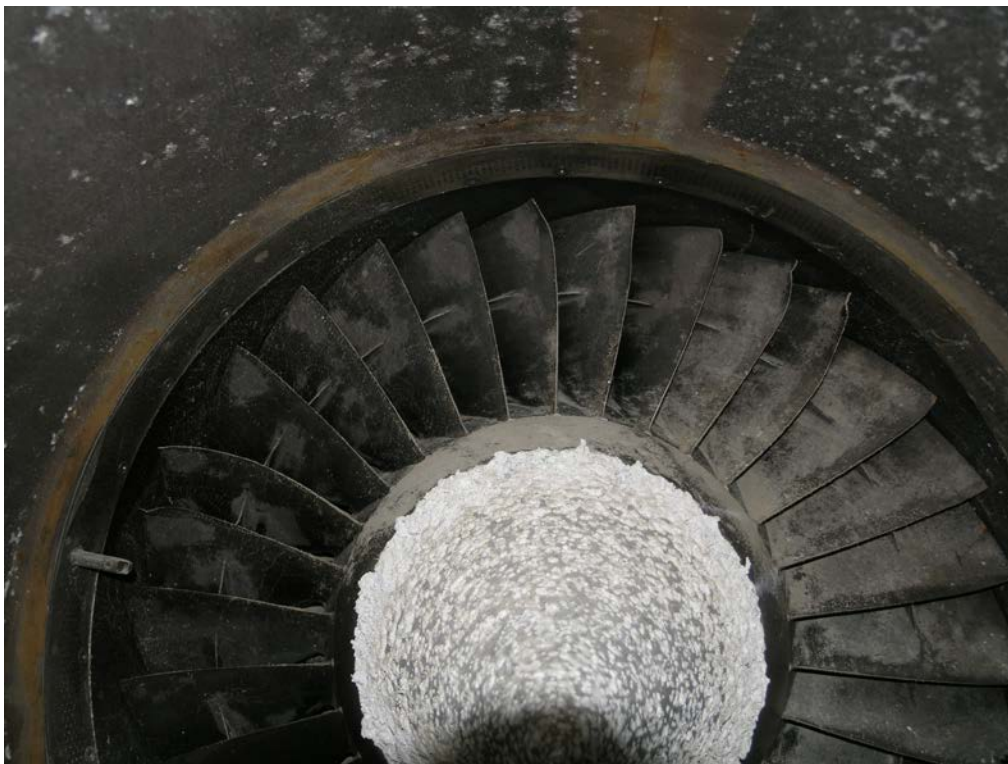
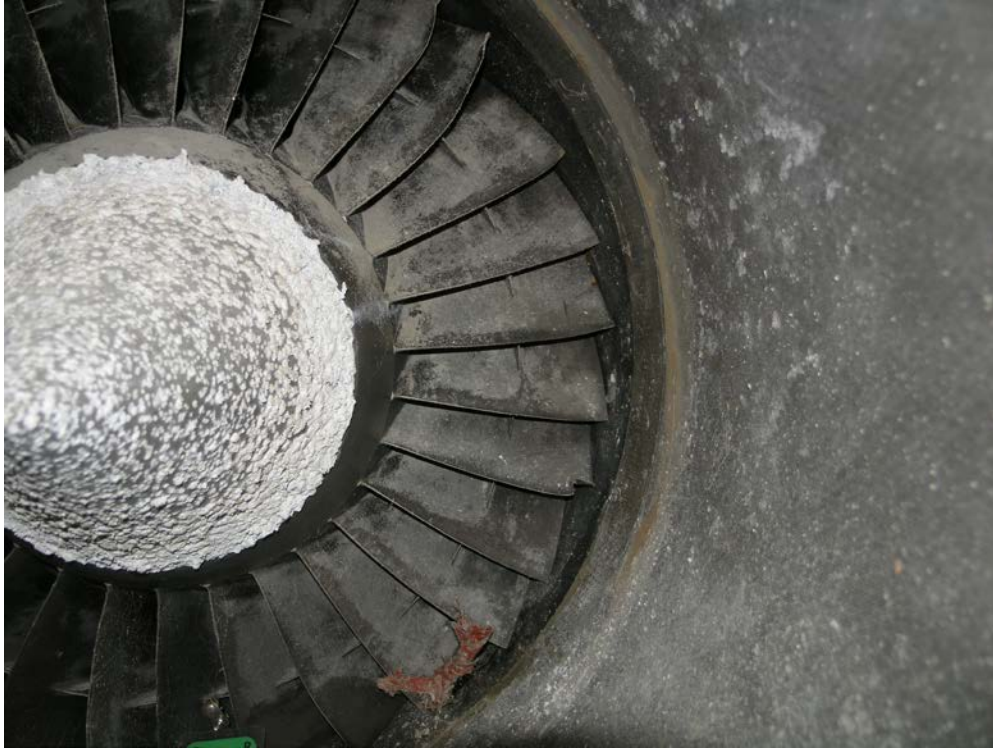
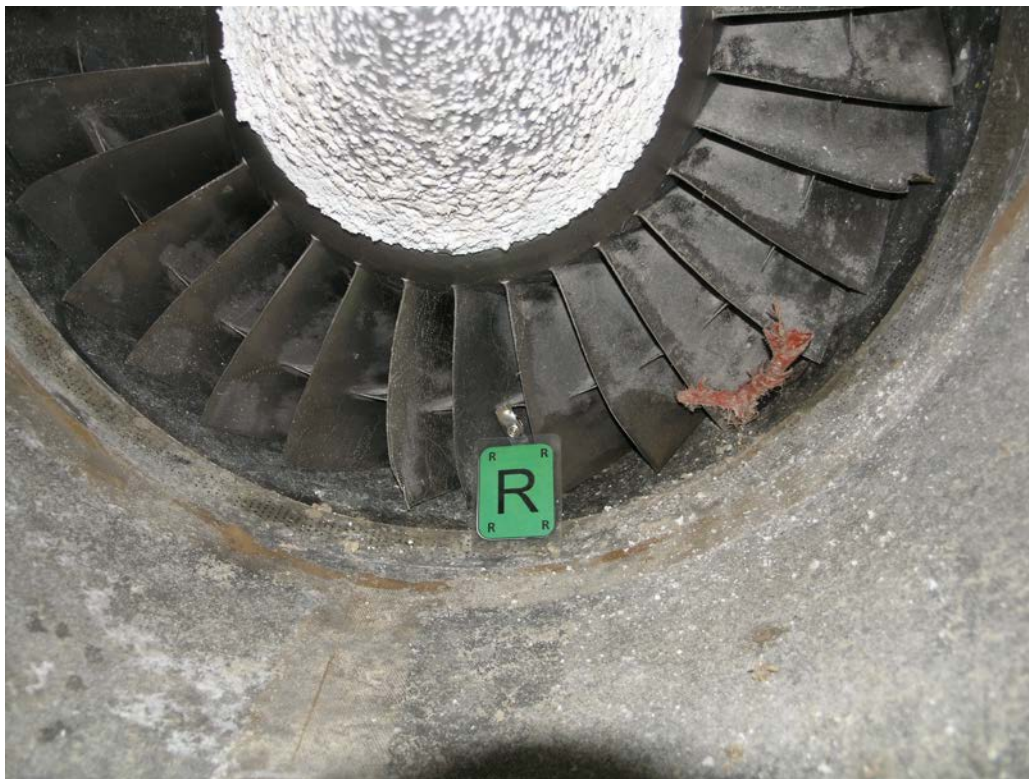
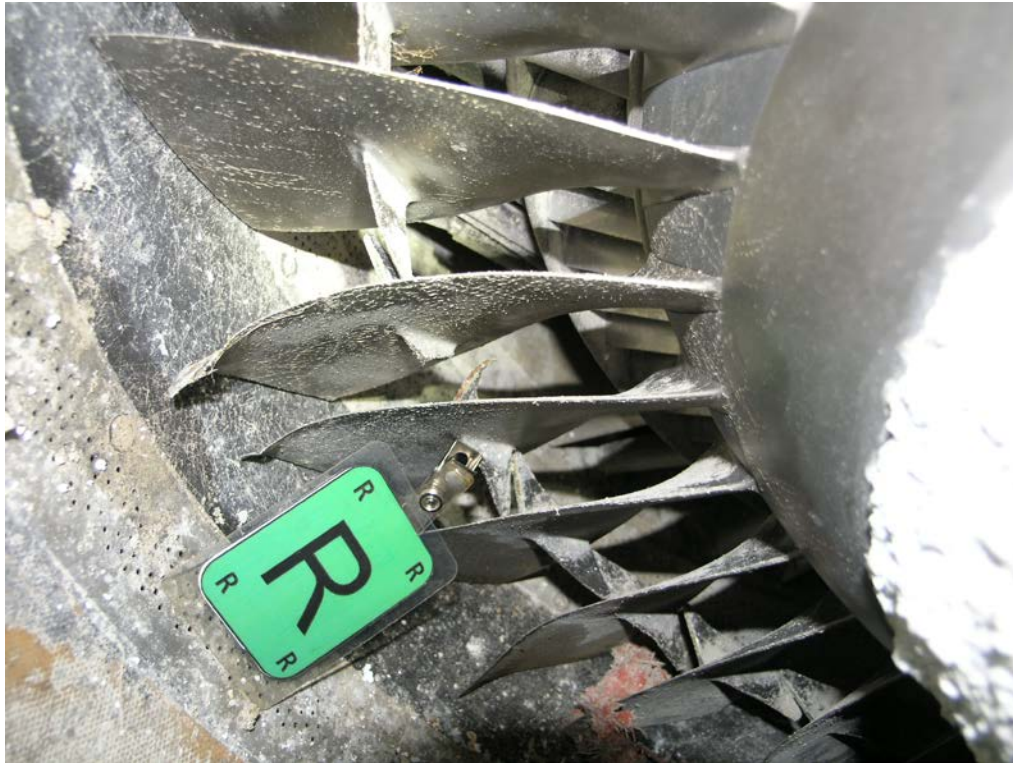
- The engine mounts were intact.
- All of the main fan blades displayed soft bending opposite the direction of rotation. (Figure 10 through Figure 15)
- Several main fan blades displayed leading edge damage typically associated with hard body impact damage. (Figure 10 through Figure 15)

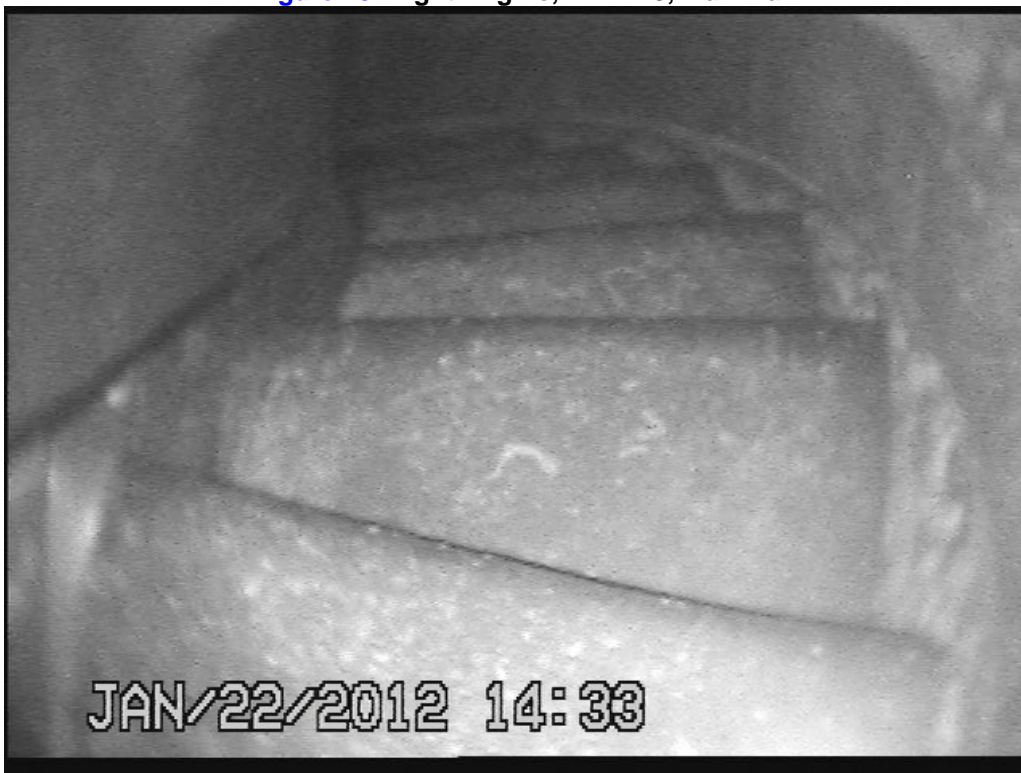
Figure 16. Right Engine, P-74715, First Stage Low Pressure Axial Compressor

- Corrosion was noted on the internal components of the engine. (Figure 16)
- The engine bleed lines were crushed at the 1 o’clock position (FLA).
- There was extensive corrosion noted to the spinner.

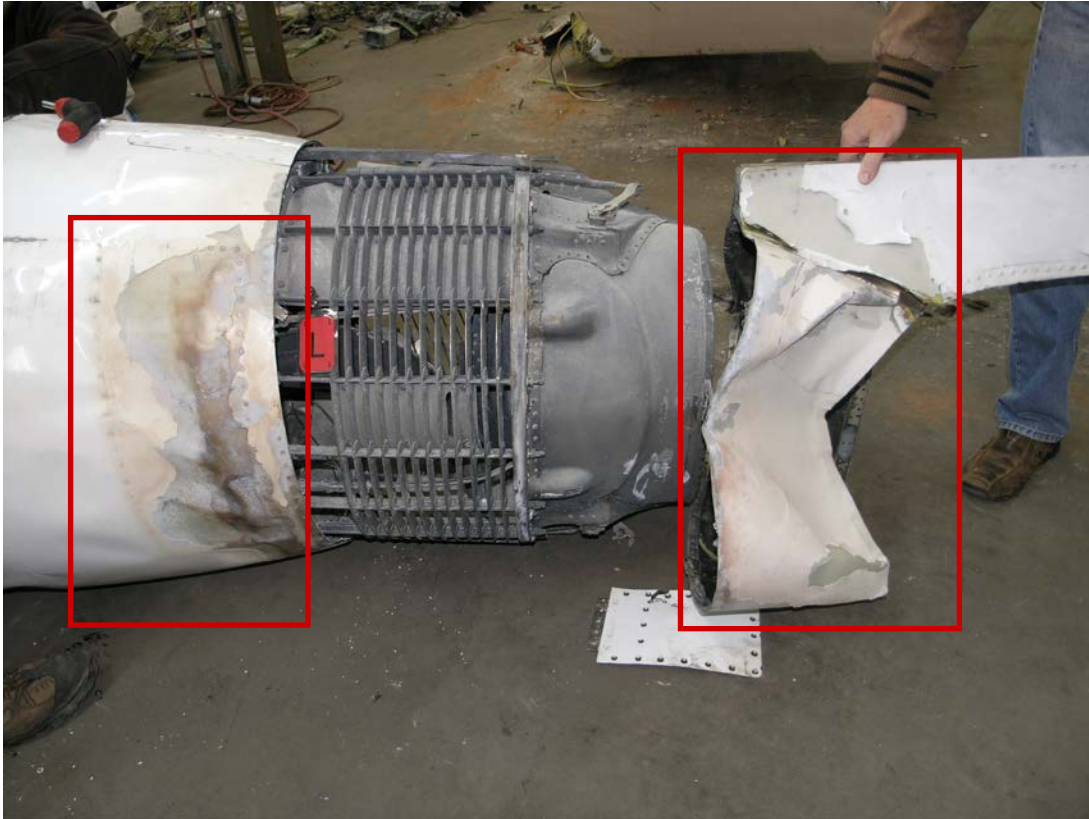
- The thrust reverser annunciator panel was located within the wreckage.
- The left engine thrust reverser was in the deployed position.
- The left engine nacelle surfaces just forward and aft of the thrust reverser cascades displayed discoloration due to heat exposure, blistering of paint, and missing paint. ([Figure 17](#))
- The right engine thrust reverser was in the stowed and latched position.
- The throttle levers were found in the full forward position.
- The throttle quadrant housing displayed edge damage to the throttle quadrant housing forward of the throttle levers.

Figure 17. Left Engine Heat Distress on Nacelle and Thrust Reverser Tail
