**Teardown & Testing Report  
Of One Model DP-F2  
Part Number 3244896-9  
Serial Number C68008**

This report presents the findings of functional testing and teardown inspection conducted on one Model DP-F2 Main Fuel Control Part Number 3244896-9 Serial Number C68008 at the Honeywell Engines Systems and Services Facility in Montreal, Canada on August 31, 2005.

The testing/teardown was conducted at the request of, and under the cognizance of National Transportation Safety Board (NTSB).

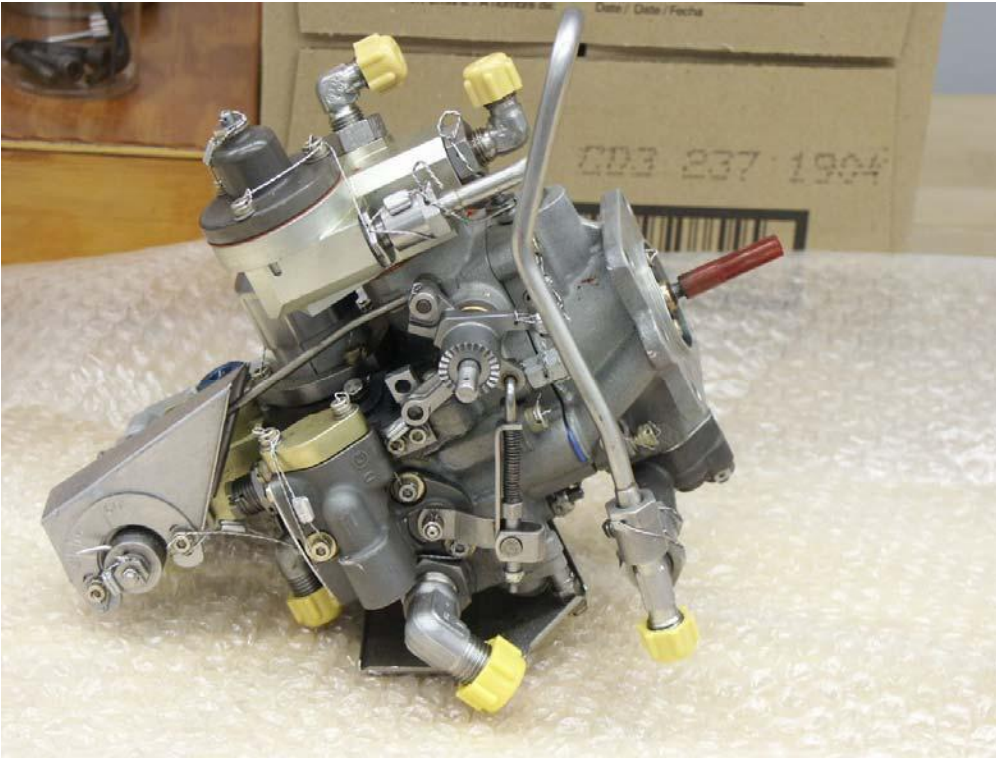
**Figure 1 as received**

- (a) The MFC was received in a plastic bag wrapped in bubble wrap. The plastic shipping base was absent. The drive coupling (not supplied by Honeywell) was attached to the driveshaft of the MFC. The manual override shield was deformed and the manual override pointer was bent by more than 45 degrees in an upward direction. Movement of the throttle was stiff due to the damage to the manual override shield. The exterior of the MFC was generally clean, however significant blue grease staining was observed at the outer drive shaft bearing.

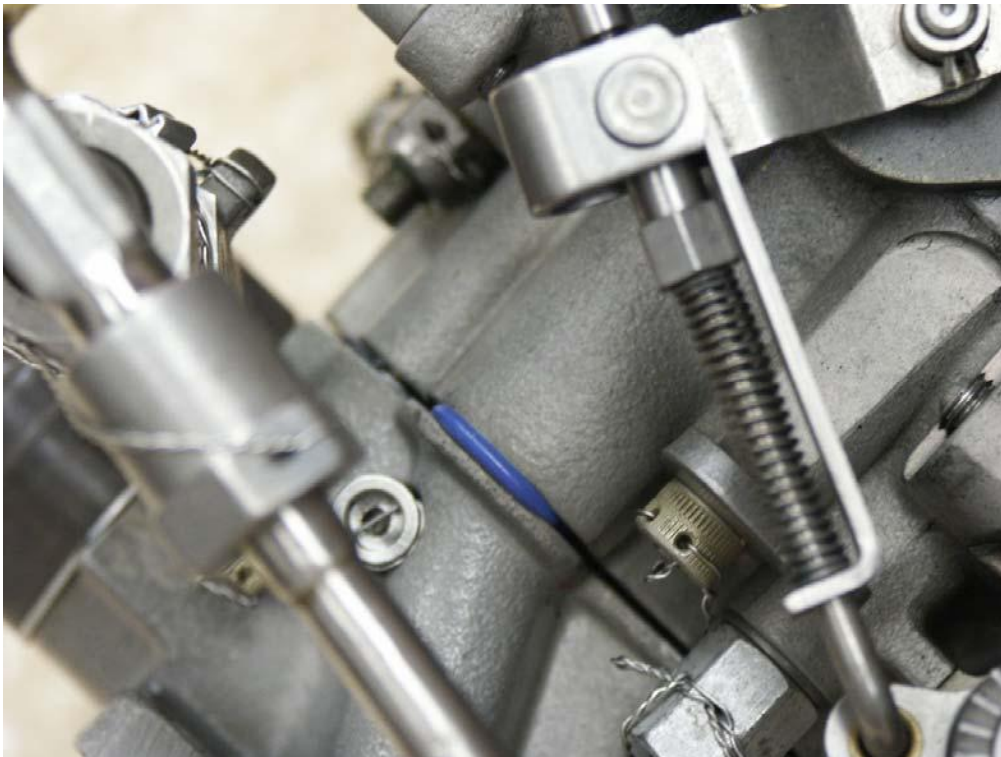
- (c) The drive body was partially separated from the flow body with a gap between the bodies measuring 0.033" close to the Px/Py face seal o-rings. Opposite this location, on the bellows side, the bodies appeared to be in contact. The drive body mounting screw closest to the P0 face seal o-ring was loose (no torque). The screw was free to move in an axial direction and was retained from falling out of the MFC only by the lockwire still attached. Approximately 1.5 threads were visible between the screw head and the washer.

- (e) Due to the body separation, functional testing of the MFC in an as-received condition was not possible. Lack of sealing at the P0 face seal o-ring would have resulted in an external fuel leak from the P0 return circuit and contamination of the pneumatic circuit. Lack of sealing at the Px and Py face seal o-rings would have resulted in the inability to schedule fuel flow higher than min flow

- d) The partially extruded P0 face seal o-ring produced a leak allowing fuel to contaminate the governor cavity as well as the Px and Py channels in the drive body. The heavy ribbon of diluted blue grease found within the governor cavity indicates that fuel contaminated the governor section while the MFC was in operation. However, as the test as received was conducted prior to the disassembly, it cannot be determined whether the ribbon of blue grease was a pre-existing condition or was produced as a result of the test.

**Figure 6 separation of bodies and extrusion of P0 o-ring**

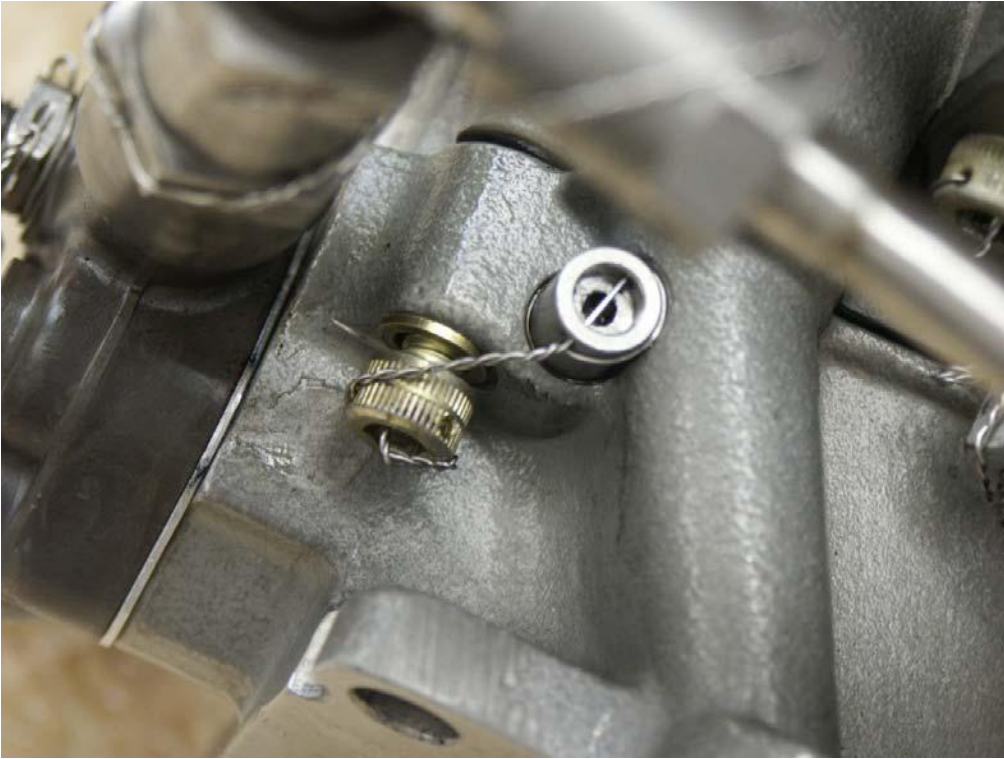
- (g) The torque on the remaining three screws was measured. The two screws adjacent to the one mentioned in (f) were found snug but with no measurable torque. They were also confirmed to be the correct P/N 953504-157. The screw opposite to that mentioned in (f) was found to have the correct amount of torque applied, but was determined to be P/N 953504-159. Therefore, during the previous shop visit the assembly of the MFC had interchanged P/N 953504-159 for P/N 953504-157.  
A subsequent tolerance study demonstrated that the long screw could be properly installed and torqued in any of the three short screw locations.

**Figure 7 mounting screw loose**

- (h) To allow for flow testing, the pulled screw was replaced and all four mounting screws were re-torqued to specifications. This re-established the proper seal between the flow body and drive body. No gap between the drive body and flow body was observed after the screws were re-torqued.

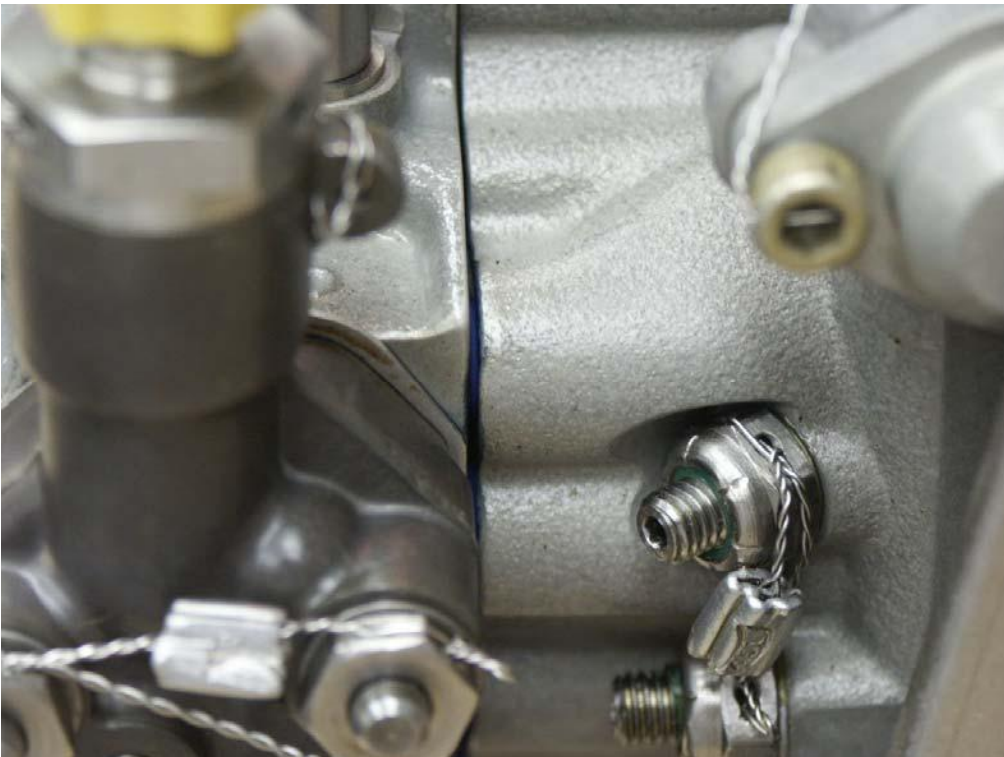
**Figure 8 separation of bodies and lack of seal at Px and Py o-rings**

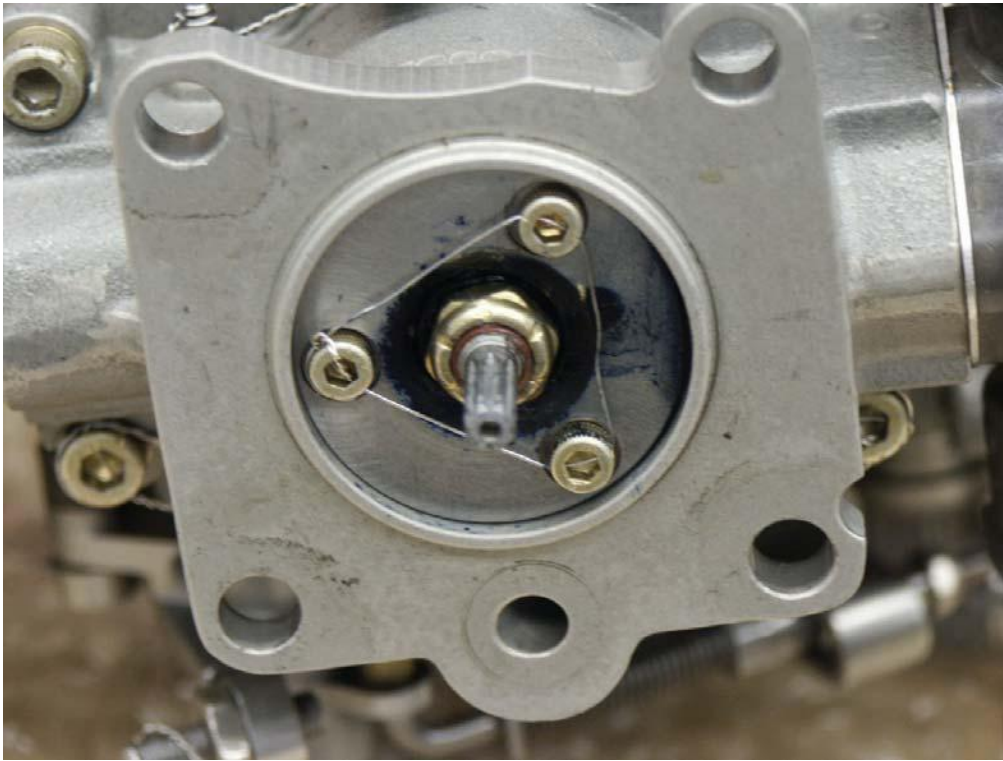
**Figure 9 drive pad blue grease dilution**

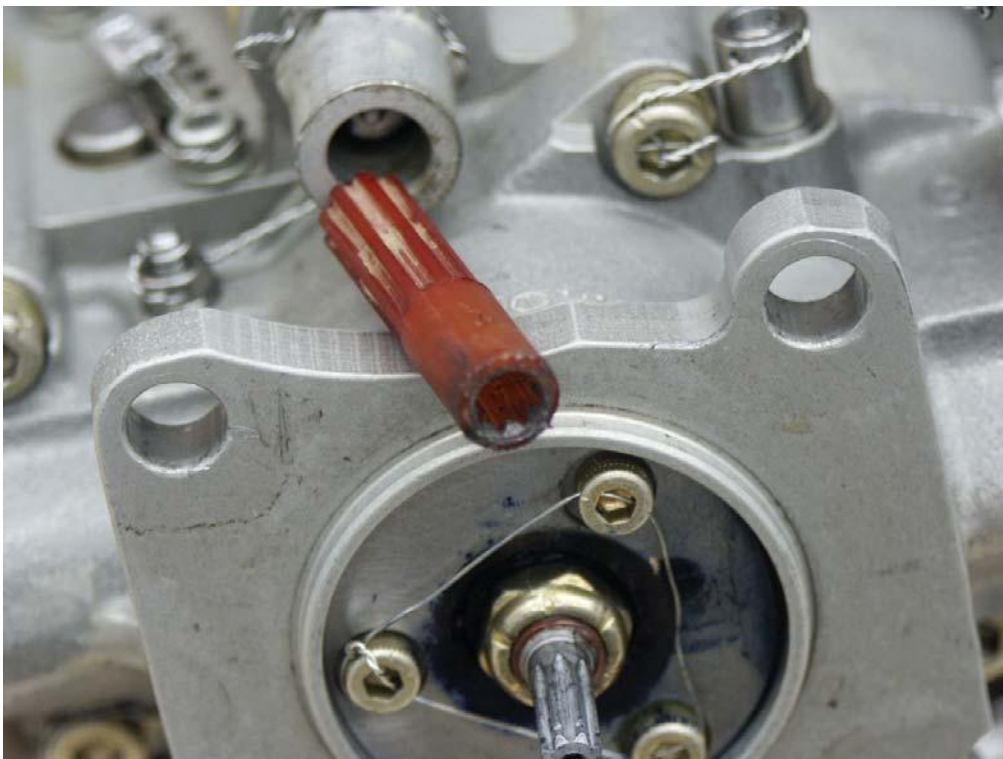
**Figure 10 drive coupling and drive pad**

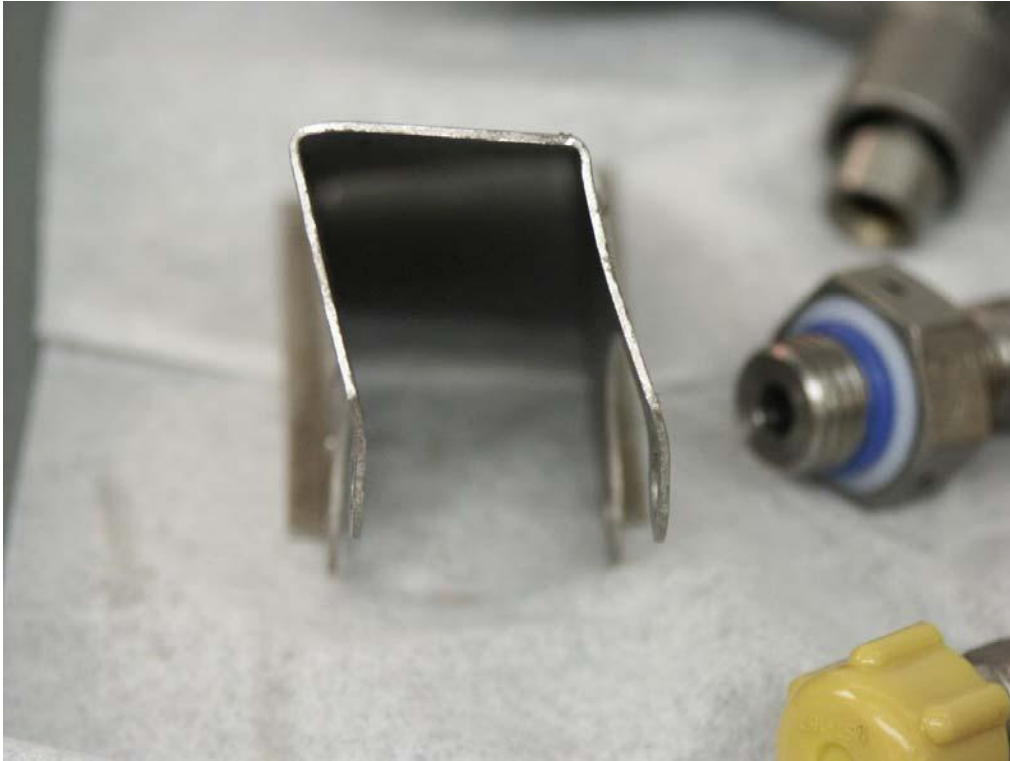
- (a) The manual override shield was removed and found generally deformed. A sharp dent on one of the edges was also observed.
- (b) The air adapter was removed and the internal cavities inspected. The gasket mating surface and all cavities were heavily fuel contaminated. The drive body mating surface was also wet with fuel and a dark blue ring was visible, following the contour of the air adapter when mounted. The dark blue ring is believed to be grease used to lubricate MFC bearings that had become diluted as a result of the fuel contamination.

- a) The exterior of the MFC suffered damage most likely as a result of a heavy impact. This was evidenced by the damage and distortion suffered by the MOR shield. Further evidence is provided by the sheared threads in the flow body (drive body mounting screw) and the drive body deformation. In addition, thread imprints are evident on the inside diameter on three of the four mounting holes in the drive body.

**Figure 11 deformation of manual override shield**

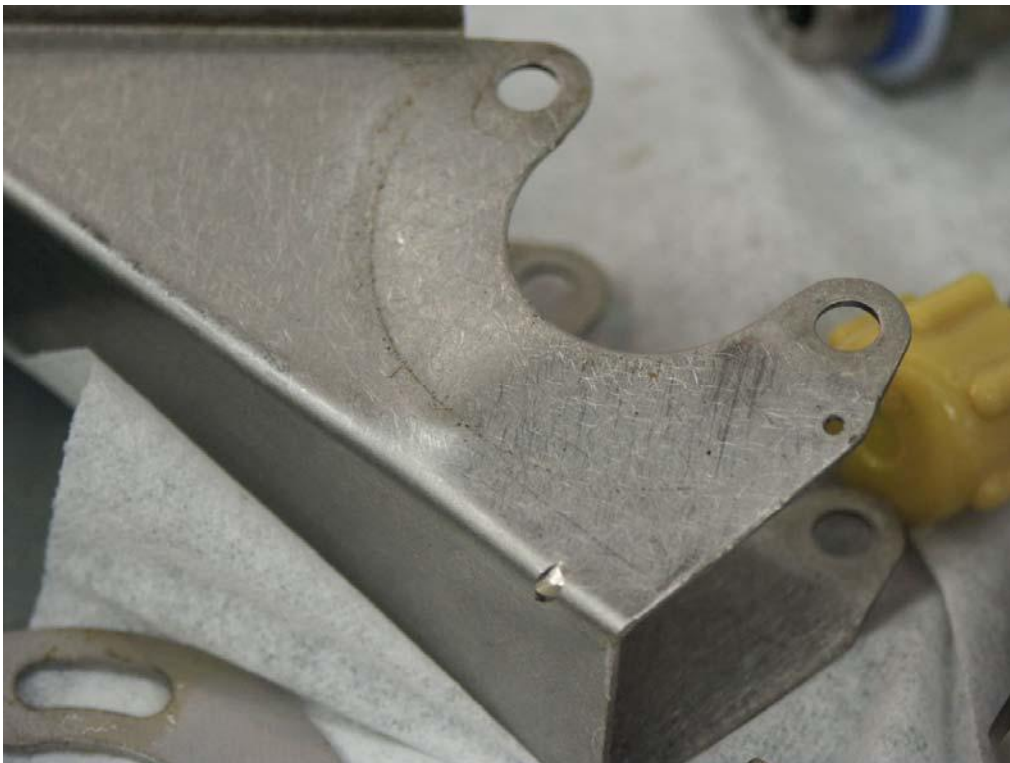
**Figure 12 deformation of shield and sharp dent**

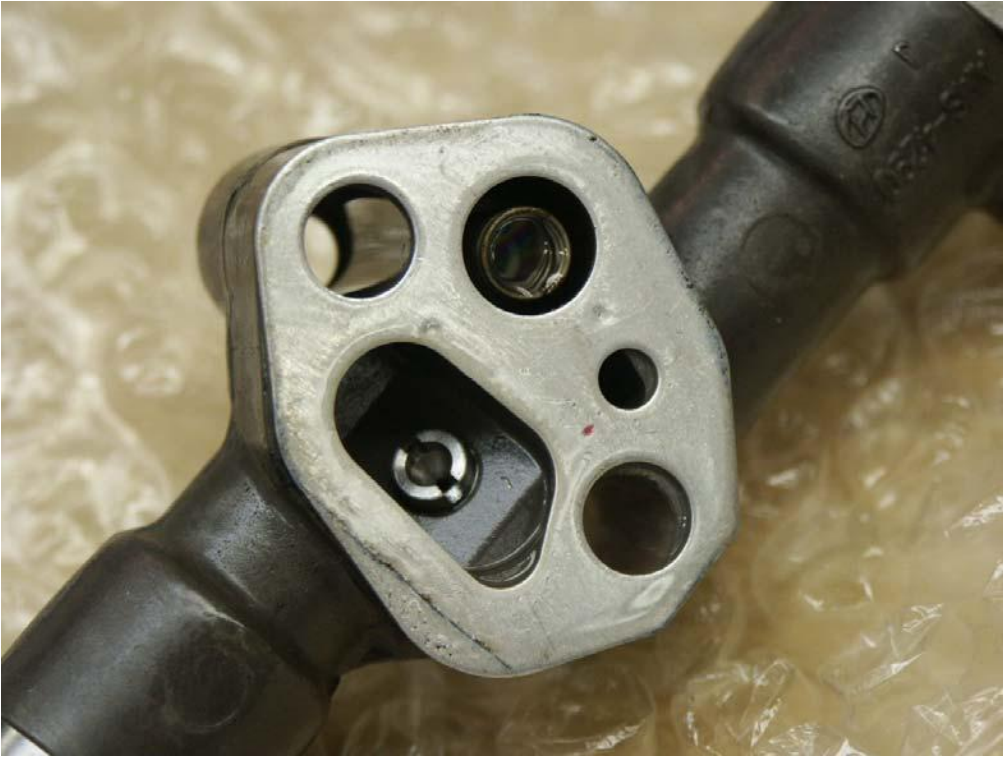
**Figure 13 air adapter cavity and gasket wet with fuel**

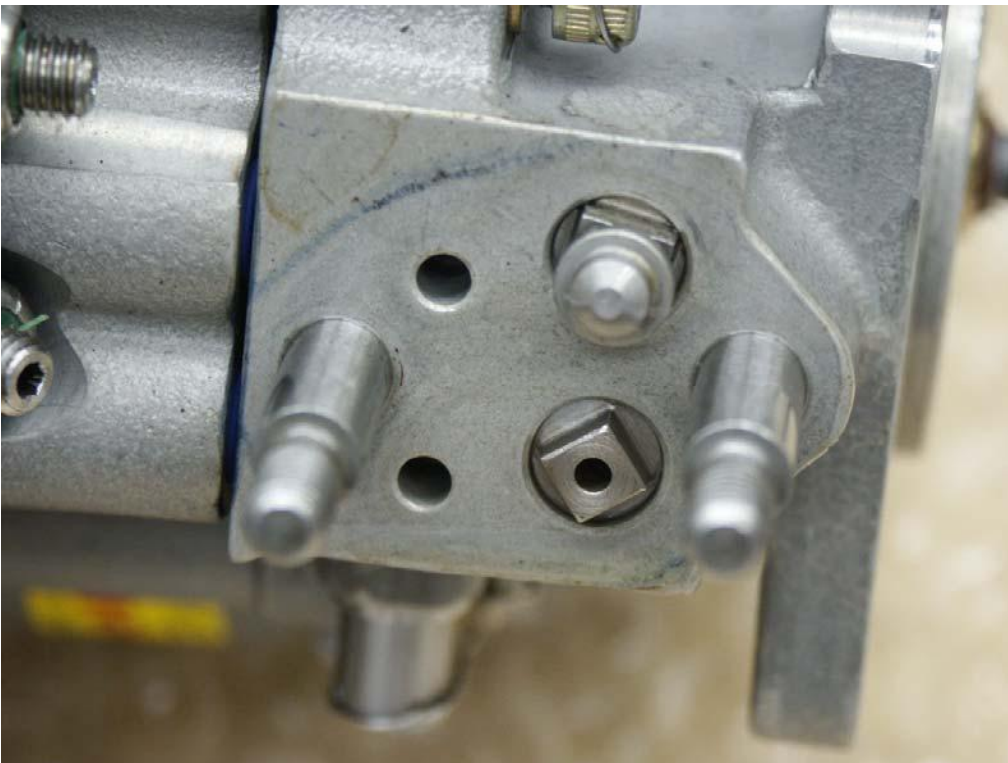
**Figure 14 drive body adapter mating surface with ring of blue grease**

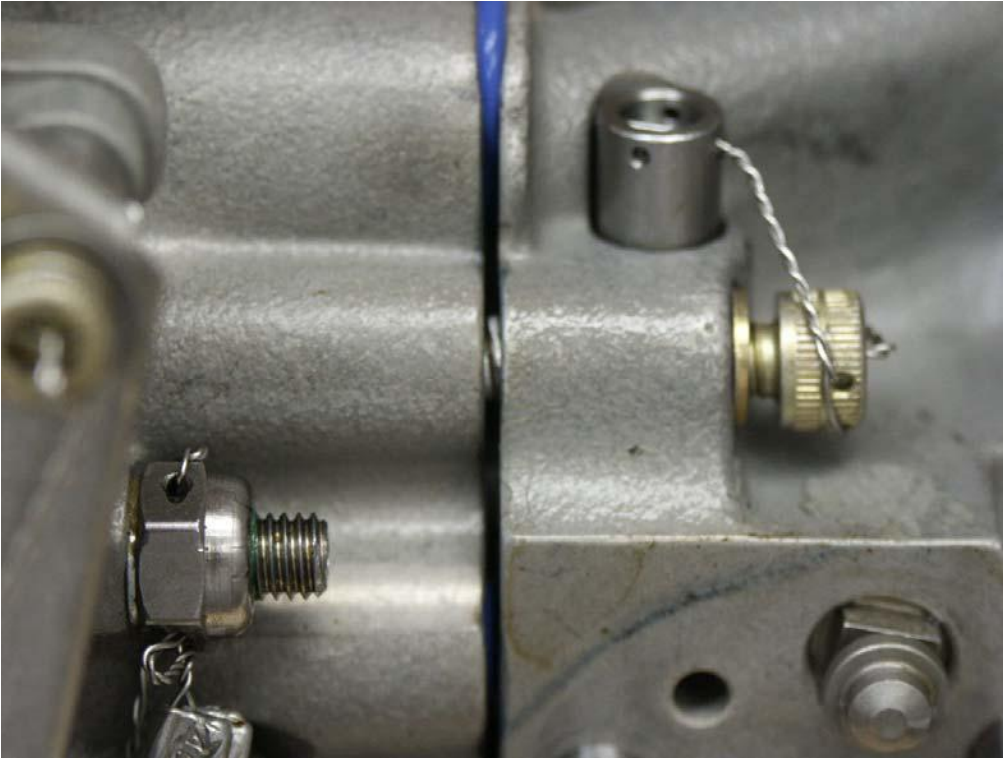
- (f) The as-received condition of the screws was established. The screw which had pulled from the body mentioned in (c) was removed for inspection. The threads in the flow body had sheared and remained attached to the removed screw. Based on the amount of pulled threads, it was determined that the thread engagement between the screw and flow body was approximately 2 and one half threads. It was also determined that the wrong screw had been installed in the position found. The required screw for this location is P/N 953504-159, with the remaining three locations shall be P/N 953504-157. Based on a length measurement, screw P/N 953504-157 was actually installed. P/N 953504-159 is 0.125" longer nominally than P/N 953504-157.

**Figure 15 extruded Po o-ring and pulled flow body threads**

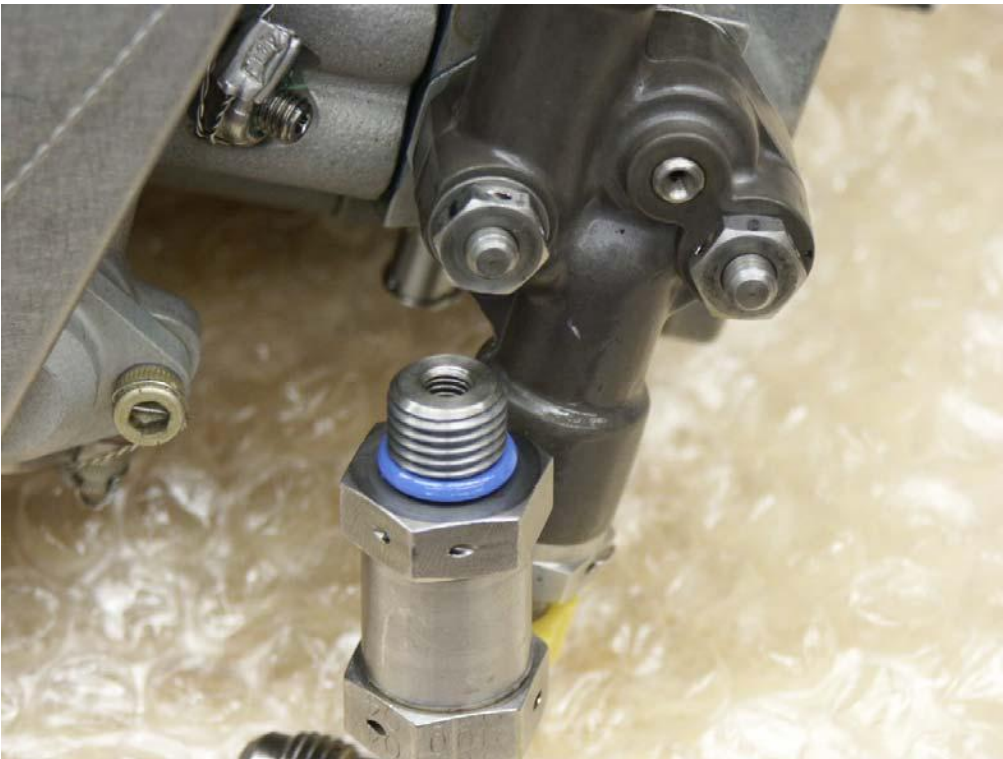
- (i) The P3 pipe was removed as part of normal practice prior to mounting the unit to the test stand. Fuel residue was observed within the pipe fitting, accompanied by a strong fuel odor. Removal of the air adapter shipping caps found the threads of the adapter wet with fuel.

**Figure 16 Pc inlet fitting wet with fuel**

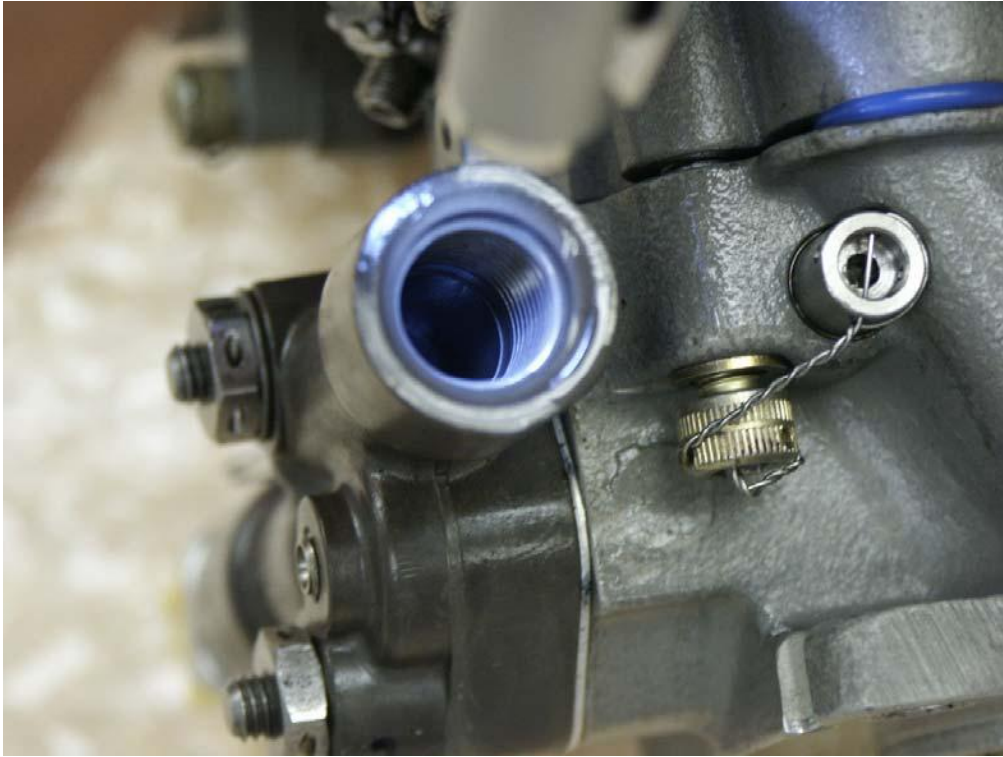
**Figure 17 air adapter Pc inlet wet with fuel**

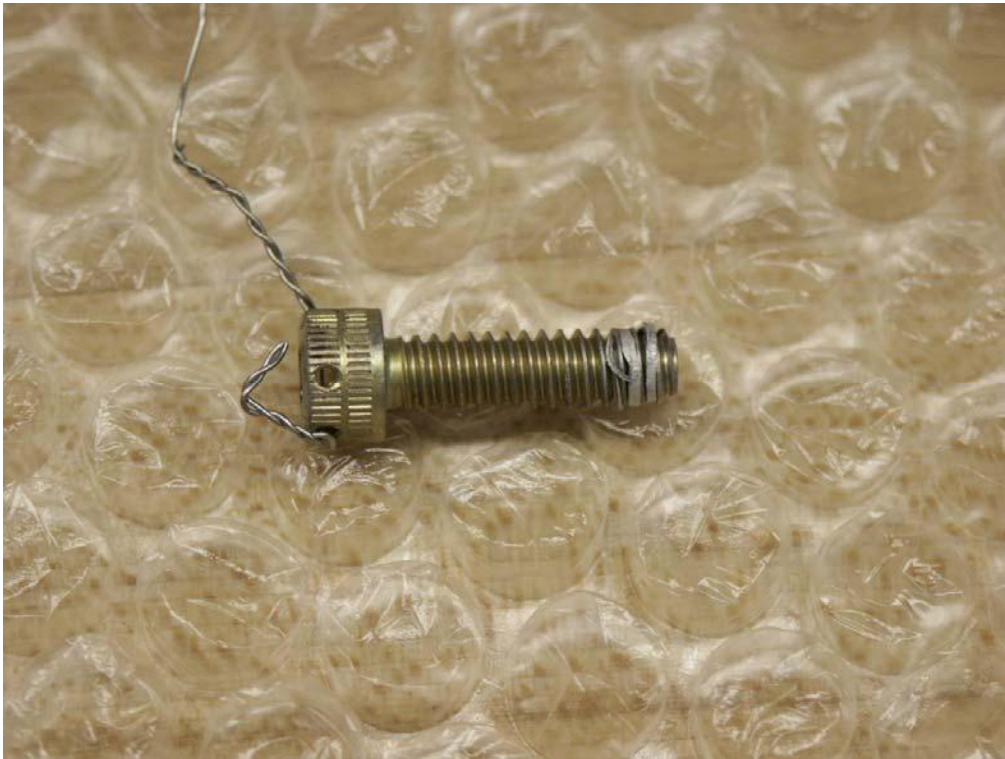
**Figure 18 pulled drive body mounting screw**

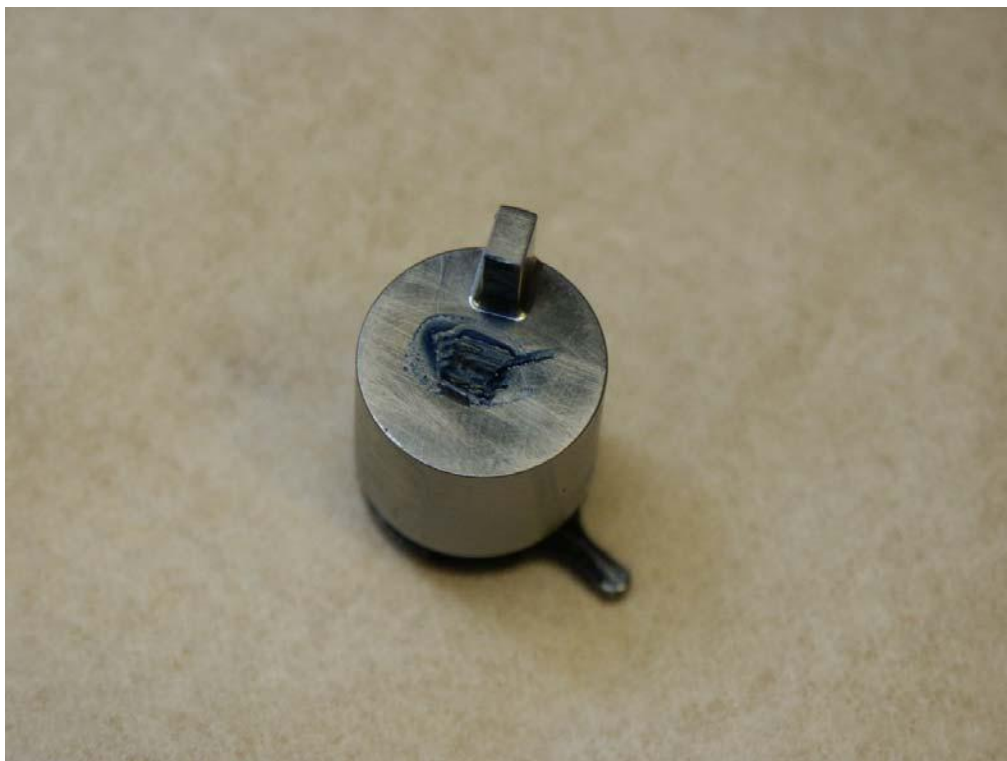
- (c) The drive body and flow body were split for examination of the governor cavity and related parts.
- (d) The spool bearing assembly was removed from the driveshaft. The top of the assembly was covered in diluted blue grease that had leaked out of the follower bearing in the enrichment lever. This was attributed to fuel entering the governor cavity and diluting the grease. This grease was observed leaking from the follower bearing.

**Figure 19 diluted blue grease on spool bearing assembly**

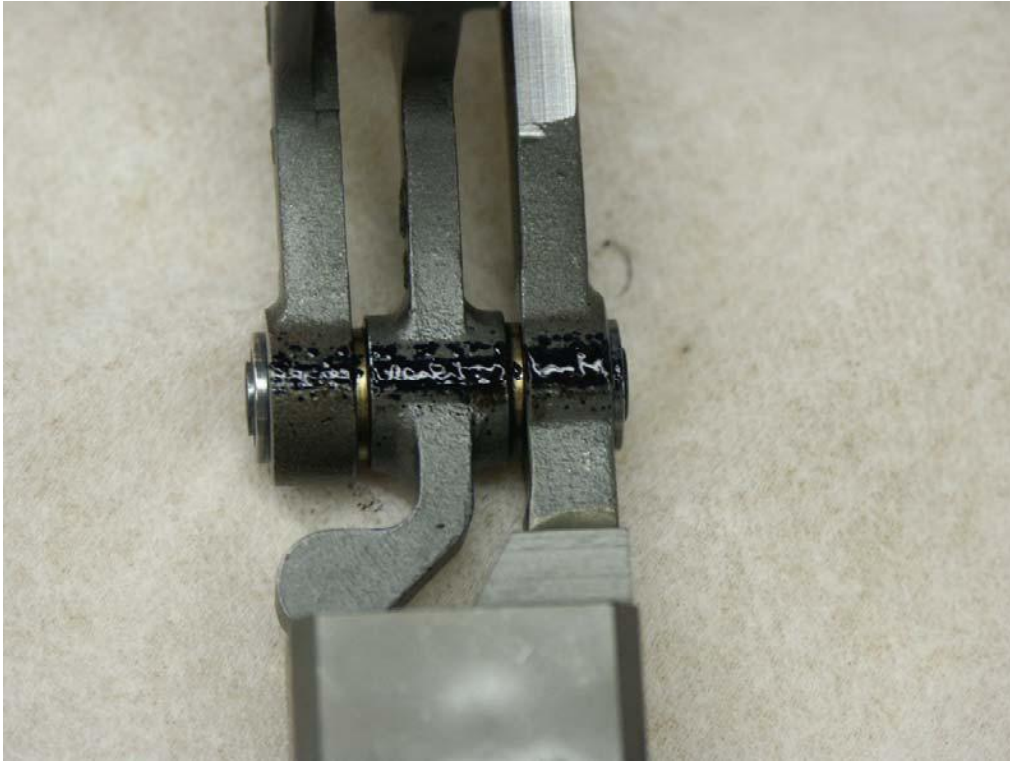
**Figure 21 lever assembly contaminated with ribbon of blue grease**

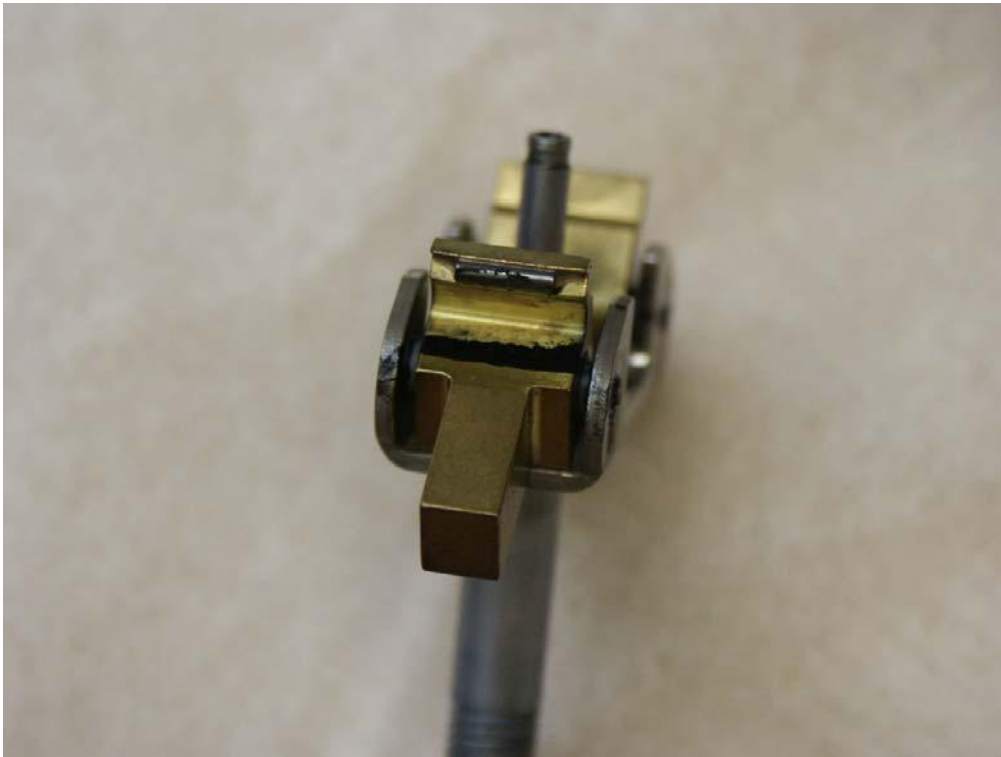
- (f) A similar ribbon of blue grease was observed on the inner wall of the drive body all the way around, as well as on the flyweights and driveshaft. The source of the blue grease is as described in (e) above.

**Figure 22 ribbon of blue grease on flyweight**

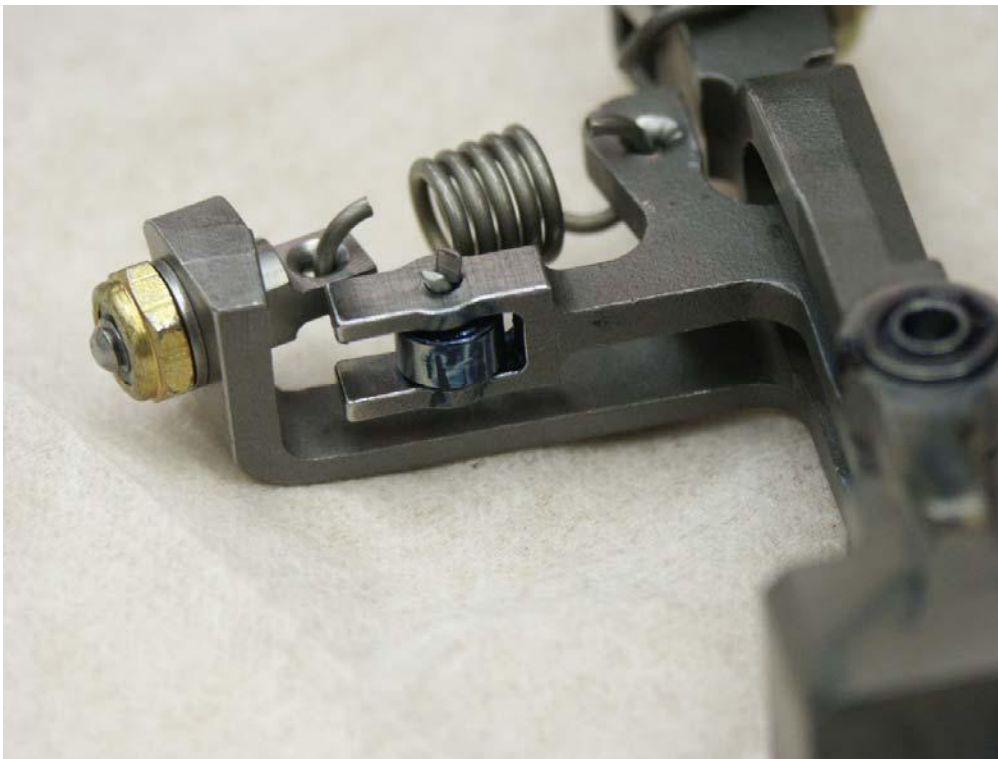
Figure 24 view of enrichment lever bearing leaking blue grease

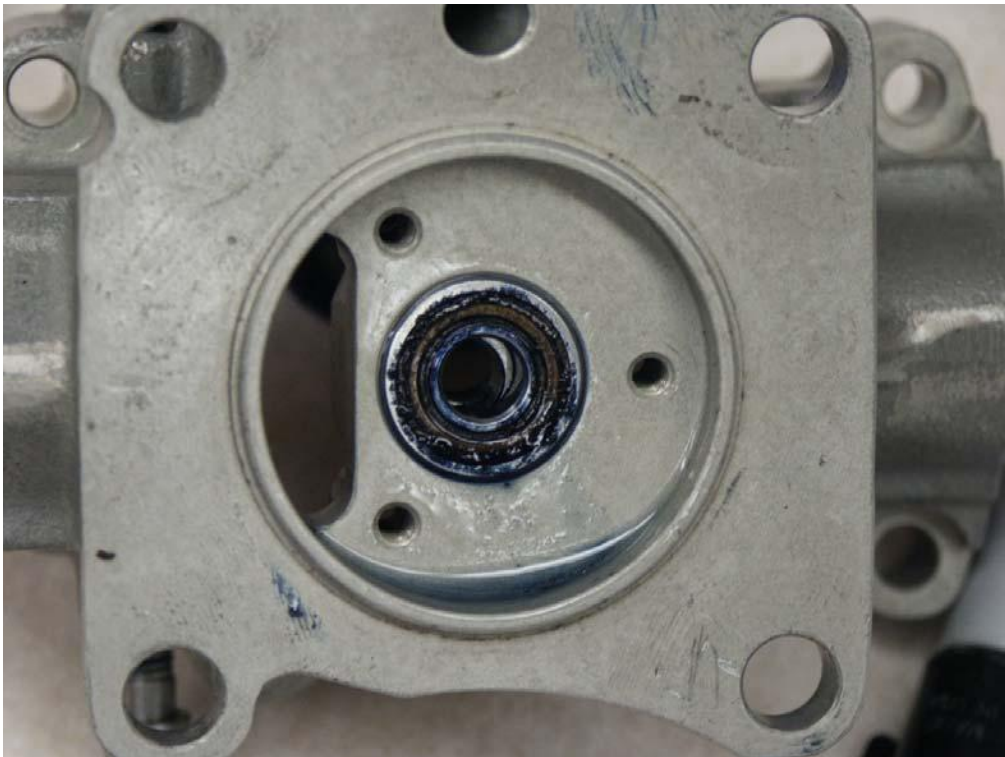
- (g) The driveshaft bearing retainer plate was removed and blue tinted fuel was found to pool within the recess of the drive body. The driveshaft bearings were covered in diluted blue grease that had leaked out as a result of the fuel contamination.

**Figure 26 fuel found underneath drive bearing retaining plate**

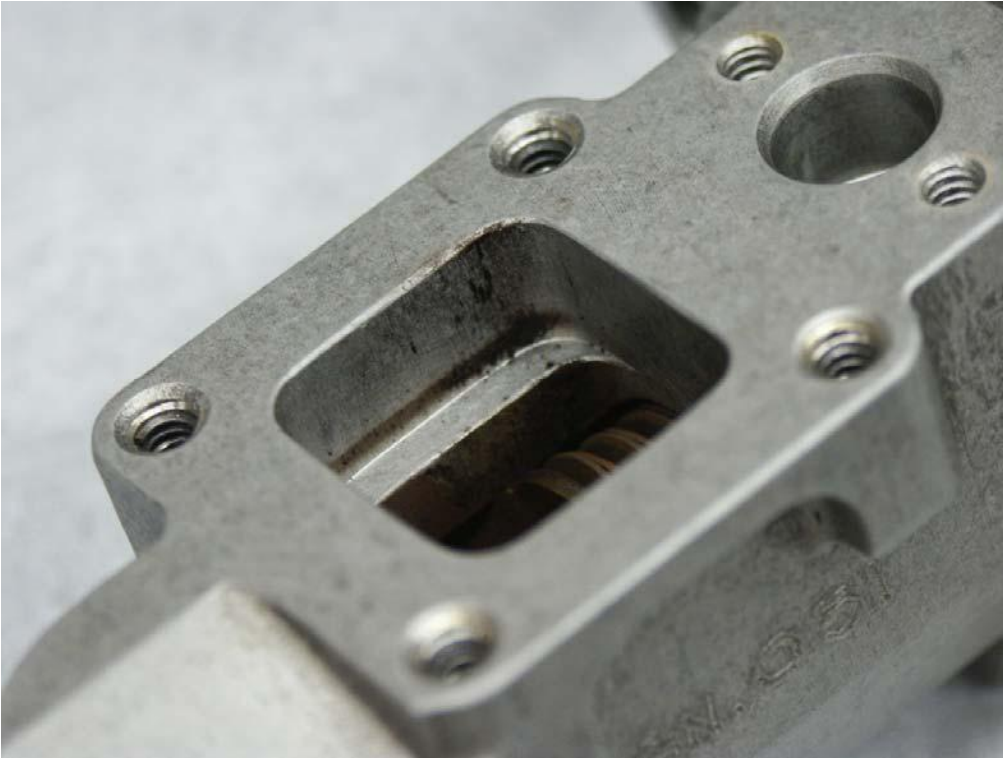
- (i) The manual override access cover was removed for inspection. Brown powdery debris was found lightly coating the bellows stop nut, wave spring, follower and housing. The debris is typical of some normal wear in this area.

**Figure 33 wear debris in bellows MOR cavity**

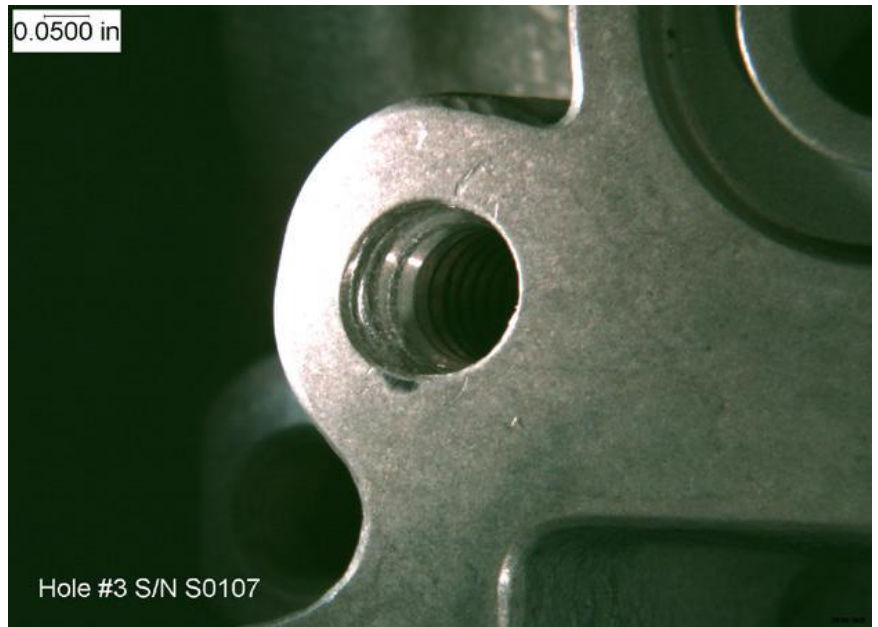
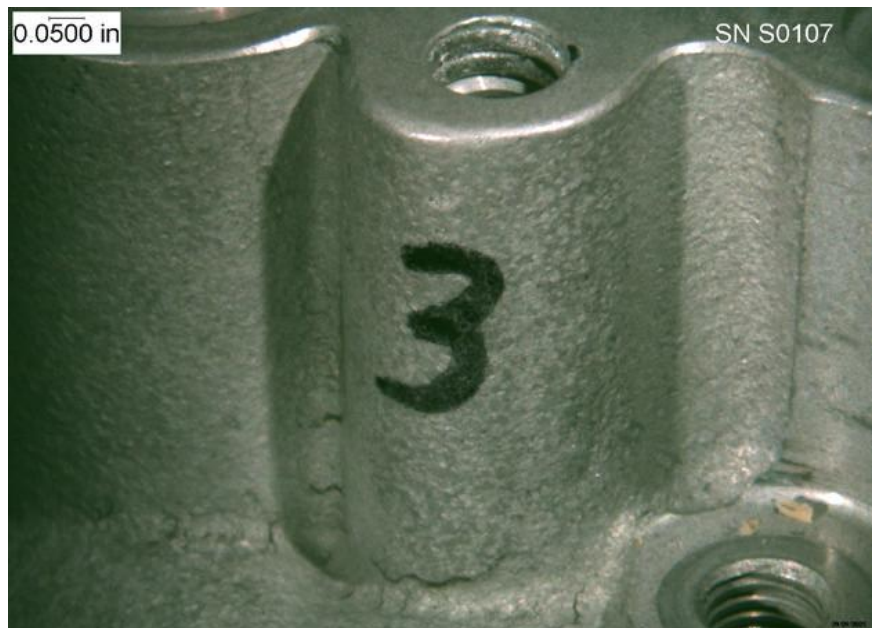
**Figure 6.**

Close up views of bolt hole #3 from which the bolt had been pulled out. Note the damage to the ID threads.

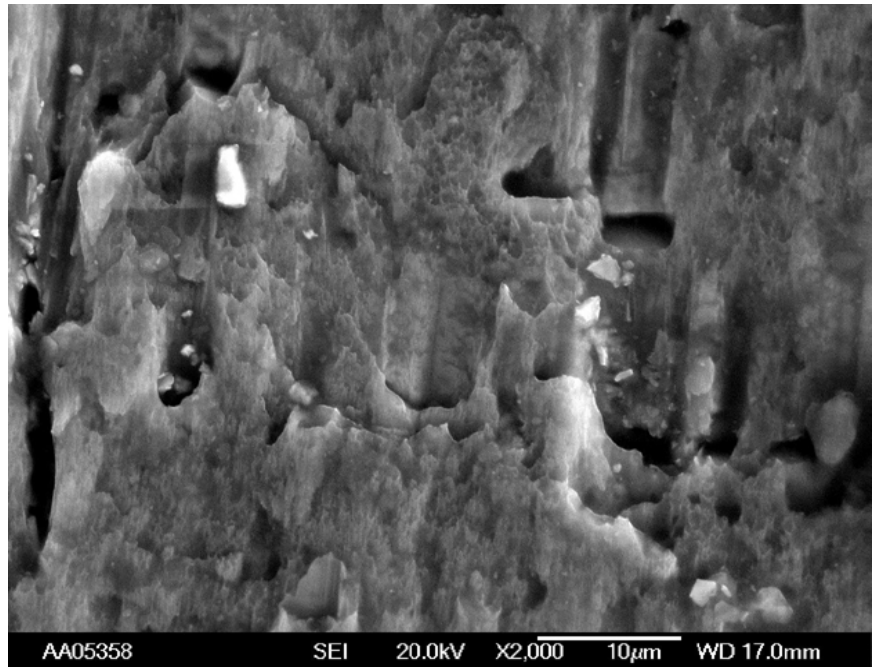
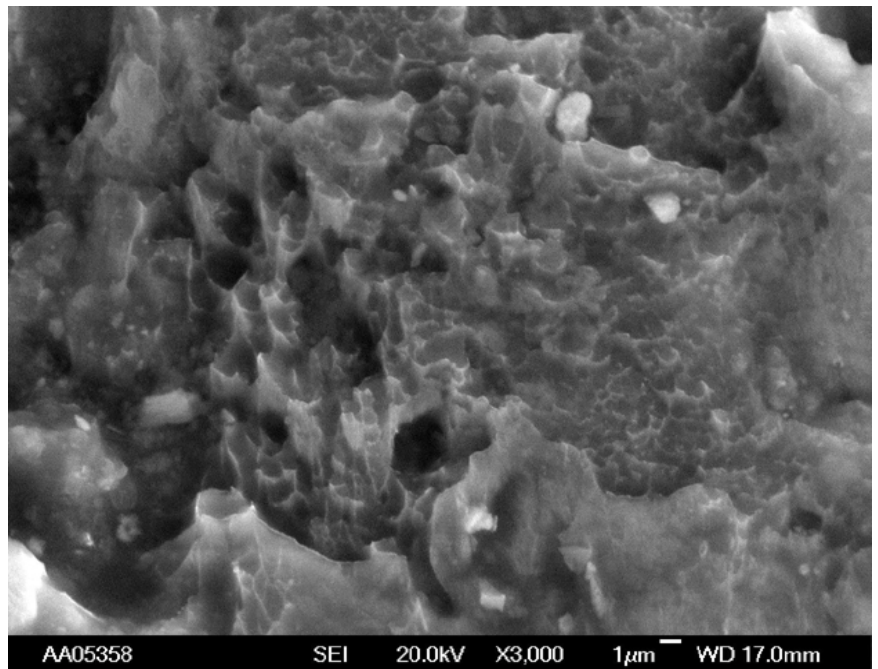
**Figure 11.**

- 1) The pullout of the bolt from the flow body was caused by a shear overload condition. See Figure 11, page 13. The direction of the shearing was along the bolt axis.
- 2) The lack of any fretting wear between the mating surfaces the the drive body and flow body indicated that the two bodies had been tightly clamped together.

SEM photomicrographs of the sheared surfaces of the material between the threads of the bolt that pulled out of hole #3 in the flow body. A shear dimple rupture morphology is evident.

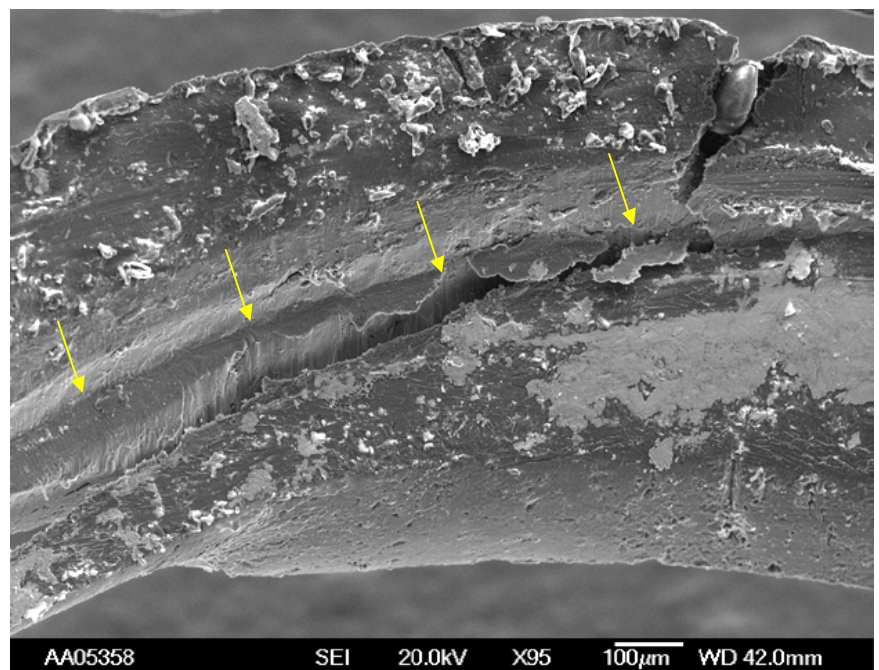
**Figure 16.**

SEM photomicrograph of region "B" of Figure 14. No significant circumferential scoring of the ID thread of the flow body by the bolt thread. Compare with the scoring found on the over torqued bolt test, Figures 18 - 21.

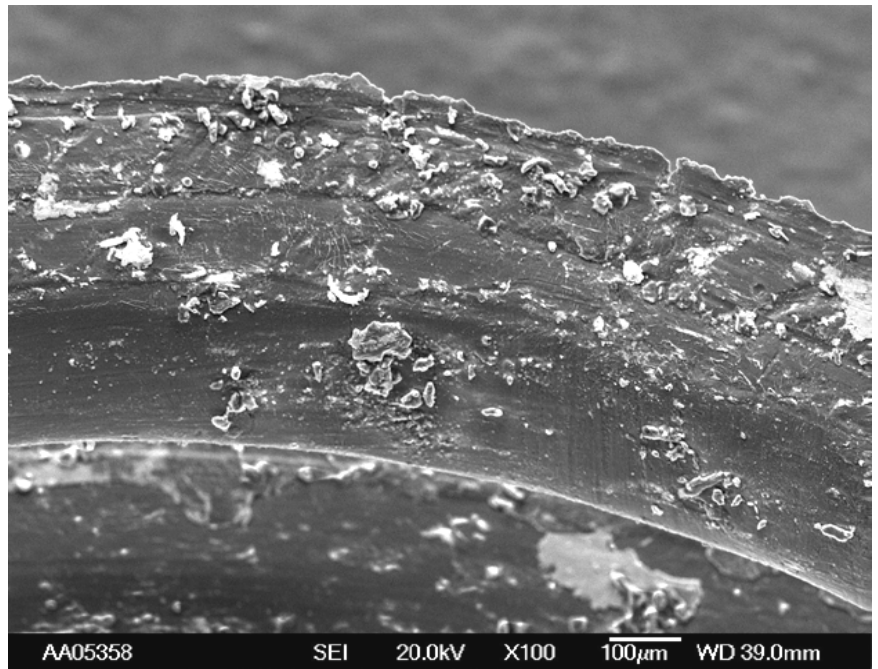
**Figure 17.**

SEM photomicrograph of region "C" of Figure 14. No significant circumferential scoring of the ID thread of the flow body by the bolt thread. Compare with the scoring found on the over torqued bolt test, Figures 18 - 20.

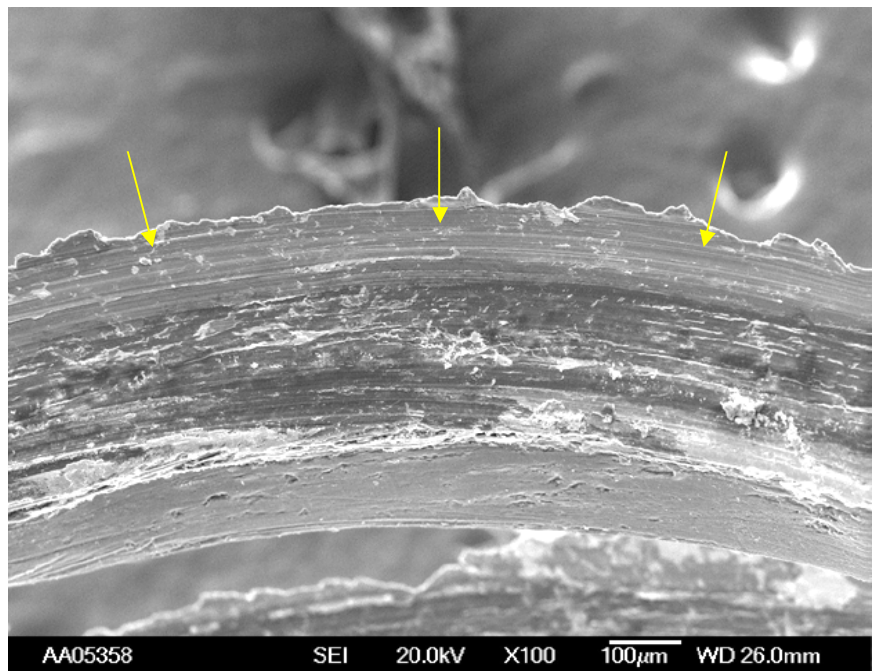
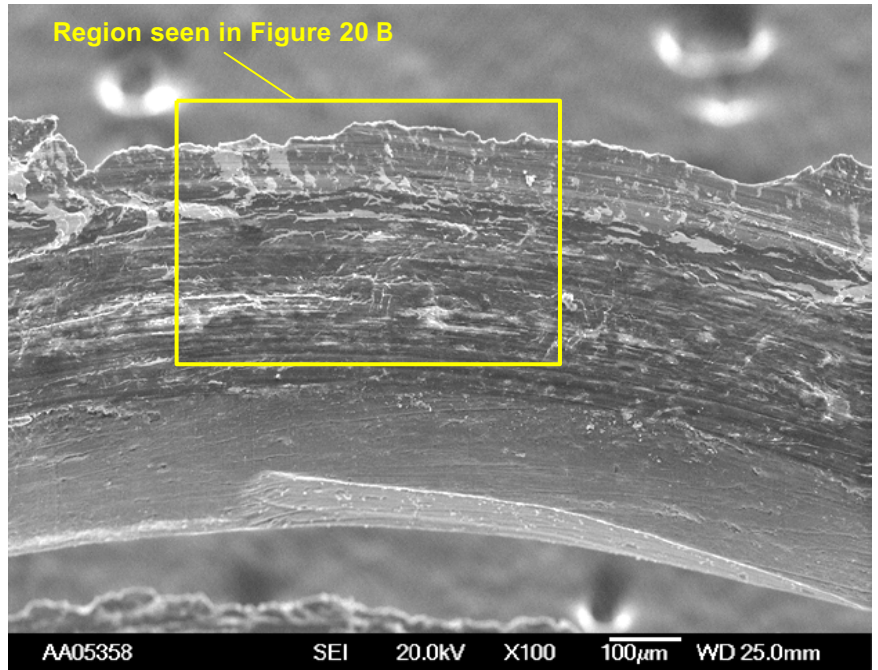
**Figure 20.**

SEM photomicrographs of region "B" of Figure 18. Over torquing of the bolt caused significant circumferential scoring of the ID thread of the flow body (arrows).
