National Transportation Safety Board
Office of Railroad, Pipeline and Hazardous Materials Investigations
Human Performance and Survival Factors Division
Washington, D.C. 20594

HUMAN PERFORMANCE GROUP CHAIRMAN'S FACTUAL REPORT

Location: Red Oak, Iowa
MP 448.3 on #2 track, Creston subdivision on BNSF Nebraska Division
Carrier: BNSF
Trains: BNSF Coal Train 9159 and BNSF MOW equipment train 9470
Date: April 17, 2011
Time: About 6:55 a.m. CDT
Number: DCA-11-FR-002

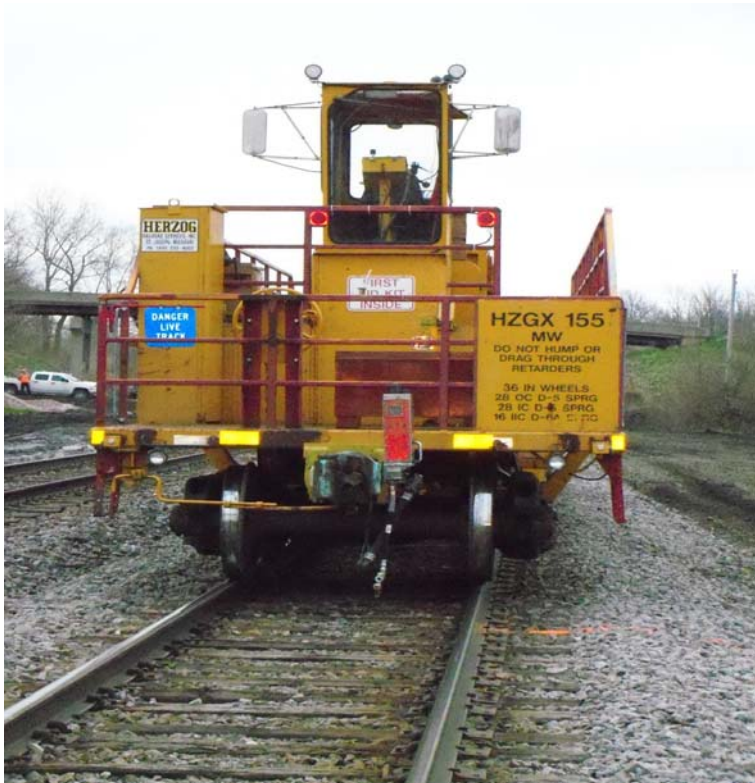
2 E Signal at MP 453.5 (CP 4535) (“Approach” signal displaying yellow):	4,658 feet
2 EA Signal at MP 450.3 (“Restricting” signal displaying red):	3,147 feet
The clip car (positioned at the point of impact):	1,364 feet

Clip car with an end of train (EOT) device (red) and reflectors.
