NATIONAL TRANSPORTATION SAFETY BOARD

Addendum 1 - Human Performance Group Chairman's Factual Report

DCA06MA064

Location: Bluegrass Airport, Lexington, KY
Date: August 27, 2006
Time: 0607 eastern daylight time¹
Operator: Comair Airlines, DBA Delta Connection
Airplane: Bombardier CRJ-100, N431CA

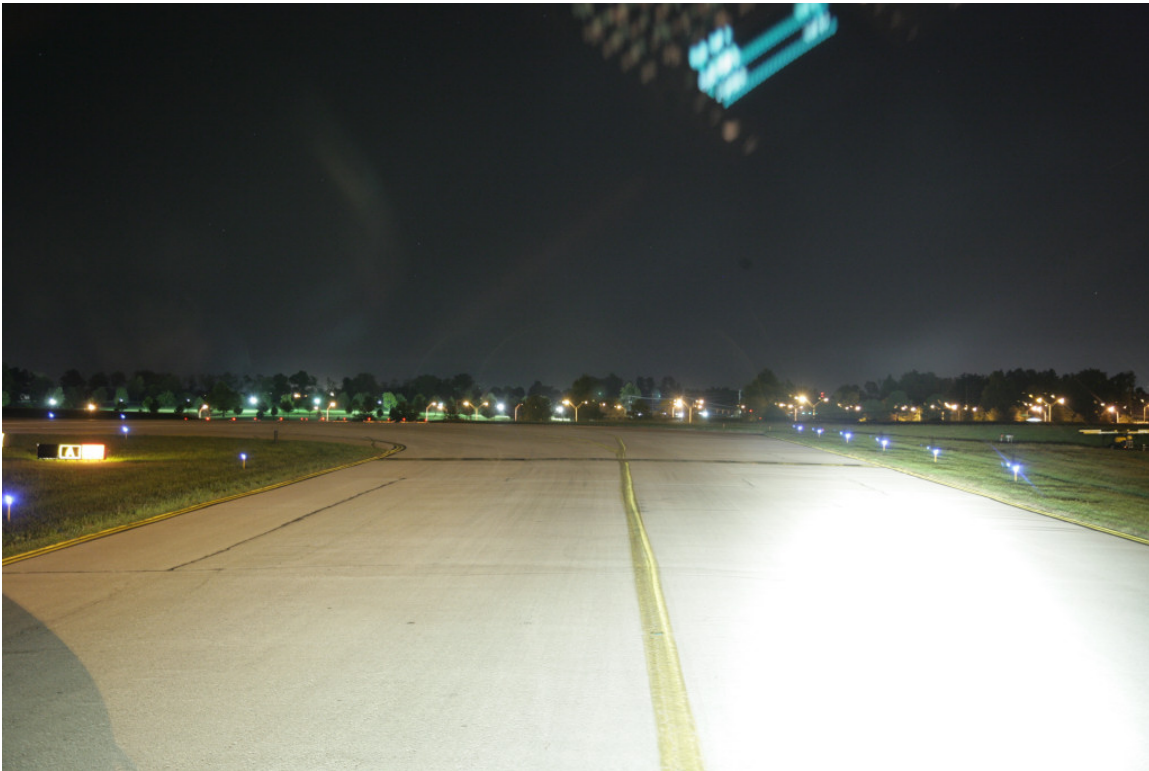
Figure 1. Position 3 - Forward view towards RW 26 hold short line. (Image is overexposed. RW 8-26 sign washed out. Horizon was not visible.)

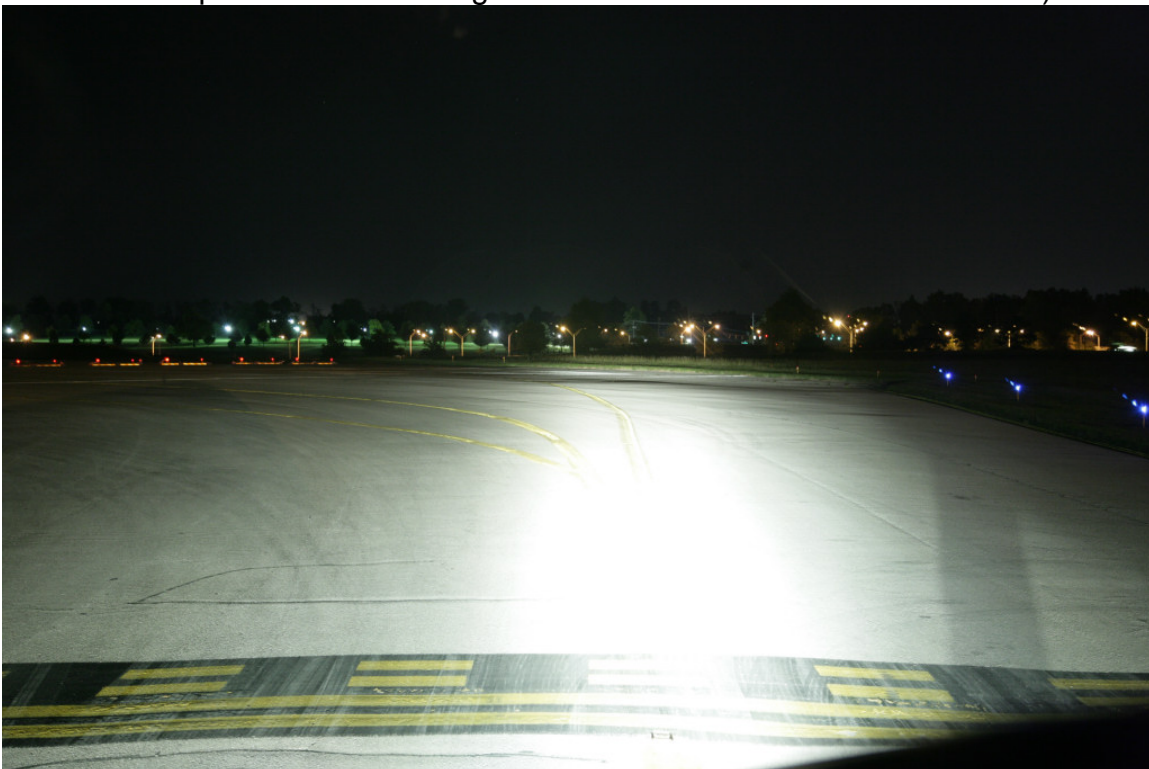
Figure 2. Position 5 – Forward view of RW 26 numbers, taxi lines, and hold short line. (Image is overexposed. Horizon was not visible.)

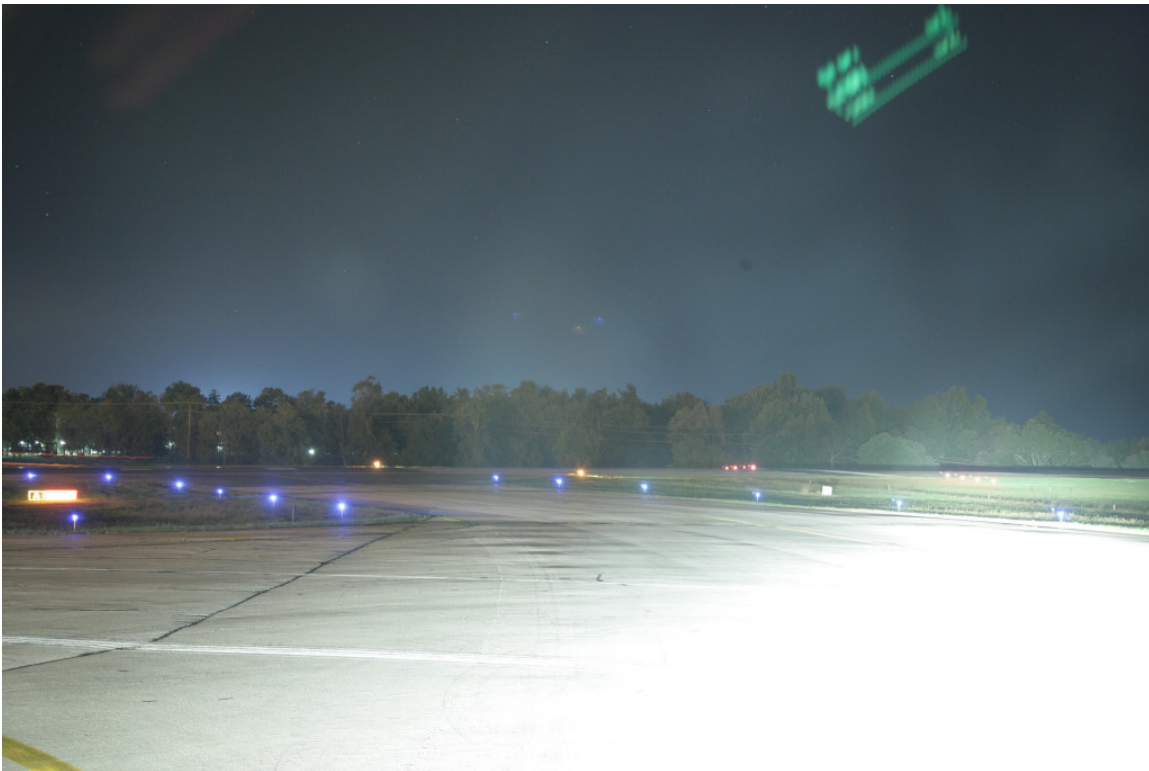
Figure 3. Position 6 – Forward view towards RW 22 hold short. (Image is overexposed. RW 4-22 sign washed out. Horizon was not visible.)

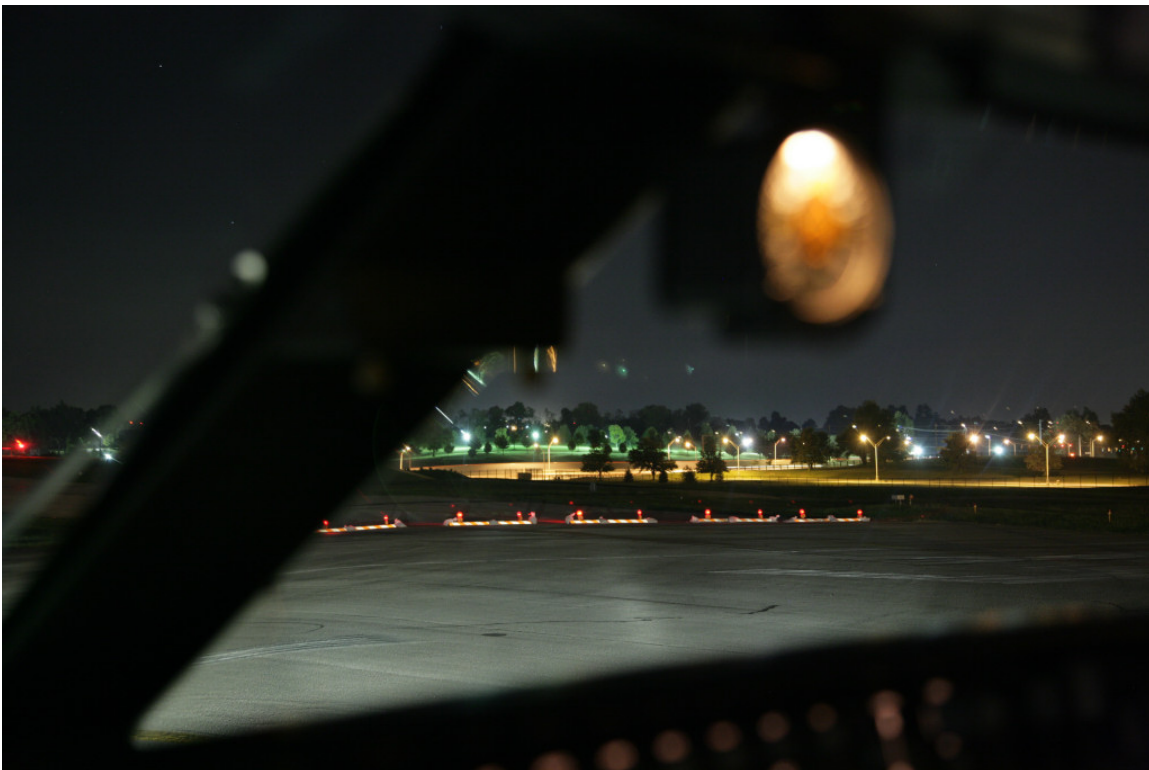
Figure 4. Position 6 – View through right windshield of barricade. (Image is overexposed. Horizon was not visible.)

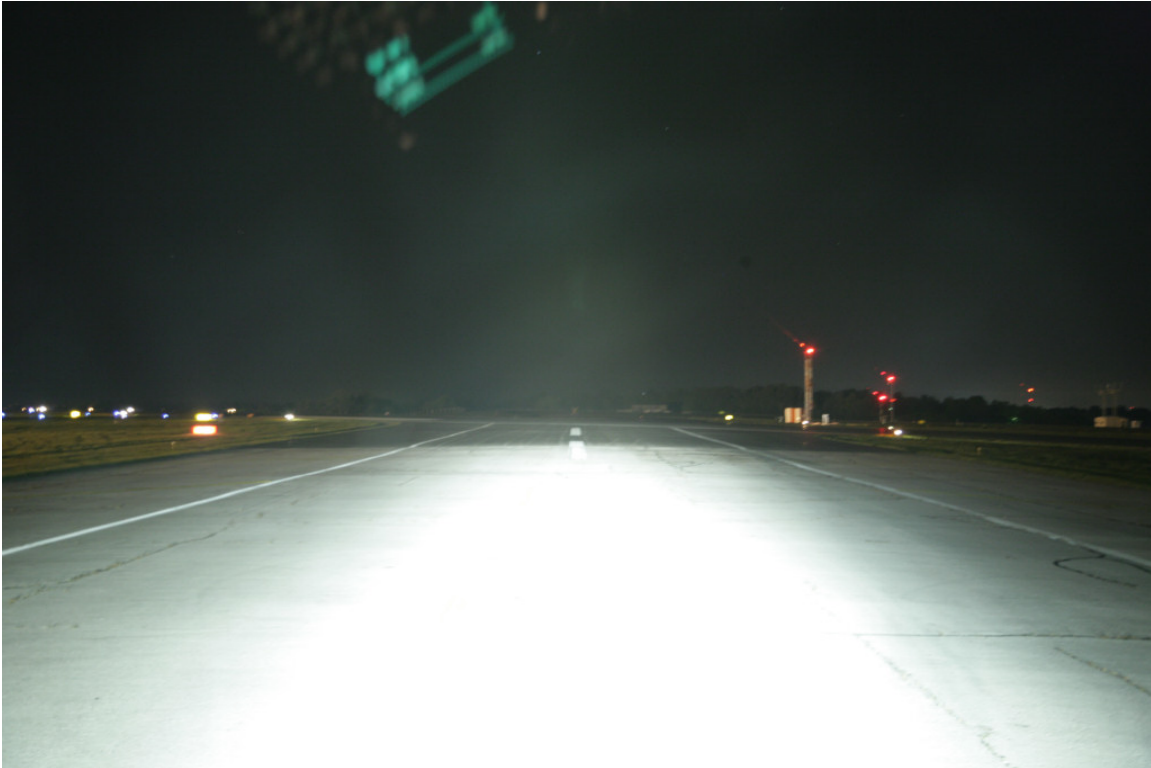
Figure 5. Position 7 – Forward view down RW 26. (Image is overexposed. RW 4-22 sign washed out. Horizon and distant structures were not visible.)

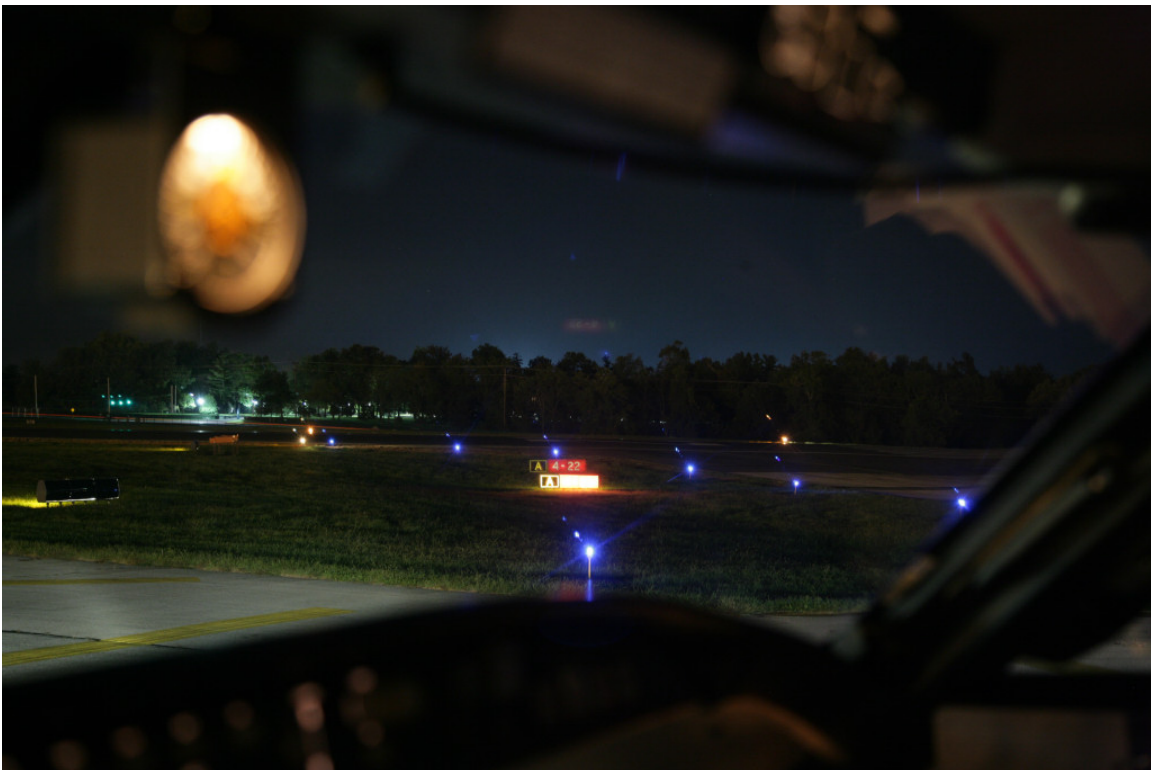
Figure 6. Position 7 – View through right windshield of RW 22 hold short line. (Image is overexposed. Horizon was not visible. RW 4-22 sign washed out and refracted.)

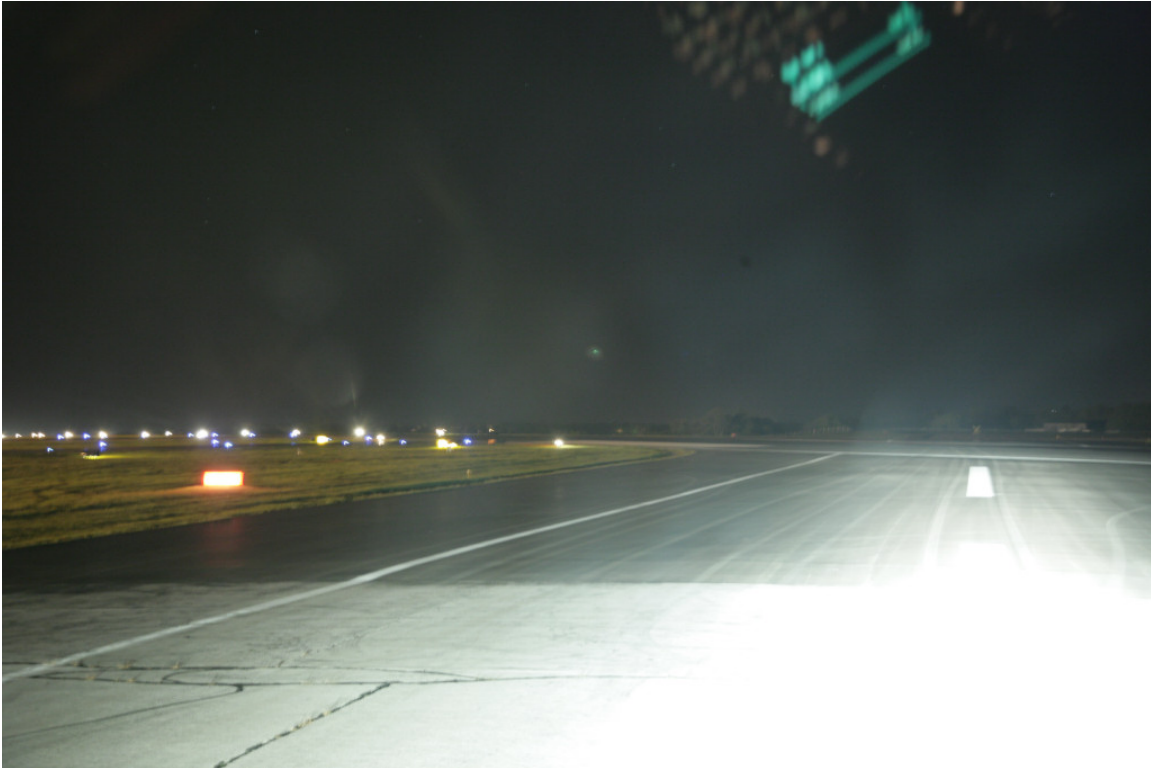
Figure 7. Position 8 – Forward left view down RW26. (Image is overexposed. Runway 4-22 sign washed out. Horizon and end of RW was not visible.)

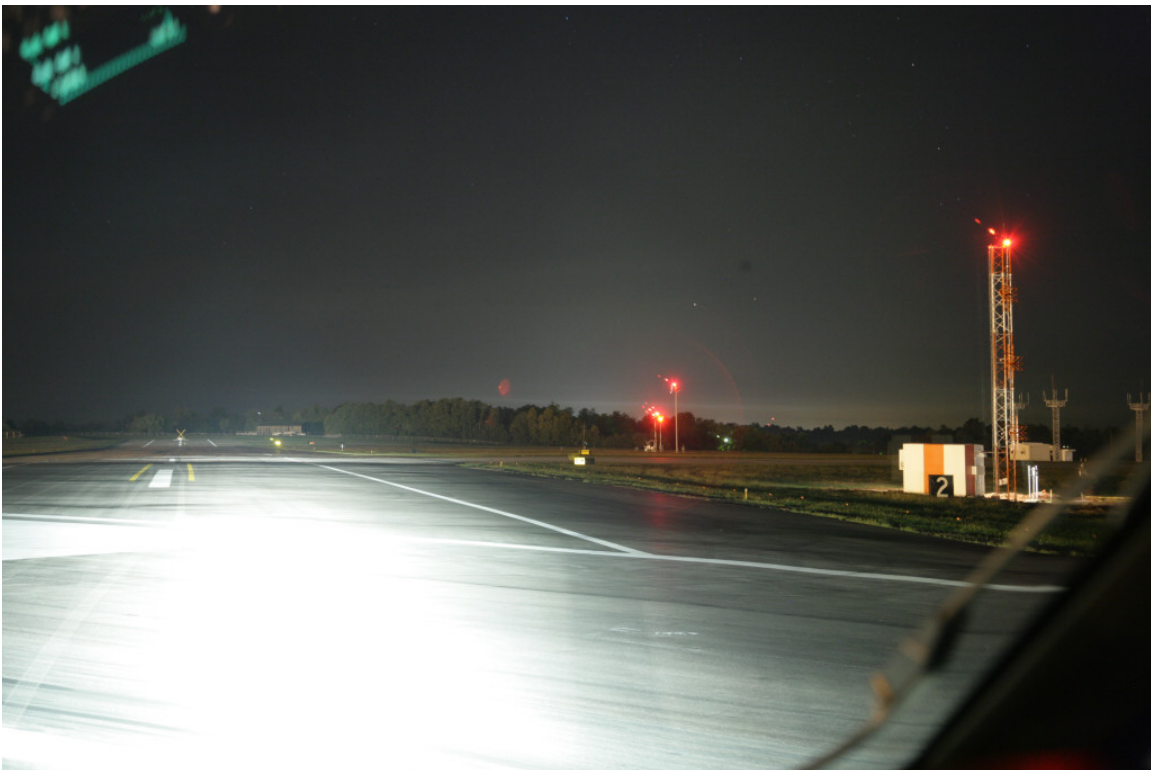
Figure 8. Position 9 – Forward right view down RW26. (Image is overexposed. Horizon, end of RW, RW remaining signs, other structures were not visible.)

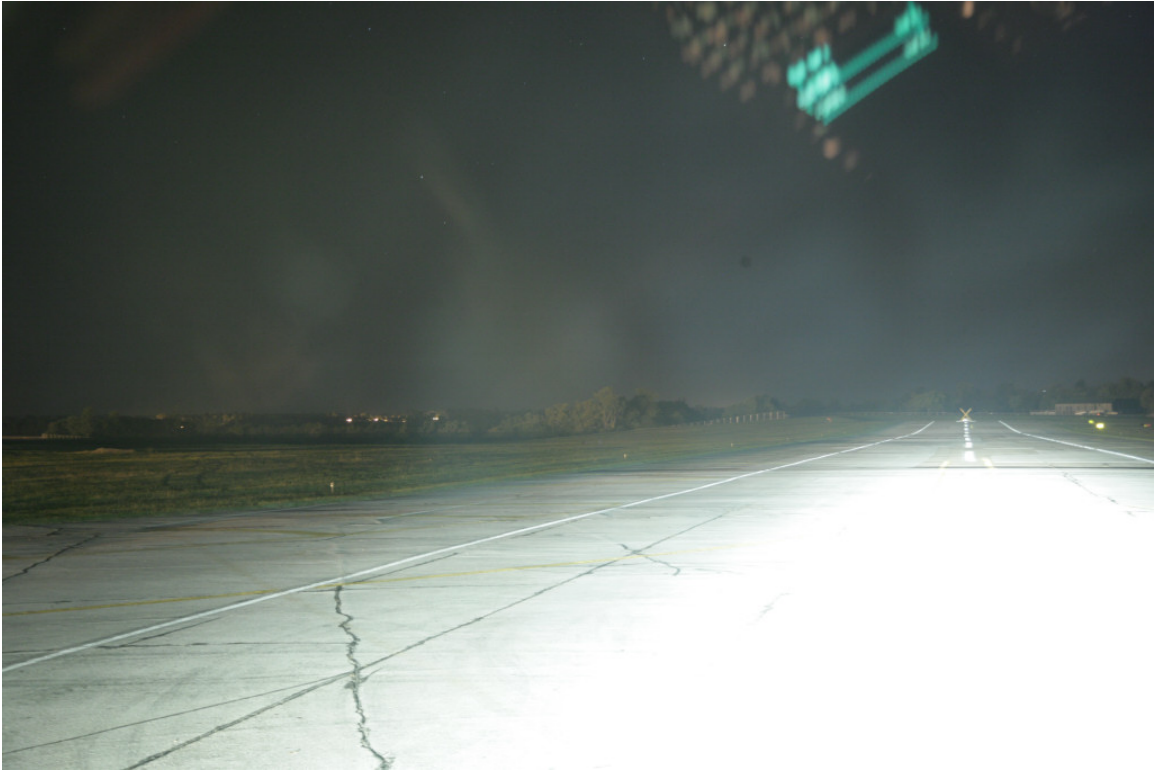
Figure 9. Position 11 – Forward left view down RW26. (Image is overexposed. Horizon, end of RW, RW closed "X", other structures were not visible.)

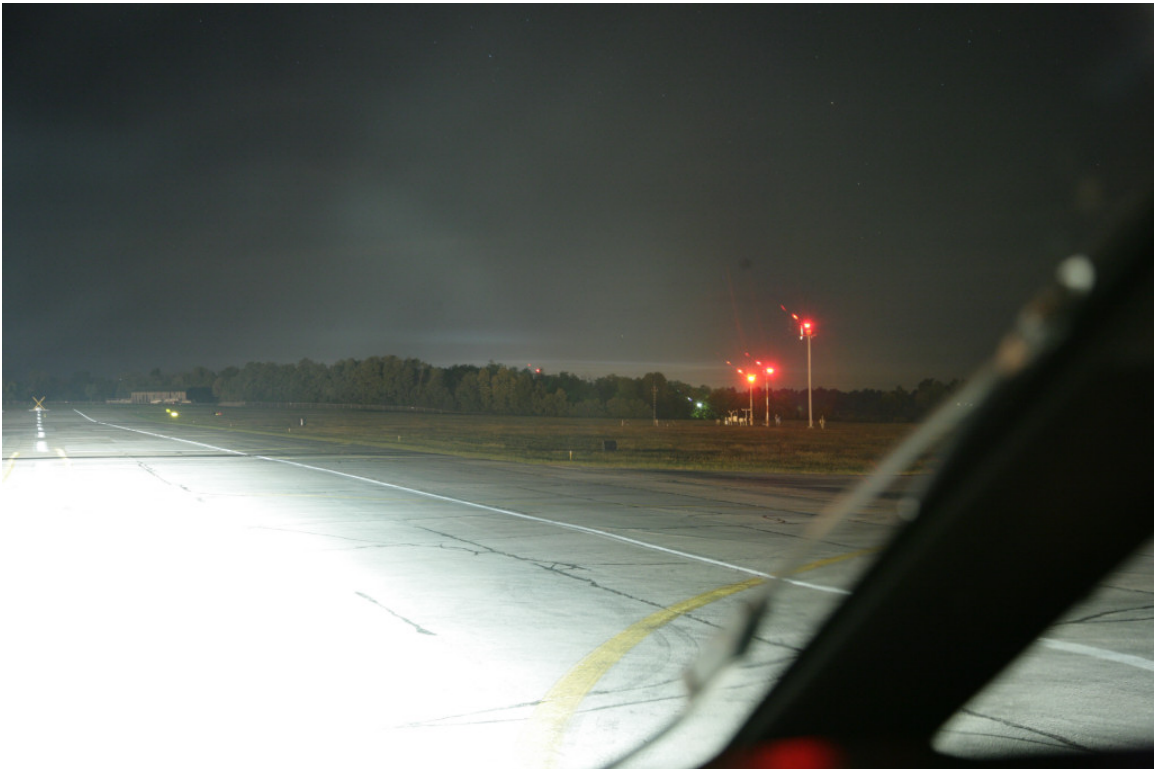
Figure 10. Position 11 – Forward right view down RW26. (Image is overexposed. Horizon, end of RW, RW closed "X", other structures were not visible.)

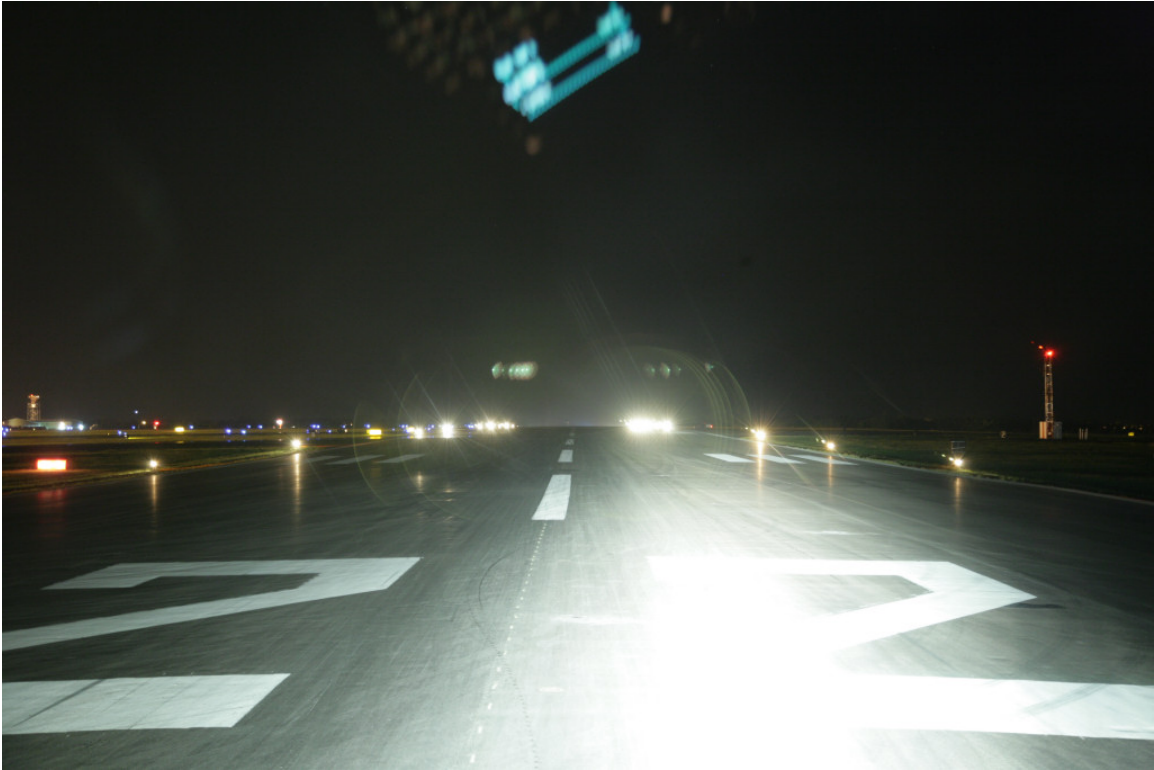
Figure 11. Position 13 – Forward view from the end of RW 22. (Image is overexposed. Horizon, RW 26-8 sign, other structures were not visible.)
