**OBSERVATIONAL STUDY FOR AIR METHODS BK117-B2 ACCIDENT,  
PERRYVILLE, MISSOURI, 7/1/2017**

October 23, 2017

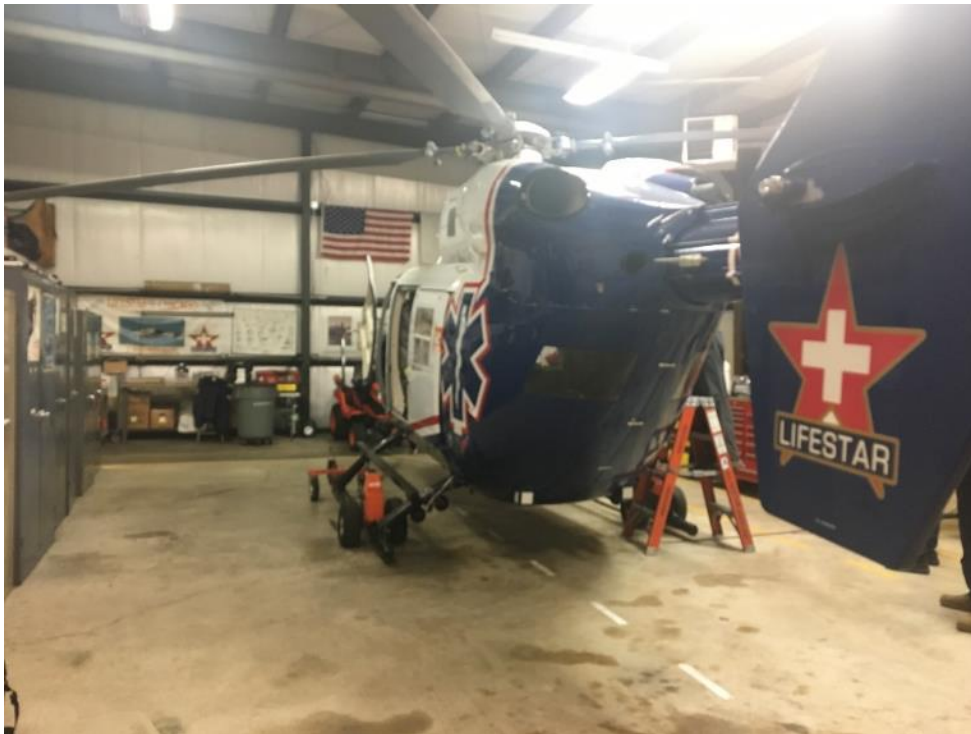
Photo 1. Exemplar BK117-B2.

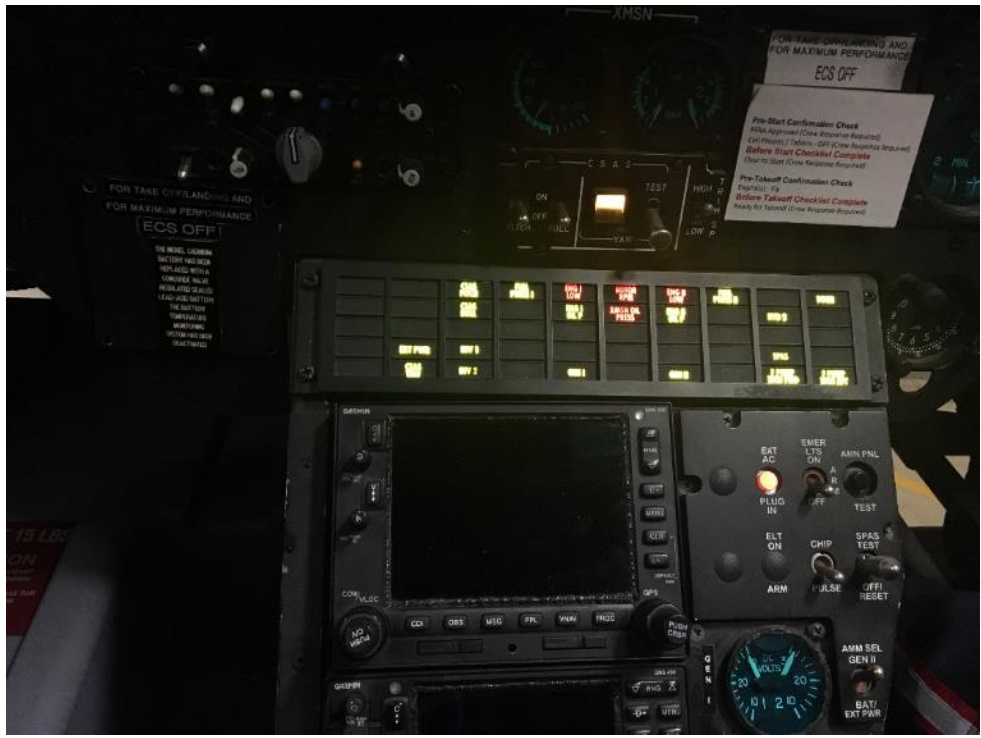
Photo 2. Caution/warning panel; instrument lights set to “OFF”; transfer pumps “OFF”; taken in hangar with hangar lights on.

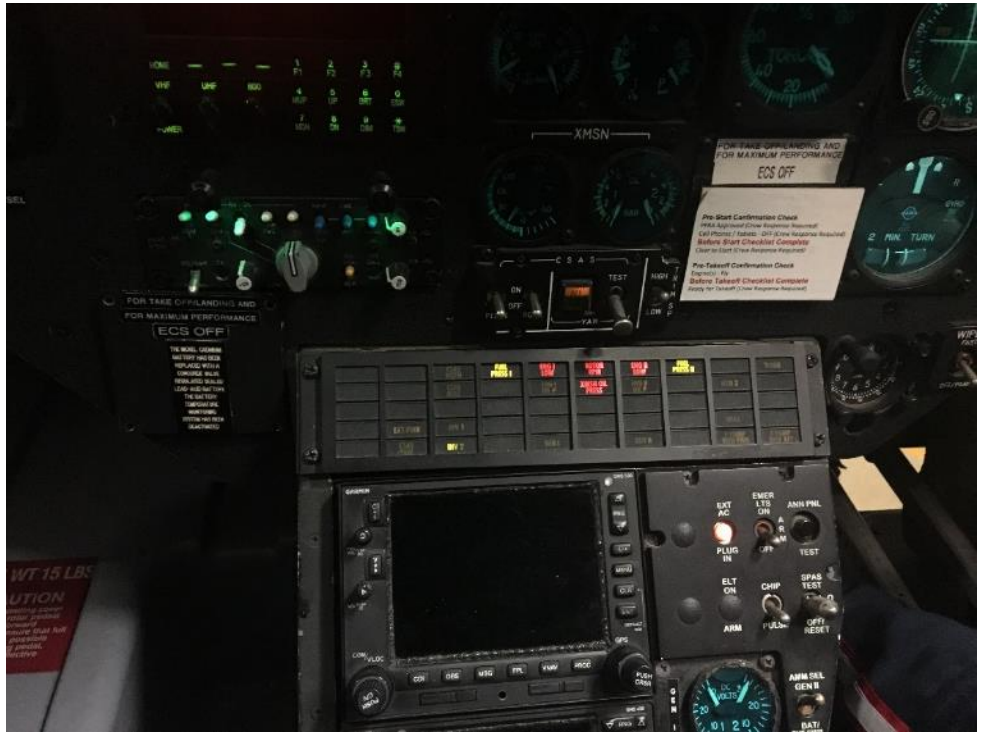
Photo 3. Caution/warning panel; instrument lights set to “BR”; transfer pumps “OFF”; taken in hangar with hangar lights on.

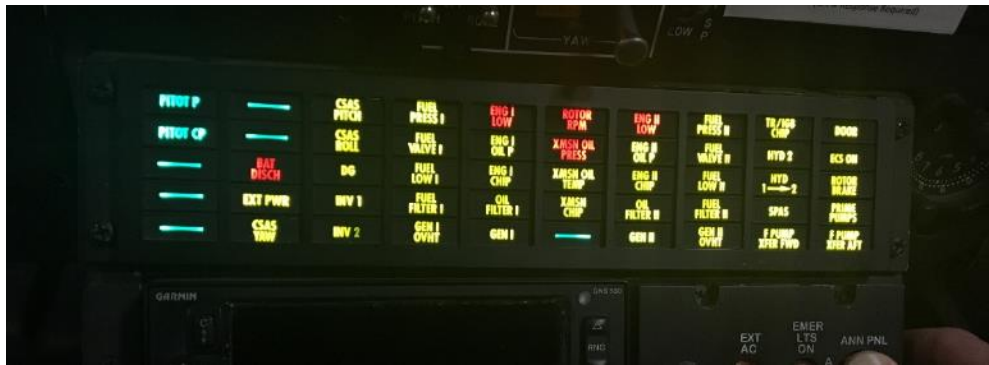
Photo 4. Caution/warning panel; instrument lights set to “OFF”; depressing annunciator panel test switch; taken in hangar with hangar lights off.

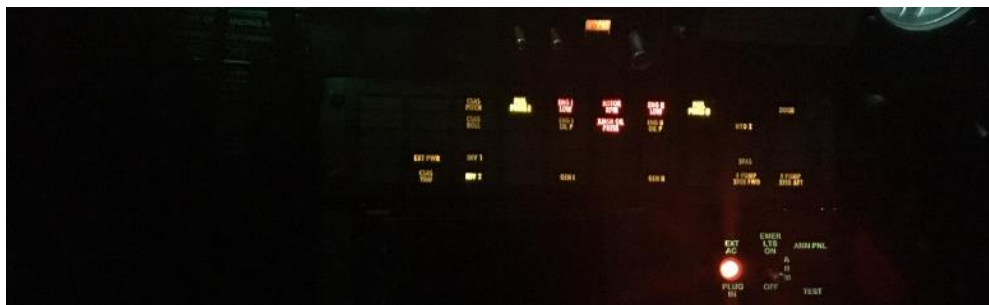
Photo 5. Caution/warning panel; instrument lights set to “BR”; transfer pumps “OFF”; taken in hangar with hangar lights off.

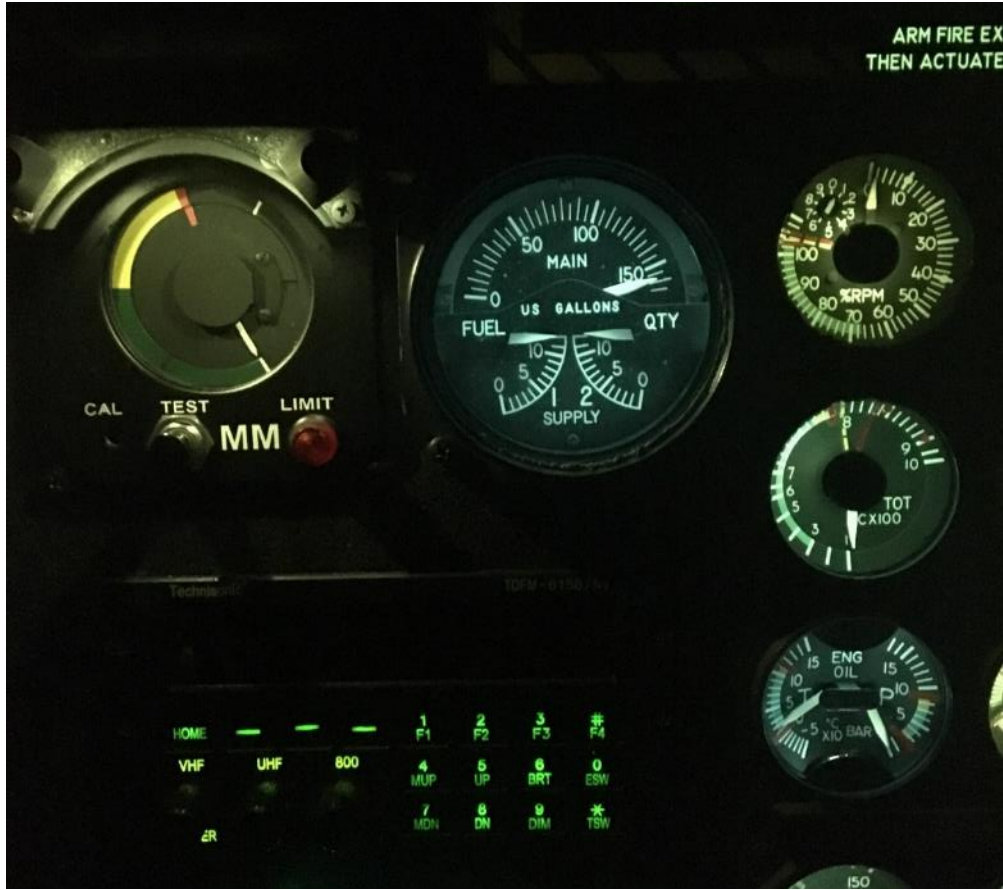
Photo 6: Fuel gauges; instrument lights set to “BR”; taken in hangar with hangar lights off.

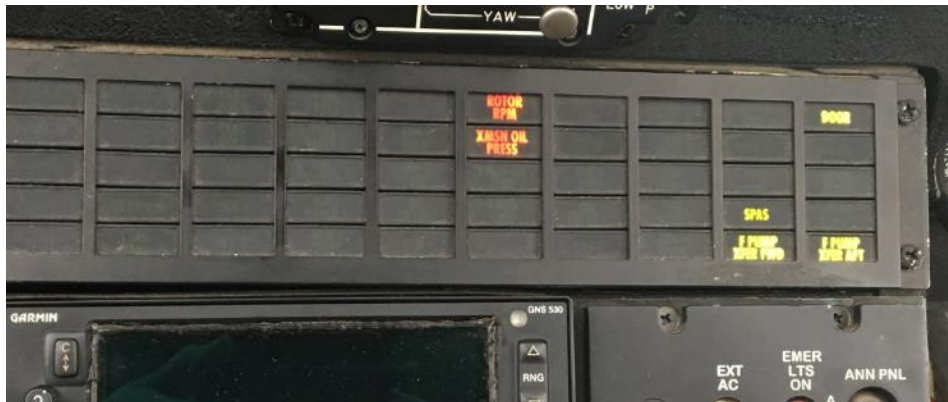
Photo 7: Caution/warning panel; instrument lights set to “Off”; transfer pumps “Off”; taken outside/daylight.

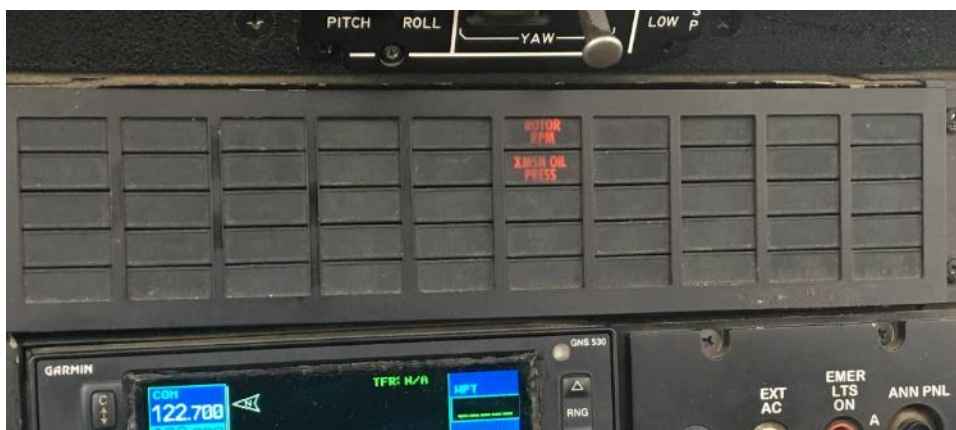
Photo 8: Caution/warning panel; instrument lights set to “BR”; transfer pumps “Off”; taken outside/daylight.

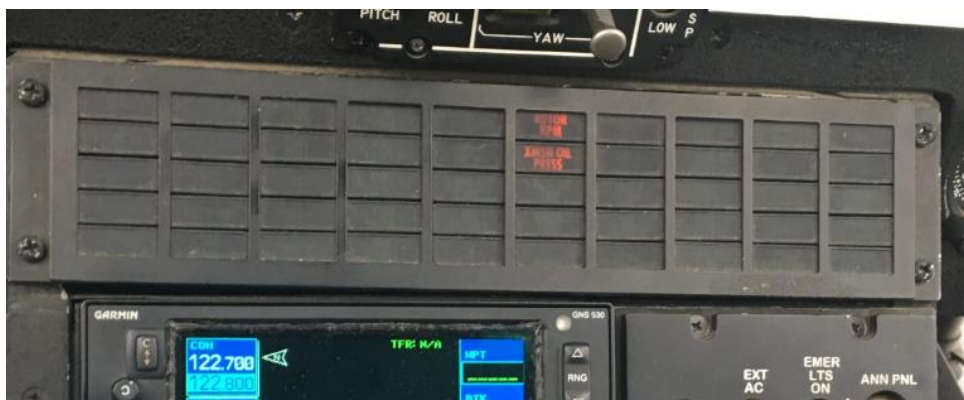
Photo 9: Caution/warning panel; instrument lights set to “BR”; transfer pumps “ON”; taken outside/daylight.

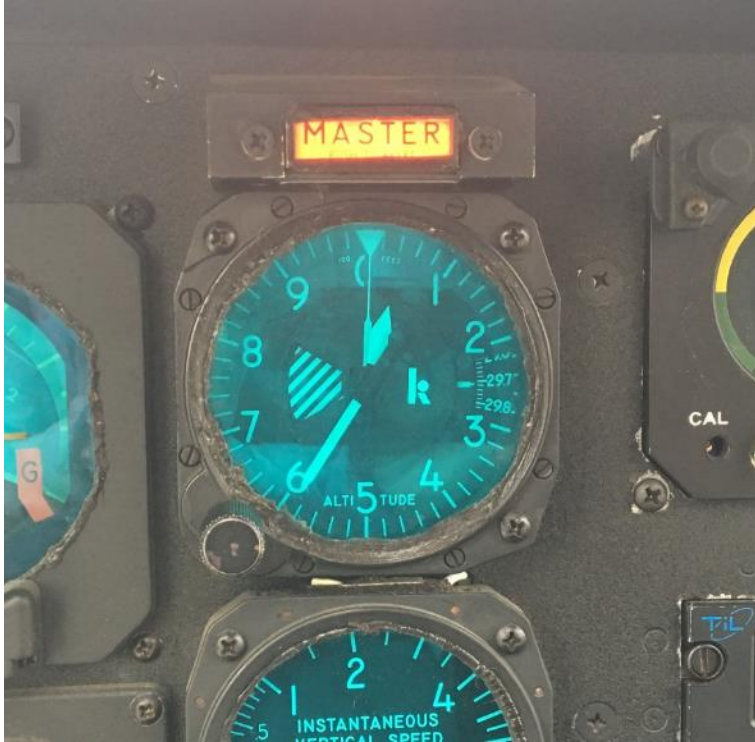
Photo 10: Master warning light; instrument lights set to “OFF”; taken outside/daylight.

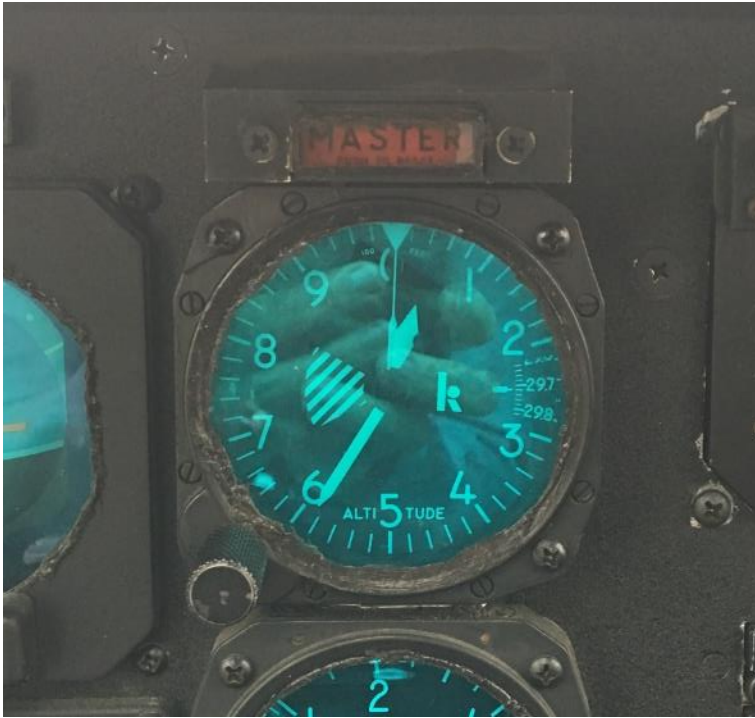
Photo 11: Master warning light; instrument lights set to “BR”; taken outside/daylight.

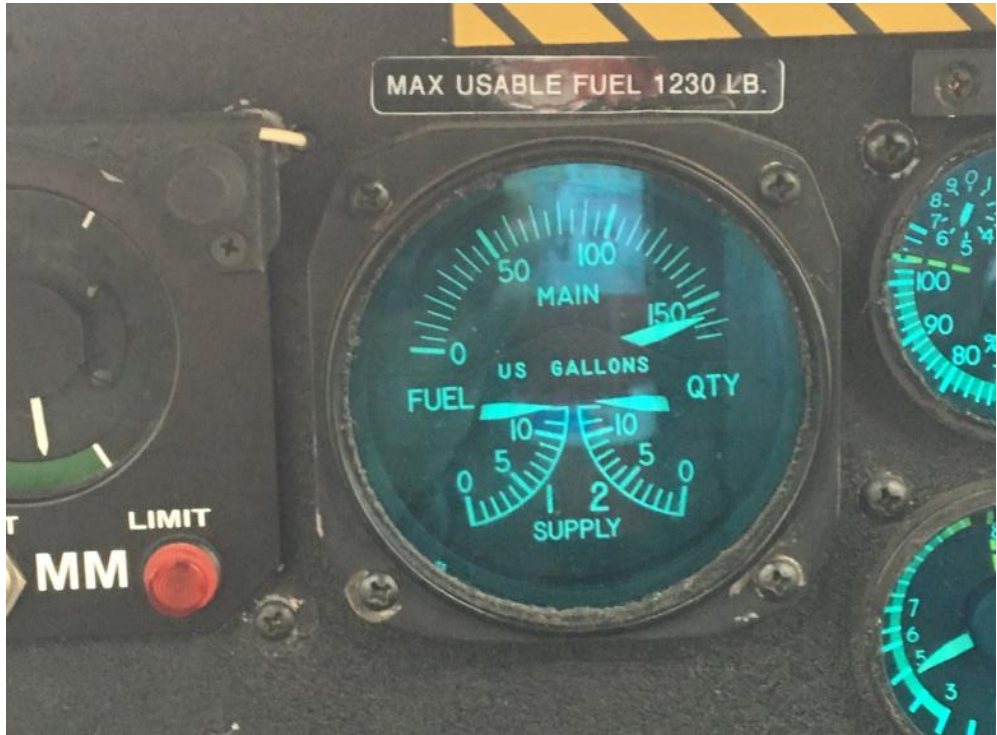
Photo 12. Fuel gauges; instrument lights set to “BR”; taken outside/daylight.

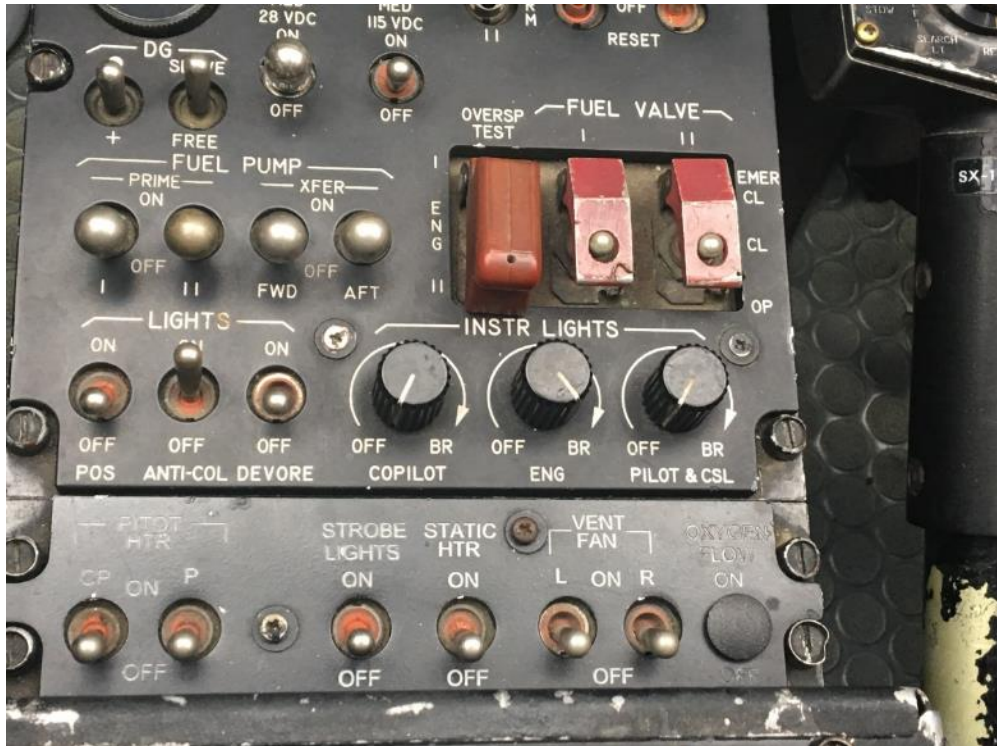
Photo 13: Center console showing location of FUEL PUMP switches and INSTR LIGHTS dials; taken outside/daylight.

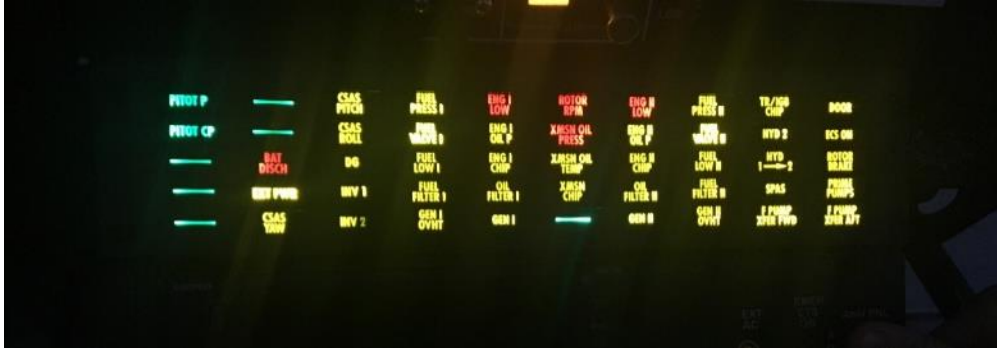
Photo 14: Caution/warning panel; instrument lights set to “OFF”; depressing annunciator panel test switch; taken about 15 minutes after sunset.

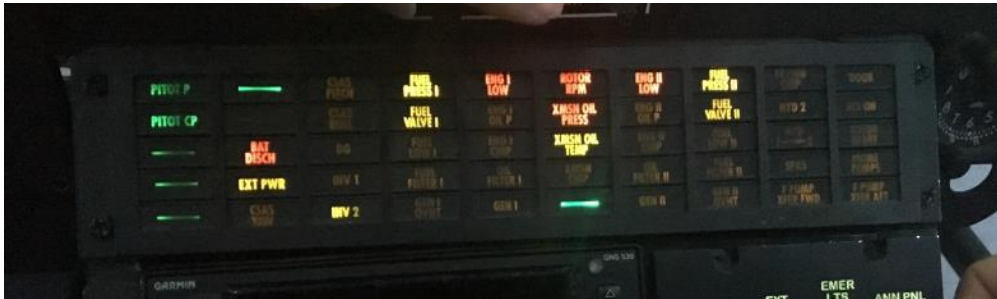
Photo 15: Caution/warning panel; instrument lights set to “BR”; depressing annunciator panel test switch; taken about 15 minutes after sunset.
