#### NATIONAL TRANSPORTATION SAFETY BOARD

#### HUMAN PERFORMANCE FACTUAL REPORT

#### I. ACCIDENT DCA17FA109

Location Charleston, WV
Date May 5, 2017
Time 0651 EDT
Vehicle Shorts SD 3-30

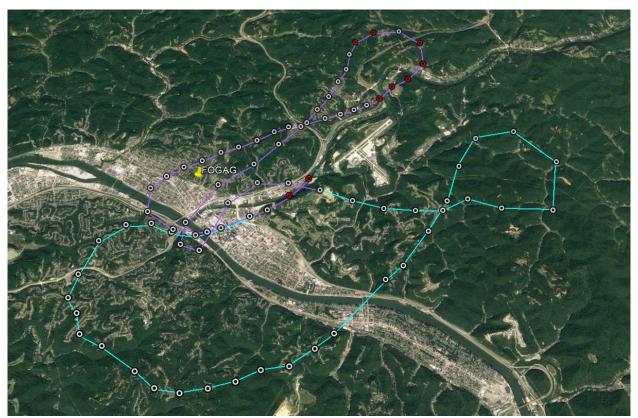
The below graphic shows the initial portion of the flight path in blue, the latter portion of the flight path in purple, and radar altitudes 1700 ft or less as filled red points.

Figure 1. December 30, 2016 flight path departing and arriving CRW.

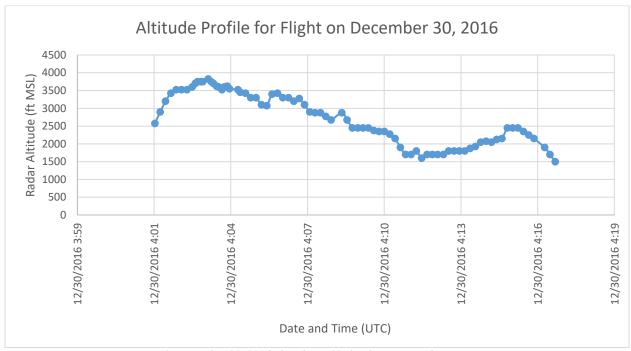
Figure 2. December 30, 2016 altitude profile for departing and arriving CRW.

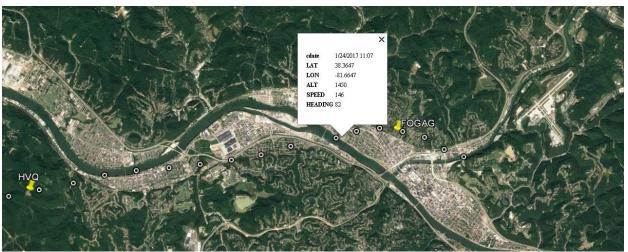
Radar information showed that during this flight radar altitude was 1450 ft MSL approximately 1 mile prior to FOGAG. This altitude was maintained until the aircraft was lined up with runway 5 and radar coverage was lost.

Figure 3. Radar location of flight on January 24, 2017 at 1450 ft msl.

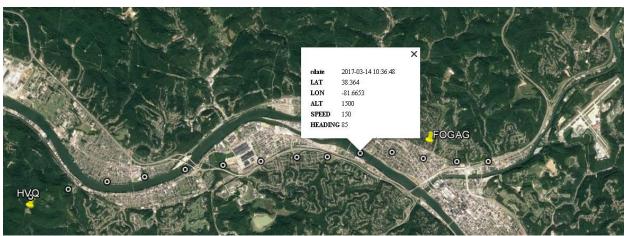
Radar information showed that during this flight, radar altitude showed 1,500 ft MSL approximately one mile prior to FOGAG. About 0.5 miles prior to FOGAG, radar altitude showed 1,600 ft MSL. About FOGAG, radar altitude showed 1,400 ft MSL. The aircraft descended to a radar altitude of 1300 before radar coverage was lost.

Figure 4 Radar location of flight on March 14, 2017 at 1500 ft msl.

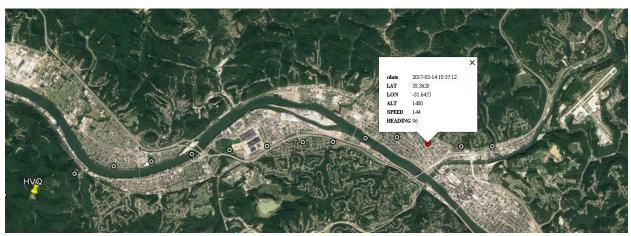
Figure 5 Radar location of flight on March 14, 2017 at 1450 ft msl.

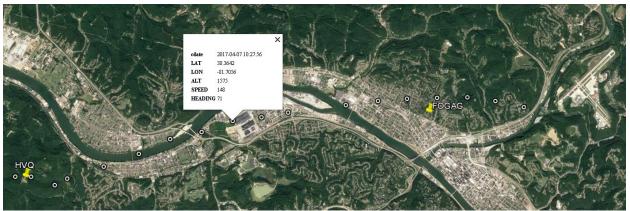
Radar information showed that during this flight, radar altitude was 1,575 ft MSL, about 3 miles prior to FOGAG. Radar altitude dropped to 1,475 ft MSL about 2 miles prior to FOGAG. The radar altitude was 1,575 about one mile prior to FOGAG and altitude crossing FOGAG was 1,600 ft MSL.

Figure 6. Radar location of flight on April 7, 2017 at 1575 ft msl.

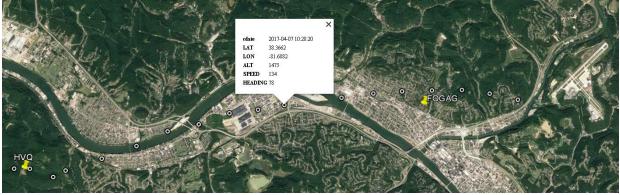
Figure 7 Radar location of flight on April 7, 2017 at 1475 ft msl.

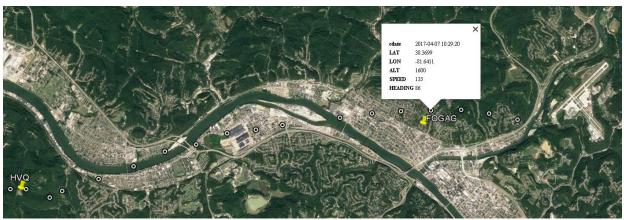
Figure 8. Radar location of flight on April 7, 2017 at 1600 ft msl.
