**NATIONAL TRANSPORTATION SAFETY BOARD  
OFFICE OF HIGHWAY SAFETY  
WASHINGTON, D.C.**

**HUMAN PERFORMANCE GROUP CHAIRMAN'S  
FACTUAL REPORT**

Vehicle: 2017 Volvo XC90, being operated by Uber Advanced Technologies Group (ATG) in autonomous mode

NTSB #: **HWY18MH010**

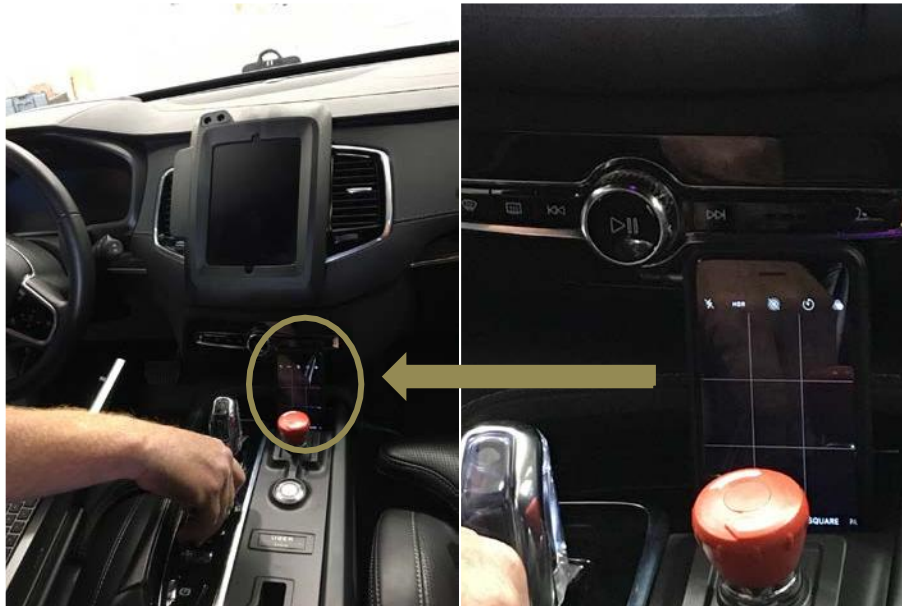
Figure 1. The interior of the accident vehicle, with an exemplar cell phone placed in a slot under the Uber-mounted tablet computer.

From the time the VO exited the parking lot to the time of the crash, the VO frequently glanced down towards the lower center console area. The Tempe Police tabulated the number of glances the VO made towards the lower center console area during a 27-minute window, from 9:31 p.m. to 9:58 p.m. During this timeframe, the VO glanced down at the same spot 204 times, of which 166 instances were when the vehicle was in motion. The Tempe Police estimated that the vehicle was in motion for 21 minutes, 48 seconds, and of that time, the VO's eyes were averted from the roadway was 6 minutes, 47.2 seconds, or approximately 32% of the time.

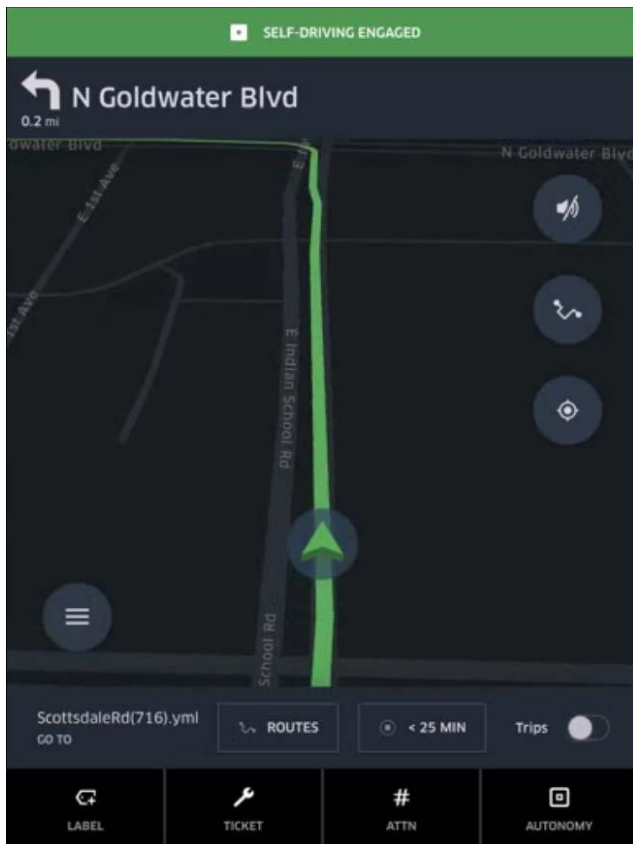
Figure 2 is a screenshot of the FSCA during the crash trip. When the SDS is engaged, as it is in Figure 2, the FSCA showed the route of the SDV in green and “Self-Driving Engaged” appeared on the top of the screen. It shows the selectable icons at the bottom of the FSCA screen. If a VO noticed a specific object of interest to the software developers (e.g., stopped school bus, emergency vehicle, an individual directing traffic) the VO would tap the “Label” icon at the bottom-left of the screen to tag the location and time the object was encountered. If an equipment issue occurred in the SDV, such as a malfunctioning dashcam, the VO would tap the “Ticket” icon at the bottom-center of the screen. If the SDV was involved in an incident or infraction, the VO would tap the “Attn” icon at the bottom-center of the screen. Finally, if the SDS incorrectly reacted to an event that should be within the scope of its capabilities but does not cause a hazardous situation, the VO would select the “Autonomy” icon on the bottom-right of the screen. If a vehicle or system issue occurs, operators were instructed to tag the issue, then either pull over or complete their mission before troubleshooting.

Figure 2. Screen capture of FSCA from the crash SDV. The screen is in night mode. The sound is off, and the map shows turn-by-turn directions. The four options at the bottom of the screen are tapped by the VO during specific situations to tag an event.

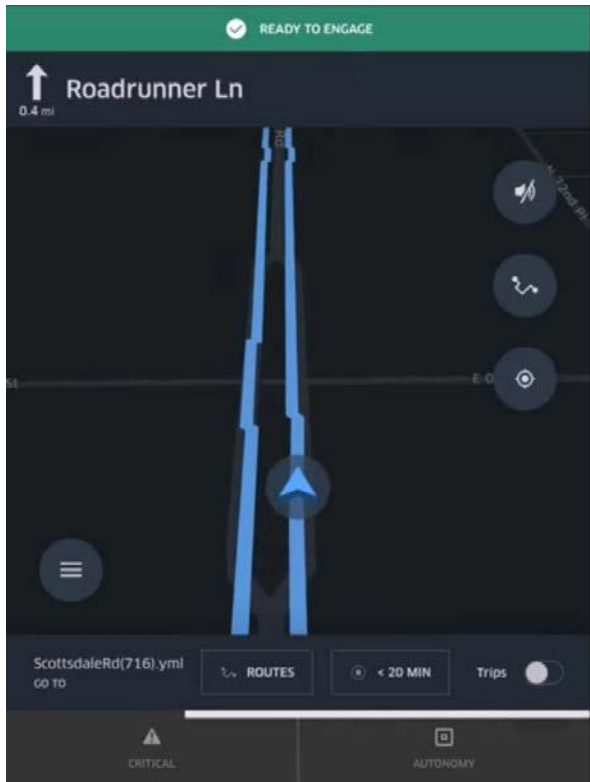
In the event the VO must take control of the SDV from the SDS, or if the SDS self-disengaged after encountering a novel situation, the route color is changed to blue and “Ready To Engage” appears at the top of the screen (Figure 3). The four default icons at the bottom of the screen are replaced for 10 seconds by icons labeled “Critical” and “Autonomy.” The “Critical” icon would be selected if the VO had to take control of the SDV due to a potentially hazardous action by the SDS, an incident, or a policy infraction. “Autonomy” would be selected in this case if the SDS performs an incorrect but not immediately hazardous maneuver. The result of selecting this “Autonomy” icon was identical to selecting the “Autonomy” icon at the bottom of the FSCA when the SDS was engaged. After 10 seconds, the default icons reappear, regardless of whether the SDS is reengaged or not.

Figure 3. Screen capture of FSCA after the SDS disengaged, about 20 minutes prior to the crash. The screen is on night mode and shows a change in the options selectable by the VO. The sound is off and the map shows turn-by-turn directions.

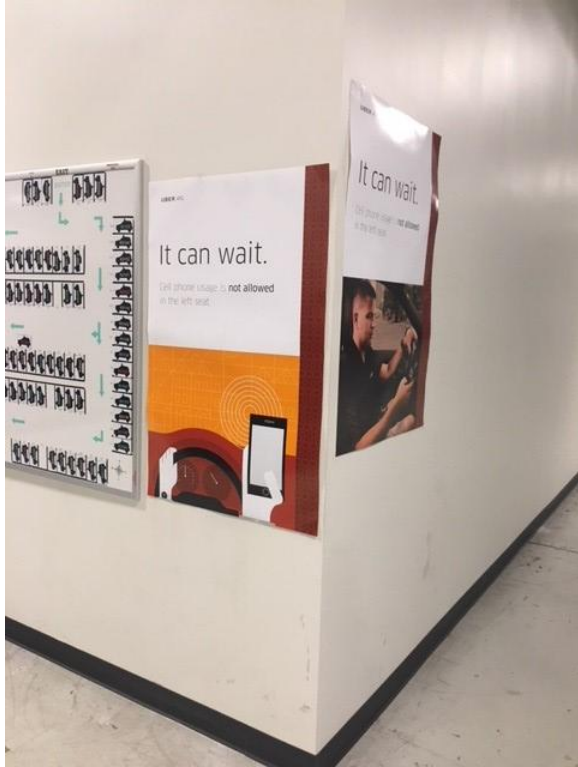
Uber ATG had a policy in place that prohibited phone usage while operating an SDV.<sup>19</sup> VOs were familiarized with the policy during orientation training, the policy was available for viewing online, and there were posters in place in the Tempe facility reminding VOs about the prohibition (see Figure 2). Uber ATG relied on each VO to report on themselves and on other VOs who violate the policy. When Uber ATG received a report, managers reviewed the video recordings to verify that the violation occurred, then meted out the penalty based on the circumstances of the violation. Uber ATG managers also had the option to perform spot checks on VOs by reviewing archival video recordings. According to data supplied to the NTSB by Uber

Figure 4. Posters in the vehicle bay of Uber ATG’s Tempe facility reminding vehicle operators not to use a cell phone while operating an SDV.
